COMPOSITE MATERIAL FIRE FIGHTING

**Presented to: International Aircraft Materials Fire Test Working
Group
Renton, Washington, USA**

**Presented By: John C. Hode
SRA International**

Date: Wednesday, March 3, 2009

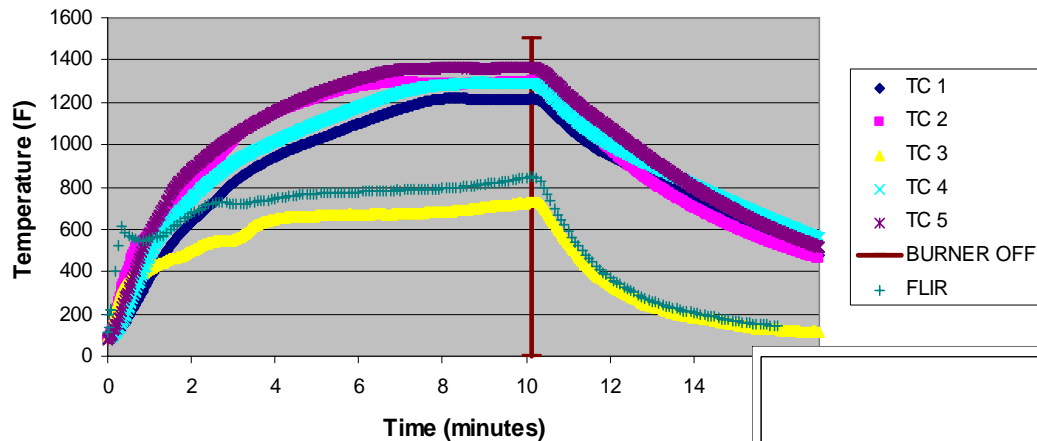
Air Force Composite Fire Test 14

- **Exposures less than 10 minutes had maximum temperatures around 700°F (374°C) on average, and occurred *after* burner removal.**
- **10 minutes exposures reached an average of 822°F (442°C), normally *prior* to burner removal.**
- **Maximum temperatures always achieved just before or just after burner removed.**

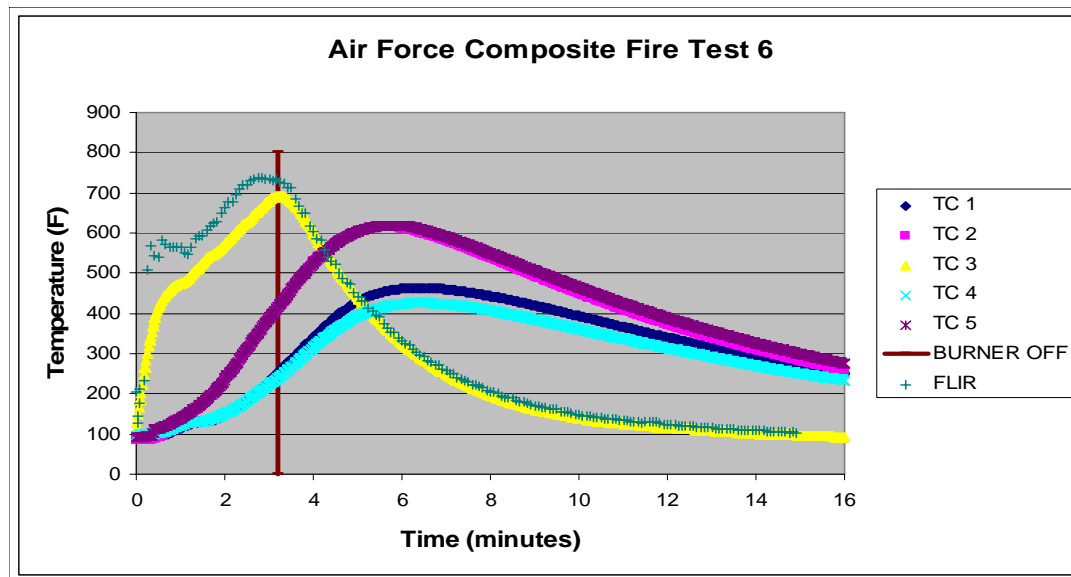
- Initial thermocouple placement caused hidden corner temperatures to be shielded during exposure, then continue to heat up after burner removal, reaching peak temperatures minutes later.

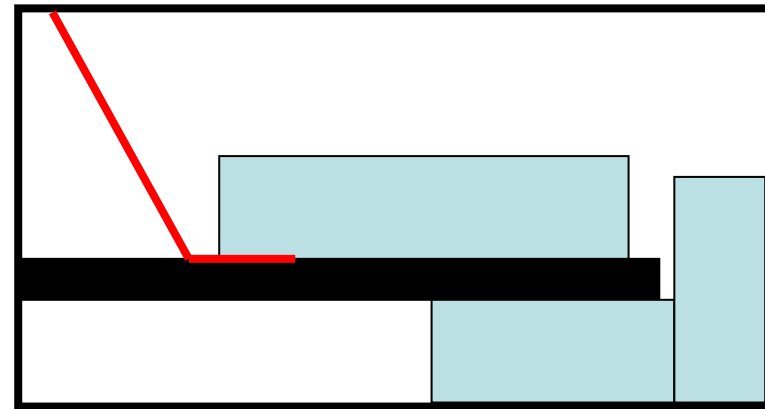
Revised thermocouple placement

- Thermocouples moved

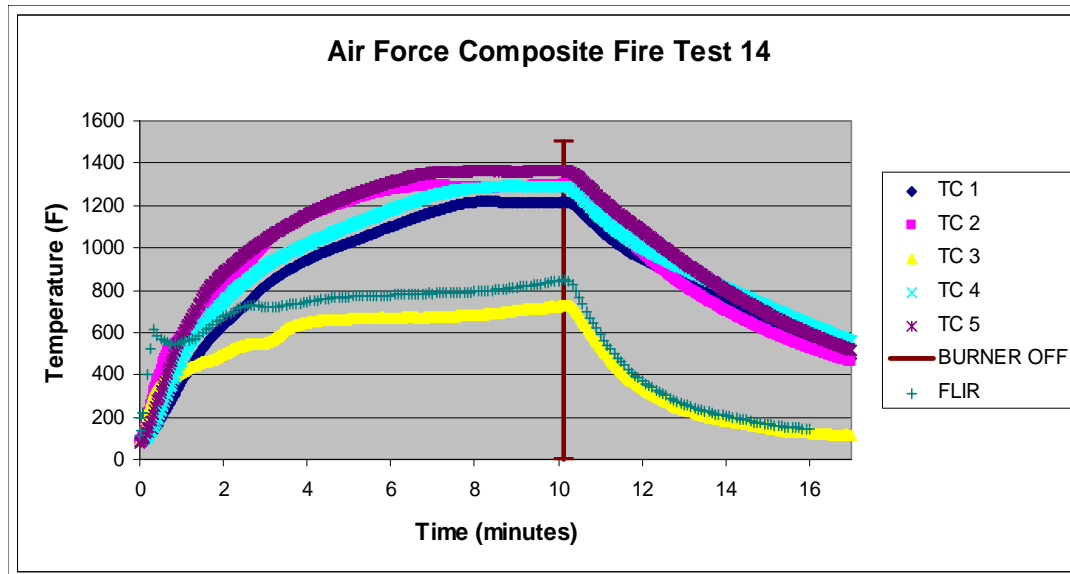
- Revised thermocouple position simulates aircraft skin with insulation backing
- Tracings no longer showed any lags
