FIRE PROTECTION TESTS IN A SMALL FUSELAGE-MOUNTED TURBOJET ENGINE AND NACELLE INSTALLATION

National Aviation Facilities Experimental Center

FINAL REPORT

1. Report No. FAA-RD-70-57		2. Government Accession No.		3. Recipient's Catalog No.	
4. Title and Subtitle FIRE PROTECTION TESTS IN A SMALL FUSELAGE-MOUNTED TURBOJET ENGINE AND NACELLE INSTALLATION				5. Report Date November 1970

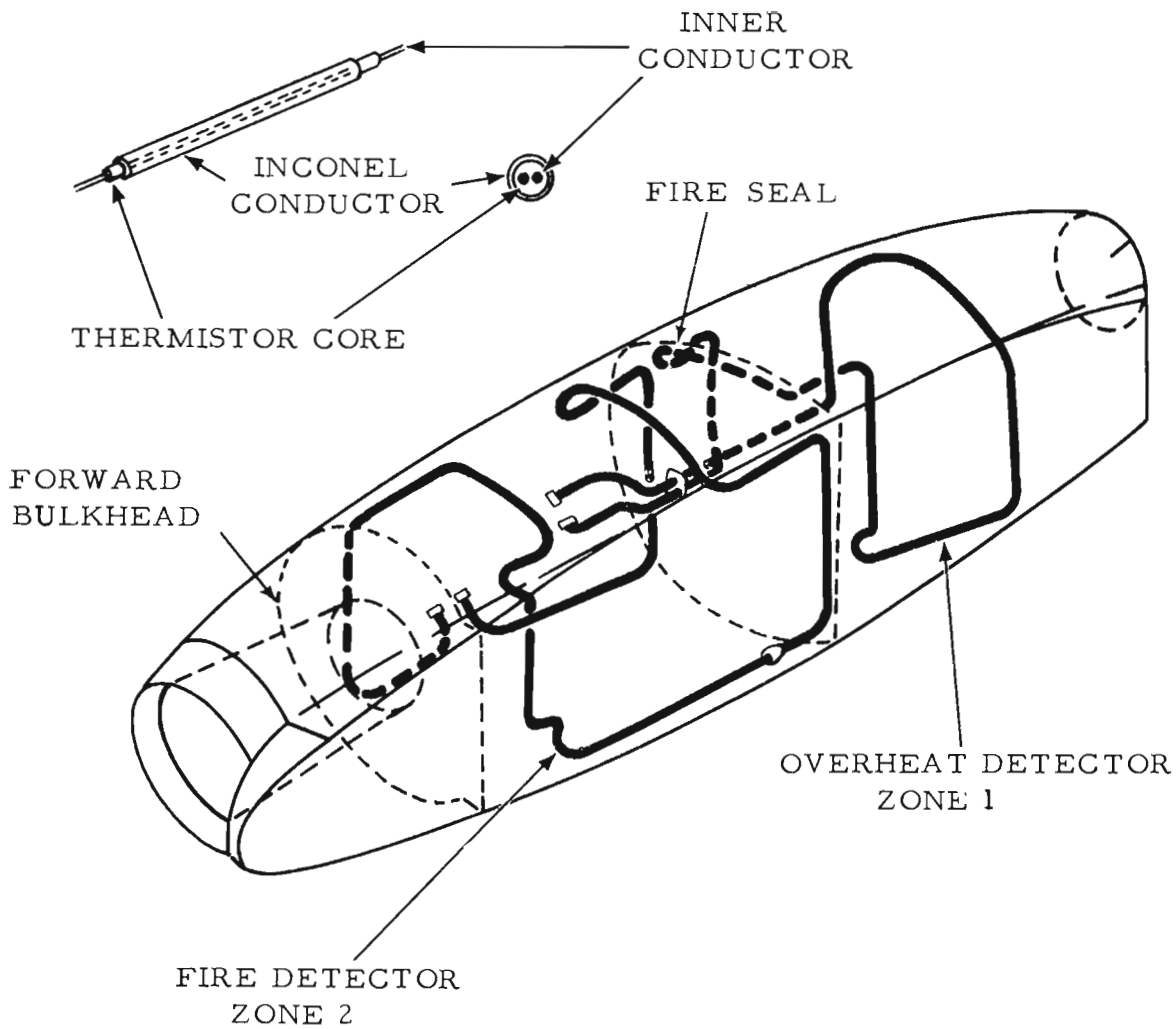
FIG. 5 NACELLE CONTINUOUS TEMPERATURE-SENSITIVE FIRE AND OVERHEAT DETECTION SYSTEMS

The continuous-type fire detection system in nacelle fire Zone II and the separate overheat continuous system in Zone I are shown in Figure 5. In the aircraft, a single warning light for the two systems in each nacelle is provided in the cockpit. A steady warning light indicates a fire in Zone II, and an intermittent light indicates an overheat situation in Zone I. However, as part of the test setup a separate warning

The Zone II continuous-type heat-sensitive fire detection system shown in Figure 5 was not routed in the lower portion of the zone. For this reason, fires which were originated at 7:30 and 6 o'clock in the lower forward portion of Zone II either were not detected or usually required a longer time for detection.

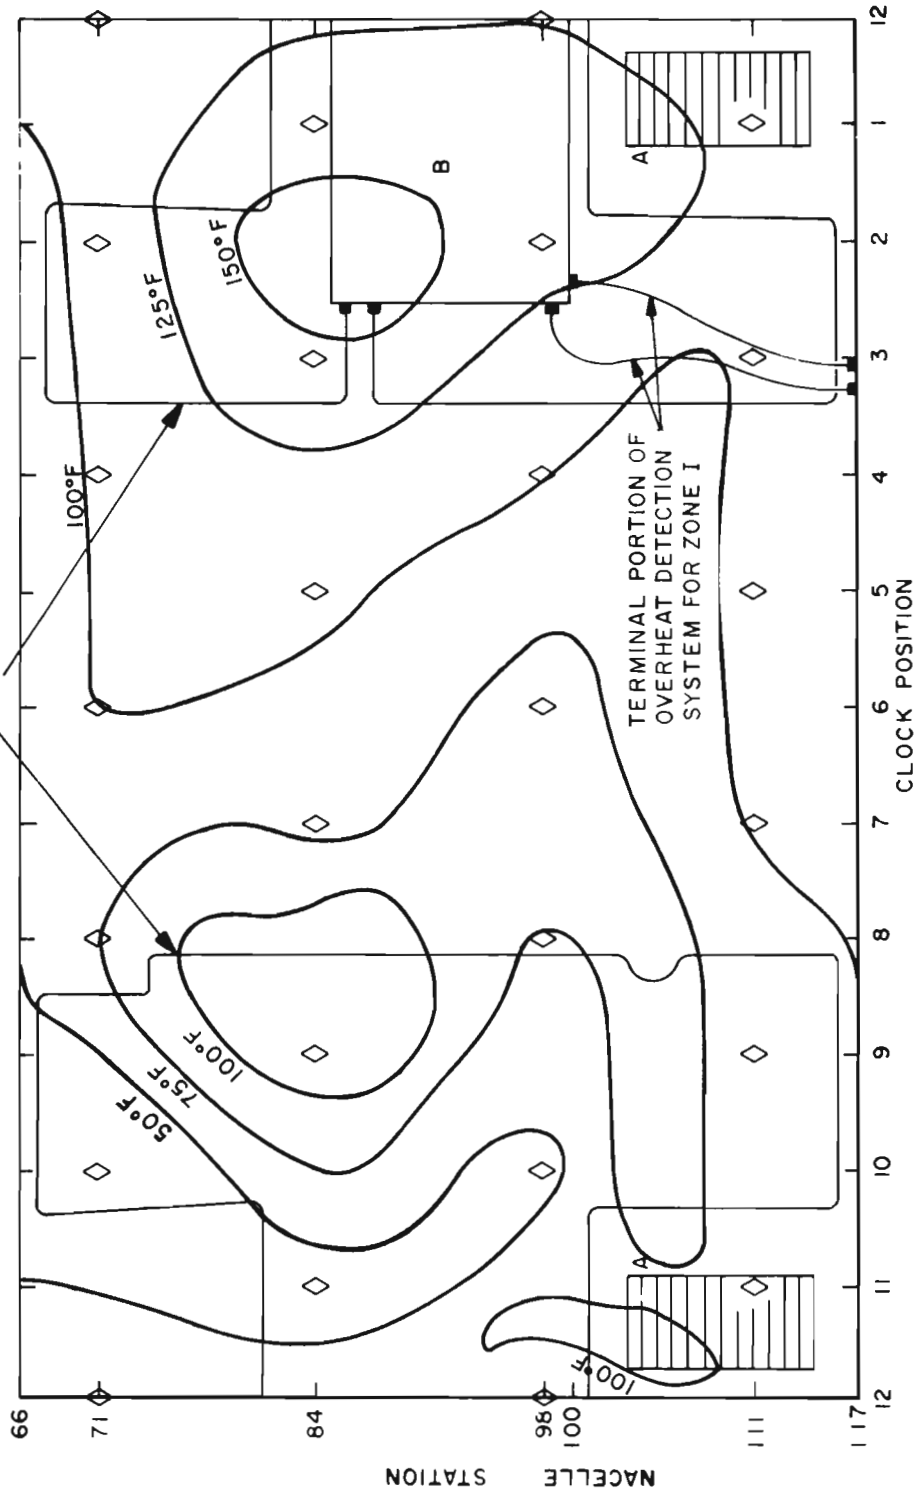
FIG. 7 ISOTHERMAL PLOT OF AMBIENT AIR TEMPERATURE IN ZONE II

Figure 7 is an isothermal plot of the normal ambient air temperature in Zone II prior to ignition of fuel. The outside ambient air temperature during this test was 21°F.

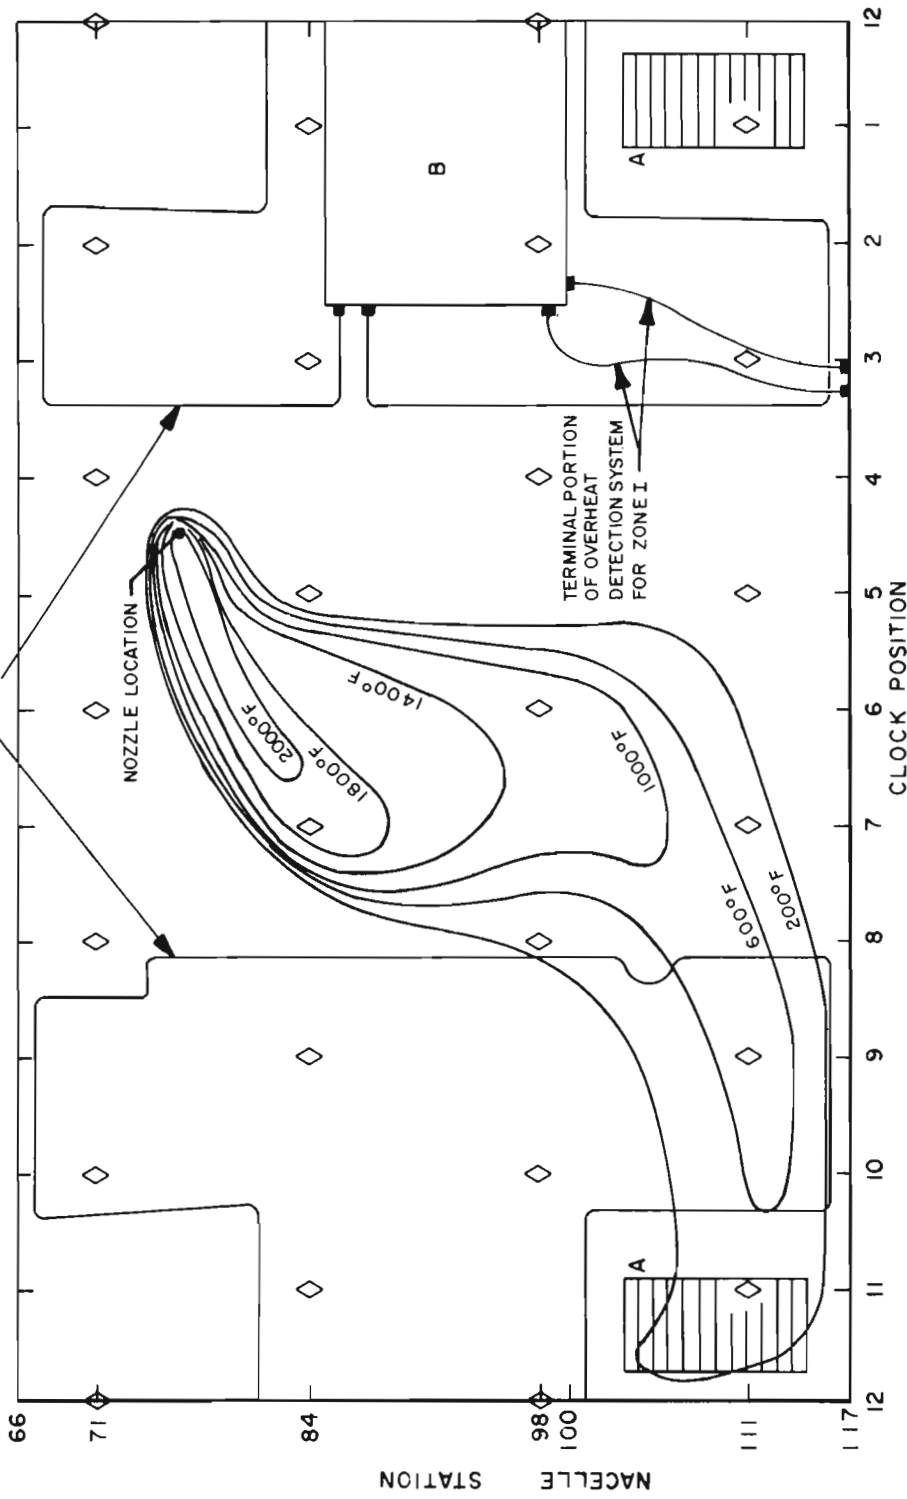
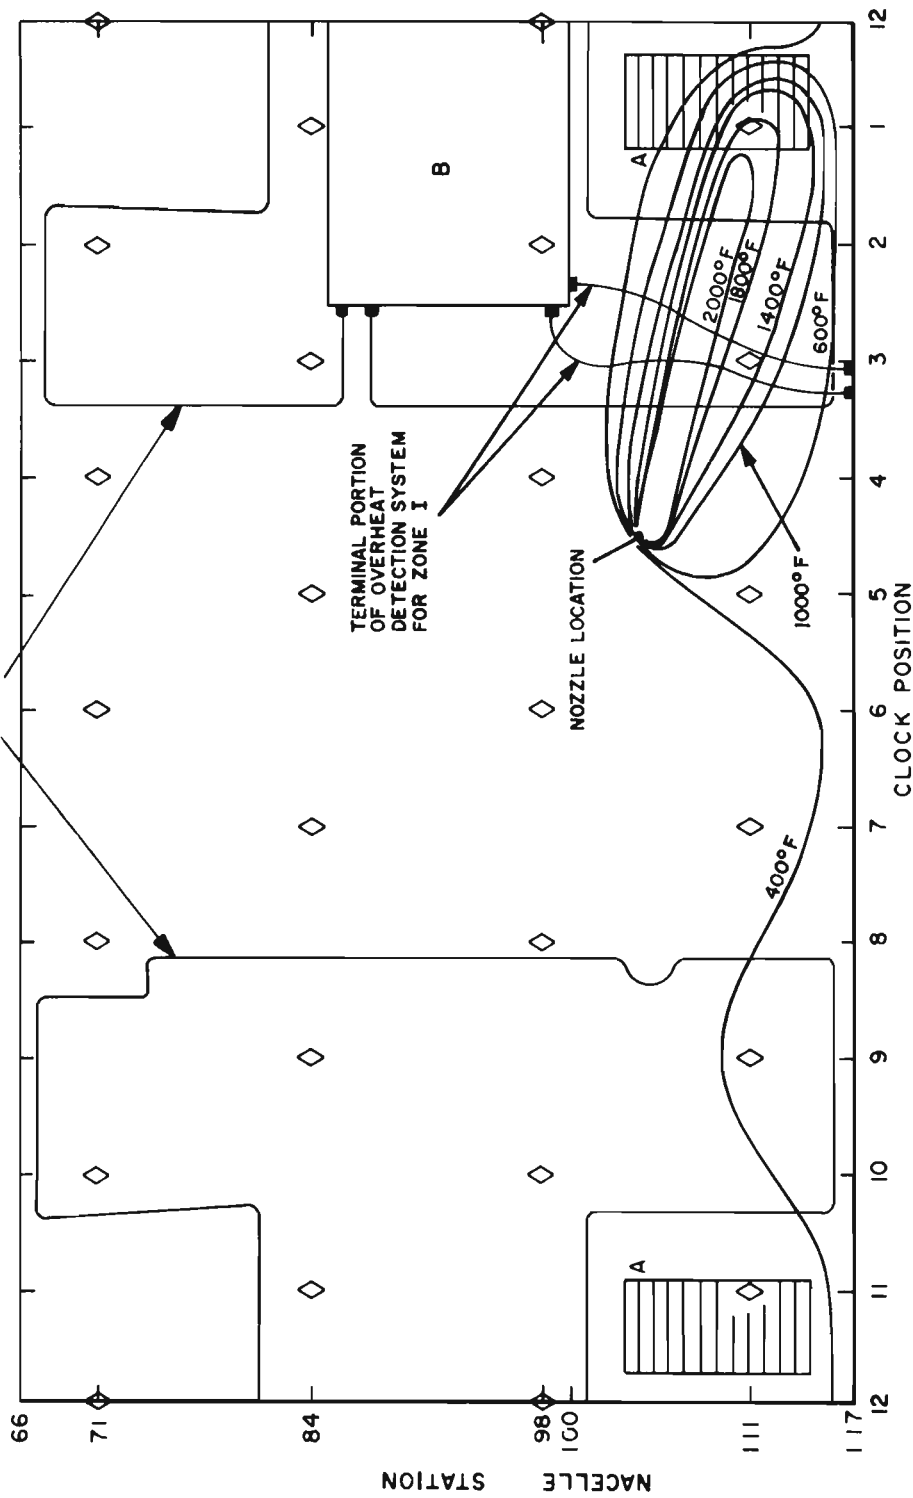
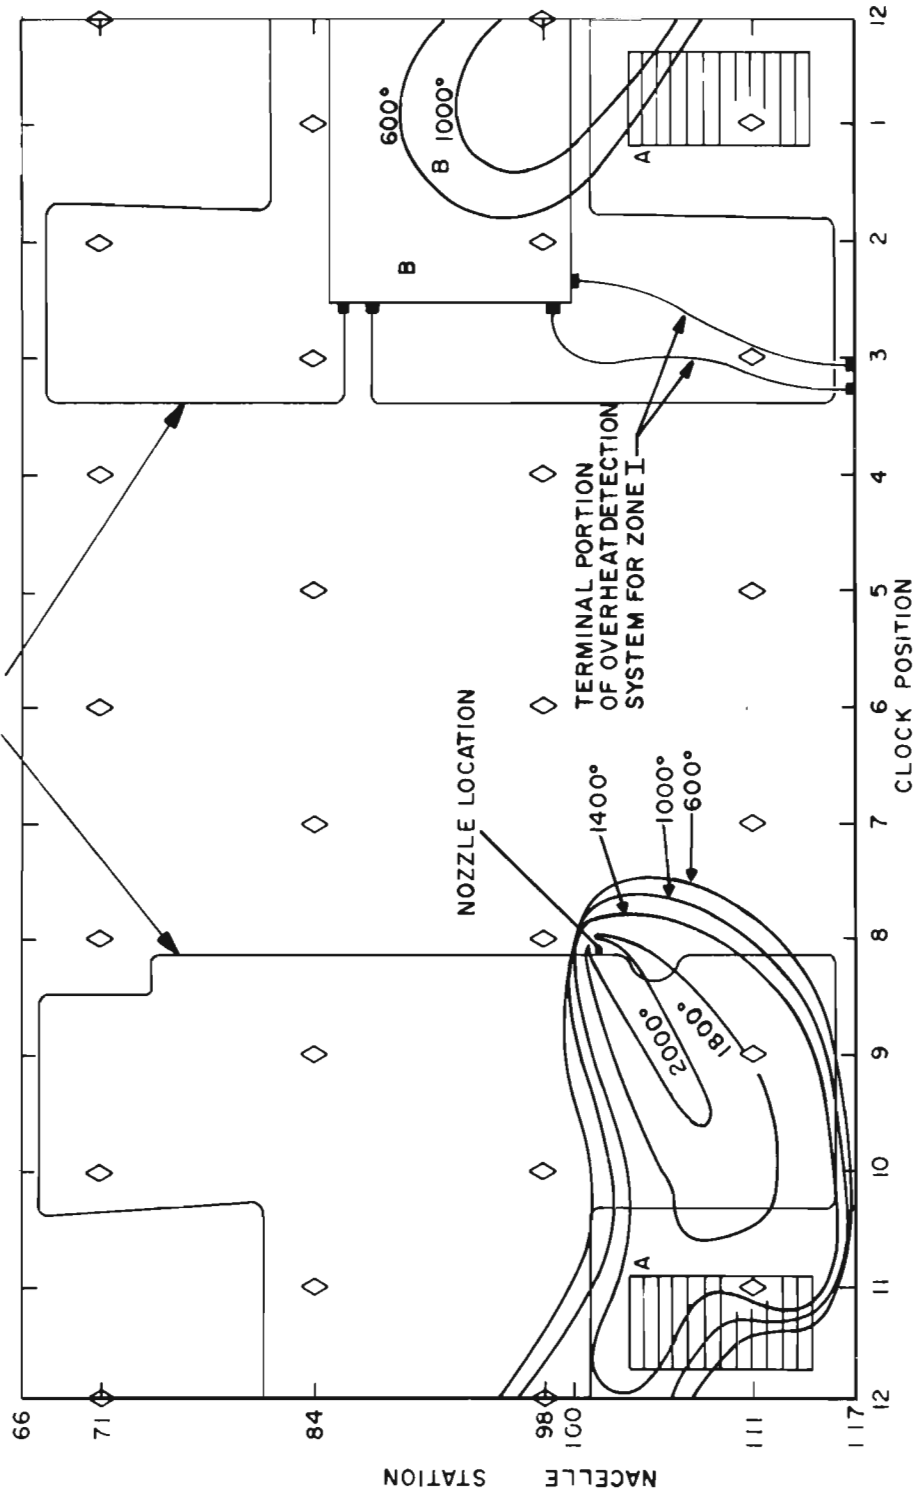
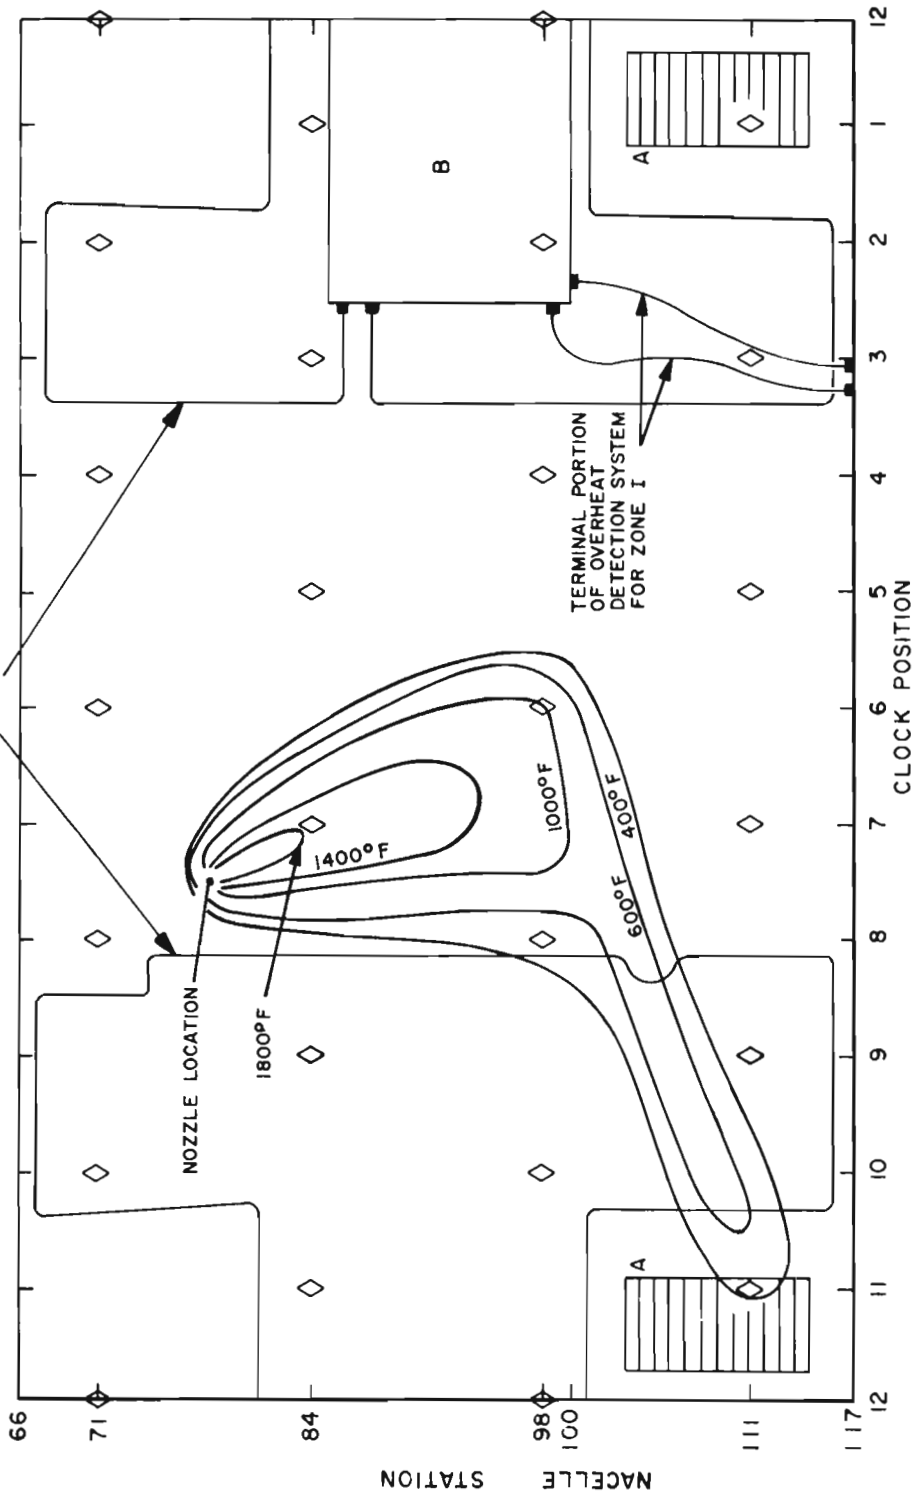
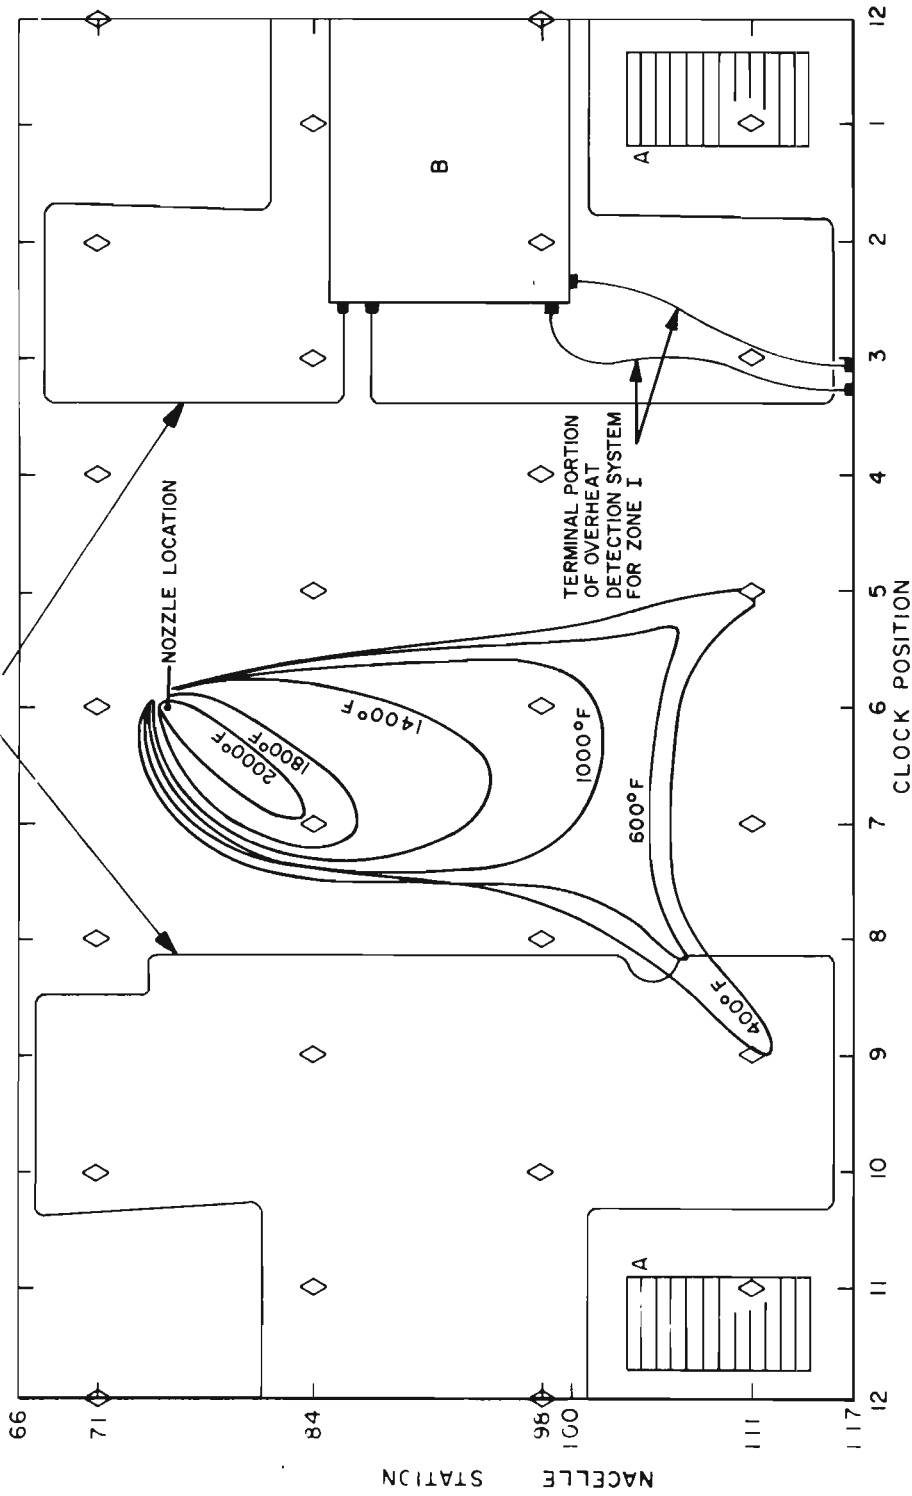
Isothermal plots of the increase in temperature above normal, resulting from 0.46-gpm JP-4 fires originated in Zone II at Locations 5A, 6A, 7A, 8A, and 9A (Figure 6), are shown in Figures 8, 9, 10, 11, and 12. These indicated the path of heat and flame from each fire location in Zone II. Flames from fires originating in the lower forward portion of Zone II propagated aft along the lower center portion of the nacelle. The flames then spread out forward of the vertical fire seal at Nacelle Station 117 and moved up and around the engine favoring the outboard side of the nacelle and egressed out the louvers in the top aft section

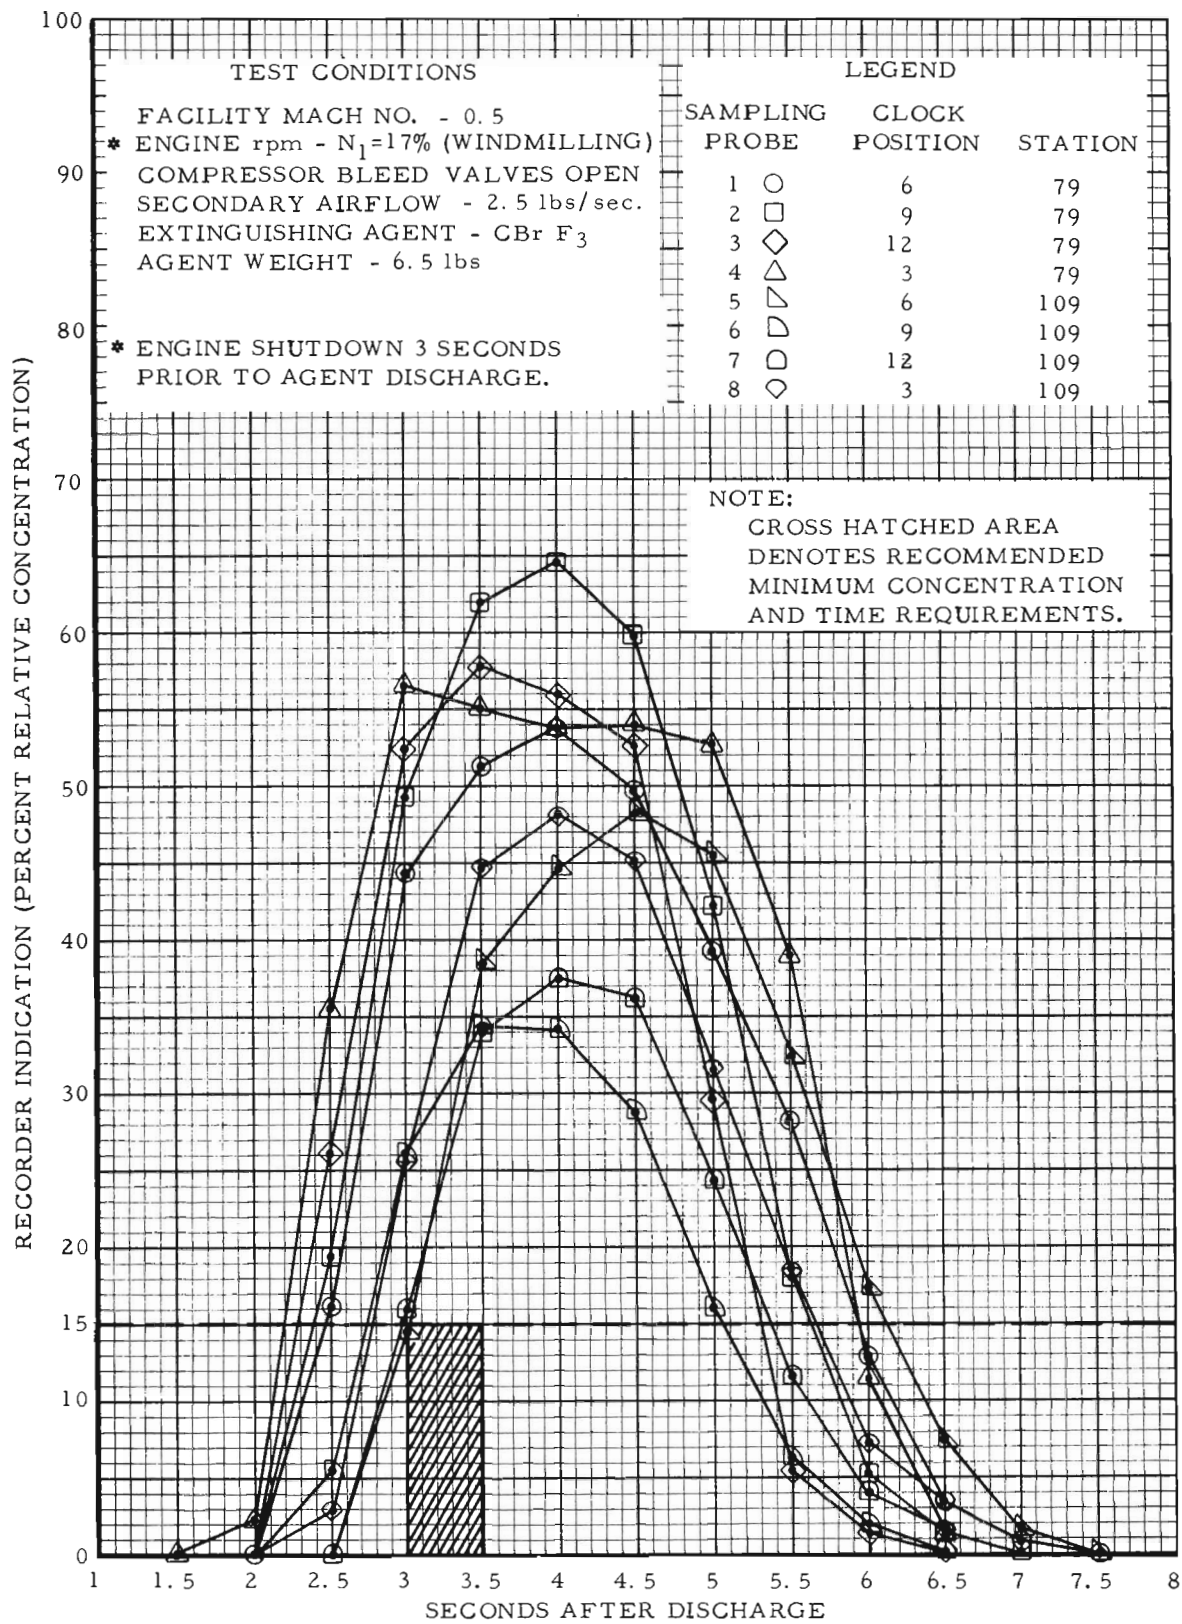
FIG. 15 EXTINGUISHING AGENT CONCENTRATION WITH 2.5-POUNDS-PER-SECOND SECONDARY AIRFLOW RATE IN ZONE II

Figures 15 and 16 show the conditions and results of the two agent concentration tests conducted. Results indicated that the installed extinguishing system exceeded by a substantial margin the recommended minimum of 15-percent relative concentration at all sampling locations simultaneously for at least a one-half second period when the extinguishing agent was released in Zone II of the nacelle under a normal simulated emergency condition (engine windmilling with a compartment airflow of 2.5 pounds per second). The extinguishing system also provided adequate concentration with respect to the recommended minimum when the agent was released in Zone II at an engine operation condition of $N_1 = 78$ percent rpm when the total compartment airflow was increased to a rate of 5.1 pounds per second.
