THE FEASIBILITY OF BURNER-CAN BURN-THROUGH THERMAL DETECTION PRIOR TO ENGINE CASE RUPTURE

FINAL REPORT

1. Report No. FAA-RD-72-134	2. Government Accession No.	3. Recipient's Catalog No.	
4. Title and Subtitle THE FEASIBILITY OF BURNER-CAN BURN-THROUGH THERMAL DETECTION PRIOR TO ENGINE CASE RUPTURE		5. Report Date January 1973

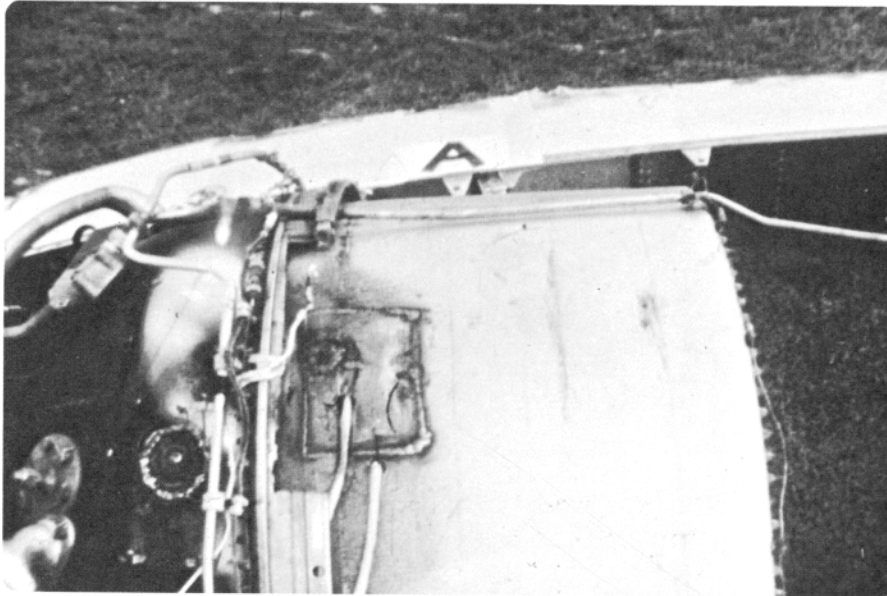
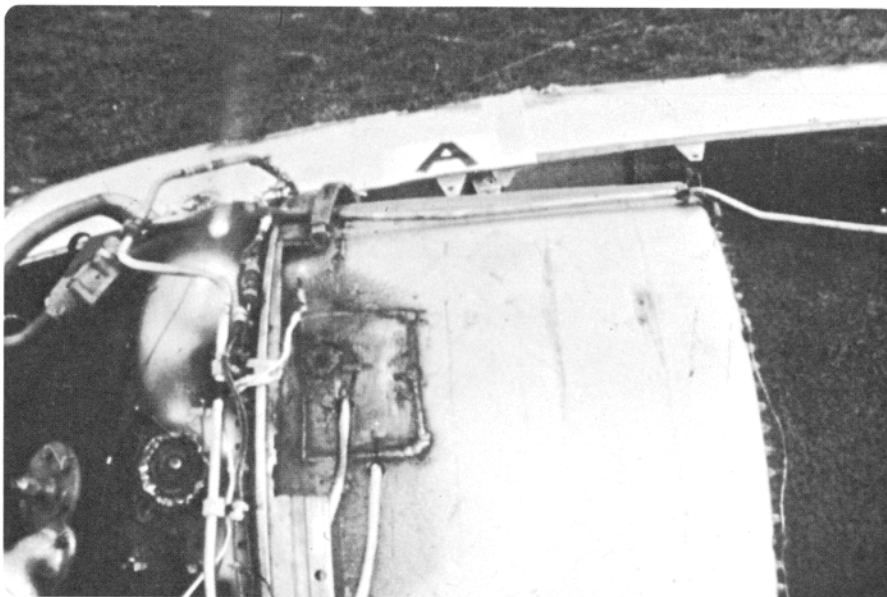
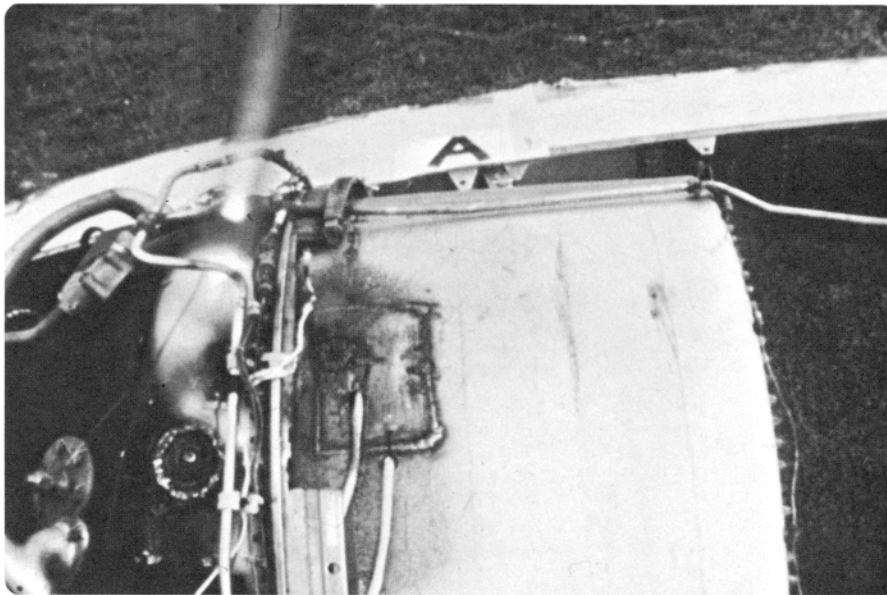
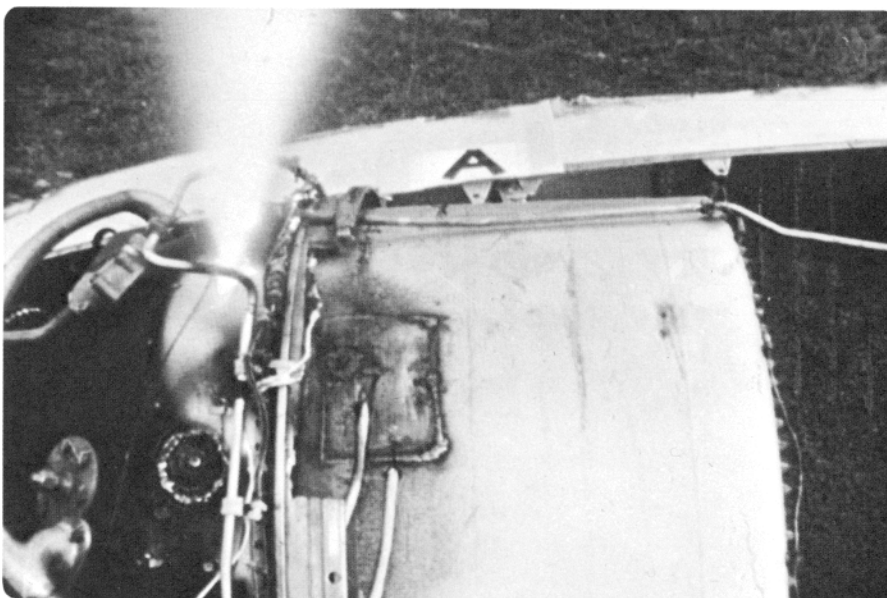
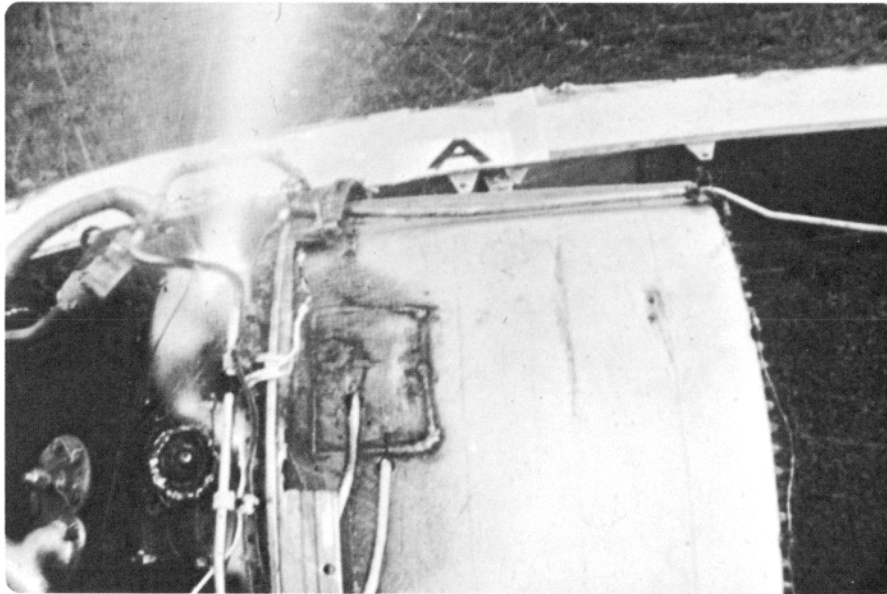
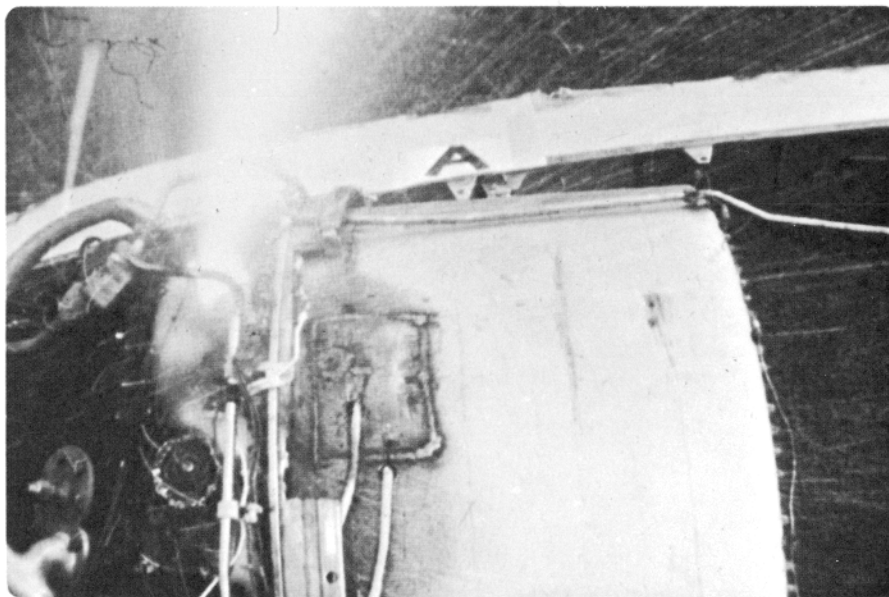
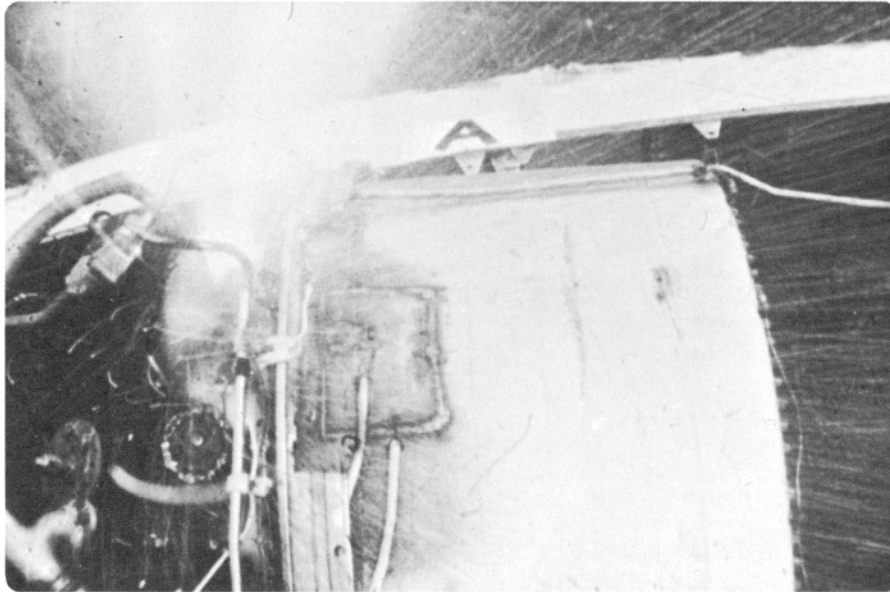
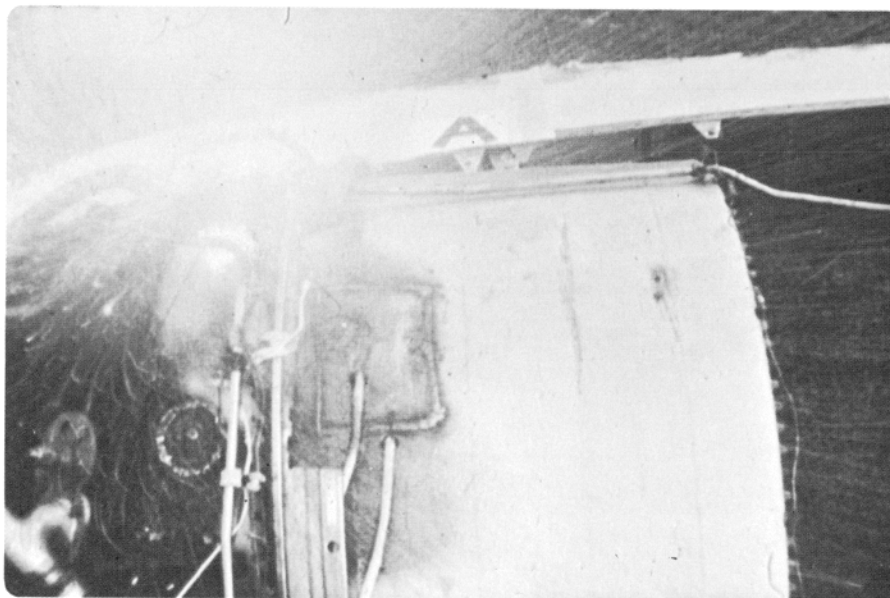
The development of a burner-can burn-through was photographed by motion picture cameras and can be seen in Figures 7 through 16. In Figure 7 the internal fuel leak had ignited and the diffuser case was just beginning to overheat (note the two hot spots on the diffuser case). Figure 8 shows the engine just prior to rupture. A large portion of the diffuser case began to glow red, and a small section of the burner can case began to overheat. The following eight photos were taken over a time span of five-tenths of a second. In Figure 9 the flame has just penetrated the diffuser case. As the rupture in the diffuser case enlarges the flame increases in diameter and length. As a result of rough and bowed edges on the burn-through hole the flame transforms itself from a single concentrated jet (Figure 12) to a larger diffused jet (Figure 16).

FIGURE 9. J57 BURN-THROUGH (TIME 0)

FIGURE 10. J57 BURN-THROUGH (TIME 1/16 SEC)

FIGURE 11. J57 BURN-THROUGH (TIME $1/8$ SEC)

FIGURE 12. BURN-THROUGH (TIME $3/16$ SEC)

FIGURE 13. J57 BURN-THROUGH (TIME 1/4 SEC)

FIGURE 14. J57 BURN-THROUGH (TIME 5/16 SEC)

FIGURE 15. J57 BURN-THROUGH (TIME 3/8 SEC)

FIGURE 16. J57 BURN-THROUGH (TIME 7/16 SEC)

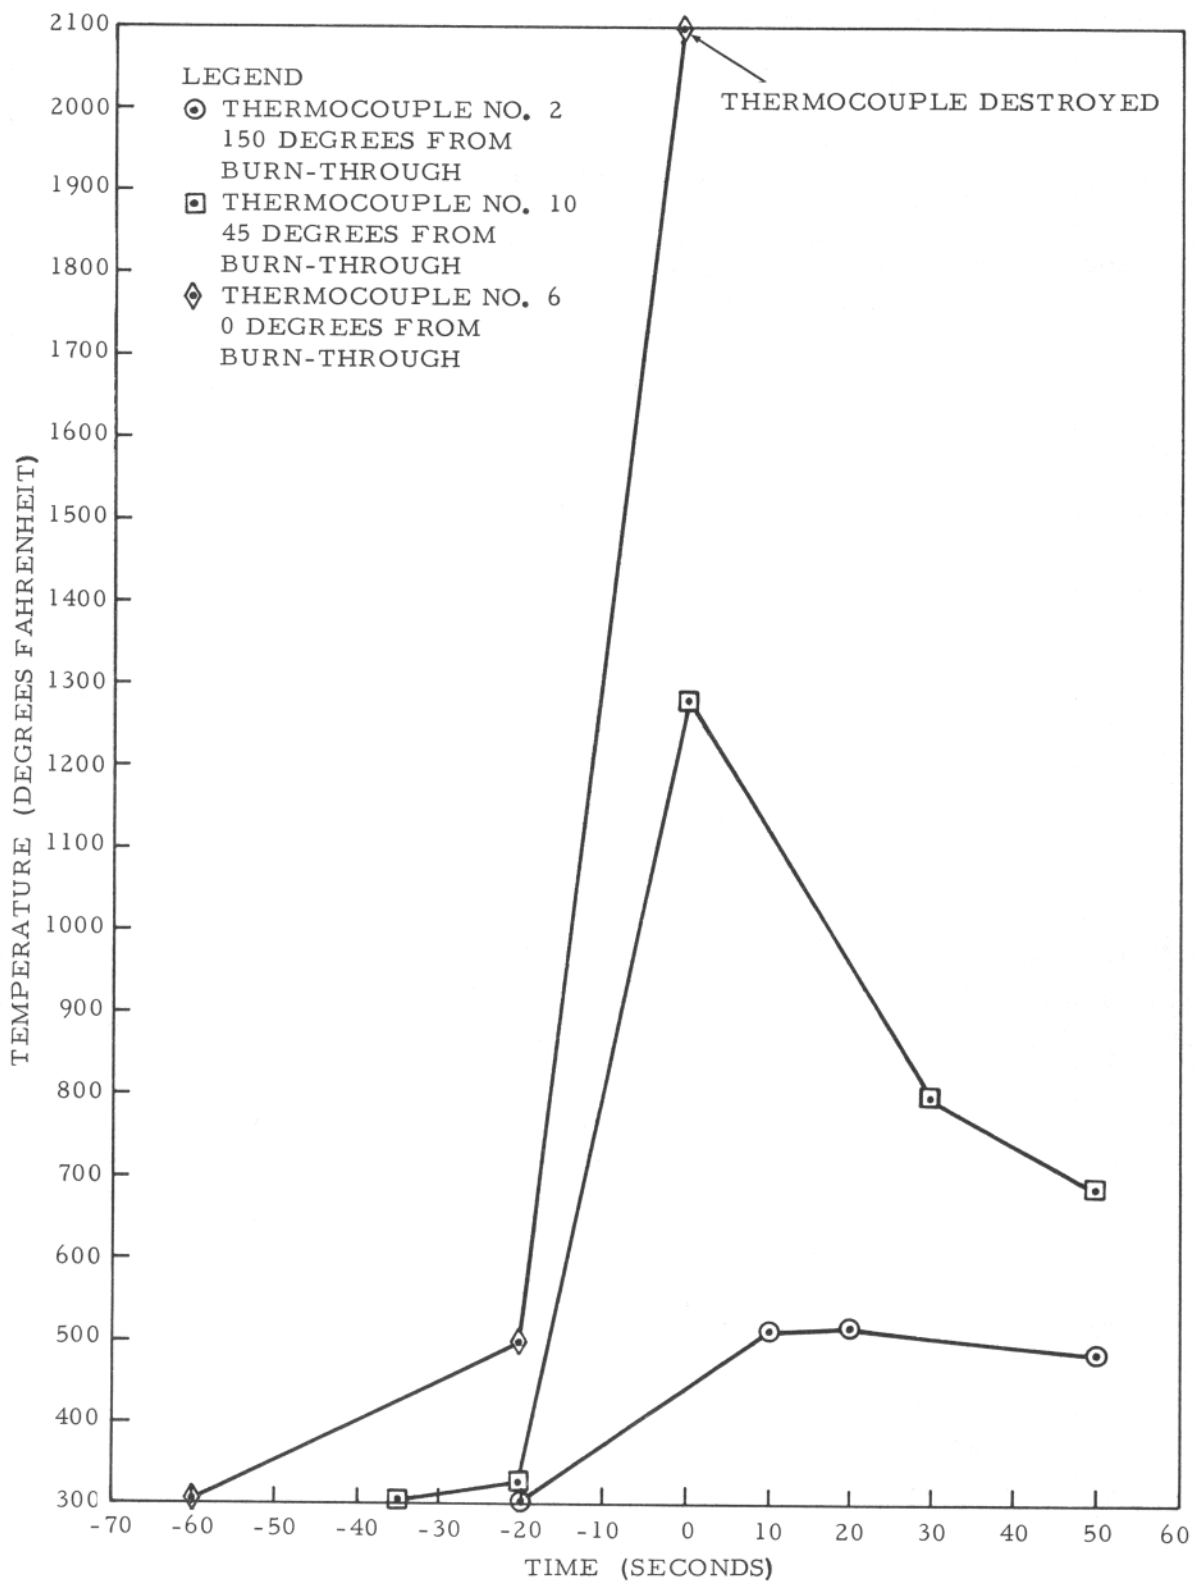
FIGURE 21. DIFFUSER CASE TEMPERATURES DURING TEST NO. 2

Test No. 2. The results of Test No. 2 can be seen in Figures 21 and 22 and the resultant damage from the burn-through in Figure 23. The burn-through hole in Test No. 2 was slightly larger than that in Test No. 1. The results of the test was similar to the first test, except the magnitude of the temperatures was not as high. This could have been caused by an earlier rupture of the diffuser case due to its weakened condition.

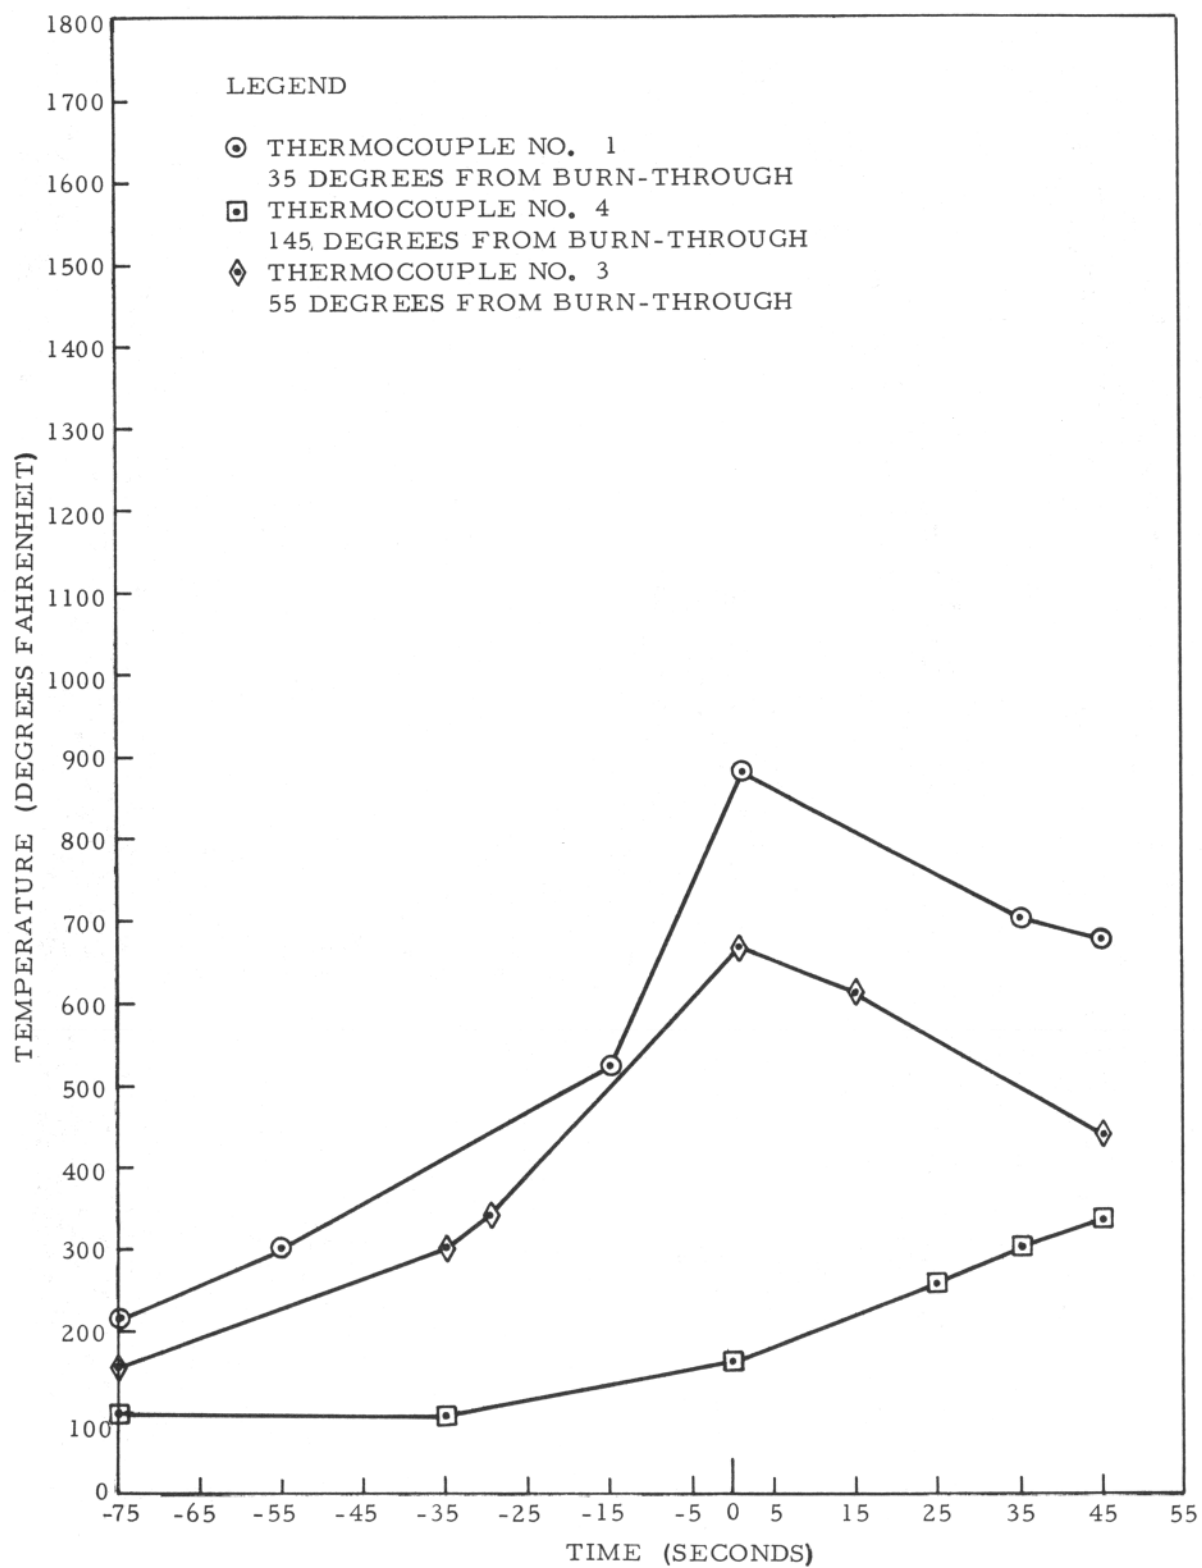
FIGURE 24. DIFFUSER CASE TEMPERATURES DURING TEST NO. 3

Test No. 3. The results of this fully-cowled-engine test is shown in Figures 24 and 25. Figures 26 through 28 show the damage caused by the burn-through. Unlike the prior two tests, the burn-through occurred in the burner can case an inch or so aft of the split line. A smaller secondary burn-through did occur just forward of the split line in the diffuser case. As a result of the location of the burn-through, the burner can case showed a much higher peak temperature than the diffuser case, whereas, the diffuser case still showed a much larger area of temperature rise.

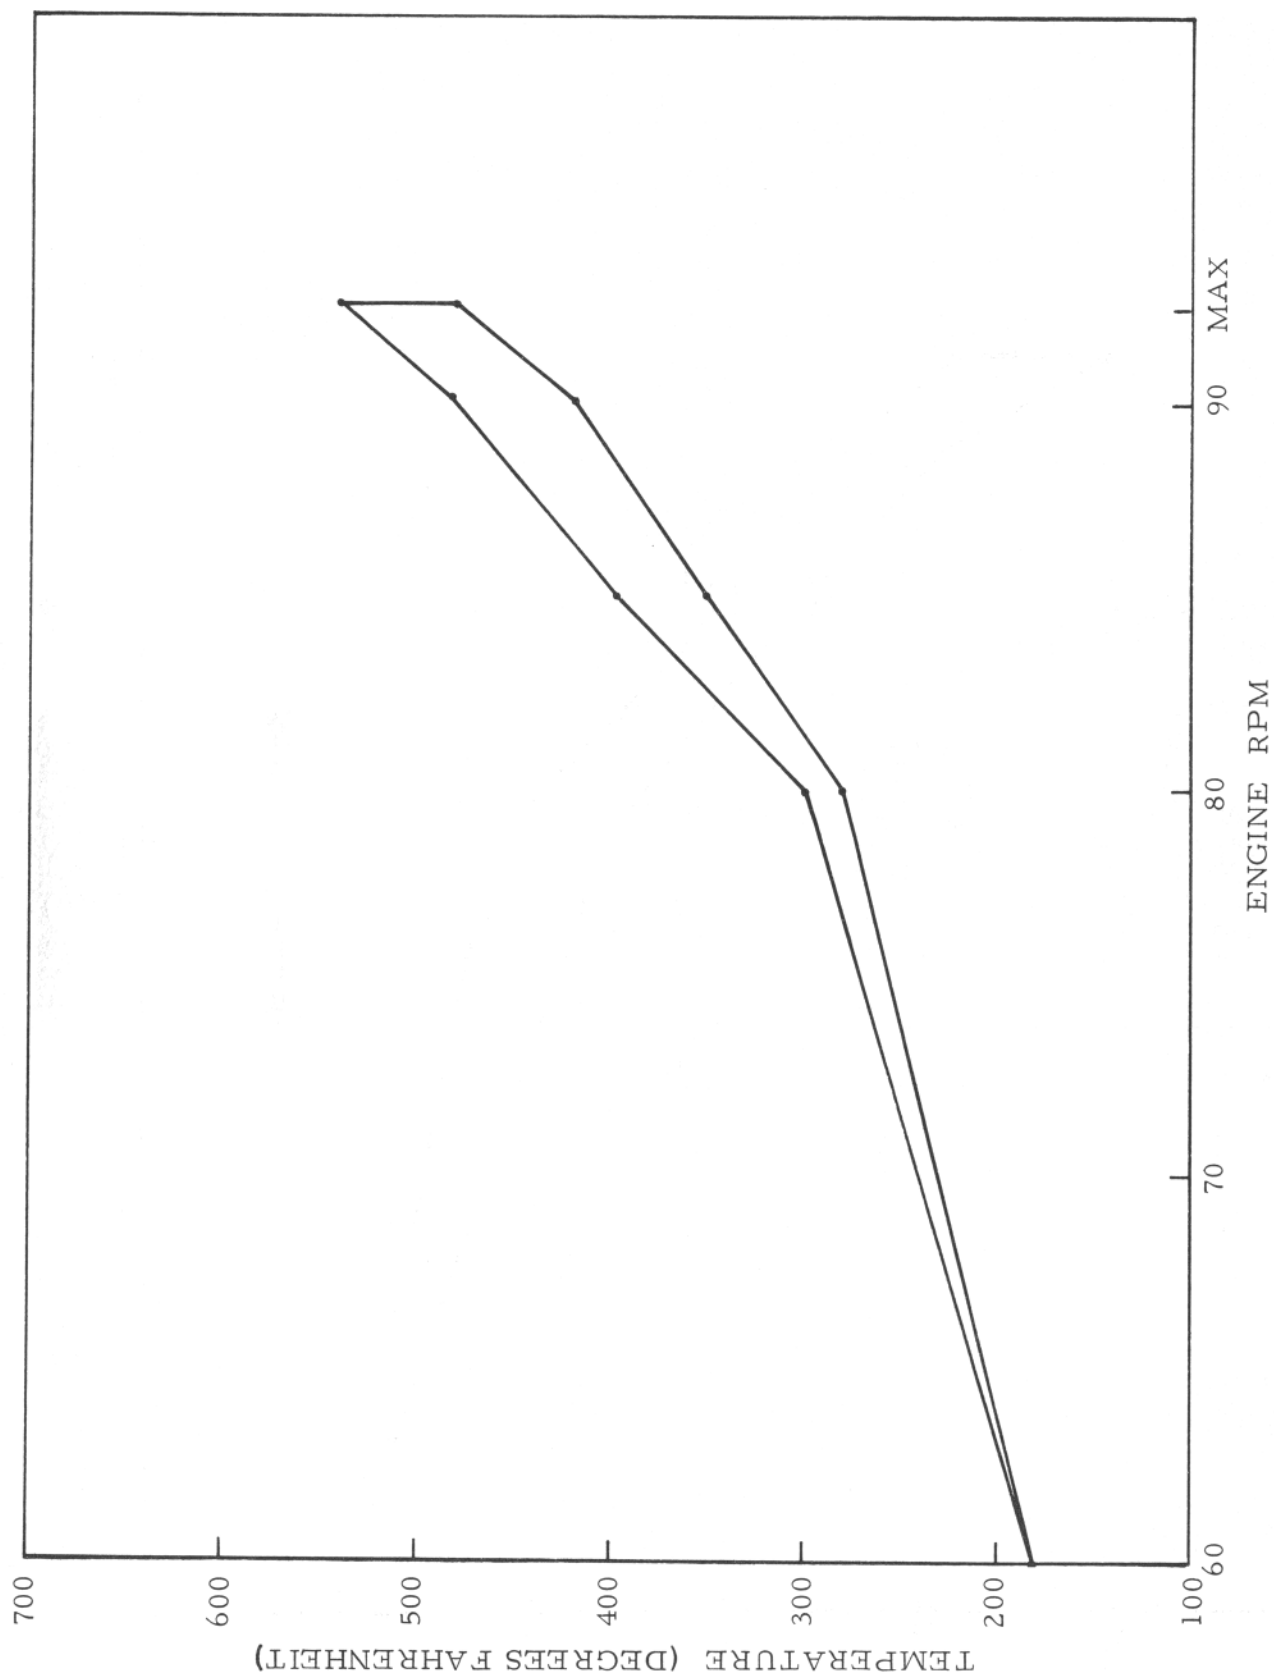
FIGURE 29. J57 ENGINE DIFFUSER CASE TEMPERATURE RANGE

The results of the background test are shown in Figures 29 and 30. The two lines on each graph represent the highest and lowest temperatures measured on the diffuser case (Figure 29) and burner can case (Figure 30) at various locations 360° around the engine.
