Investigation of Accidental DC-7 Fire Damage Occurring June 28, 1989

DOT/FAA/CT-TN89/55

U.S. Department of Transportation
Federal Aviation Administration

Technical Center
Atlantic City International Airport, N.J. 08405

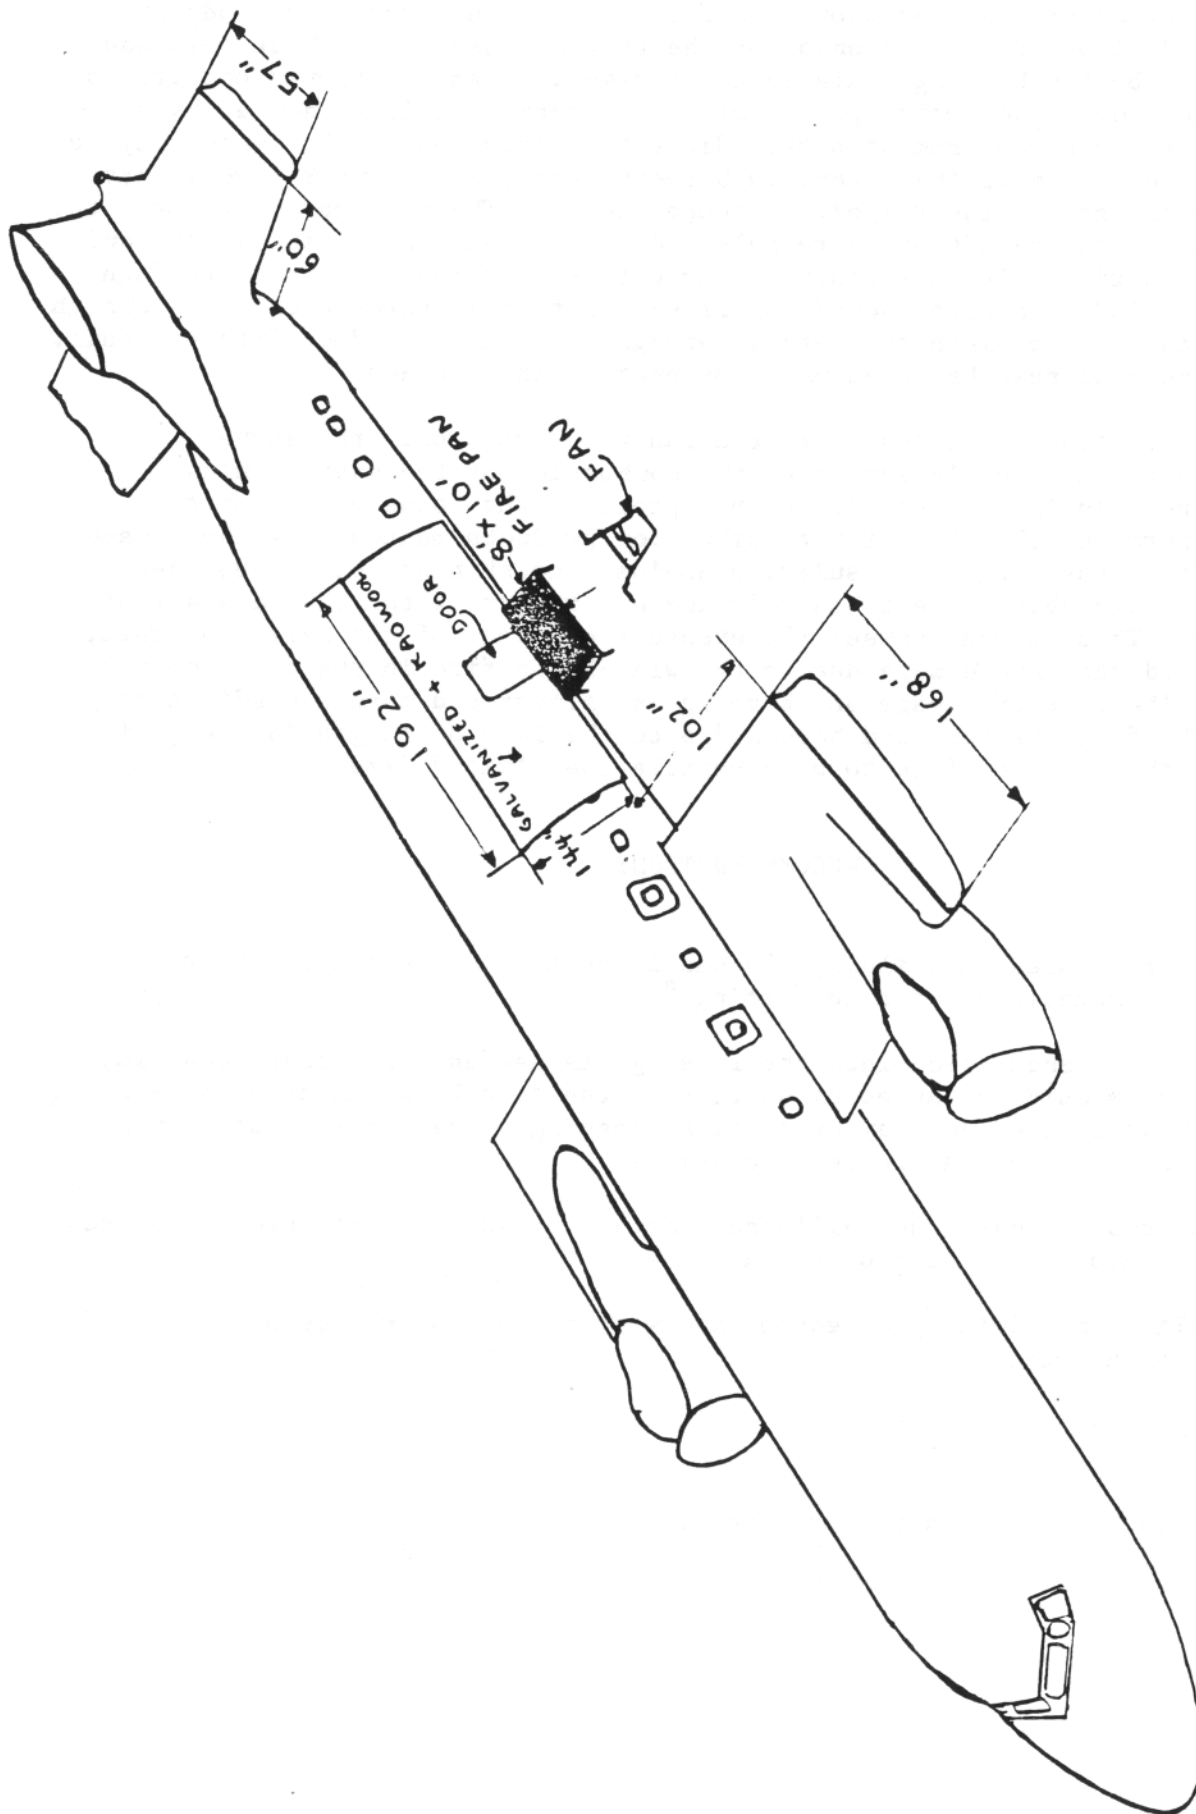
FIGURE 1. DC-7 TEST MODIFICATIONS

The aircraft was specially modified to be used as a fire test article. The wings were removed outboard of the landing gear, and the tail was cut off at the root, with the horizontal stabilizer cut, leaving a stub 60 inches outboard from the fuselage. The exterior of the fuselage was fire hardened in the vicinity of the aft passenger entry door which was removed. The doorway and the fuselage around the doorway were covered by steel sheeting installed over a layer of KAOWOOLTM insulation blanket. The fire hardening extended from the top center of the fuselage to 12 inches below the doorway, 6.5 feet forward of the doorway, and 6.5 feet aft of the doorway. An 8- by 10-foot fire pan was installed at the base of the doorway to simulate an external fuel fire (see figure 1).

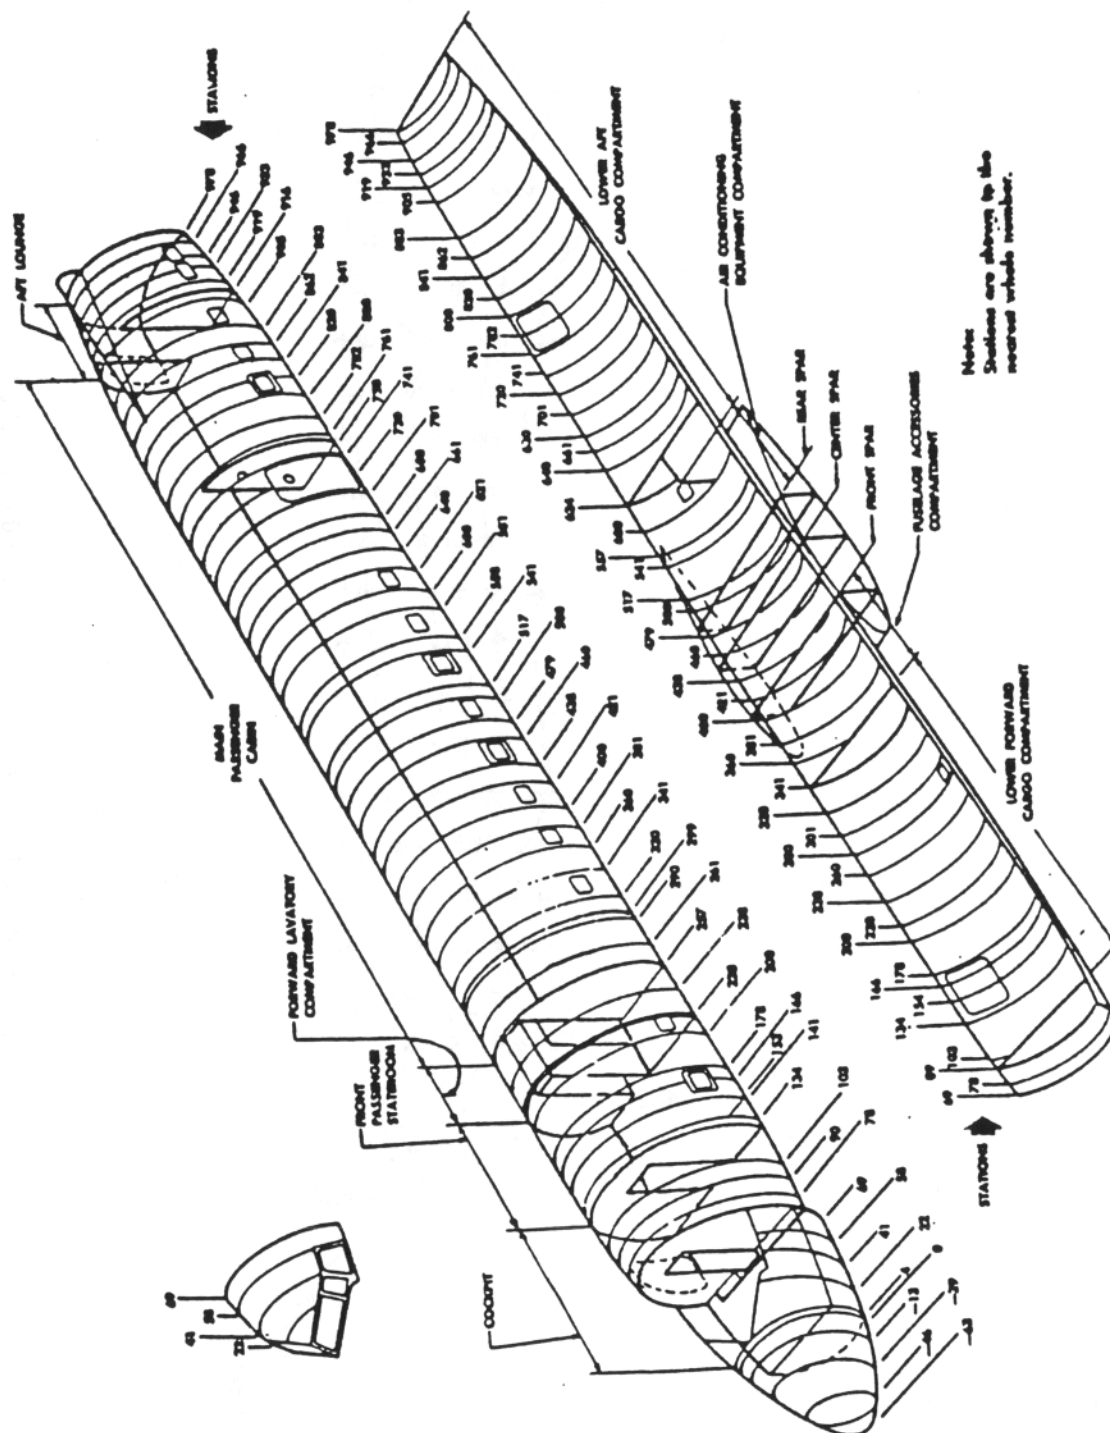
FIGURE 2. FUSELAGE STATIONS

The interior of the aircraft was fire hardened from station 533 to station 782. (These stations are in 1-inch intervals and are shown in figure 2.) The floor, was covered by steel sheeting, while the sidewalls, and ceiling were covered by steel sheeting over kaowool blankets. The cabin partitions, seats, galleys, and lavatories were removed from the aircraft with the exception of the forward lavatory compartment and the cockpit bulkhead. The entire cabin forward and aft of the fire hardened section retained the original panels and acoustical insulation.

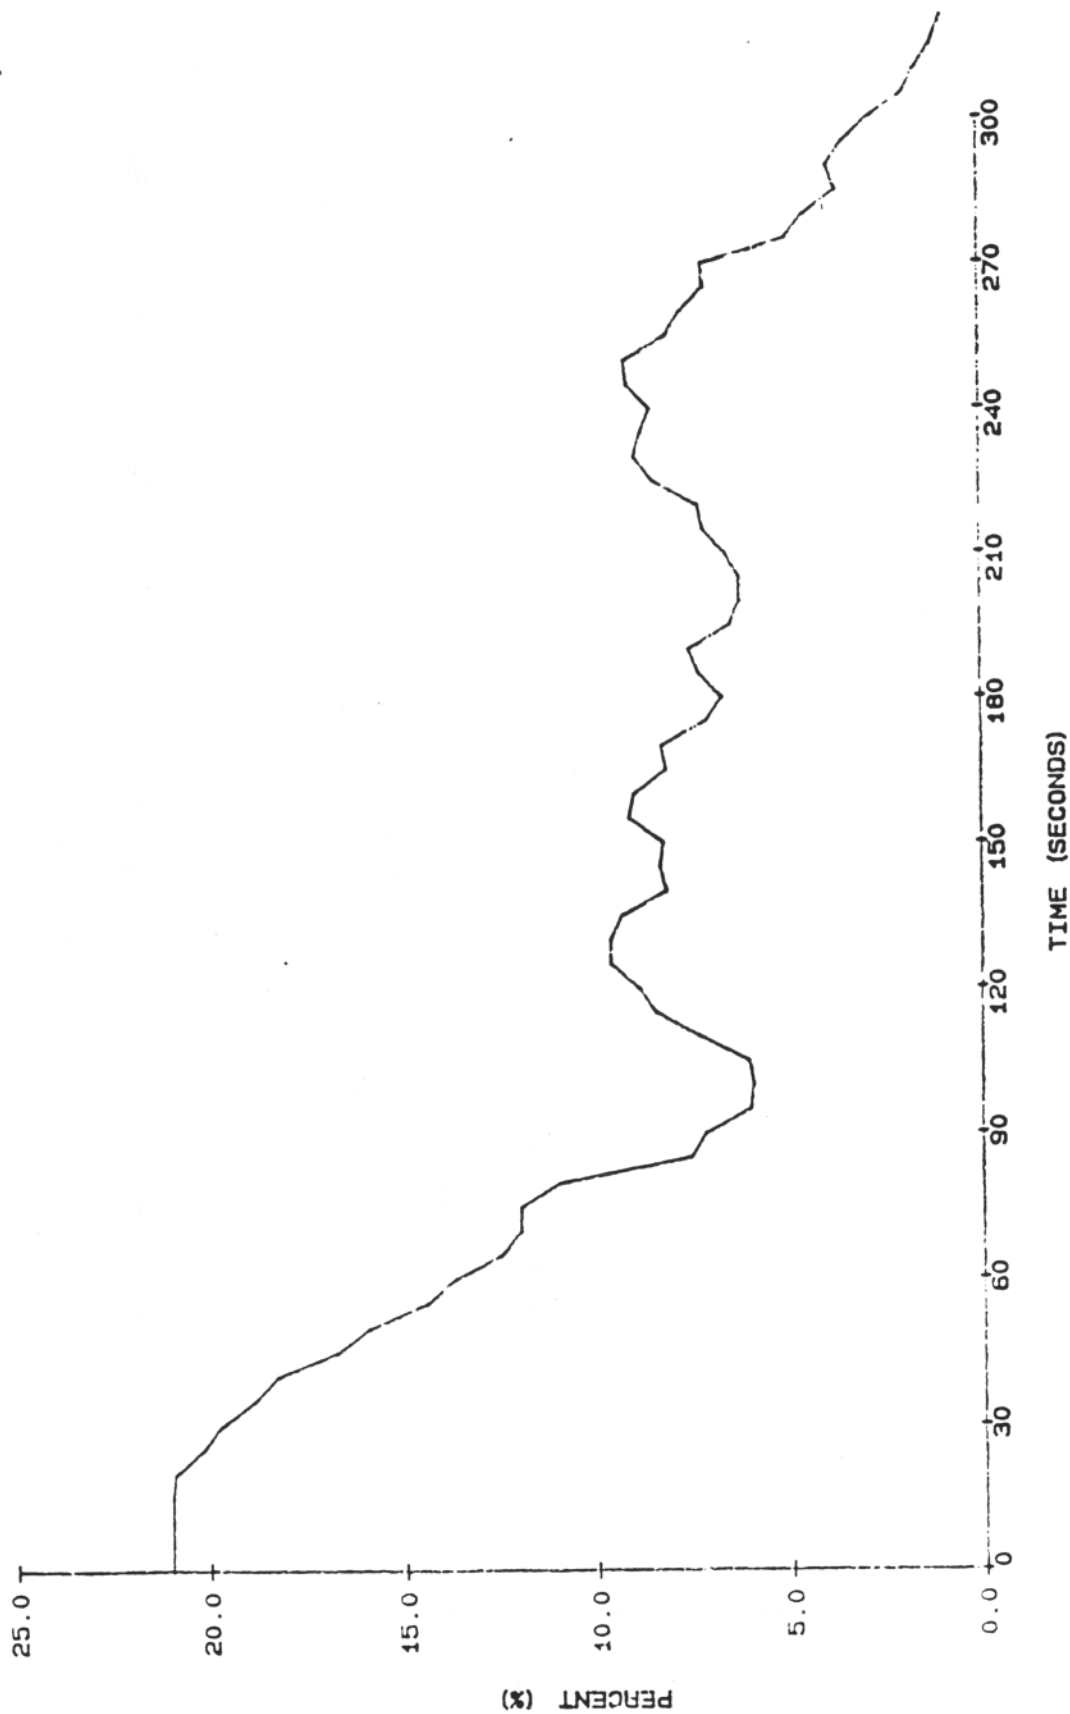
FIGURE 8. OXYGEN CONCENTRATION AT STATION 32 AT THE 5-FOOT HEIGHT DURING TEST

From figures 8 through 11, it should be noted that the concentrations of oxygen were reduced to about 5 percent at all the sampling stations by the conclusion of the test. Also, the concentrations of carbon dioxide rose to 10 percent after about 2 minutes and remained there, as indicated by figures 12, 13, and 14. The carbon monoxide levels reached between 1.5 and 2 percent during the latter half of the test, as indicated by figures 15 through 18. The smoke density data indicate practically no visibility after about the first minute of the test.
