FOR LESS INJURIES AFTER EMERGENCY EVACUATION

Hiroaki TOMITA
Chief Air Carrier Airworthiness Engineer
Civil Aviation Bureau of Japan
Ministry of Transport

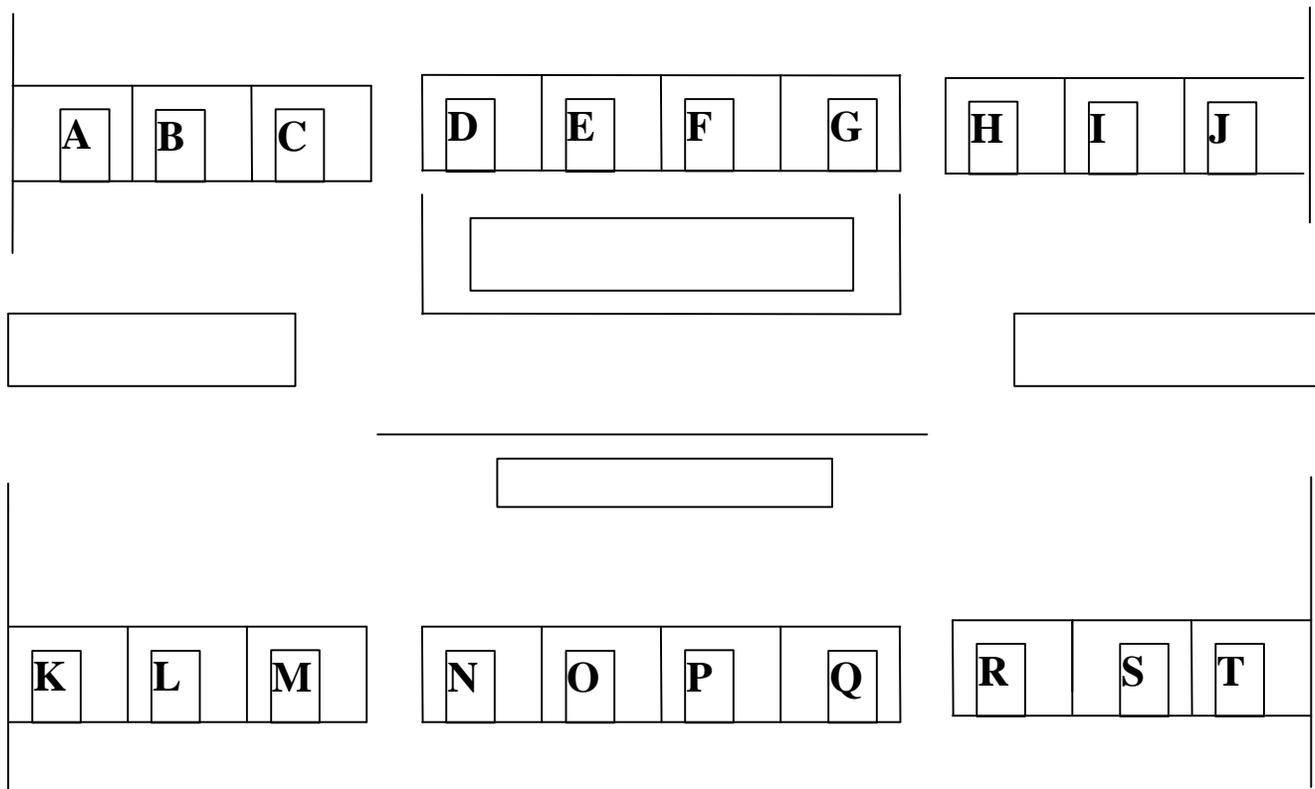
FIGURE 1

An exit seat means each seat that has a direct access to an exit and that is located rearward of the aisle connecting the left exit and the right exit. Those seat behind partition, galley, or lavatory are not regarded as an exit seat. In the above figure, those seats marked with “K”, “L”, “M”, “R”, “S”, and “T” are defined as an exit seat and others are not.

Some Japanese operators had already introduced the exit seat system in their evacuation procedures. However since there were differences in procedures and concept between operators, it is considered necessary to develop the definition of an exit seat for a smooth introduction by every operator. Following survey of the exit seat system in use by foreign operators, the task force developed the definition, as schematically shown in Figure 1. In addition the task force determined the role of the exit seat occupants. The task force was of the opinion that there are some tasks that should be performed by the cabin crew themselves and therefore should not be transferred to the exit seat occupants. For instance judgment as to whether the exit door should be opened or not should remain as one of the cabin crew's duties. As a result, the role of an exit seat occupant was confined to the followings:
