**DOT/FAA/AR-00/13**

# **Benefit Analysis for Aircraft 16-g Dynamic Seats**

Final Report

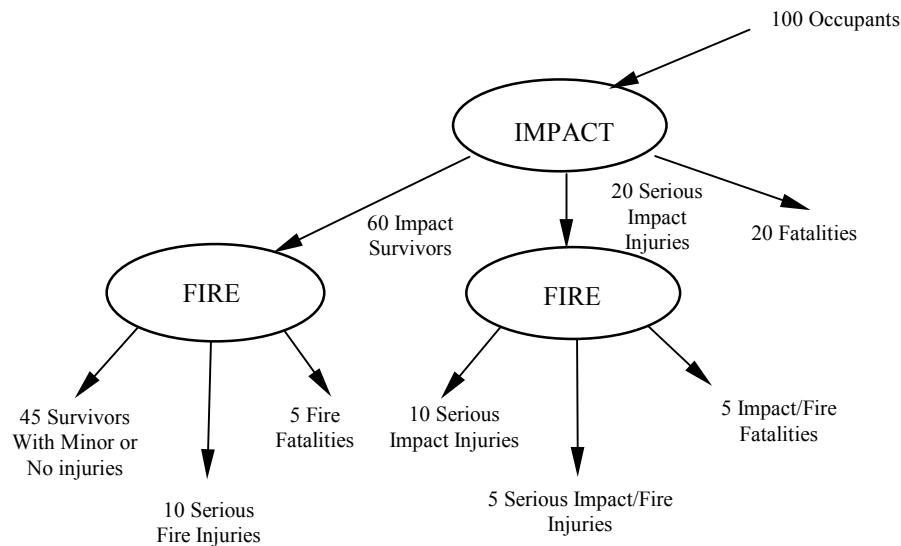
A mathematical model, known as a Survivability Chain (see figure 1) has been developed, by RGW Cherry & Associates Ltd. It enables an assessment to be made of the overall effect on survivability, from improvements made to survivability factors, taking into account injuries that may be sustained by occupants. In this case, the survivability factor is 16-g dynamic seats.

FIGURE 1. EXAMPLE OF SURVIVABILITY CHAIN FOR AN ACCIDENT SCENARIO

In this example, of the 100 occupants in the scenario there are:

- 45 uninjured survivors.
- 25 serious injuries, 10 as a result of the impact, 10 as a result of the fire, and 5 seriously injured as a result of the impact and fire.
- 30 fatalities, 20 as a result of the impact, and 10 as a result of the fire (5 of whom sustained nonfatal injuries from the impact).

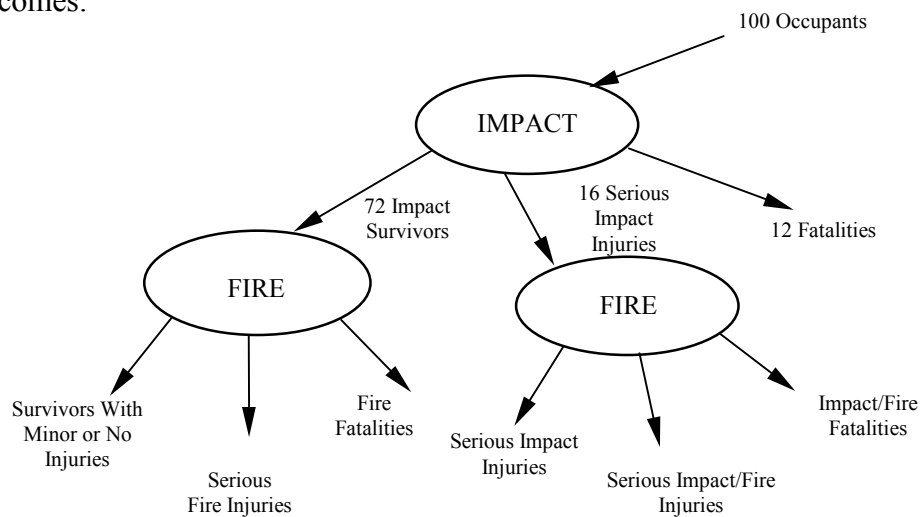
If improvements are made to an impact-related survivability factor, such that there are only 12 fatalities and 16 seriously injured of the 100 occupants, the Survivability Chain then becomes:

FIGURE 2. EXAMPLE OF SURVIVABILITY CHAIN SHOWING POSSIBLE IMPROVEMENTS IN IMPACT-RELATED SURVIVABILITY FACTOR

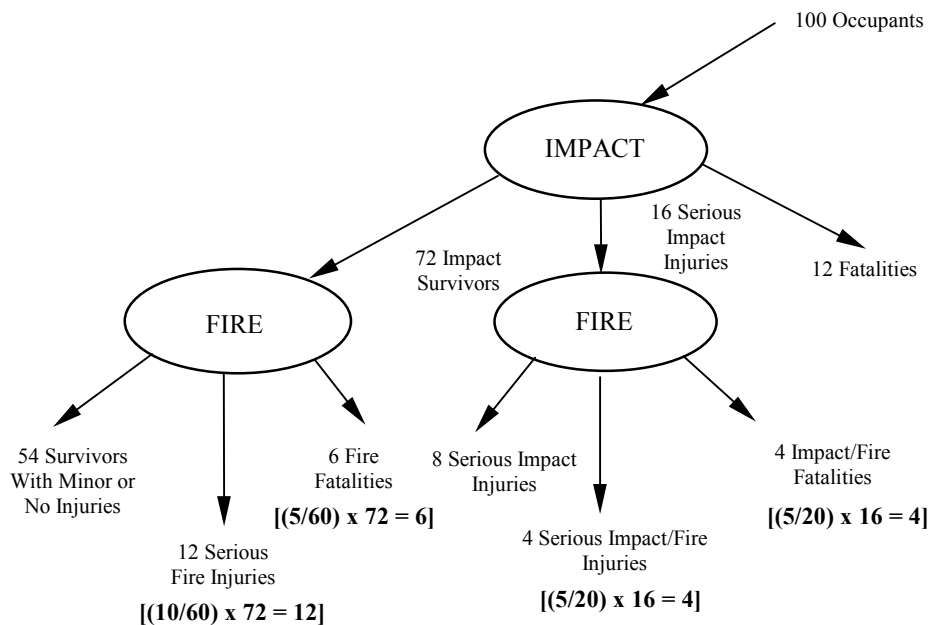
It is known from the accident that  $5/60^{\text{th}}$  of those that survive the impact uninjured and  $5/20^{\text{th}}$  of those that sustain injuries from the impact subsequently died because of the fire. Furthermore,  $10/60^{\text{th}}$  of those that survive the impact are seriously injured due to fire and  $5/20^{\text{th}}$  of those that sustain serious injuries from the impact also sustain serious injuries because of the fire. It is assumed that these ratios are constant for this particular scenario.

On this basis an assessment of the numbers of fatalities and injuries may be made as follows:

FIGURE 3. EXAMPLE OF SURVIVABILITY CHAIN SHOWING THE OVERALL IMPROVEMENTS IN SURVIVABILITY

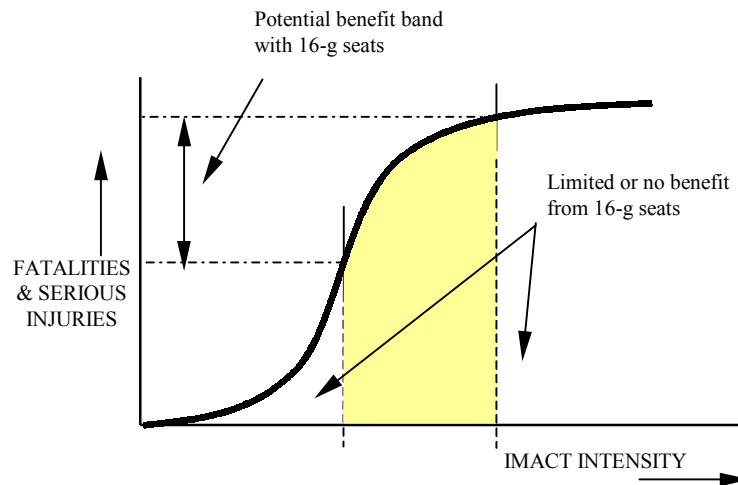
From a previous study [1], it was suggested that the proportion of fatal and serious injuries in an accident scenario was of a form similar to that shown in figure 4. It is evident that there will not be any benefit from the introduction of 16-g seats when the impact intensity is beyond their level of resilience. Furthermore, at impact intensities below those sustainable by 9-g seats, there would be little benefit beyond that afforded by improvements to seat design associated with the enhanced Head Injury Criteria.

FIGURE 4. POTENTIAL LIVES SAVING WITH 16-g SEATS

This limits the number of ground impact related accidents that would benefit from the introduction of 16-g seats.

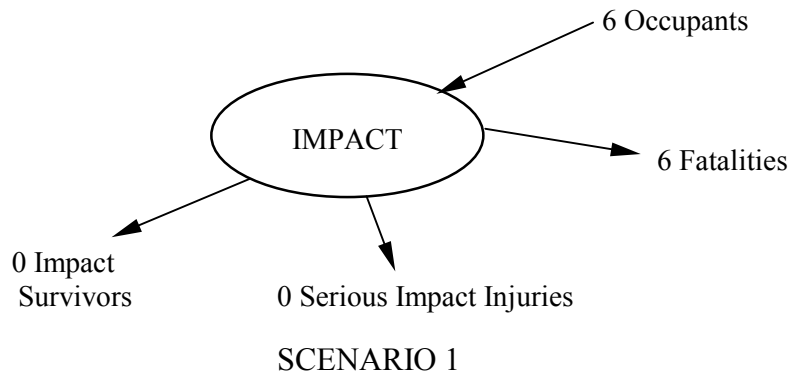
**Scenario 1** is the area occupied by the flight and cabin crew. It is assumed that all perished as a direct result of the impact.

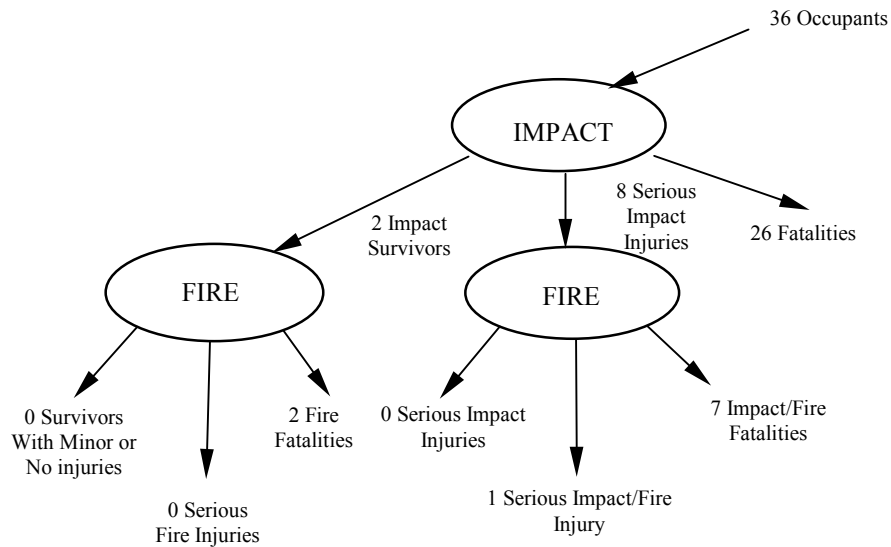
SCENARIO 2

**Scenario 2** is the forward part of the passenger cabin in which it is assessed there were 36 passengers. Based on the statements in the accident report the survivability chain is as follows:

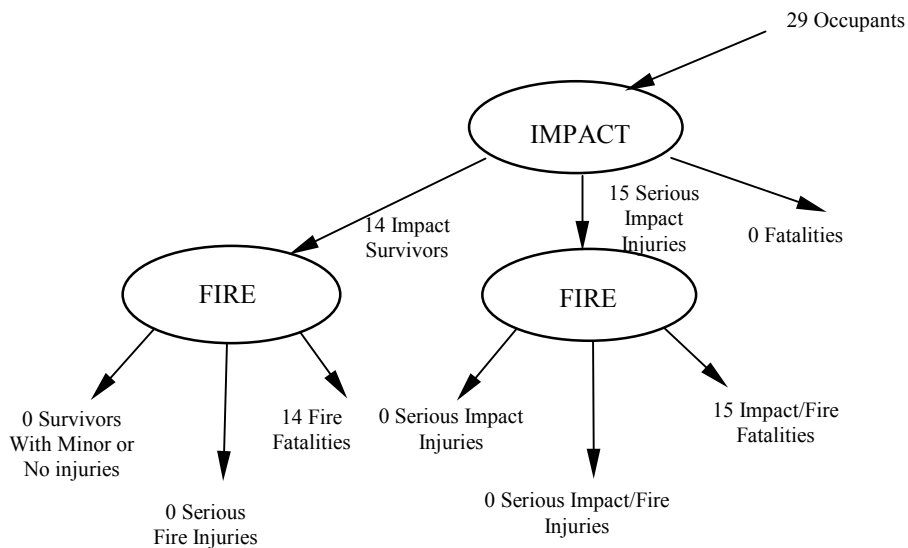
SCENARIO 3

**Scenario 3** is the aft part of the passenger cabin in which it is assessed that the remaining 29 passengers were located. Based on the statements in the accident report the survivability chain is as follows:

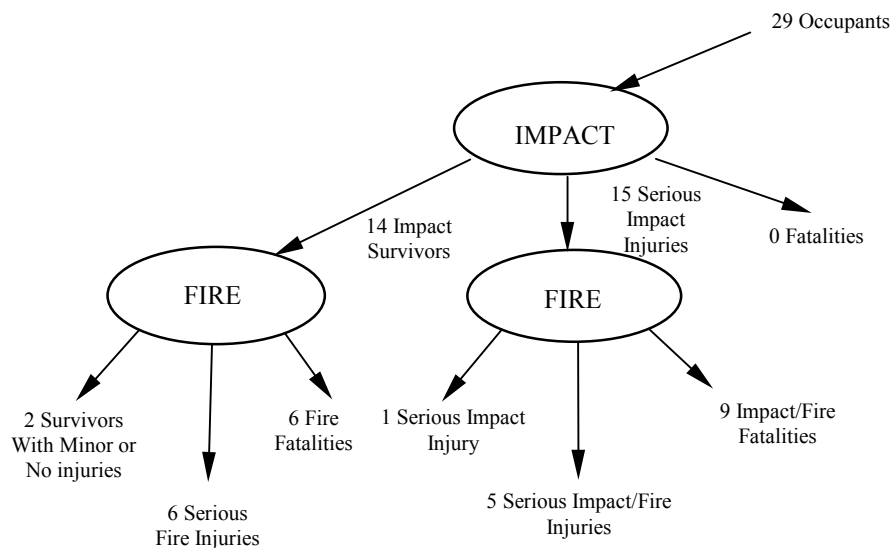
Furthermore from the analytical study described in reference 1 of the main report, it was suggested: “...the occupants that were injured by the impact had approximately half the chance of surviving the fire than the impact survivors.”

On this basis had the aircraft been configured to the latest standard of fireworthiness requirements the survivability chain for this scenario would be as follows:

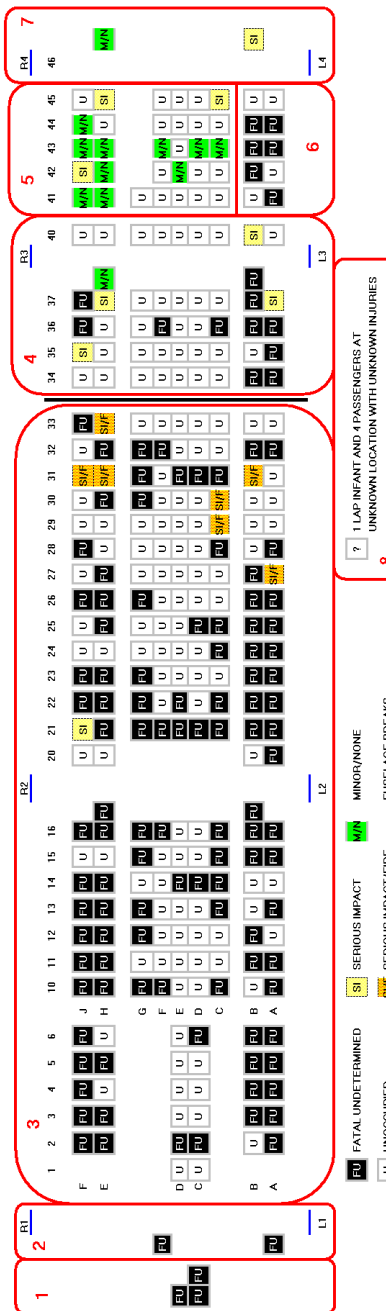
This accident is considered as having eight scenarios, as shown in figure A-1.

FIGURE A-1. LOCATION OF INJURIES AND SCENARIOS

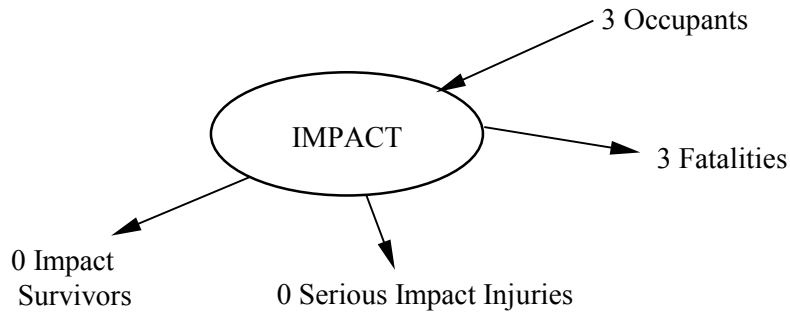
SCENARIO 1

**Scenario 1** represents the cockpit area containing three flight crewmembers. Since fire was reported only in the mid-section, it has been assumed that the flight crew suffered fatal injuries in the impact.

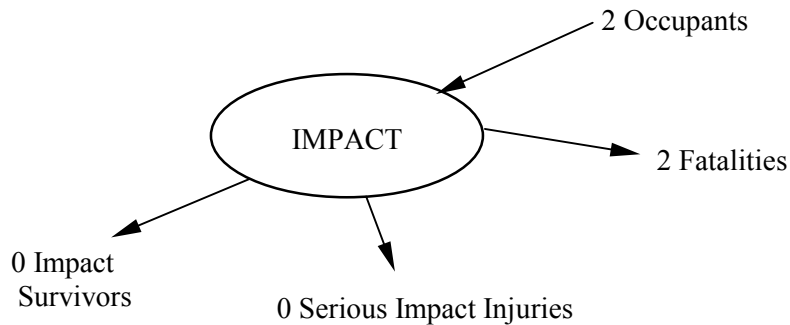
SCENARIO 2

**Scenario 2** represents the area occupied by the two forward flight attendants. Since fire was reported only in the mid-section, it has been assumed that the forward flight attendants suffered fatal injuries in the impact.

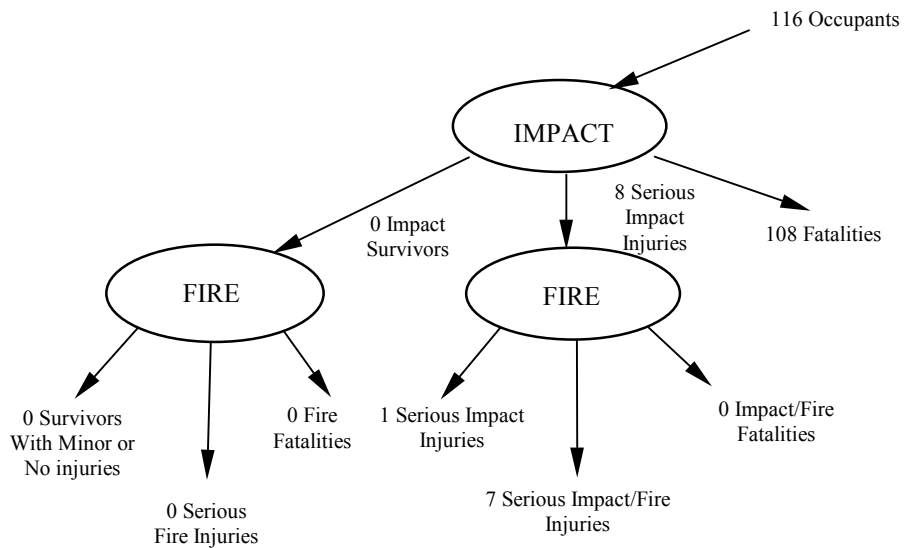
SCENARIO 3

**Scenario 3** represents the main cabin from seat row 1 to seat row 33 where the fuselage break occurred. Full details of occupant injury are not known but this area disintegrated after the aircraft struck water tanks and there is unlikely to be any benefit from the introduction of 16-g seats. Therefore the breakdown of injuries will have no bearing on the outcome of this analysis and all fatalities have been assumed to be from impact forces.

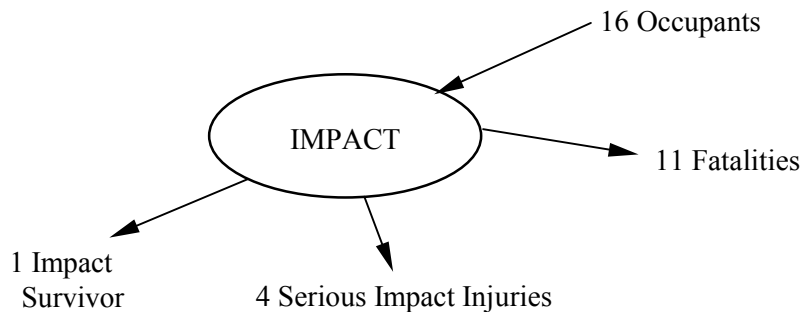
SCENARIO 4

**Scenario 4** represents seat row 34 to seat row 40, located at the front of the rear section and subjected to massive disruption of cabin floor, walls, and ceiling. Full details of occupant injury are not known but due to the extent of the cabin disintegration there is unlikely to be any benefit from the introduction of 16-g seats. Therefore the breakdown of injuries will have no bearing on the outcome of this analysis and all fatalities have been assumed to be from impact forces.

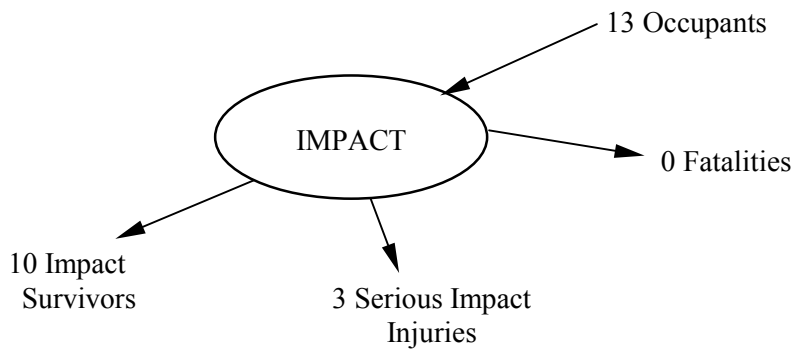
SCENARIO 5

**Scenario 5** represents the middle and right side sections of seat rows 41 to 45, which were relatively undamaged. Three occupants could not escape due to their impact injuries and were removed by fellow passengers and rescue personnel. Ten occupants reported minor or no injuries.

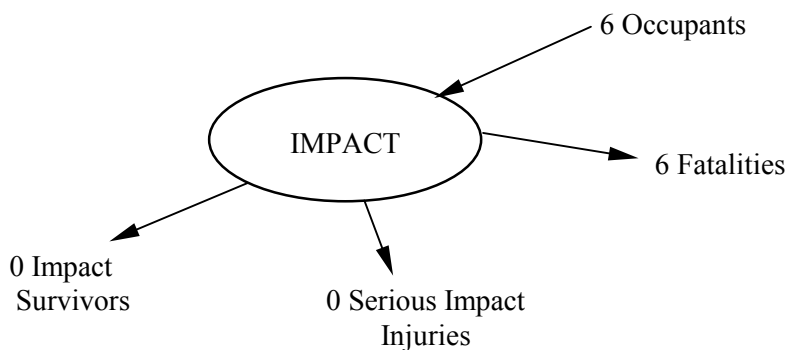
SCENARIO 6

**Scenario 6** represents the left side of seat rows 41 to 45. The left wall was missing and the six occupants who were seated next to the wall suffered fatal injuries and these have assumed to have been caused by the impact forces that removed the wall.

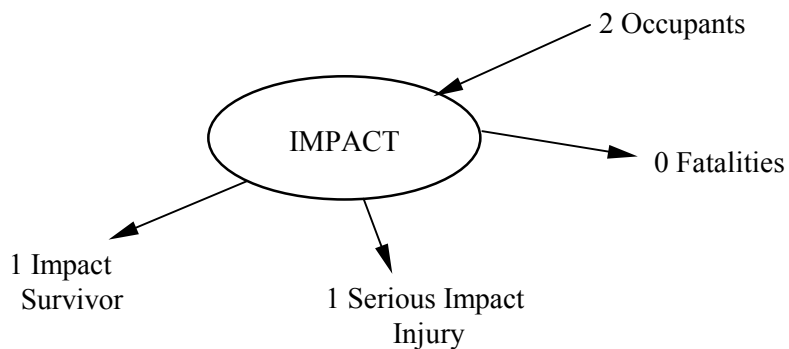
SCENARIO 7

**Scenario 7** represents the area containing the two rear flight attendants. One suffered serious injuries due to the impact and the other escaped with minor or no injuries.

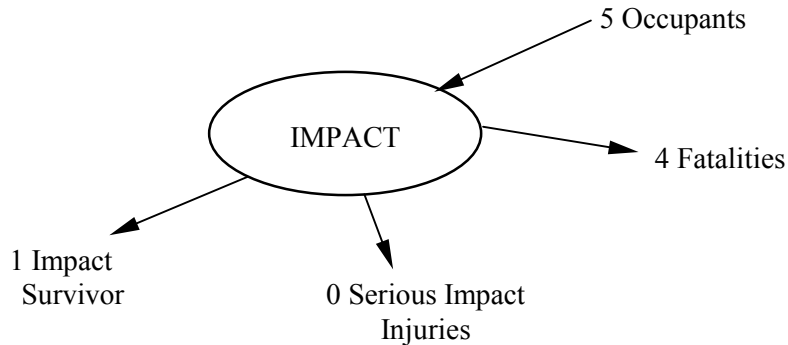
SCENARIO 8

**Scenario 8** contains the five occupants for which seat location and injury were unknown. Absence of information results in the following simplified survivability chain. It was reported that 26 passengers and 3 cabin attendants survived the accident. However in figure A-1 the injury location diagram only identified 25 passengers and 3 cabin attendants. Therefore, 1 of the unknown seat location passengers must have received minor or no injuries since it was not significant enough to be reported officially.

The four unknown seat location passengers have been assumed to have died from the impact. This is consistent with the destruction of the aircraft.

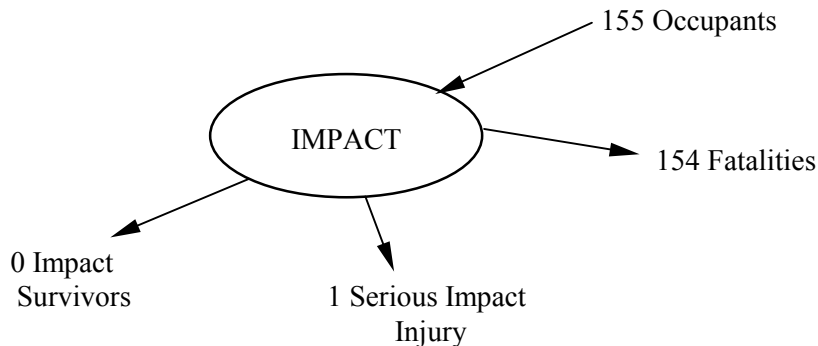
Due to the massive disintegration of the fuselage structure, this accident was considered as a single scenario, encompassing the whole cabin.

This accident involved a considerable impact and the cabin area disintegrated during the crash sequence. It was reported that all of the passenger seats were separated from the fuselage and were scattered along the wreckage path. In addition, external examination of the occupants showed that all had sustained multiple injuries. Therefore, due to this large amount of structural disruption, it is assessed that the introduction of 16-g seats would not have provided any additional benefit in this accident.

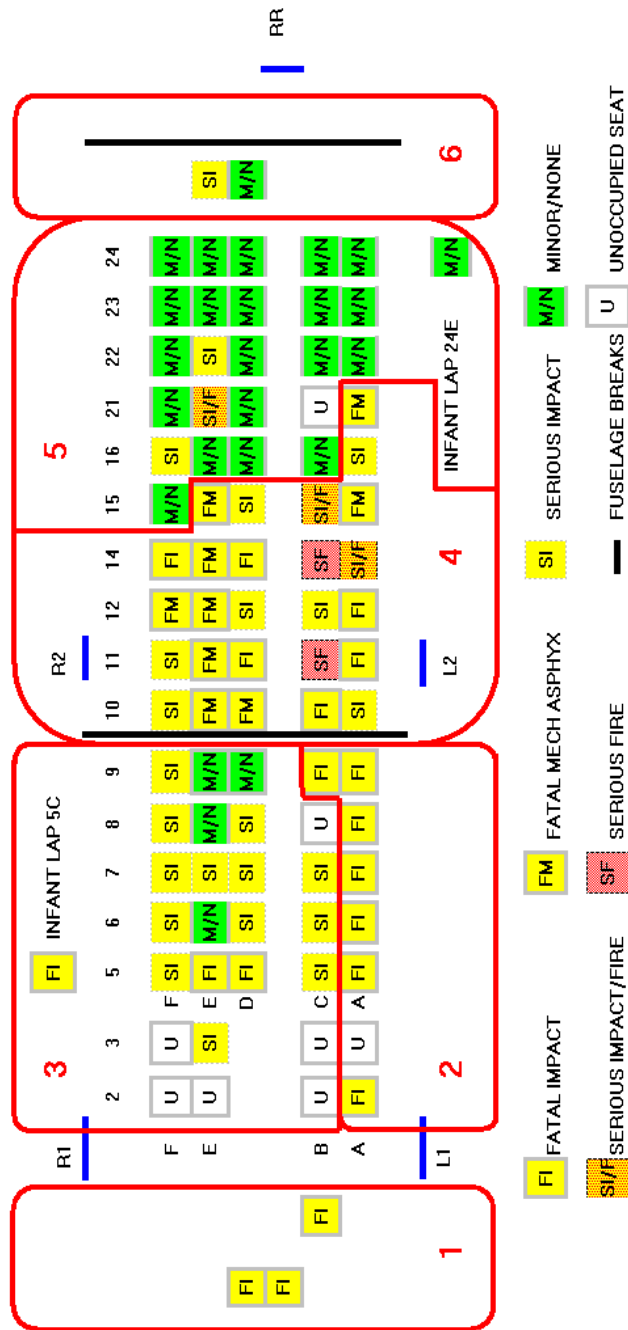
This accident is divided into six separate scenarios, as shown in figure A-2.

FIGURE A-2. LOCATION OF INJURIES AND SCENARIOS

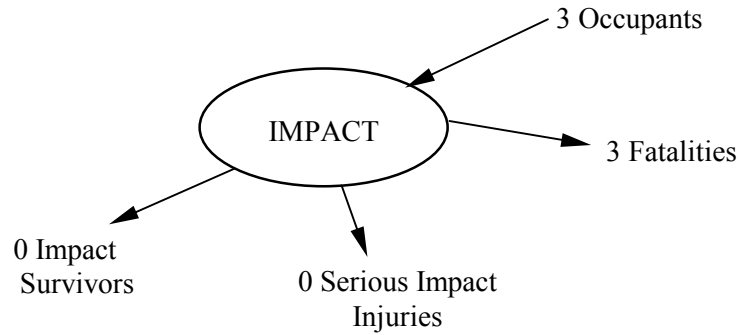
SCENARIO 1

**Scenario 1** contains the flight deck and the vestibule where two flight crew and one cabin attendant died from impact injuries.

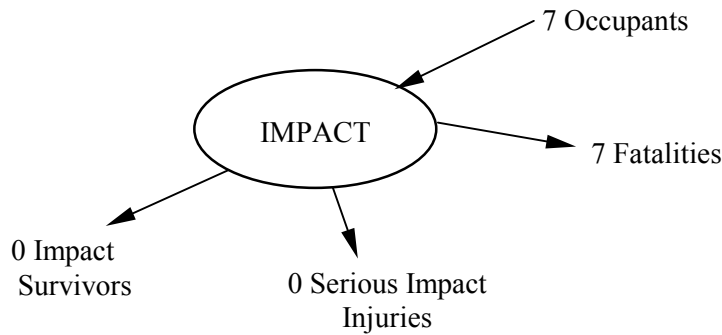
SCENARIO 2

**Scenario 2** contains the forward left side of the fuselage, seats 2A to 9A and 9C, where there were seven impact fatalities. Conditions for passengers seated in these seats are considered nonsurvivable due to the severe damage in this area. The forward fuselage came to rest on its left side and it was badly damaged. This included loss of some areas of the floor and ceiling. Much of the exterior skin and underlying structure was torn away and found along the wreckage path.

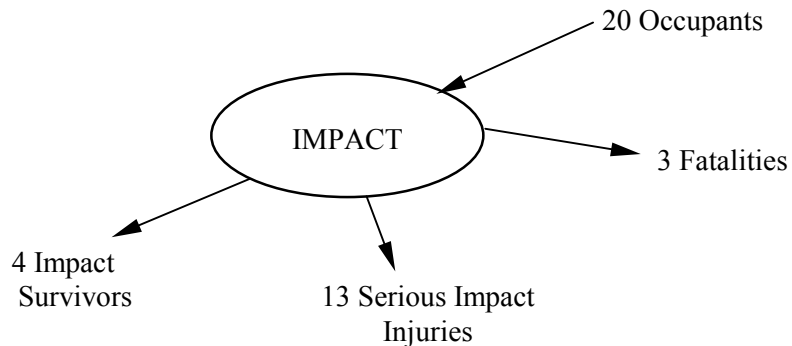
SCENARIO 3

**Scenario 3** contains rows 2 to 9 on the right side and seats 2B to 8B. The right side of the fuselage was distorted and dented in several places near the forward baggage door. Some passengers were thrown out of the cabin. There were 20 passengers in this section and 2 died from impact injuries, 13 suffered serious impact injuries, and 4 received minor or no injuries.

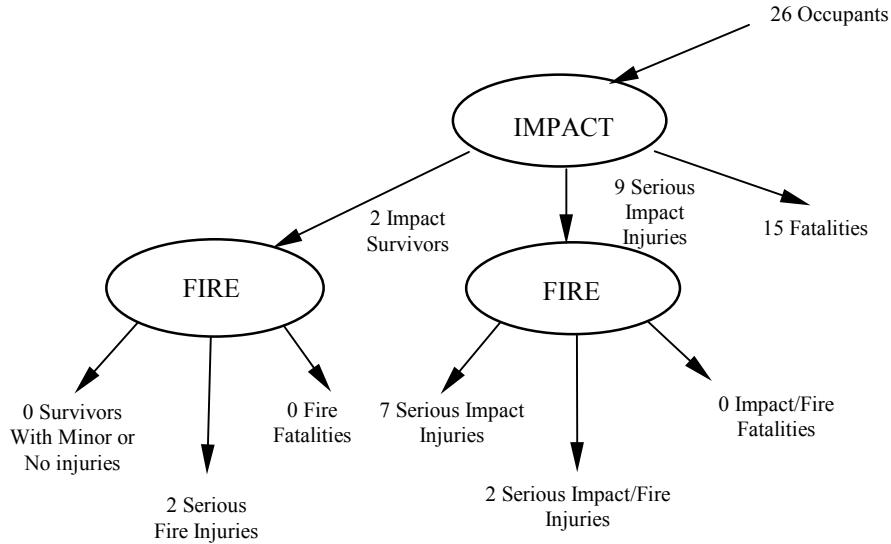
SCENARIO 4

**Scenario 4** contains rows 10 to 14, seats 15A, C, D, and E, 16A, and 21A. This section of the fuselage came to rest inverted. There were 26 passengers in this scenario. Nine died from mechanical asphyxiation, six died from impact injuries, seven suffered serious impact injuries, two suffered serious fire burns, and two suffered serious impact and fire burns.

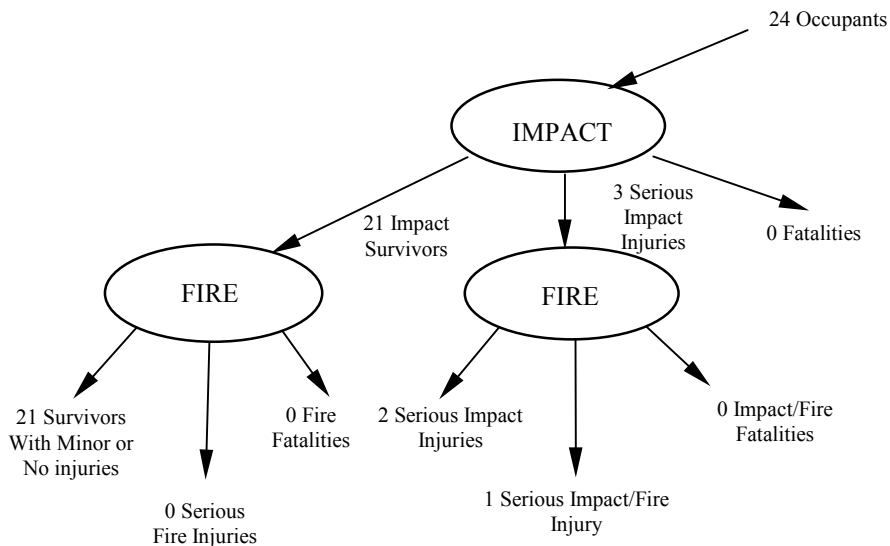
SCENARIO 5

**Scenario 5** contains passenger seats 15F, 16C, D, E, and F, 21C, D, E, and F and rows 22 to 24. This section of the fuselage came to rest inverted. There were 24 passengers in this scenario. Two suffered serious impact injuries, 1 suffered serious impact and fire burns, and 21 received minor or no injuries.

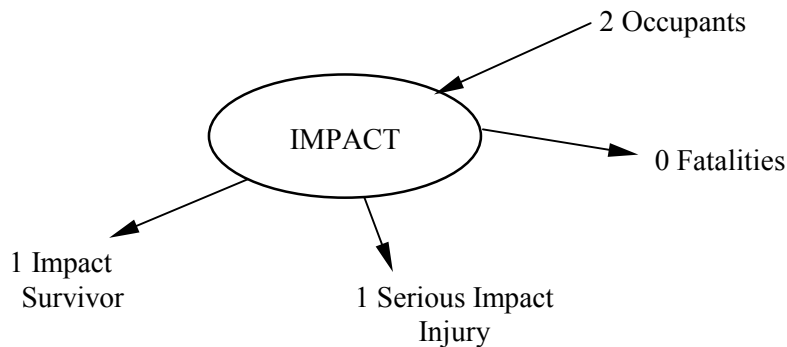
SCENARIO 6

**Scenario 6** contains the two flight attendants stationed at the rear of the aircraft. One flight attendant sustained serious impact injuries and the other received minor or no injuries.

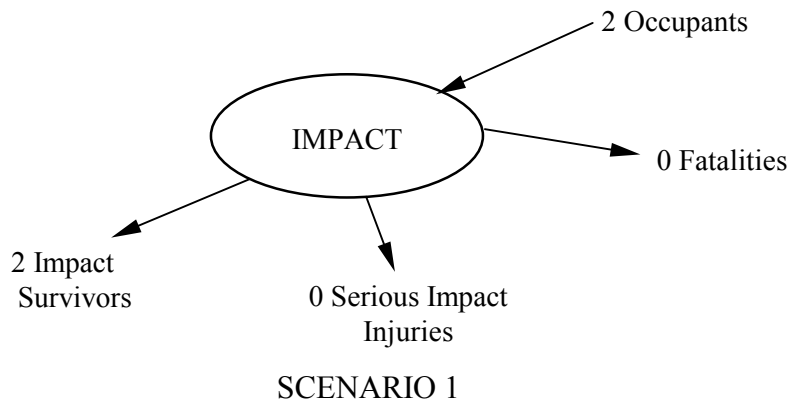
**Scenario 1** represents the cockpit area where the two flight crewmembers were located. Both flight crewmembers sustained minor or no injuries.

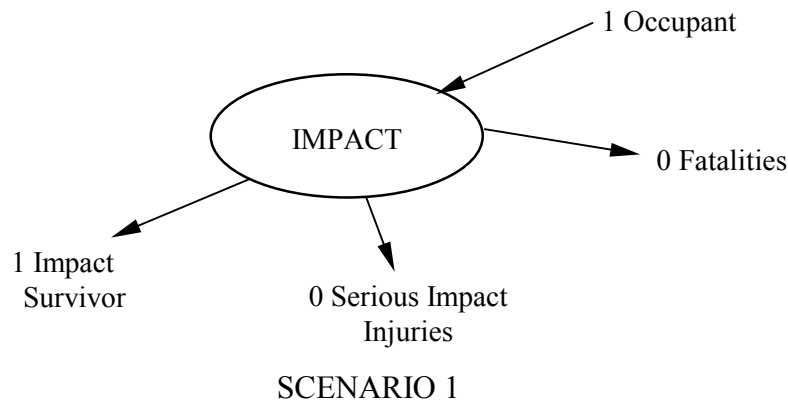
**Scenario 2** represents the forward vestibule area occupied by a flight attendant who sustained minor or no injuries.

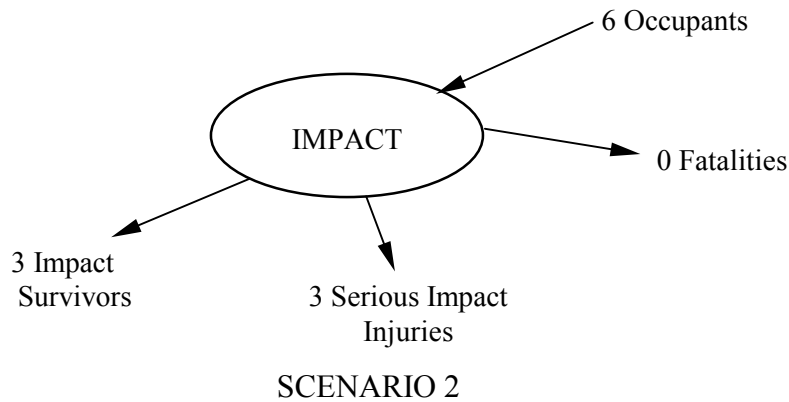
**Scenario 3** represents that portion of the passenger cabin containing seats 1DE, 2DE, and 3DE. This was reported to be the most heavily damaged area during impact with ground equipment. There were six occupants in this area, three sustained serious injuries, and three were uninjured. The survivability chain for this area is:

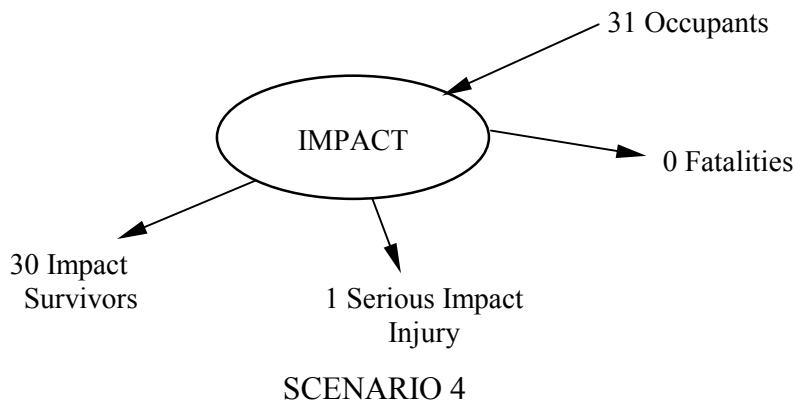
**Scenario 4** represents the remainder of the passenger cabin. There were thirty-one occupants in this area, one sustained serious injuries, and thirty were uninjured. The survivability chain for this area is:

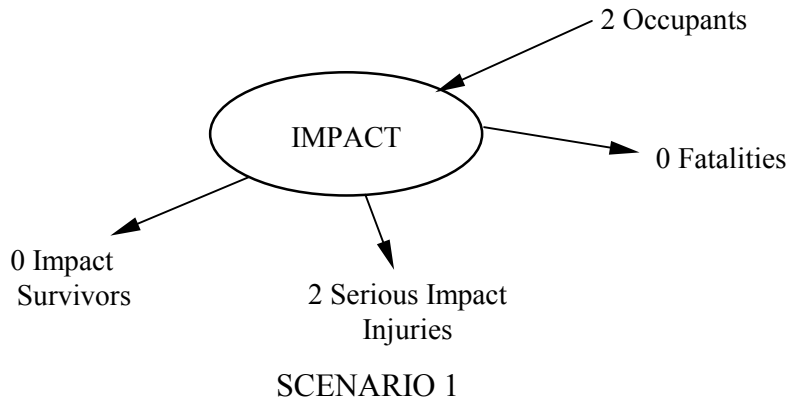
**Scenario 1** represents the flight deck area containing two-flight crew, both of whom were seriously injured. The survivability chain for this area is:

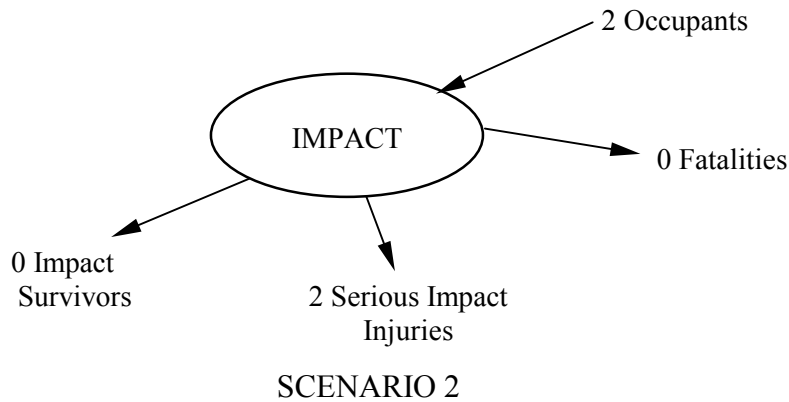
**Scenario 2** represents that area of the cabin in which the two forward flight attendants were located, both of whom were seriously injured. The survivability chain for this area is:

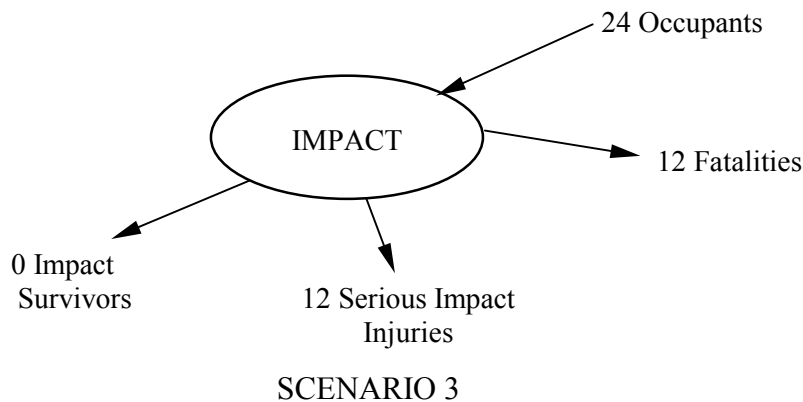
**Scenario 3** represents that portion of the passenger cabin between seat rows 1 and 5 inclusive. There were 24 passengers in this area, 12 sustained fatal injuries and 12 were seriously injured. The survivability chain for this area is:

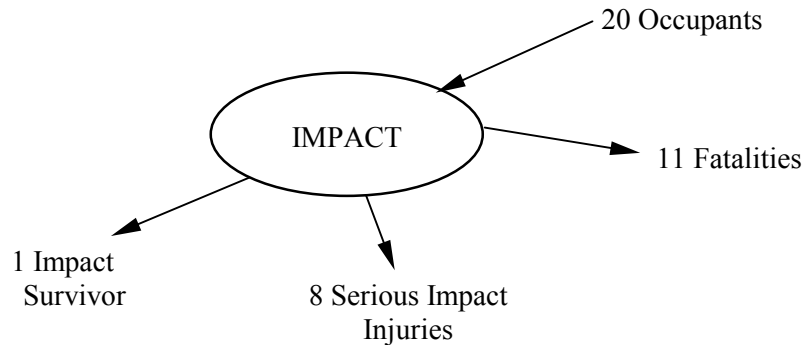
SCENARIO 4

**Scenario 4** represents that portion of the passenger cabin between seat rows 6 and 9 inclusive. There were 20 occupants in this area, 11 sustained fatal injuries, and 8 were seriously injured. The survivability chain for this area is:

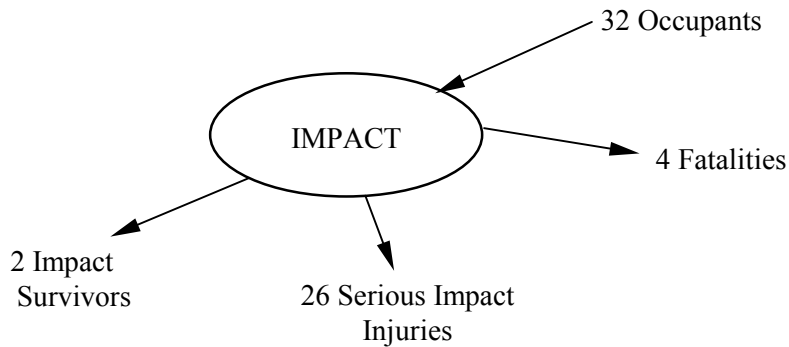
SCENARIO 5

**Scenario 5** represents that portion of the passenger cabin between seat rows 10 and 17 inclusive. There were 32 occupants in this area, 4 sustained fatal injuries, and 26 were seriously injured. The survivability chain for this area is:

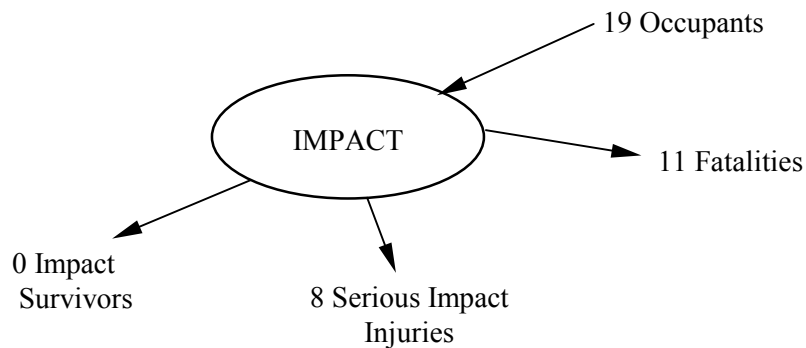
SCENARIO 6A

**Scenario 6A** represents that portion of the passenger cabin between seat rows 18 to 24 inclusive on the starboard side of the aircraft and the aisle seats on the port side in rows 19 to 23 inclusive. There were 19 occupants in this area, 11 sustained fatal injuries, and eight were seriously injured. The survivability chain for this area is:

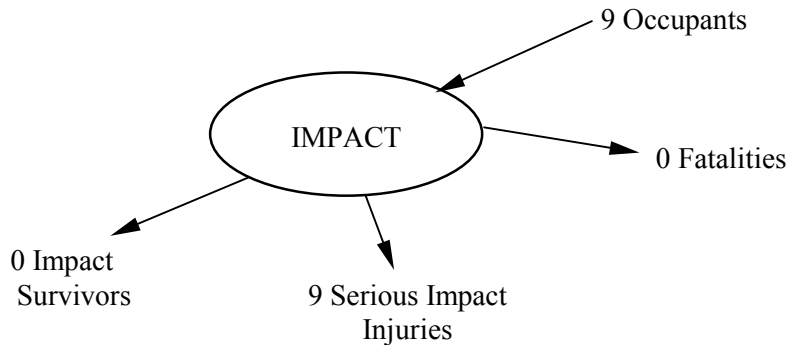
SCENARIO 6B

**Scenario 6B** represents that portion of the passenger cabin containing the port triple seat in row 18 and the port centre and window seats in rows 18 to 23 inclusive. There were nine occupants in this area all of who were seriously injured. The survivability chain for this area is:

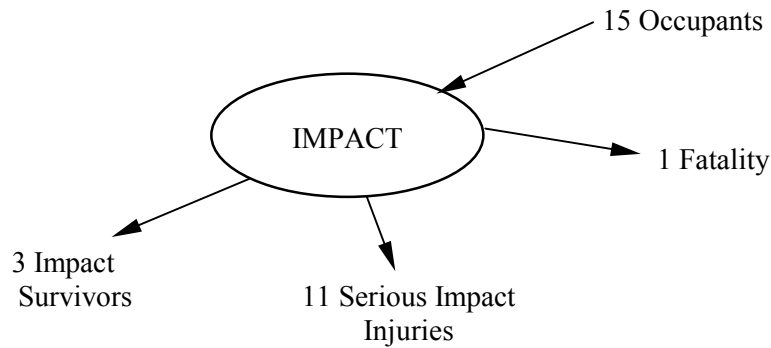
SCENARIO 7

**Scenario 7** represents that portion of the passenger cabin from seat rows 25 to 27 on the starboard side and seat rows 24 to 27 on the port side. There were 15 passengers in this area, 1 of whom sustained fatal injuries, and 11 were seriously injured. The survivability chain for this area is:

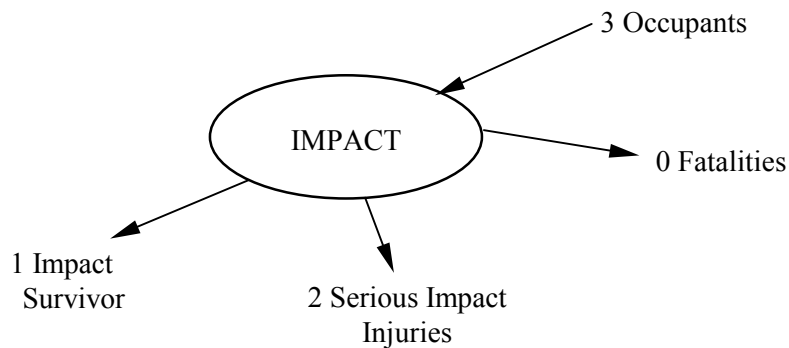
SCENARIO 8

**Scenario 8** represents that area of the cabin in which the three aft flight attendants were located, two of who were seriously injured and one survived uninjured. The survivability chain for this area is:

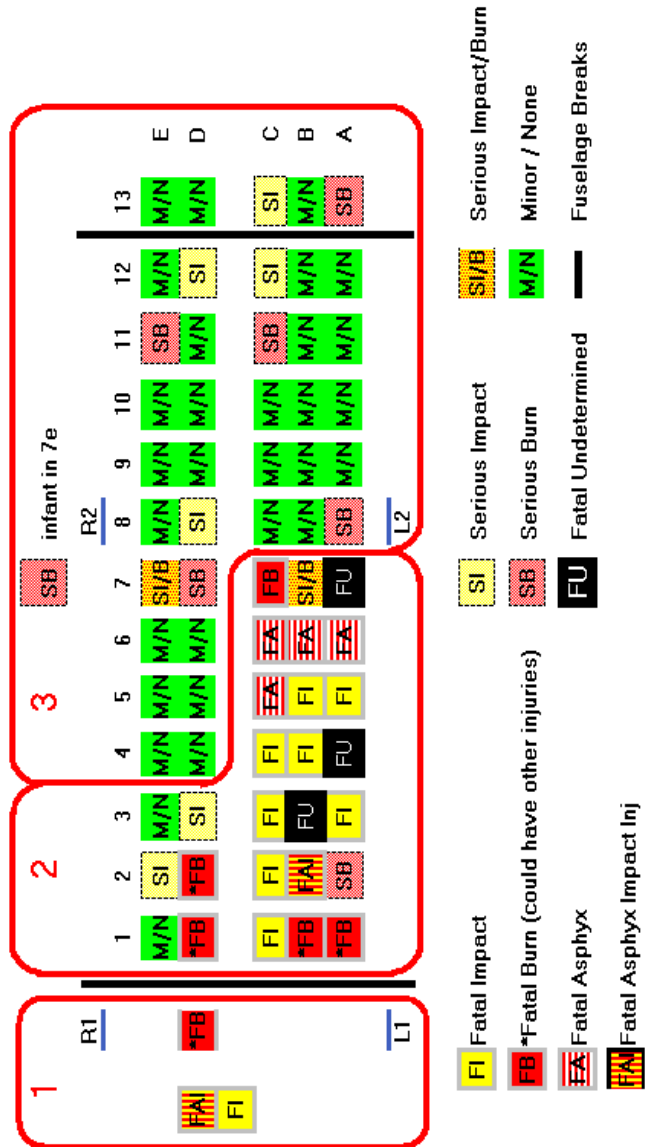
FIGURE A-5. LOCATION OF INJURIES AND SCENARIOS

This accident is divided into three separate scenarios, as shown in figure A-5.

It should be noted that since the g levels in this area were assessed to have exceeded 16 g's, no benefit is assigned from an improved seat standard. If these were not the case, scenario 2 would have been divided into smaller scenarios.

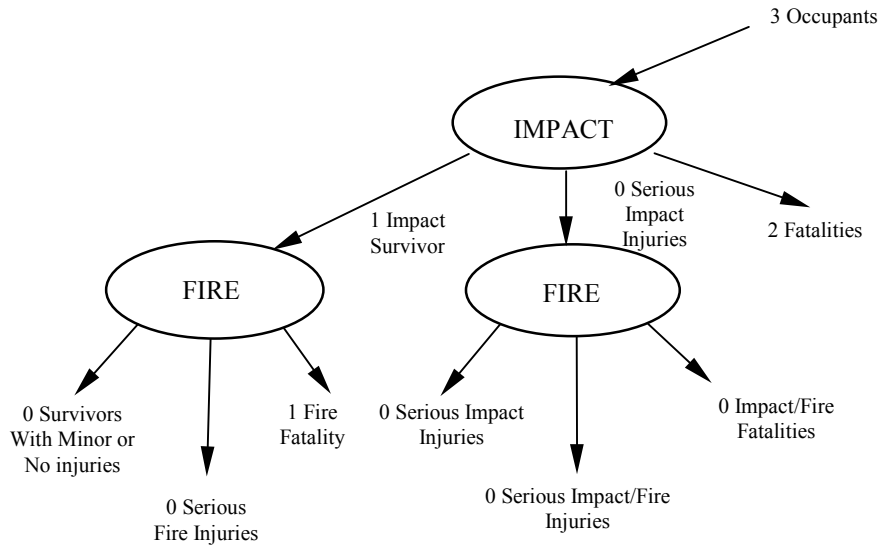
SCENARIO 1

**Scenario 1** contains the flight deck and vestibule where two flight crew died from impact and 1 cabin attendant died from fire burns.

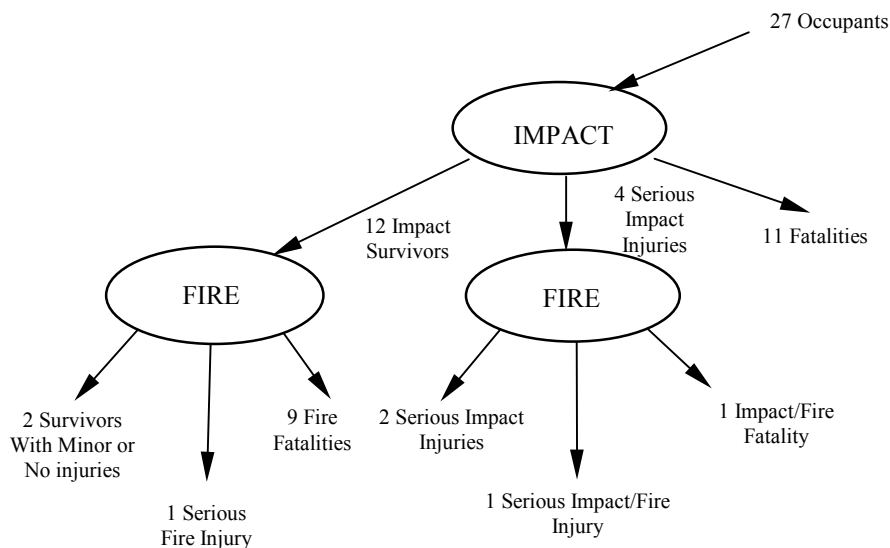
SCENARIO 2

**Scenario 2** contains the forward passenger cabin area (rows 1 to 3 and 4 to 7, seats A, B, and C) where there were eight impact-related fatalities, five fire burns fatalities, four asphyxiation/toxicity fatalities, one fatal impact/fire injury, three undetermined fatalities, two serious impact injuries, one serious fire injury, and one serious impact/fire injury. The aircraft accident report stated that the bodies recovered at the crash site were badly burned in the subsequent fire, which made it difficult to determine the various injuries and specific causes of death. Therefore it is assumed that those occupants who suffered fatal fire burns could have sustained other injuries before the bodies were burned; i.e., they might have died of impact but because the bodies were subsequently badly burned, the earlier injuries could not be identified.

The passenger seats in this section were severely deformed at the seat beams. The majority of these seats were subjected to deceleration forces with significant components in the sideward and downward directions during the final phase of the crash. Therefore it is assumed that the three undetermined fatal passengers died from impact injuries.

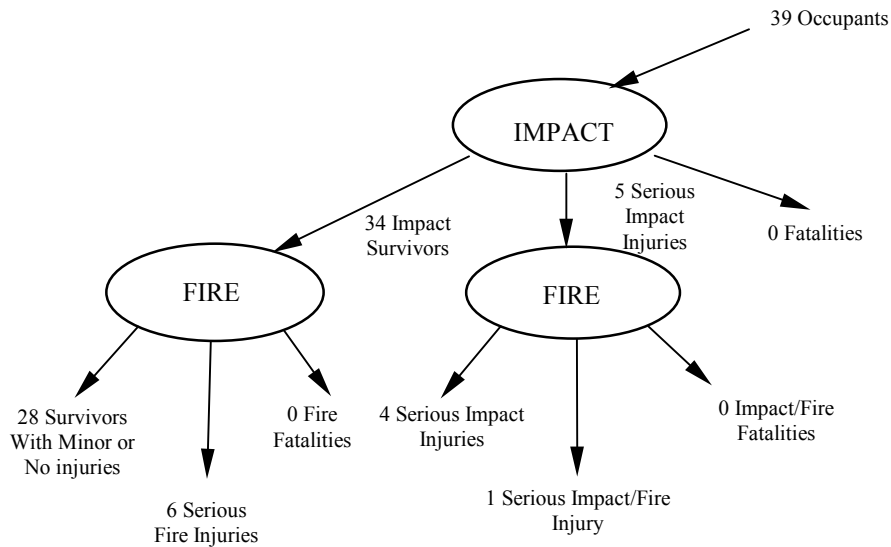
SCENARIO 3

**Scenario 3** contains the rest of the passenger cabin – Rows 8 to 13 and 4 to 7, seats D and E. This scenario contained 38 passengers plus 1 infant. From the injury profile, 4 passengers suffered serious impact injuries, 1 passenger suffered serious impact and fire injuries, 5 passengers and 1 infant suffered serious fire burns, and 28 passengers received minor or no injuries.

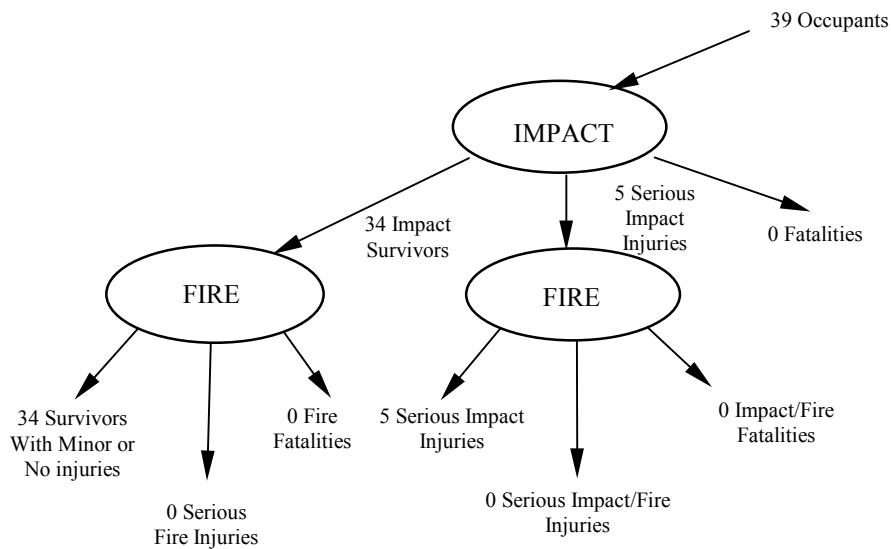
### SCENARIO 3

The aircraft was configured with fire-blocking seat cushions but the cabin materials did not meet the heat release standards required by current regulations. It is optimistically assumed that had the cabin materials met the current regulations there would have been no fire injuries in this scenario. The survivability chain is therefore modified as follows:

With 16-g seats the number of serious impact injuries in this section might have been reduced. On this basis, the best estimate is that the five passengers with serious impact injuries would have been saved.

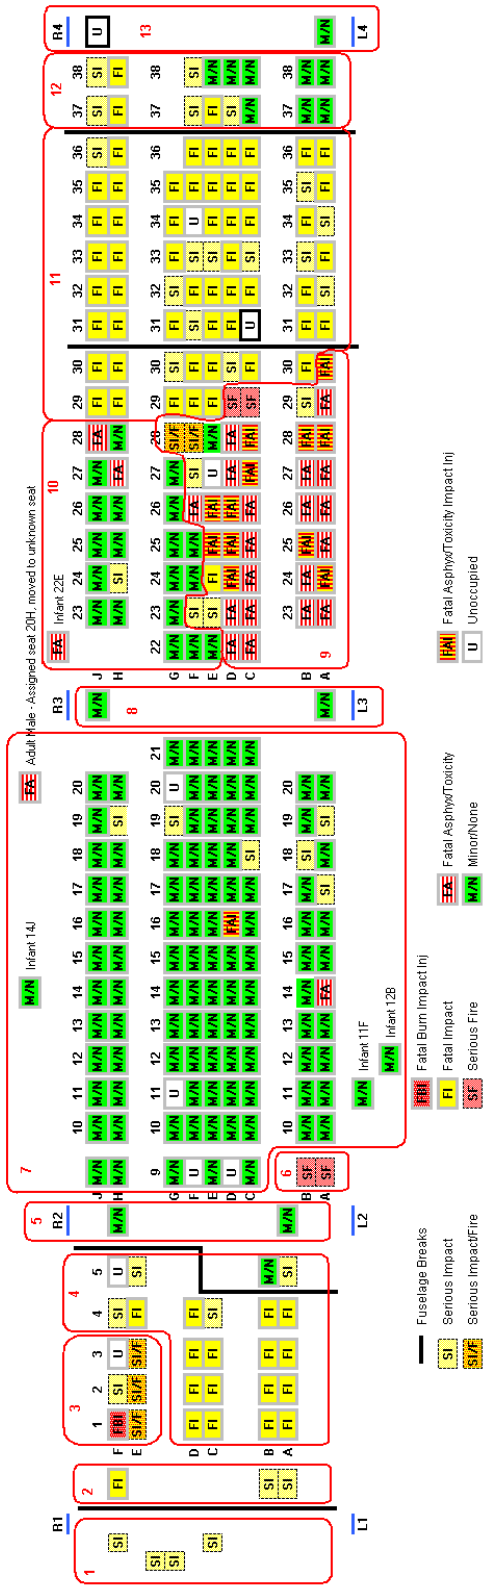
FIGURE A-6. LOCATION OF INJURIES AND SCENARIOS

This accident is considered as having thirteen scenarios, as shown in figure A-6. It should be noted that of the 285 passengers, detailed information from the accident report is provided for only 284.

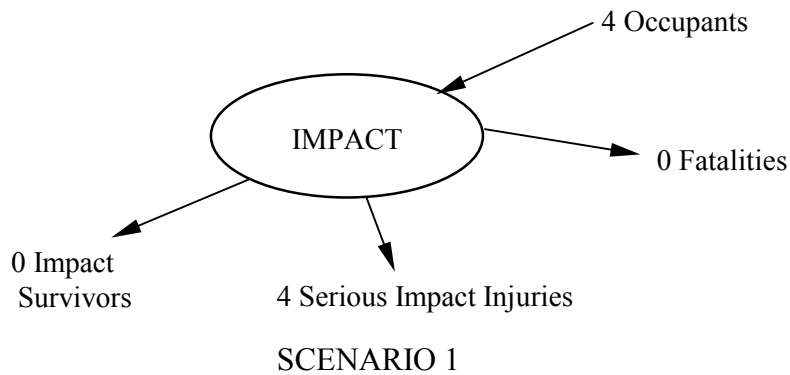
**Scenario 1** represents the cockpit area where it is assessed that the three flight crewmembers and the occupant of the jump seat were located—all of whom survived although serious impact injuries were encountered.

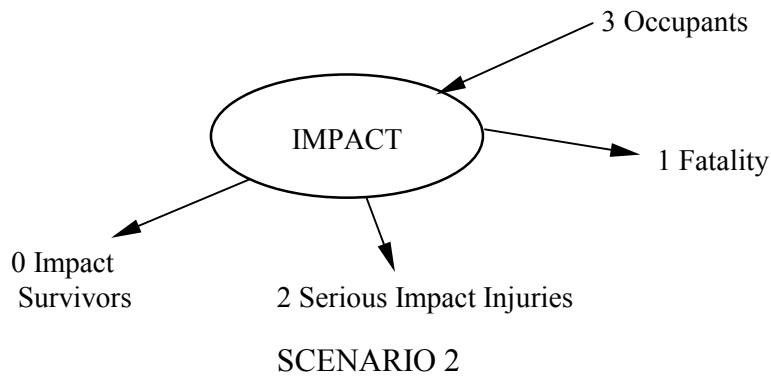
**Scenario 2** represents the area occupied by the forward flight attendants, one of whom sustained fatal impact injuries and the remaining two sustained serious impact injuries.

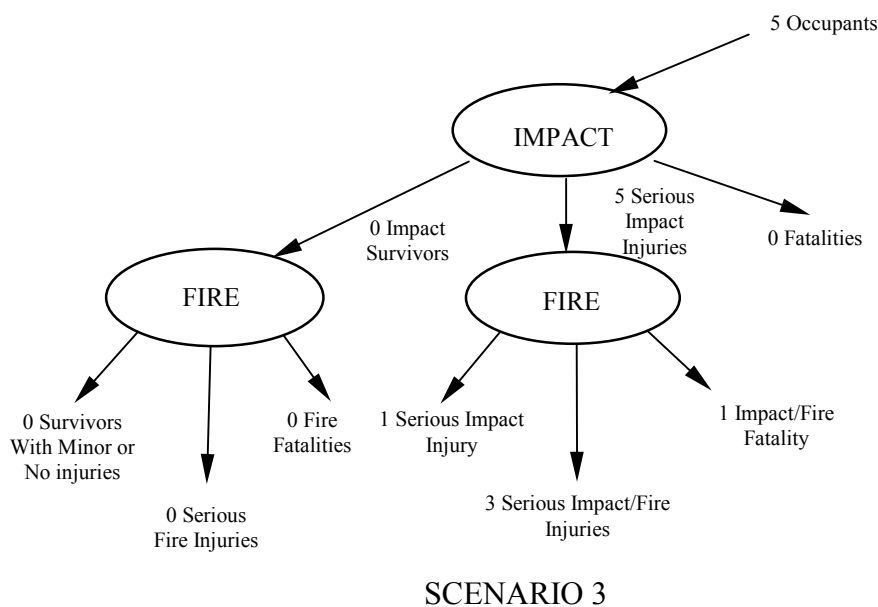
**Scenario 3** represents seats 1E, 1F, 2E, 2F, 3E, and 3F. There were five occupants of this scenario, one of who sustained fatal injuries. The remaining four were seriously injured.

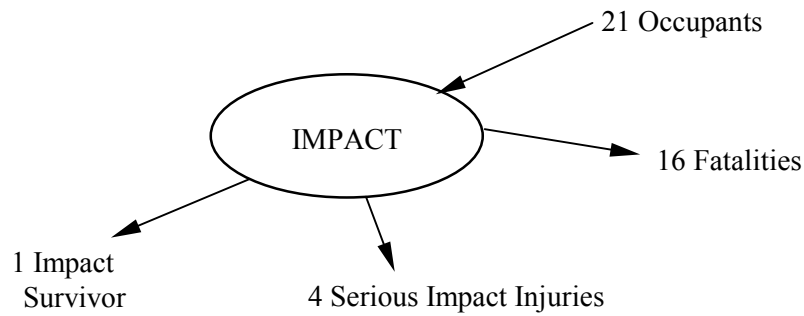
SCENARIO 4

**Scenario 4** represents the remainder of the first-class cabin. It is assessed that this portion of the cabin contained 21 occupants of whom 16 sustained fatal injuries as a result of impact trauma.
