**DOT/FAA/AR-00/13**

# **Benefit Analysis for Aircraft 16-g Dynamic Seats**

Final Report

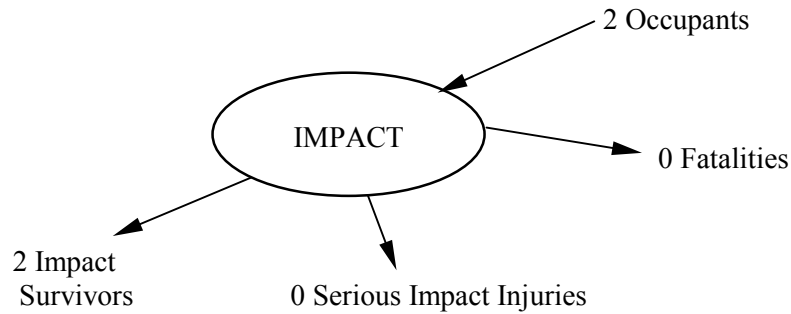
SCENARIO 5

**Scenario 5** represents the area occupied by the R2 and L2 flight attendants, both of whom escaped serious injury.

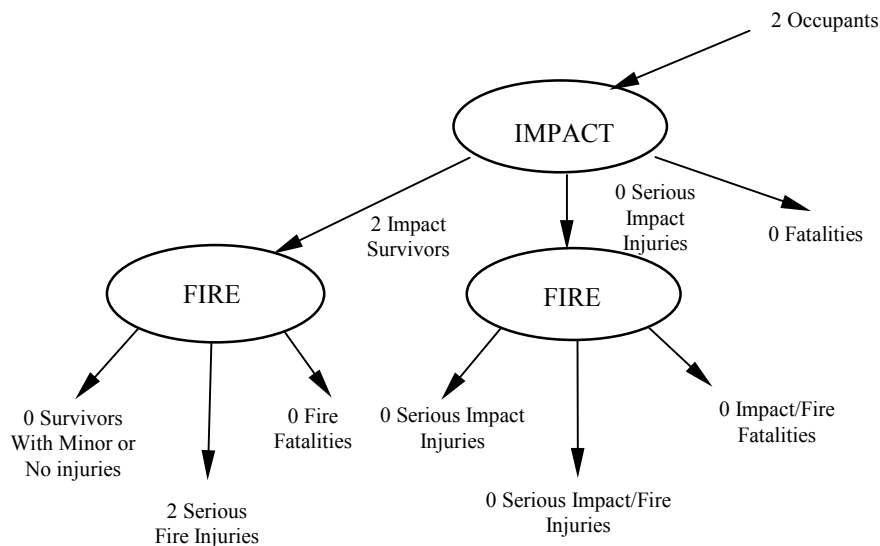
SCENARIO 6

**Scenario 6** represents the area in which seats 9A and 9B were located. The occupants of these seats both sustained serious burns.

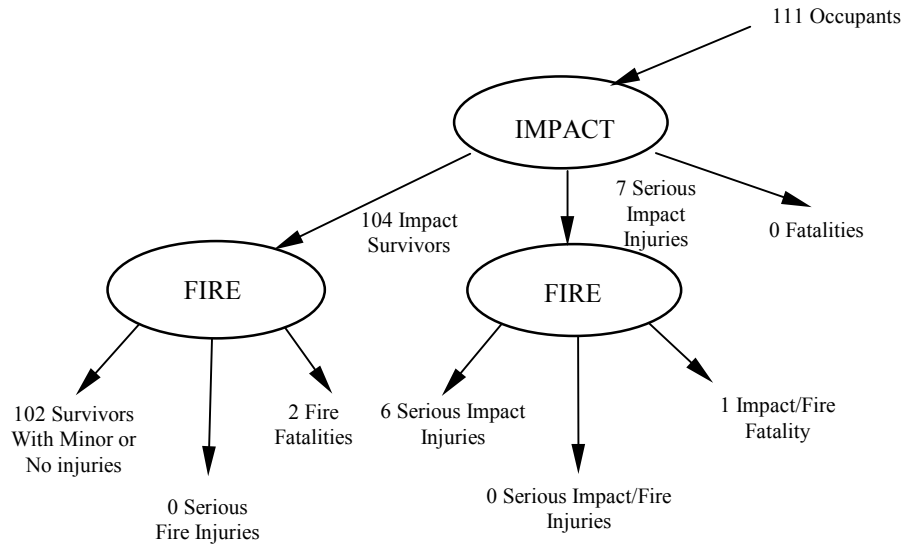
SCENARIO 7

**Scenario 7** represents the remainder of the passenger cabin from seat rows 9 to 21 inclusive. It is assessed that this portion of the cabin contained 111 occupants of which 3 were fatalities resulting from asphyxiation.

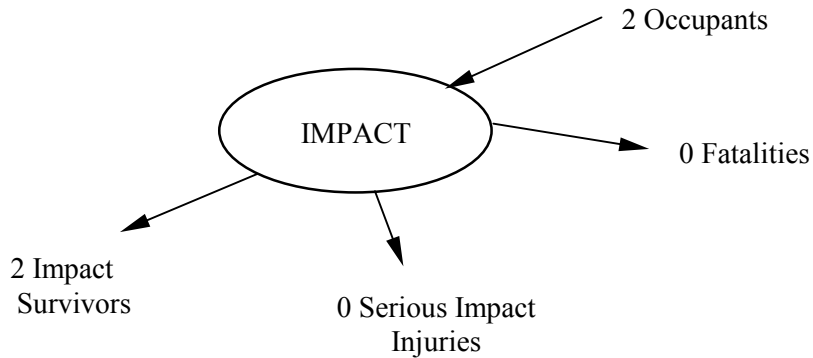
SCENARIO 8

**Scenario 8** represents the area occupied by the R3 and L3 flight attendants, both of whom escaped serious injury.

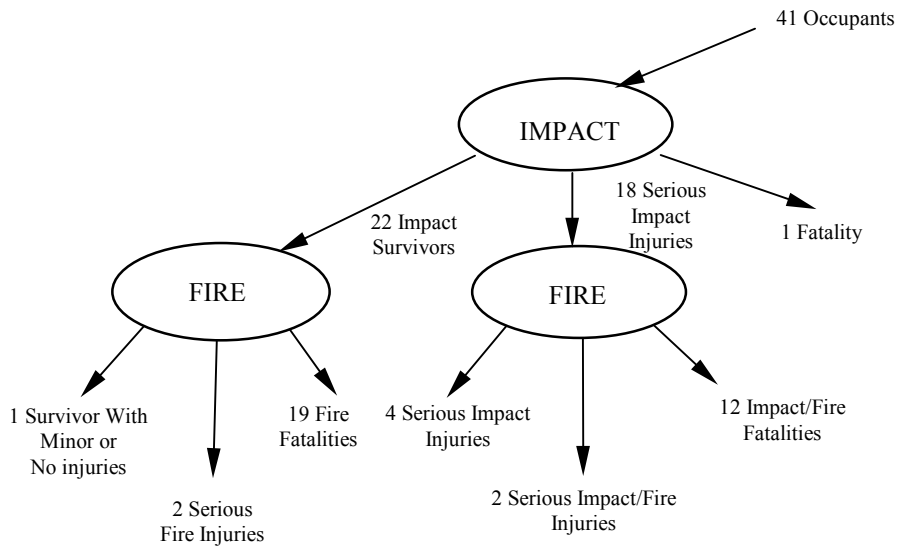
SCENARIO 9

**Scenario 9** represents the area of the main cabin in which the majority of occupants suffered fatal injuries from asphyxiation.

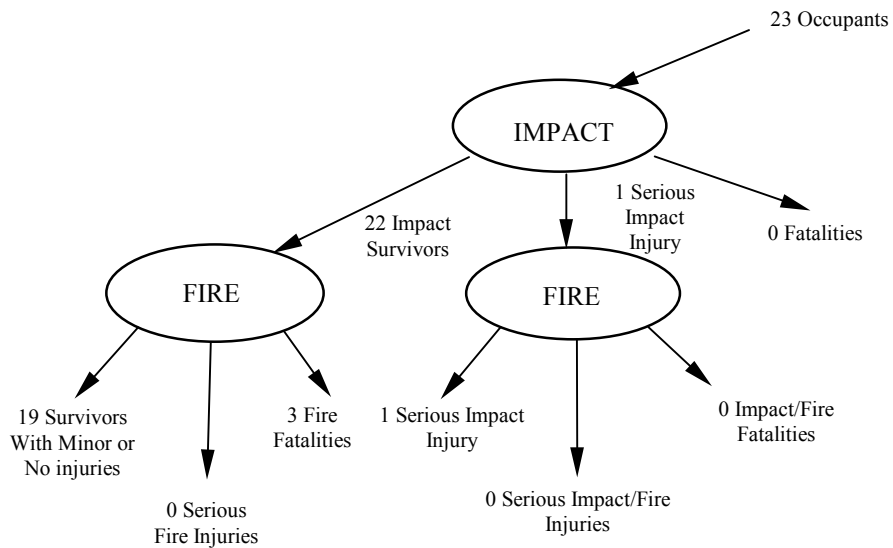
SCENARIO 10

**Scenario 10** represents the area of the main cabin directly opposite from Scenario 9, in which many occupants escaped with minor or no injuries.

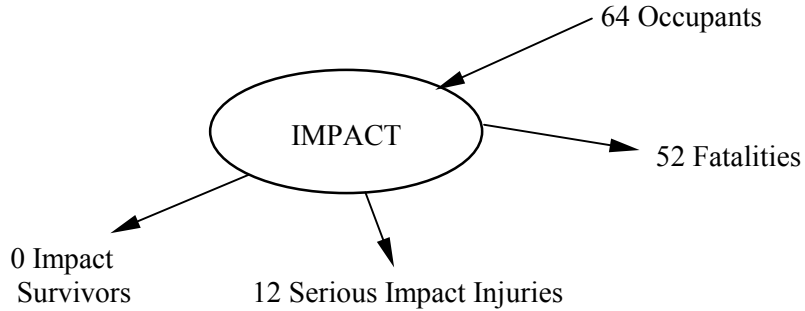
SCENARIO 11

**Scenario 11** represents the remainder of the passenger cabin aft to seat rows 36. It is assessed that this portion of the cabin contained 64 occupants of which 52 sustained fatal injuries as a result of impact trauma.

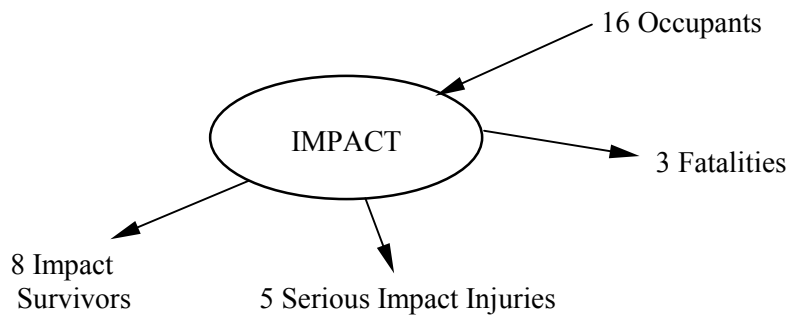
SCENARIO 12

**Scenario 12** represents the passenger cabin aft of seat row 36. It is assessed that this portion of the cabin contained 16 occupants of which 3 sustained fatal injuries as a result of impact trauma.

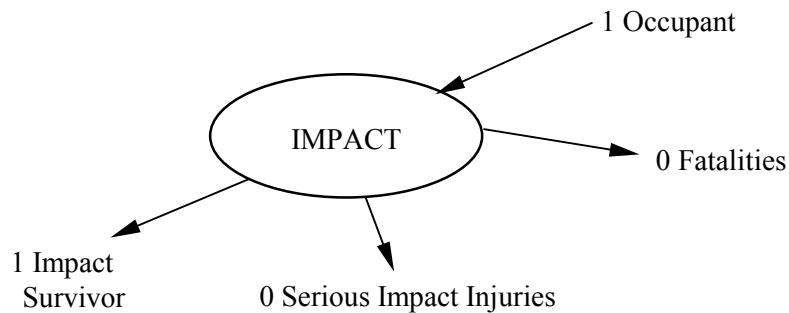
SCENARIO 13

**Scenario 13** represents the area occupied by the aft flight attendant, who escaped serious injury.

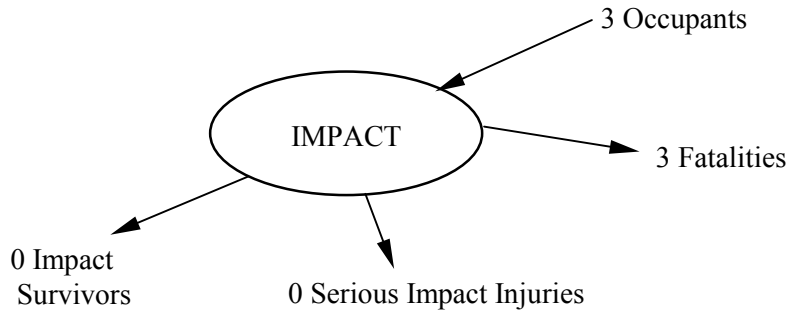
SCENARIO 1

**Scenario 1** represents the cockpit area where the three flight crewmembers were located.

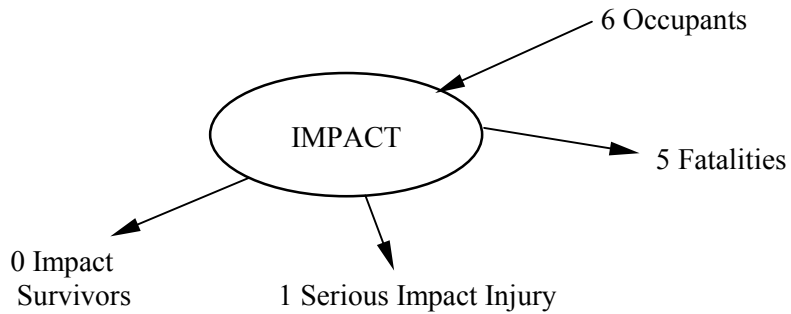
SCENARIO 2

**Scenario 2** represents the areas occupied by the flight attendants.

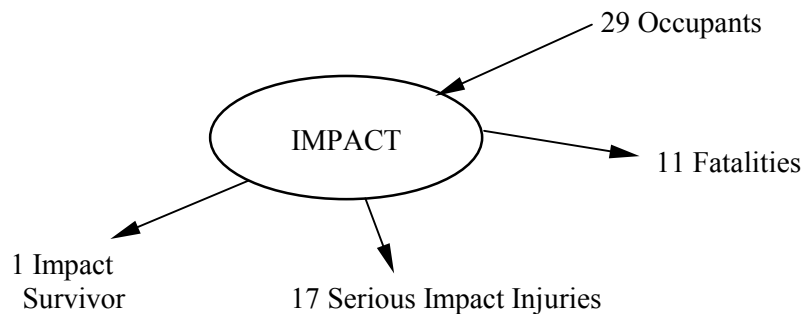
SCENARIO 3

**Scenario 3** represents passenger seat rows 1 through 8, which were located in the forward separated fuselage section.

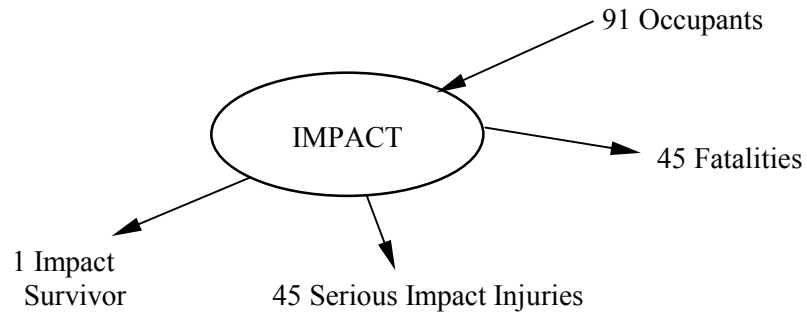
SCENARIO 4

**Scenario 4** represents passenger seat rows 9 through 24, located in the middle separated fuselage section.

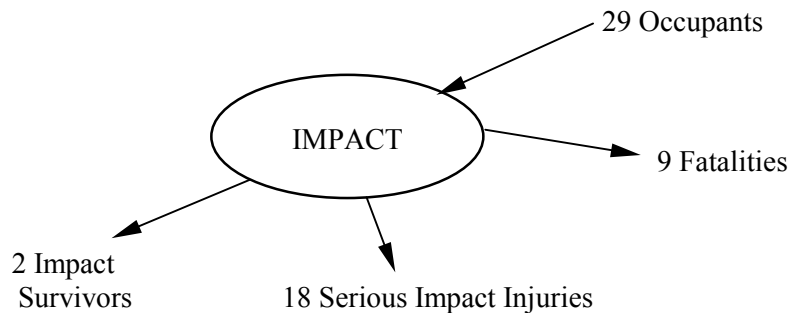
SCENARIO 5

**Scenario 5** represents passenger seat rows 25 through 29, located in the rear separated fuselage section.

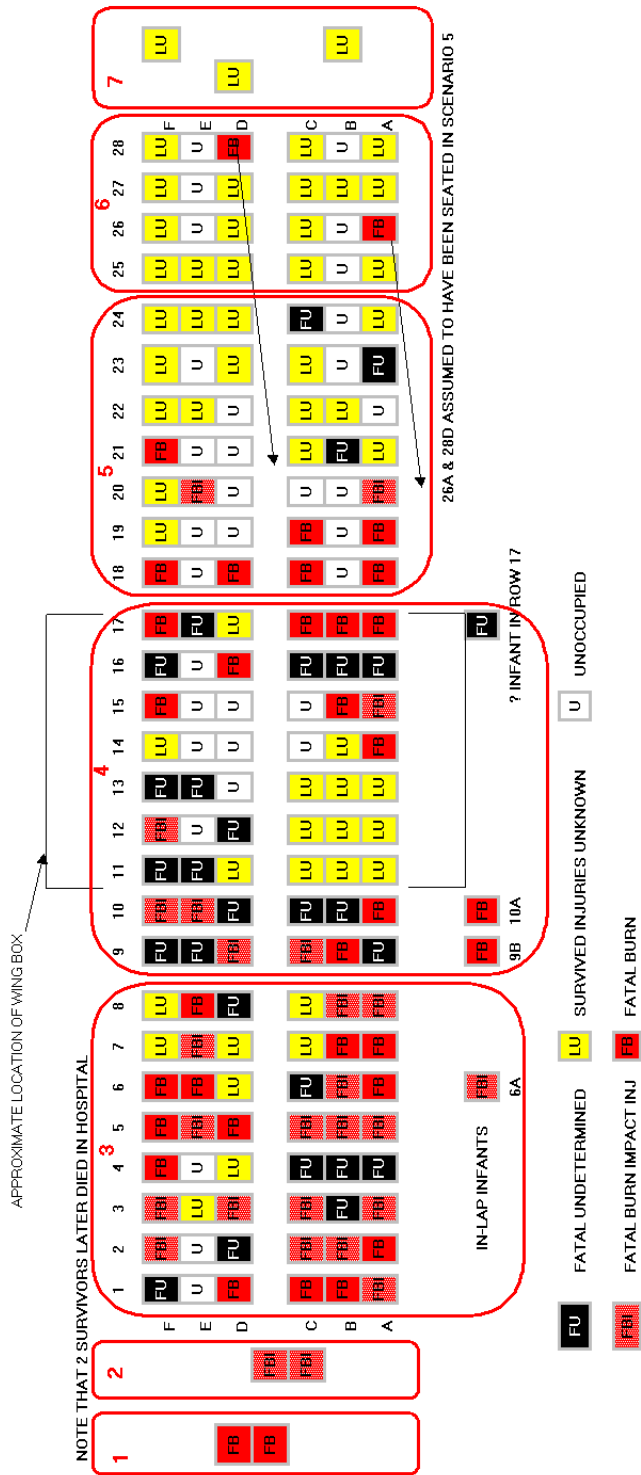
FIGURE A-8. LOCATION OF INJURIES AND SCENARIOS

This accident is considered as having seven scenarios, as shown in figure A-8.

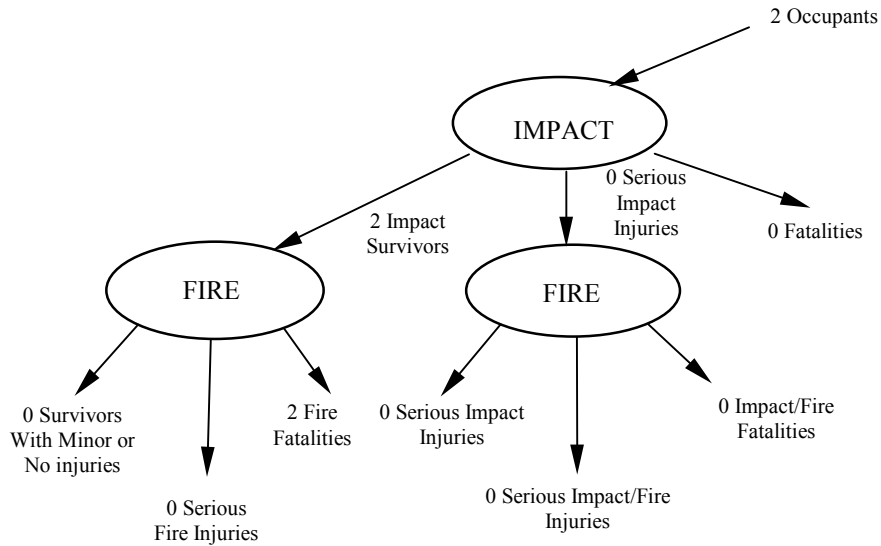
SCENARIO 1

**Scenario 1** represents the cockpit area containing two flight crewmembers, who suffered fatal injuries due to the fire.

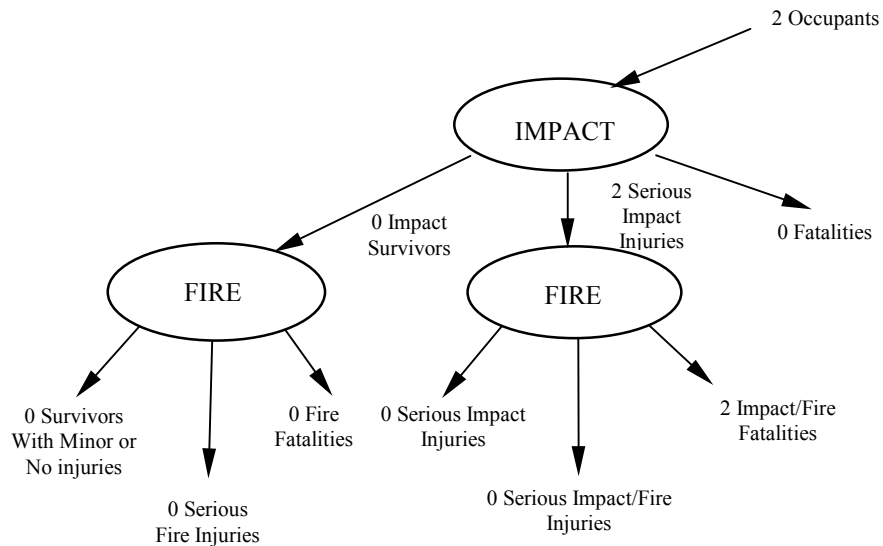
SCENARIO 2

**Scenario 2** represents the forward vestibule area containing two cabin crewmembers, who suffered fatal injuries due to impact and the fire.

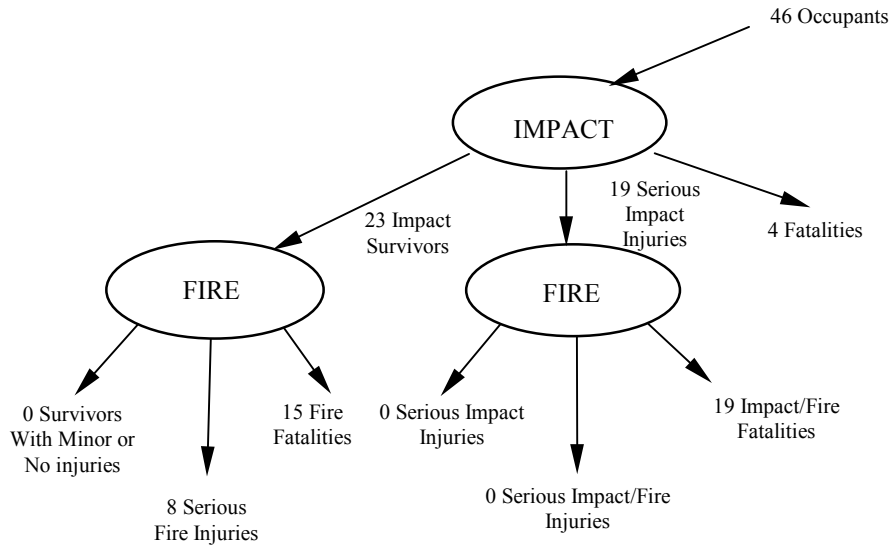
**SCENARIO 3**

**Scenario 3** represents passenger seat rows 1 through 8, containing 46 passengers.

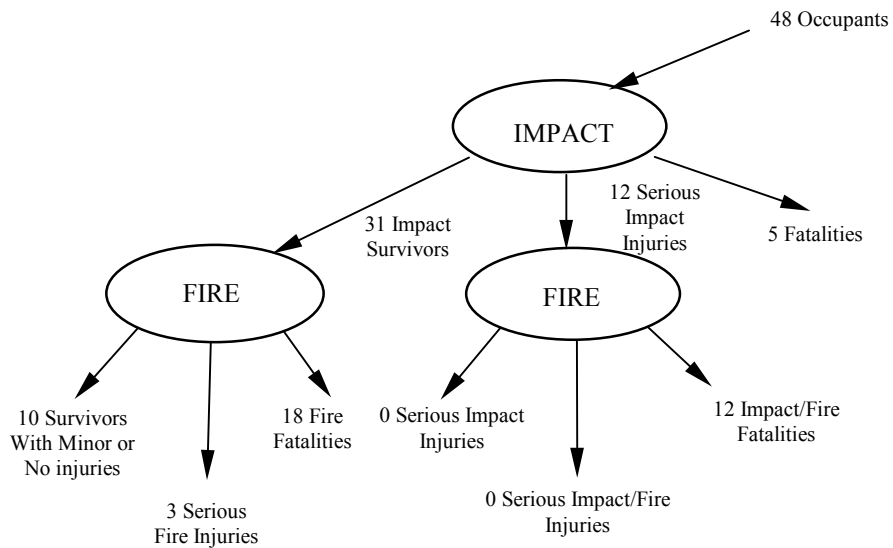
**SCENARIO 4**

**Scenario 4** represents passenger seat rows 9 through 17, containing 48 passengers.

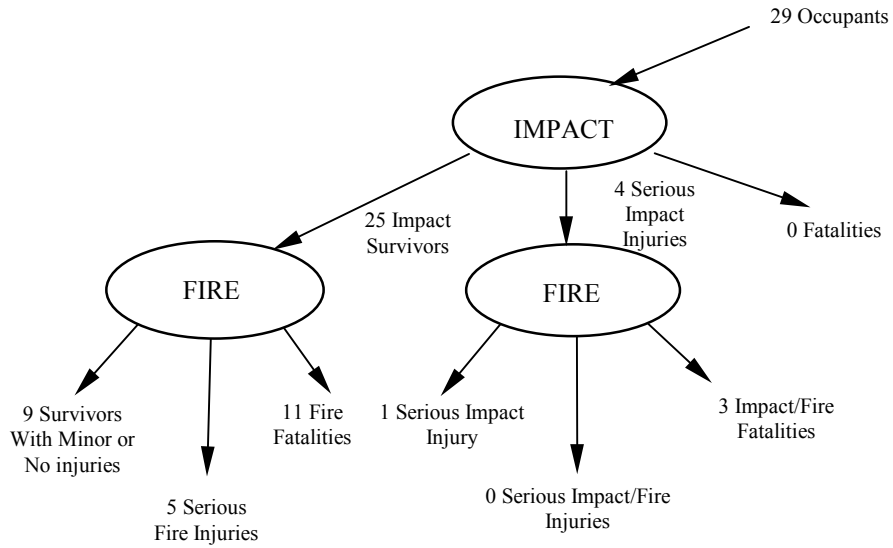
**SCENARIO 5**

**Scenario 5** represents passenger seat rows 18 through 24, containing 29 passengers.

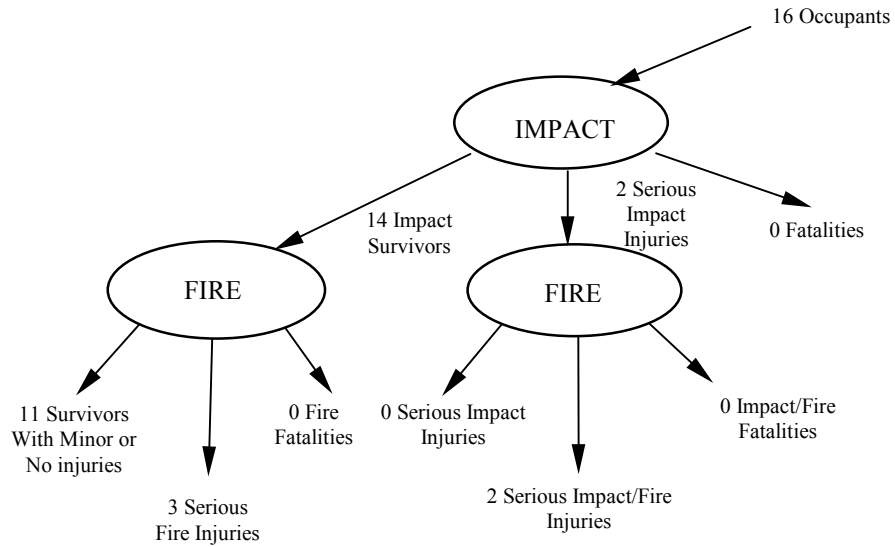
**SCENARIO 6**

**Scenario 6** represents passenger seat rows 25 through 28, containing 16 passengers.

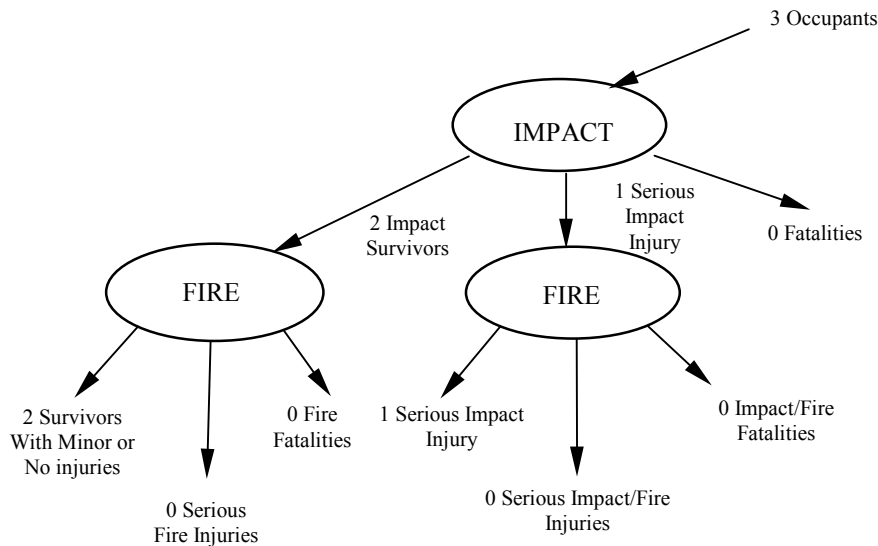
SCENARIO 7

**Scenario 7** represents the rear cabin crewmember area containing three cabin crew, one of which suffered serious injuries when hitting her head after being thrown out of her seat.

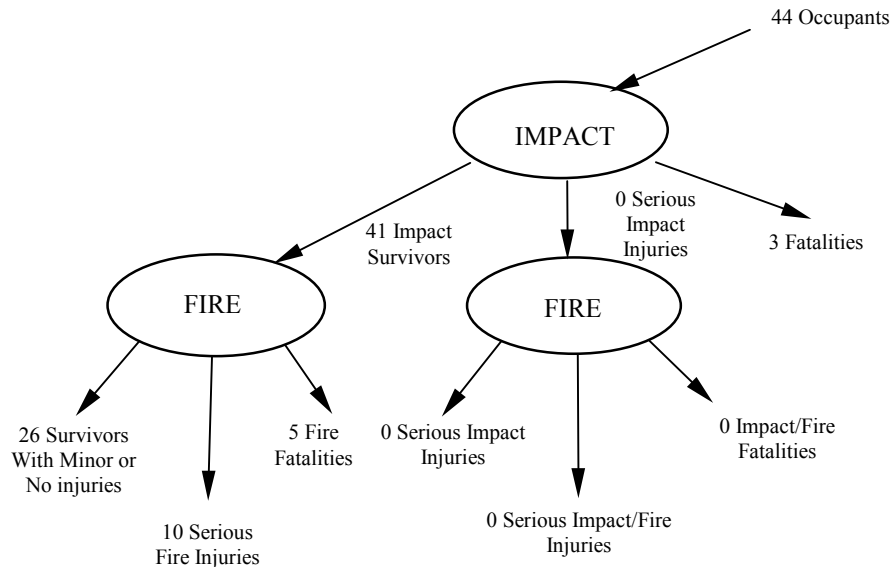
Details of seat location and injuries were available for only some of the occupants; therefore this accident was considered as a single scenario encompassing the whole cabin.

It has been assumed that the 10 serious injuries were due to the ensuing fire because the only impact forces came directly from the B727's wing penetrating the fuselage, causing impact fatalities.

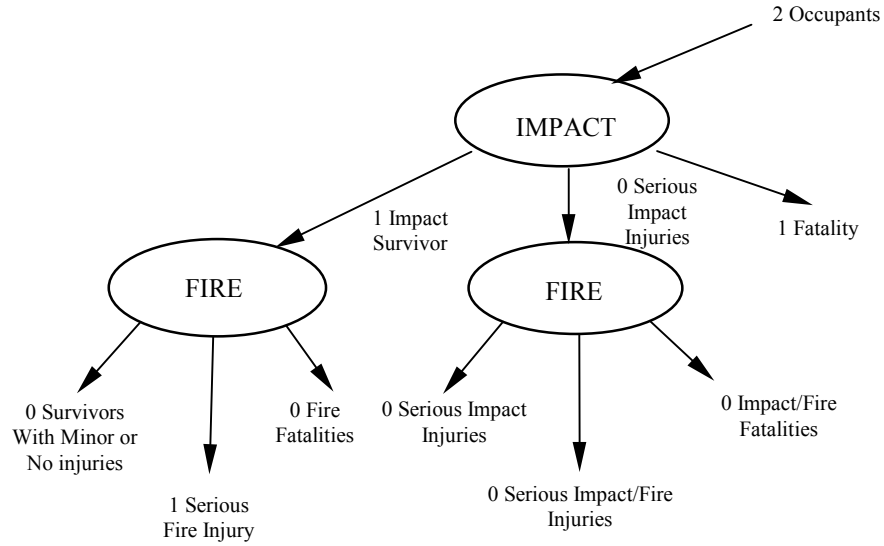
SCENARIO 1

**Scenario 1** represents the flight compartment area. Of the two flight crew occupying this area, the captain sustained fatal injuries as a result of the impact. The other flight crew suffered serious fire burns.

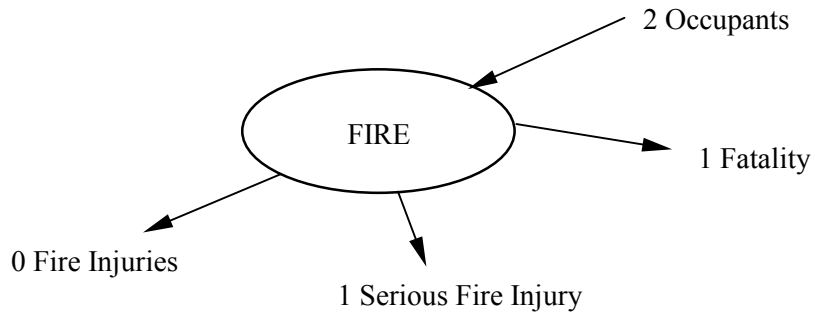
SCENARIO 2

**Scenario 2** represents the forward flight attendant area. One flight attendant died of asphyxia due to smoke inhalation and the other suffered serious fire burns.

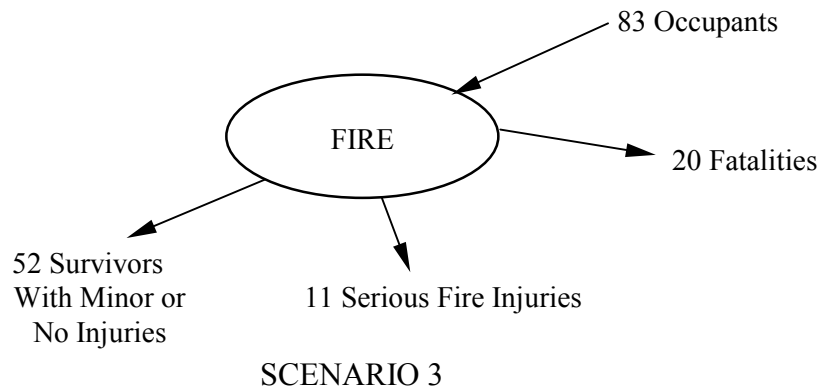
**Scenario 3** represents the entire passenger cabin containing seat rows 1 to 22. This scenario contains 83 passengers. Nineteen passengers died of asphyxia due to smoke inhalation. One passenger died due to thermal burns. Eleven passengers suffered serious fire burns.

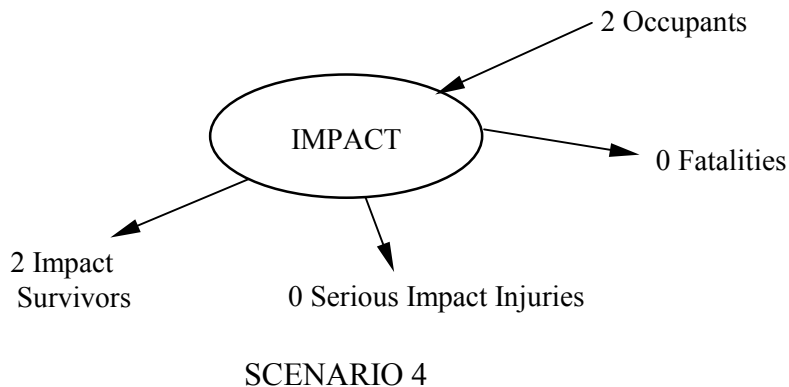
**Scenario 4** represents the aft cabin attendant area, which contains two flight attendants. Both of them suffered minor or no injuries.

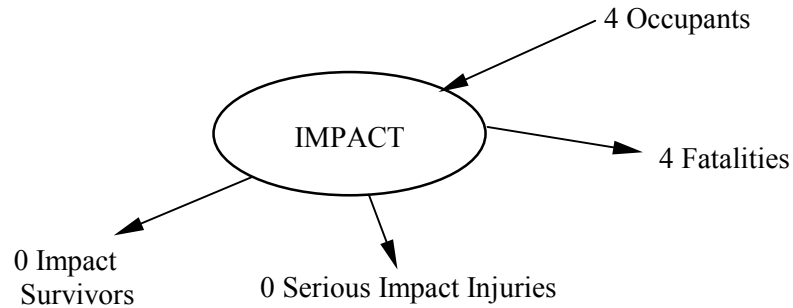
SCENARIO 1

**Scenario 1** represents the flight deck and the vestibule area containing two flight crew and two cabin crew. All four crewmembers sustained fatal impact injuries in the impact.

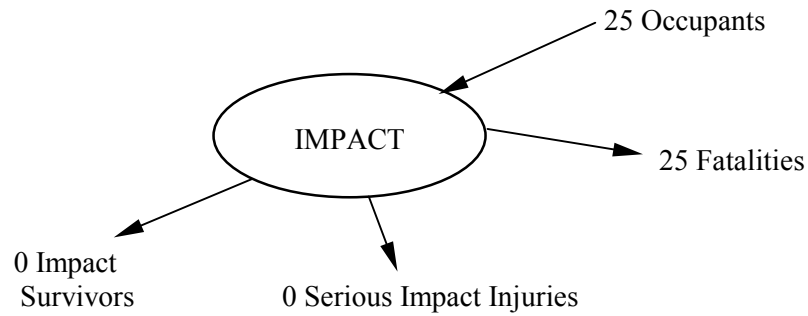
SCENARIO 2

**Scenario 2** represents seat rows 1 to 8. It is assumed that there were 25 passengers in this section and all died as a result of the impact.

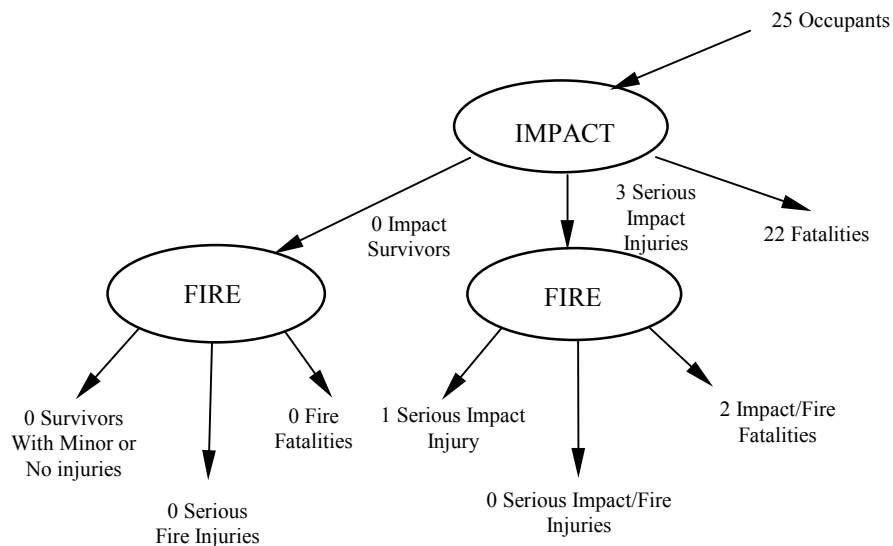
SCENARIO 3

**Scenario 3** represents seat rows 9 to 18. It is assumed that there were 25 passengers in this section and 22 of the passengers died as a result of the impact. Two passengers died as a result of impact and fire. One passenger sustained serious impact injuries. This passenger was ejected in his seat and received fractured ankles.

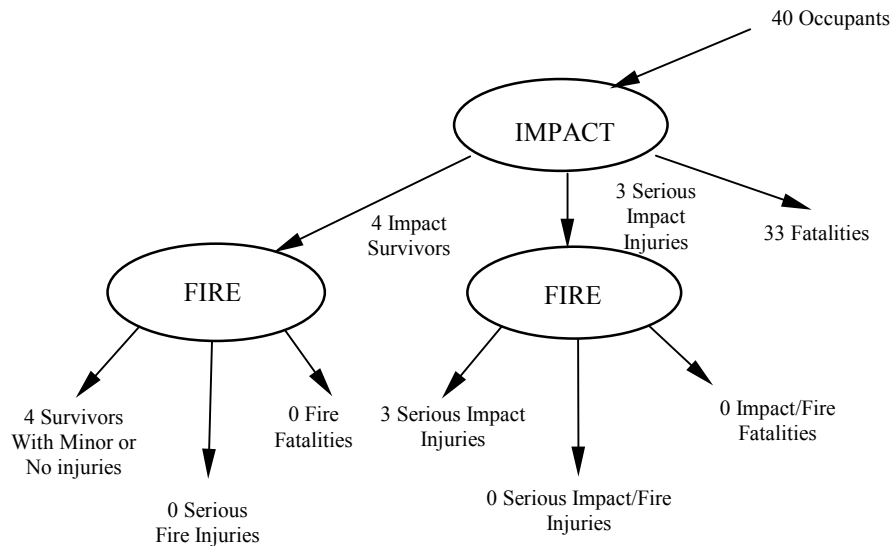
SCENARIO 4

**Scenario 4** contains seat rows 19 to 31. It is assumed that there were 40 passengers in this section, 33 passengers died as a result of the impact. Three passengers sustained serious impact injuries and four with minor or no injuries.

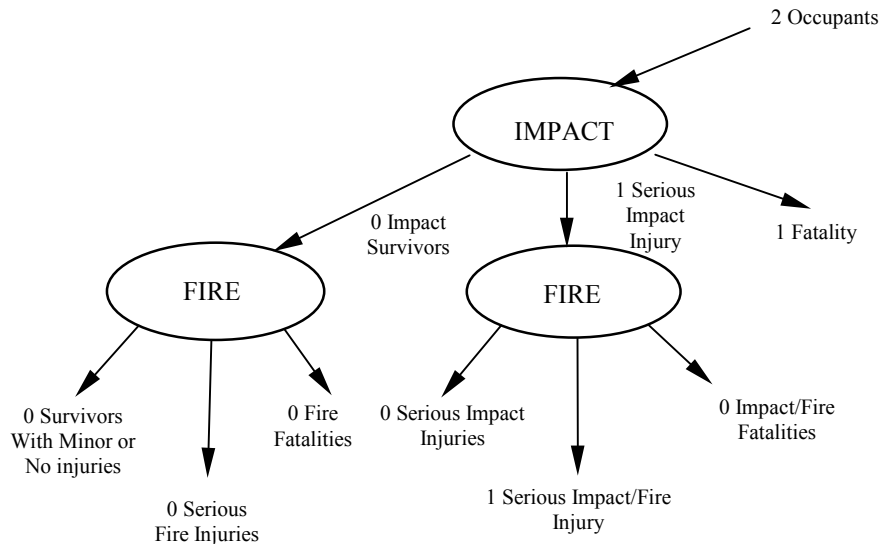
SCENARIO 5

**Scenario 5** represents the rear cabin crew area, containing two flight attendants. One flight attendant died as a direct result of the impact and the other flight attendant is assumed to have sustained serious injuries as a result of impact and fire.

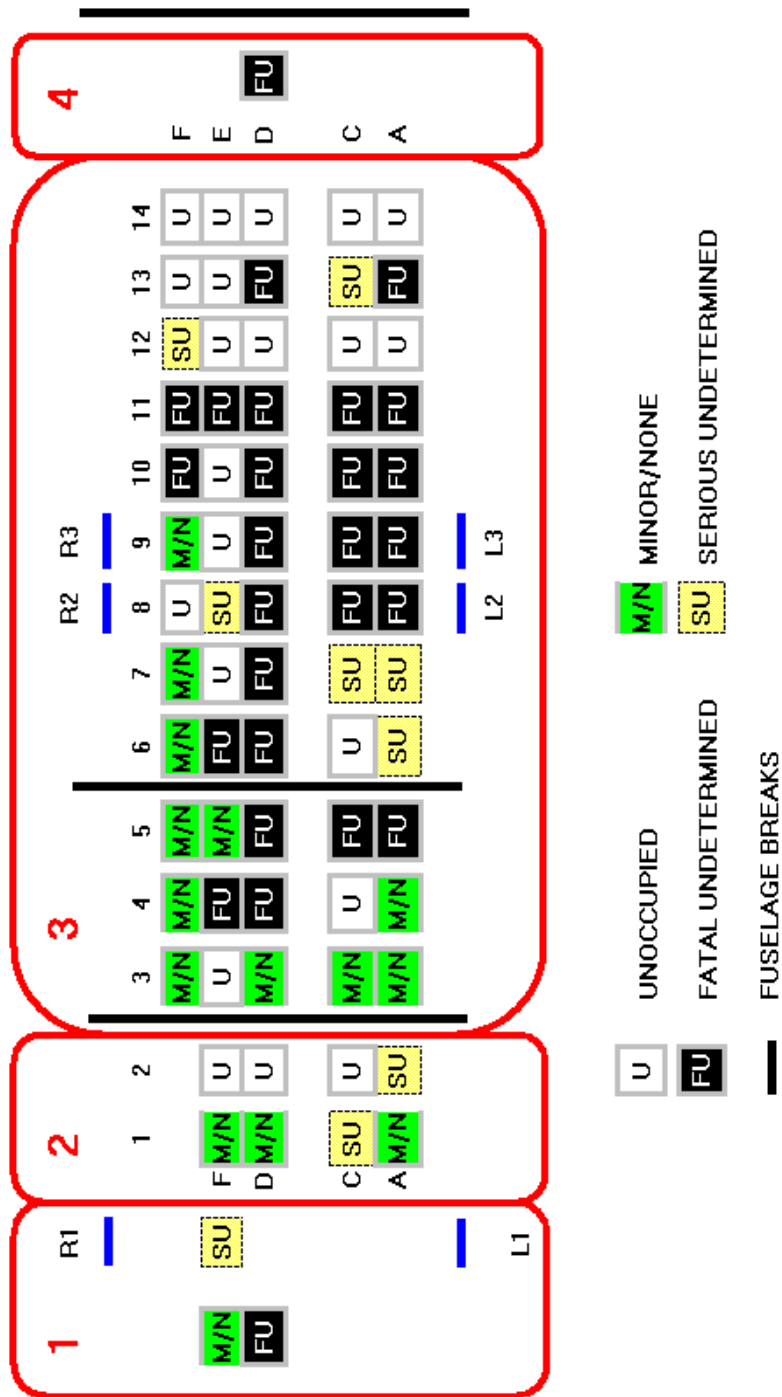
This accident is divided into four separate scenarios, as shown in figure A-11. Within scenario 3, three survivability chains were used to represent the injuries.

FIGURE A-11. LOCATION OF INJURIES AND SCENARIOS

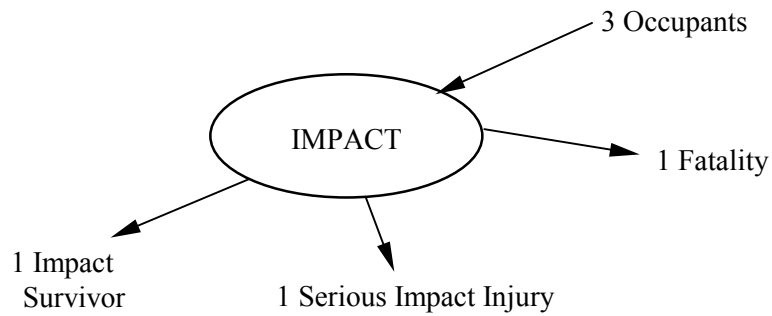
SCENARIO 1

**Scenario 1** contains the flight deck and the forward galley area which was subjected to impact damage. The scenario contains two flight crew and one flight attendant. Due to absence of detailed documentary evidence on the location of injuries, it is assumed that the captain died of blunt force trauma and the flight attendant sustained serious impact-related injuries. This is based on the fact that the left side and bottom of this section were crushed by impact forces. A hole was in the fuselage skin to the left of the captain's seat. The floor on the left side of the cockpit and the captain's seat pedestal were displaced upward. The right side of the forward fuselage near the roof exhibited compression wrinkles. There was no sign of any fire damage in this section.

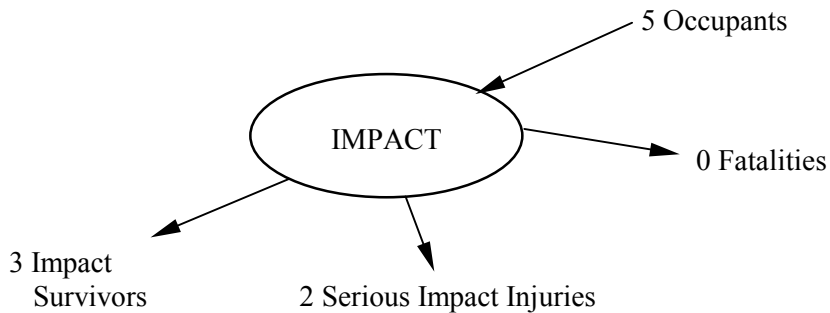
SCENARIO 2

**Scenario 2** contains passenger seat rows 1 and 2 which were subjected to impact damage. The scenario contains five passengers, three of whom suffered minor or no injuries and two suffered serious injuries.

Due to the absence of detailed documentary evidence on the location of injuries, it is assumed that the two injured passengers sustained serious impact-related injuries. This section suffered impact damage and the right side of the forward fuselage near the roof exhibited compression wrinkles. There was no sign of any fire damage in this section.

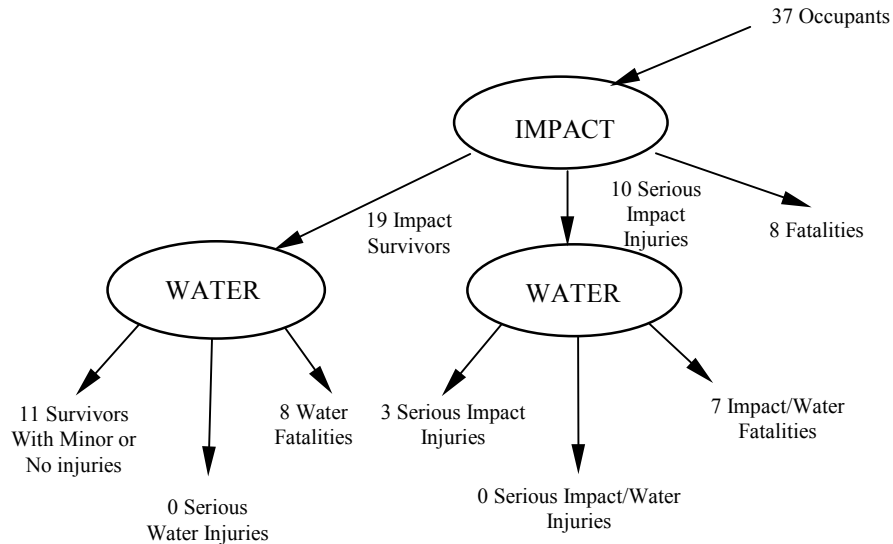
CHAIN 1

**Scenario 3 - Chain 1** represents those occupants in seat rows 3 to 14 who were subjected to the impact and then immersion in water. It contains 37 passengers. Eight passengers suffered fatal impact injuries, 7 passengers sustained serious injuries and died as a result of drowning, 8 passengers sustained minor impact injuries and died as a result of drowning, and 11 passengers received minor or no injuries. Due to the absence of detailed information on the location of injuries, it is assumed that three of the six seriously injured survivors sustained only impact injuries, but not head injuries.

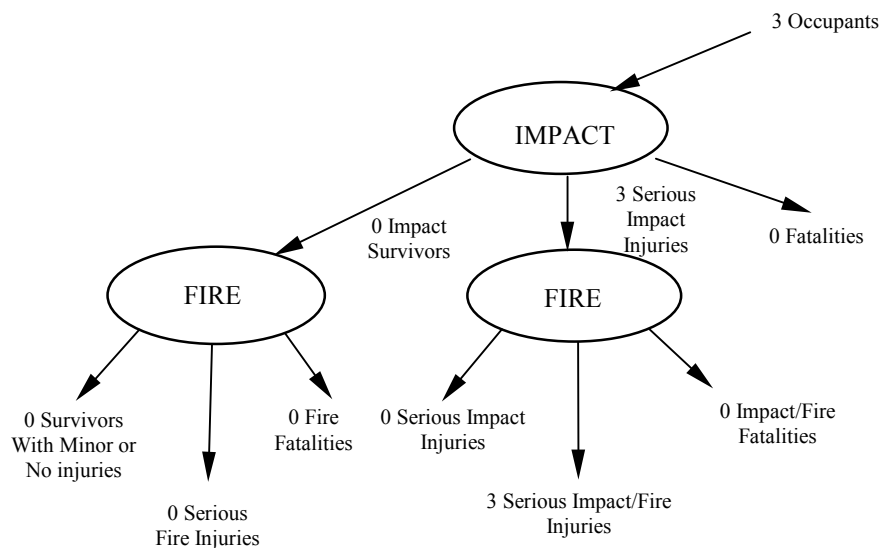
CHAIN 2

**Scenario 3 - Chain 2** represents those occupants seated between rows 6 to 13 who were seriously injured in the accident. Due to the absence of detailed information on the location of injuries, it is assumed that the three seriously impact injured survivors also suffered thermal burns but no head injuries. This is consistent with the data in the accident report.

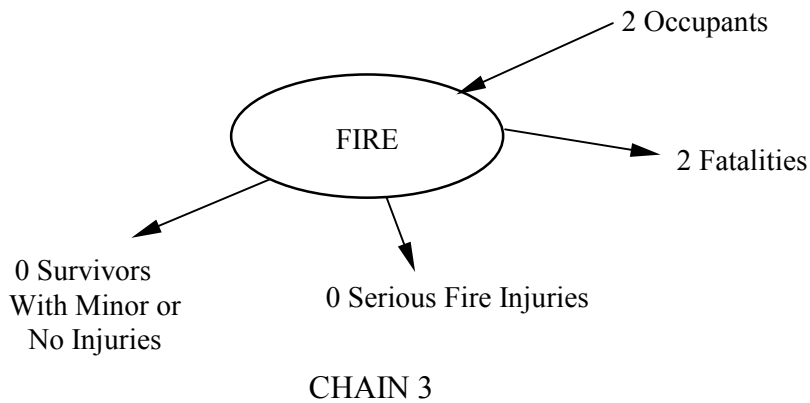
**Scenario 3 – Chain 3** represents the two occupants seated between rows 3 to 14 who were killed by the postaccident fire.

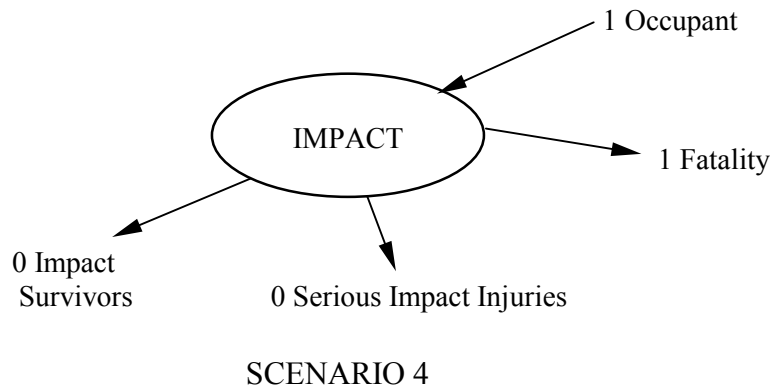
**Scenario 4** represents the rear flight attendant's area which contains one flight attendant. Due to absence of detailed documentary evidence on the location of injuries, it is assumed that the flight attendant died of blunt force trauma.

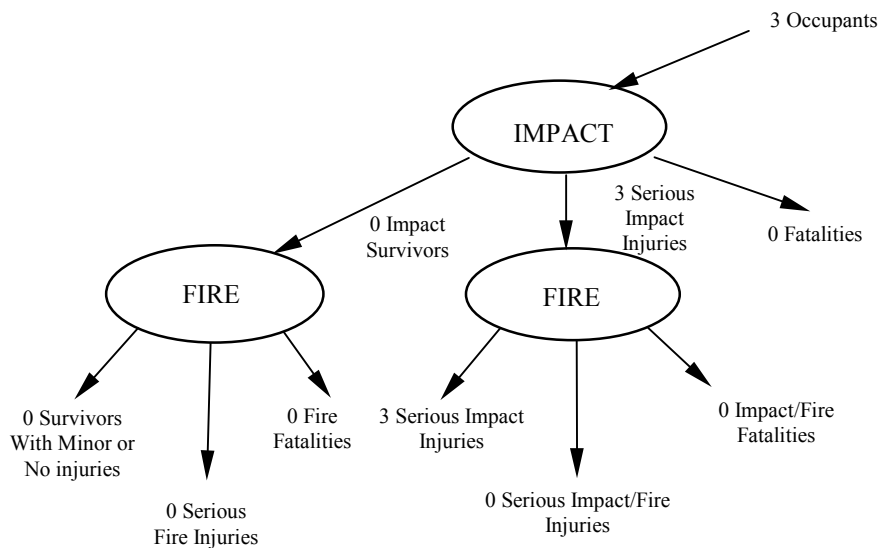
CHAIN 2

It is assumed that the aircraft was not configured with cabin materials compliant with the heat release requirements of the FAR 25 at amendment 61. It is further assumed that had this been the case the three impact injured passengers would not have sustained fire injuries. The survivability chain is thus modified as follows:

Since detailed information on seat related injuries is not available, the high assessment is taken as there being no change in the number of passengers seriously injured in the impact. The low assessment is based on all three passengers surviving the impact uninjured had fully compliant 16-g seats been installed. The median assessment is taken as being the average of these two extremes. This assessment is summarised as follows:

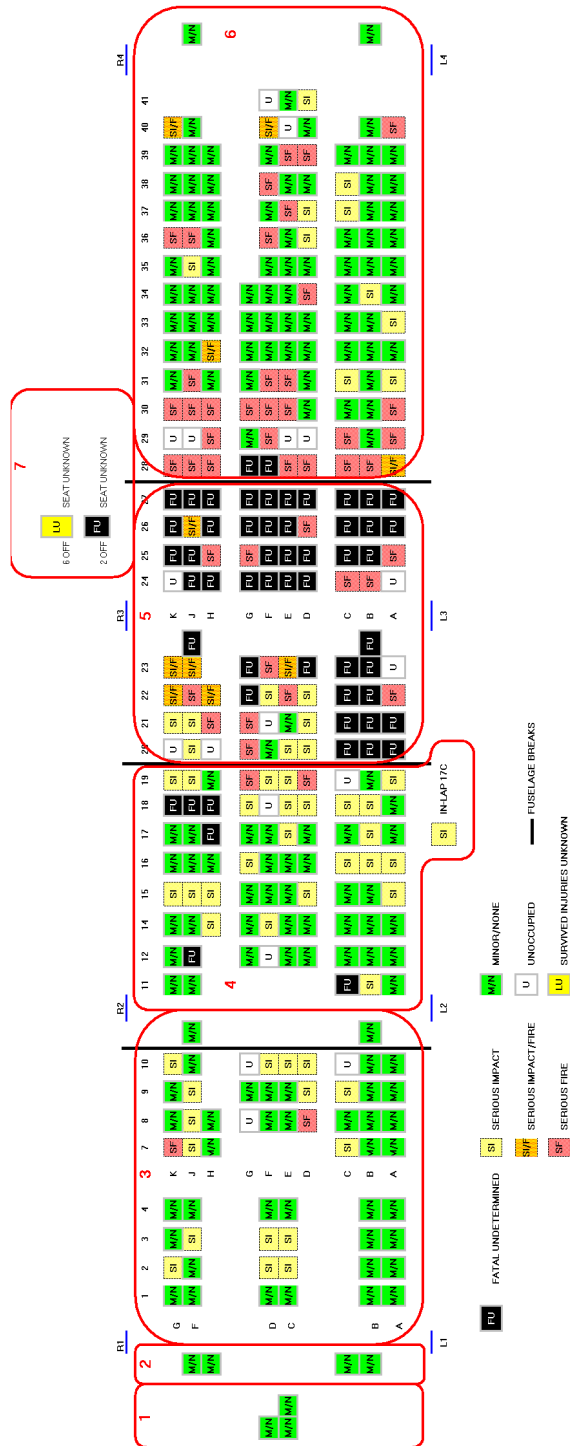
This accident is divided into seven separate scenarios, as shown in figure A-12. Scenarios 3 to 6 are bounded by the fuselage ruptures.

FIGURE A-12. LOCATION OF INJURIES AND SCENARIOS

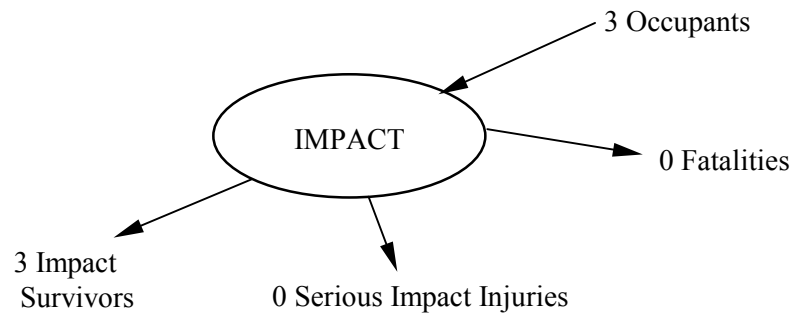
SCENARIO 1

**Scenario 1** contains the flight deck area which was subjected to the impact and was not fire damaged. The scenario contains the three flight crew.

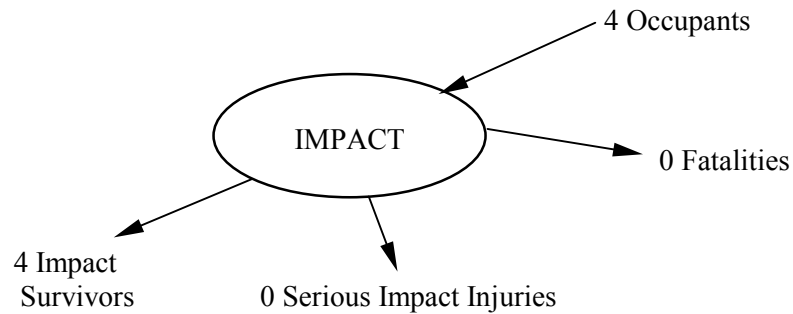
SCENARIO 2

**Scenario 2** contains the forward flight attendant area and encompasses four flight attendants, none of whom sustained serious or fatal injuries.

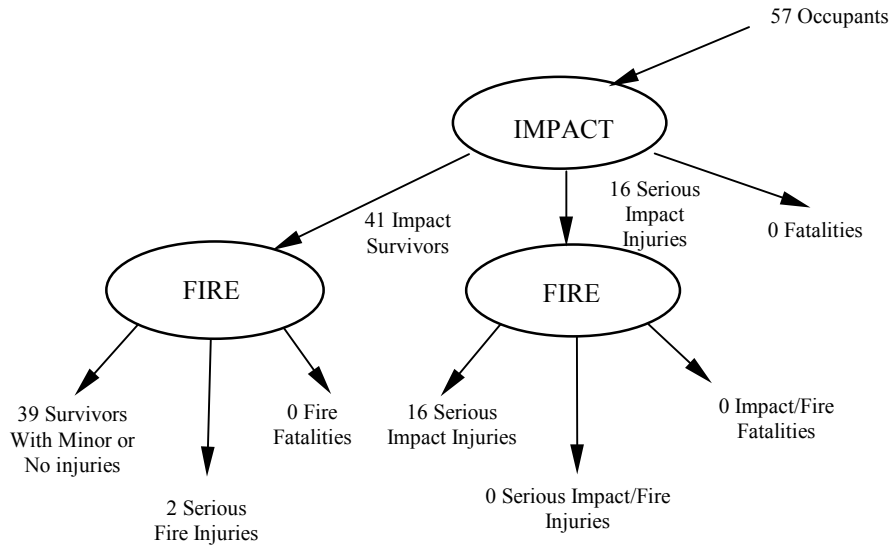
### SCENARIO 3

**Scenario 3** contains the forward fuselage, seat rows 1 to 10, which was subjected to the impact and was not fire damaged. The scenario contains 2 crew and 55 passengers. Two passengers in this scenario sustained serious fire injuries in the accident. It is assumed that the injuries were caused by fire outside the cabin during the evacuation.

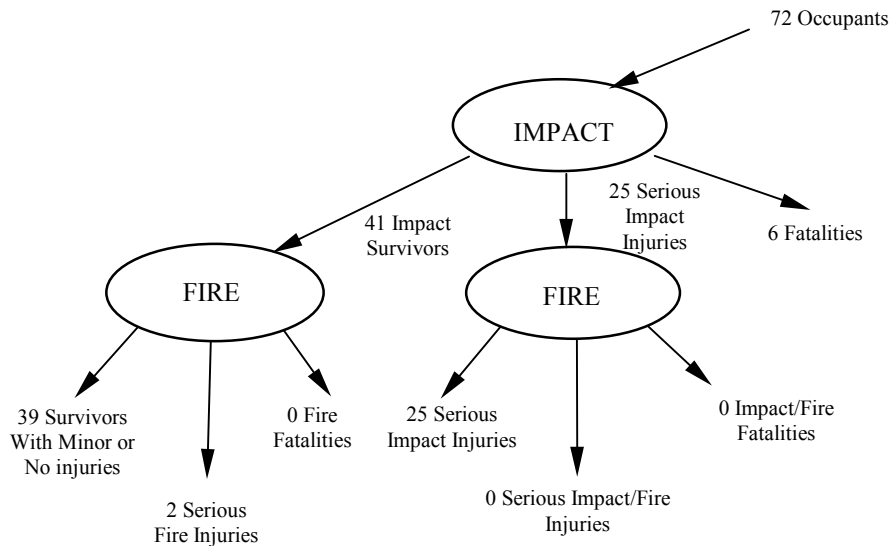
### SCENARIO 4

**Scenario 4** contains the mid-forward section, seat rows 11 to 19, which was subjected to the impact and was not fire damaged. The scenario contains 72 passengers. This section contained no fire during the accident therefore it is assumed that the six occupants who sustained undetermined injuries were killed by impact. This is supported by the fact that a large number of occupants in this section were ejected during the impact. Two passengers suffered serious injuries from fire but they were located at a fuselage break, and it is assessed that either the fire spread locally across the break or they sustained injuries during egress.

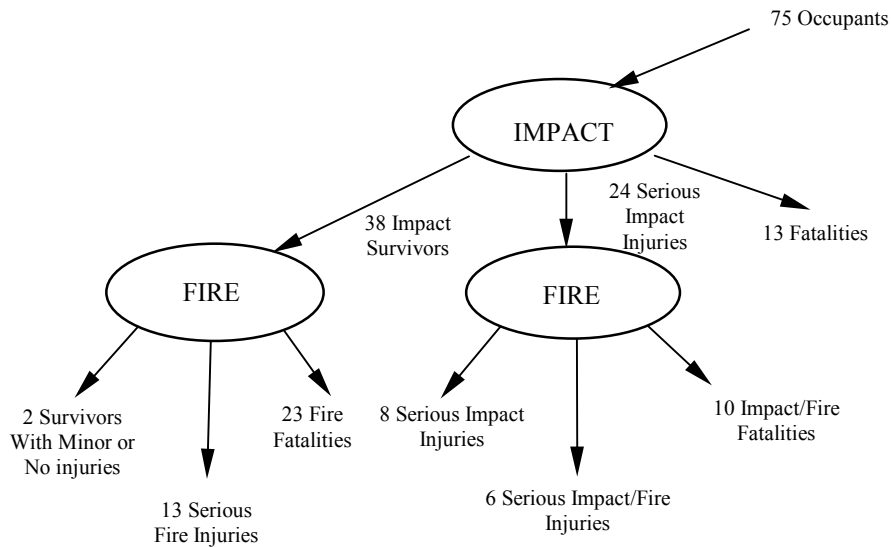
SCENARIO 5

**Scenario 5** contains the mid-rearward section, seat rows 20 to 27, which suffered an explosion and fire after the initial impact. The scenario contains the 2 crew and 73 passengers. It was reported that some of the passengers died as the fuselage split and it is therefore assumed that 13 of the undetermined fatally injured passengers, located along the separation, were killed by impact trauma or were thrown out. Of the remaining 33 fatalities, the 2 flight attendants were known to be killed from the fireball. Of the remaining 31 undetermined fatalities it is assumed that occupants in seat rows 21 to 23 suffered impact injuries and then died from the fire, and occupants in seat rows 24 to 26 were killed by fire only.

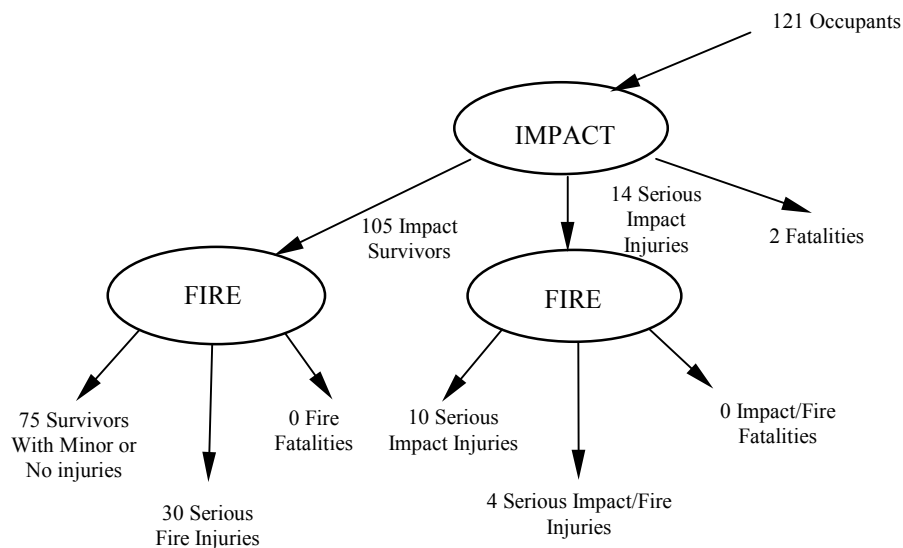
SCENARIO 6

**Scenario 6** contains the rear section, seat rows 28 to 41, and the rear flight attendant area, which was subjected to fire after the initial impact. The scenario contains 2 crew and 119 passengers. It is assumed that the two occupants seated in row 28F and G were killed by impact trauma as the fuselage split into sections.
