**DOT/FAA/AR-00/13**

# **Benefit Analysis for Aircraft 16-g Dynamic Seats**

Final Report

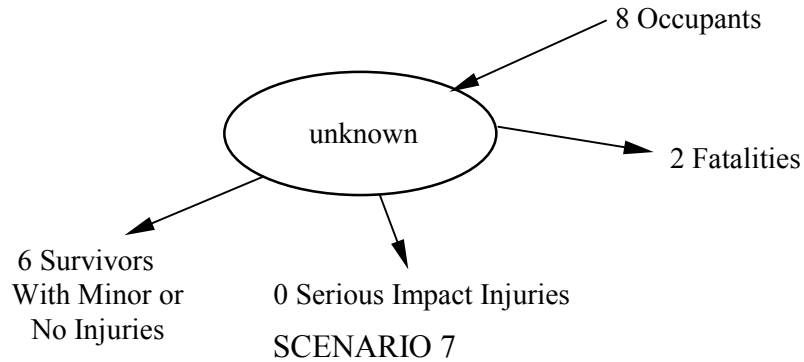
**Scenario 7** contains the eight occupants for which seat location and injuries were unknown. Absence of information results in the following simplified survivability chain. The six unknown injuries have been assumed minor or none since they were not significant enough to be reported officially. It is not possible to determine the cause of death for the two fatalities.

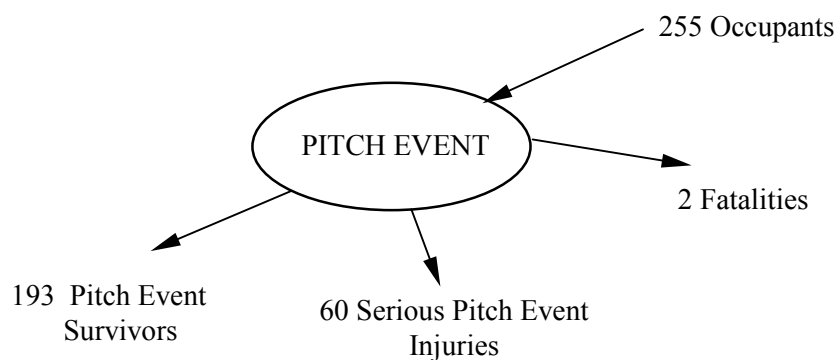
SCENARIO 1

Due to the lack of information on occupant location during the event, the aircraft has been considered as one scenario containing all occupants.

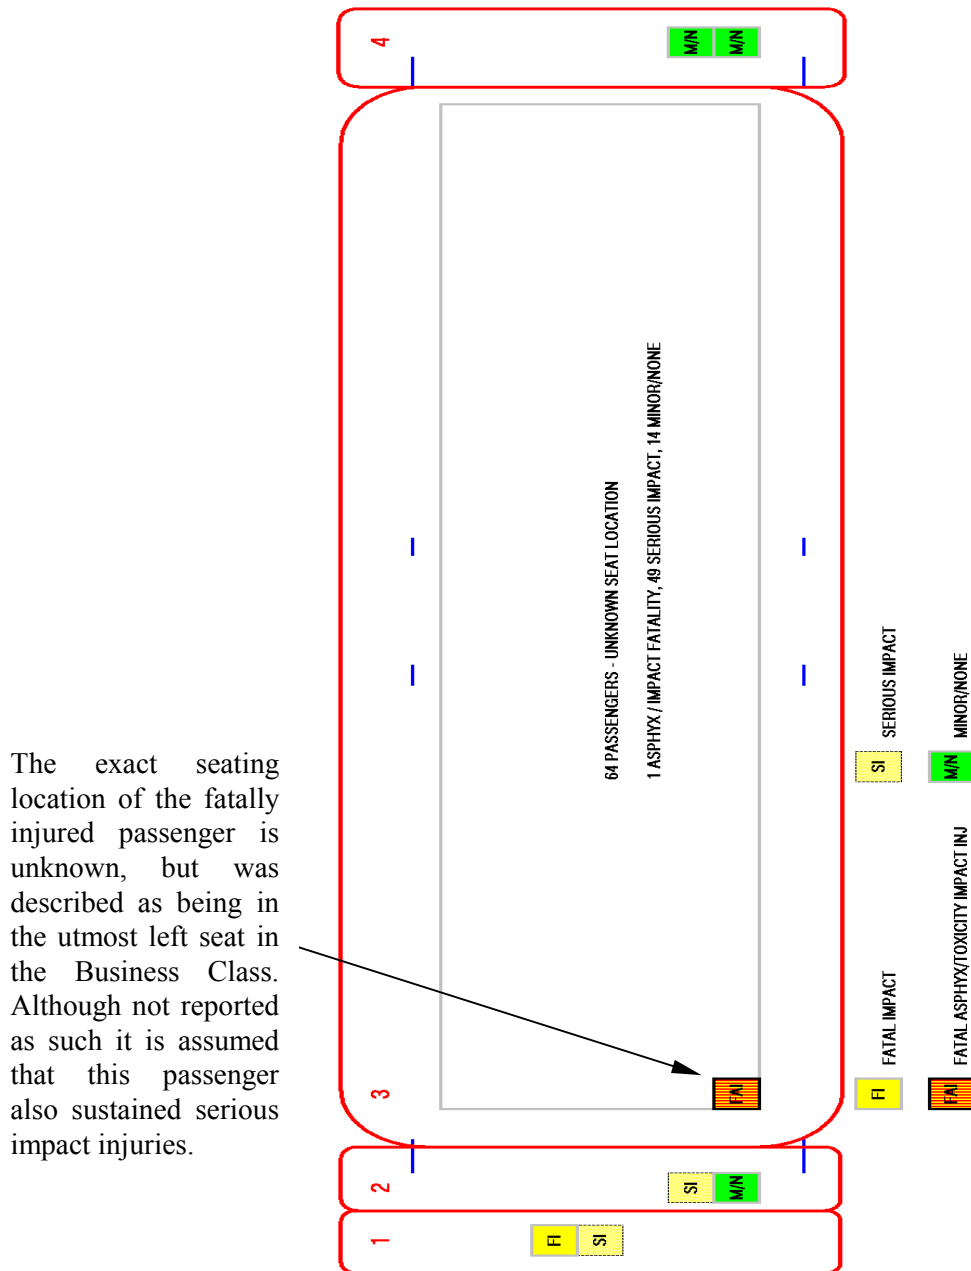
This accident is divided into four separate scenarios, as shown in figure A-13.

FIGURE A-13. LOCATION OF INJURIES AND SCENARIOS

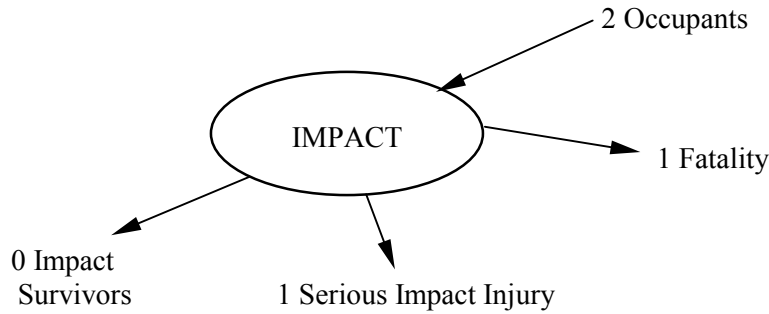
SCENARIO 1

**Scenario 1** contains the flight deck area where one flight crewmember died and the other sustained serious injuries from the impact.

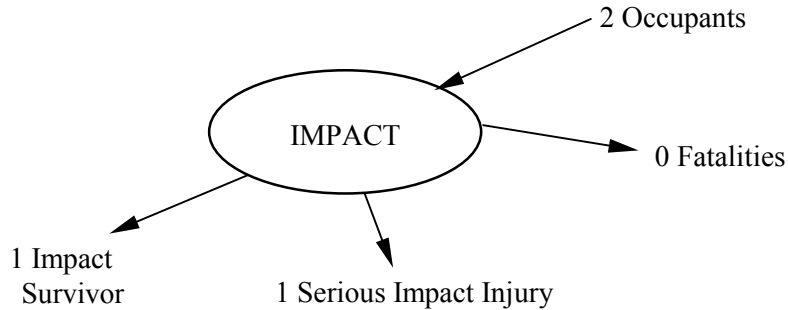
SCENARIO 2

**Scenario 2** contains the forward flight attendant area where only the chief steward sustained serious injuries from the impact. The scenario contains two flight attendants.

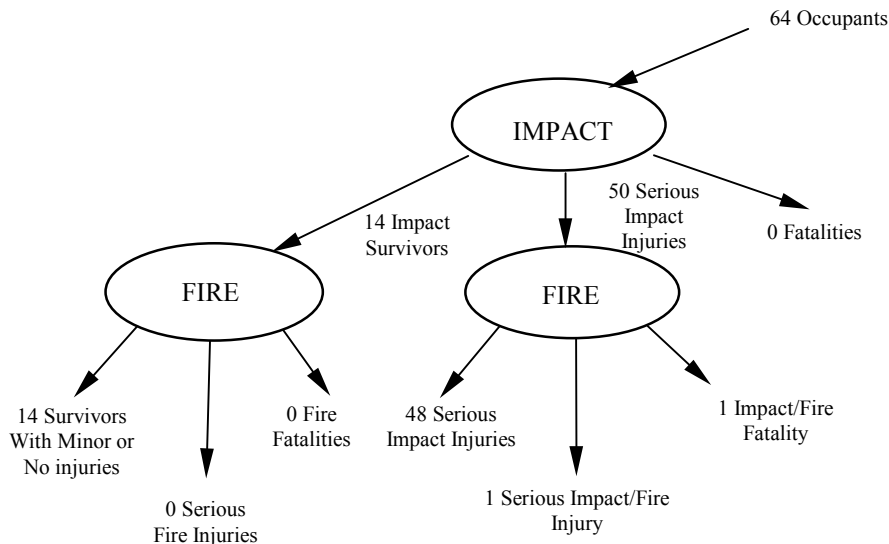
SCENARIO 3

**Scenario 3** contains the whole passenger cabin. This has been used because of limited detail on passenger locations during the accident. The scenario contains all 64 passengers. Fifty passengers received serious injuries as a result of the impact and one of these passengers died from intoxication.

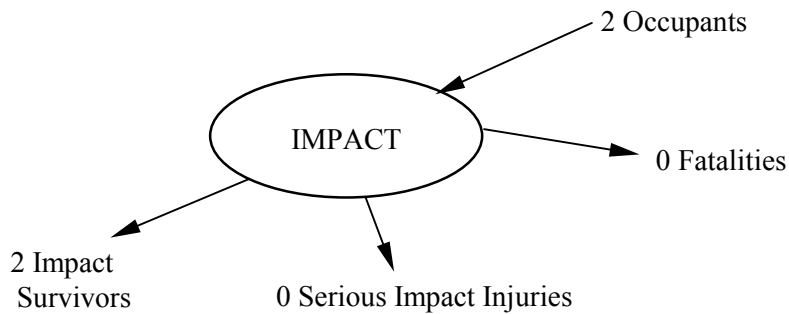
SCENARIO 4

**Scenario 4** contains the rear flight attendant area where the two flight attendants received minor or no injuries from the impact.

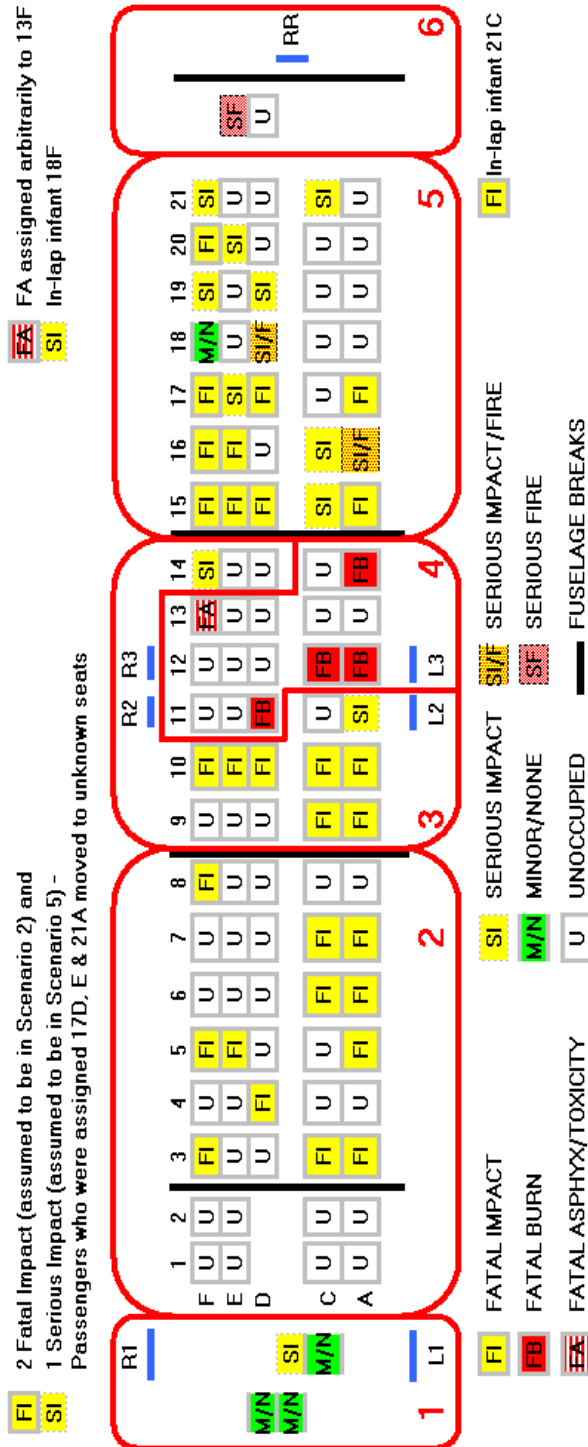
This accident is divided into six separate scenarios, as shown in figure A-15.

FIGURE A-15. LOCATION OF INJURIES AND SCENARIOS

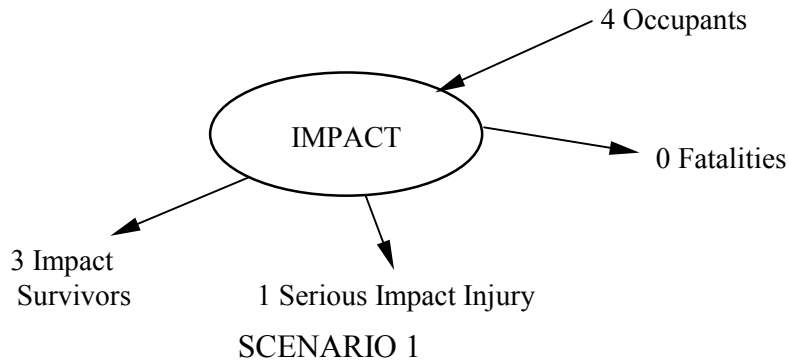
**Scenario 1** represents the flight deck and the vestibule area containing two flight crew and two cabin crew. One cabin crewmember sustained serious injuries and the others received minor or no injuries in the impact.

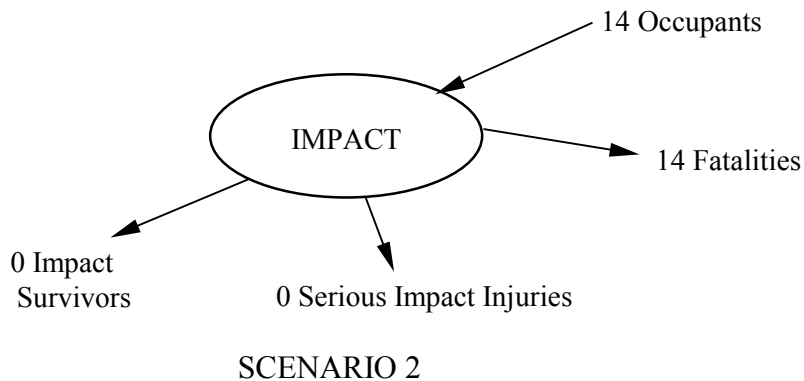
**Scenario 2** represents the first class and part of the coach cabin area (rows 1 to 8) containing 12 fatally injured passengers. This section impacted two large hardwood trees and passenger seats were crushed against them. Due to the destruction of the fuselage in this section, it is assumed that the two impact fatalities of unknown seat location (originally assigned seats 17D and 17E) had moved to this part of the aircraft, since there were more unoccupied seats available in this section. Therefore, the total number of impact fatalities in this scenario is assessed to be 14.

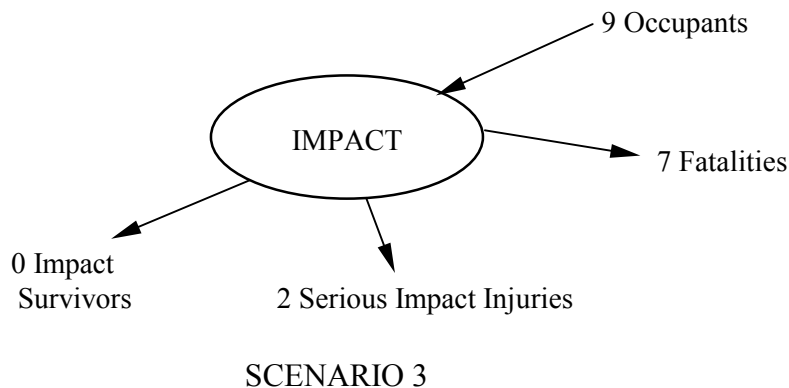
**Scenario 3** represents passenger seat rows 9 and 10 and seats 11A and C and 14D, E, and F, which suffered impact damage and postaccident fire. Seven passengers suffered fatal impact injuries and two passengers suffered serious impact injuries. There were no fire injuries.

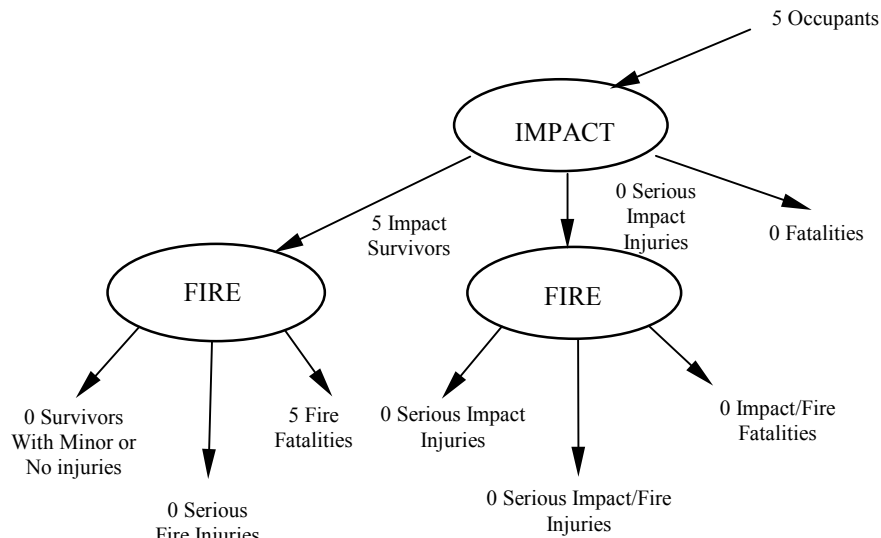
SCENARIO 4

**Scenario 4** represents passenger seat rows 12 and 13 and seats 11D, E, and F and 14A and C, which suffered impact damage and postaccident fire. Five passengers sustained fatal burn injuries. No passengers were injured as a result of the impact.

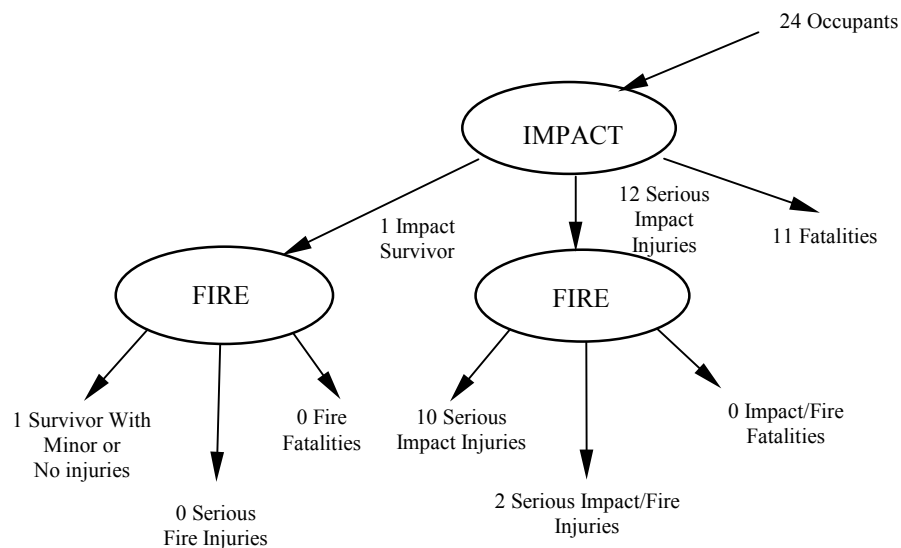
SCENARIO 5

**Scenario 5** represents passenger seat rows 15 through 21, containing 23 passengers (including 2 in-lap infants). Eleven passengers suffered fatal impact injuries, nine passengers sustained serious impact injuries, two passengers suffered serious impact and fire injuries, and one passenger received minor or no injuries. It is assumed that the passenger who suffered serious impact injuries of unknown location (originally assigned seat 21A) had moved to the unoccupied seat in 20A or 20C in front. Therefore, the total number of occupants in this scenario is assessed to be 24.

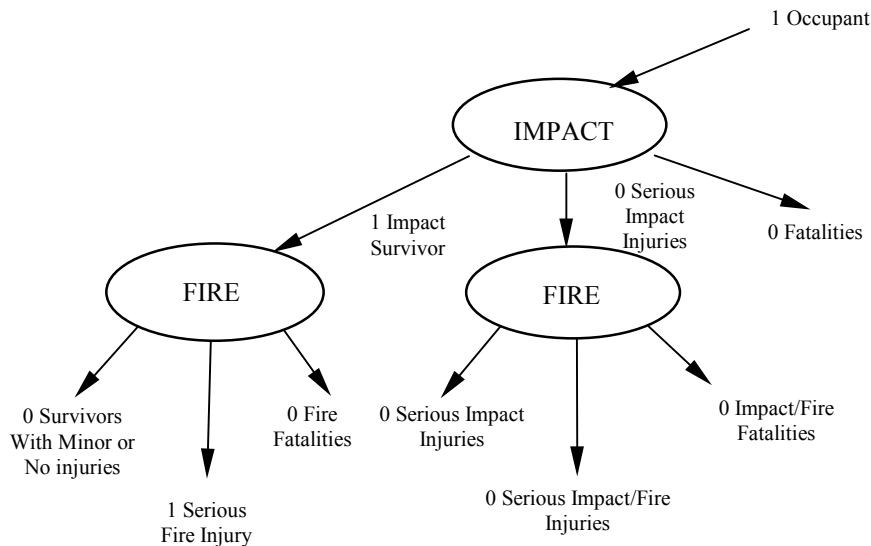
SCENARIO 6

**Scenario 6** represents the rear cabin crew area, containing one flight attendant. The flight attendant suffered serious fire burns in the accident.

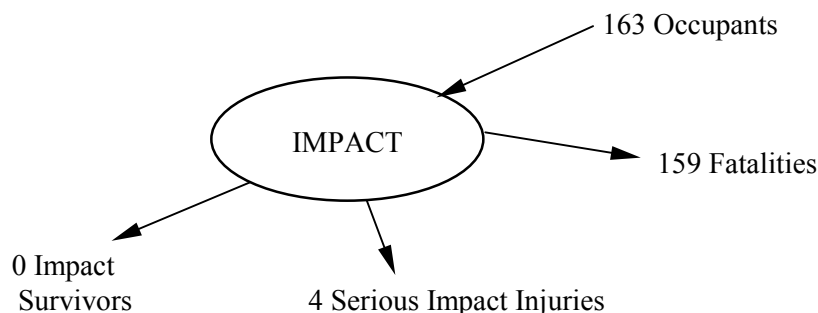
Due to the massive destruction of the aircraft, this accident was considered as a single scenario encompassing the whole cabin.

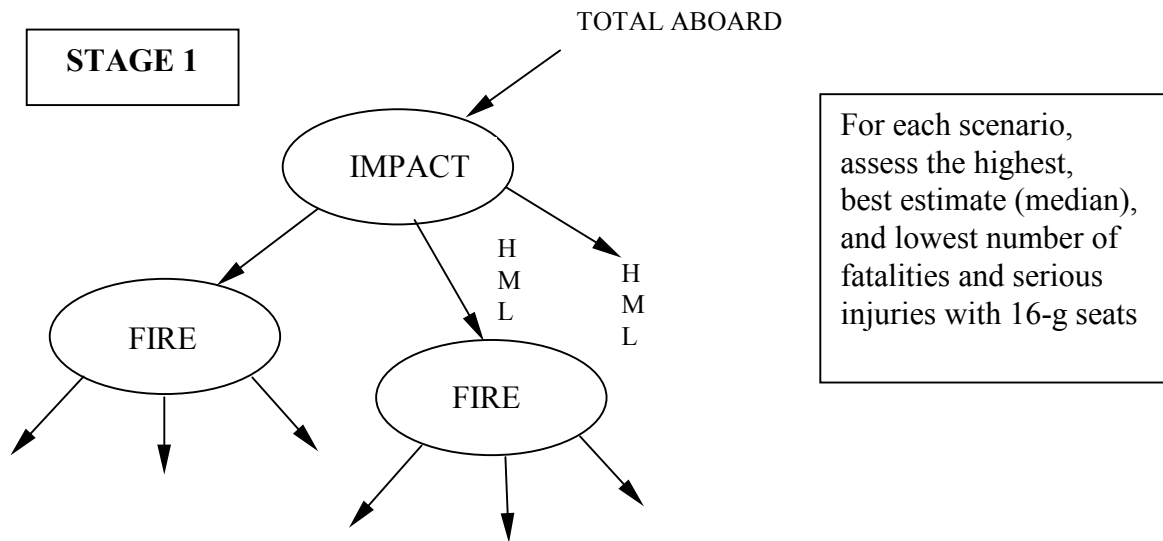
FIGURE B-1. STATISTICAL MODELLING PROCESS, STAGE 1

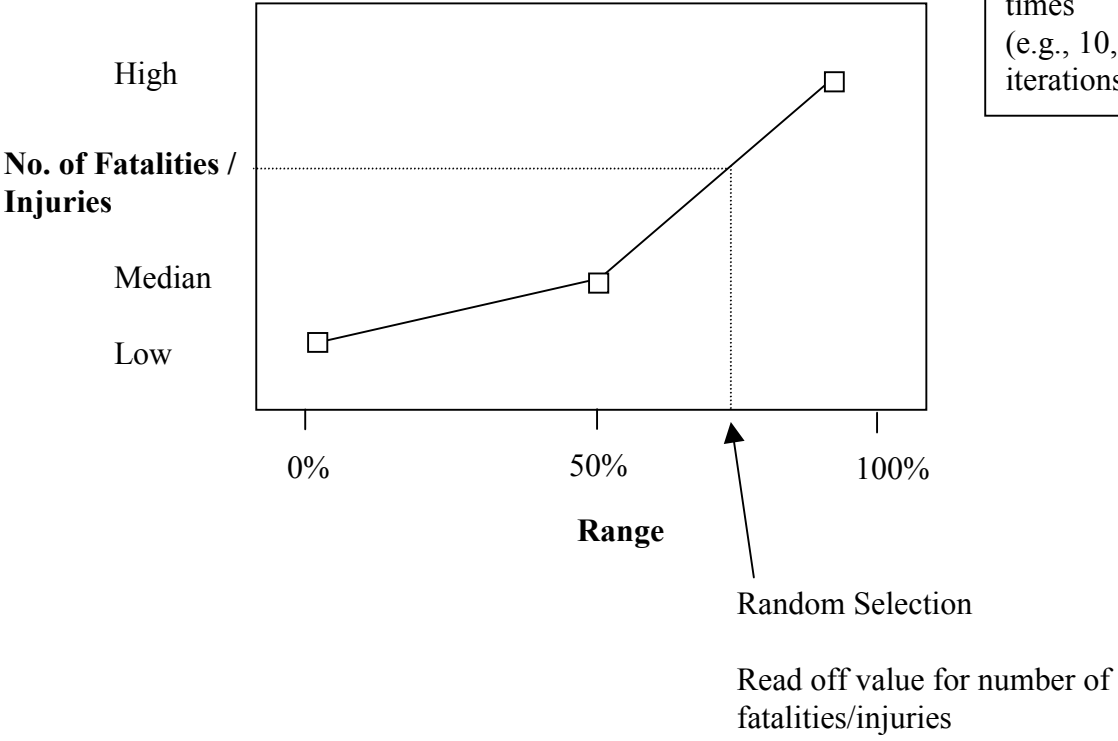
Repeat stages  
2 and 3 many  
times  
(e.g., 10,000  
iterations)

FIGURE B-2. STATISTICAL MODELLING PROCESS, STAGE 2

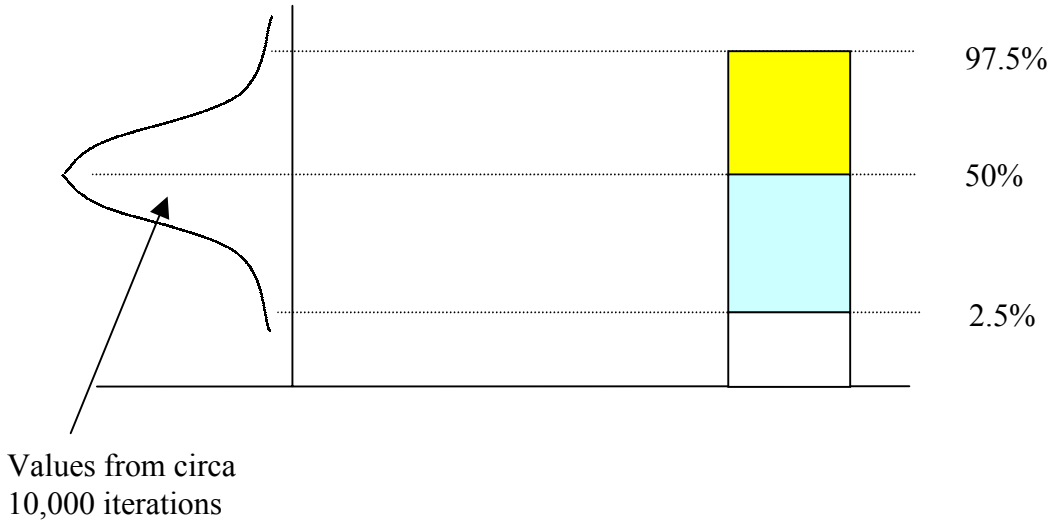
From statistical distribution, read off 97.5, 50, and 2.5 percentiles.

FIGURE B-4. STATISTICAL MODELLING PROCESS, STAGE 4

Stage 4 of the process is simply to determine the 2½, 50, and 97½ percentiles from the resulting distributions to ascertain a mean and likely range for the prediction.
