DOT/FAA/AR-99/57

Fuselage Burnthrough Protection for Increased Postcrash Occupant Survivability: Safety Benefit Analysis Based on Past Accidents

September 1999

Final Report

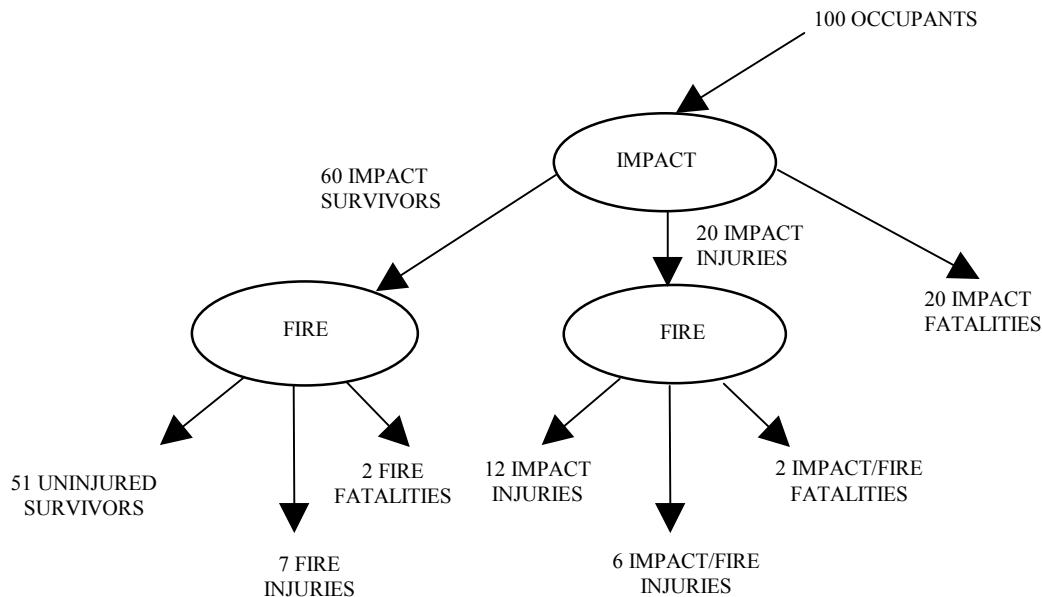
FIGURE 3. EXAMPLE OF SURVIVABILITY CHAIN SHOWING POSSIBLE IMPROVEMENTS IN SURVIVABILITY AS A RESULT OF FUSELAGE FIRE HARDENING

If improvements were made to fuselage fire hardening, such that it was assessed there were now only 2 fatalities and 6 seriously injured of the 20 impact injured occupants and only 2 fatalities and 7 seriously injured of the 60 impact survivors, then the survivability chain becomes as shown in figure 3.

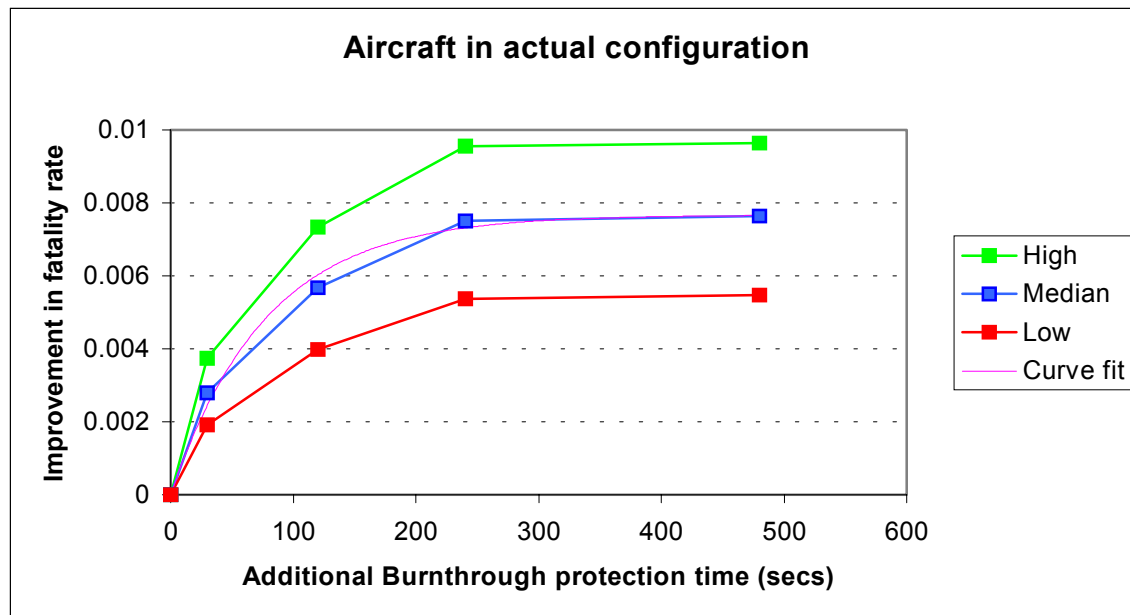
FIGURE 5. VARIATION OF IMPROVEMENT IN FATALITY RATE WITH ADDITIONAL BURNTHROUGH PROTECTION TIME FOR THE SEVENTEEN AIRCRAFT IN ACTUAL CONFIGURATION

The graph is shown overlaid with a least squares exponential curve fit for the median line having the formula $0.0077(1 - e^{(-0.013t)})$ where t is the additional burnthrough protection time in seconds.

It should be noted that the coefficient 0.0077 is the horizontal asymptote and represents the maximum assessed improvement in fatality rate with a perfectly fire-hardened fuselage.

These results are summarised in table 3 for the best estimate (median) of number of lives saved over the period 1966 to 1993 and the average per year. They are also displayed graphically in figures 5 and 6.

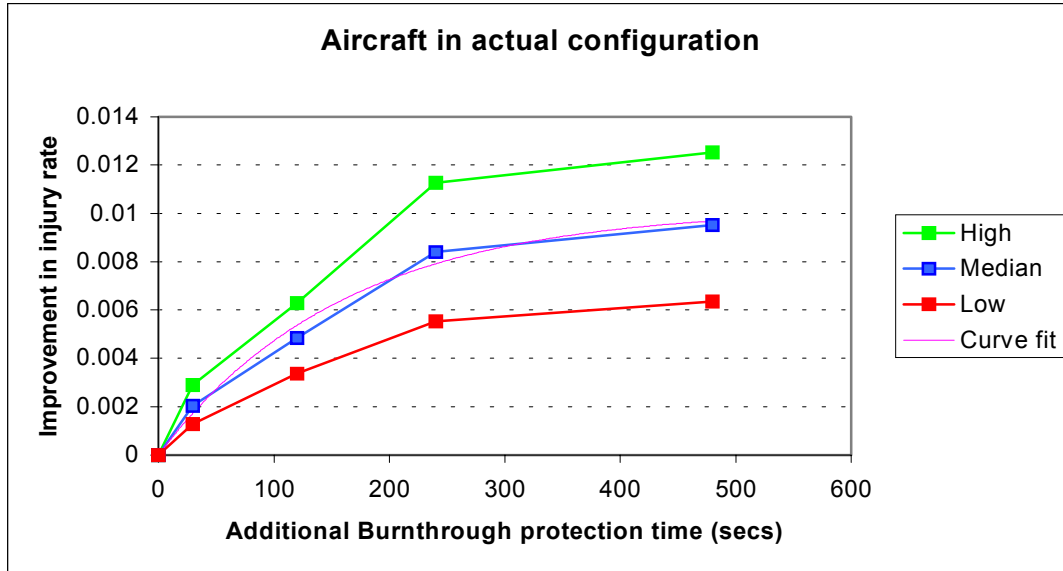
FIGURE 6. VARIATION OF IMPROVEMENT IN INJURY RATE WITH ADDITIONAL BURNTHROUGH PROTECTION TIME FOR THE SEVENTEEN AIRCRAFT IN ACTUAL CONFIGURATION

The graph is shown overlaid with a least squares exponential curve fit for the median line having the formula $0.0102(1 - e^{(-0.0063t)})$ where t is the additional burnthrough protection time in seconds.

It should be noted that the coefficient 0.0102 is the horizontal asymptote and represents the maximum assessed improvement in injury rate with a perfectly fire-hardened fuselage.

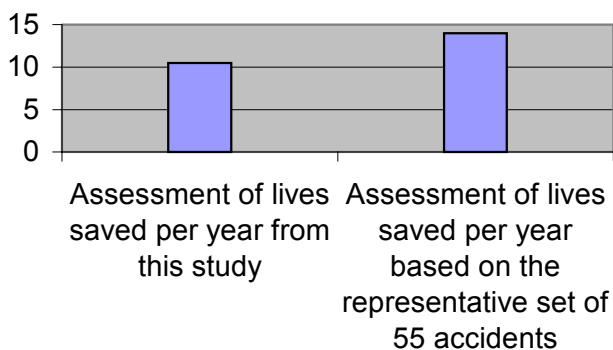
FIGURE 9. BAR CHART SHOWING COMPARISON BETWEEN THE RESULTS FROM THIS STUDY AND THAT DERIVED FROM THE REPRESENTATIVE SET

The similarity of the two values suggests that the prediction of benefit, taking into account the accidents for which data are not available, is reasonably accurate.

A comparison has also been made between the predictions of benefit from this analysis and those derived from a study of a representative set of survivable accidents as described in section 5.3.2. The results compare reasonably well as shown in figure 9.

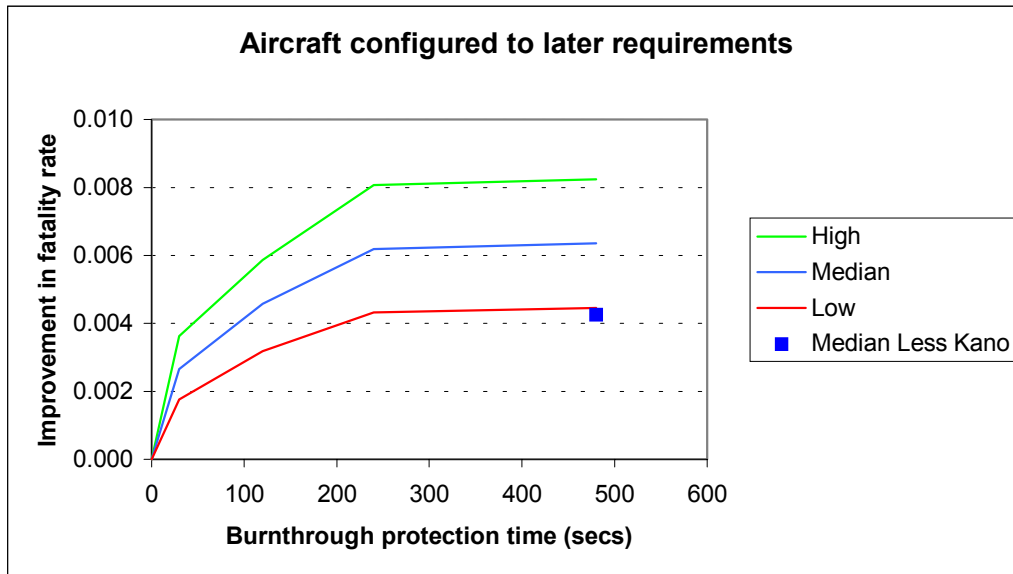
FIGURE 10. REDUCTION IN MEDIAN IMPROVEMENT WITH HIGHEST CONTRIBUTING ACCIDENT REMOVED

The accident, which contributed the highest number of lives saved by burnthrough protection at 8 minutes (the longest time assessed), was in Kano on 22 January 1973. This accident contributed a median saving of 52 lives. If this accident is removed from the analysis the median number of lives saved per year reduces by 1.9, i.e., 5.7 reduces to 3.8. While this is a significant reduction,

the value still is just on the edge of the range assessed by this analysis prior to applying the correction factor of 1.84 as discussed in section 5.1 of this report. If information were available for all burnthrough accidents then the deletion of one accident would have less of an effect.

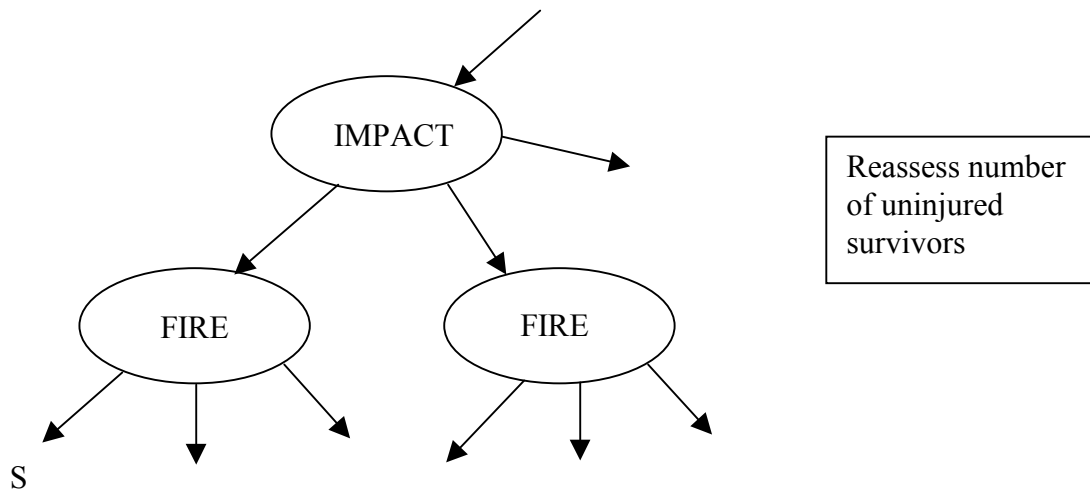
Figure A-3. Statistical Modelling Process, Stage 3

Evaluate injury rate improvement using:

$$S_F = \frac{S_B - S}{T}$$

A similar technique is used for fatality rate improvement.

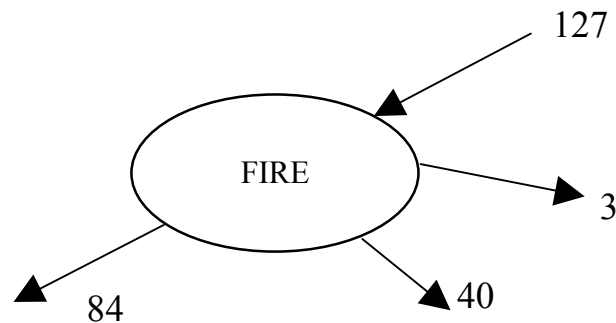
SCENARIO 1

For Scenario 1, it is assessed that later requirements would have improved flammability standards such that the occupants would have had additional time to escape. It is assessed that two of the fatalities would have escaped with non-fatal injuries.

The survivability chain for Scenario 1 therefore becomes:

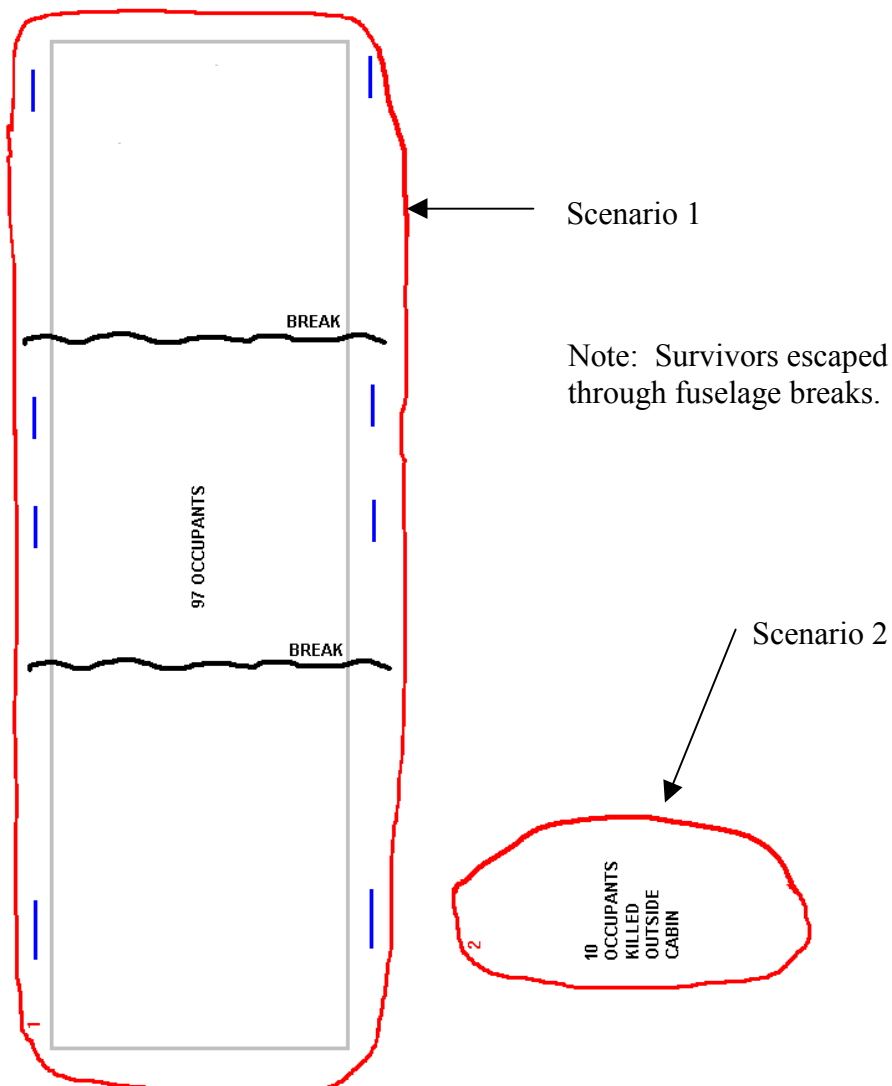
3. Location of Injuries and Scenarios

Based on the above it is assessed that the prime burnthrough route was through the rear underside of the fuselage skin. However there was insufficient information to be conclusive about detailed burnthrough areas. The fire also entered through fuselage breaks.

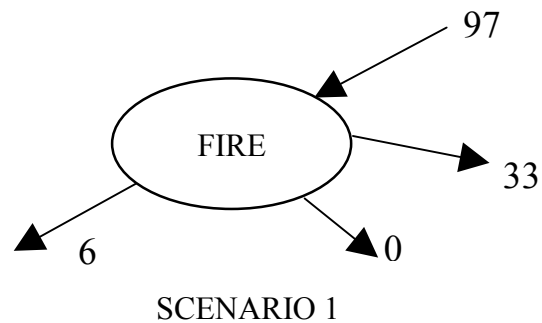
Scenario 1 contains the main cabin area. Evacuation was carried out through a fuselage break because the left exits were jammed and the right exits were blocked by fire. The scenario contains the 97 occupants including crew and passengers.

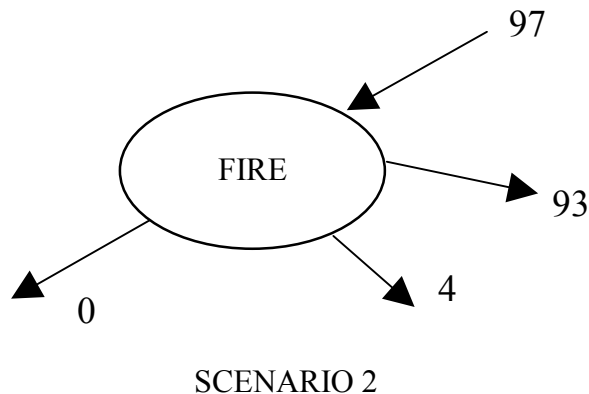
Scenario 2 contains the main passenger cabin, which suffered internal fire and had only the two left overwing exits available for egress. It includes all passengers and flight attendants. Survivor statements indicate that the cabin occupants were moving up and down the cabin trying to locate and open exits. Most were found overcome by smoke crowded near the exits.
