DOT/FAA/CT-91/2

# Development and Growth of Inaccessible Aircraft Fires Under Inflight Airflow Conditions

David Blake

Final Report

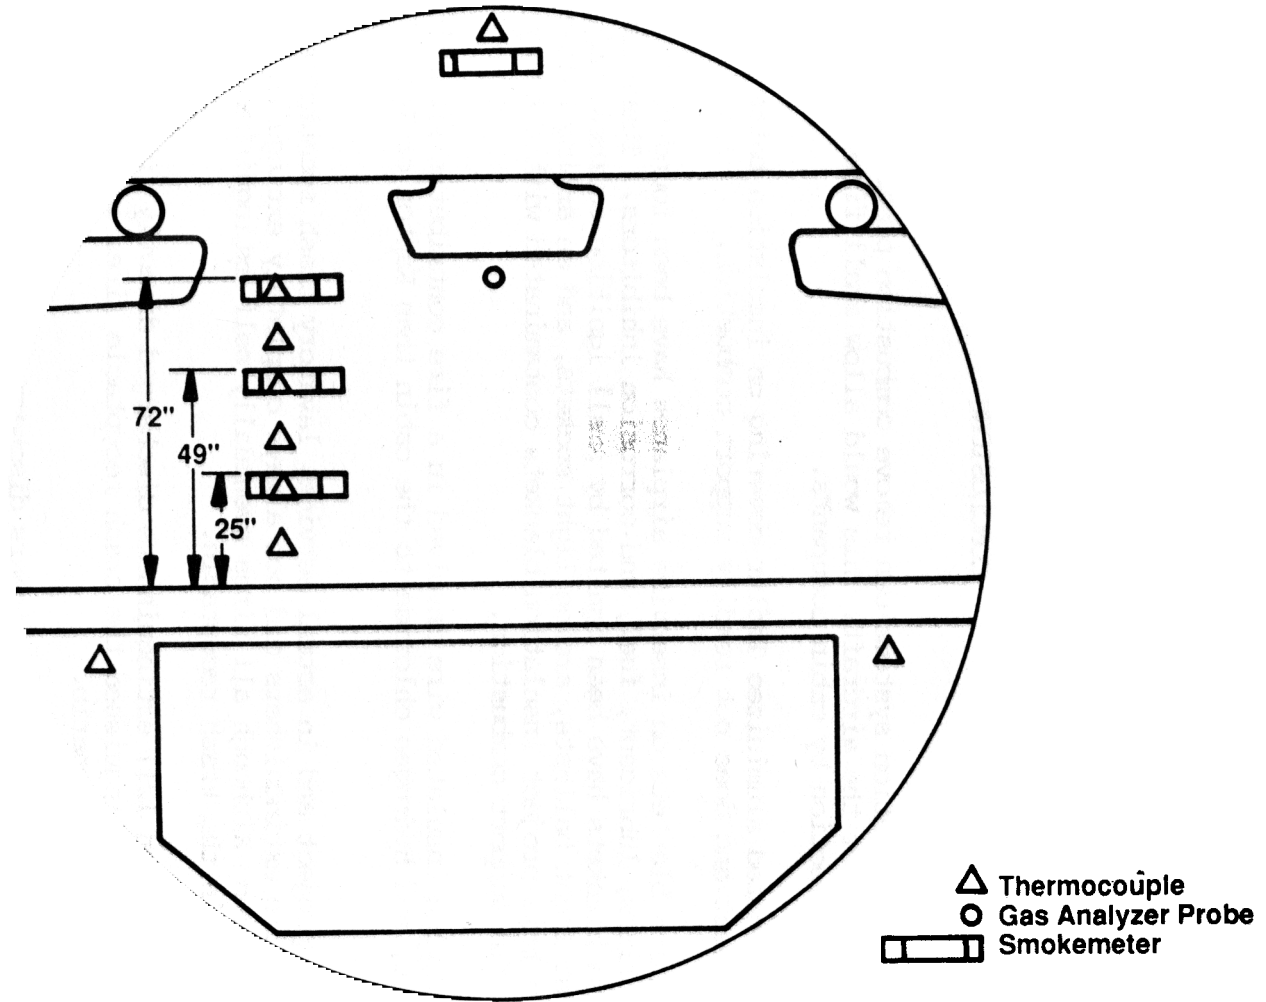
FIGURE TEST ARTICLE INSTRUMENTATION--TOP VIEW

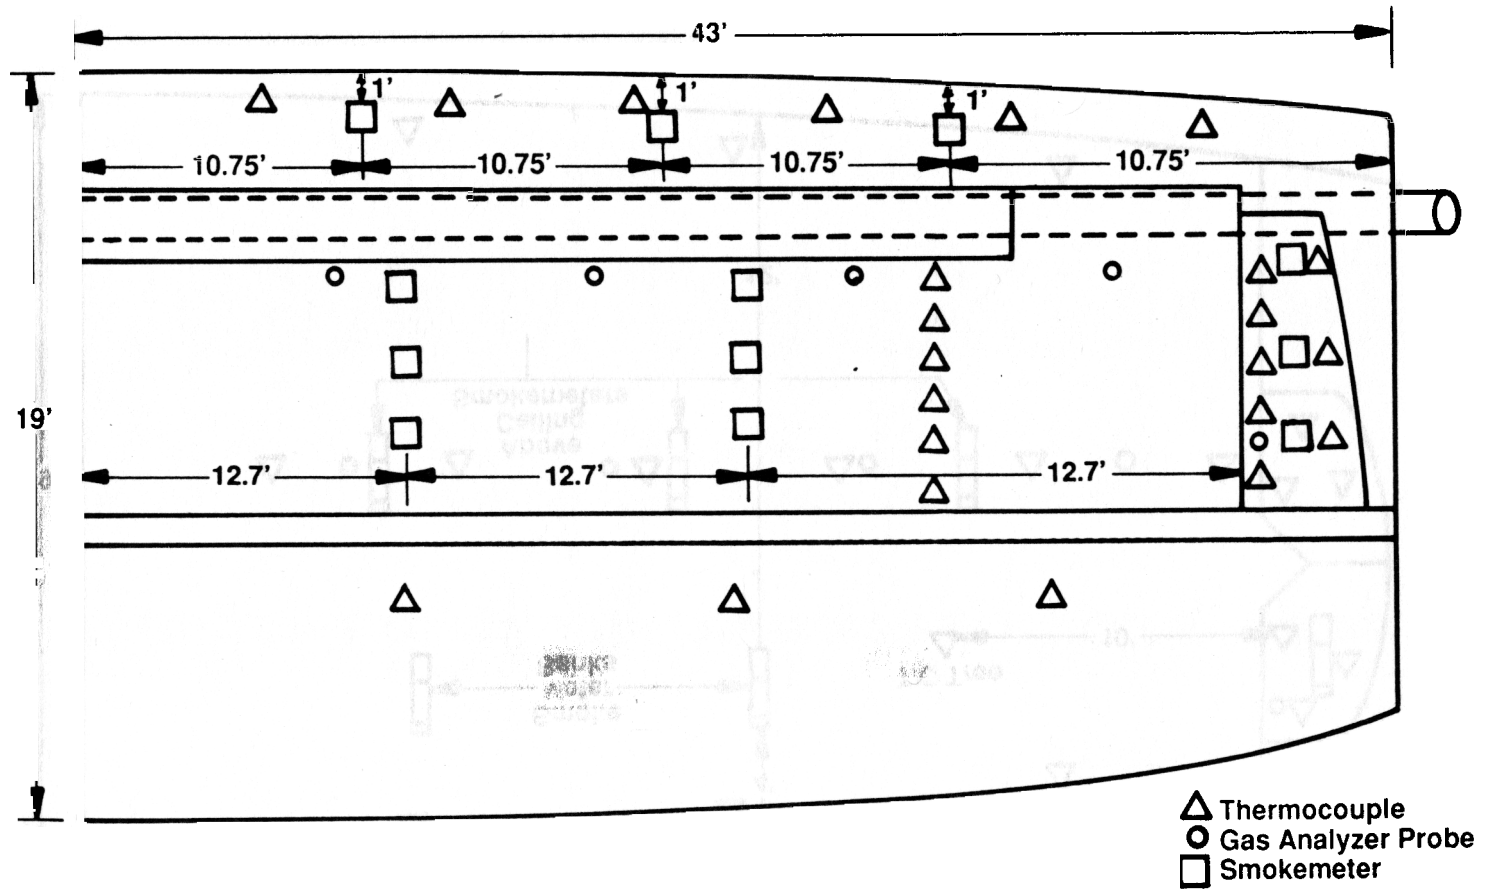
FIGURE 2. TEST ARTICLE INSTRUMENTATION--SIDE VIEW

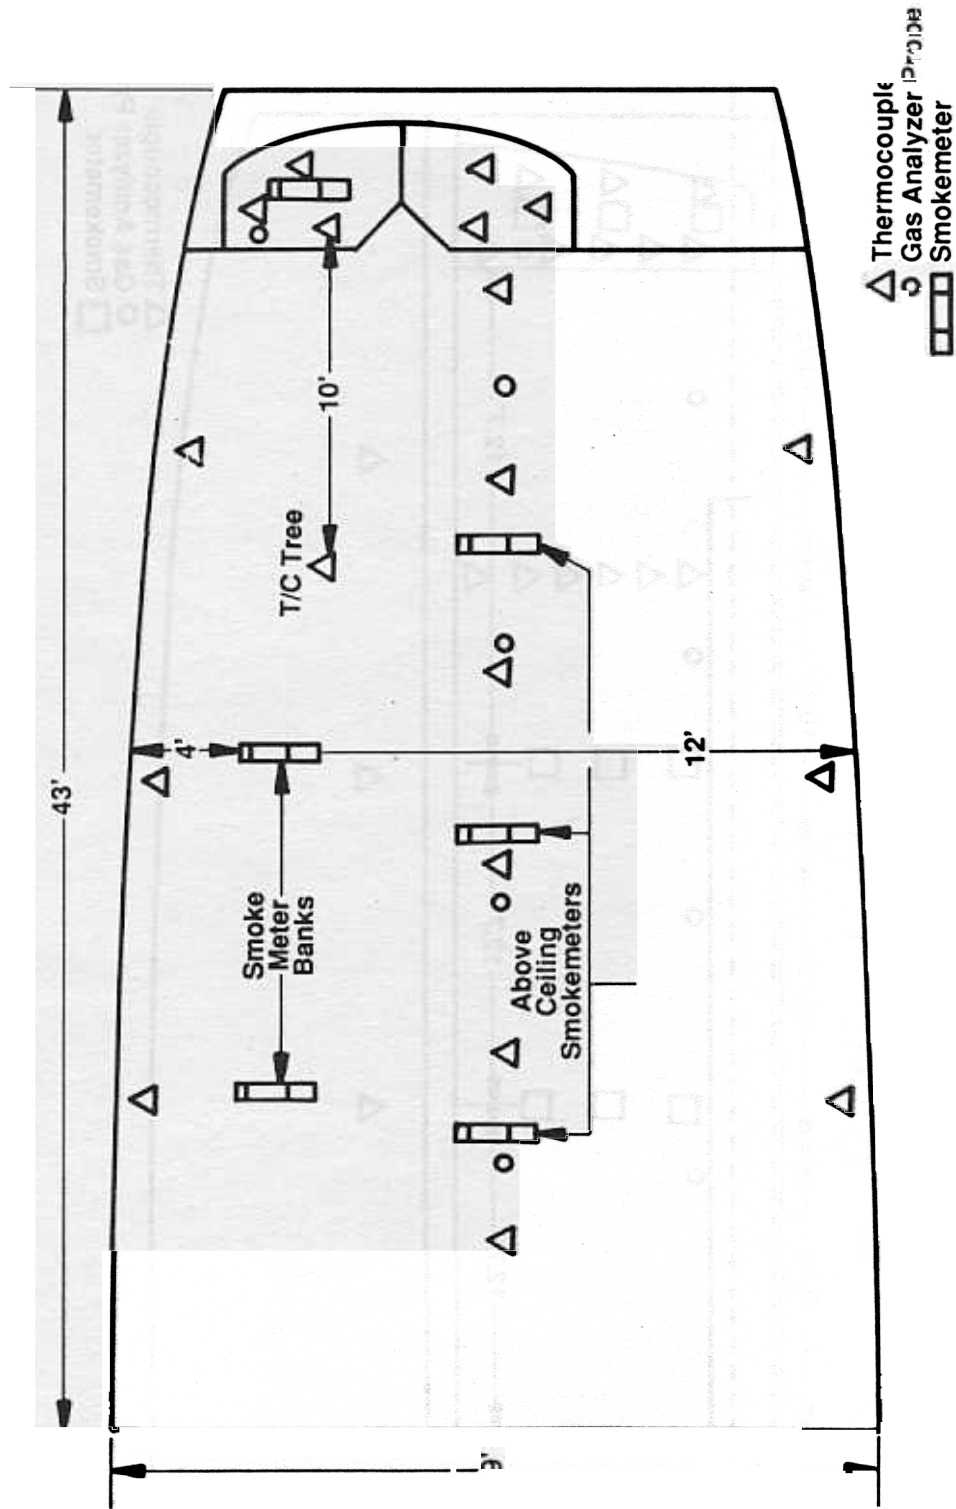
FIGURE INSTRUMENTATION—END VIEW

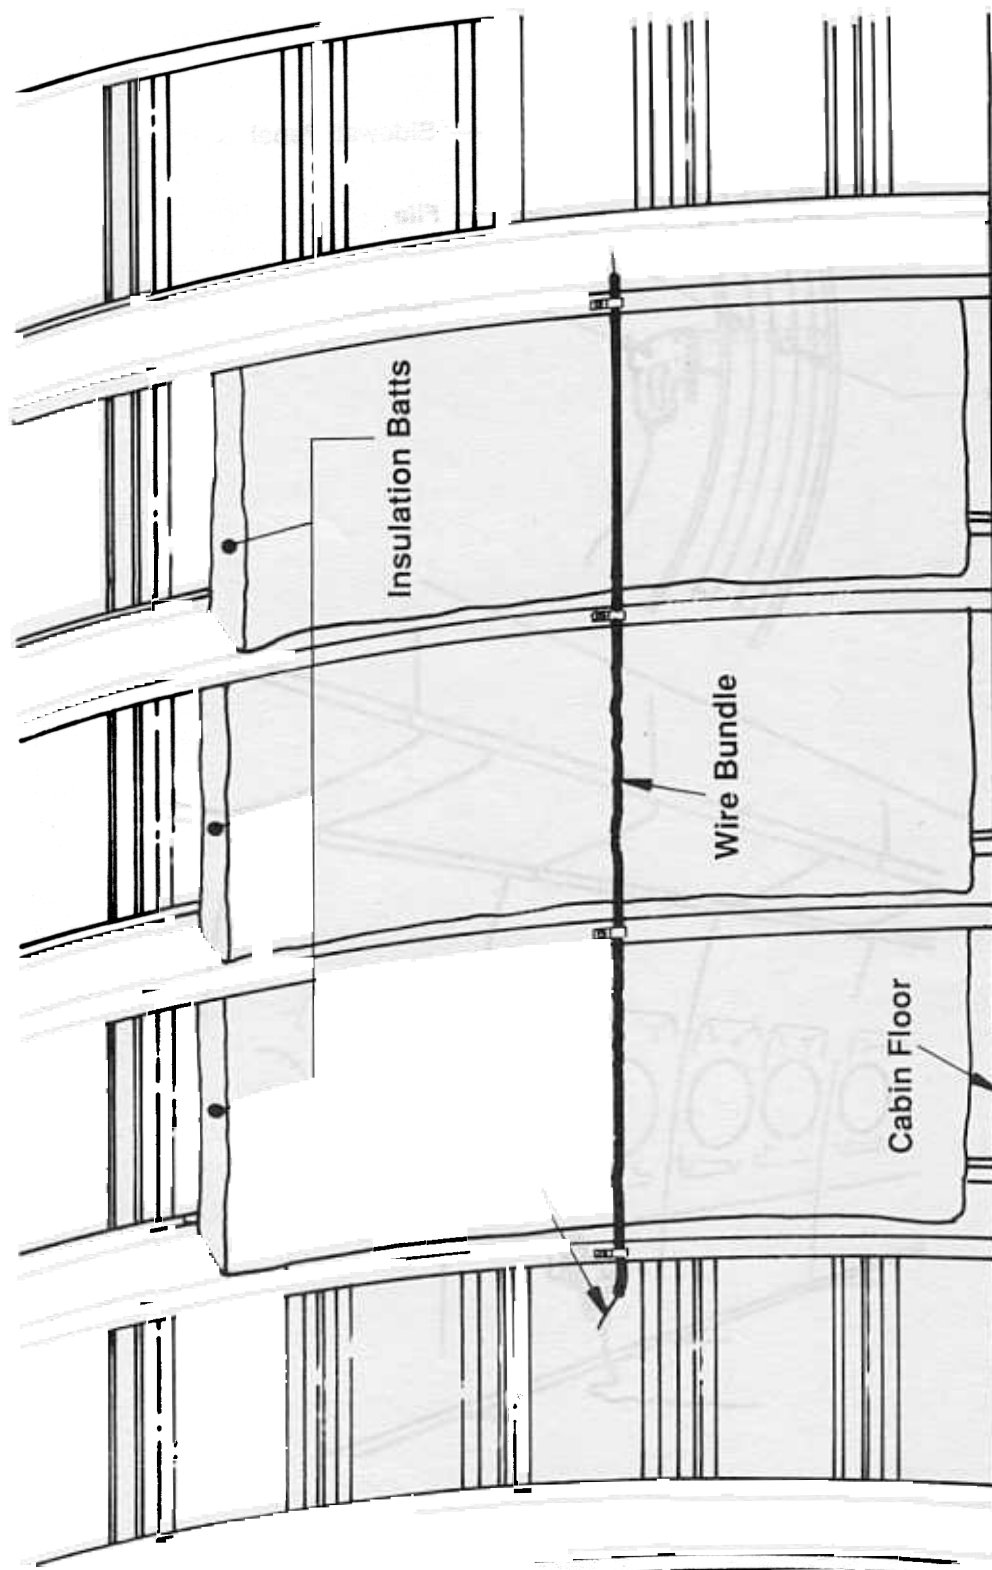
FIGURE 4. OVERHEATED WIRE BUNDLE

In this scenario a 3-foot section of a wire bundle with a length of nichrome wire added to the bundle was attached to the test article between the lavatory wall and the aircraft skin. Several fiberglass insulation batts were placed between the wire bundle and the outside skin as in figure 4. Current was passed through the nichrome wire to heat it and the wire bundle. Five different types of Orcon Corporation insulation covers were tested in this scenario. They were An-22 aluminized Tedlar™, AN-19 aluminized Tedlar, AN-4C aluminized Tedlar, KN-80 polyimide Kapton™, and AN-26 polyester Mylar™. All test fires self-extinguished. The aluminized Tedlar and polyester Mylar coverings melted away from the wire bundle and were slightly burned in several areas. The polyimide Kapton covering only melted where it was in direct contact with the burnt wire bundle but did not burn. The smoke detectors did not alarm during any of these tests, and the smoke meters in the cabin did not measure any reduction in light transmission. Smoke and a strong burning smell were present in the test cell following these tests, but there was little or no smell inside the test article. The cabin ventilation system carried the smoke and fumes into the cheek area and then out the outflow valve into the test cell.

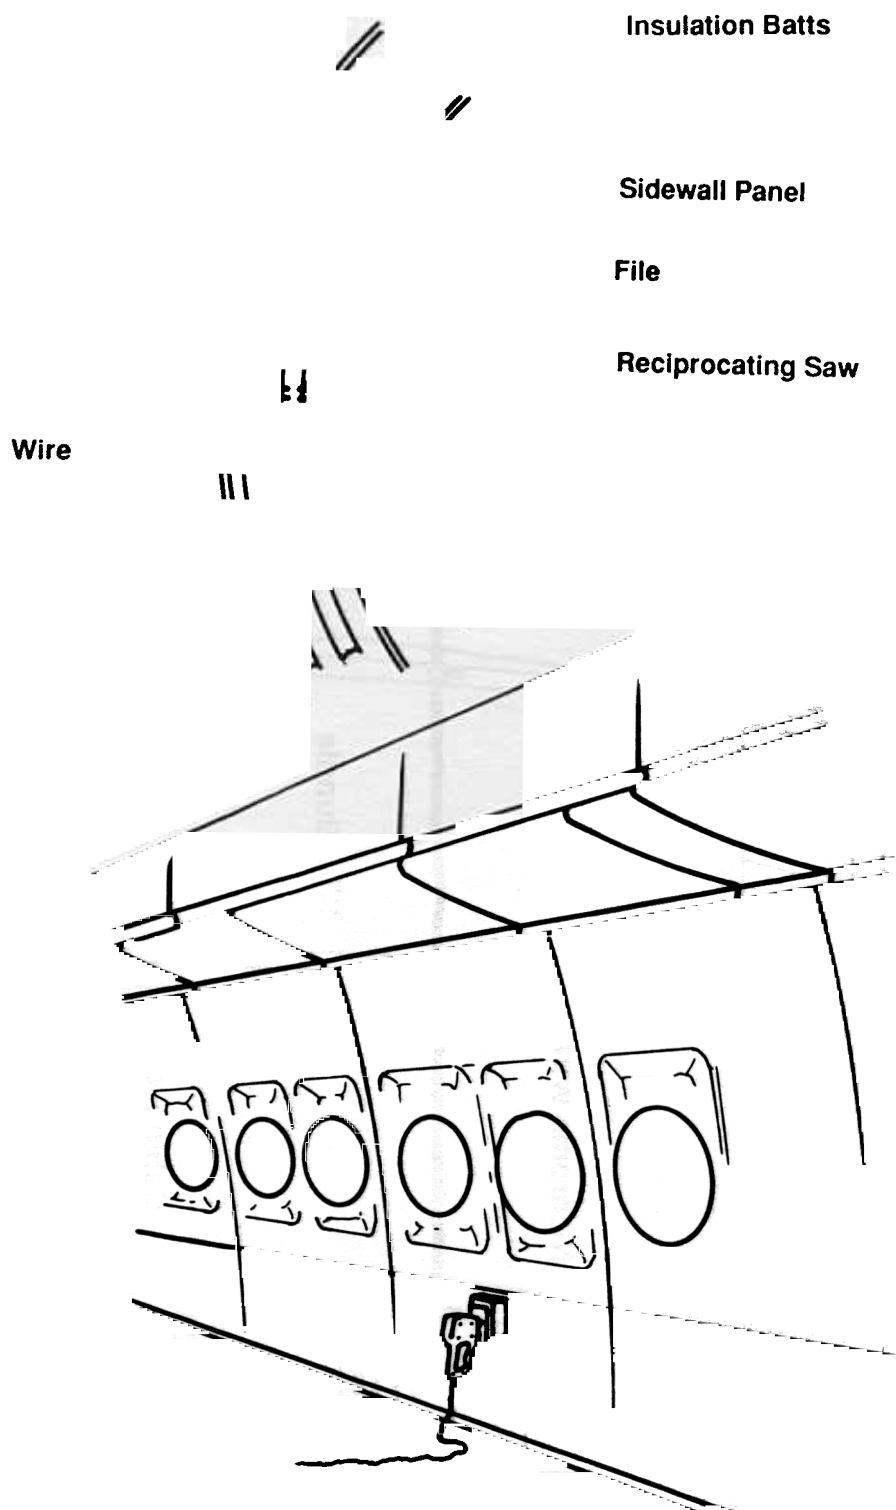
FIGURE 5. CHAFED WIRE BUNDLE BEHIND SIDEWALL

This scenario simulated a short in a bundle of Kapton insulated wire caused by chafing and the subsequent dry arc tracking that occurs when the circuit breakers are reset. Kapton is a highly thermally resistant material and is the most common aircraft wiring insulation. However, Kapton has a greater propensity for arc tracking than other types of wiring insulation, and it produces the most intense arc should arc tracking occur (references 1 and 2). A bundle of Kapton insulated wire was placed behind a cabin sidewall panel with a fiberglass insulation batt (with an aluminized Tedlar covering) between the wire bundle and the aircraft skin and another batt between the wire bundle and the sidewall panel. A reciprocating saw with a small file in place of the blade was attached to the sidewall panel and used to chafe the wire bundle. Figure 5 shows the configuration for this test scenario. The wire bundle consisted of 7 wires. Two wires were connected to each phase of a 220-volt, three-phase power supply with the seventh wire connected to ground. Each of the hot wires were protected by a 10-amp aircraft type circuit breaker. The test procedure was to energize the wire bundle and then chafe it with the saw until an arc occurred and a circuit breaker tripped. The breaker was reset which usually resulted in an additional arc and tracking to another wire in the bundle. The breakers were continually reset until arcing no longer occurred. The aluminized Tedlar insulation cover melted and burned away from the area of arcing and then quickly self-extinguished in tests 7, 9, 10 and 11. In those tests, the smoke detectors in the lavatory did not alarm and the smoke meters in the cabin and above the cabin ceiling recorded negligible levels of reduction in light transmission. In test 8, the arcing ignited the insulation cover which burned up to the bottom of the window and then self-extinguished. The decorative coating on the cabin side of the aluminum sidewall panel started to melt and peel away. Both of the lavatory smoke detectors alarmed at 11 minutes 34 seconds into the test. The lowest light transmission level measured in the cabin was 92 percent. This was measured by the smoke meter 72 inches from the floor in mid cabin. There was a negligible increase in cabin temperature and gas (CO, CO<sub>2</sub>) levels.

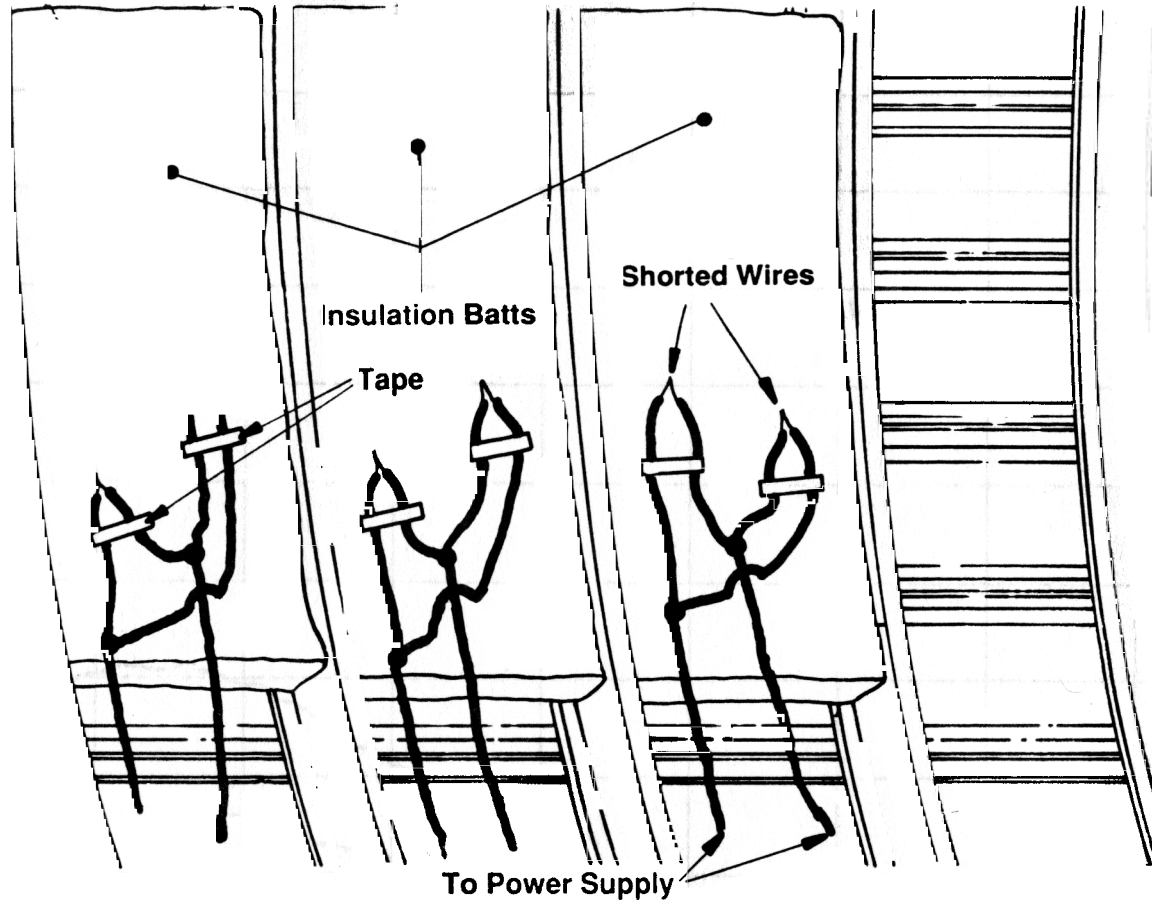
FIGURE 6. ARCING WIRES IN CHEEK AREA

This scenario simulated an arcing wire against an insulation batt in the cheek area. Fiberglass insulation with aluminized Tedlar covering was placed against the aircraft skin in the cheek area from the bottom of the cargo sidewall to the bottom of the cabin floor. Wires connected to a 220-volt, three-phase power supply were taped against the insulation batts and shorted together. Figure 6 shows the configuration for this test scenario. Tests 12, 13, and 16 used uncontaminated insulation covers. In these tests the arcs burned holes through the covers and the fiberglass insulation. The aluminized Tedlar covers were ignited by the arc, and small flames continued to burn for several minutes before self-extinguishing. Smoke detectors in the lavatory did not alarm, and smoke meters in the cabin measured only negligible smoke levels.

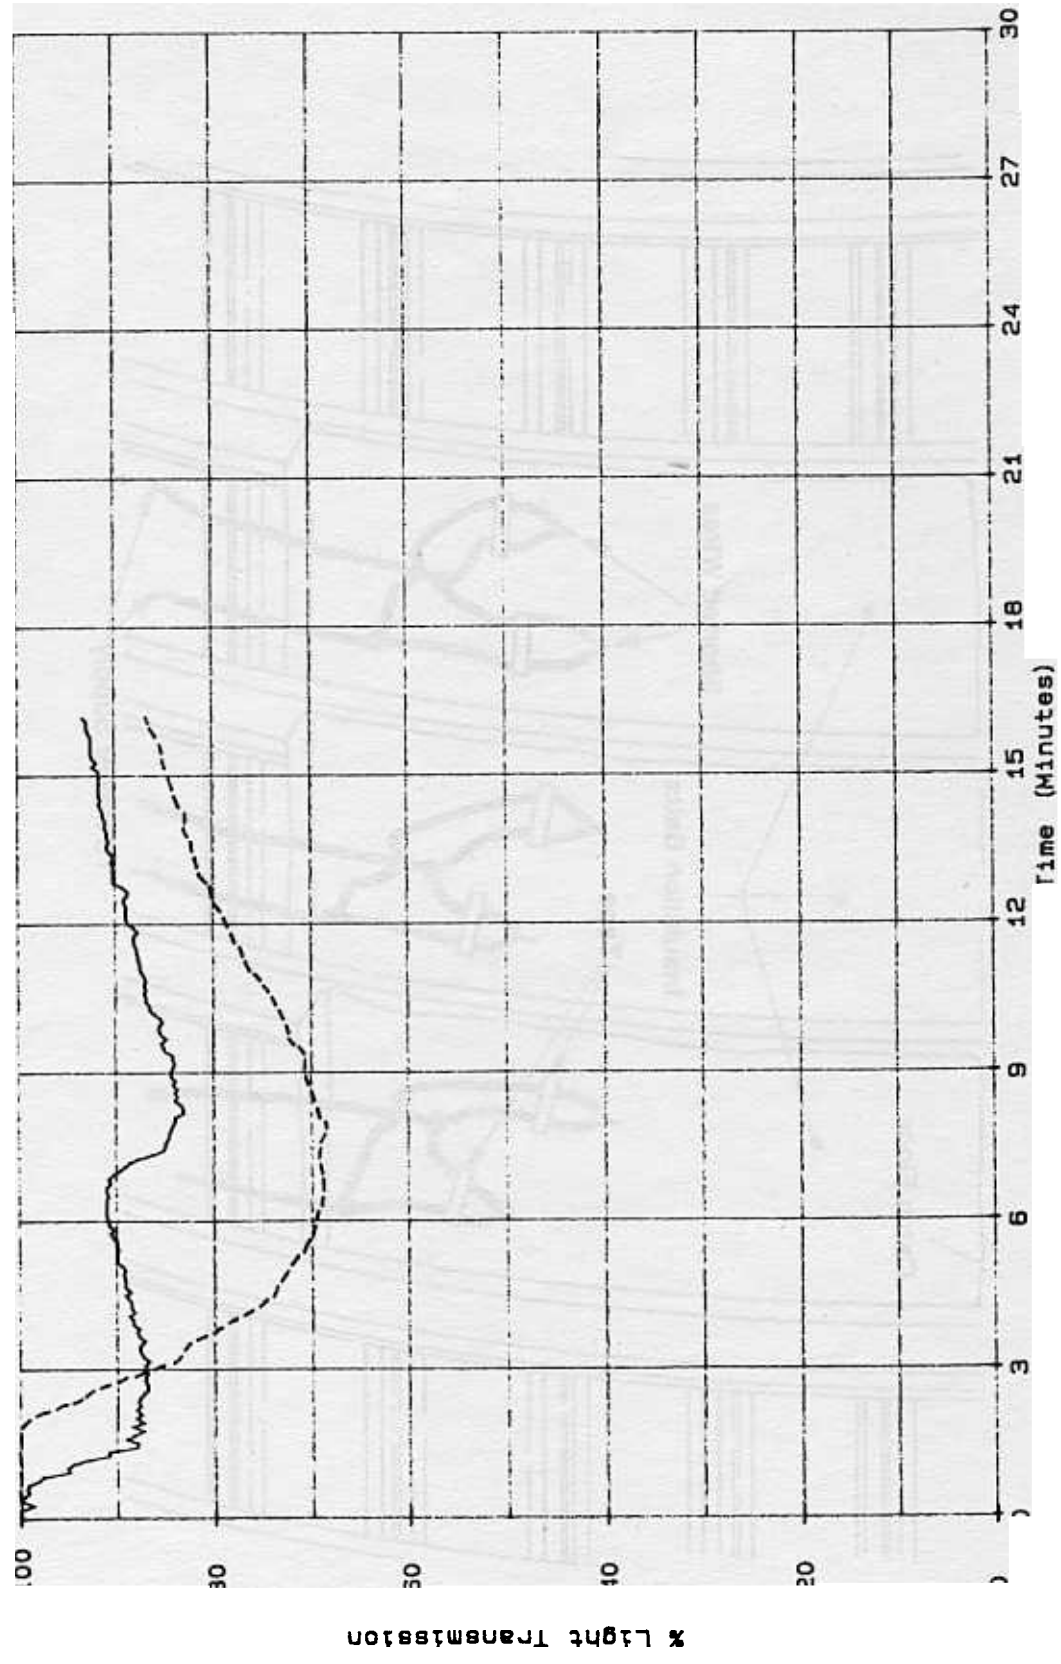
— Test 20  
- - - Test 21

FIGURE 7. SMOKE LEVELS IN CABIN--TESTS 20 AND 21

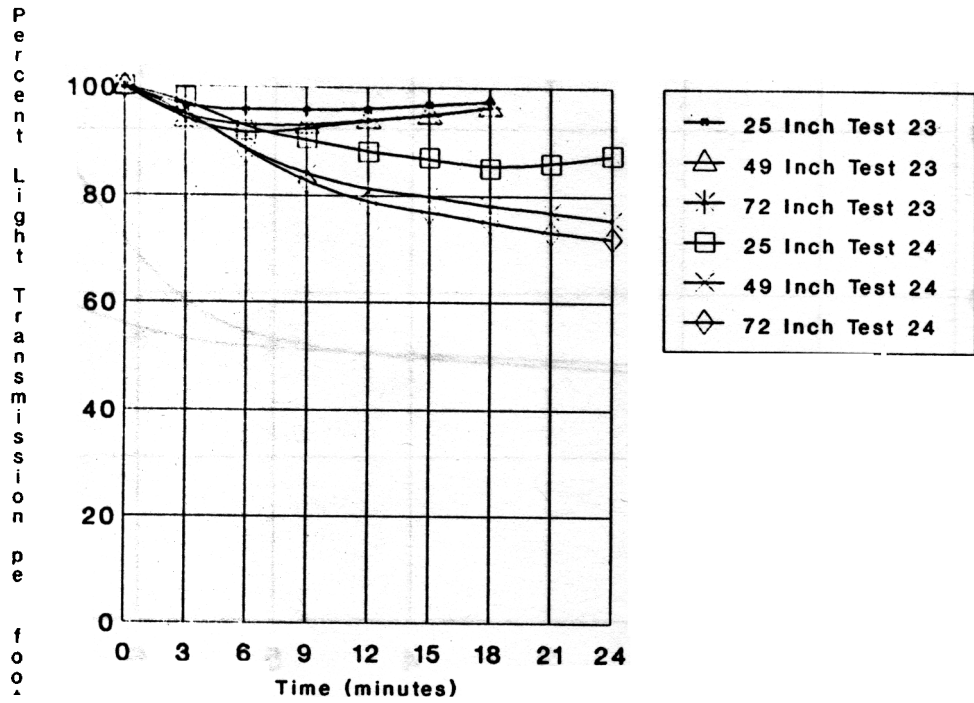
•Ventilation turned off at 4:12 in test 24

FIGURE 8. MID CABIN SMOKE--TESTS 23 AND 24

Test 24 and 25 used the same initial conditions as test 23. In these tests however, the cabin ventilation system was turned off and the outflow valve was closed as soon as the first smoke detector alarmed. In both tests, the first smoke detector to alarm was the photoelectric detector under the sink in the lavatory. This occurred at 4:12 in test 24 and 4:00 in test 25. Figure 8 is a graph of the smoke meter data in the cabin for tests 23 and 24 and shows that ventilation shutoff increased cabin smoke levels.

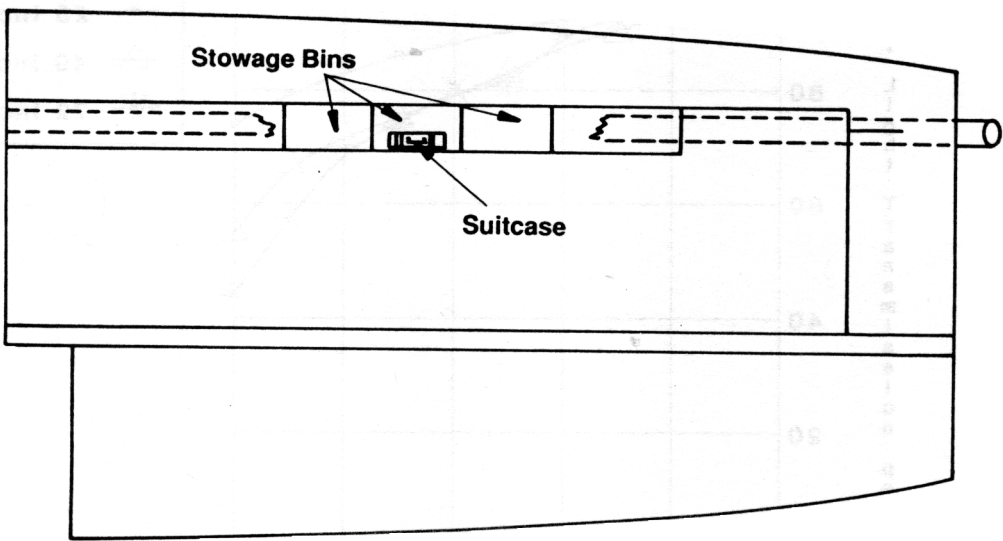
FIGURE 9. SUITCASE IGNITED IN STOWAGE BIN

In this scenario, a small suitcase was filled with rags and placed in a overhead stowage bin. Fiberglass insulation with aluminized Tedlar covering was installed between the stowage bin and the aircraft skin. A small quantity of alcohol was poured onto the rags, and the suitcase was ignited with nichrome wire. Figure 9 shows the configuration for these tests. In both tests, the top of the stow bin was burning within 1 minute of the start of the test. The fire completely destroyed the stow bin that the suitcase was in and damaged the bins on either side in both tests. In both tests, the thermocouple in the front of the cabin at the 6-foot level recorded a temperature rise of approximately 30 °F during the

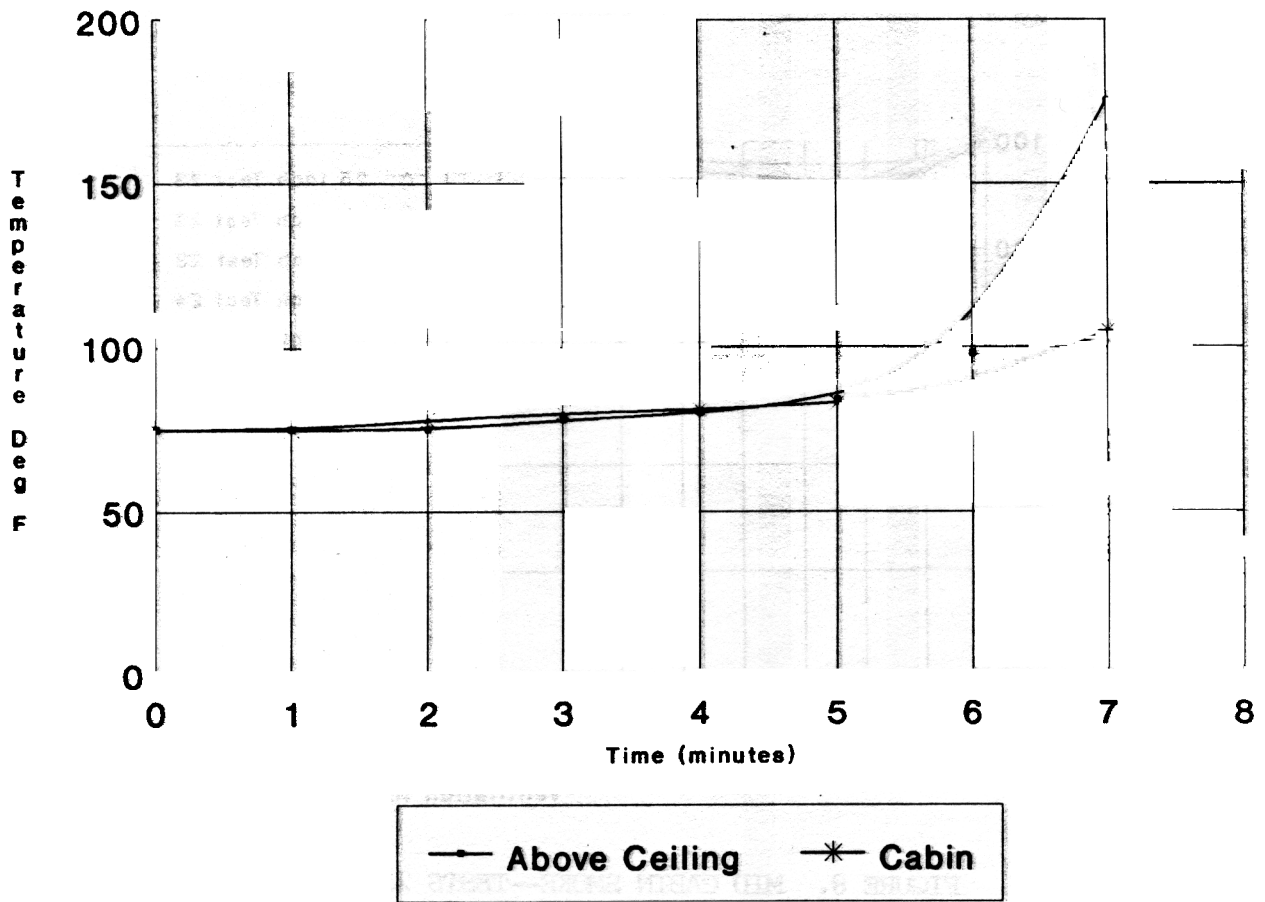
FIGURE 10. TEMPERATURES--TEST 30

test, and the maximum temperature measured by the thermocouples above the cabin ceiling was 175 °F. Figure 10 shows the temperature above the cabin ceiling and at the 6-foot level in the cabin for test 30. Light transmission was reduced to approximately 45 percent in mid cabin and to near zero above the cabin ceiling in both tests. Smoke levels in mid cabin for test 29 are shown in figure 11. The stowage bins used in this scenario were tested in the Ohio State University rate of heat release calorimeter. This is the flammability requirement, described in FAR 25.853, Appendix F, Part IV, for ceiling and sidewall panels, partitions, galleys, and overhead stowage bins that became effective in August of 1988. Although these stowage bins were removed from service prior to August 1988 and therefore were not required to pass this new flammability test, they did meet the criteria that were in effect from August 1988 to August 1990. The 2-minute total heat release was 86.34 kW\*min/m<sup>2</sup> and the peak heat release rate was 73.44 kW/m<sup>2</sup>. The criteria in effect from August 1988 to August 1990 were a maximum total heat release of 100 kW\*min/m<sup>2</sup> and a maximum peak heat release rate of 100 kW/m<sup>2</sup>. After August of 1990, the criteria became more stringent; i.e., a maximum total heat release of 65 and a maximum peak heat release rate of 65.

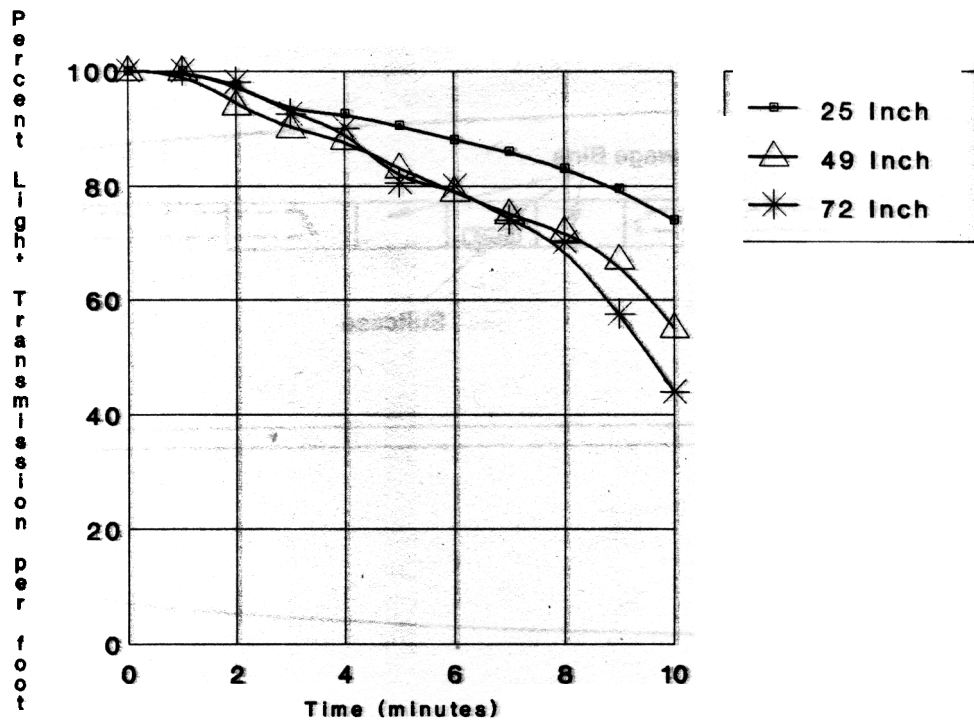
FIGURE 11. MID CABIN SMOKE--TEST 29

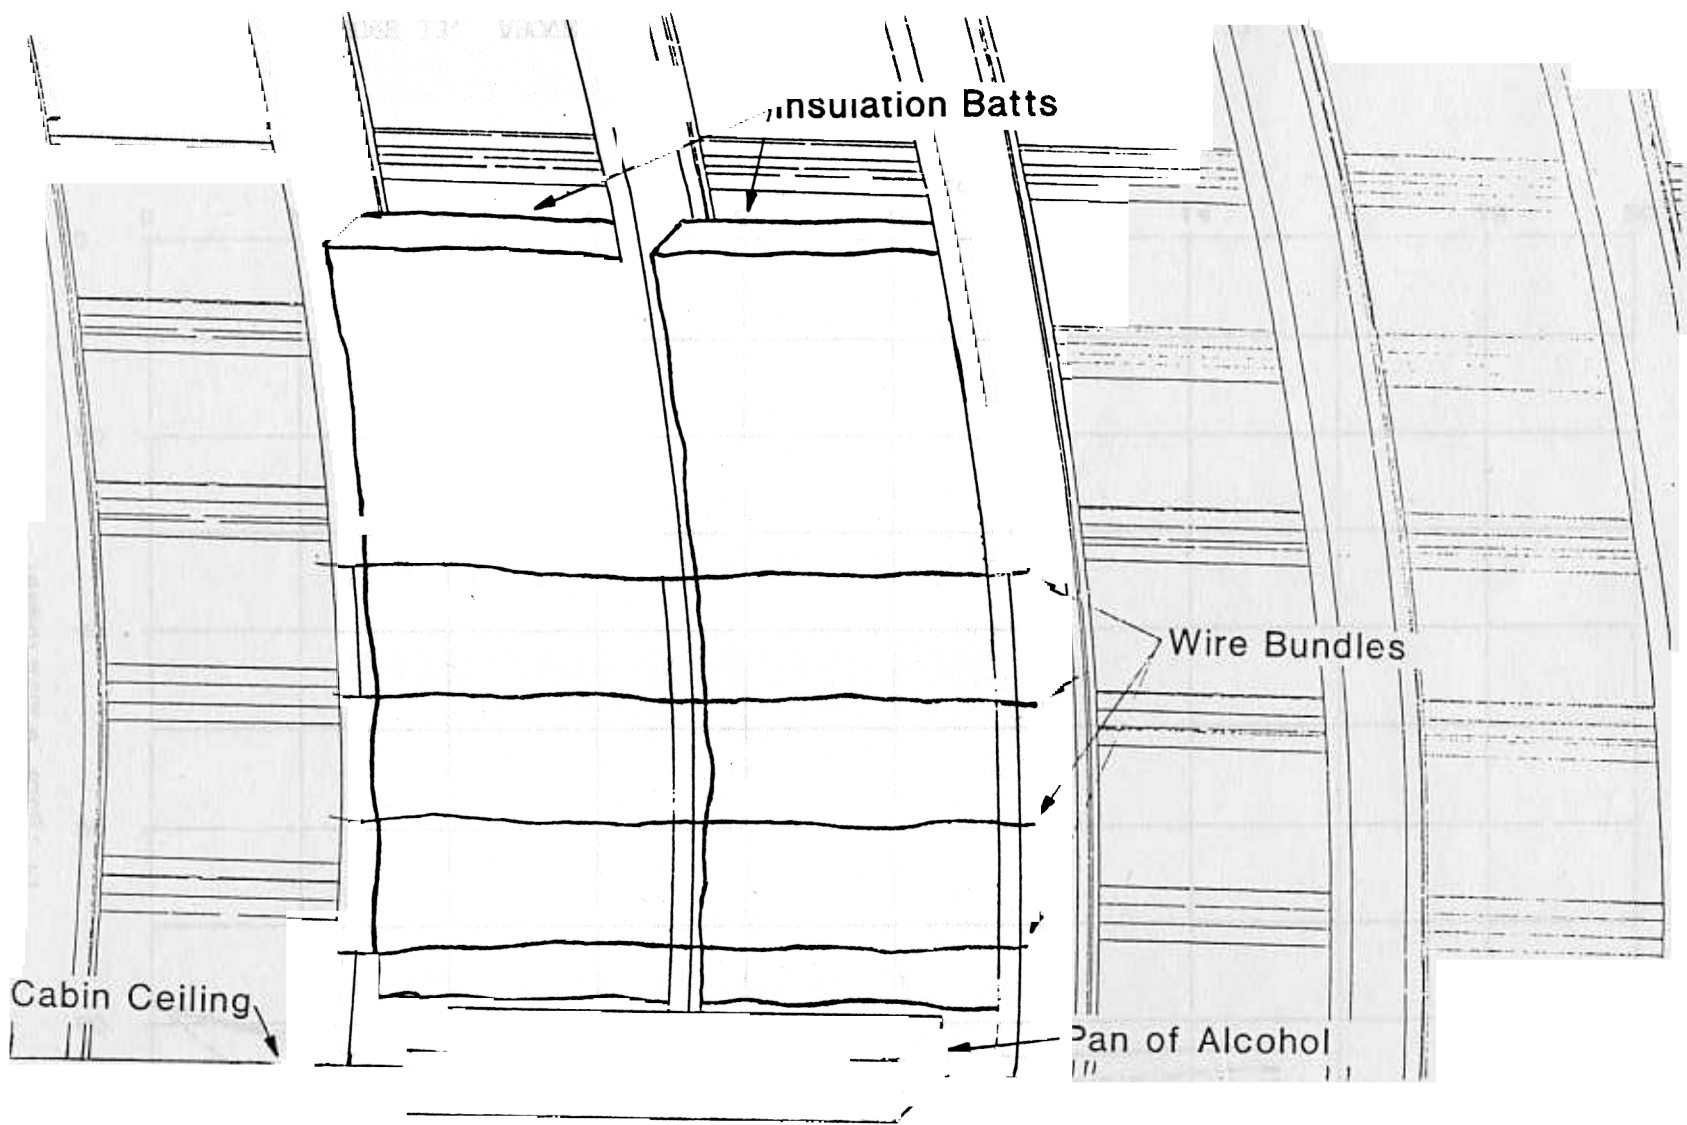
FIGURE 12. WIRE AND INSULATION IGNITED ABOVE CABIN CEILING

This scenario exposed three different combinations of wire bundles and insulation batts to a pan of burning alcohol above the cabin ceiling. The purpose of these tests was to evaluate the hazards introduced into the cabin from a relatively small amount of burning material. The three combinations of materials were Kapton insulated wire bundles against Kapton covered fiberglass insulation (test 31); polyvinyl chloride (PVC)/nylon insulated wire bundles against aluminized Tedlar covered fiberglass insulation (test 32); and Tefzel (ethylene tetra fluoro-ethylene) insulated wire bundles against aluminized Tedlar covered fiberglass insulation (test 33). Four wire bundles of twenty 22-gauge wires each were used in each test. Two insulation batts were installed against the aircraft outer skin, and the wire bundles were installed against the insulation batts. A pan of alcohol was positioned at the bottom of the insulation batts just above the cabin ceiling. Figure 12 shows the test configuration for this scenario.

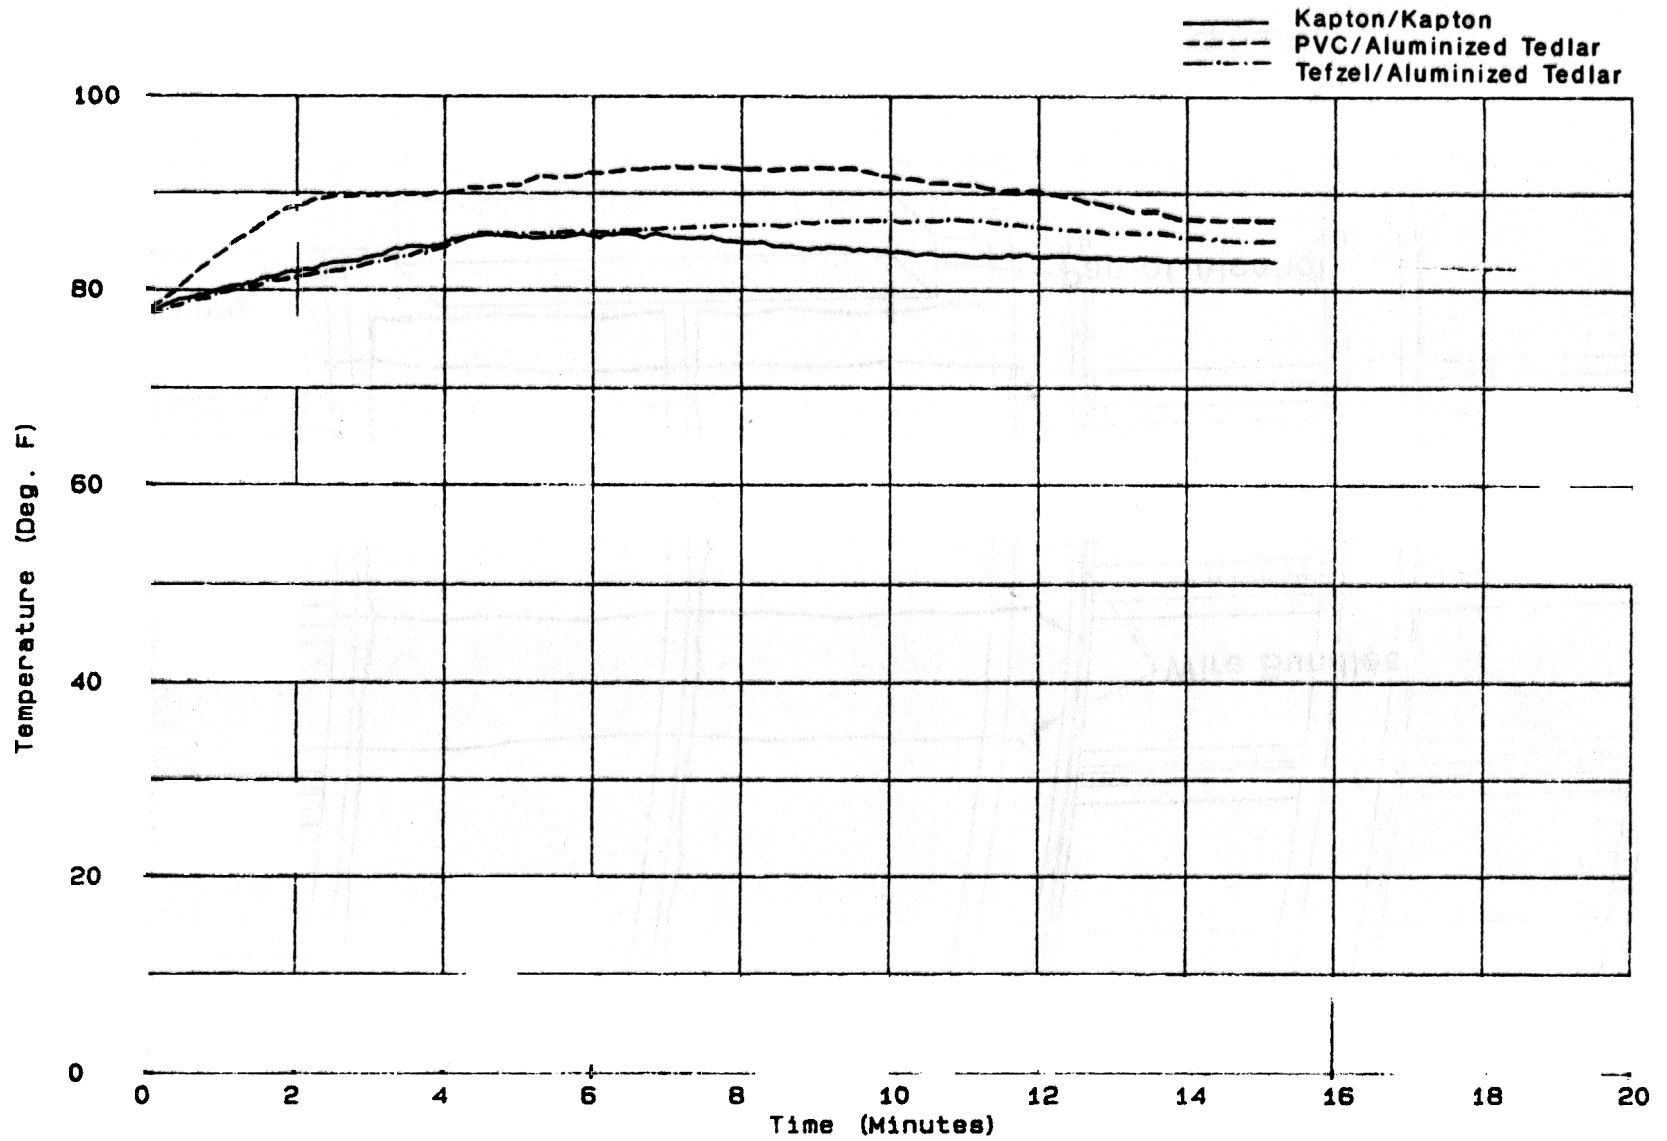
FIGURE 13. ABOVE CEILING AVERAGE TEMPERATURE--TESTS 31, 32, AND 33

Test 32, with PVC wire and aluminized Tedlar insulation batts, produced significantly more smoke and heat than tests 31 and 33. Figure 13 shows the average temperature above the cabin ceiling for the three tests. The temperature is the average of the six thermocouples in the 950-cubic-foot space above the ceiling. Figures 14 and 15 show the average smoke levels for the three smoke meters above the ceiling and the three smoke meters in mid cabin. It can be seen from these graphs that the main source of smoke and heat in test 32 was from the PVC wire insulation, since test 33 used the same aluminized Tedlar insulation covering as test 32 but produced much less smoke and heat. A PVC/nylon wire insulation will not pass the current flammability test for aircraft wiring which was imposed in 1972. However, it was installed on some aircraft manufactured prior to that date, many of which are still in service. Kapton and Tefzel insulated wires do pass the current flammability test. Figures 16, 17, and 18 show the wire bundles and insulation before and after each of the three tests.

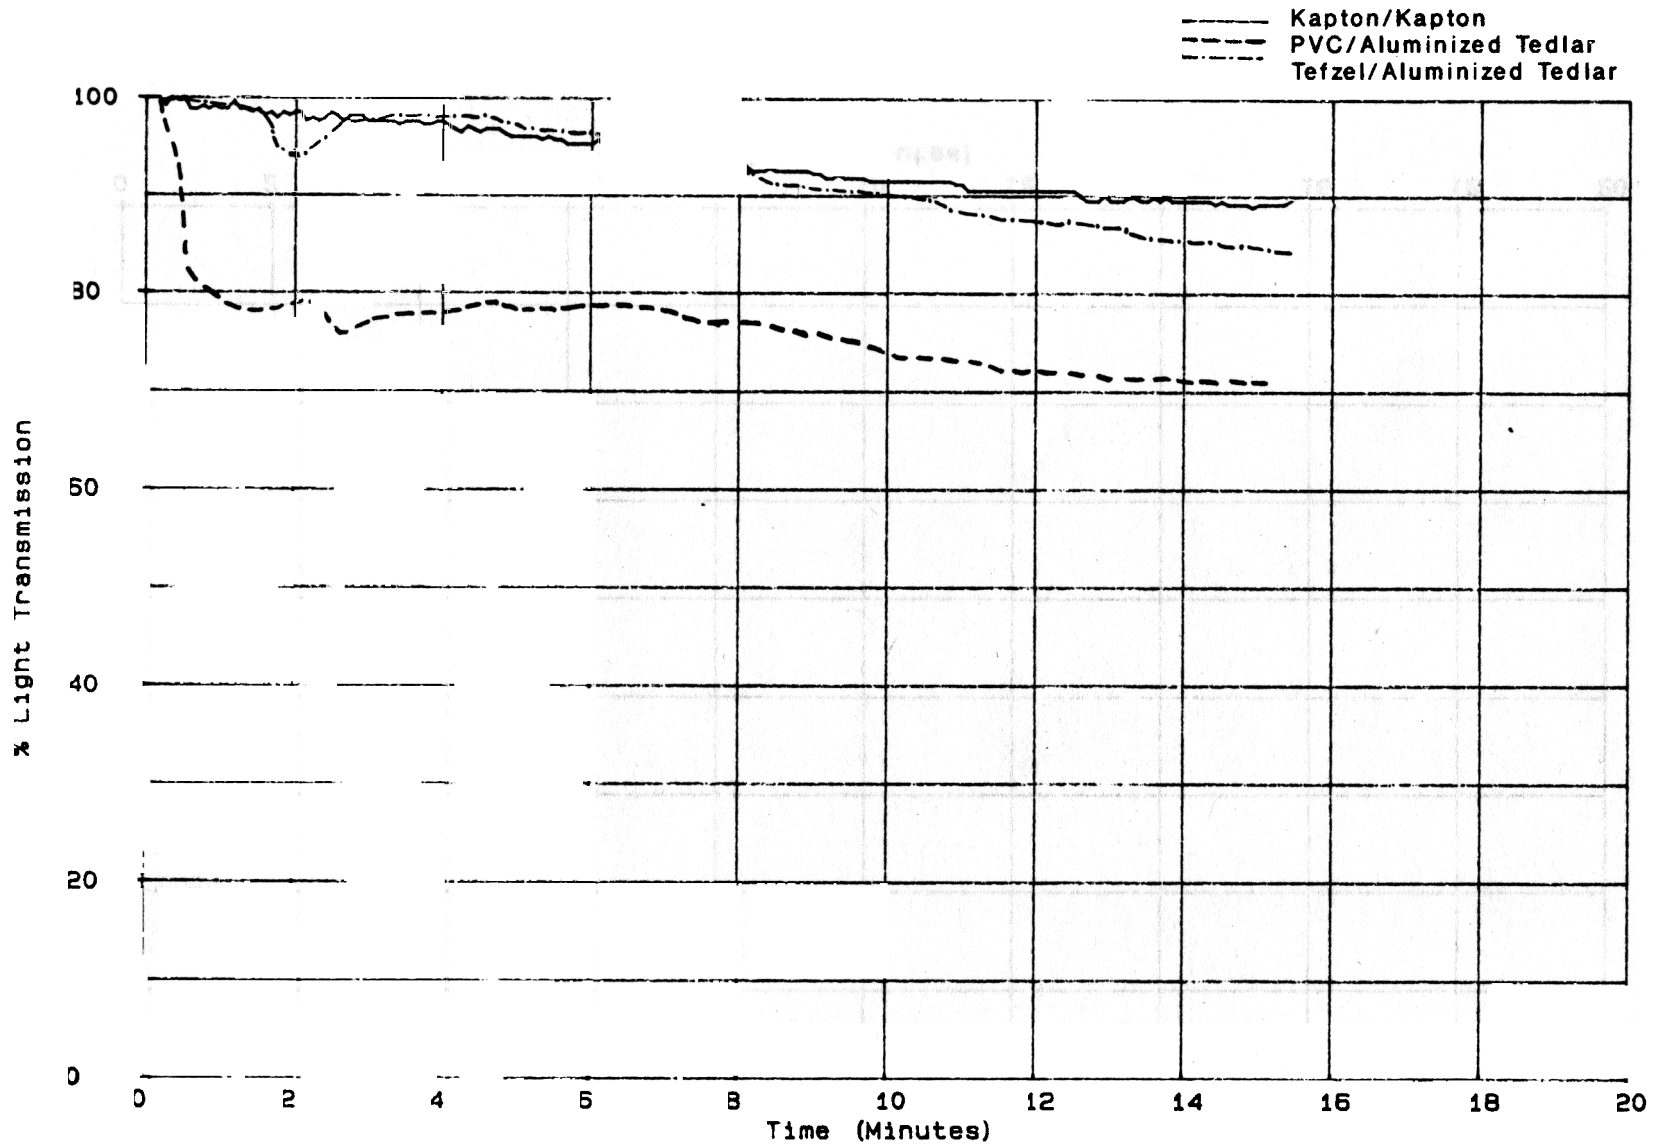
FIGURE 14. ABOVE CEILING AVERAGE SMOKE LEVEL--TESTS 31, 32, AND 33
