DOT/FAA/CT-91/2

# Development and Growth of Inaccessible Aircraft Fires Under Inflight Airflow Conditions

David Blake

Final Report

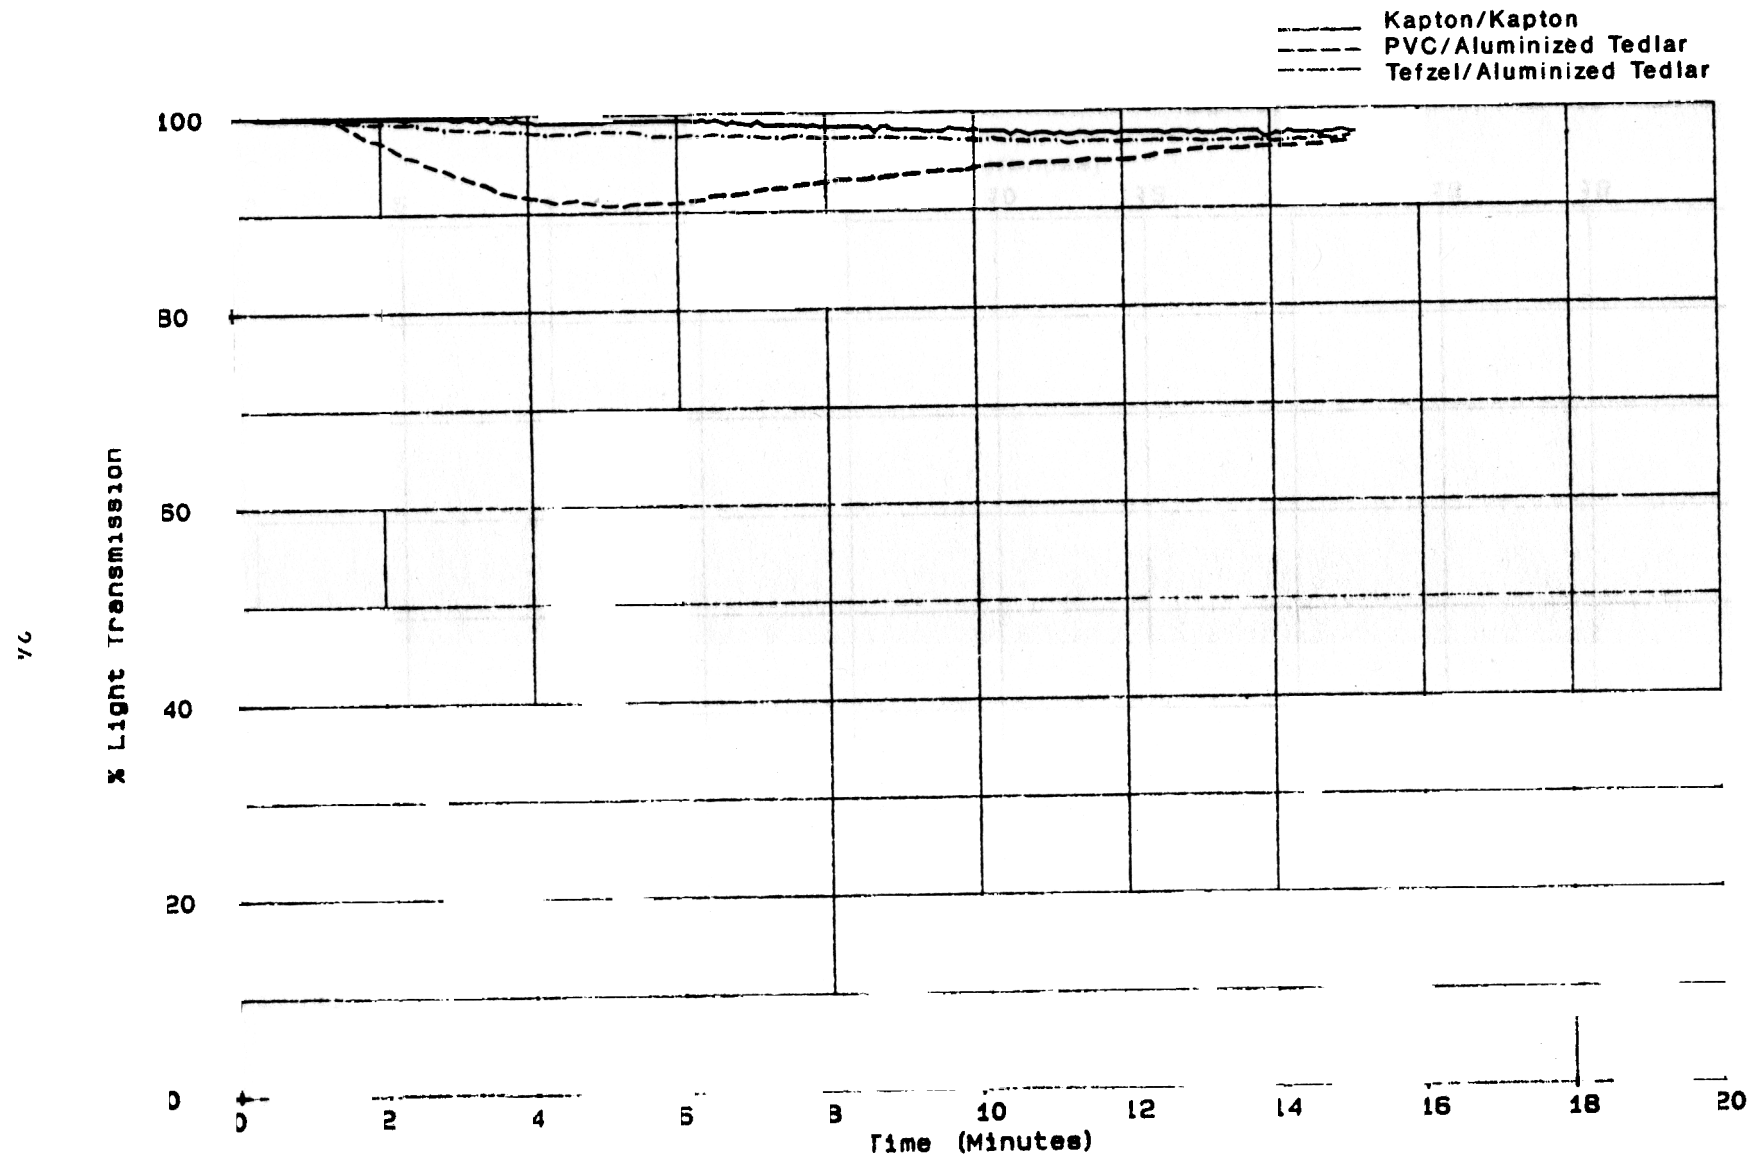
FIGURE 15. MID CABIN AVERAGE SMOKE LEVELS--TESTS 31, 32, AND 33

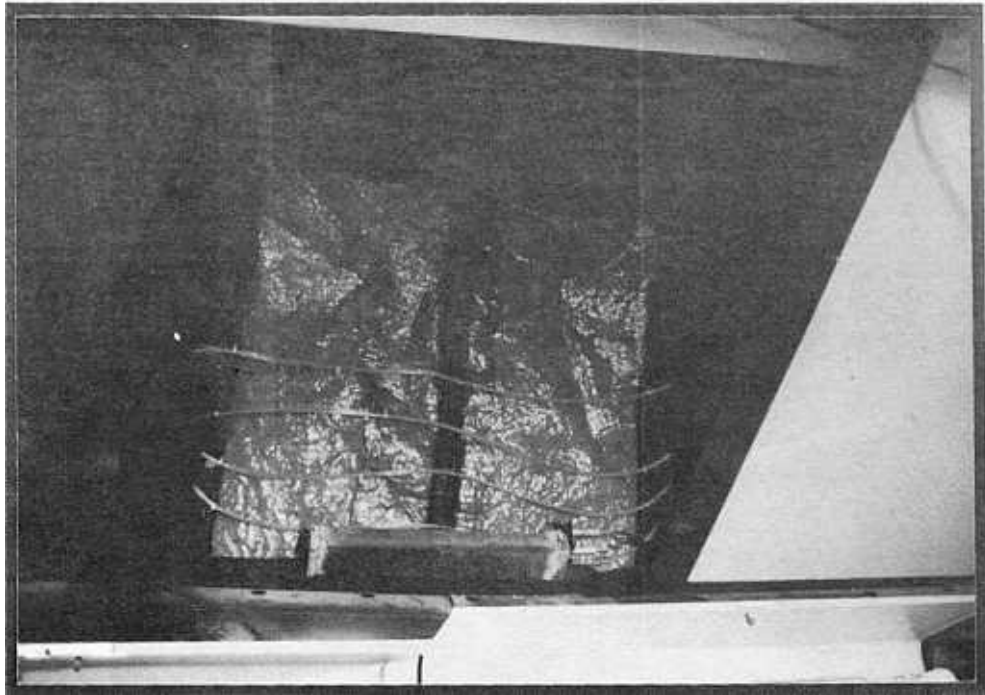
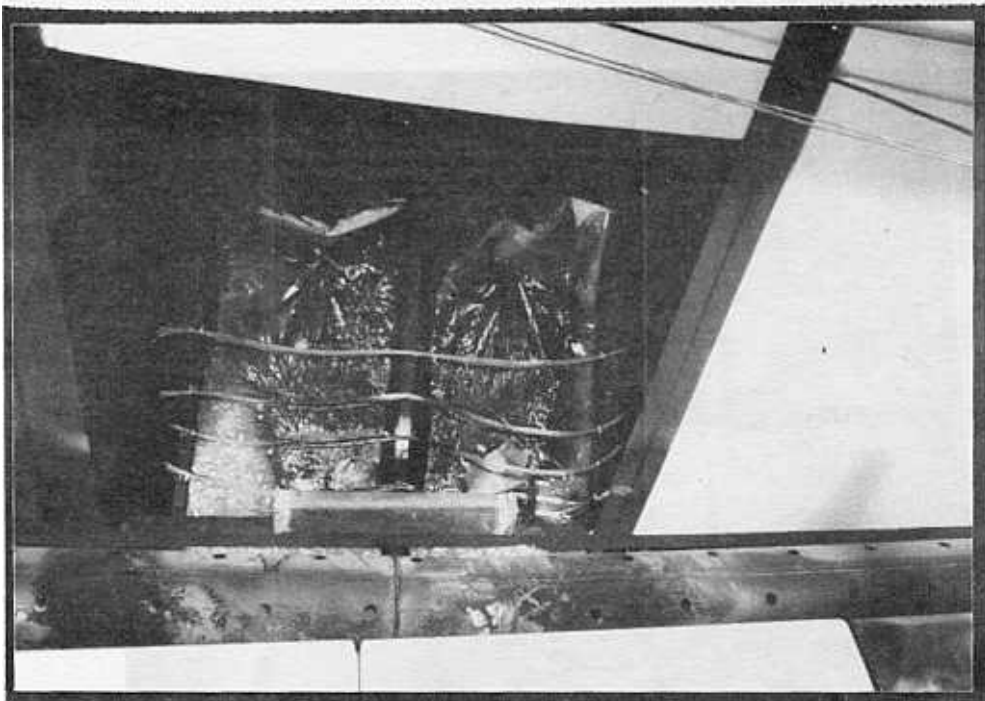
FIGURE 16. WIRE AND INSULATION BEFORE AND AFTER-TEST 31  
(Kapton Wire Insulation/Kapton Covered Batts)

Test 32, with PVC wire and aluminized Tedlar insulation batts, produced significantly more smoke and heat than tests 31 and 33. Figure 13 shows the average temperature above the cabin ceiling for the three tests. The temperature is the average of the six thermocouples in the 950-cubic-foot space above the ceiling. Figures 14 and 15 show the average smoke levels for the three smoke meters above the ceiling and the three smoke meters in mid cabin. It can be seen from these graphs that the main source of smoke and heat in test 32 was from the PVC wire insulation, since test 33 used the same aluminized Tedlar insulation covering as test 32 but produced much less smoke and heat. A PVC/nylon wire insulation will not pass the current flammability test for aircraft wiring which was imposed in 1972. However, it was installed on some aircraft manufactured prior to that date, many of which are still in service. Kapton and Tefzel insulated wires do pass the current flammability test. Figures 16, 17, and 18 show the wire bundles and insulation before and after each of the three tests.

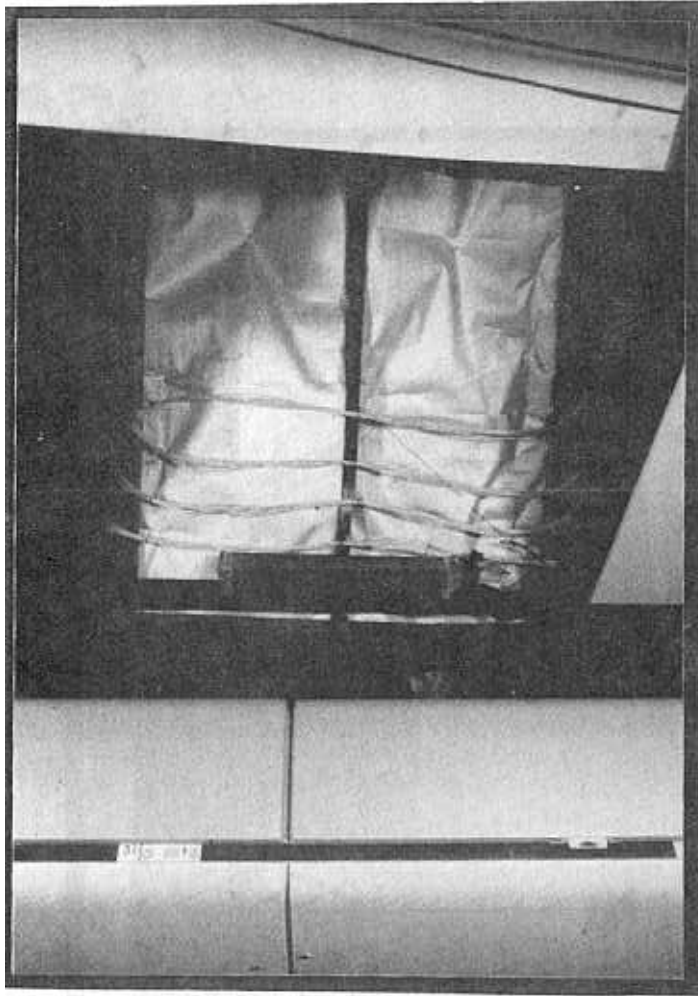
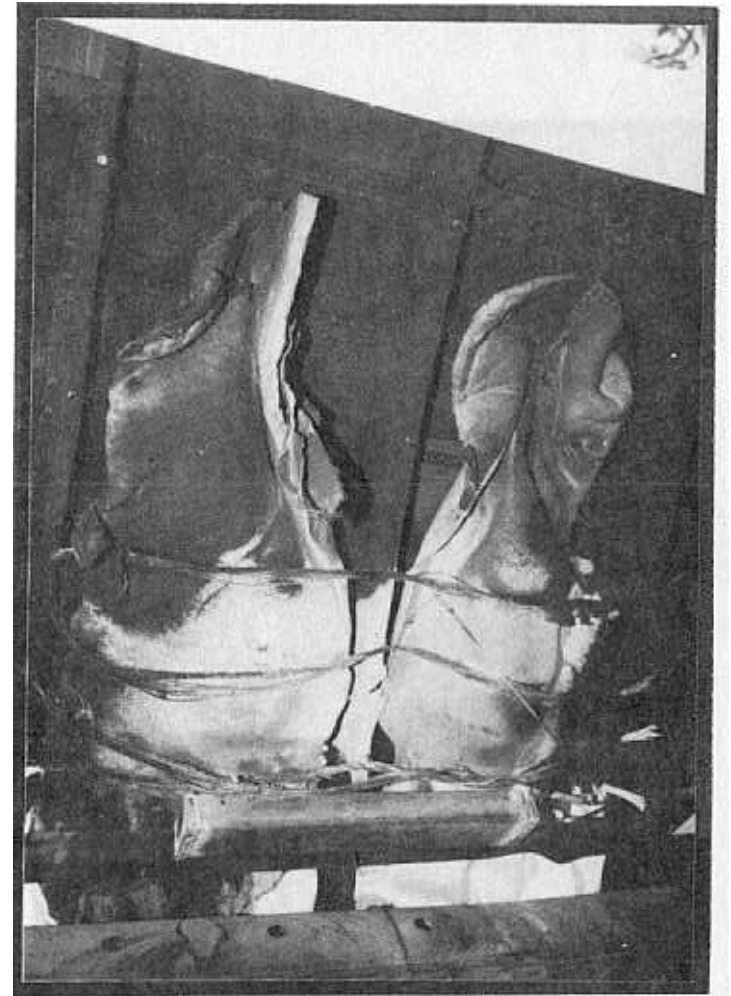
FIGURE 17. WIRE AND INSULATION BEFORE AND AFTER-TEST 32  
(PVC Wire Insulation/Aluminized Tedlar Covered Batts)

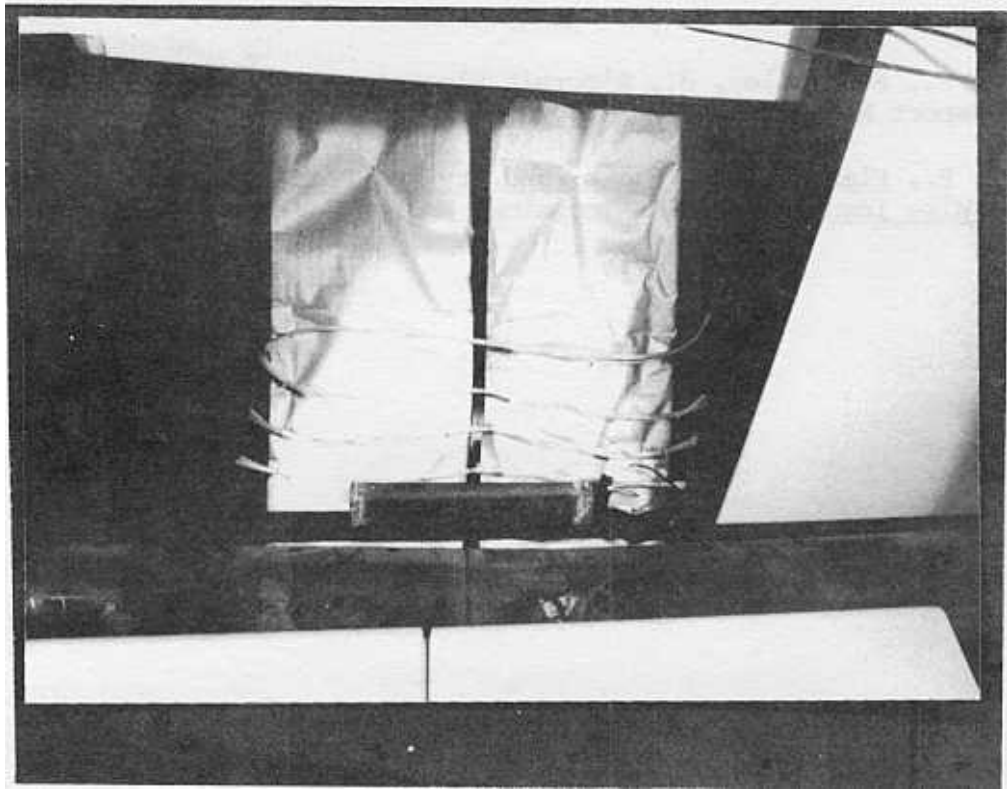
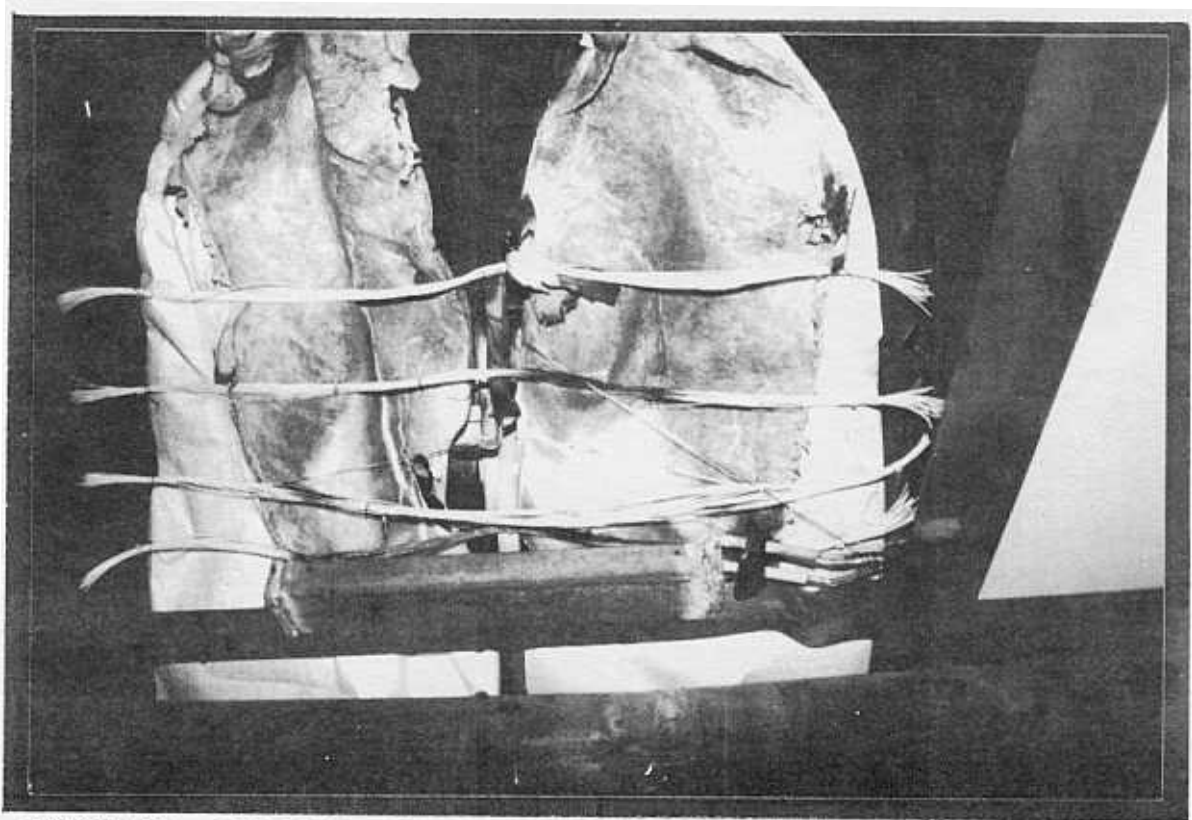
FIGURE 18. WIRE AND INSULATION BEFORE AND AFTER-TEST 33  
(Tefzel Wire Insulation/Aluminized Tedlar Covered Batts)
