**A Report on Improvement of Cabin Equipment to Enhance
Cabin Safety against Aircraft Jolt in Flight**

March 2003

Research Committee on Aircraft Safety Enhancement

commissioned by
Civil Aviation Bureau of Japan
(JCAB)

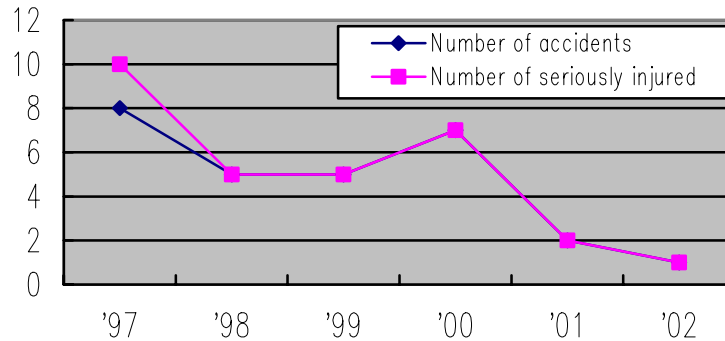
Figure 6. The effect of turbulence procedure (flight attendants)

On the other hand, the number of flight attendants who got seriously injured because of not returning to their seats immediately after seat belt signs illuminated decreased greatly in last two years as shown in Figure 6. It is guessed that the turbulence procedure is very effective to reduce flight attendant injuries.

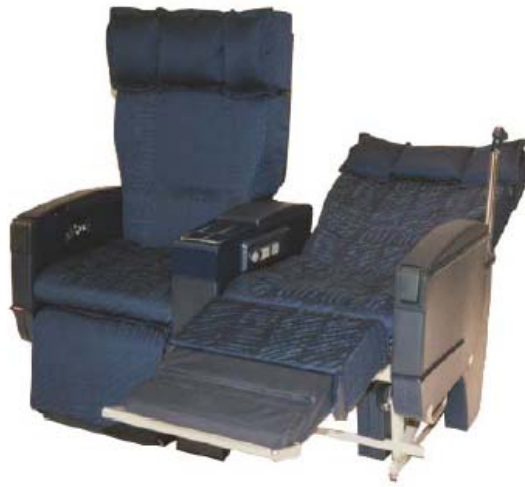
Figure 7. Passenger seat with a vertical bar behind an armrest (SICMA)

Handgrips in Figures 7 to 9 are installed on the armrests. These seats are already approved by FAA and installed in some airplanes.

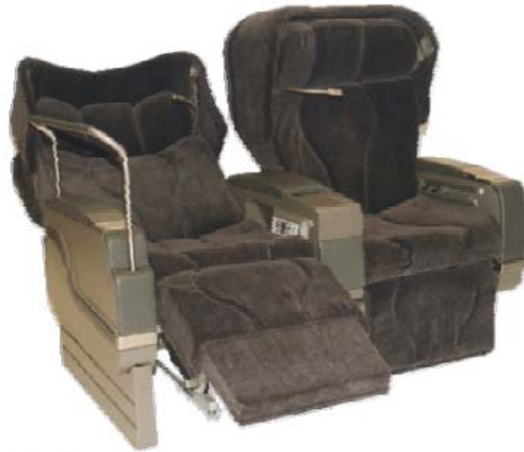
Figure 8. Passenger seat with a horizontal bar on an armrest (SICMA)

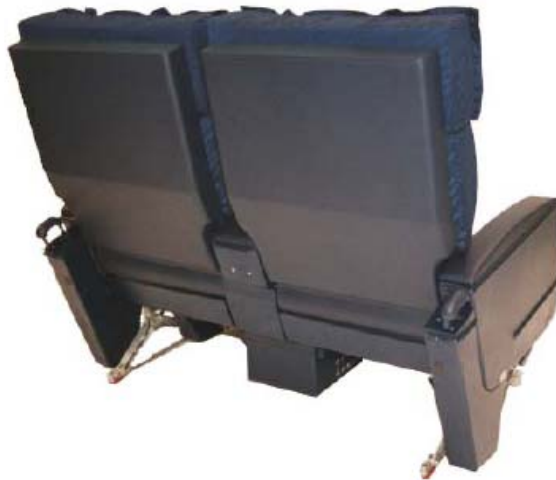
Figure 9. Passenger seat with a handgrip behind an armrest (SICMA)

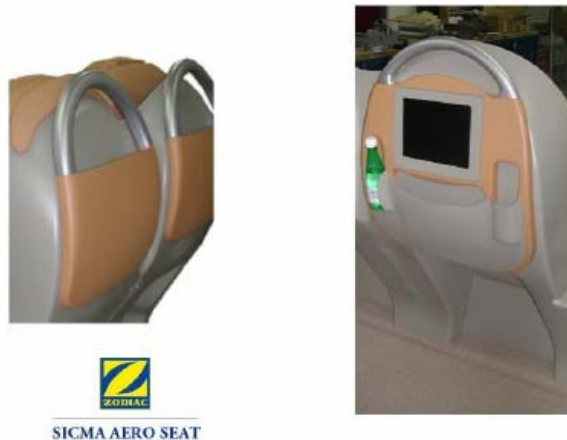
Figure 10. Passenger seat with a handgrip on the backshell (SICMA)

Moreover, SICMA is working on the passenger seats with handgrips installed on the backshell as shown in Figure 10. The handgrips in Figure 10 are made of aluminum. There may be a concern regarding the possible head injury problem, nevertheless the material should be sufficiently hard to give confident grip which is the first purpose of the handgrip : to be sufficiently strong and rigid to allow to a passenger to be supported in case of turbulence.

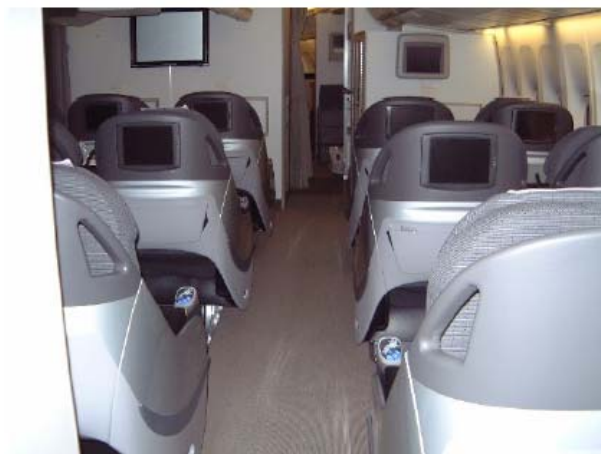
Figure 11. Passenger seats with handgrips in the backshell (BEA)

On the other hand, B/E AEROSPACE supplies seats equipped with handgrips to Japan Airlines. The photograph of these seats is shown in Figure 11. These seats are for business classes, and are to fulfill the legal requirements of FAR25.785 (j) and FAA Advisory Circular 25-17 like SICMA.

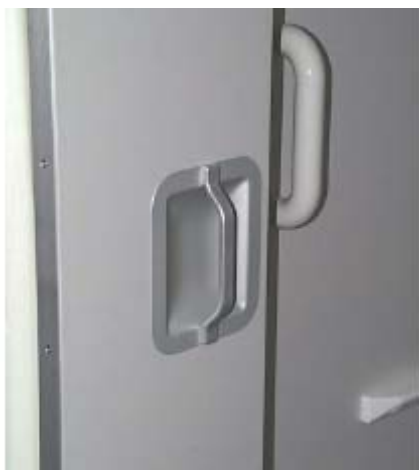
Figure 12. The embedding type handrail equipped on the toilet outer wall

3-3-1 Handrails equipped on the toilet outer wall (Figures 12 and 13)

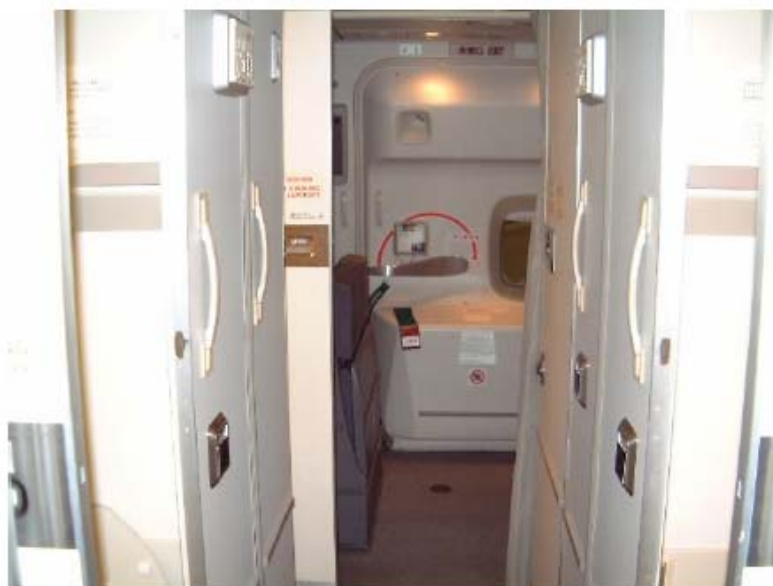
Figure 13. The suitcase handle equipped on the toilet outer wall

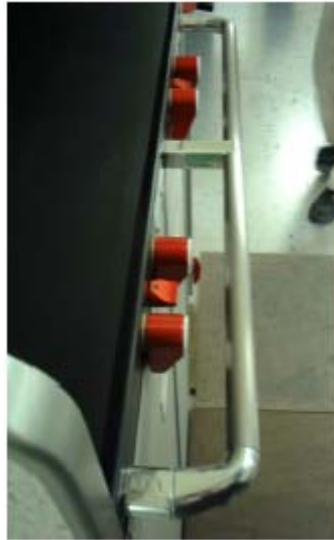
The gap between the galley counter and the handhold was widened so that hands can be inserted easily for easy grasping.

Figure 14. Improved handholds in a galley

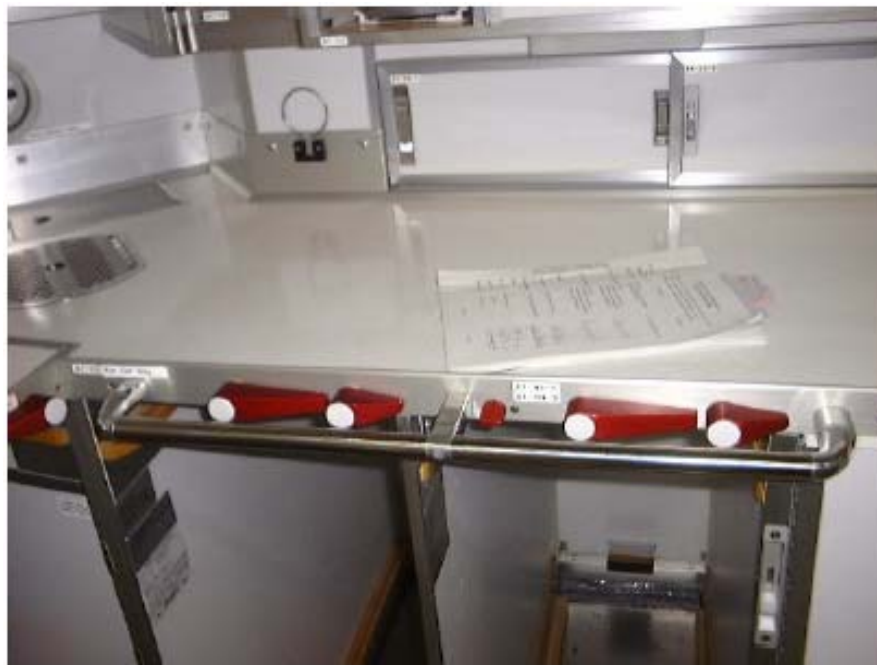
Figure 15. Improved handholds in a galley

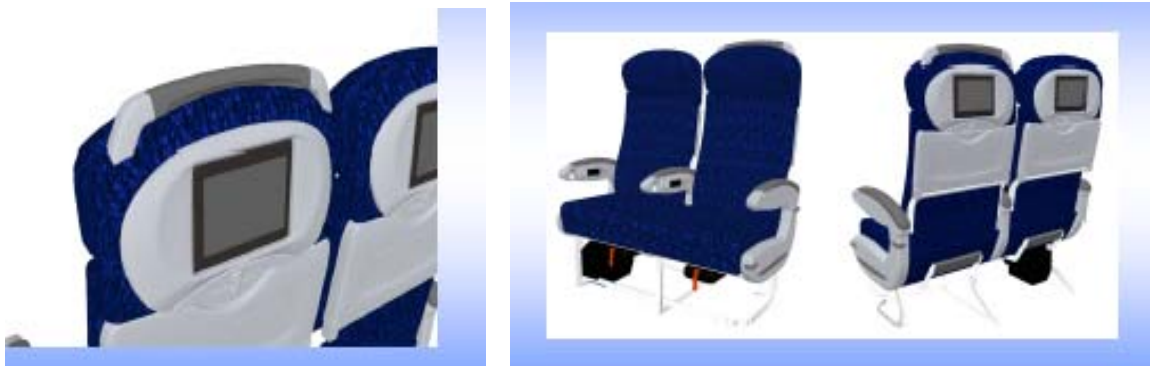
4-3-1 Handgrips on the top of passenger seats

A handgrip is installed on the top of a seatback without deforming the external shape of the seat. If the seat pitch is 31 inches or under, a passenger in the backseat may hit his/her forehead against the handgrip, it can be used only for the backmost row. Assumed design load is set to 300 pounds.

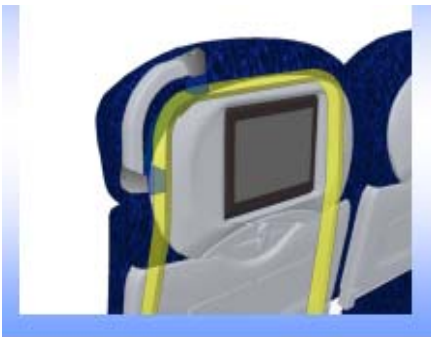
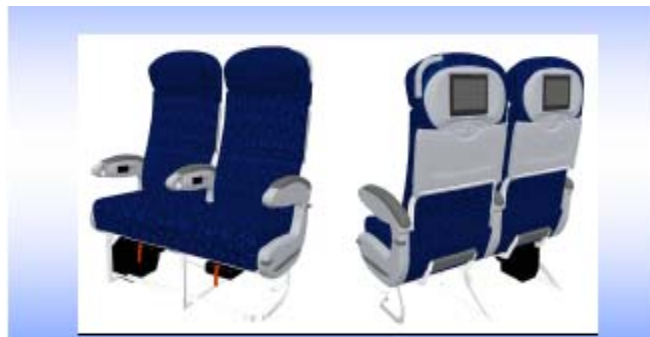
4-3-2 Handgrip on the shoulder of passenger seat

A handgrip is installed on the shoulder of a seatback where the cushion is scooped out. It is applicable to any seat position because passengers have no risk of hitting their foreheads against it. Assumed design load is set to 300 pounds.
