# CORROSION PROTECTION OF AEROSPACE GRADE MAGNESIUM ALLOY ELEKTRON™ 43 FOR USE IN AIRCRAFT CABIN INTERIORS

7<sup>th</sup> Triennial International Fire & Cabin  
Safety Research Conference

Sarah S. Baillio

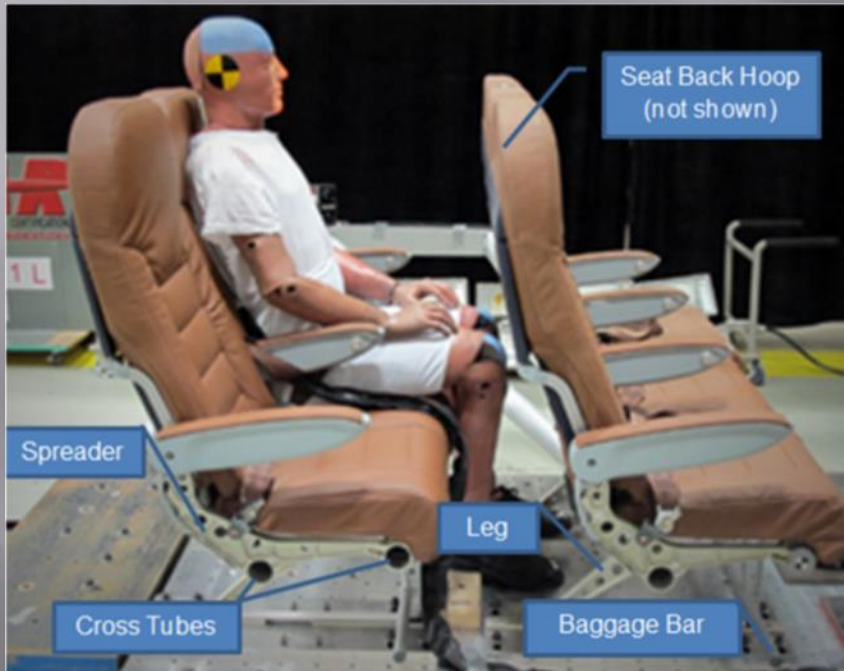
## DOT-FAA-AR-11-3: EVALUATING THE FLAMMABILITY OF VARIOUS MAGNESIUM ALLOYS

Current flammability testing is being supported strongly by the FAA Technical Center. Large, machined primary components of the seats (legs, spreaders, cross tubes) will be excellent candidates for magnesium usage.

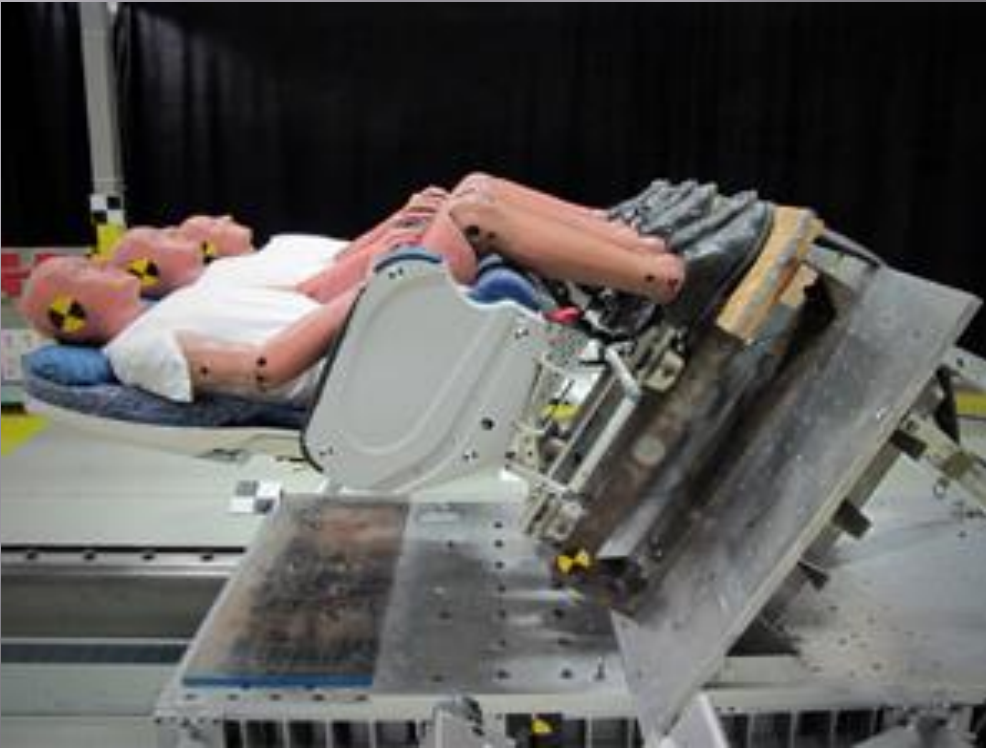
Dynamic test requirements include 16G longitudinal, 14G download structural, and 16G front row head and knee path evaluations

For each test, blunt force trauma, seatback deformation, and sharp edges will be evaluated. The lumbar and femur loads will also be assessed.

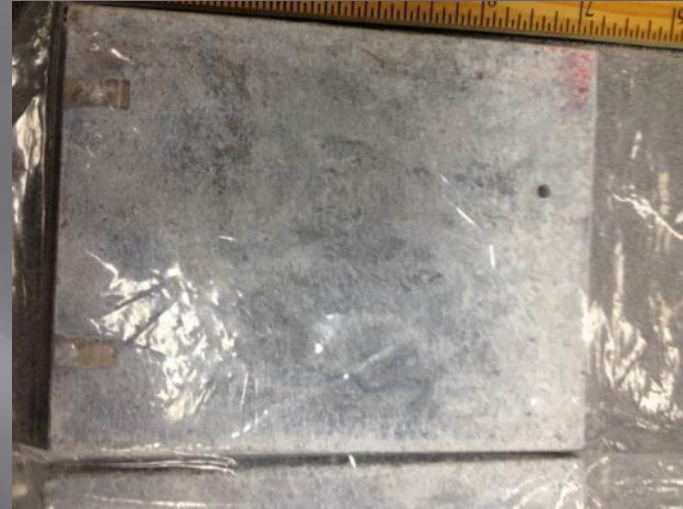
## □ General corrosion

- In aqueous solutions, an electrochemical reaction results in the dissociation of magnesium with water to produce a crystalline film of magnesium hydroxide and hydrogen gas.
- General corrosion can be reduced by utilizing high-purity alloys without introducing flux inclusions.

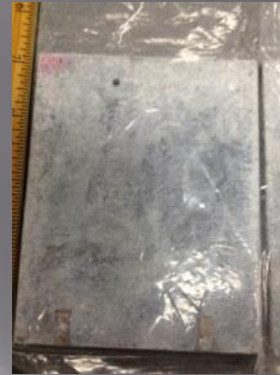
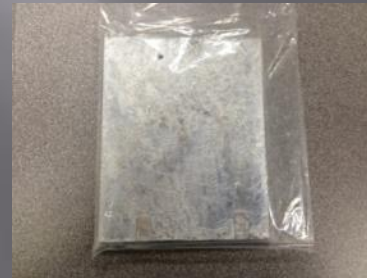
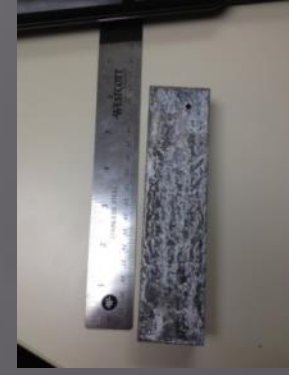
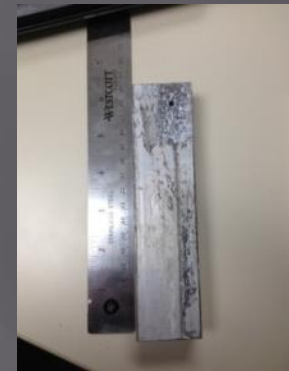
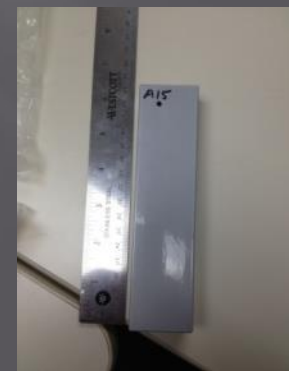
- ❑ Elektron 43 tested with Aluminum 7075-T651 as a baseline
- ❑ Three surface conditions
  - Bare
  - Trivalent chromate coating
  - Trivalent chromate coating + TGIC powder coat
- ❑ Metals performed equivalently in all surface conditions

- It was shown that the magnesium alloy Elektron 43 performed at the same level of corrosion resistance of aluminum alloy 7075-T651 for all three surface conditions: bare, trivalent chromate coated, and trivalent chromate coated plus powder coated.

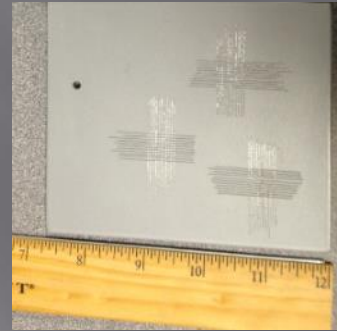
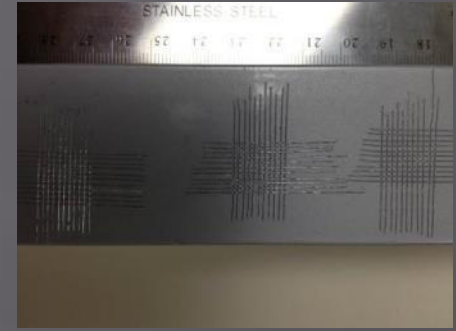
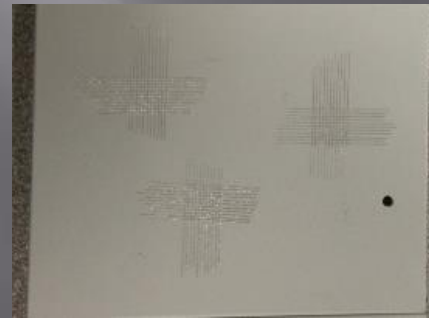
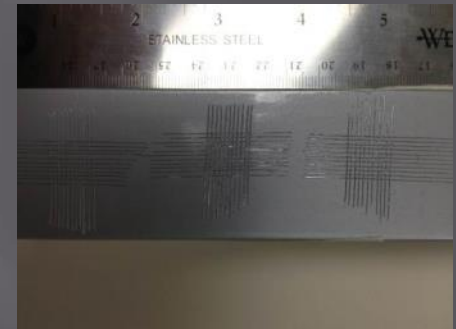
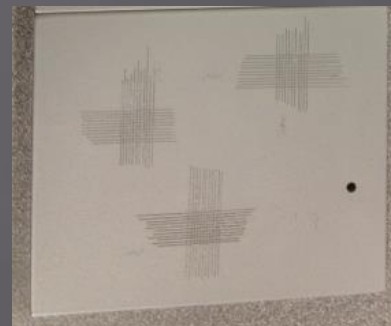
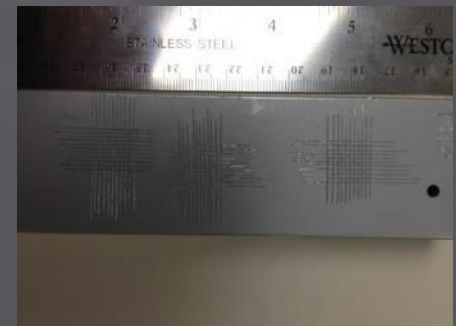
- ▣ Adhesion loss is rated on a scale of 1B to 5B, with 1B representing complete separation and 5B representing no separation.
- ▣ All tested samples were scored with a 5B.

- Adhesion testing showed that the trivalent chromate coating formed an excellent substrate for the powder coat. All samples were rated at the highest level; no loss of protective coating was observed.

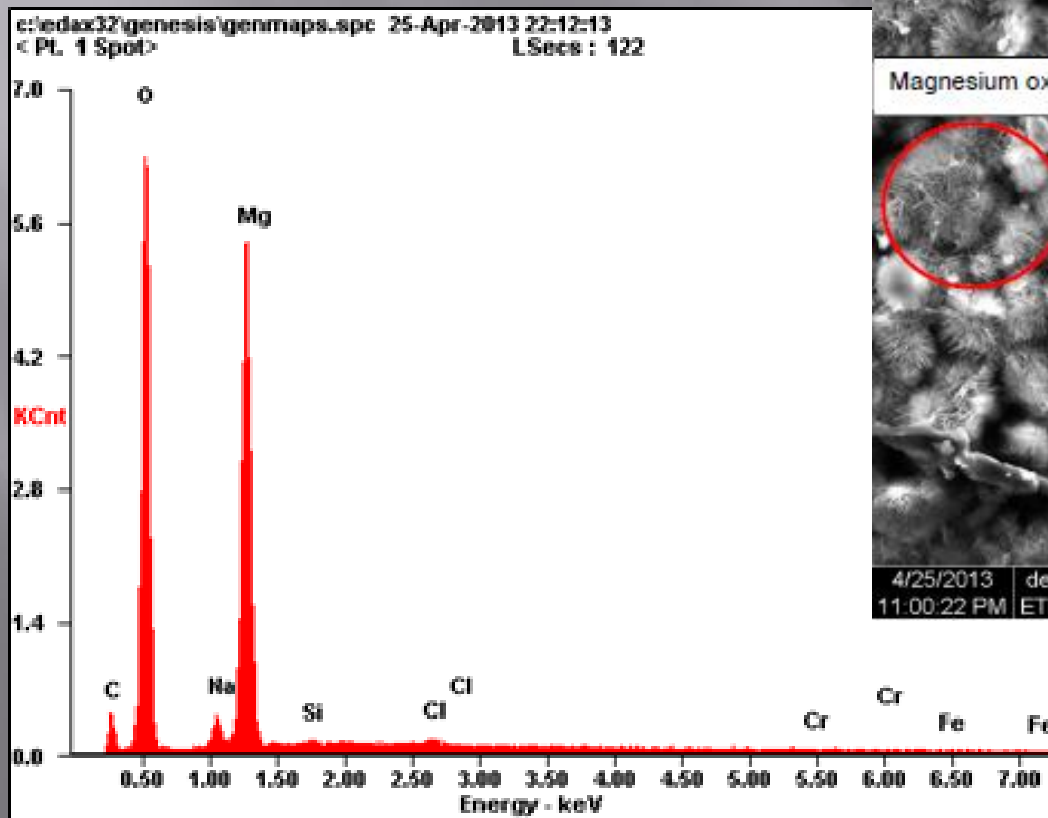
- Following salt spray testing, the samples with the most evidence of corrosion products were selected for additional analysis.

- For bare samples, the corrosion products were composed of magnesium oxide and magnesium hydroxide. The lack of the protective films resulted in pitting.
- The samples which received a trivalent chromate coating exhibited the same corrosion products, but in thicker sections. EDAX revealed the presence of fluorine and chromium from the damaged coating.
- The samples which received a trivalent chromate coating as well as powder coat performed very well. No pitting, cracks, or other corrosion was evident. Corrosion products were limited to areas that had not been protected, such as tooling holes. The surface of the powder coated sample exhibited no build-up of corrosion products.
