DOT/FAA/AR-11/3

Evaluating the Flammability of Various Magnesium Alloys During Laboratory- and Full-Scale Aircraft Fire Tests

Timothy R. Marker

Final Report

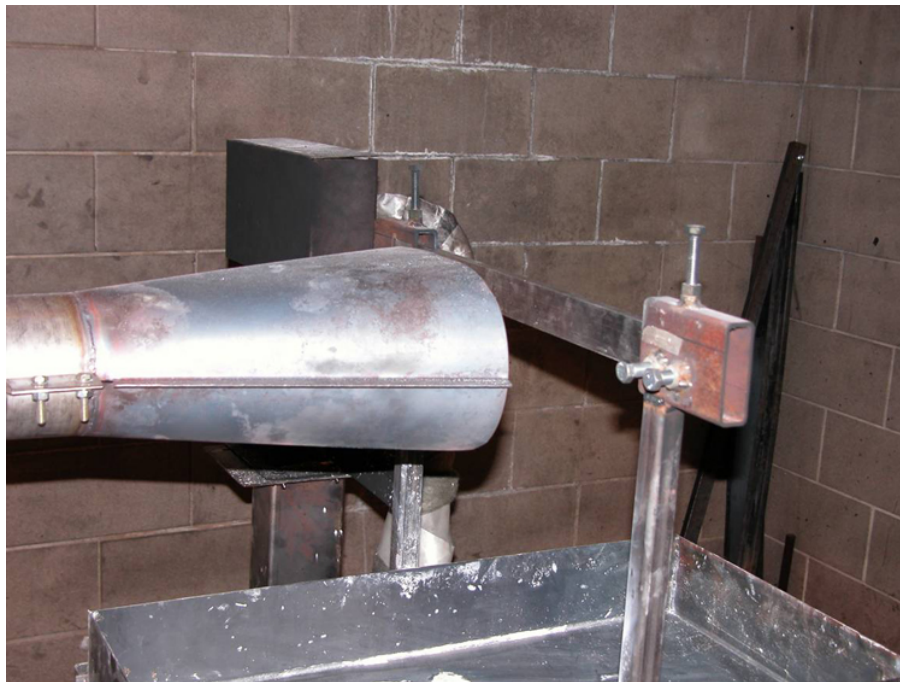
Figure 2. Magnesium Alloy Bar Sample Mounted in Test Apparatus Prior to Test

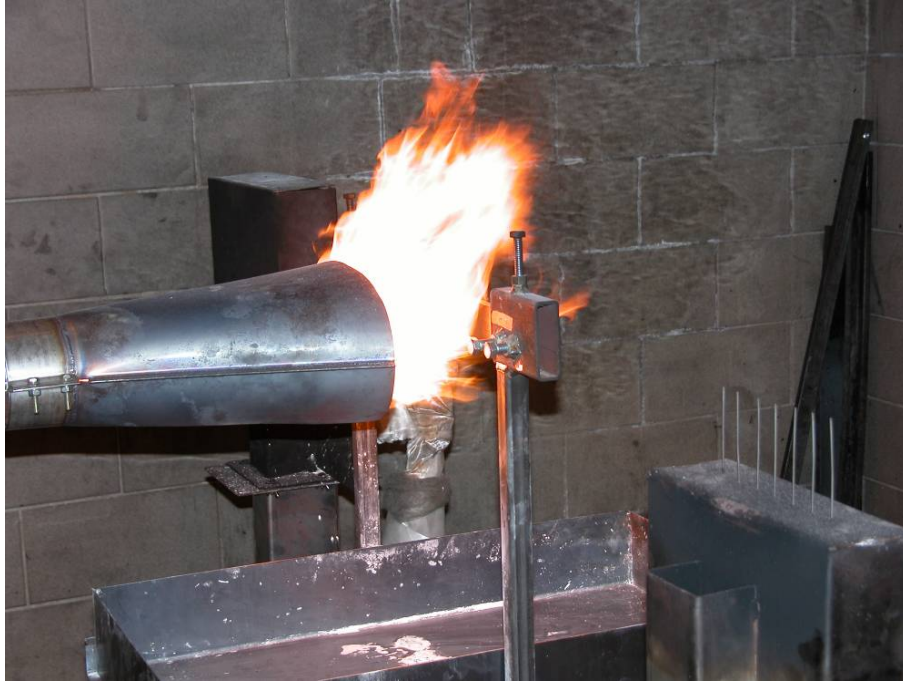
Figure 3. Magnesium Alloy Bar Sample Exposed to Burner Flames

During a typical test, the burner was turned on and allowed to warm for a period of 2 minutes. Following this step, the rolling cart assembly holding the magnesium alloy bar sample was moved in front of the burner (figure 3). The samples were exposed to the burner for 3, 4, or 5 minutes, depending on the thickness of the bar sample being tested. Within this exposure

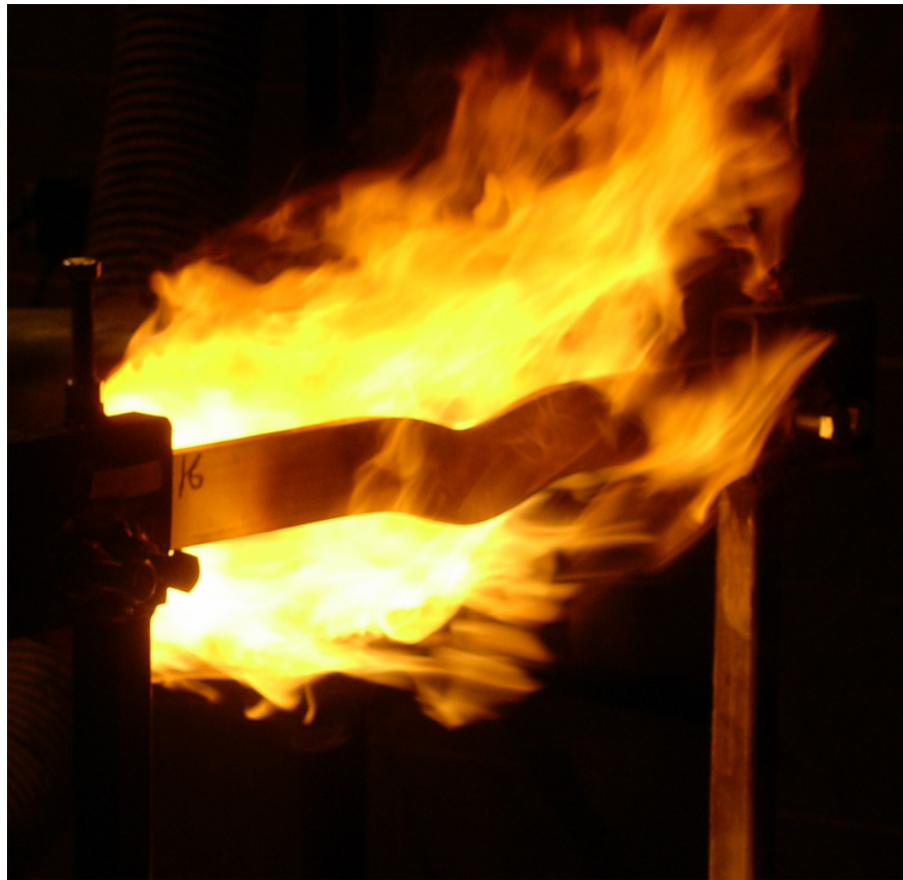
Figure 4. Magnesium Alloy Bar Sample Immersed in Flames, Just Prior to Melting

period, the bar samples would typically droop or distort just prior to melting, and often, a large center section of the bar sample would fall into a catch pan mounted below (figures 4 and 5). In these instances, the molten pieces in the catch pan continued to burn for varying periods of time. Once the bar sample melted and a portion of it fell into the catch pan, the remaining pieces attached to the sample holder would either ignite and continue to burn (figure 6), or depending on the type of alloy, they would quickly self-extinguish.

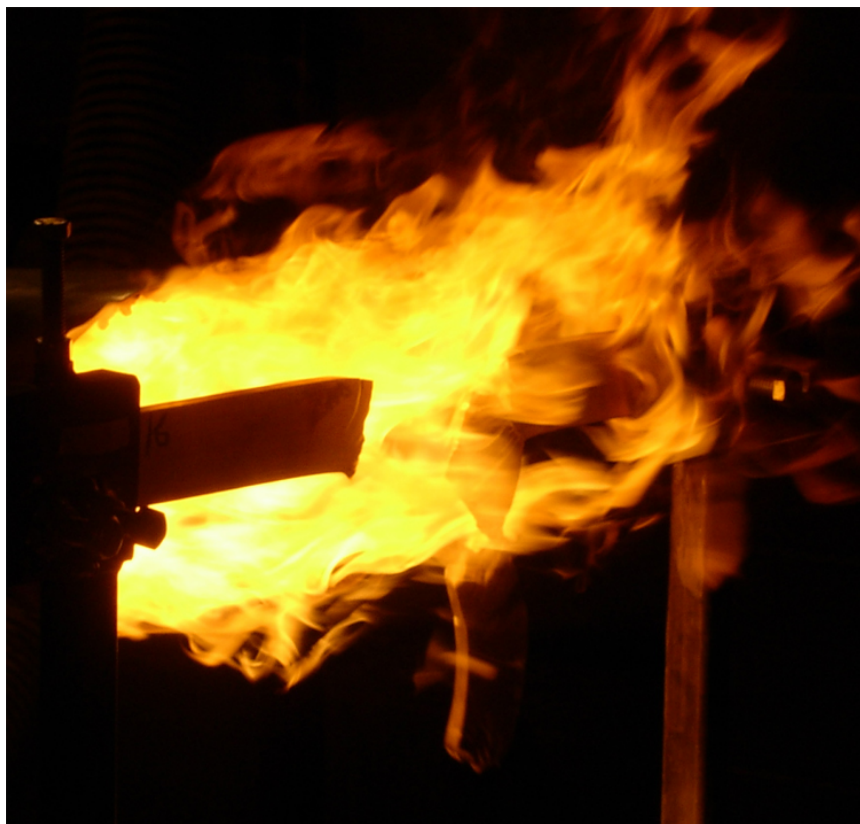
Figure 5. Center Section of Bar Sample Falling Into Catch Pan After Melting

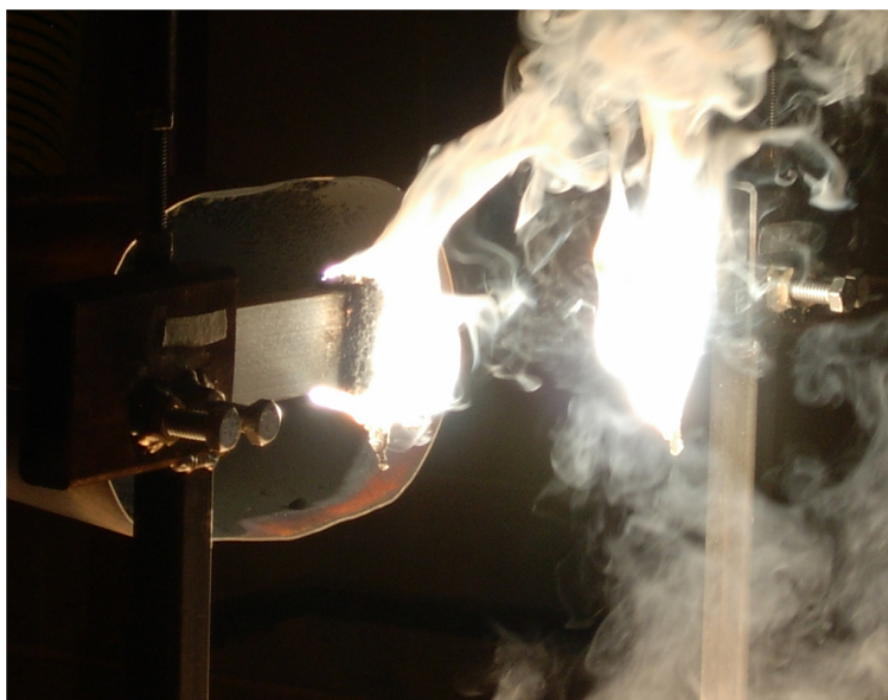
Figure 6. Ignition of Magnesium Alloy Following Burner Flame Exposure

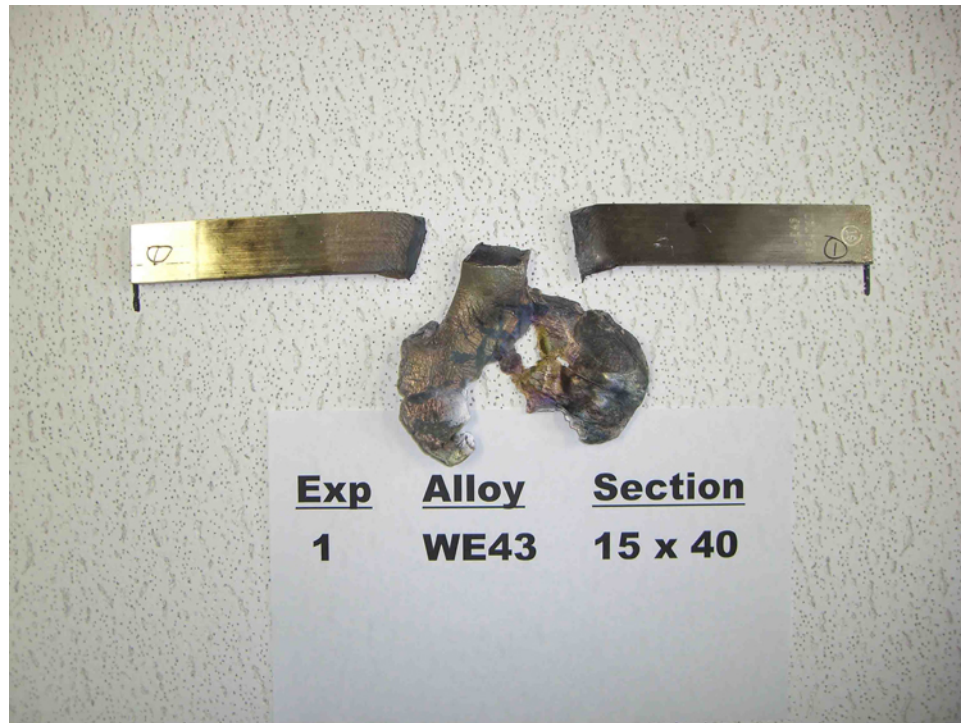
Figure 7. Posttest Inspection Showing Molten Center Section Removed From Catch Pan

The catch pan was filled with dry talc to prevent any splattering of molten materials and to aid in the safe extinguishment of burning samples. After the burner was shut off and all burning had subsided, the sample pieces were cooled and removed for inspection (figure 7). Various parameters were measured and recorded during the test, including the sample dimensions, the time the burner flame was turned off, the time the sample melted, the time the sample self-extinguished, and whether or not any melted pieces that fell into the catch pan were still burning.

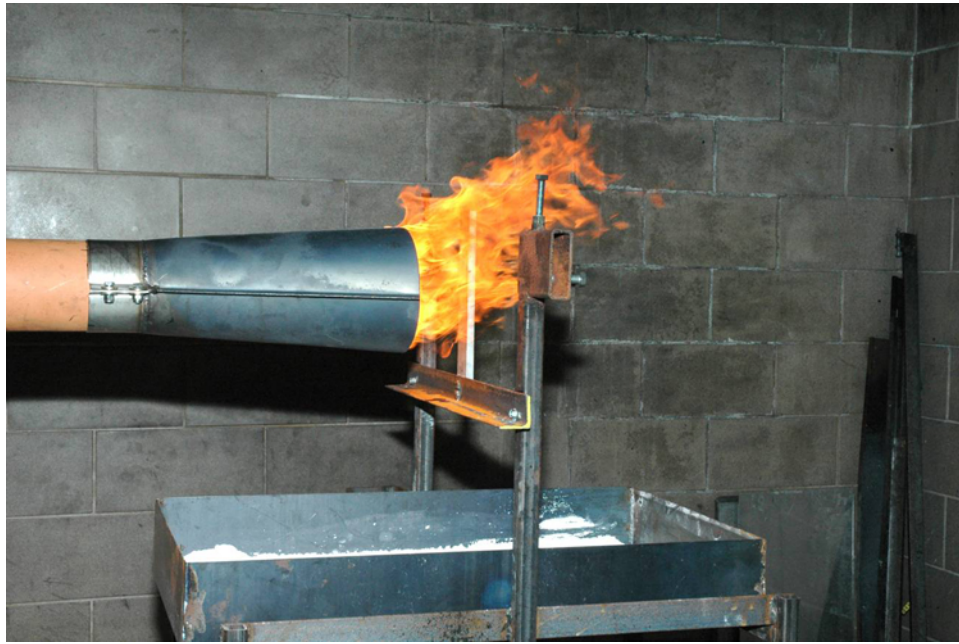
Figure 9. Magnesium Alloy Sample Mounted Vertically

A slightly different approach was also investigated in test 20, where the sample bar was shortened and oriented vertically rather than horizontally (figure 9). It was difficult to determine the exact impact of orienting the sample in this manner since this test was performed on a sample of AZ-31, which had burned consistently after burner removal. It was clear that this orientation prevented the separation of a large mass of the test sample during the melting process, which was common when mounting the samples horizontally. By mounting vertically, the molten section of sample ran down the unmolten section like a candle; this tendency kept the sample hotter, since the molten mass was still in contact with the sample.

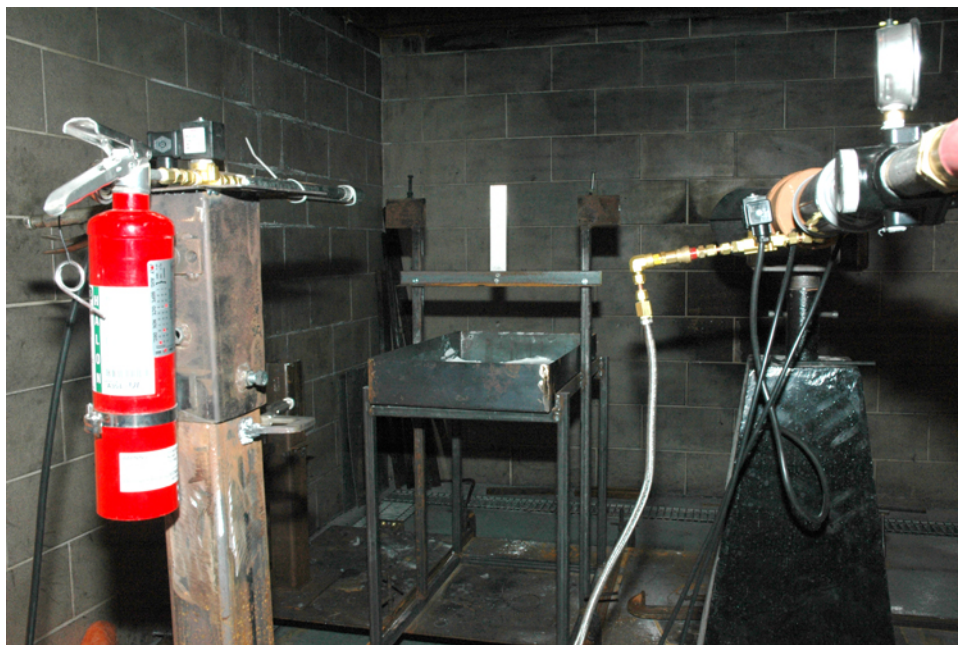
Figure 10. Hand-Held Extinguisher Test Configuration

To study their effectiveness against magnesium alloy fires, a separate test stand was constructed to mount a remotely controlled extinguisher, which could be activated once the burning magnesium alloy sample was rolled to a preset location in front of it (figure 10). Several pretest firings were performed to ensure accuracy with the extinguisher discharge plume. Since a limited quantity of magnesium alloy bar stock was available, it was decided to cut the samples in half, yielding twice as many test samples. The samples were then mounted vertically in the sample holder.

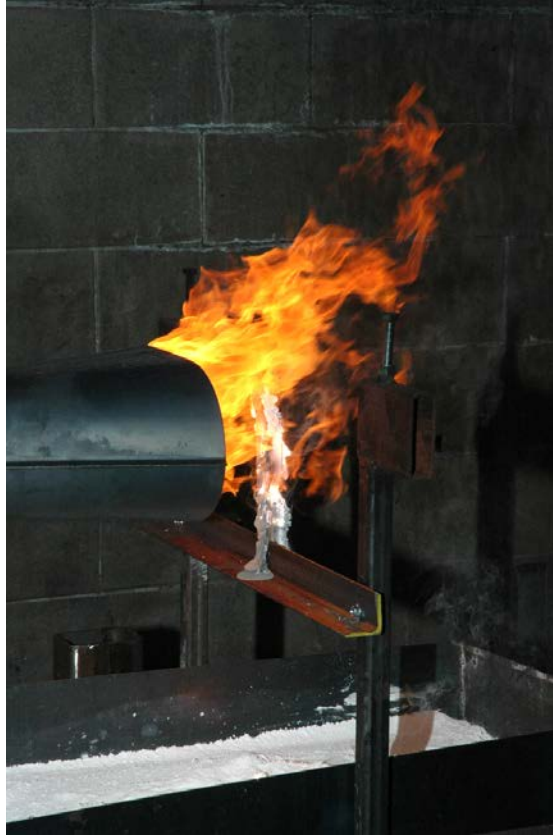
Figure 11. Vertically Mounted Sample Just Prior to Extinguisher Discharge

During the first test series, a Halon 1211 extinguisher was mounted into position, and an AZ-31 sample was mounted to the rolling cart assembly. The burner was warmed for 2 minutes, and then the cart was rolled directly in front of the burner, allowing flame impingement. The cart was kept in this position until the sample had melted sufficiently, and there was evidence of fire (figure 11). At this point (approximately 4 minutes), the burner was shut off, and the cart was immediately rolled in front of the fire extinguisher stand.

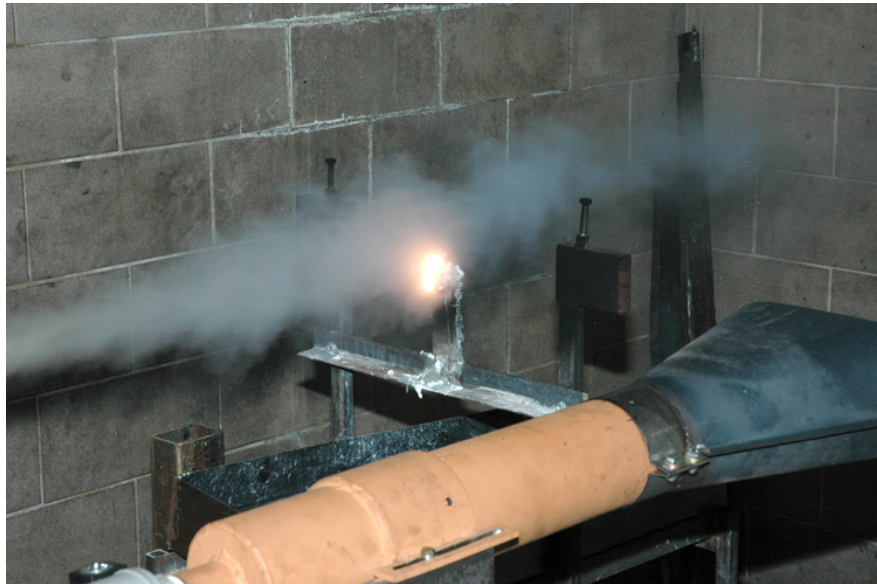
Figure 12. Extinguisher Stream Being Directed Across Burning Magnesium Alloy Sample

Once the cart abutted its prepositioned stop, the extinguisher was activated, producing a directed stream across the burning test sample (figure 12).

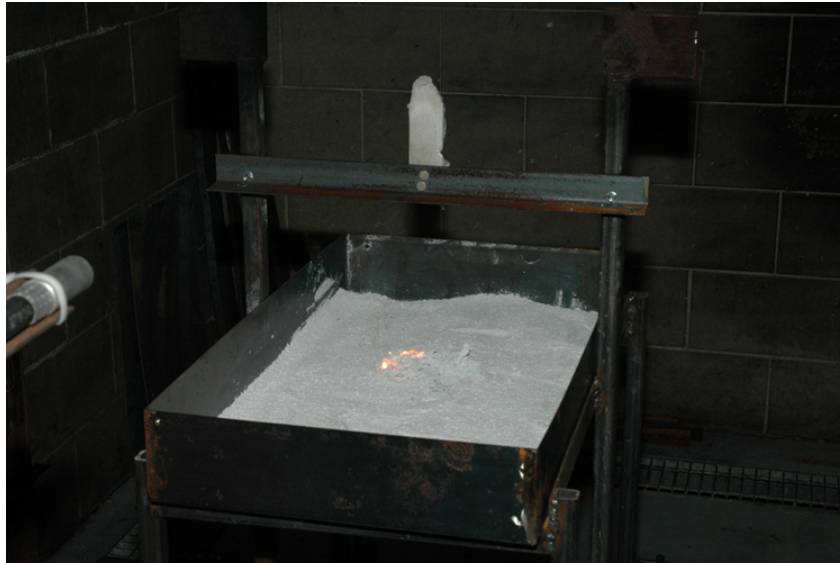
Figure 13. Section of Molten Test Sample in the Catch Pan After Extinguisher Discharge

The extinguisher activation typically caused a large piece of the burning test sample to fall into the catch pan (figure 13). This was problematic, as the extinguishing agent stream was initially aimed at the upper section of the test sample where the burning was taking place. Once this upper section fell into the catch pan, the agent was no longer directed at any burning material, so it was difficult to determine the impact of the extinguishing agent on the sample.

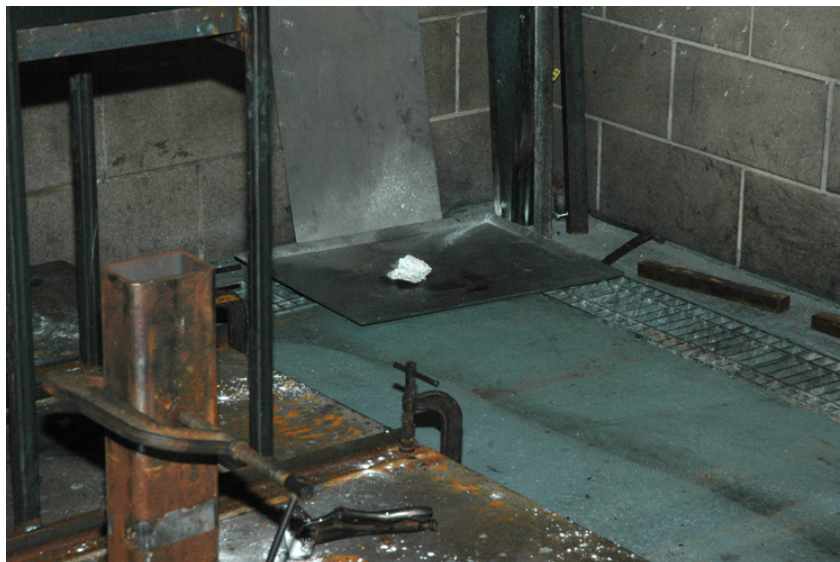
Figure 14. Molten Mass of ZE-10 Alloy Removed From the Catch Pan and Placed on the Floor

To obtain a more accurate assessment of the extinguisher capability, a burning piece of the ZE-10 alloy was removed from the catch pan during the second test and positioned on a sheet of aluminum on the floor of the test area. This allowed a stream of agent to be manually directed into the burning mass of material (figure 14).

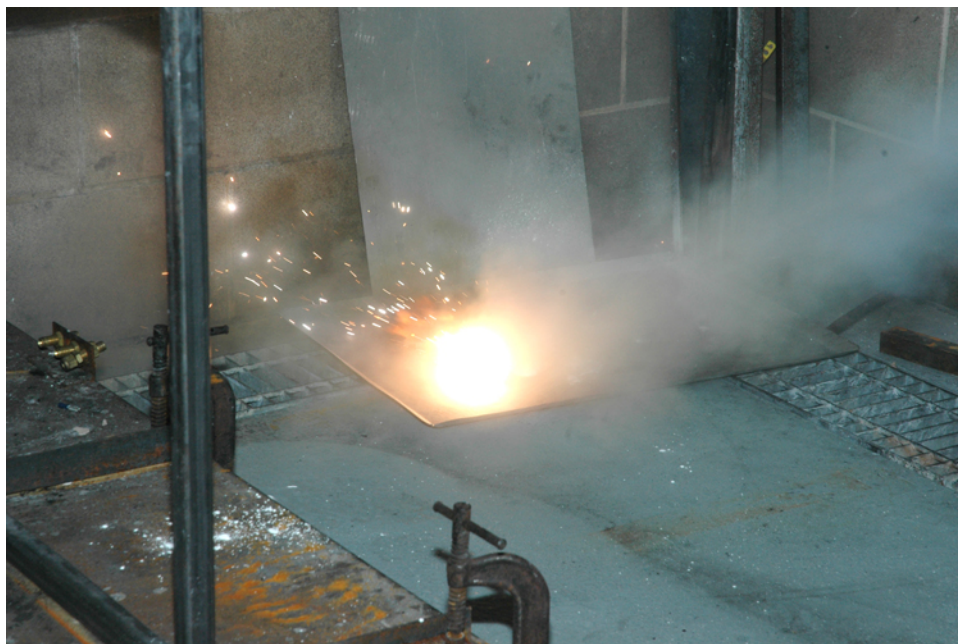
Figure 15. Molten ZE-10 Reacting to Stream of Halon 1211

A Halon 1211 extinguisher was discharged directly at the burning material, which flashed violently upon contact (figure 15). This confirmed that the Halon 1211 extinguishing agent had no effect on the burning material, and perhaps, exacerbated it.

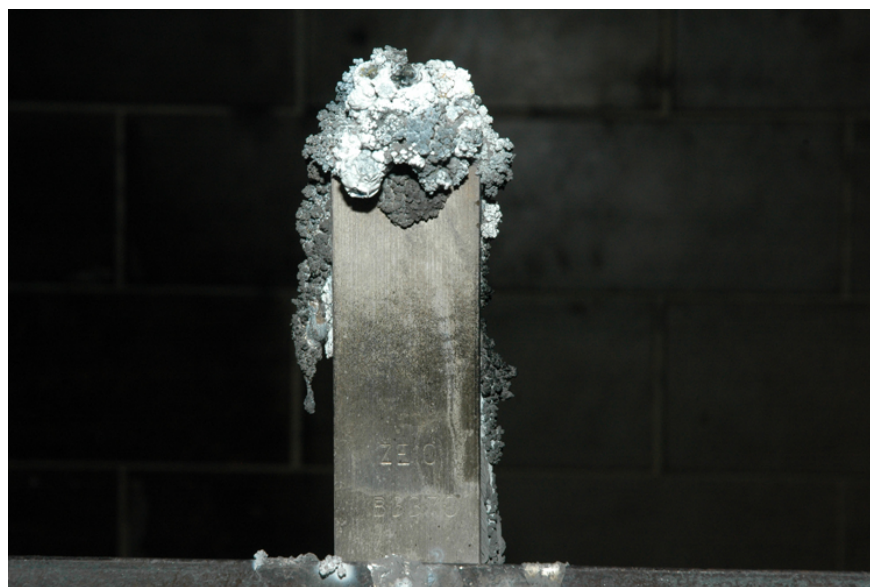
Figure 16. Strange Oxidation on ZE-10 Sample Following Agent Application

During the final three tests with the FE-36 extinguishing agent, a peculiar oxidation formed on the vertical sample following agent discharge (figure 16). The formation occurred quickly, as the flames subsided and the sample cooled.

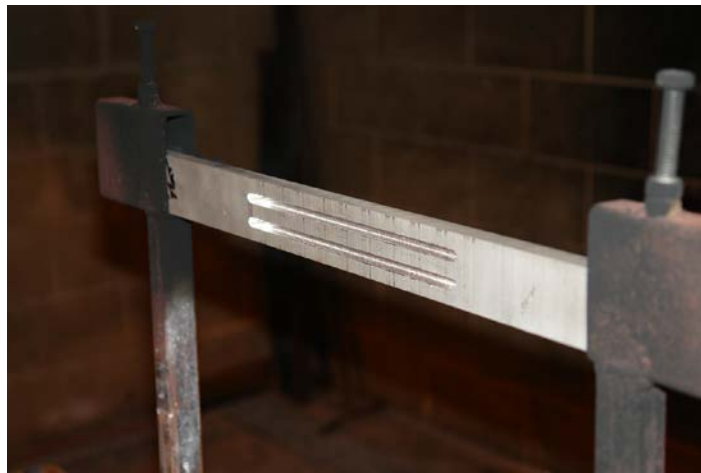
Figure 17. Magnesium Alloy Test Sample Bar With a Milled Cross Section

To create a more realistic test condition mimicking a machined leg or spreader, one of the thinner WE-43 test sample bars was modified using a milling machine. Two 10-inch-long longitudinal channels were milled into the test sample bar to create a thinner cross-sectional area where the heat from the burner was concentrated (figures 17 and 18). The longitudinal channels were square in shape, approximately 0.25 inch wide by 0.25 inch deep.

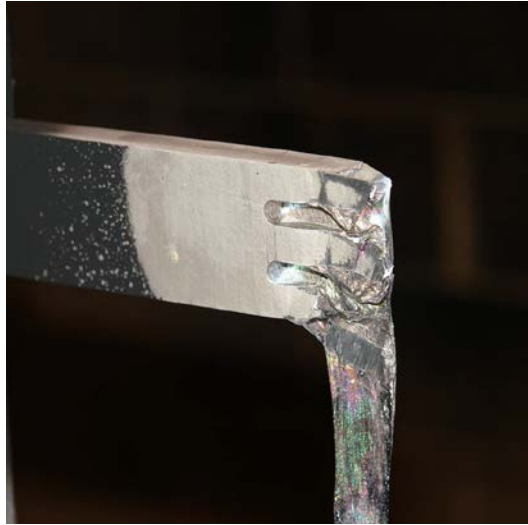
Figure 19. Posttest Photograph of Milled Bar Test Sample

Following burner warm-up, the test samples were exposed for a period of 4 minutes, at which point the burner was switched off. Melting occurred at approximately 2 minutes 30 seconds. The machining did not appear to cause the test sample to become more flammable, as the melting process was similar to previous tests of nonmilled samples (figure 19).

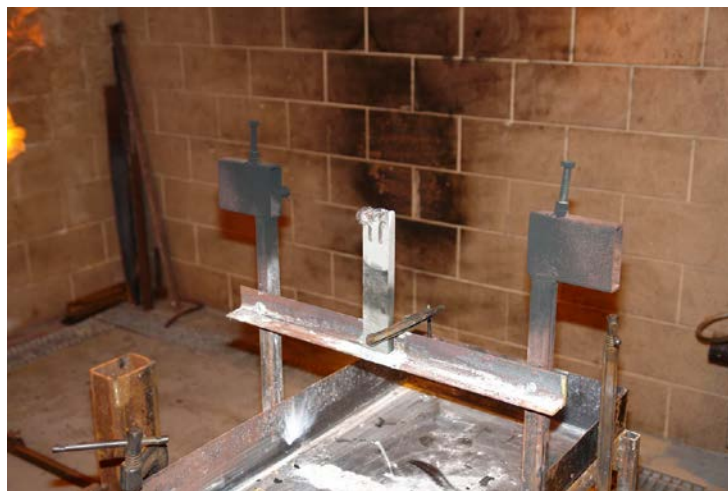
Figure 20. Posttest Photograph of Milled Sample Mounted Vertically

One additional test was conducted using a vertically mounted, milled test bar sample (figure 20). A remnant piece from the previously milled sample was used for this test. The milled sample was clamped into place and exposed to the burner until melting was observed. The orientation had no effect on the flammability of the sample, as the burning subsided within 10 seconds of removing the burner.

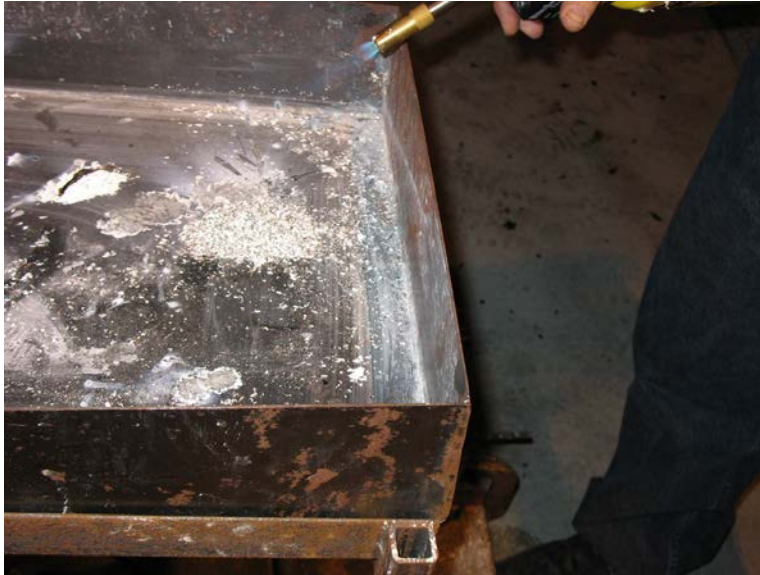
Figure 21. Torch Used to Ignite a Small Pile of Magnesium Alloy Millings

During the first test, the magnesium alloy millings captured from the milling process in the previous test were piled into a small mound in the catch pan (figure 21). A hand-held methylacetylene-propadiene propane (MAPP) gas torch was used to ignite the pile of material. The millings were relatively easy to ignite with the torch, due to their high surface-area-to-volume ratio (figure 22). This high ratio allowed the millings to heat quickly and melt rapidly, providing the proper conditions for ignition. A second test was run in which a pile of millings was placed on top of a piece of aircraft-grade carpeting in the catch pan. The millings were ignited with the torch as in the previous test. Despite the intense light given off by the material, the resulting fire did not spread beyond the diameter of the pile of millings.

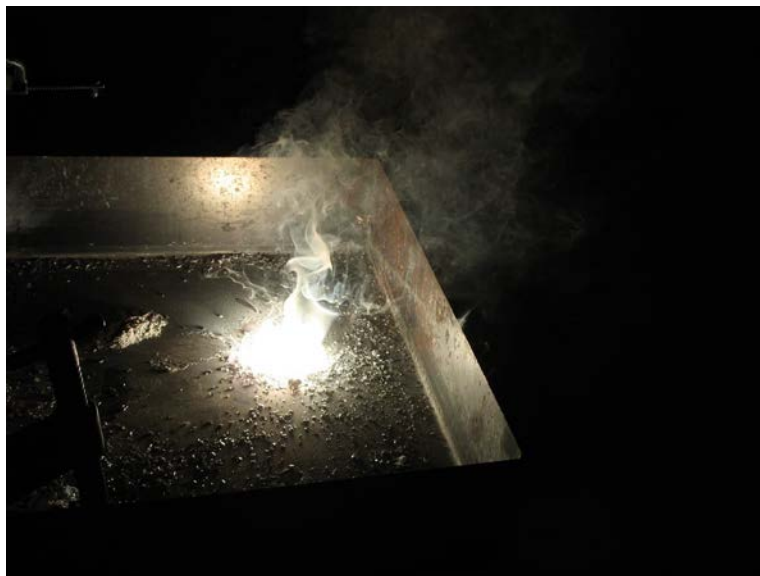
Figure 22. Small Pile of Magnesium Alloy Millings on Fire

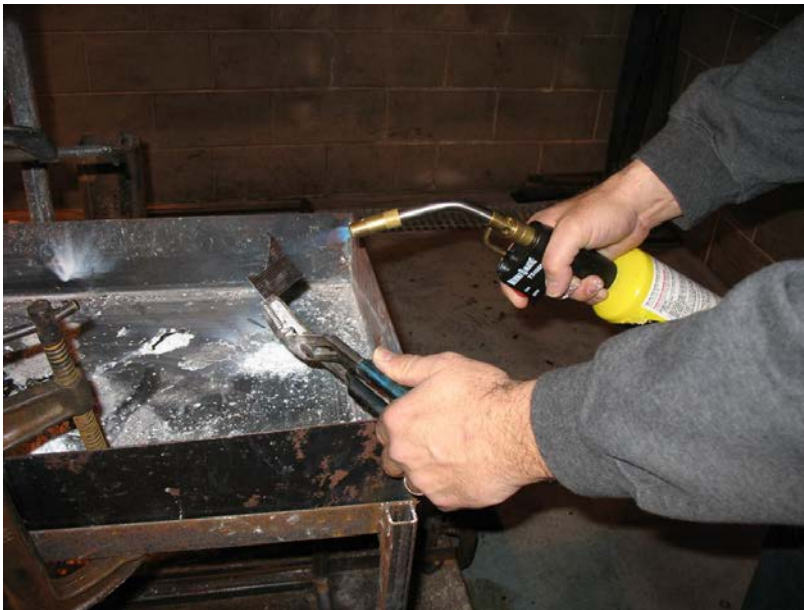
Figure 23. Thin Sliver of Magnesium Alloy Being Heated With Torch

Another series of tests were run using small slivers of magnesium alloy sawn from a bar sample. An industrial band saw was used to produce the thin slivers, in both crosswise and lengthwise fashion. It was difficult to obtain uniformly sawn samples, as they measured approximately 0.0625 to 0.125 inch in thickness. The slivers were held using a pair of pliers, and heated using the MAPP gas torch (figure 23). Similar to the pile of millings, the sliced samples had high surface-area-to-volume ratios, making them easy to ignite. Once ignited, the samples would continue to burn until nearly or completely consumed (figure 24).

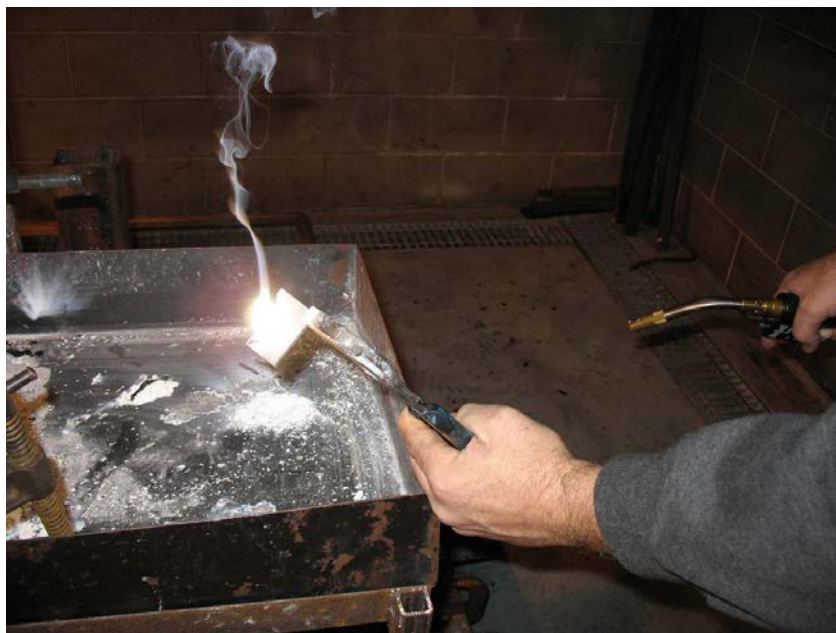
Figure 24. Thin Sliver of Magnesium Alloy on Fire After Being Heated With Torch

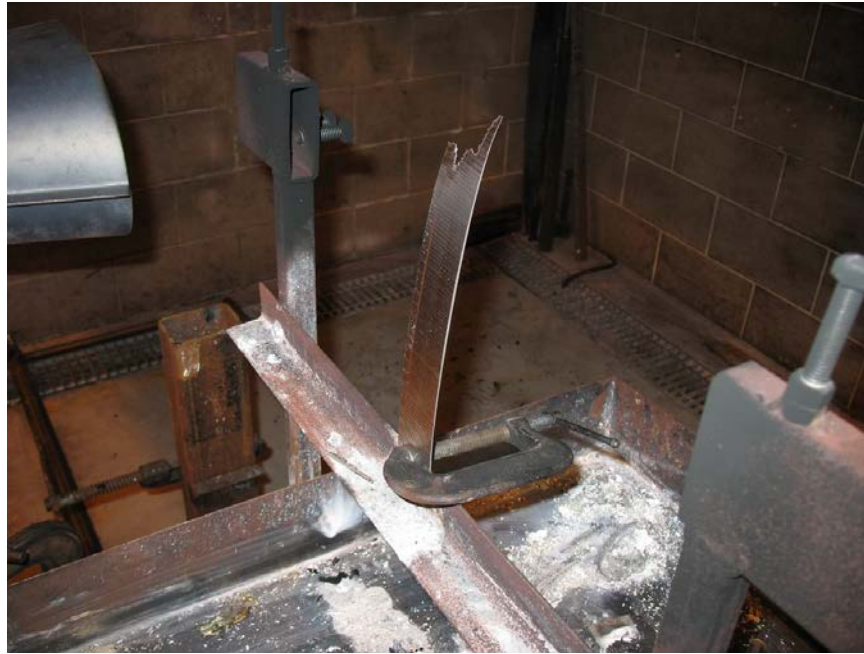
Figure 25. Longitudinal Slice of Magnesium Alloy Positioned Vertically in Front of the Burner

A longitudinal slice of the magnesium alloy was sawn from the length of a sample bar and clamped vertically in front of the oil burner (figure 25). Following burner warm-up, the sample was exposed until melting began (approximately 1 minute). The melting caused the sample to slump downward at which point the burner was turned off (figure 26). Although a significant percentage of the sample had melted during exposure, it did not ignite.

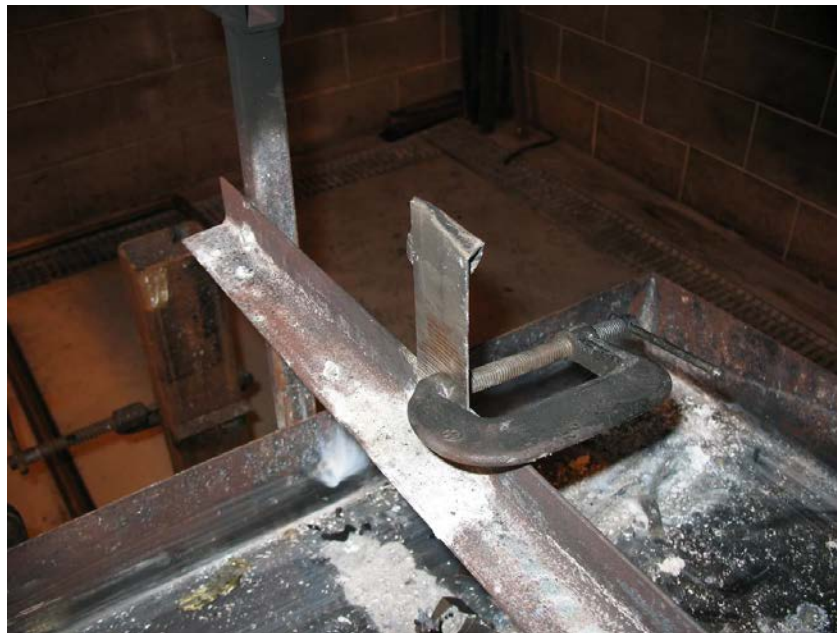
Figure 26. Vertically Mounted Slice After Self-Extinguishment

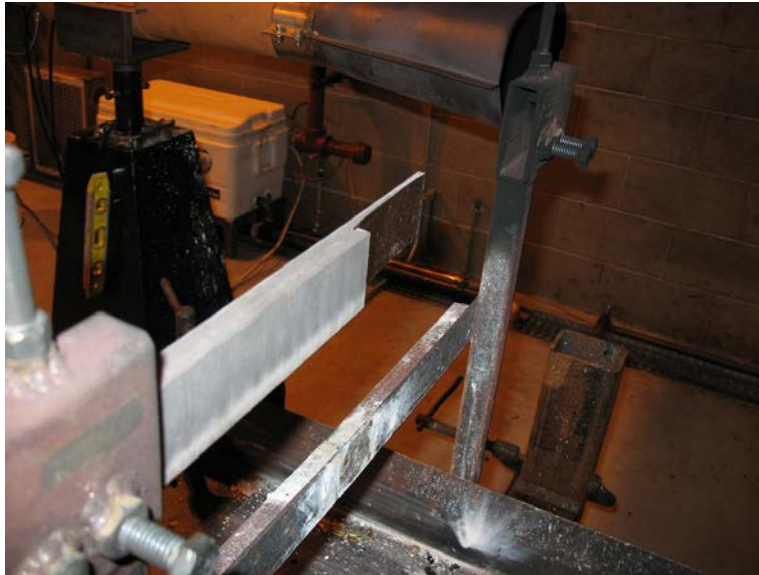
Figure 27. Sectioned Bar Sample Positioned Horizontally in Front of the Burner

A final laboratory test was conducted on a modified bar sample. The sample was sliced lengthwise and sectioned, removing approximately 25% (figure 27). The sample was clamped in place horizontally, with the sectioned area positioned in front of the burner. The sectioned area was approximately 0.125 to 0.1875 inch in thickness. Following burner warm-up, the sample was exposed for approximately 2 minutes, at which point it melted and ignited (figure 28). The burner was subsequently turned off.

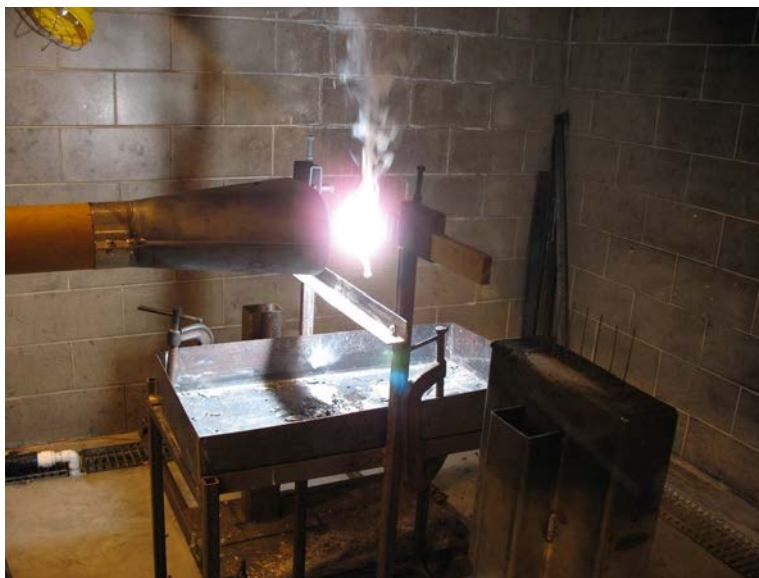
Figure 28. Sectioned Magnesium Alloy Bar Sample Ignited Using Oil Burner

The sample continued to burn for several minutes, with molten pieces of the sample falling into the catch pan. This was an unexpected result, as the previous test series using the vertically mounted slice did not ignite following melting.

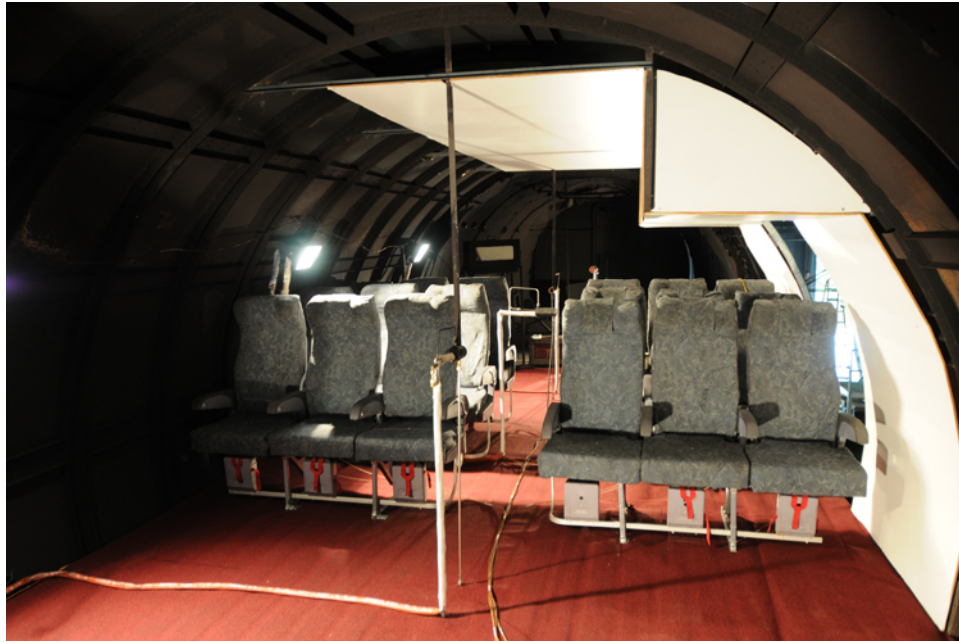
Figure 33. Typical Full-Scale Test Configuration With Seats, Panels, and Carpet Installed

Aircraft-grade wool/nylon carpet was used in all tests. The carpet covered approximately 20 feet of the length of the cabin, centered at the fuselage opening. Aircraft-grade, fiberglass-faced, Nomex crushed-core honeycomb panels were used to mock-up the cabin in the immediate area of the fuselage fire opening. The honeycomb panels were used in the sidewall area, the ceiling, and overhead stowage bin areas, and met the current FAA flammability requirements (figure 33).

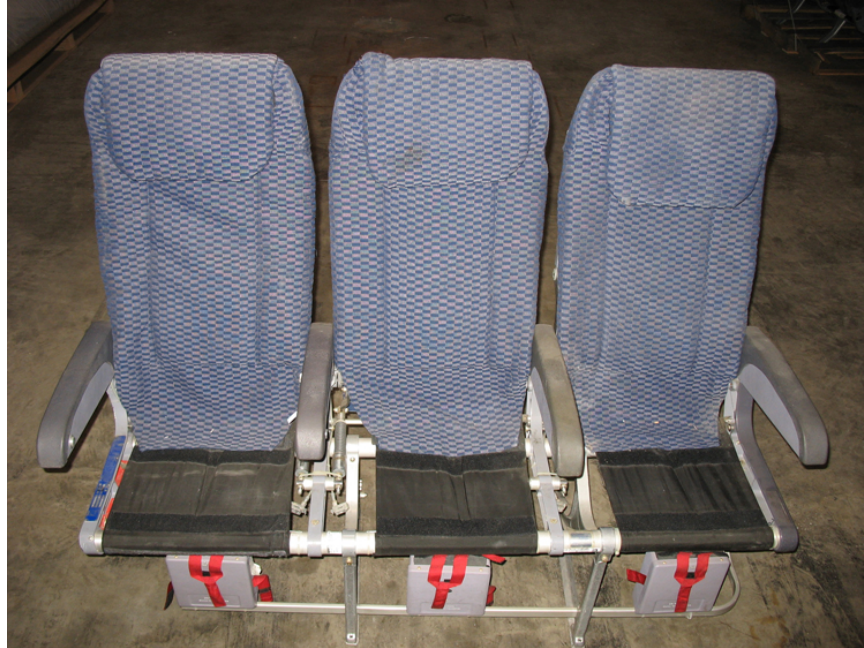
Figure 34. Original B/E 990 Seats

As mentioned previously, four full-scale tests were originally planned for the study: a baseline test, a good-performing magnesium alloy test, a poor-performing magnesium alloy test, and a test in which the primary and additional secondary components would be machined from a good-performing magnesium alloy. The test configuration would consist of three rows of aircraft triple seats situated inside the fuselage, centered around the fire opening. A total of 24 triple seats were purchased from an aircraft interior spares dealer, The Avianor Group, of Mirabel, Montreal, Canada (6 triple seats were used for each of the four tests). The purchased seats were B/E model 990, manufactured by B/E Aerospace of Wellington, Florida. Although the purchased seats contained the necessary structural components, they arrived without the bottom seat cushions (figure 34).

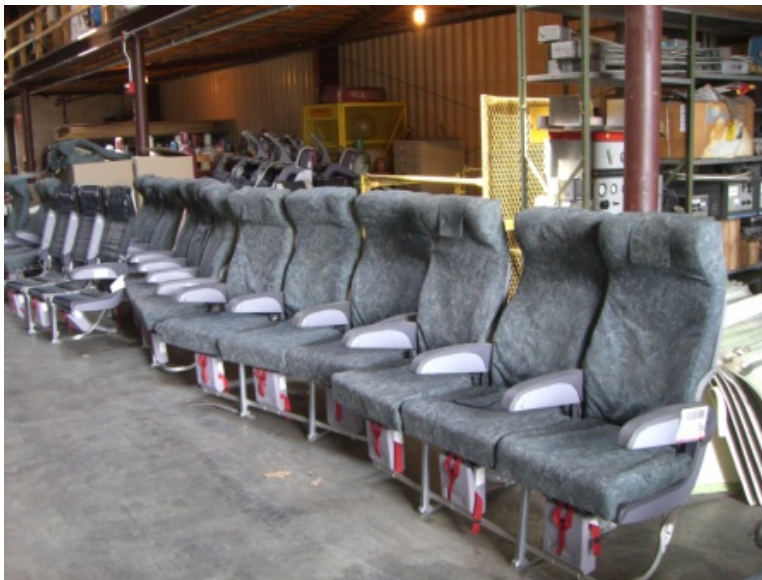
Figure 37. Completed B/E 990 Assemblies With Olive-Colored Cushion Materials

The supplied blue dress covers were removed, and the olive dress covers and bottom seat cushions were installed on the B/E 990 seats in preparation for the full-scale test (figure 37).

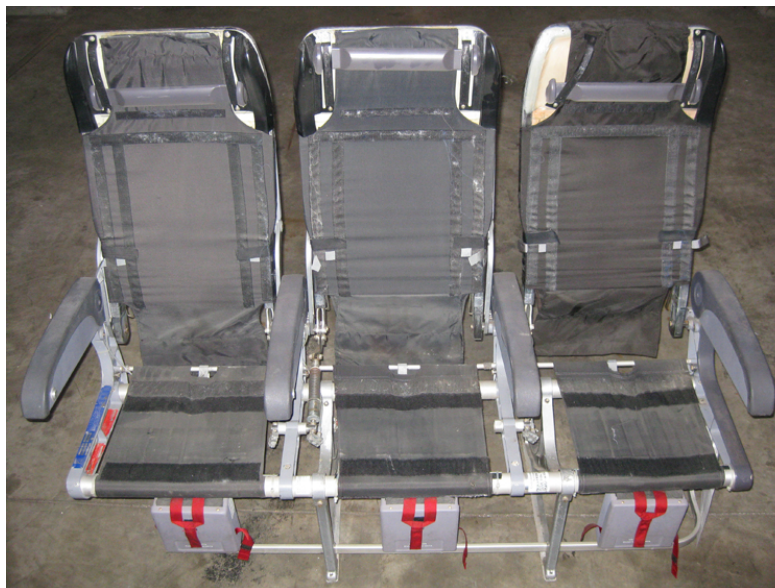
Figure 39. B/E 990 Triple Seat With Cushions and Covering Removed Revealing Bolsters

cushioning not offered by the very thin fiberfill used. The seatback frame also contained numerous plastic parts, including bolsters in the headrest area (figure 39). The high percentage of plastic parts in the seatback structure, in combination with the carbon/epoxy frame and limited fire-retardant foam, was not typical of conventional aircraft seat construction and had not been previously evaluated in full-scale tests.

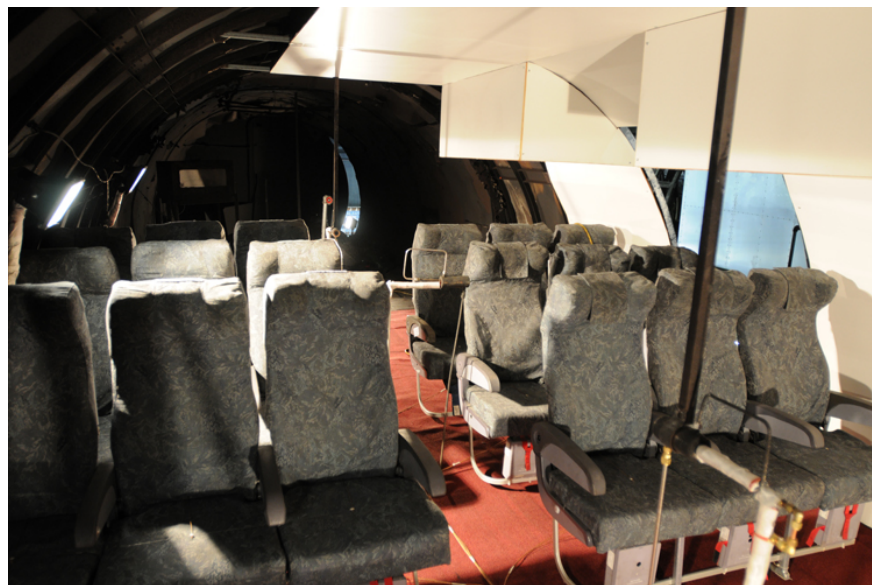
Figure 41. Baseline Test 1 Cabin Configuration

After all three rows of triple seats were installed in the test fuselage, thermocouples were mounted on the top surface of each of the bottom seat cushions (figure 41). The thermocouples were used to track the fire spread, in the event the internal cameras became obscured during the test. The thermocouples were held in place with steel safety wire.

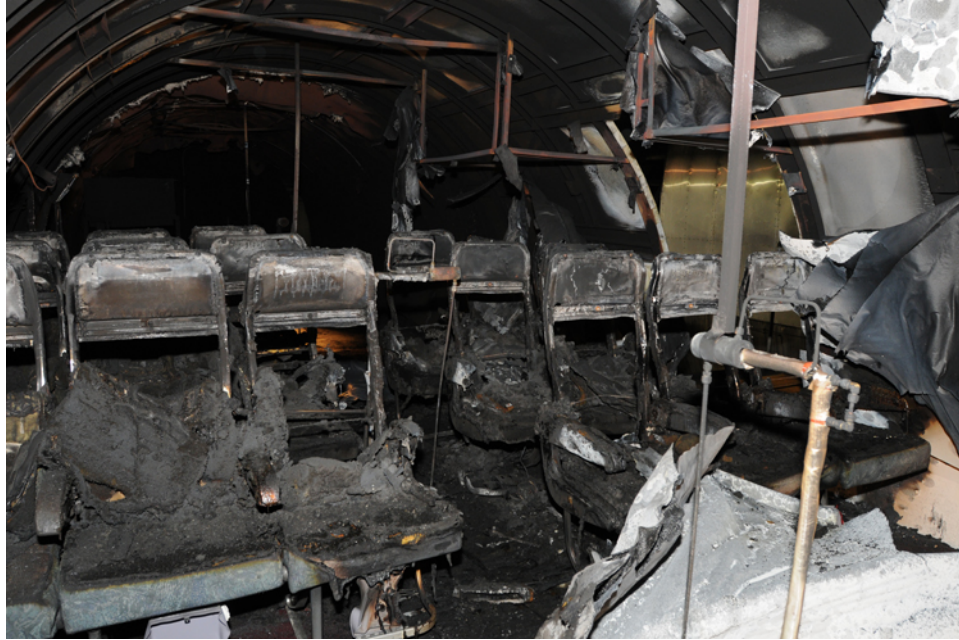
Figure 42. Baseline Test 1 Cabin Materials Following Test Fire

A posttest inspection revealed significant damage to the interior materials (figure 42). A majority of the honeycomb sidewall and ceiling panels were consumed, and significant damage to the seat assemblies was evident, particularly in the seatbacks. The damage clearly showed the fire was able to jump the aisle and involve the seat materials farthest from the fire entry point.

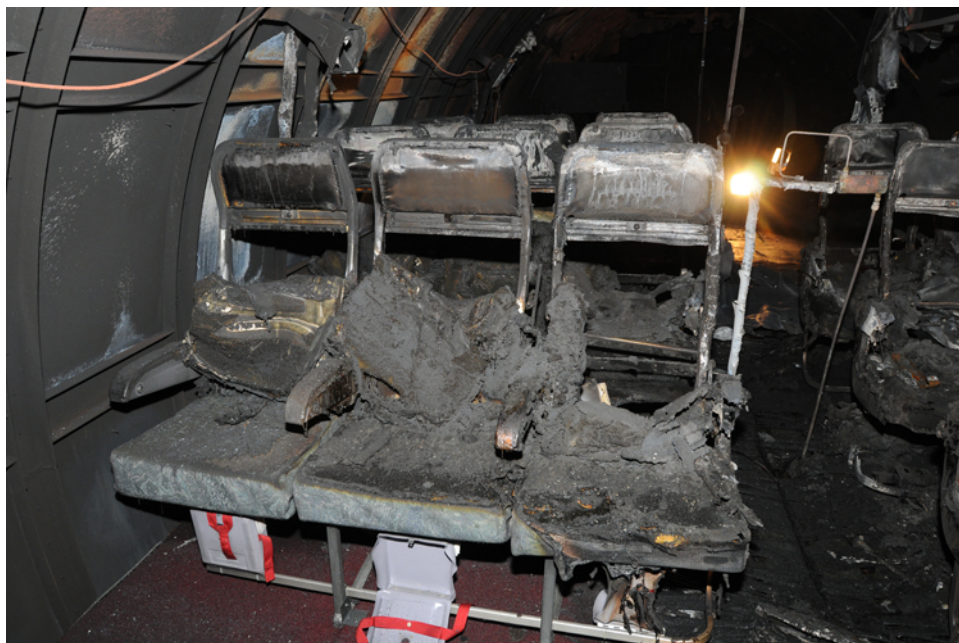
Figure 43. Seatback Materials Consumed and Cushioning Remnants Displaced

A closer inspection of the seating materials revealed that the seatback assemblies played a significant role in the spread of fire. The stretched nylon suspension system and miscellaneous thermoplastic parts were completely consumed in all seat places. The cushioning materials on the seatback assemblies were largely consumed, with remnants indicating the materials had collapsed onto the surface of the bottom cushion (figure 43). A large percentage of the bottom seat cushions were consumed on the seat assemblies closest to the fire opening; the bottom cushions on the far side of the fuselage were burned on the top, but remained intact. In general, it appeared the bottom seat cushions were not the cause of the rapid fire spread, but had burned more out of consequence from the seatbacks igniting quickly and collapsing onto the bottom cushions.

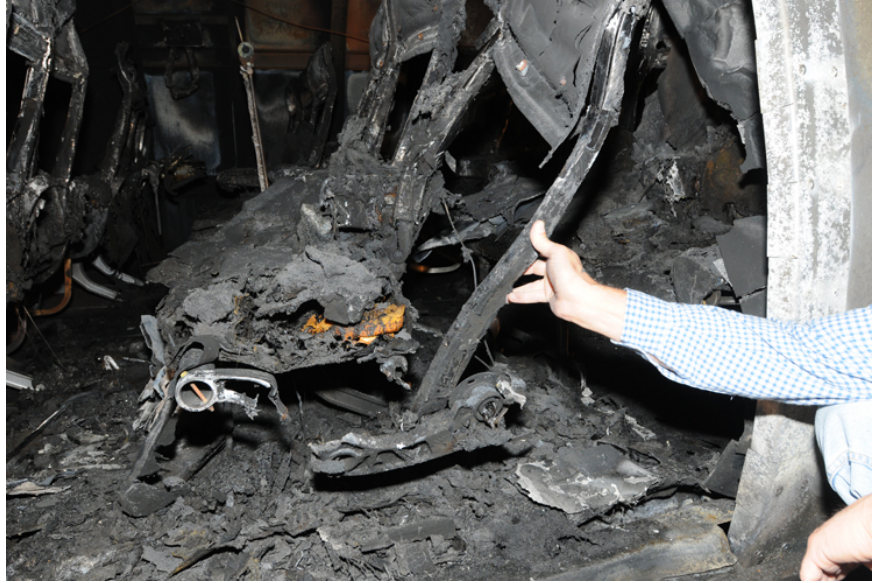
Figure 44. Portside Row 2 Seat Primary Spreader Component

Despite the large amount of seating materials consumed during the fire, it was interesting to note that only a very small amount of the primary aluminum components had melted. The outboard spreader on the port side, row 2 seat sustained the most melting (figure 44). The forward half of the spreader component was still attached to the forward cross tube, which had warped from the heat, but did not melt through. The aft cross tube on this seat had clearly melted through, with an end piece still connected to part of the melted spreader.
