DOT/FAA/AR-11/3

Evaluating the Flammability of Various Magnesium Alloys During Laboratory- and Full-Scale Aircraft Fire Tests

Timothy R. Marker

Final Report

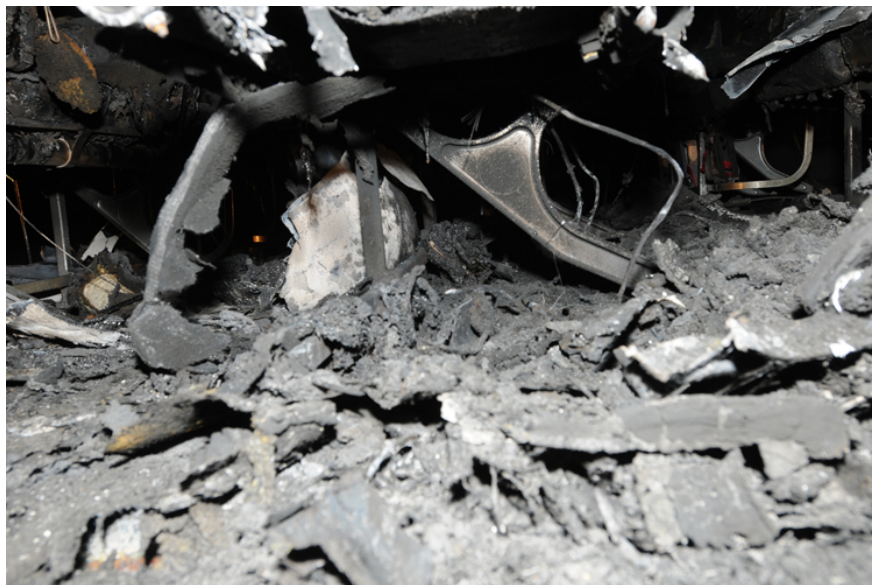
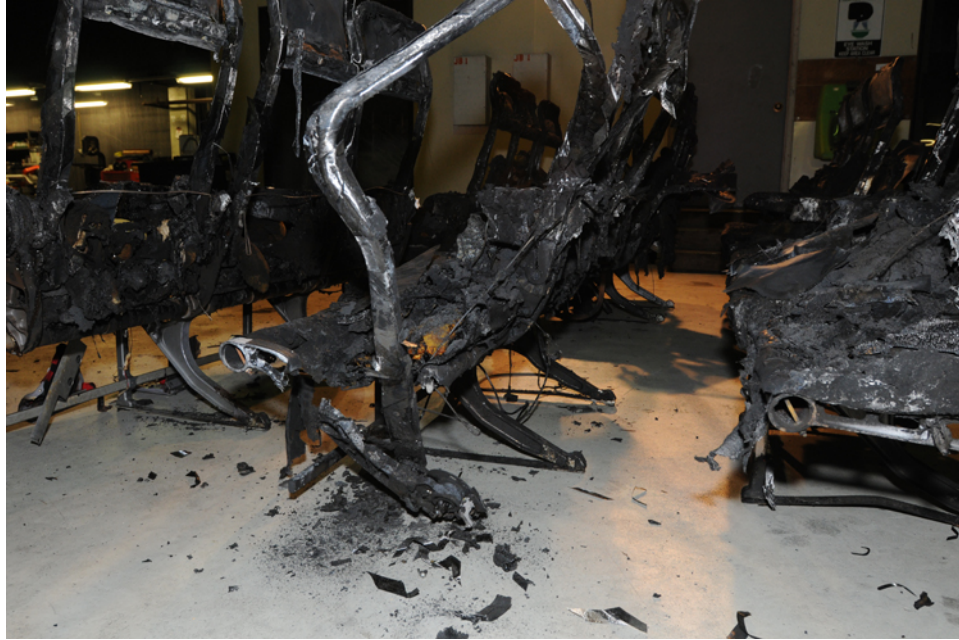
Although the outboard spreader was a fairly massive component, the cross tubes were very thin-walled by comparison and were anticipated to melt during the test. Most surprisingly, the leg assembly experienced no melting (figures 45 and 46). This indicated that the test was not run for a sufficient duration, which would be a concern for subsequent tests involving an evaluation of magnesium alloys. Laboratory-scale tests showed conclusively that the alloys were required to be in a molten state before any ignition would occur. Since the amount of melting in this Baseline 1 test was minimal overall, it was questionable whether this would be a good basis for evaluating the magnesium alloys.

Figure 45. Close-Up View of Outboard Leg Assembly of the Portside Row 2 Seat

Figure 46. Close-Up of Portside Row 2 Seat Assembly

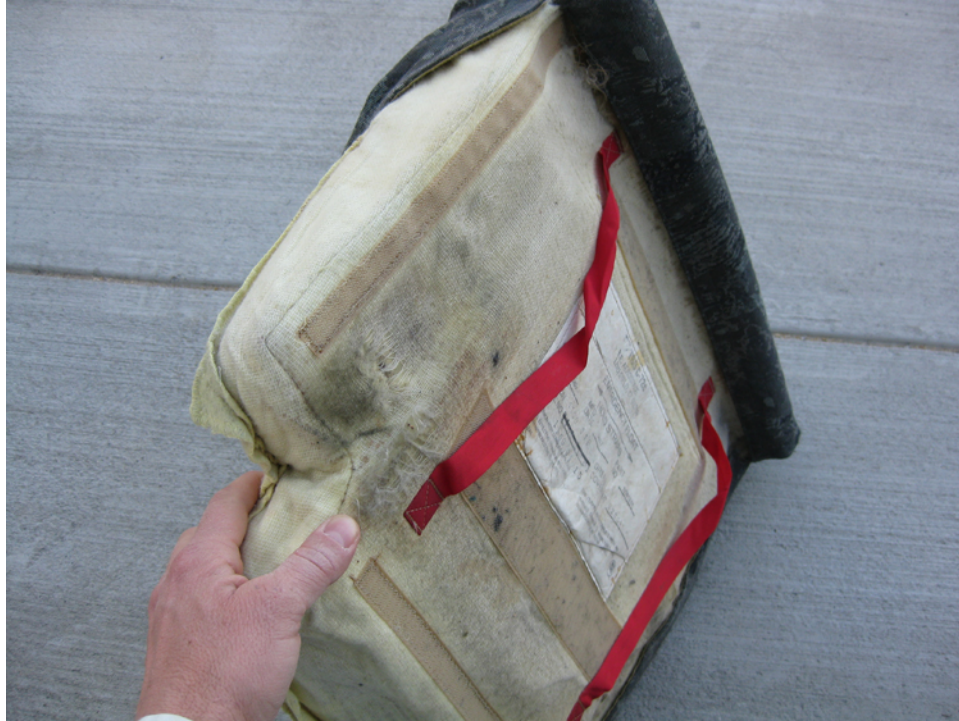
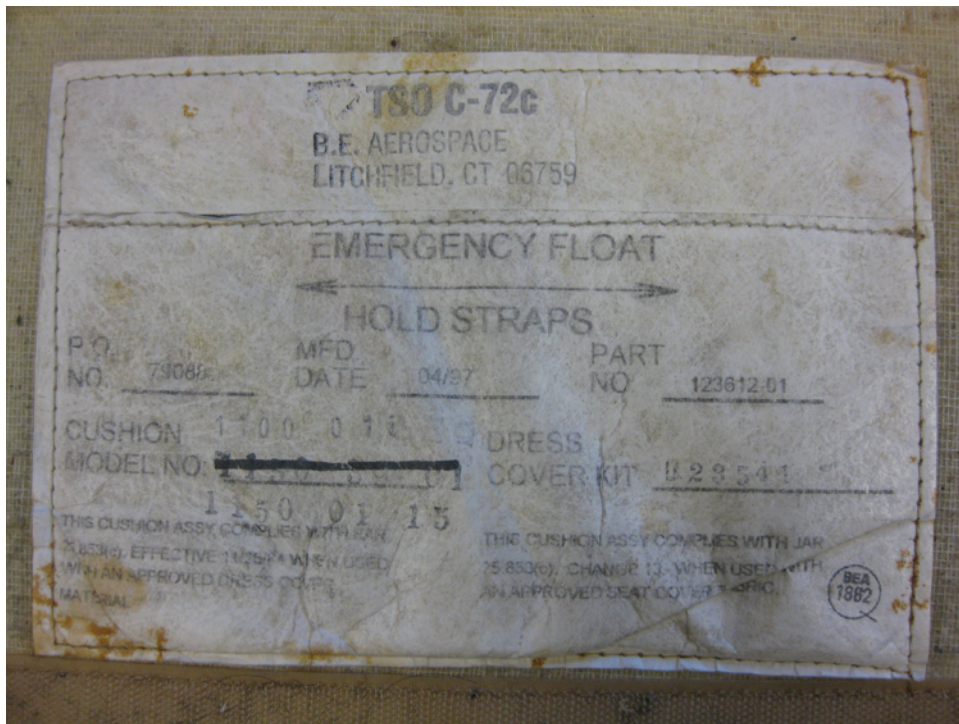
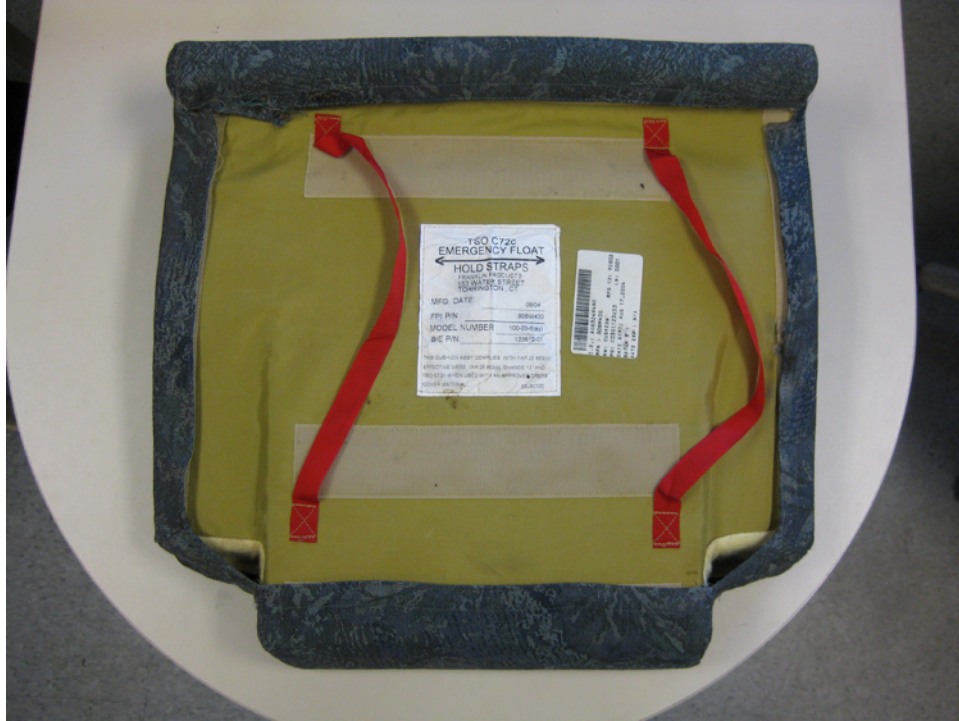
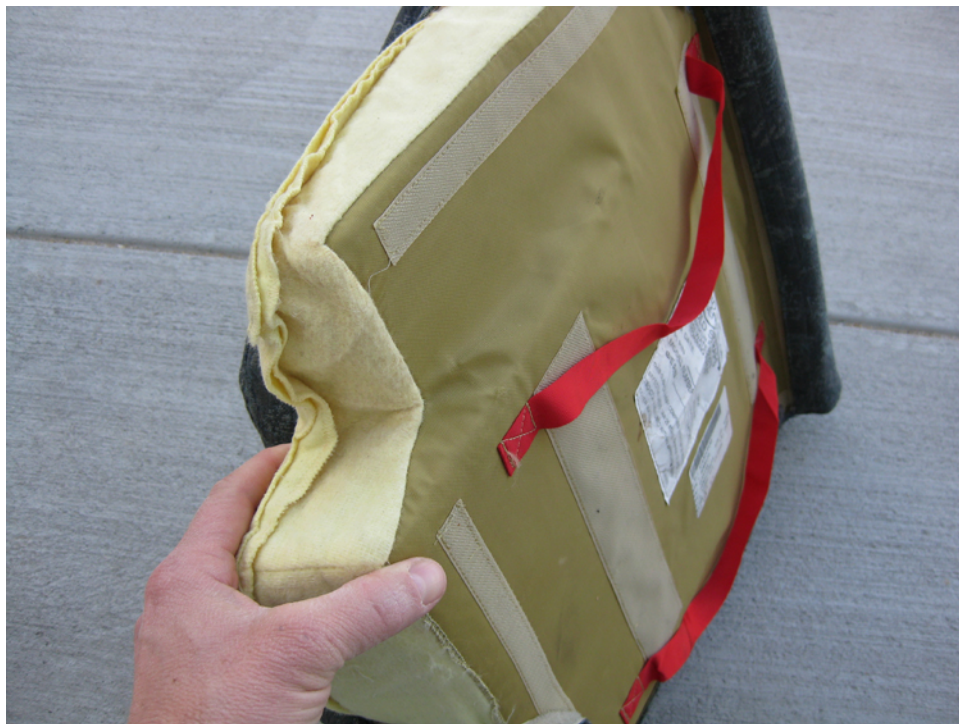
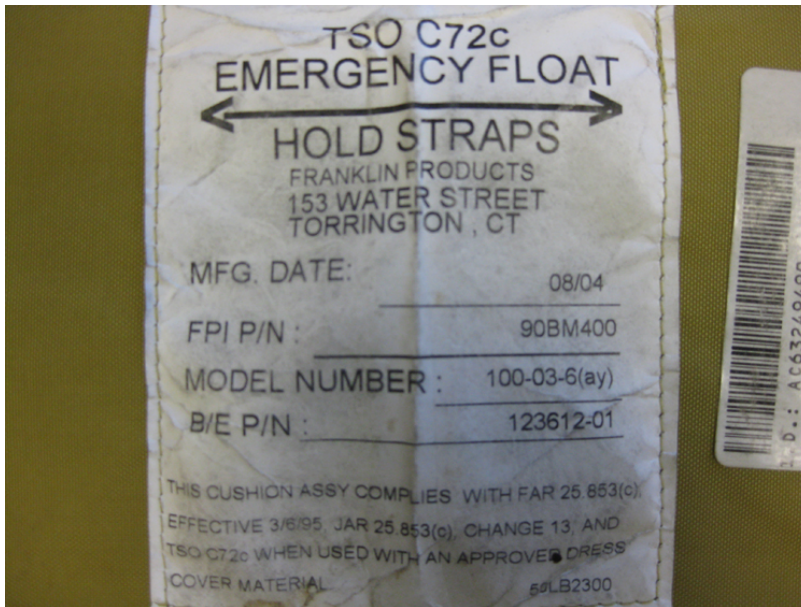
Because the test resulted in flashover conditions being reached so quickly, there was concern over the test configuration and materials used. Since the panels and carpet had been used in previous full-scale tests with no adverse affect, they were ruled out. This focused the attention on the seating materials and the use of the exhaust fan to draw the fire into the test fuselage. Upon removing the burned materials from the test fuselage, the bottom seat cushions were inspected with greater scrutiny, revealing inconsistent construction. In some cases, the bottom cushions included a felt-type, fire-blocking layer, while others appeared to lack a fire-blocking layer, indicating they were fire-hardened foam (blocking layer not used). Since there was some concern over the performance of the seat materials, the untested cushions were removed from the remaining seat assemblies in storage. The inspection revealed a number of different types of bottom cushions, including the (presumably) original units manufactured by B/E Aerospace (figures 50 and 51). A close-up photograph of the inspection tag on the bottom side reveals the manufacturing details, including the statement that it complies with FAR 25.853 (c), which is the flammability test using the oil burner (figure 52). Other units were manufactured by Franklin Products (figures 53 and 54). The Franklin Products inspection tag revealed a similar statement of compliance with FAR 25.853 (c) (figure 55).

Figure 50. Bottom View of Bottom Seat Cushion Used in Baseline Test 1 With B/E Aerospace Markings

Figure 51. Side View of Bottom Seat Cushion Used in Baseline Test 1 With B/E Aerospace Markings

Figure 52. B/E Aerospace Manufacturer's Plate on Bottom Seat Cushion Used in Baseline Test 1

Figure 53. Bottom View of Bottom Seat Cushion Used in Baseline Test 1 With Franklin Products Markings

Figure 54. Side View of Bottom Seat Cushion Used in Baseline Test 1 With Franklin Products Markings

Figure 55. Franklin Products Manufacturer's Plate on Bottom Seat Cushion
Used in Baseline Test 1

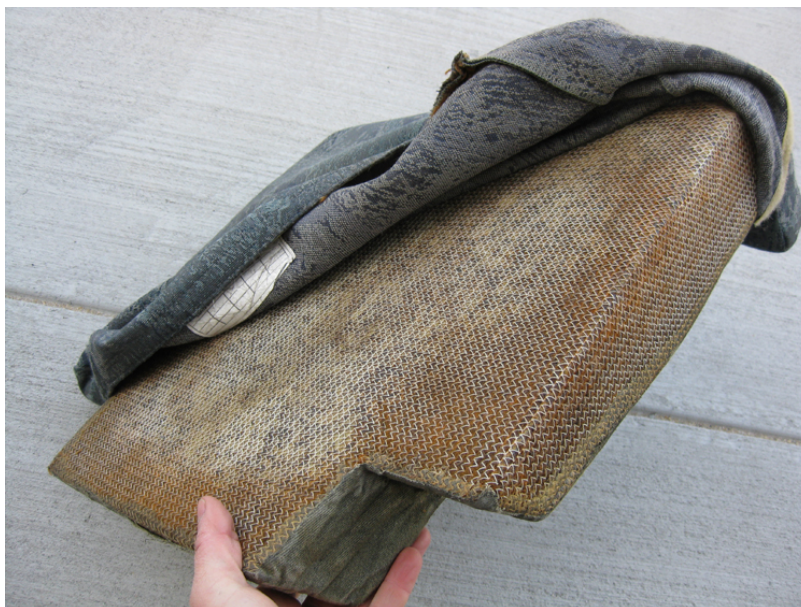
Although these two types of bottom seat cushions appeared to meet the current flammability requirements, a third cushion type was found that did not include any fire-blocking layer (figure 56). Furthermore, this particular unit had no inspection tag or other information identifying it or its compliance level (figure 57). It can only be assumed that this unit was a fire-hardened foam cushion, but this information could not be confirmed, since the seats were purchased from an aircraft spares dealer who did not keep any compliance records.

Figure 56. Side Angle View of Bottom Seat Cushion Used in Baseline Test 1 With no
Fire-Blocking Layer or Inspection Tag

Figure 57. Bottom View of Bottom Seat Cushion Used in Baseline Test 1 With no Fire-Blocking Layer or Inspection Tag

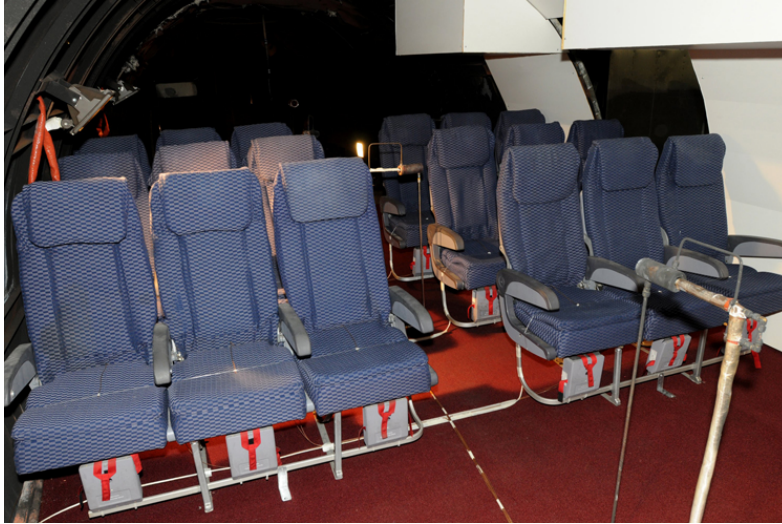
Figure 59. Baseline Test 2 Configuration

Because of the poor performance of the seatback configuration in Baseline Test 1, a change was also made to the fiberfill cushion material for Baseline Test 2. The seat cushion backs were cut open in the back, and the original fiberfill was removed. The material was replaced with DAX Foam™, a flexible, closed-cell polymeric foam that contains expandable graphite as a fire retardant². The foam material is the U.S. version of a Kay-Metzeler foam produced in the United Kingdom. Reports from industry indicate the combination of DAX Foam and upholstery fabric meets FAR 25.853 (c), with a resulting weight loss of approximately 6% (10% is the maximum allowable per the requirement). All other B/E 990 seat structures and hardware remained identical to those used in Baseline Test 1. The completed B/E 990 seats with backs containing DAX Foam were installed in the test fuselage identical to Baseline Test 1 (figure 59).

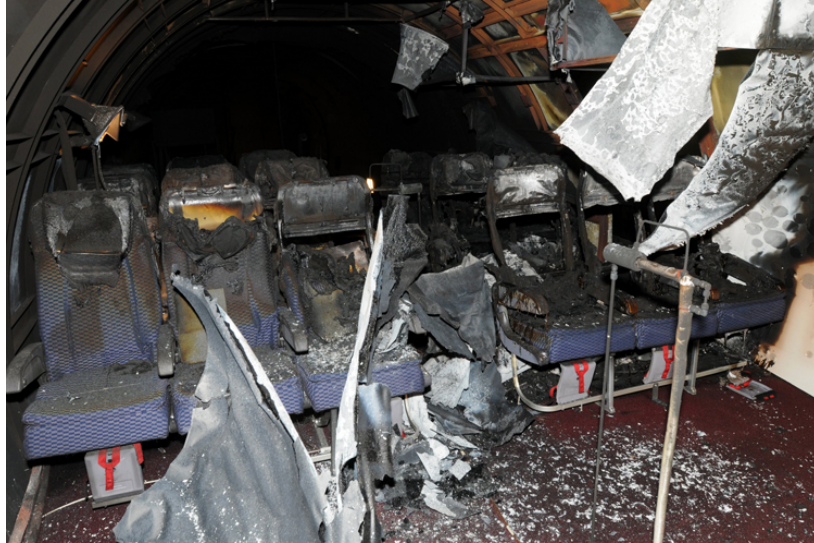
Figure 60. Baseline Test 2 Cabin Materials Following Test Fire

The pan fire was extinguished at 5 minutes 30 seconds with AFFF, and the interior fire self-extinguished a few minutes later. A posttest inspection of the fuselage revealed significant fire damage to the materials, similar to the previous baseline test. A majority of the honeycomb sidewall and ceiling panels were consumed with remnant pieces suspended from steel safety wire at various places in the ceiling and stowage bin areas (figure 60). Again, substantial damage to the seat assemblies was evident, particularly the seatbacks. The damage clearly showed the fire was able to jump the aisle and involve the seat materials farthest from the fire entry point.

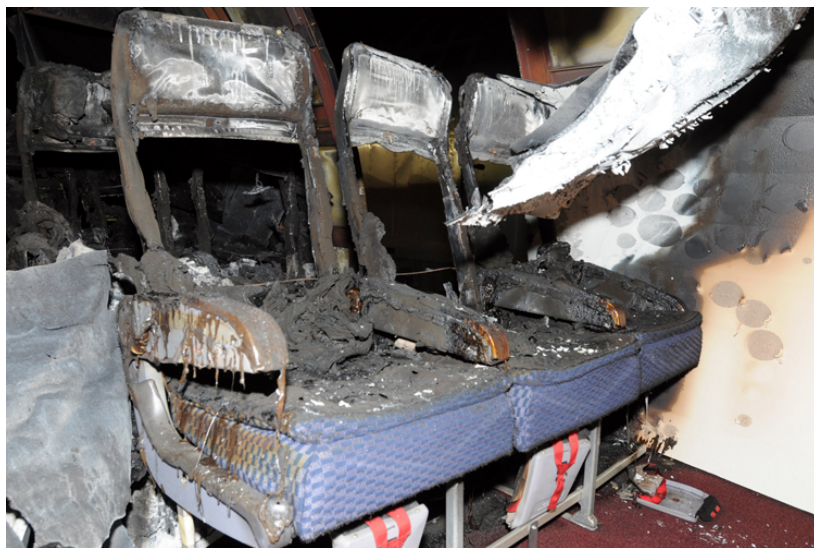
Figure 61. Close-Up View of Portside Triple Seat in the Baseline 2 Test

A closer inspection of the seating materials revealed that the seatback assemblies, including the stretched nylon suspension system and miscellaneous thermoplastic parts, were completely consumed in all of the portside seats (figure 61). The seatback cushion materials were largely consumed, with remnants collapsed and piled onto the upper surface of the bottom cushion. The portside row 2 and 3 bottom seat cushions were largely consumed, while the portside row 1 seats did not appear as damaged. However, upon examination of these cushions, it was discovered that they were deplete of foam, as if the inside had burned and the fire-blocking layer did not. Also of note were the thermoplastic life vest boxes, which were largely intact and unburned, except in the direct impingement areas. This result indicated the materials near the floor (seat cushion and lower) were in a zone of lesser severity than the materials higher up in the cabin during this particular postcrash scenario.

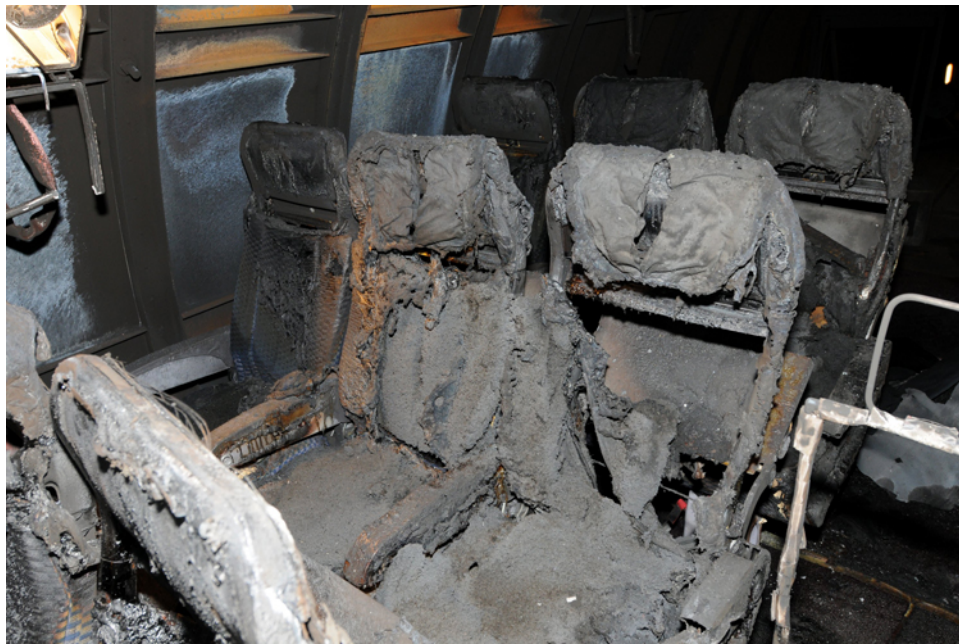
Figure 62. Close-Up View of Starboard-Side Triple Seat in the Baseline 2 Test

The seatback cushions on the starboard side were noticeably less fire damaged than the portside materials (figure 62). Only the starboard-side aisle seats showed similar slumping of the seatback materials onto the bottom seat cushions. Although heavily fire damaged, the materials were still in place on the seatbacks, in contrast to the portside seatbacks, which were largely void of materials. The bottom seat cushions on the starboard side also exhibited signs of being hollow, where the interior foam was consumed, leaving a shell of fire-blocking layer and charred dress cover.

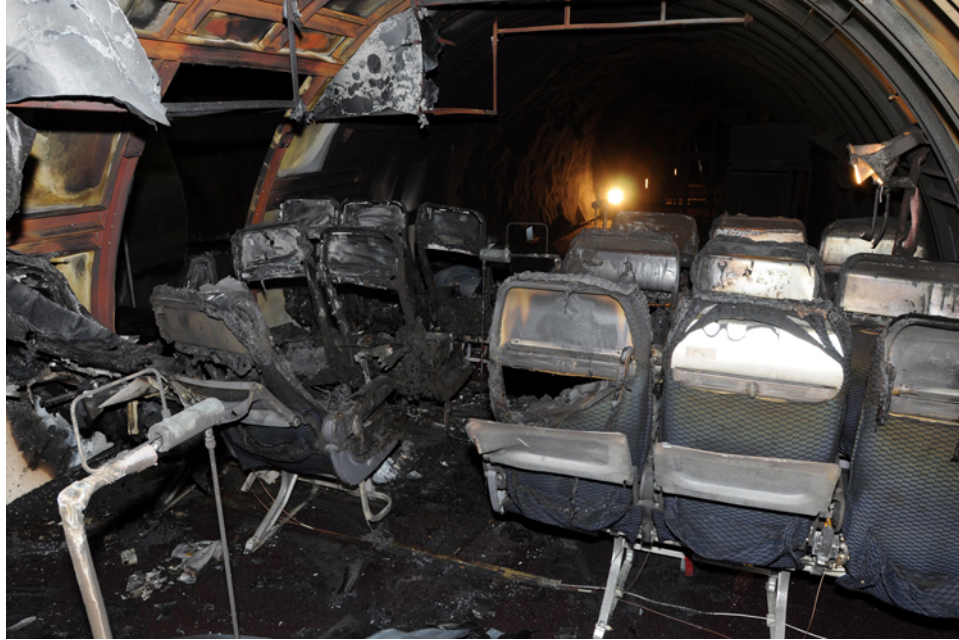
Figure 63. Aft Cabin View, Showing Portside and Starboard Seat Damage

A view from the aft cabin revealed a noticeable dividing line between the portside and starboard-side damage (figure 63). Although the fire had crossed the aisle at some point during the test, there was a noticeable difference in the level of damage on either side. The portside seatback assemblies were extensively damaged, with all cushion materials consumed. The carbon frame was also heavily damaged on all portside seats, and in some cases, it had collapsed. In contrast, the seatbacks on the starboard side were relatively intact, with the dress cover still visible from the aft view of the triple seat in row 3.

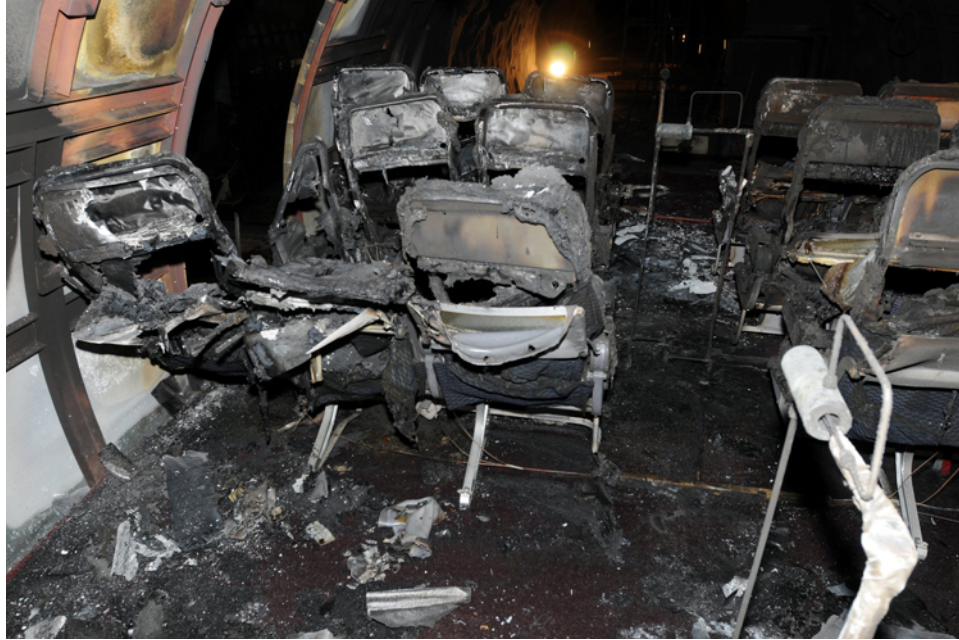
Figure 64. Aft Cabin View of Portside Seats Showing Back Assembly Structure Collapse

A closer view of the portside seats revealed several of the carbon seatback frames had collapsed, as the frame appeared to lose structural integrity once the epoxy resin was consumed in the fire (figure 64). The collapse of the structure likely aided in the spread of fire, as the seatbacks were observed igniting early in the fire sequence via fuselage-mounted cameras. Once the structure collapsed, it could have fallen into an adjacent material, causing it to ignite and spread the fire. The seatback structure collapse also impacted the performance of the DAX Foam used there. This foam is a polyurethane with graphite added, and when hit by a flame, the polyurethane burns down until the outer layer is predominantly graphite. In a laboratory setting, a static performance state is quickly reached, since there is no structural collapse of the steel test frame. However, occasional failures of this material can occur during a laboratory test, when the dress cover (typically leather) contracts and breaks apart the foam. This progression exposes new polyurethane foam, which then has to burn down to form a new graphite barrier. In the Baseline Test 2, the burning and failure of the seatback structure would have broken apart the DAX Foam in the cushion as it fell. This likely caused substantially more of the DAX Foam to burn than if it were held in a static position³. Also of note were the thermoplastic tray tables, which were almost completely consumed on the portside seats.

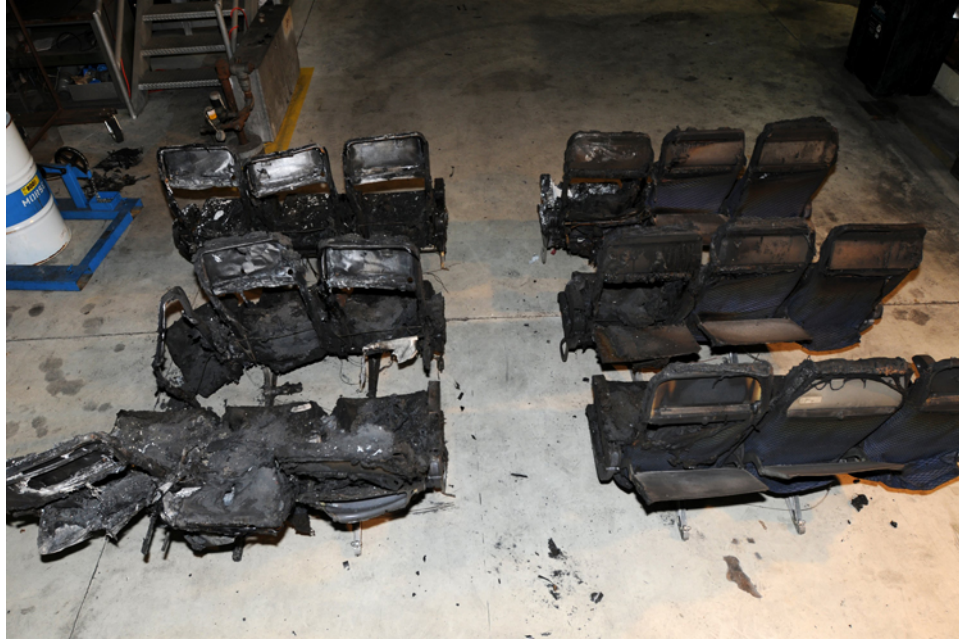
Figure 65. Seats Placed on Test Facility Floor for Inspection

Following a thorough inspection of the materials in the cabin, the seats were removed and placed on the test facility floor for further examination (figure 65). With the exception of the triple seat located adjacent to the fire opening, there was no melting of the primary components on any of the other seats. The portside row 2 seat assembly sustained the majority of the fuel fire heat and experienced rear cross tube and left-side leg melting (figure 66). Although this melting was not considered widespread, it was similar to the extent of melting experienced on the magnesium alloy bar samples tested in the laboratory and, therefore, had the potential to allow the magnesium components to ignite in subsequent full-scale tests.

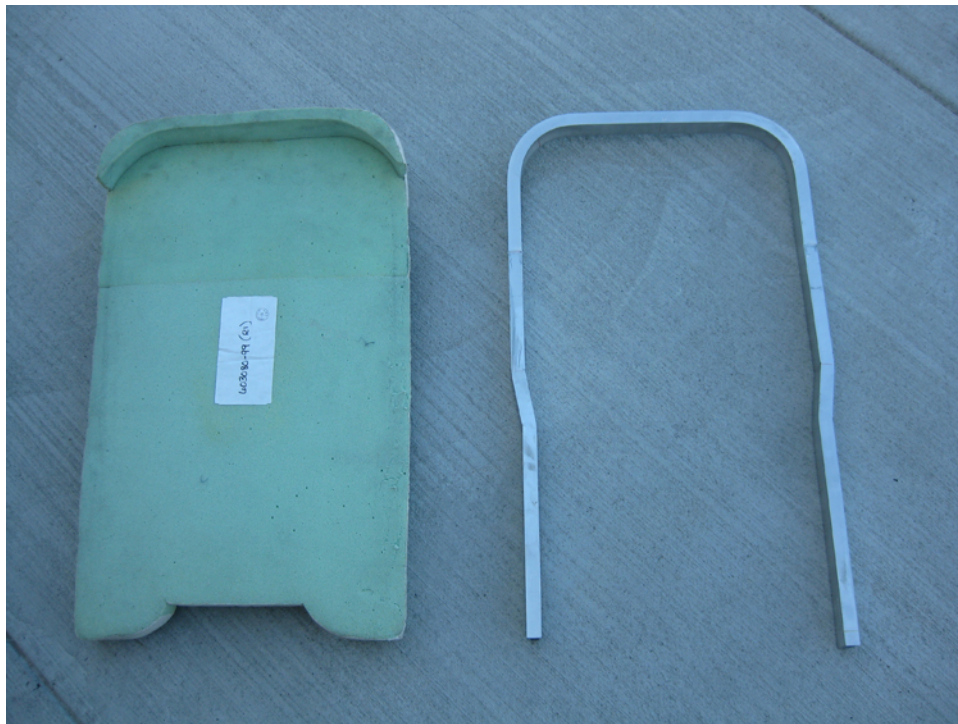
Figure 71. Fire-Hardened Foam and Fabricated Aluminum Frame

The new seatback concept was simple, yet retained the original shape and size of the B/E 990 seatback. Chestnut Ridge Foam, Inc. had previously retrofitted a shipset of B/E 990 seatbacks for a business-jet customer, and as a result, they had a back cushion available, which simplified the selection process. This eliminated the need for a costly design and development process. A sample of this cushion was sent to the FAA, and an aluminum box frame was developed to fit the pattern (figure 71). To bend the aluminum tubing to the correct pattern, a special hydraulic tube-bending machine was purchased.

The aluminum used for the frame was Al 2024-T3, and measured 0.75 by 1.5 inches. Chestnut Ridge also had available a dress cover for this particular assembly that was supplied for test fitting the prototype assembly (figure 72).

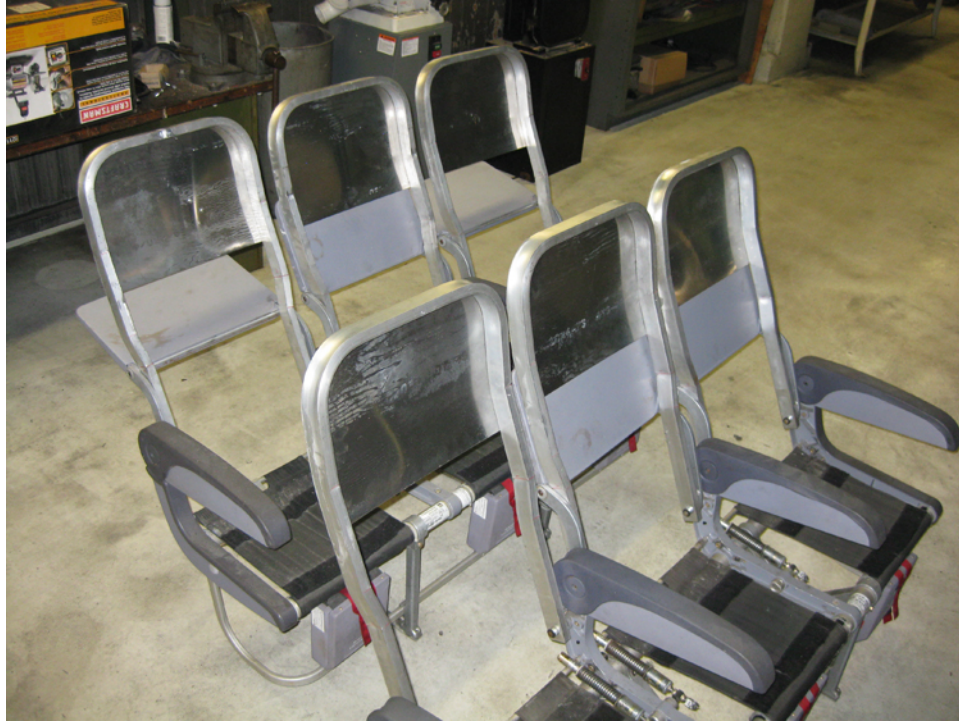
Figure 73. Seatback Assemblies Being Fabricated and Mounted on B/E 990 Seats

A total of 90 cushion assemblies were ordered from Chestnut Ridge, which was sufficient for five complete full-scale tests (18 seat cushions for each test). This would enable execution of the original four tests (baseline plus three magnesium alloy tests) and would provide extra materials in the event that a test malfunctioned or additional tests needed to be conducted. In addition, 90 dress covers were ordered from Preferred Aviation, Inc. of Miami, Florida, to fit each cushion. Preferred Aviation had supplied the dress cover that was used in the prototype development. By coincidence, the dress covers were supplied in Continental Airlines livery and matched the bottoms supplied with the B/E 990 seats. All additional materials were ordered, and fabrication began as the materials were received.

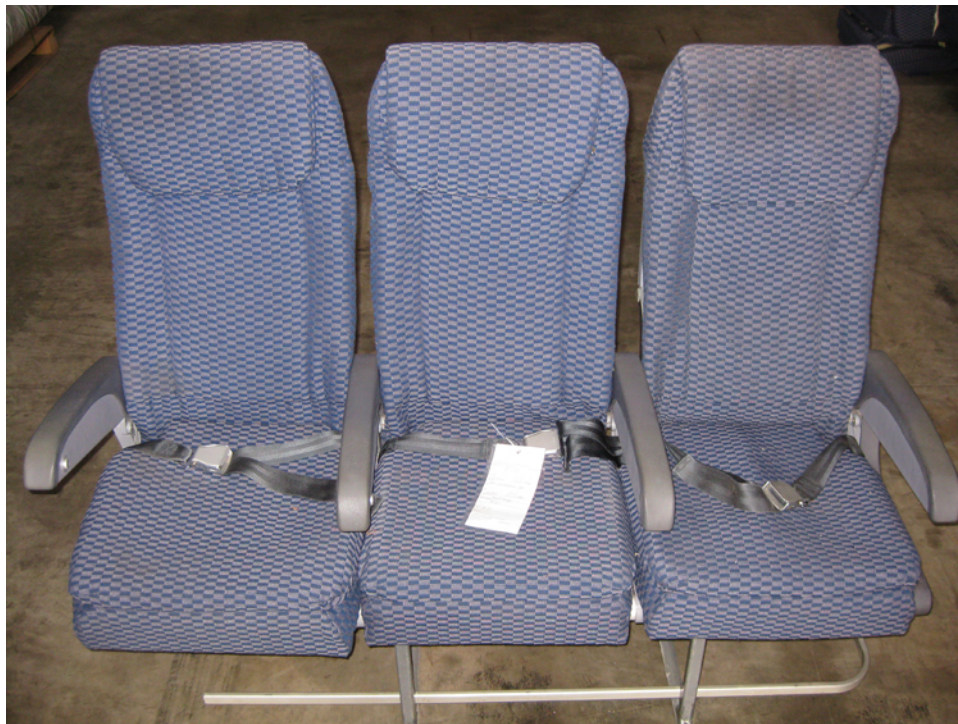
Figure 75. Additional B/E 990 Seats

Aside from the materials purchased for the seatback fabrication, additional B/E 990 seats needed to be purchased, since the original order contained only enough to conduct four tests. Since two additional baseline tests were conducted, at least 12 additional triple seats were needed. An order was placed with a different aircraft spares dealer. Universal Asset Management, Inc. of Memphis, Tennessee, supplied 24 additional B/E 990 seats. The seats received were in very good condition and contained all the necessary cushion materials, including the fire-blocked bottom seat cushions. The seats were outfitted with Continental Airlines livery (figure 75).

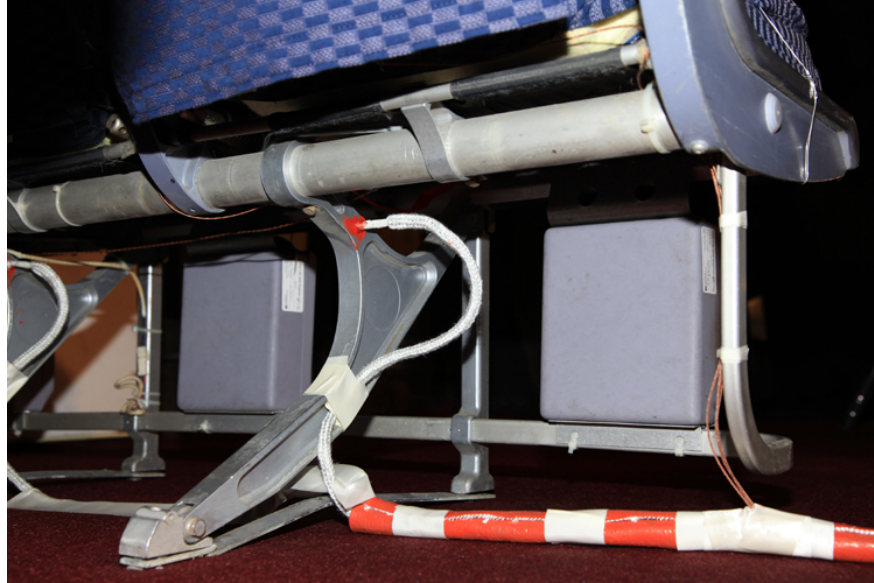
Figure 77. Typical Embedded Thermocouple Arrangement in Seat Leg

As shown in the earlier laboratory-scale tests, it was necessary for the magnesium alloy materials to melt before any ignition would occur. To determine if the magnesium alloy seat components reached their melting temperatures during the full-scale tests, thermocouples were embedded into the seat leg components. The most practical method for doing this was to drill a small-diameter hole and insert a metal-sheathed thermocouple into the borehole. As a safety measure, the thermocouples were held in place using high-temperature, room-temperature vulcanizing (RTV) silicone (figure 77). The RTV silicone also prevented the thermocouple from inadvertently measuring air temperature from the surrounding area by sealing the sensor in the borehole, thereby measuring only the core metallic temperature. This measurement technique was not perfected until Baseline Test 3. The lead wires from the thermocouples were also wrapped in a heat-resistant sheath to protect them from fire damage.

During Baseline Tests 1 and 2, only five thermocouples were used to monitor the leg frame temperatures: one in each of the three portside seats and two in the starboard-side seat in row 2. It was agreed that additional thermocouples should be mounted in the legs of the seats for all subsequent tests, as this information is useful in determining the extent of component melting. During Baseline Test 3, three additional thermocouples were added to the leg frames, for a total of eight (figure 78).

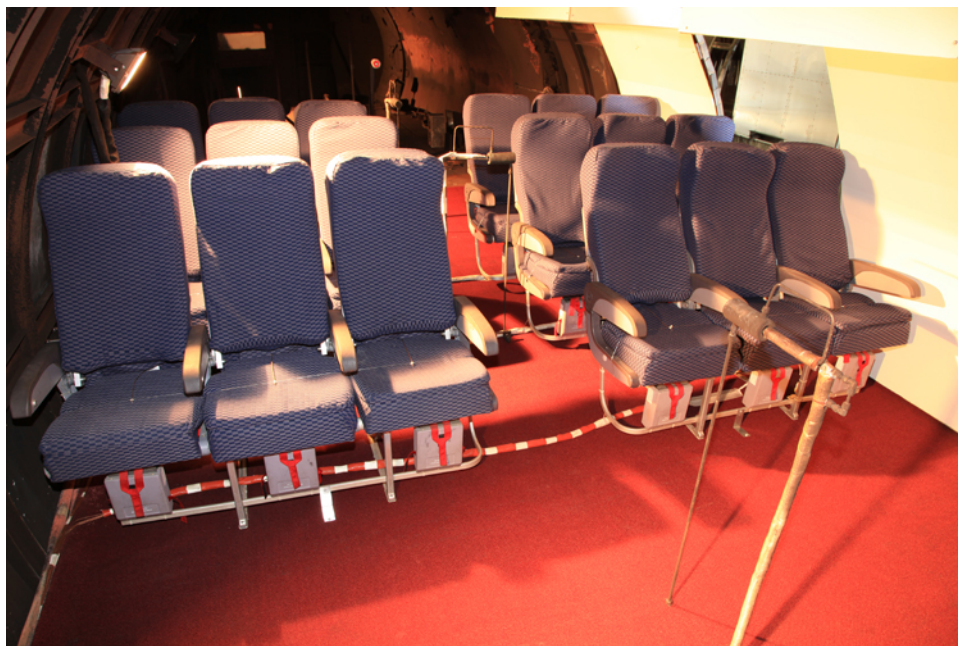
Figure 79. Baseline Test 3 Configuration

All seatback construction was completed, and the fully dressed seats were installed in the test fuselage, which had been previously outfitted with honeycomb sidewalls, ceiling panels, and stowage bins, and carpeting (figures 79 and 80). The fuel pan was loaded with 55 gallons of JP-8 fuel, and a final check of the instrumentation was performed. All cabin doors were checked to ensure there were no other openings except the aft L3 door, which was partially open as in previous tests, to allow the entrance of make-up air for combustion. The data collection system was initiated just prior to fuel pan ignition, and the fire was started. In contrast to the previous two baseline tests, the fire did not appear to spread into the cabin as quickly. There was excellent visibility from all cameras at the 1-minute point, with only localized burning on the seat directly in the fire opening. The visibility remained clear at the 2-minute point, as the fire began to spread on the sidewall panels around the periphery of the fire opening and progressed forward and aft on the stowage bin panel surfaces. The aft upper camera clearly showed less visibility and greater quantities of smoke compared with the aft lower camera. At 3 minutes, the aft lower camera was moderately clear, with smoke density beginning to rise. Forward cameras showed the seatbacks on all portside seats were on fire near the tops, but there was no evidence of involvement on the starboard-side seats at this point. By 3 minutes 40 seconds, flashover conditions began to develop, with increased turbulence in the smoke at the ceiling, and visible flames on much of the ceiling surface. Flashover continued, with complete obscuration of the cameras at 4 minutes 15 seconds. The test continued unabated for another 45 seconds after camera obscuration in an effort to cause more extensive melting. The extended test time and component melting would be necessary during subsequent magnesium alloy tests, as the previous laboratory-scale results indicated the materials had to melt first before ignition would occur.

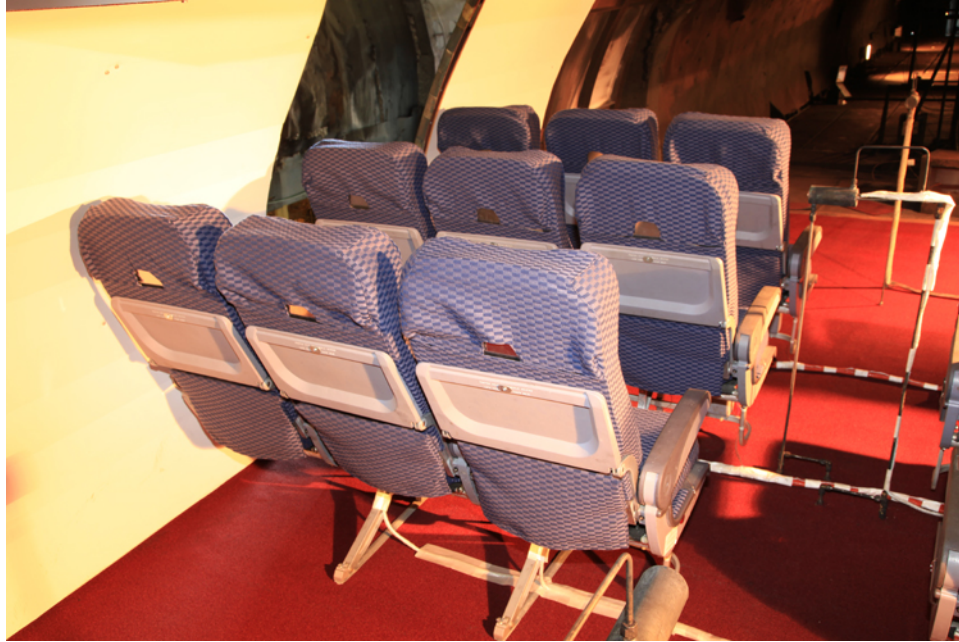
Figure 80. Aft View of New Seatback Assemblies Used in Baseline Test 3

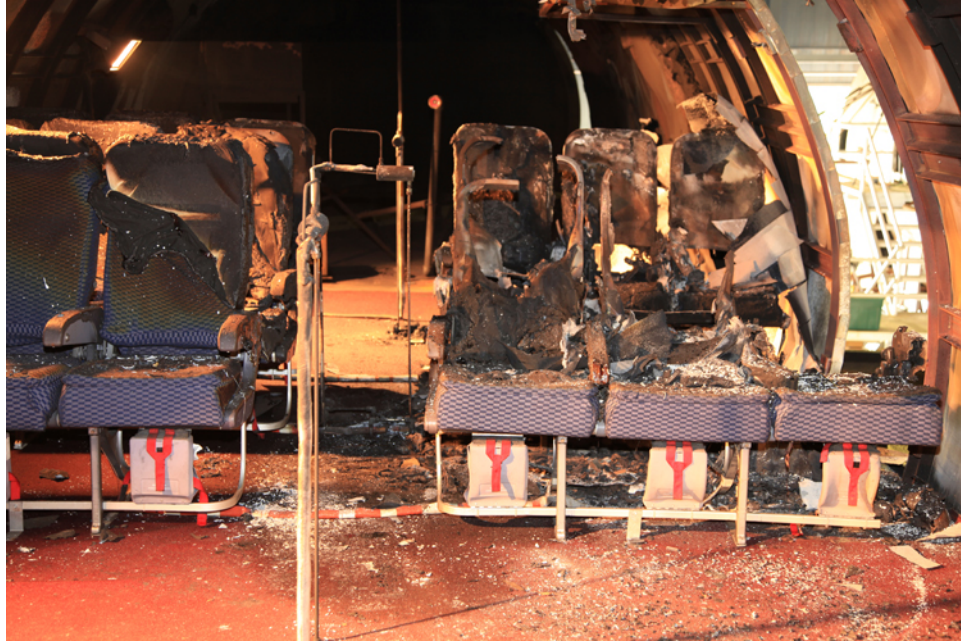
Figure 81. Baseline Test 3 Damage to Portside Seats

A posttest inspection revealed a number of the portside seatbacks were consumed, including the aluminum frames (figures 81 and 82). The starboard-side seatbacks were largely intact, with only surface burning and charring of the fabric dress cover (figures 83 and 84).

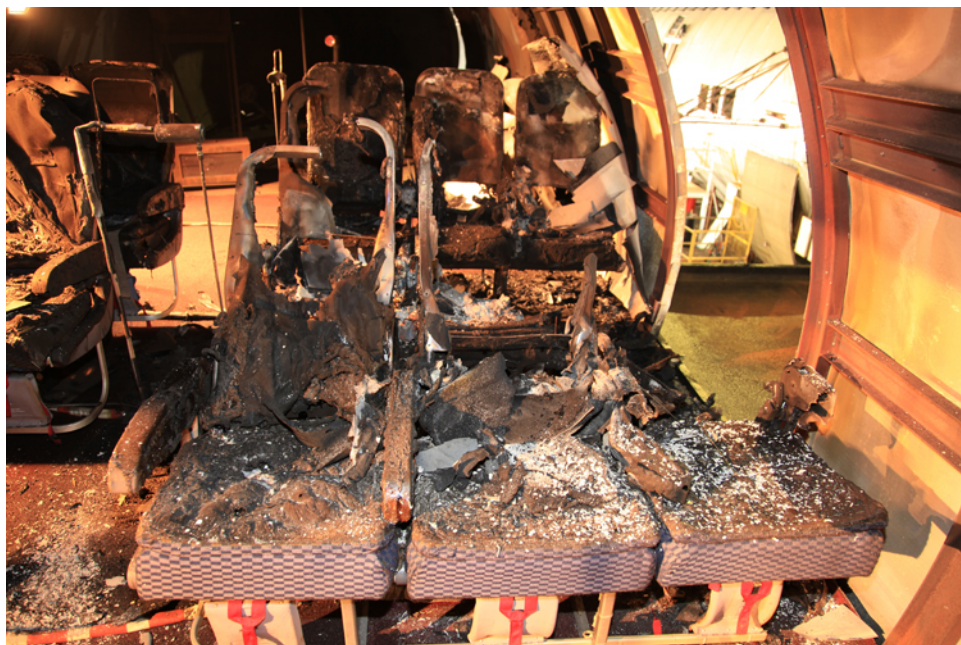
Figure 82. Close-Up of Portside Triple Seats Showing Melted Aluminum Seatbacks

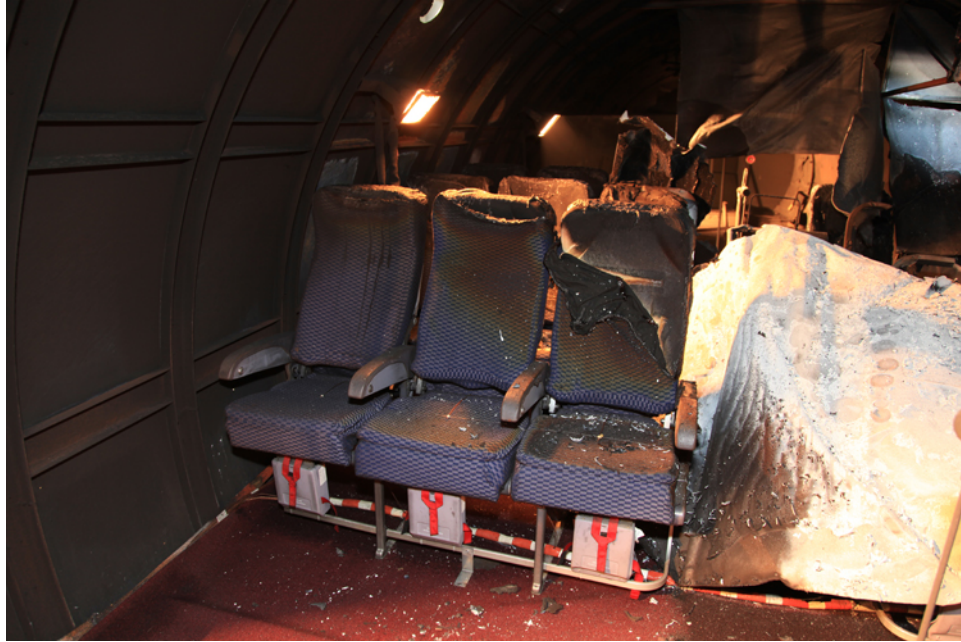
Figure 83. Posttest Starboard-Side Seats in Baseline Test 3

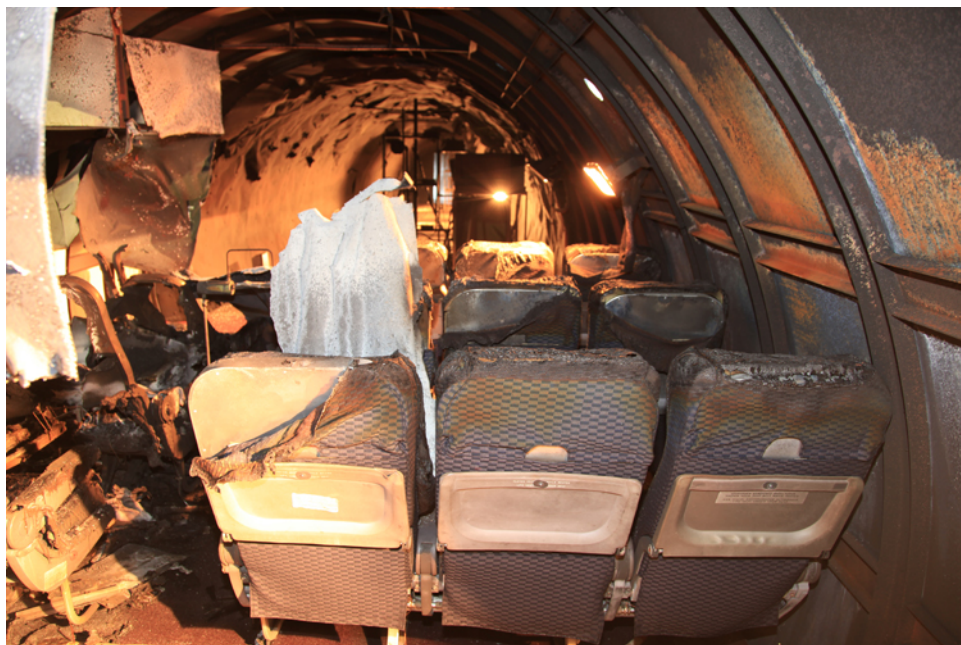
Figure 84. Aft View of Starboard-Side Seats

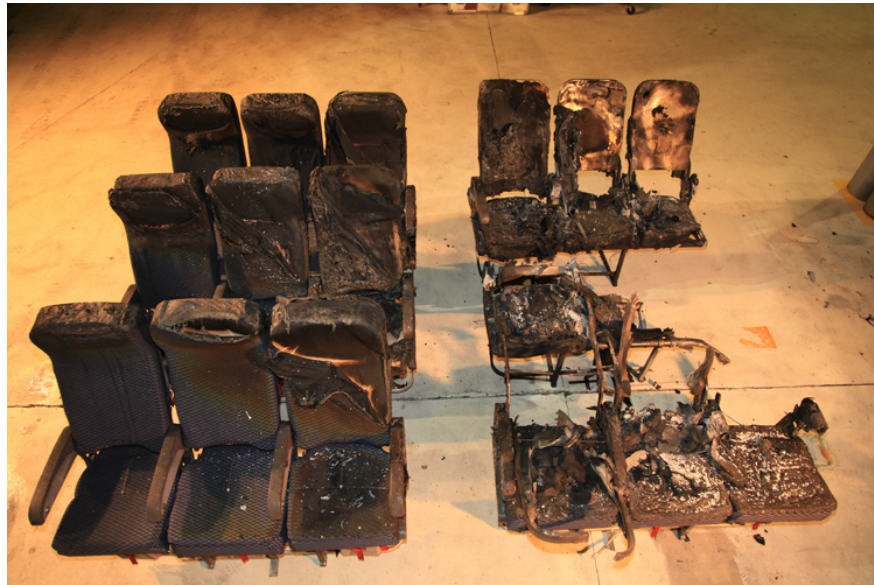
Figure 85. Seats Removed From Fuselage Following Baseline 3 Test

To facilitate a closer inspection of the burned materials, the seat structures were carefully removed from the fuselage and put on the floor of the test facility, positioned in the same orientation as in the test (figure 85). The damage clearly indicated the newly designed seatbacks had prevented extensive flame spread, as the starboard-side seats were heavily charred but the seatback materials were still intact. The 5-minute test duration appeared sufficient, as there was thorough melting of the seat frame near the fire opening, which was the desired result

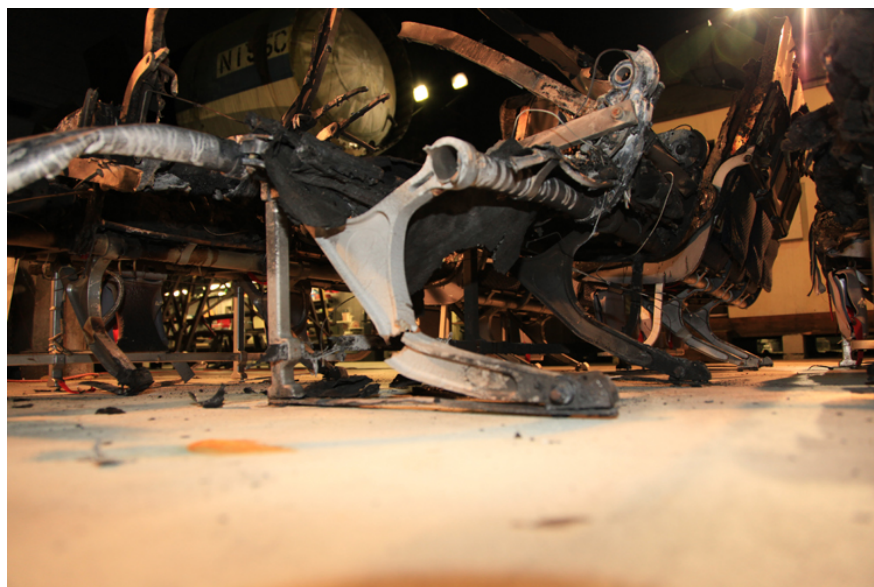
Figure 86. Close-Up of Melted Seat Structure Primary Components

(figure 86). The close-up photographs show that both cross tubes were melted, along with the outboard leg component and outermost spreader assembly. The next inboard spreader assembly had partially melted and was lying on the fuselage floor. Although they were not primary components, the seatback frames and most of the lower baggage bar on this triple seat were also completely melted. These results indicated a successful test condition had been established. The conditions resulted in thorough melting of the primary components, but the overall atmospheric conditions were not so severe that subsequent magnesium alloy materials could not be effectively evaluated.

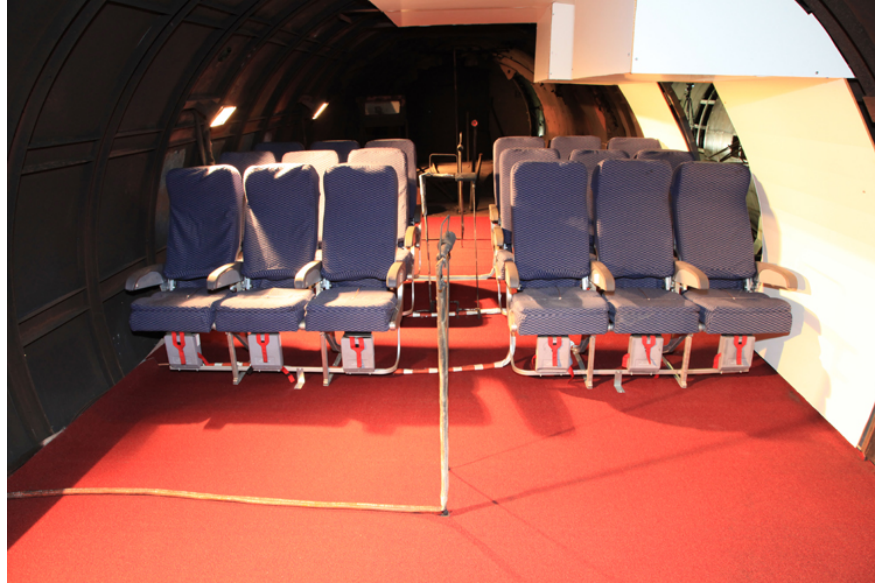
Figure 97. Pretest Configuration for WE-43 Magnesium Alloy Test

The WE-43 alloy had shown excellent resistance to ignition during the laboratory-scale tests. For this reason, it was selected as the good-performing material for the full-scale test evaluation. The good-performing WE-43 alloy was chosen for the first test, since it would be pointless to continue with the study if this material did not perform well under full-scale, realistic conditions. The machined WE-43 parts were received, and the seats were assembled. This was a difficult task, as it was necessary to first disassemble each B/E 990 triple seat, and then reconstruct it using the WE-43 alloy components (legs, spreaders, and cross tubes). Since no assembly diagrams were available, the process was slow, with technicians continually referring to a fully assembled B/E 990 triple seat. The newly designed seatback assembly, identical to that used in Baseline Test 3, was added to each leg frame assembly. The completed assemblies were installed in the furnished test fuselage, and the thermocouples were installed on the leg frames as in the previous test. All other instrumentation was checked prior to the test (figures 97 and 98).

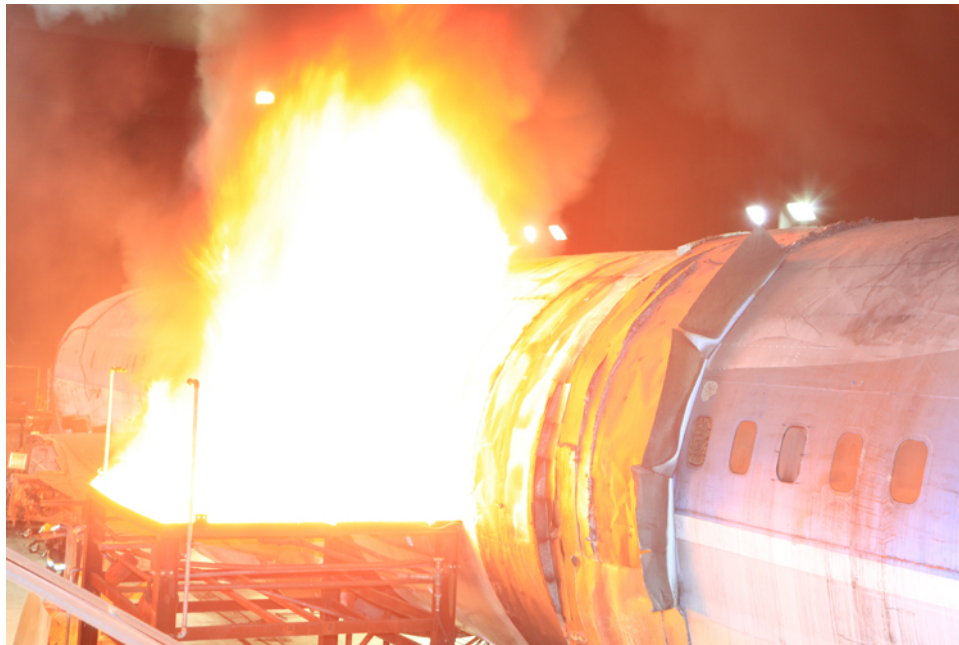
Figure 99. External Pan Fire During WE-43 Magnesium Alloy Test

The fuel pan was loaded with 55 gallons of JP-8 fuel, and a final check of the instrumentation was performed. All cabin doors were set as they were in previous tests, to create identical pretest conditions. The data collection system was initiated just prior to fuel pan ignition, and the fire was started (figure 99). As in Baseline Test 3, the fire did not appear to spread into the cabin as quickly, with excellent visibility from all cameras at the 1-minute point, and only localized burning on the seat directly in the fire opening. The visibility remained clear at the 2-minute point, as the fire began to spread on the sidewall panels around the periphery of the fire opening and progressed forward and aft on the lower surface of the stowage bins. By 2 minutes 30 seconds, the fire started to involve the ceiling panel in the fire opening, while the visibility of
