DOT/FAA/AR-11/3

Evaluating the Flammability of Various Magnesium Alloys During Laboratory- and Full-Scale Aircraft Fire Tests

Timothy R. Marker

Final Report

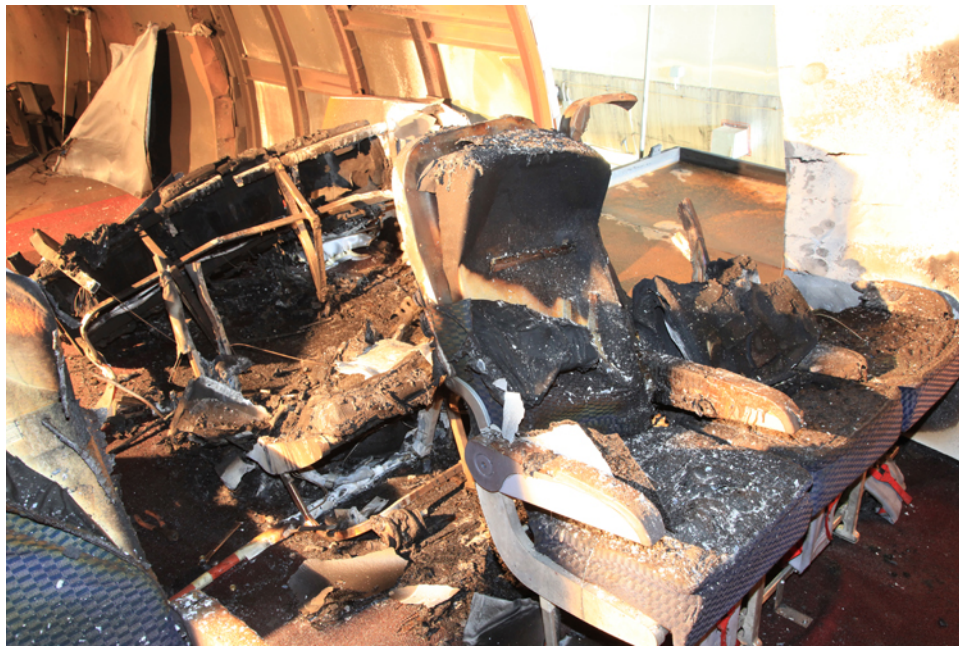
Figure 100. The WE-43 Magnesium Alloy Posttest Results

A posttest inspection revealed that a number of the portside seatbacks were consumed, including the aluminum frames (figure 100). The fire had also caused the hold-down straps on the portside row 3 seat to melt, allowing the seat to tip over backwards (figure 101). It is not clear at what point during the fire sequence this occurred, but it does not appear to have impacted the test results in any way. It is also possible that this occurred much later in the test, perhaps as a result of the water nozzle stream, which was concentrated in the row 2 seat area. Although it was directed at the row 2 seat, the stream could have deflected off the remaining seat structure, causing the row 3 seat to become unstable. The starboard-side seatbacks were largely intact, with only surface burning and charring of the fabric dress cover (figure 102).

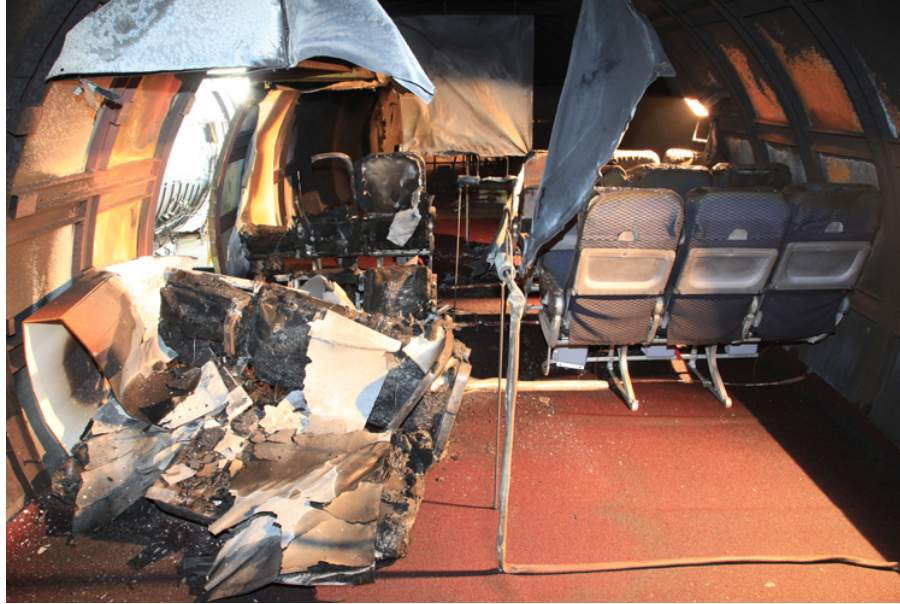
Figure 101. The WE-43 Magnesium Alloy Test Showing Portside Row 3 Seat Tipped Over

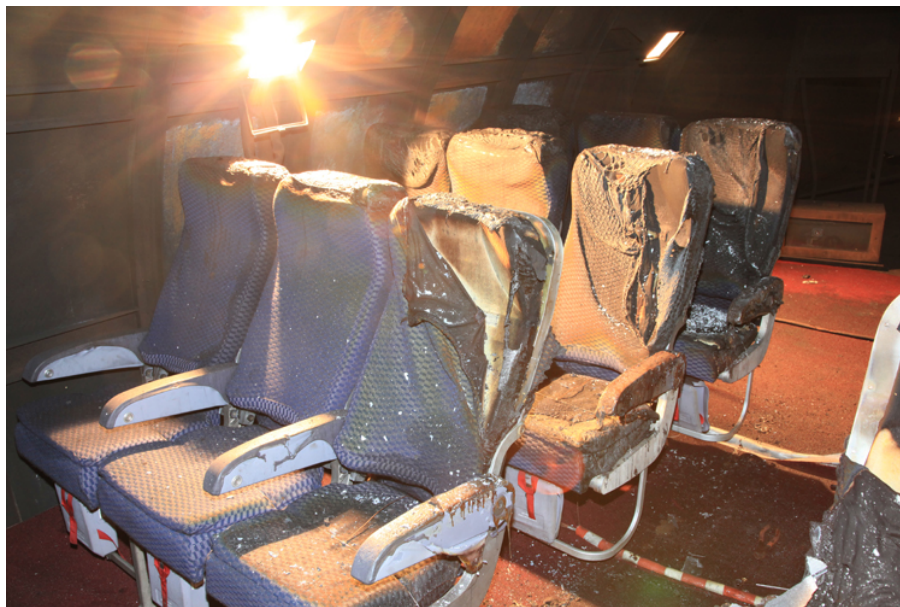
Figure 102. Starboard-Side Seats Showing Minimal Damage

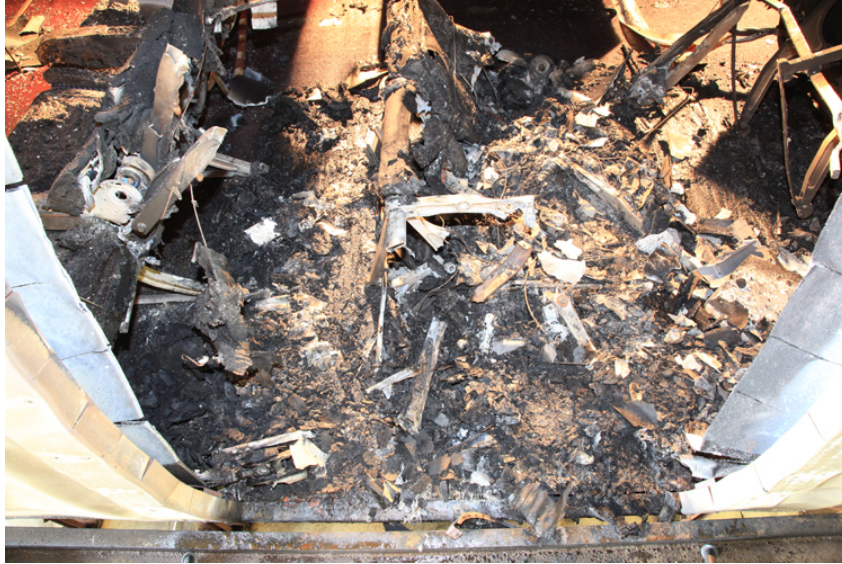
Figure 103. View Through Fire Opening Showing Row 2 Frame Remnants

A closer look at the portside seats indicated there was considerable melting of the row 2 seat assembly's primary components (figure 103). The two outer spreaders, both cross tubes, and the outer leg experienced melting during the test. This result was similar to Baseline Test 3, in which several primary seat components had also melted. This and the results from Baseline Test 3 confirmed that the test conditions were ideal, with thorough melting of the primary components while survivable conditions remained for approximately 4 minutes.

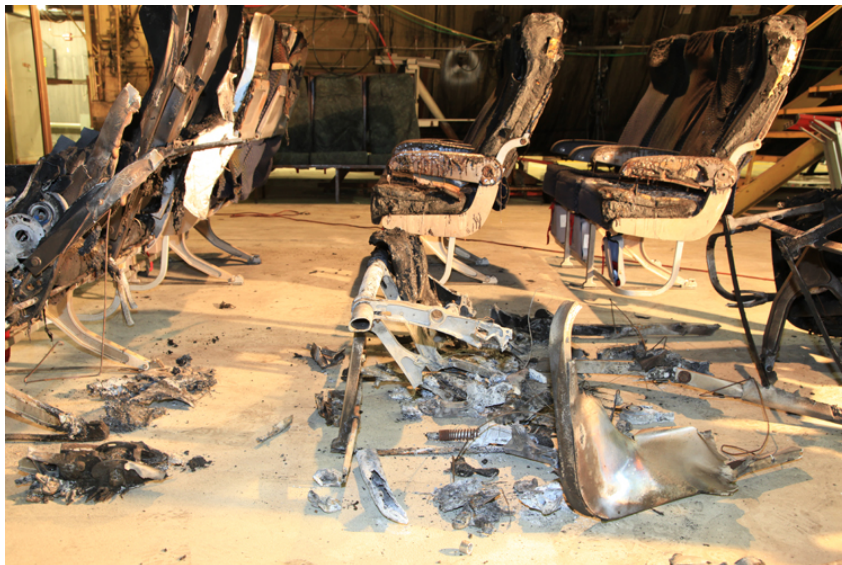
Figure 104. Seat Frames on the Floor of the Test Facility Showing Evidence of Magnesium Burning

The seats were carefully removed from the test fuselage and placed on the test area floor for further inspection. After removing some of the melted cushioning and dress cover, it was clear that the magnesium alloy was involved in the fire, as several pieces showed signs of ignition (figure 104).

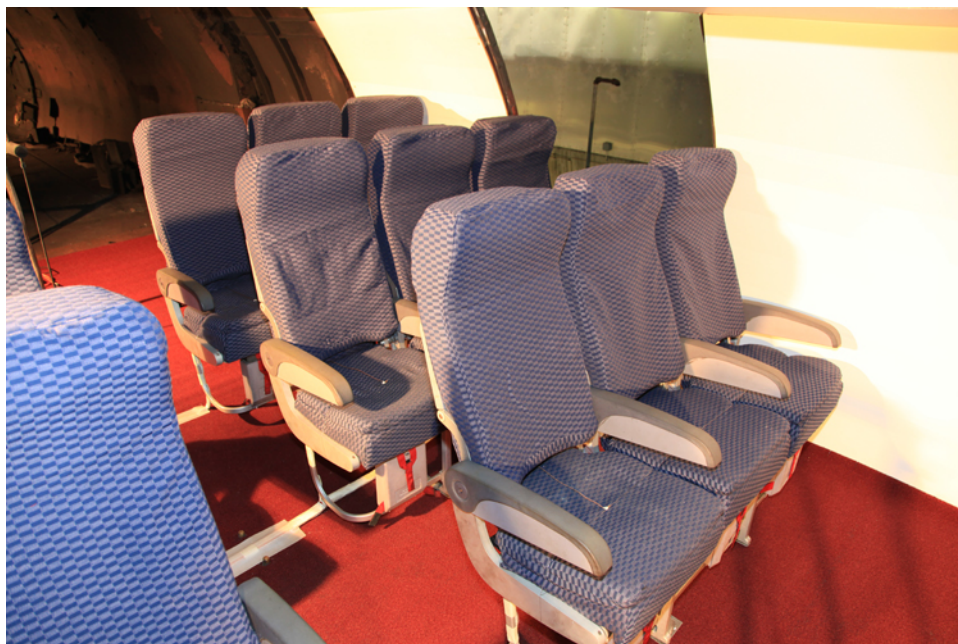
Figure 105. Pretest Configuration for AZ-31 Magnesium Alloy Test

The machined AZ-31 parts were received and the seat assemblies were constructed. This process was much easier the second time, as the technicians were more familiar with the seat construction and the required disassembly/reassembly. As in the WE-43 test, it was necessary to first disassemble six standard B/E 990 seats, and then reconstruct them using the AZ-31 alloy components supplied by Magnesium Elektron and Wonder Machine. The newly designed seatback assemblies (identical to those used in Baseline Test 3 and the WE-43 magnesium alloy test) were added to each leg frame assembly. The completed assemblies were installed in the furnished test fuselage, and the thermocouples were installed on the leg frames as in the previous tests. All other instrumentation was checked prior to the test (figures 105 and 106).

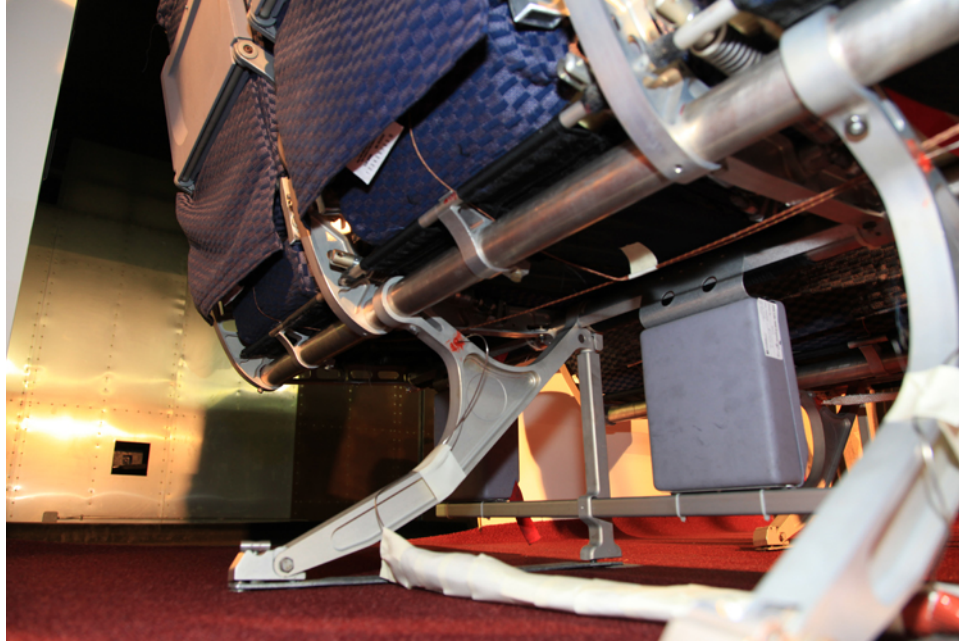
Figure 106. The AZ-31 Components Showing Thermocouple Installed on the Leg Component

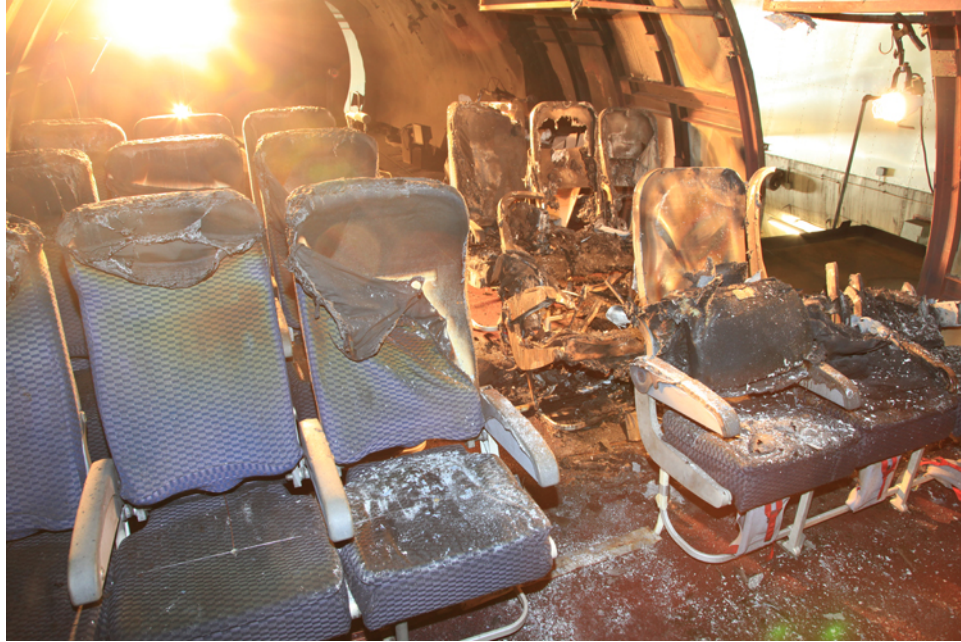
Figure 107. Posttest Conditions for AZ-31 Magnesium Alloy

A posttest inspection revealed that a number of the portside seatbacks were totally consumed, including the aluminum frames (figure 107). The portside row 2 seat assembly sustained the most damage, as expected, with no visible evidence of any remaining seatback frames. Although the fire had severely impacted this seat assembly, the portside row 1 seat assembly still contained a visible seatback, as well as a partial seatback frame in the middle seat position (figure 108). It was difficult to determine how much of the row 2 seat assembly damage was from the initial fuel fire or from the subsequent magnesium fire during the observation period.

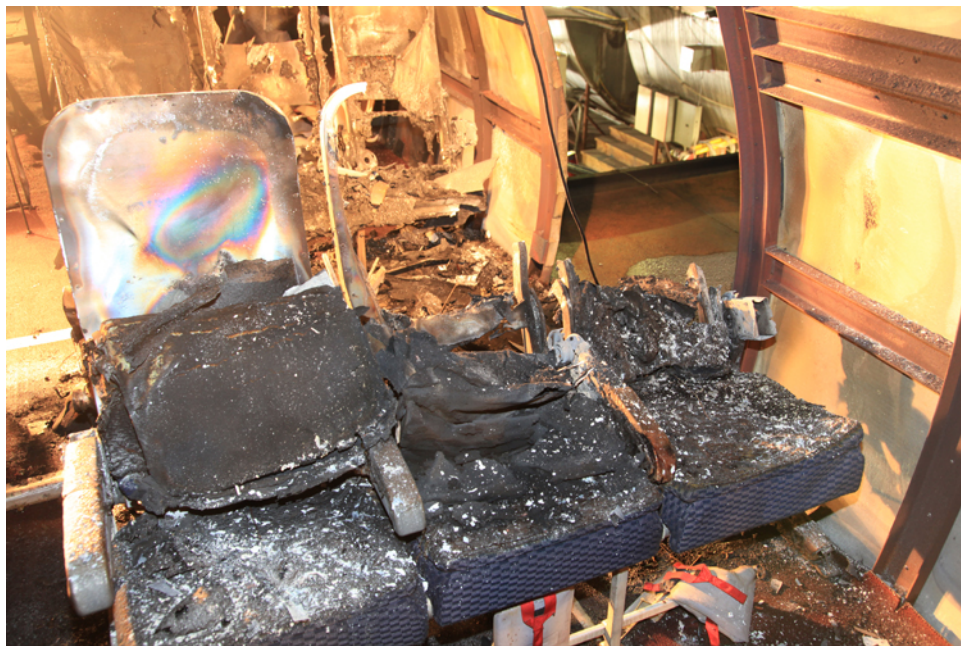
Figure 108. Portside Row 1 Seat Assembly Posttest for the AZ-31 Magnesium Alloy Test

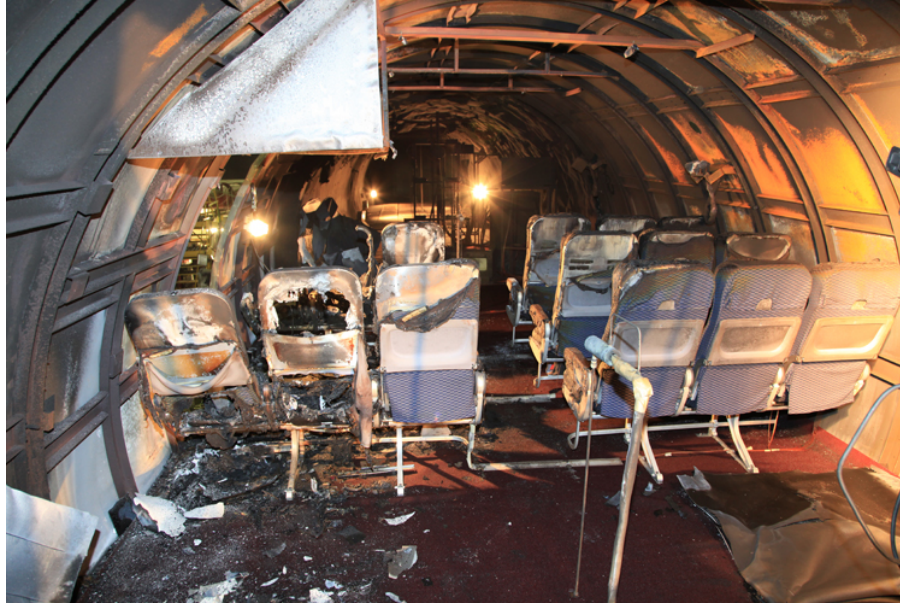
Figure 109. Aft View of Fire Damage for AZ-31 Magnesium Alloy Test

The starboard-side seatbacks were largely intact, with only surface burning and charring of the fabric dress cover and aisle-side arm rests. The thermoplastic tray table assemblies from all starboard-side seats were still intact, with no other damage observed (figure 109).

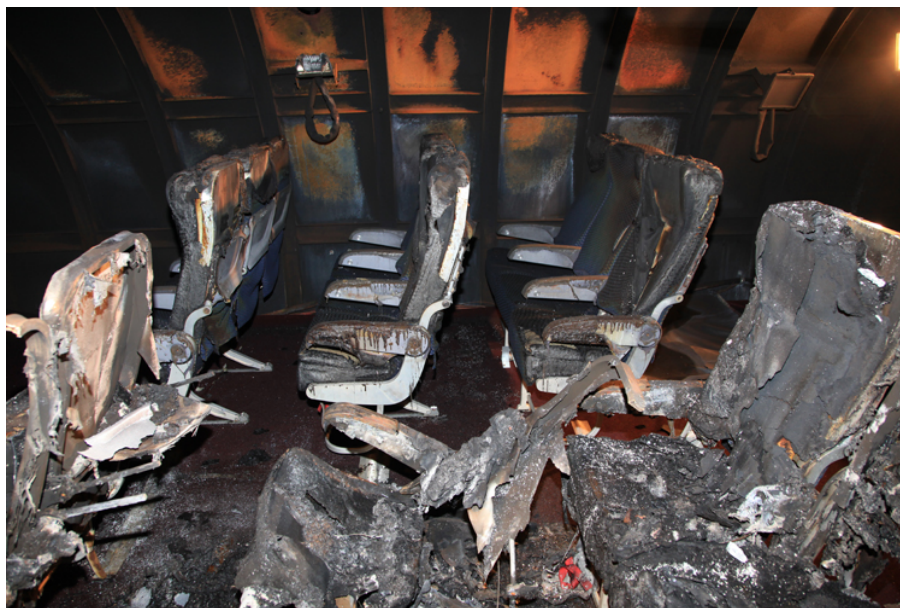
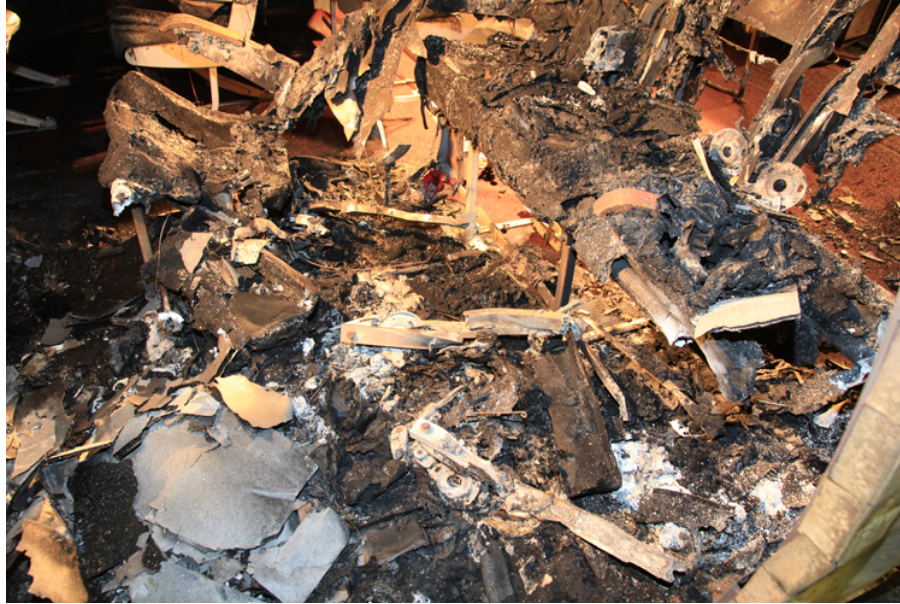
Figure 110. Portside Row 2 Seat Frame Damage Following AZ-31 Magnesium Alloy Test

Figure 111. Portside Row 2 Seat Frame Remnants

A closer inspection of the portside row 2 seat showed the extent of the damage (figures 110 and 111). The cross tubes and three of the four spreaders sustained heavy damage, with only small remnants of these components remaining on a small section of the unconsumed seat structure. The more massive leg assemblies also showed signs of fire involvement, with patches of whitish, magnesium oxide remaining on certain areas near the leg components. The magnesium oxide resulted from the reaction of the burning magnesium alloy with the water spray. The portside row 3 seat also exhibited fire damage, with the outboard spreader plate and part of the forward cross tube melted, leaving similar patches of magnesium oxide on the fuselage floor.

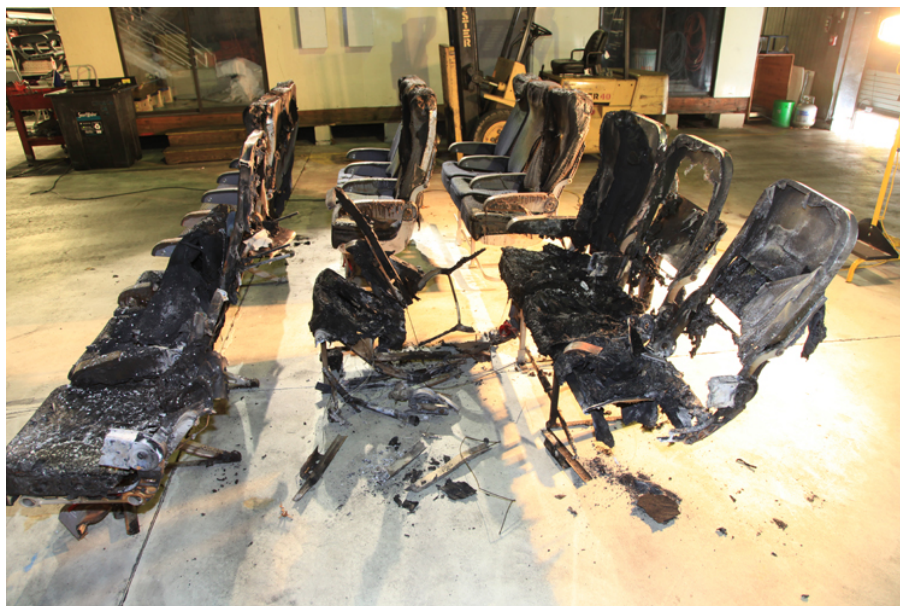
Figure 112. The AZ-31 Magnesium Alloy Seats on the Test Facility Floor

The seats were carefully removed from the test fuselage and placed on the test facility floor for further inspection. After removing some of the melted cushioning and dress cover, it was clear that a significant amount of AZ-31 magnesium alloy from the portside row 2 seat was involved in the fire because the remaining structure showed signs of ignition (figure 112). Additional pieces of magnesium alloy recovered from the vicinity of this seat assembly also showed signs of burning. A tedious inspection of the remaining parts revealed signs of burning magnesium alloy, which corroborated the video coverage during the observation period, in which several pockets of intense light were observed.

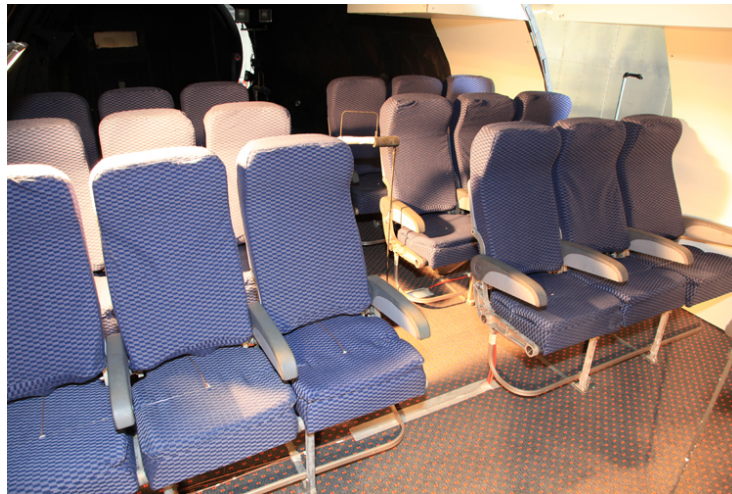
Figure 121. The WE-43 Test Configuration With Additional Magnesium Alloy Components

Once the machined WE-43 primary components were received and the fabricated seatback frame and baggage bars were completed, the seat structures were assembled. The newly fabricated WE-43 seatback assemblies were identical in size to those used in Baseline Test 3 and previous magnesium alloy tests. The completed assemblies were then installed in the test fuselage, and the thermocouples were installed on the leg frames, as in the previous tests. All other instrumentation was checked prior to conducting the test (figures 121 and 122).

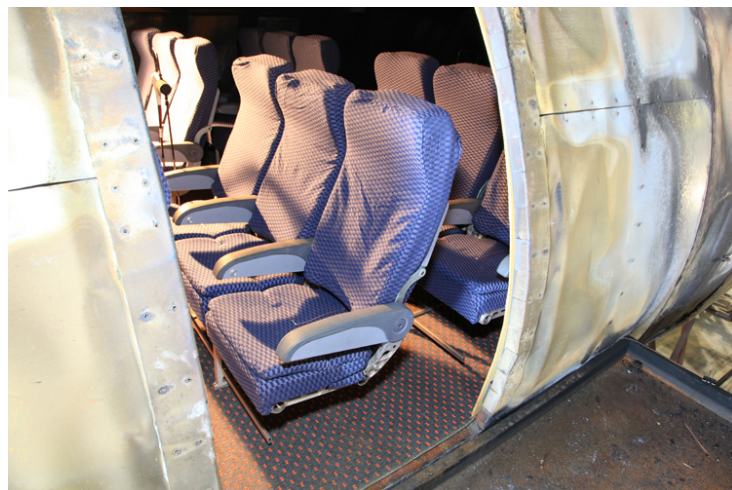
Figure 122. The WE-43 Test Configuration With Additional Magnesium Alloy Components Viewed Through the Fire Opening

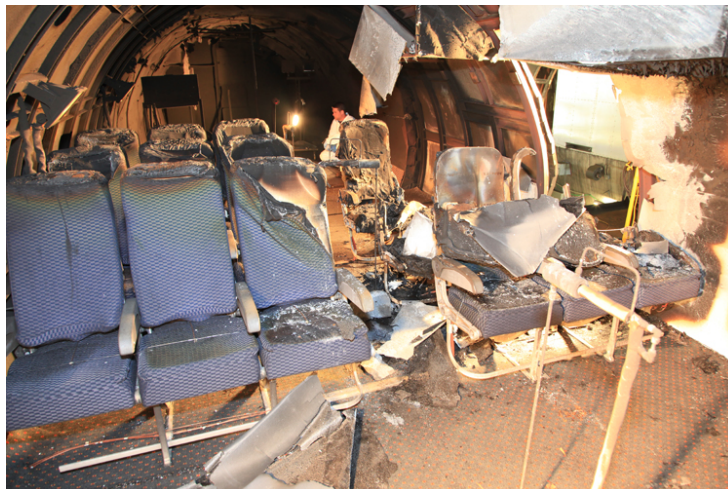
Figure 123. The WE-43 Test With Additional Magnesium Alloy Components, Posttest

A posttest inspection revealed a number of the portside seatbacks were totally consumed, including the magnesium frames (figure 123). As in the previous test, the portside row 2 seat assembly sustained extensive fire damage, with evidence of substantial melting of the magnesium alloy seatback frames. The remaining portions of these components fell aftward onto the row 3 seat (figures 124 and 125). Although the fire had severely impacted this seat assembly, the portside row 1 seat assembly still contained a visible seatback, as well as a partial seatback frame at the middle seat place. This result was nearly identical to the previous test. It was again difficult to determine how much of the row 2 seat assembly damage was from the initial fuel fire or from the subsequent fire during the observation period.

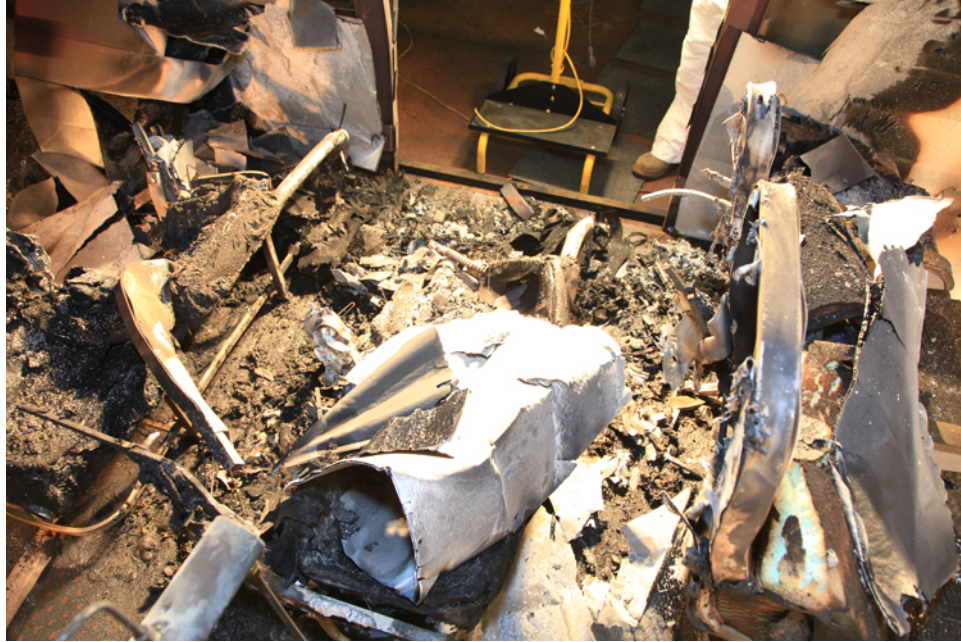
Figure 124. The WE-43 Test With Additional Magnesium Alloy Components, Row 2 Seat

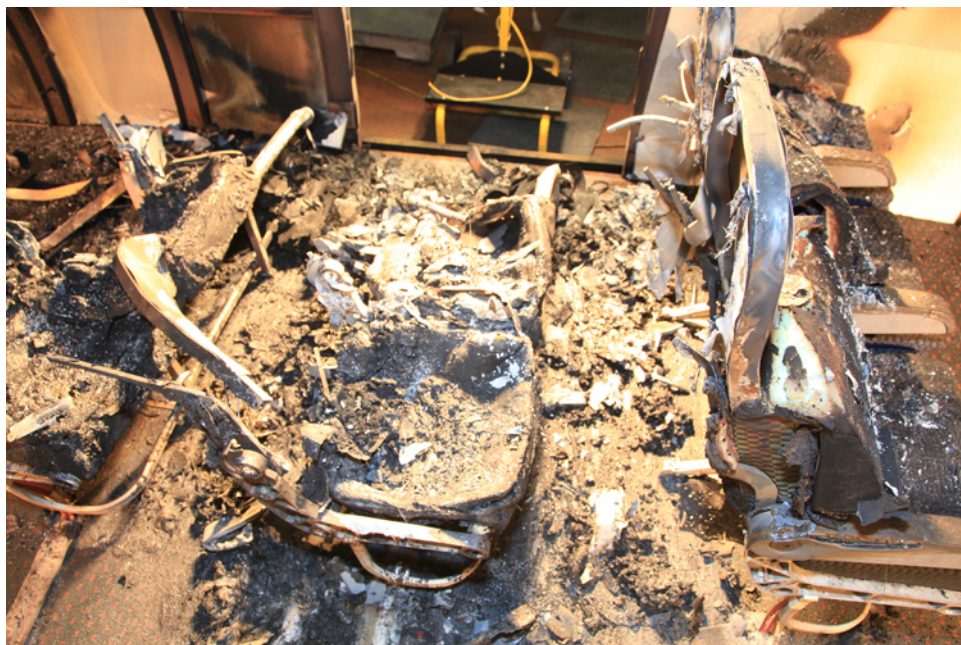
Figure 125. Close-Up of Portside Row 2 Seat (Ceiling Panel Removed)

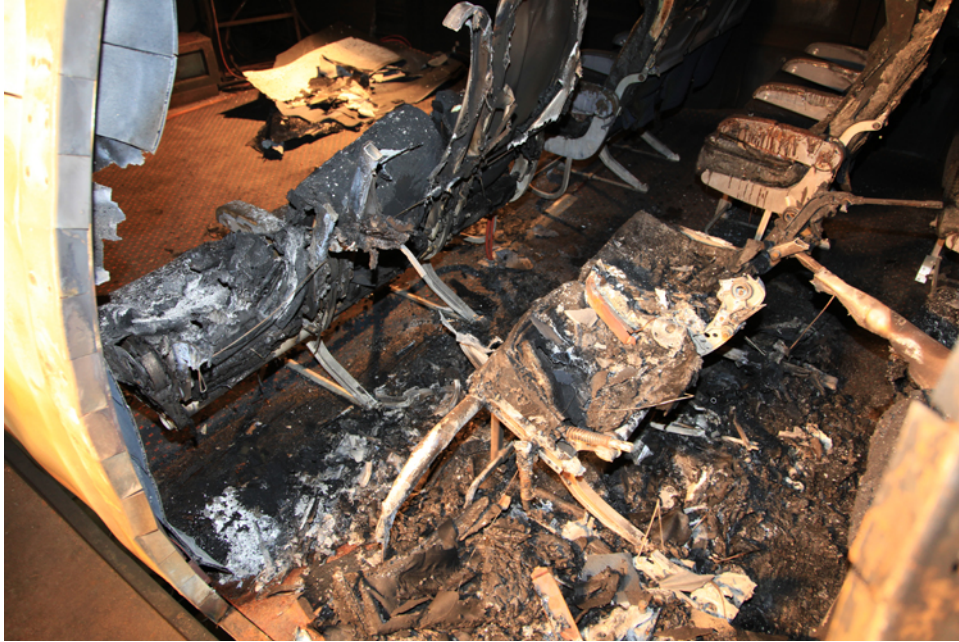
Figure 126. View of Row 1 and Row 2 Seat Assemblies Through Fire Opening

Several additional photographs were taken of the portside seat frames through the fire opening. It appears the fire entered the opening and caused the majority of the damage to the row 2 and row 3 seats, and left the seat structure from row 1 largely intact (figures 126 and 127).

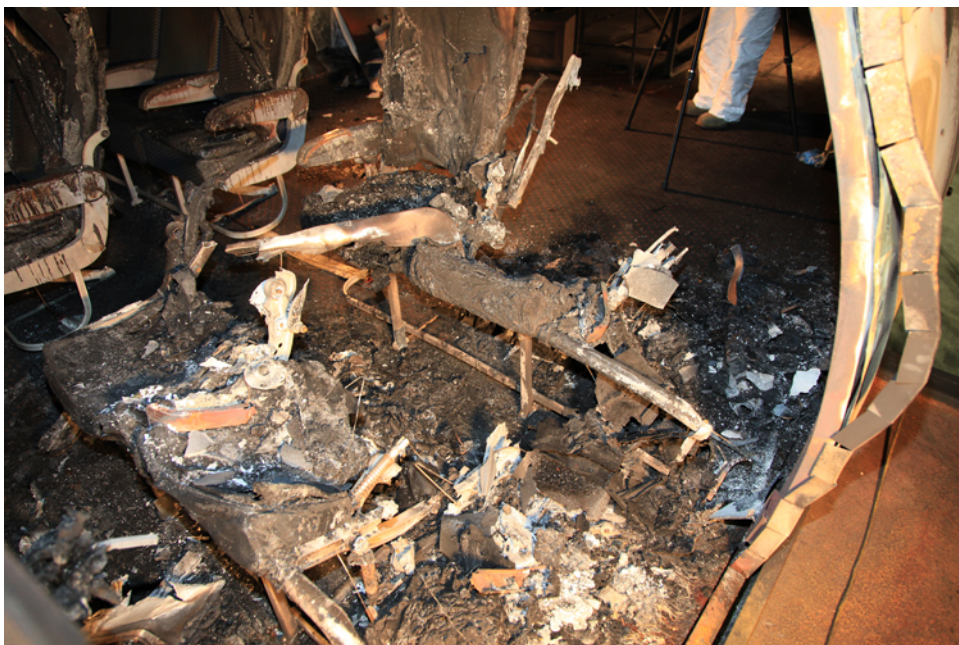
Figure 127. View of Row 2 and Row 3 Seat Assemblies Through Fire Opening

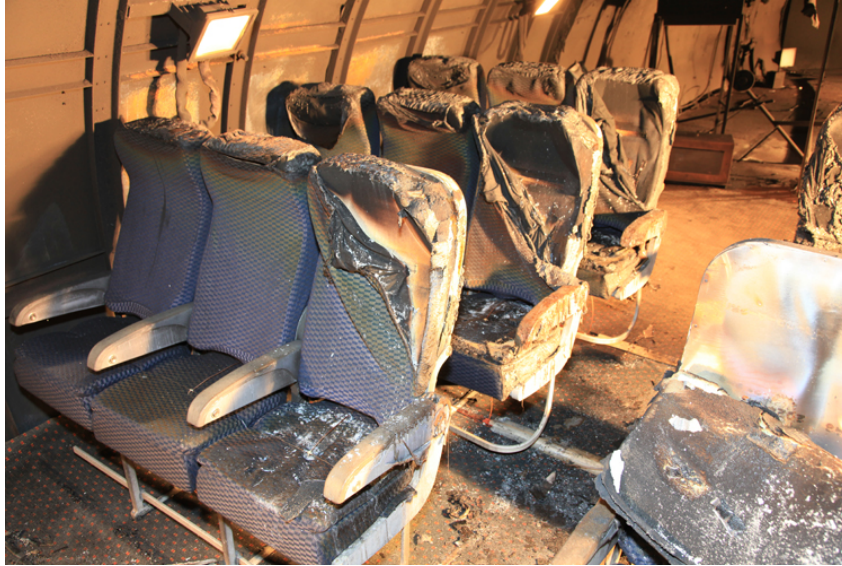
Figure 128. Forward View of Starboard-Side Seat Assemblies

Although the damage to the portside seat assemblies was extensive, the starboard-side seats were relatively intact, with charring of the fabric dress covers on all aisle-side seats (figure 128).

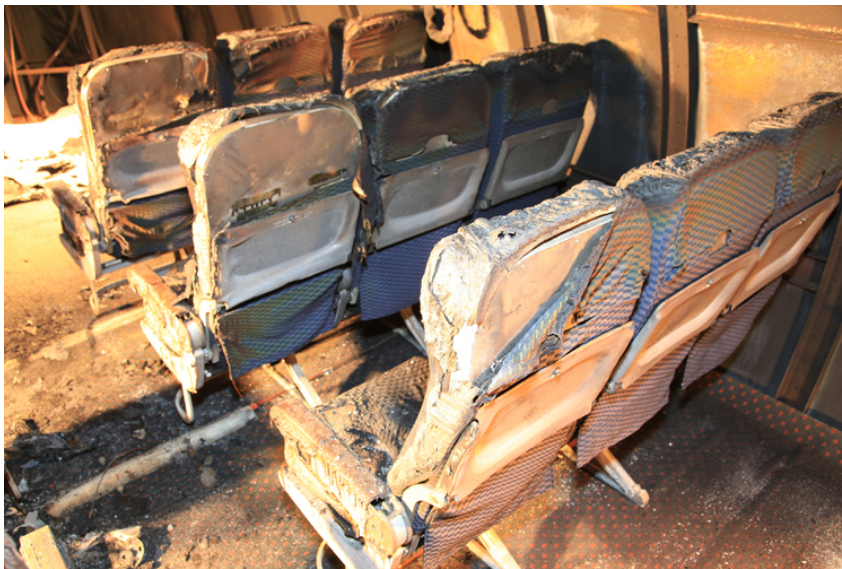
Figure 129. Aft View of Starboard-Side Seat Assemblies

An aft view of the starboard-side seats (figure 129) shows that all thermoplastic tray tables were still in place, although the aisle seat tray tables showed signs of melting.

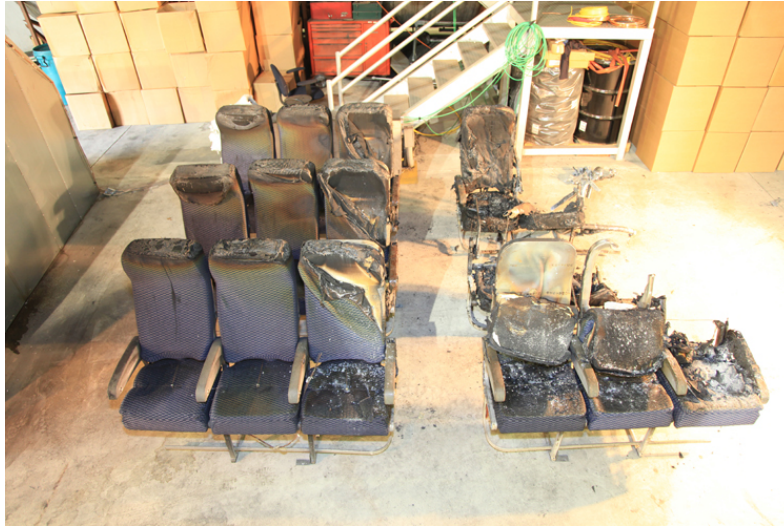
Figure 130. The WE-43 Test With Additional Magnesium Alloy Components, Seats Placed on the Test Facility Floor

The seats were carefully removed from the test fuselage and placed on the test facility floor for further inspection (figure 130). After removing most of the remaining melted cushioning and dress cover, it was clear that a significant amount of WE-43 magnesium alloy from the portside row 2 seat was involved in the fire. The primary component damage from the row 2 seat included both cross tubes, the outermost spreaders (2), and portions of the outer leg assembly. For the row 3 seat, the damage included both cross tubes and two outermost spreaders. In addition, all but one of the seatback frames from the row 2 and 3 seat assemblies were

completely melted. Additional pieces of magnesium alloy recovered from the vicinity of these two seat assemblies also showed signs of burning. An inspection of the remaining parts attached to the seat assemblies revealed characteristic signs of minor magnesium alloy burning, which corroborated the video coverage of several light bursts during the observation period.

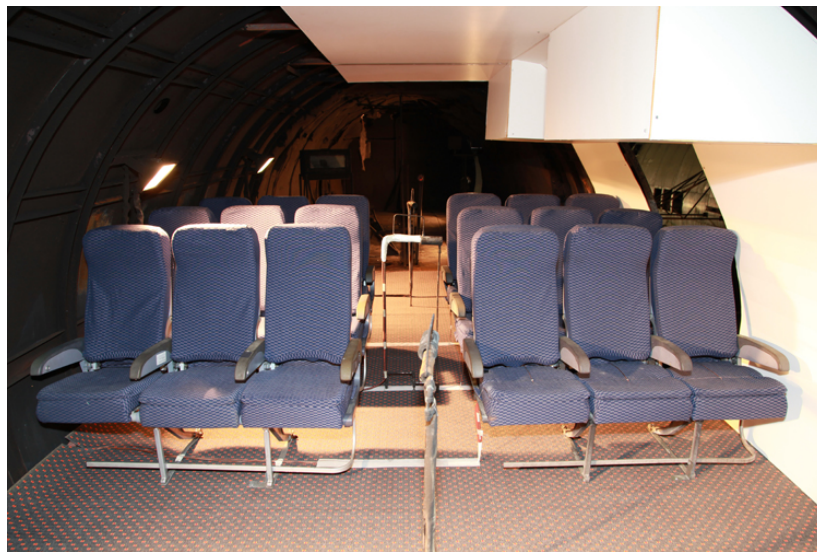
Figure 131. Starboard Seats on Port Side of Test Fuselage (Repeat Test)

All starboard-side seats containing WE-43 components from the previous test were stripped of their cushion materials, thoroughly cleaned, inspected, and outfitted with new cushion and dress cover materials. These seats were then positioned in the port side of the test fuselage, which contained the typical arrangement of honeycomb sidewall and ceiling panels, honeycomb stowage bins, and carpeting. The seat frames were outfitted with the typical array of thermocouples installed in the seat leg components. Following this, the original B/E 990 seats with FAA-fabricated aluminum seatback assemblies were installed on the starboard side of the test fuselage. All other instrumentation was checked prior to the test (figure 131).

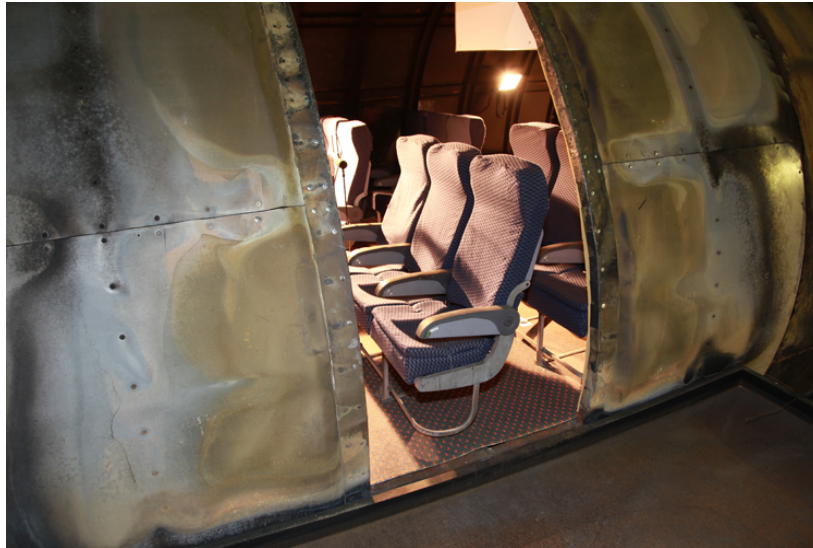
Figure 132. Starboard-Side Seat Assembly in Fire Opening, With Curved Baggage Bar
(Repeat Test)

Although the seats positioned in the port side of the test fuselage contained flat spreaders on the outboard side of the seat, the seats were able to be positioned up against the sidewall fairly close with no significant issues. The seat positioned in the fire opening now had the curved portion of the baggage bar exposed to the fire, thus exposing an additional, small and likely insignificant, amount of magnesium alloy (figure 132).

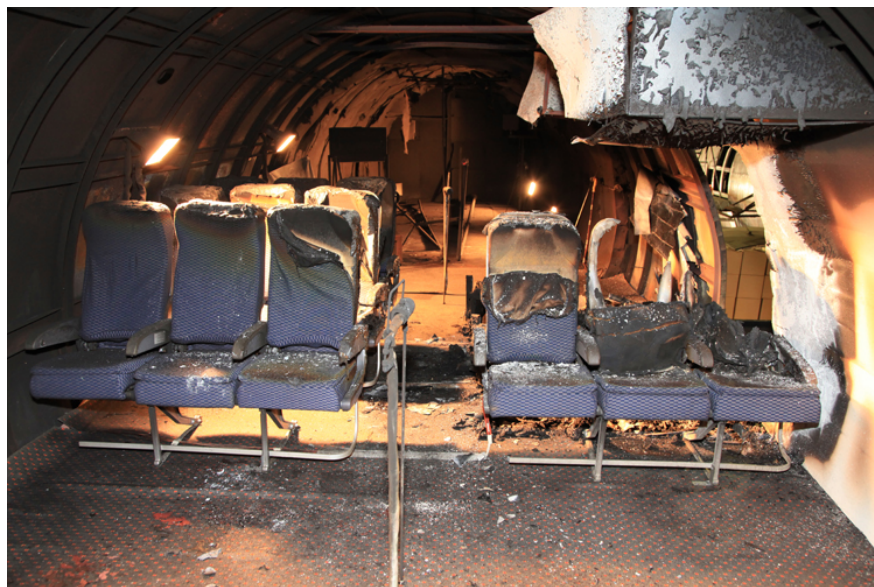
Figure 133. The WE-43 Repeat Test With Additional Magnesium Alloy Components, Posttest

A posttest inspection revealed a number of the portside seatbacks were totally consumed, including the magnesium frames (figure 133). As in the AZ-31 test, the portside row 2 seat assembly sustained extensive fire damage, with evidence of substantial melting of the row 2 and row 3 magnesium alloy seatback frames. The remaining portions of these assemblies had fallen aftward onto the row 3 seat (figures 134 and 135). It appeared that the cross tubes on both the row 2 and row 3 seats had melted, allowing a collapse of a majority of the seat structure (figure 136). Although the fire had severely impacted these seat assemblies, the portside row 1 seat assembly still contained a visible seatback, as well as a partial seatback frame in the middle seat place. This result was nearly identical to the AZ-31 test. It was again difficult to determine how much of the row 2 and row 3 seat assembly damage was from the initial fuel fire or from the subsequent interior fire during the observation period.

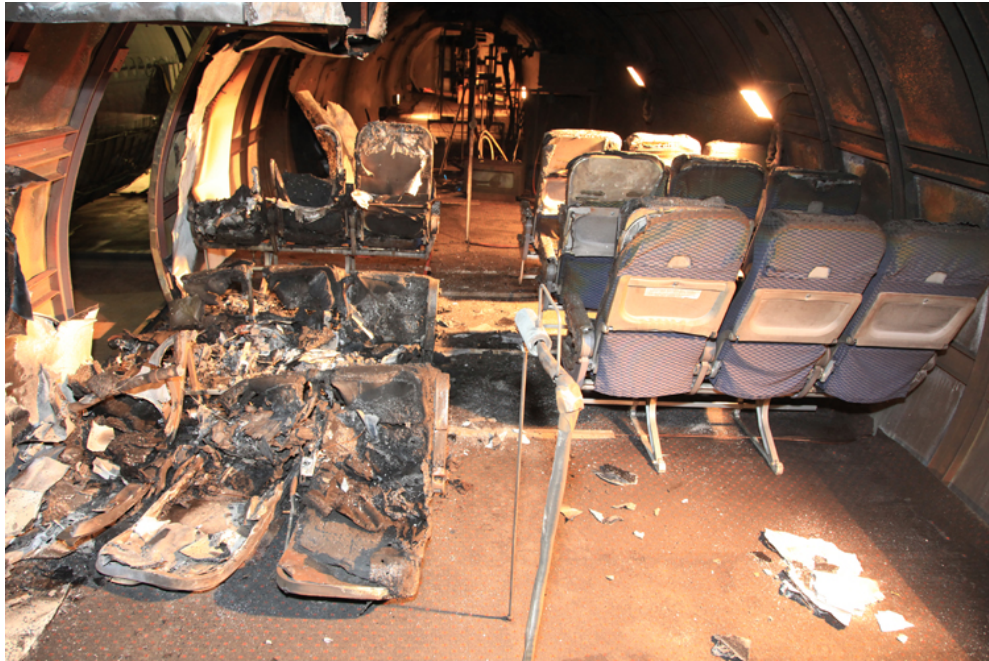
Figure 134. The WE-43 Repeat Test With Additional Magnesium Alloy Components, Aft View

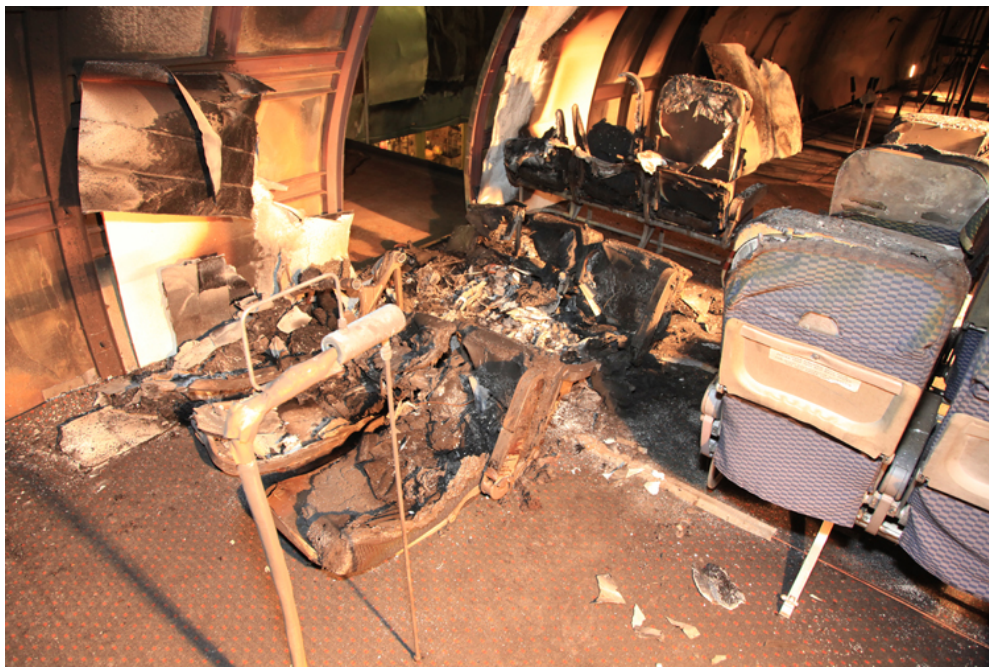
Figure 135. The WE-43 Repeat Test With Additional Magnesium Alloy Components, View of Portside Seats

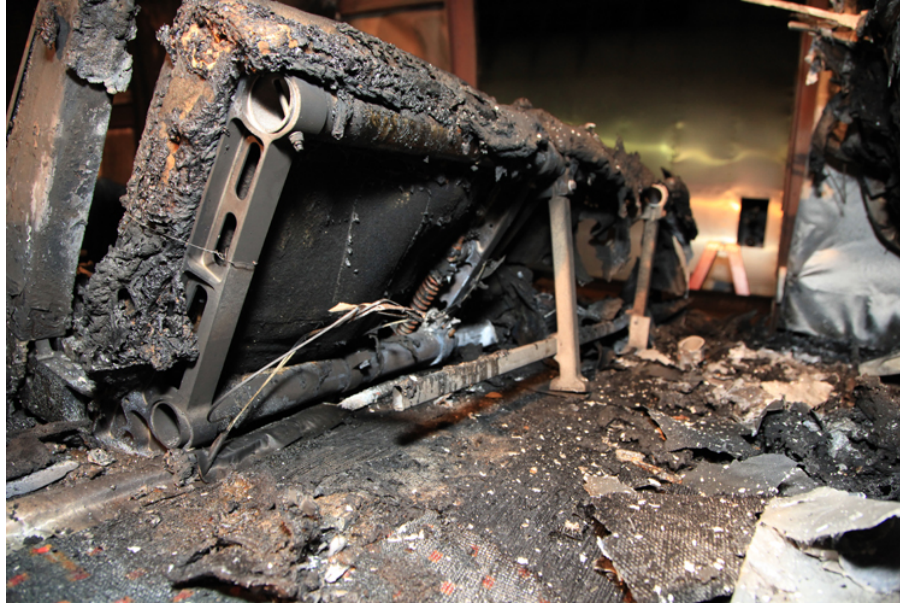
Figure 136. The WE-43 Repeat Test With Additional Magnesium Alloy Components, Close-Up of Portside Row 2 Seat Structure

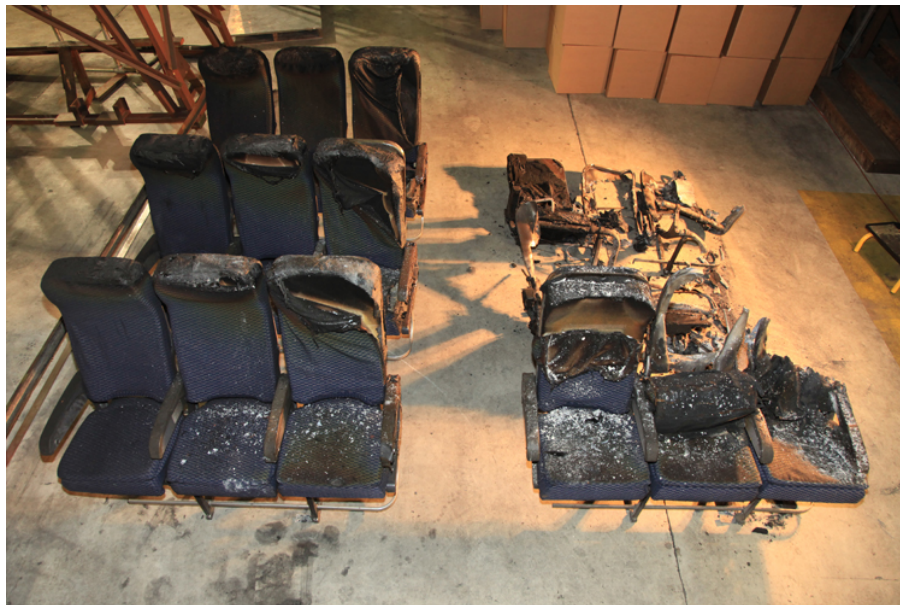
Figure 137. The WE-43 Repeat Test With Additional Magnesium Alloy Components, Seats on the Test Facility Floor

As standard practice, the seats were carefully removed from the test fuselage and placed on the test facility floor for further observation and documentation (figure 137). Once the seats were repositioned as they had been in the cabin, the damage pattern was observed to be similar to the previous test in which the portside row 2 and row 3 seat assemblies sustained the majority of the fire damage.

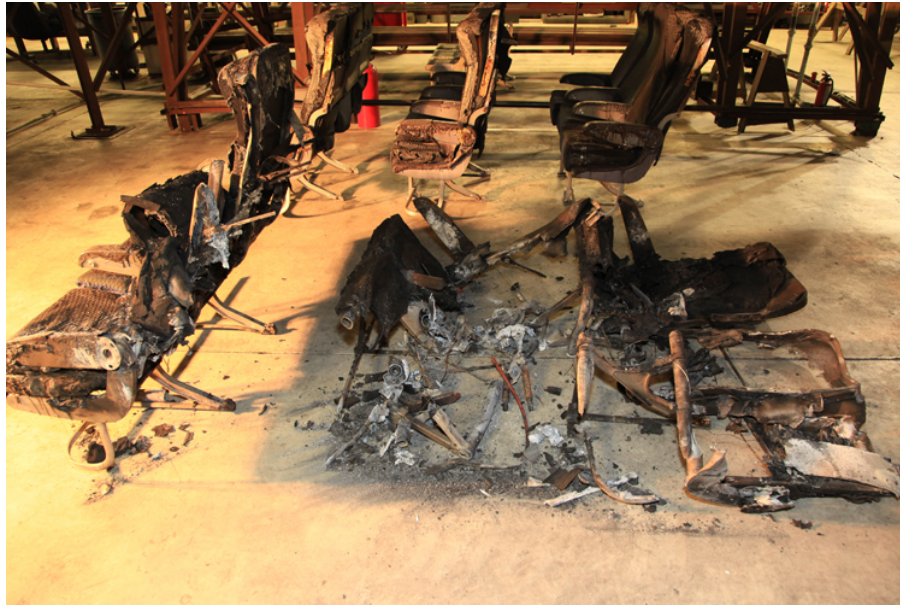
Figure 138. The WE-43 Repeat Test With Additional Magnesium Alloy Components, Damage to Portside Seat Assemblies

An inspection of the portside row 2 and row 3 seats revealed extensive melting and burning of the cross tubes and spreaders (figure 138). The damage indicated the possibility that the row 2 seat assembly collapsed rearward following melting/burning of the cross tube component, thereby igniting the row 3 seat assembly from below, and perhaps aiding in the melting of the row 3 seat cross tube components.

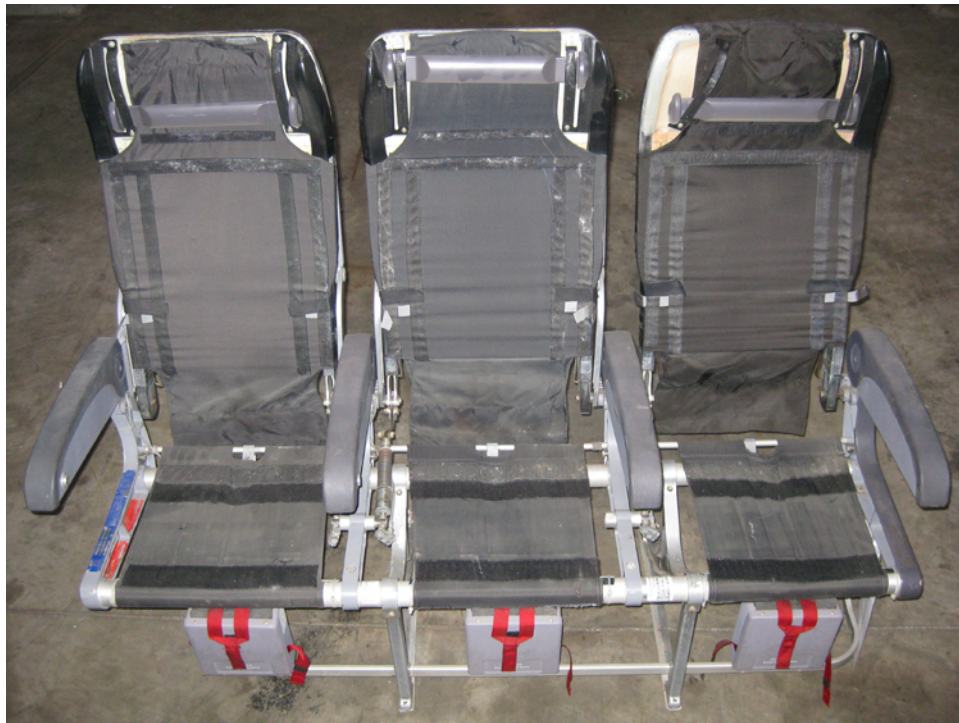
Figure A-1. The B/E 990 Standard Seat Components

The two initial full-scale baseline tests determined the flammability of the seatback assembly of the B/E Aerospace (B/E) 990 seats was poor. The seatback assembly was an atypical design, using a frame constructed of an epoxy-impregnated carbon fiber unidirectional tape with thermoplastic components in the headrest area. In addition, there was no metallic or aluminum support pan, but rather a nylon fabric that stretched across the frame to act as a suspension (figure A-1). The back cushion was very thin with minimal foam and appeared to contain a fiberfill material in place of the typical urethane foam.

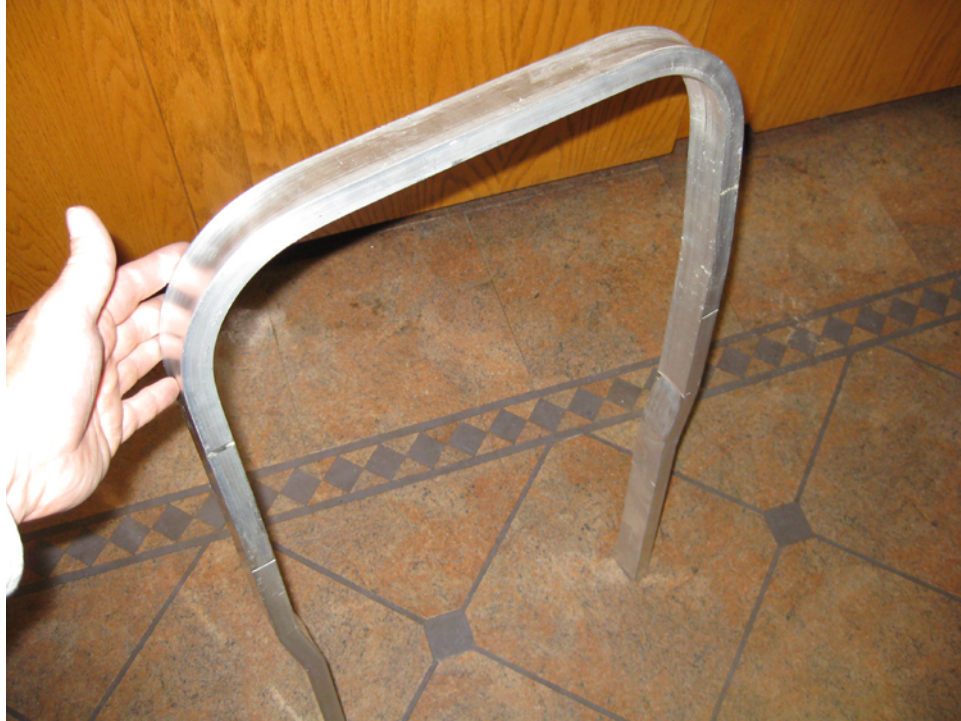
Figure A-2. Aluminum Seatframe Used in Alternate Seatback Assembly

During the two baseline tests, the seatback assembly became involved in the fire very early in the test sequence, contributing to a rapid flashover event in which the conditions became nonsurvivable very quickly. It was agreed that under these conditions, it would be difficult to accurately measure the contribution of the magnesium components used in the seatframe during subsequent tests. For this reason, an alternate seatback was designed to fit the B/E 990 seat assembly. The alternate design used an aluminum frame and a fire-hardened foam cushion in place of the existing materials (figures A-2 through A-5).
