DOT/FAA/AR-11/3

Evaluating the Flammability of Various Magnesium Alloys During Laboratory- and Full-Scale Aircraft Fire Tests

Timothy R. Marker

Final Report

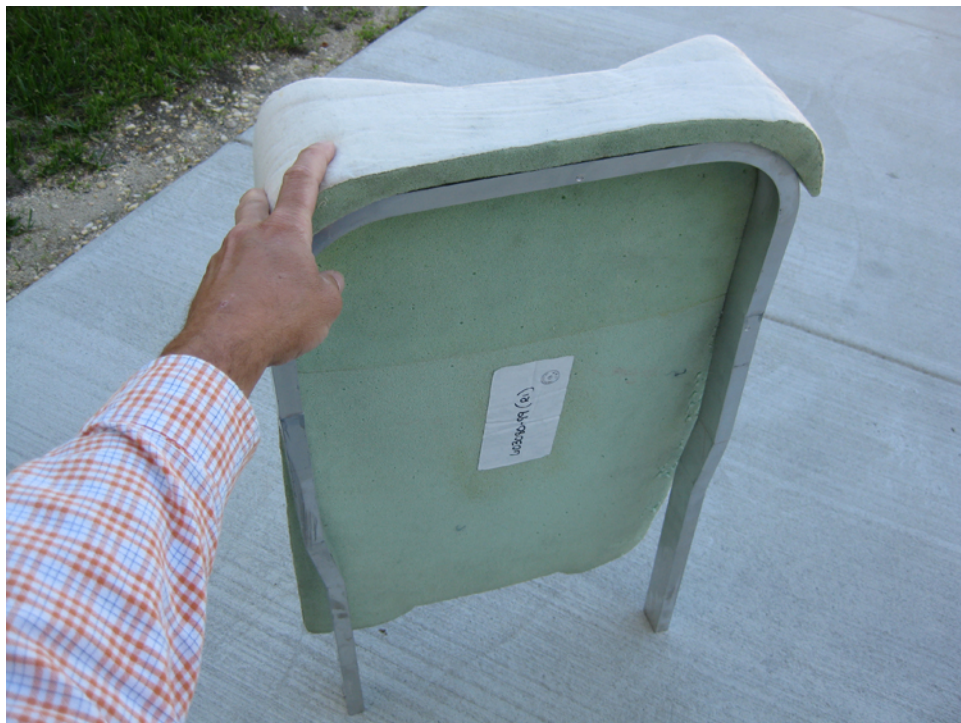
Figure A-3. Fire-Hardened Foam Used in Alternate Seatback Assembly

During the two baseline tests, the seatback assembly became involved in the fire very early in the test sequence, contributing to a rapid flashover event in which the conditions became nonsurvivable very quickly. It was agreed that under these conditions, it would be difficult to accurately measure the contribution of the magnesium components used in the seatframe during subsequent tests. For this reason, an alternate seatback was designed to fit the B/E 990 seat assembly. The alternate design used an aluminum frame and a fire-hardened foam cushion in place of the existing materials (figures A-2 through A-5).

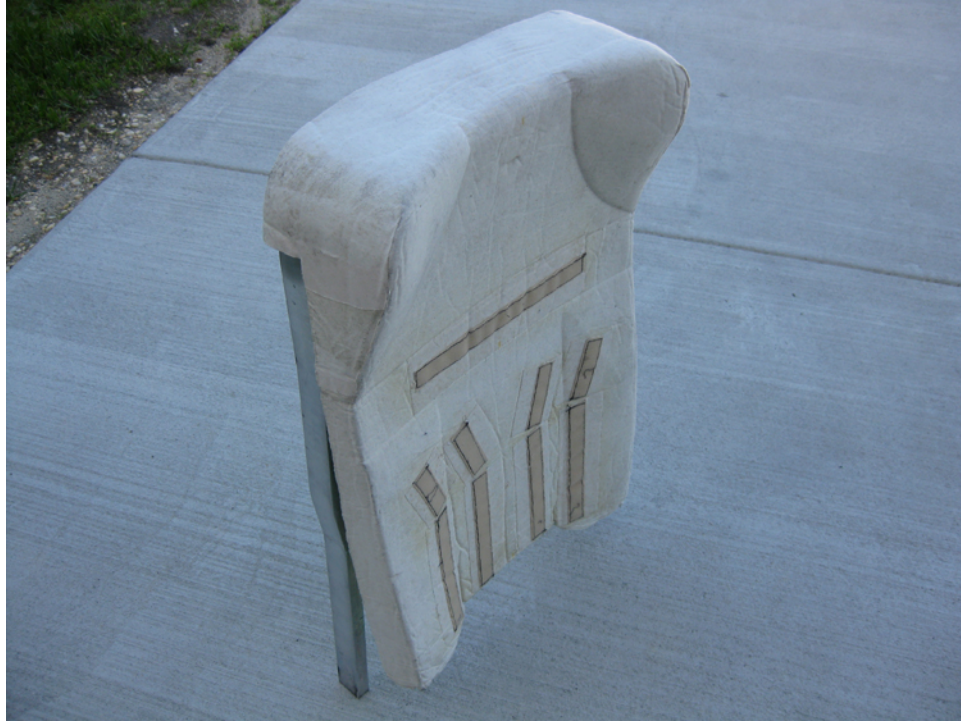
Figure A-4. Front View of Fire-Hardened Foam Used in Alternate Seatback Assembly

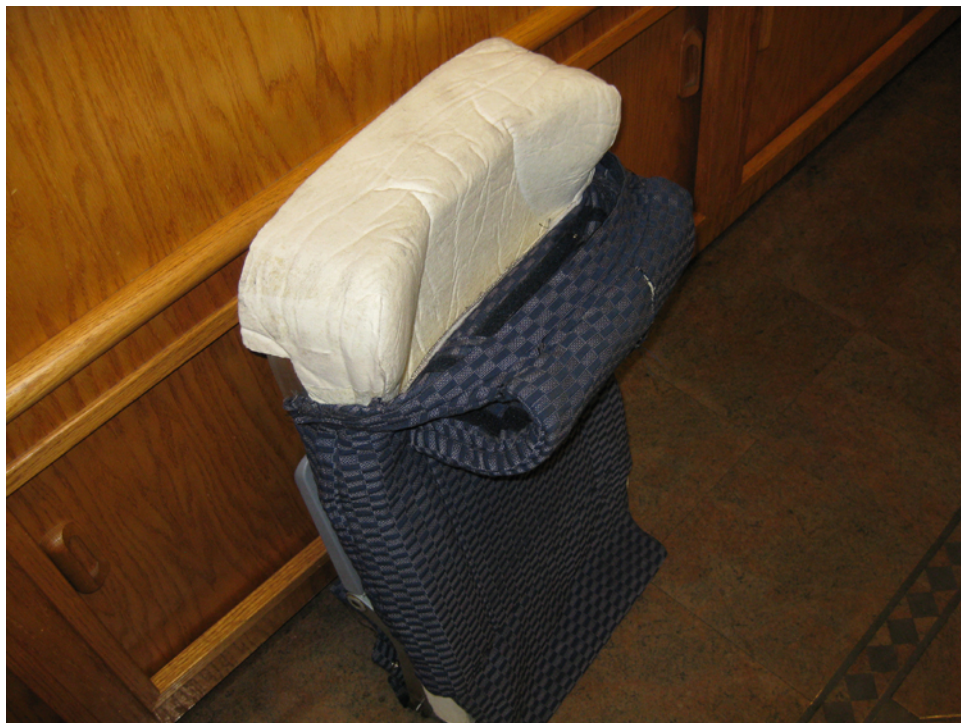
Figure A-5. Front View of Dress Cover Used in Alternate Seatback Assembly

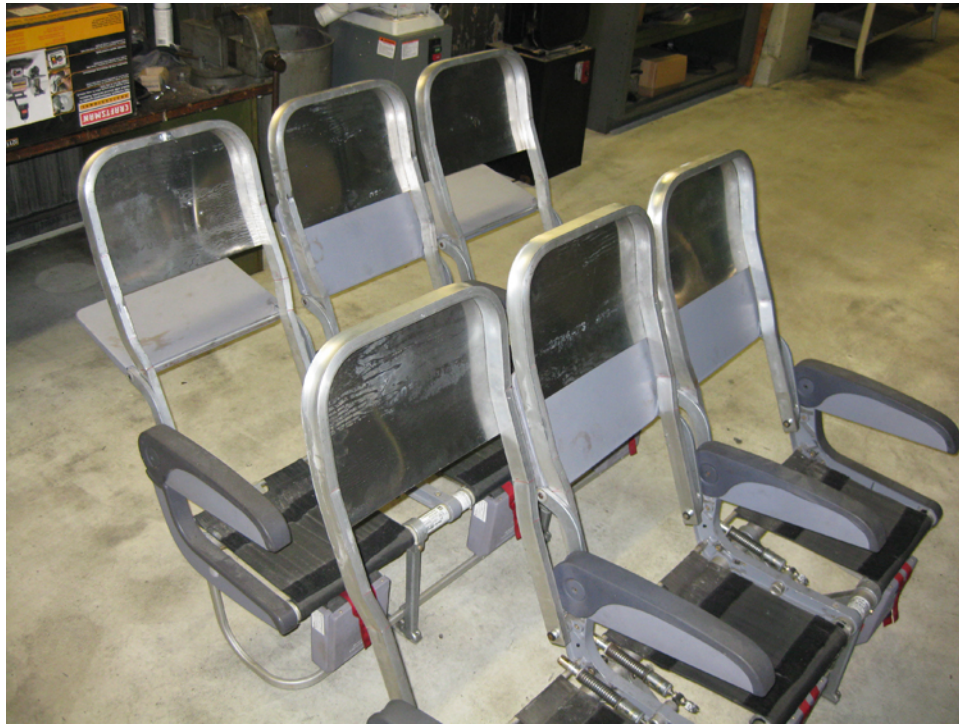
Figure A-6. Fabrication of Seat Assemblies Using Alternate Seatbacks

Additional details were designed and fabricated for use in the alternate seatback assembly, including front and back pan structures used to strengthen the frame. The completed seatback frames were then mass-produced and mounted to the B/E 990 triple coach seat lower frames (figure A-6). Components such as the tray tables and arms, as well as the map pockets were all retained from the original B/E 990 s eatback frames and incorporated into the alternate assemblies.

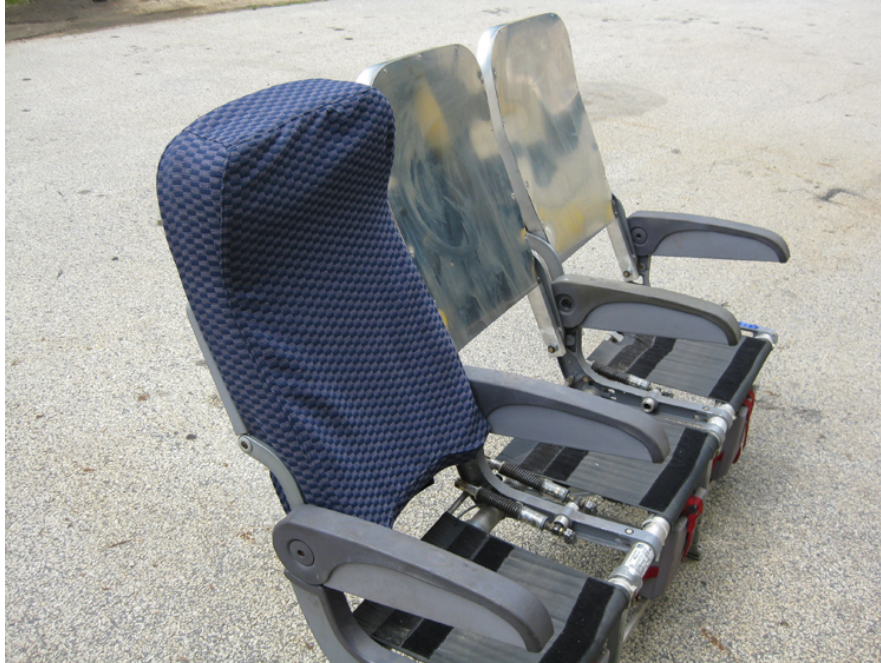
Figure A-7. Partially Completed Seat Assemblies Showing Front Pan Structure

The forward pan structure was then fabricated and installed on the back frames, and the final assembly involved mounting the foam cushioning and dress cover materials (figure A-7).

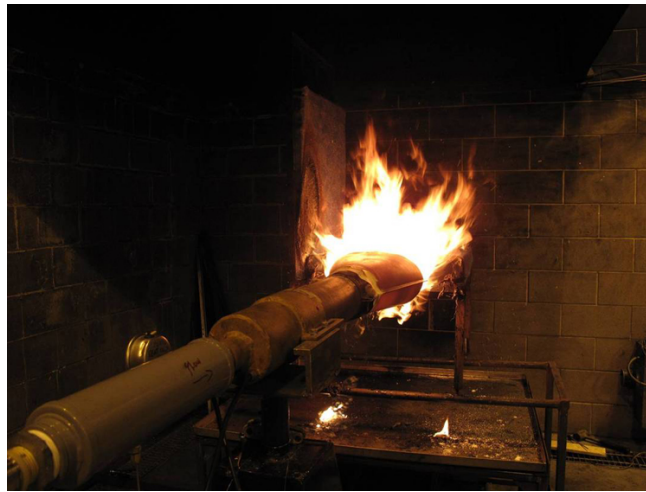
Figure A-8. Baseline Test 3 Cushion Sample During Laboratory Test (typical)

Prior to conducting the tests, the burner equipment was calibrated to ensure the output was within acceptable limits. Following the required 2-minute burner warm-up, the Baseline Test 3 sample cushions were rolled in front of the burner flames. The test requirement calls for a 2-minute exposure of the seat cushion materials to the burner flame. During the test, the burner flames were largely confined to the surface of the bottom cushion and did not rapidly spread to the back cushion (figure A-8). This result confirmed the superior performance of this cushion

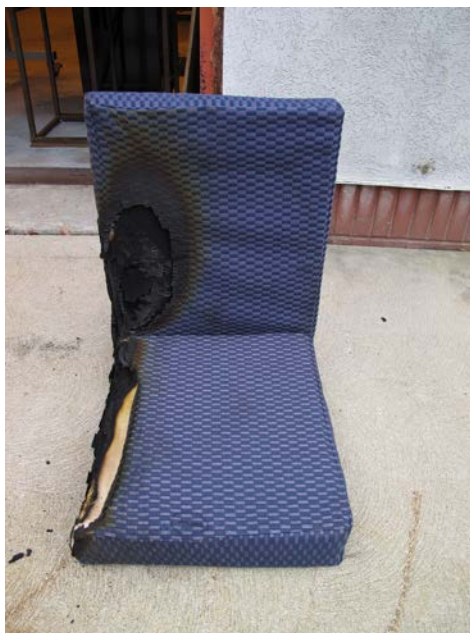
Figure A-9. Baseline Test 3 Standard Cushion Sample 1

The tested samples were removed from the test apparatus and placed on the test facility floor for photographs (figures A-9 through A-11).

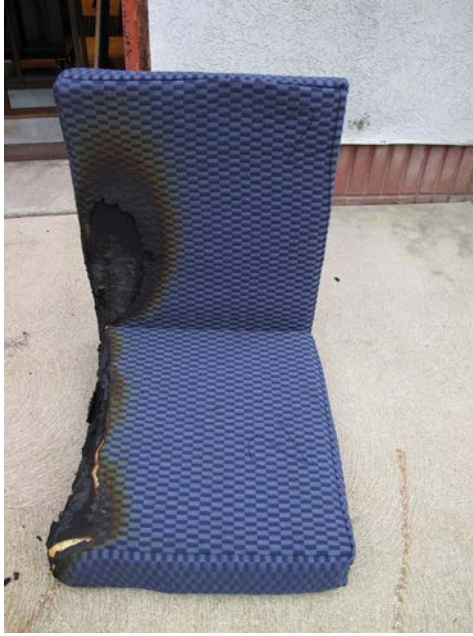
Figure A-10. Baseline Test 3 Standard Cushion Sample 2

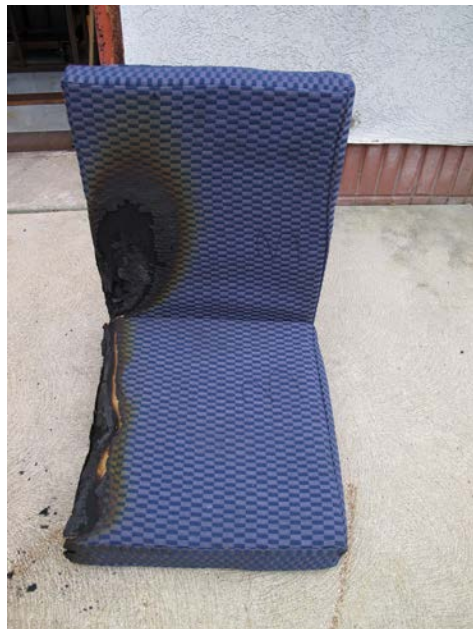
Figure A-11. Baseline Test 3 Standard Cushion Sample 3

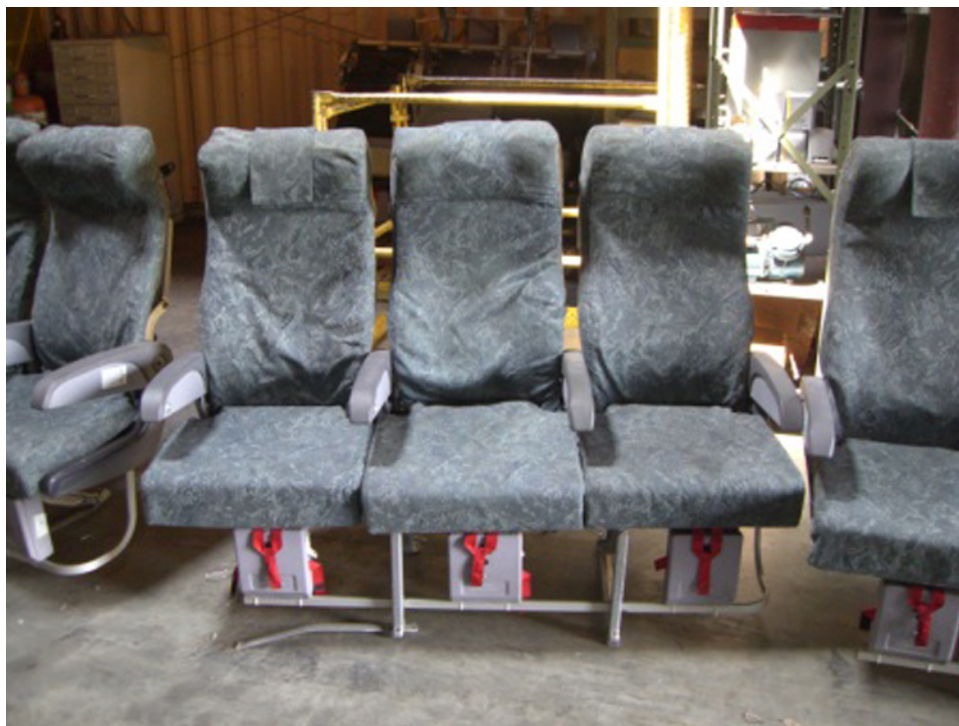
Figure B-1. Baseline Test 1 Triple Coach Seat With Olive-Colored Dress Cover

Surplus triple coach seats were purchased for conducting full-scale tests (figure B-1). The initial full-scale baseline test determined the flammability performance of the seats, which were constructed of standard, aluminum alloy primary seat components. Subsequent full-scale tests determined the performance of the seats when magnesium alloy was substituted in place of the aluminum alloy used in the primary components.

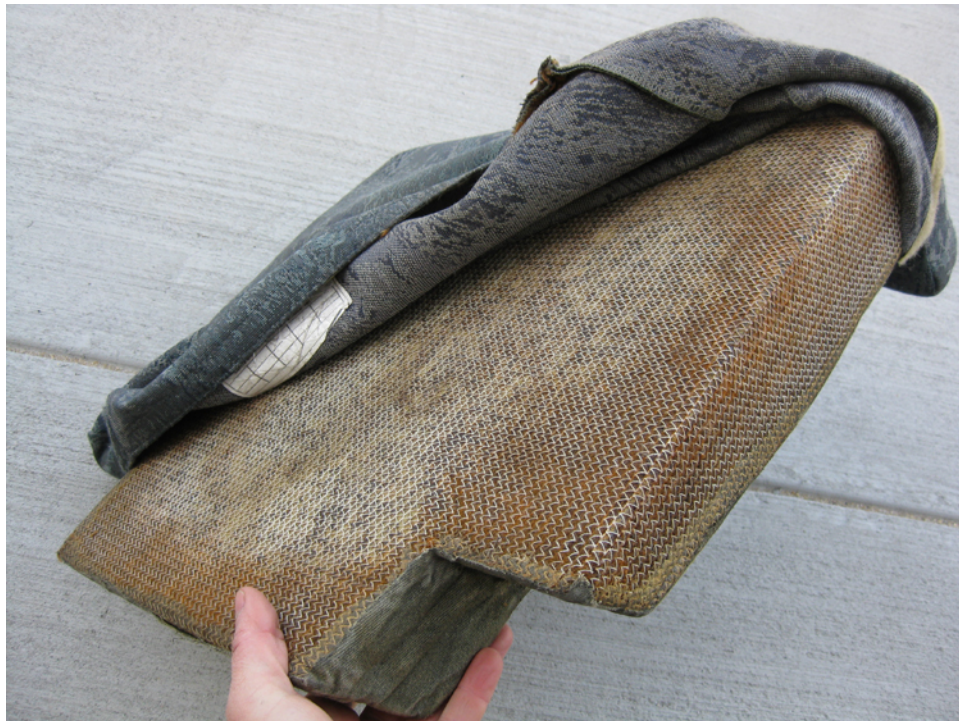
Figure B-3. Baseline Test 1 Bottom Seat Cushion (style 1) Revealing
No Fire-Blocking Layer

An inspection of the triple coach seat cushion materials used in the Baseline 1 full-scale test revealed that three different styles of bottom cushions were supplied. One style contained no obvious fire-blocking layer material (figures B-2 and B-3). Although no fire-blocking layer was observed, it was assumed that this particular seat cushion foam was a fire-hardened type, precluding the need for an additional fire-blocking layer. Another style used a fire-blocking layer with original B/E Aerospace labeling on the material (figures B-4 through B-6). A third style of seat cushion was also discovered, which used a fire-blocking layer manufactured by Franklin Products (figures B-7 through B-9).

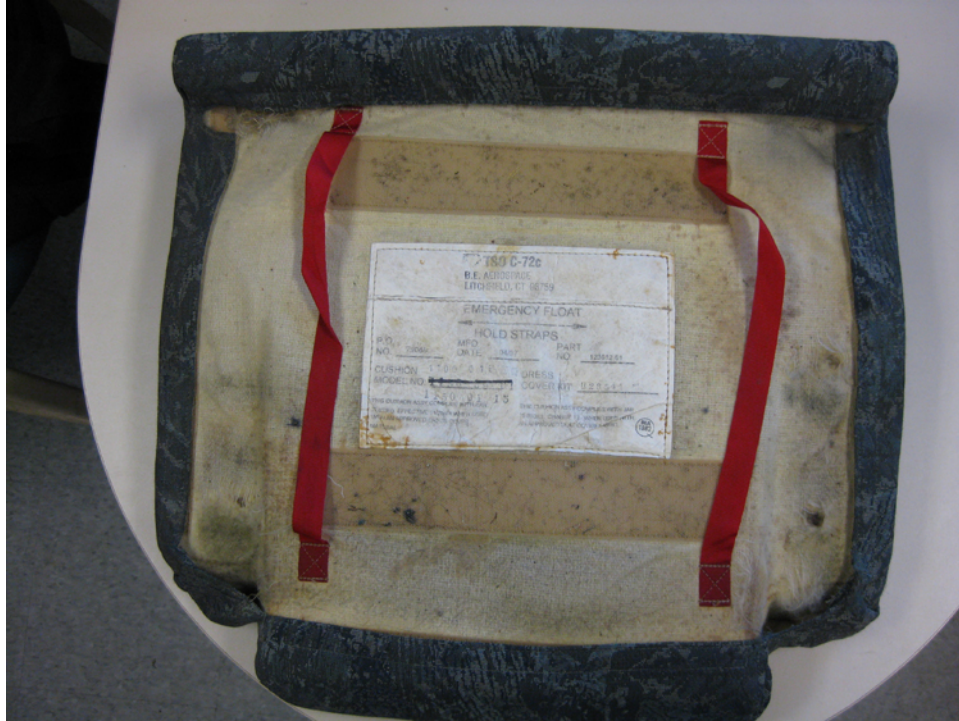
Figure B-4. Bottom View of Baseline Test 1 Bottom Seat Cushion With B/E Aerospace Fire-Blocking Layer

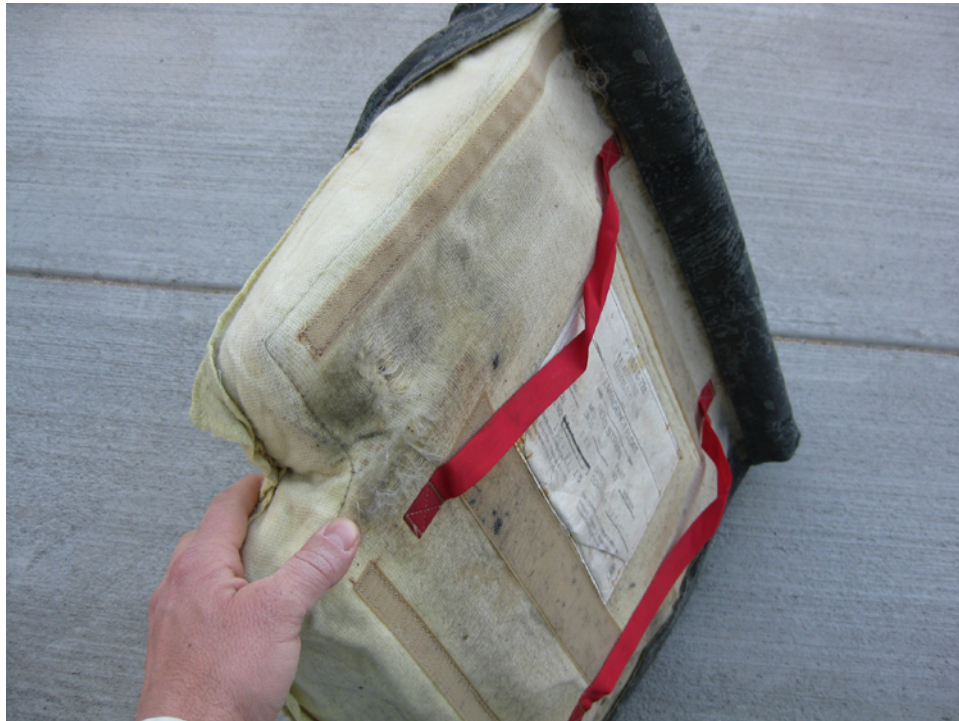
Figure B-5. Side View of Baseline Test 1 Bottom Seat Cushion With B/E Aerospace Fire-Blocking Layer

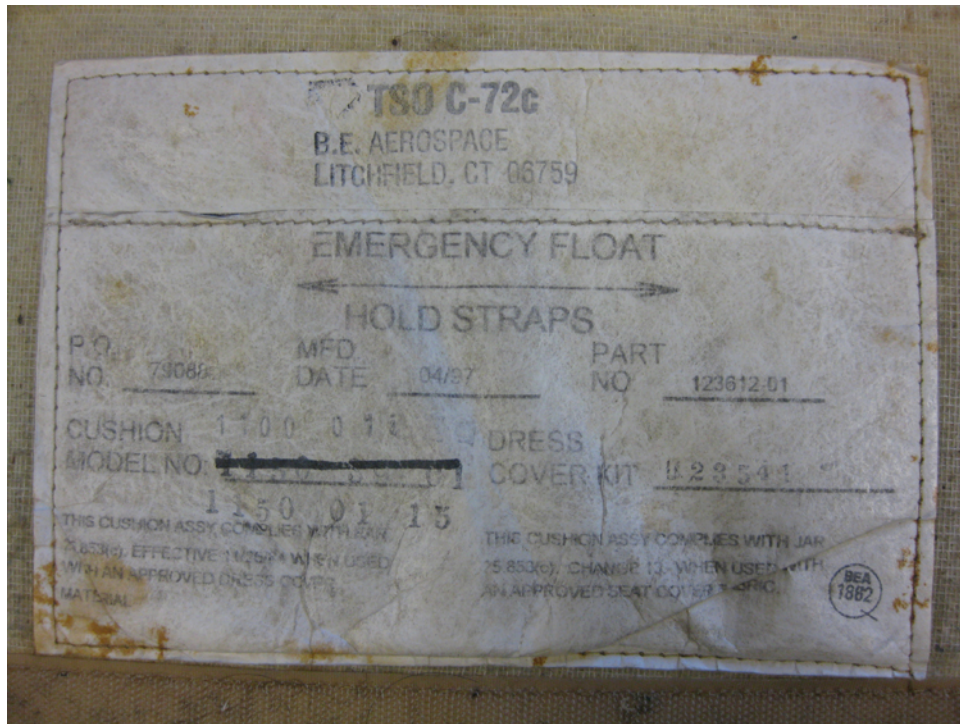
Figure B-6. Close-Up of Baseline Test 1 Bottom Seat Cushion With B/E Aerospace Fire-Blocking Layer

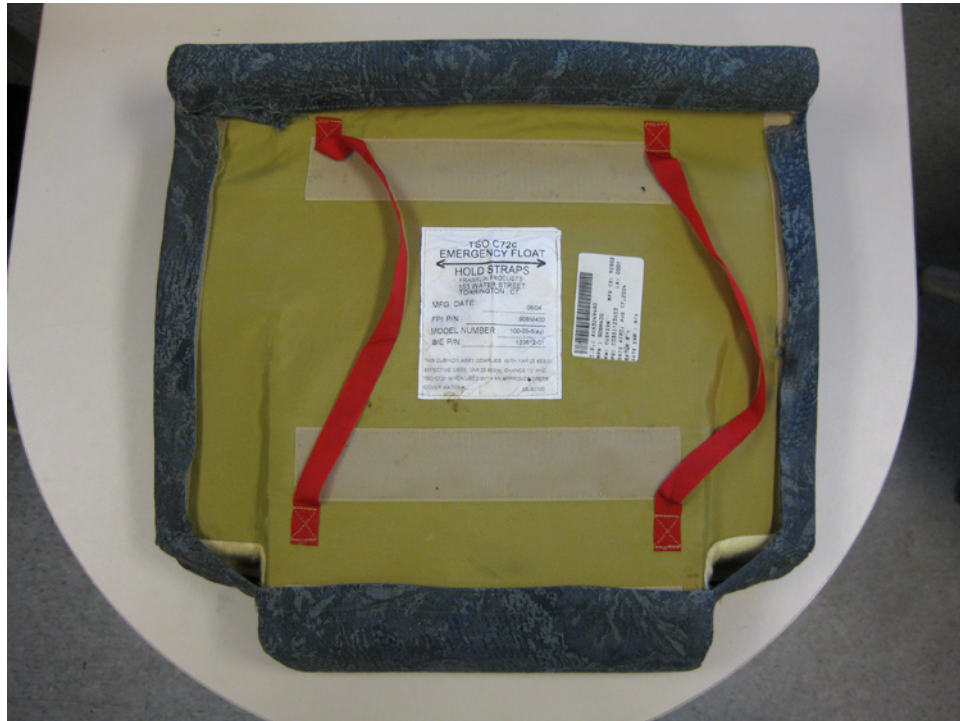
Figure B-7. Baseline Test 1 Bottom Seat Cushion With Franklin Products Fire-Blocking Layer

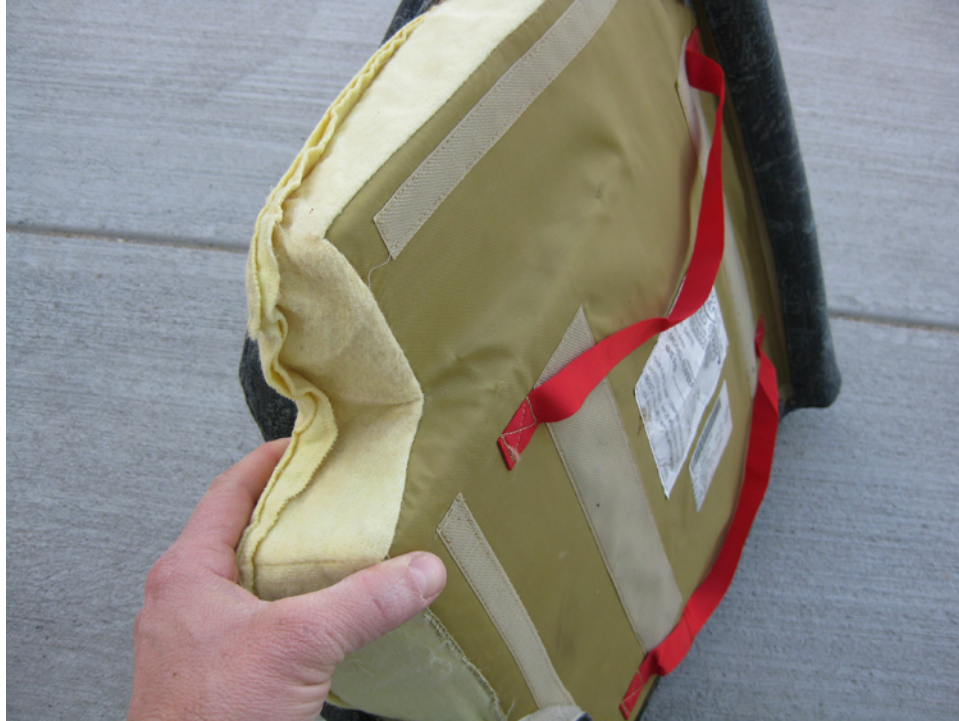
Figure B-8. Side View of Baseline Test 1 Bottom Seat Cushion With Franklin Products Fire-Blocking Layer

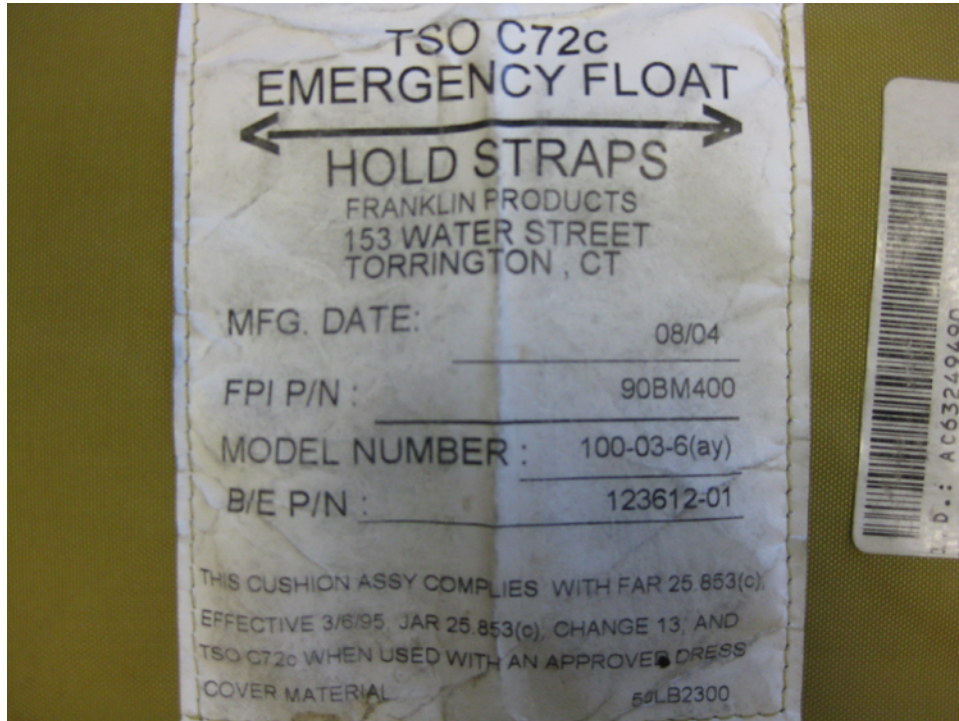
Figure B-9. Close-Up of Baseline Test 1 Bottom Seat Cushion With Franklin Products Fire-Blocking Layer and Label

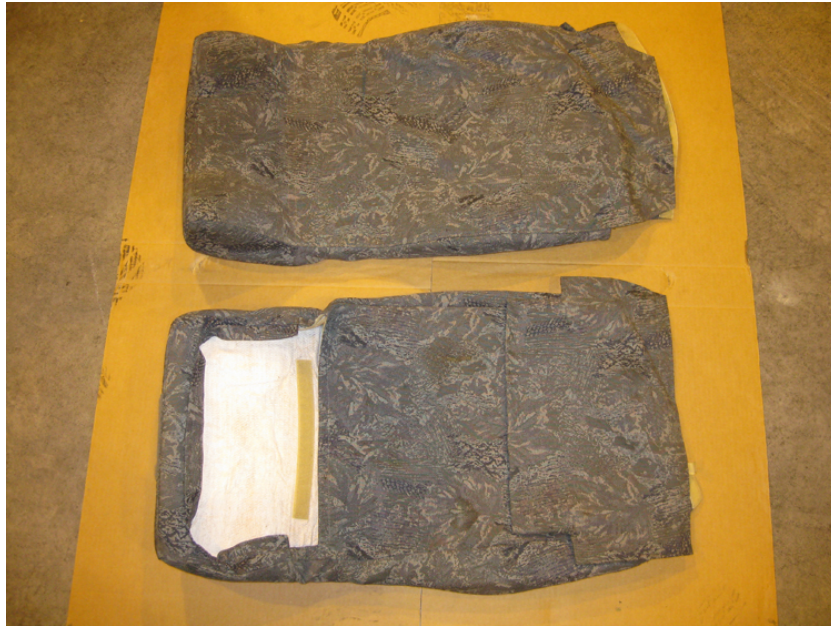
Figure B-10. Baseline Test 1 Back Cushion Containing Fiberfill Material

The cushion back materials used in the Baseline 1 full-scale test were also inspected, revealing the entire seatback system was not a typical design. The frame was constructed of an epoxy-impregnated carbon fiber unidirectional tape with a nylon fabric suspension system (no metallic pan component). The back cushion was very thin with minimal foam (figure B-10). The cushion appeared to contain a fiberfill material in place of the typical urethane foam.

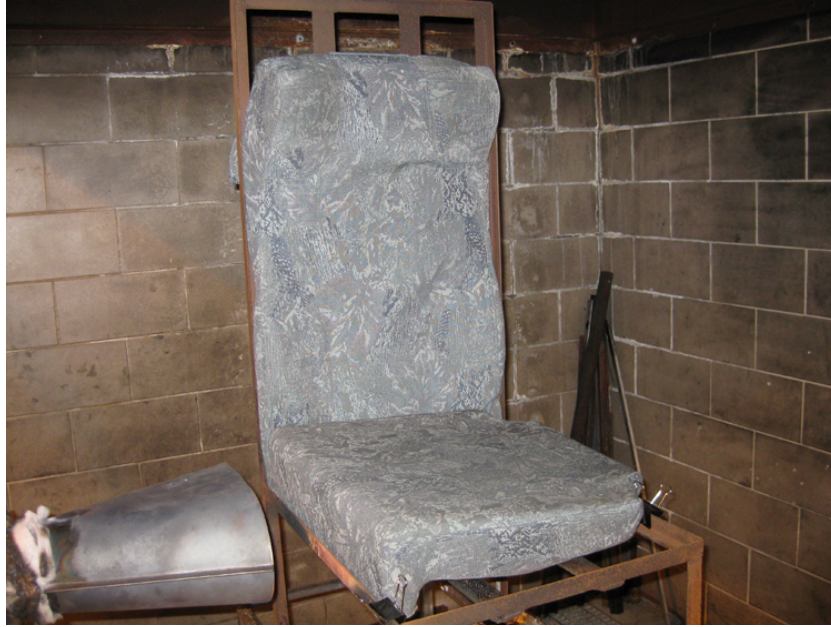
Figure B-11. Baseline Test 1 Cushions Attached to Laboratory-Scale Test Rig

A decision was made to rotate the bottom cushion 90° for all tests, so that the flat surface of the front of the cushion would face the test burner flames (figure B-11). This would prevent the burner flames from protruding under the contoured cushion, which would not typically occur if the samples were the proper shape and size. The back cushions were clamped to the vertical test frame to prevent collapse during the test.

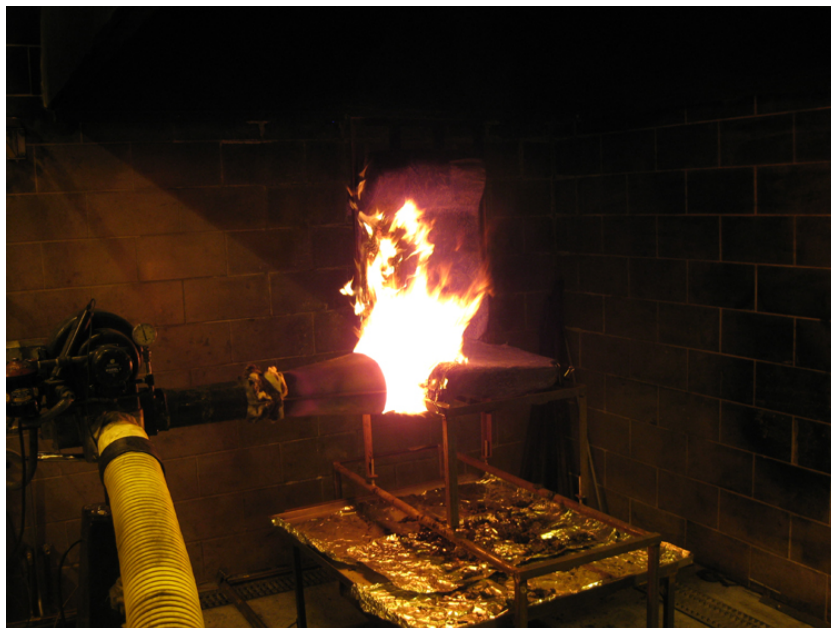
Figure B-12. Baseline Test 1 Bottom Seat Cushion During Laboratory-Scale Test (typical),
First Frame

Following the required 2-minute burner warm-up, the Baseline Test 1 sample cushions were rolled in front of the burner flames. The burner flames quickly spread onto the surface of the cushion bottom and back materials (figures B-12 through B-14). Although there were three different types of bottom cushions being tested, they all appeared to burn similarly.

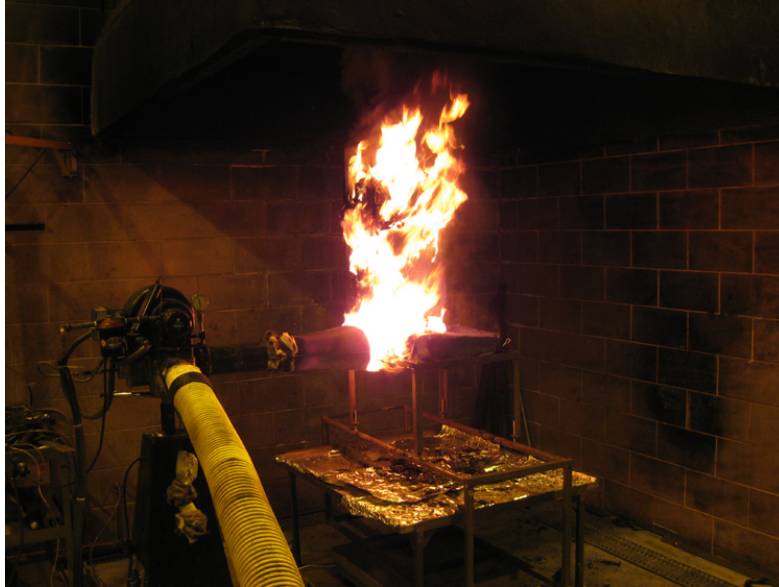
Figure B-13. Baseline Test 1 Bottom Seat Cushion During Laboratory-Scale Test (typical),
Second Frame

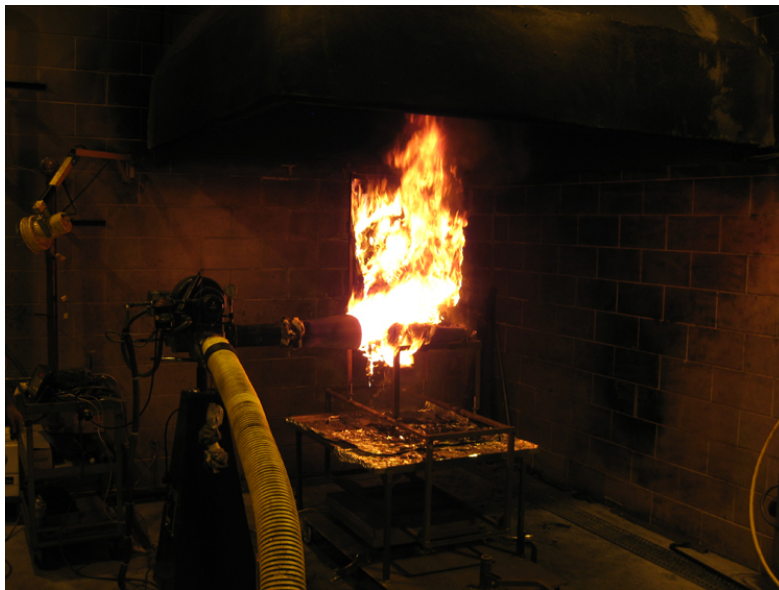
Figure B-14. Baseline Test 1 Bottom Seat Cushion During Laboratory-Scale Test (typical),
Third Frame

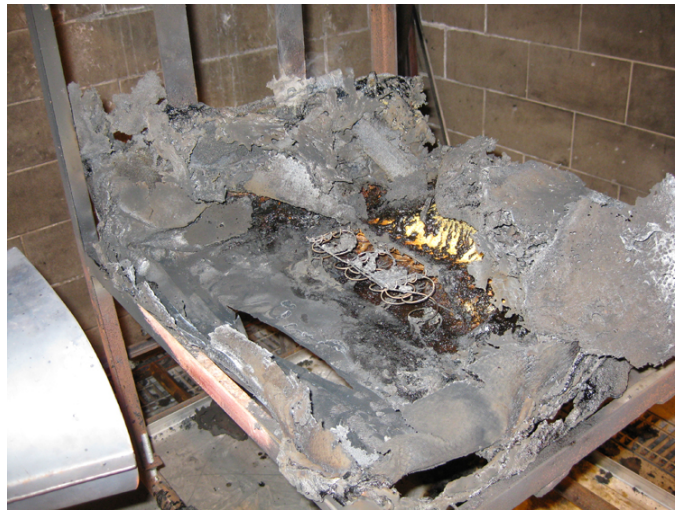
Figure B-15. Close-Up View of Baseline Test 1 Cushion Following Laboratory-Scale Test (typical)

During the tests, the seatback cushion was largely consumed, regardless of bottom cushion type, with remnant material slumped onto the remaining bottom cushion. Figures B-15 and B-16 show the remnants of two of the tests. The tabulated results, including weight percentage losses, are included in table B-1. The results clearly indicate high weight losses associated with the seatback cushion system, ranging from 55% to 66% of the initial weight. Although the bottom cushions performed much better when compared to the seatback cushions, only the style using the Franklin Products fire-blocking layer came close to the 14 CFR pass-fail requirement, which required 10% or less weight percentage loss. Although these tests were not run in accordance with the seat cushion flammability test specified in 14 CFR 25.853c Appendix F, Part II, due to the lack of standardized test samples, they were a representation of the general fire performance of the materials and confirmed the poor performance of the seatback cushion.

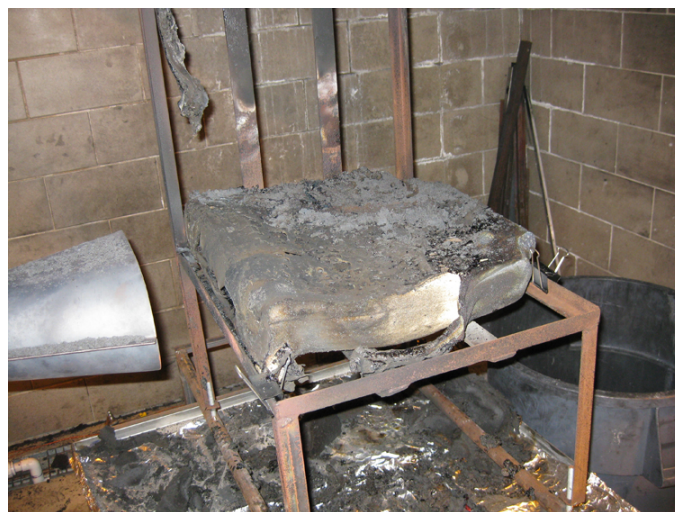
Figure B-16. Baseline Test 1 Cushion Following Laboratory-Scale Test (typical)

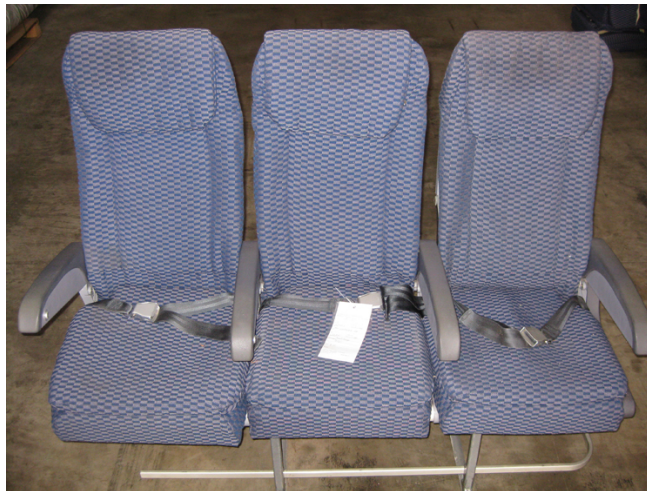
Figure B-17. Baseline Test 2 Triple Coach Seat With Blue-Colored Dress Cover

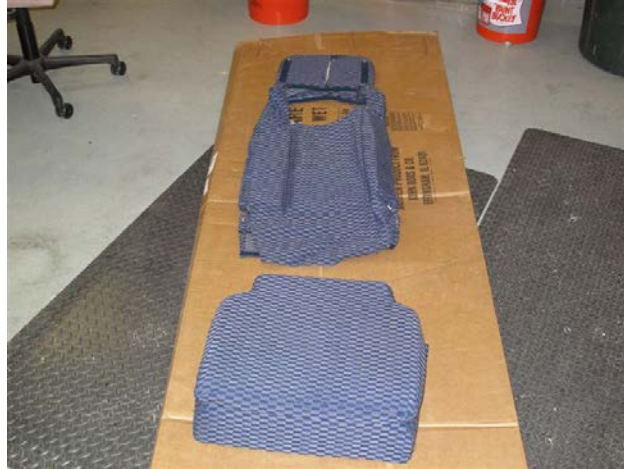
Figure B-18. Baseline Test 2 Bottom Seat and Seatback Cushions

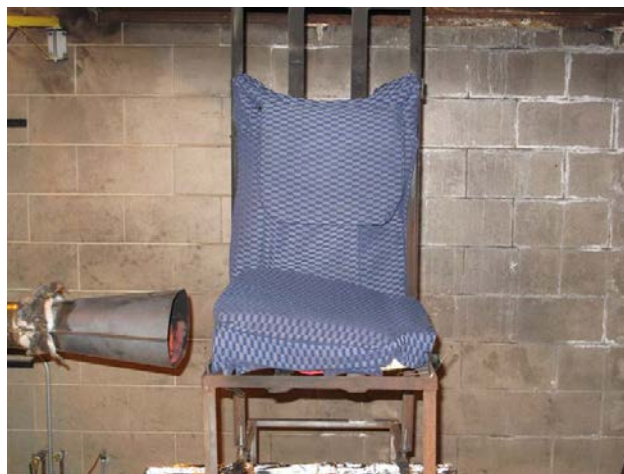
Figure B-19. Front View of Baseline Test 2 Cushions Prepared for Testing in Laboratory-Scale Test Rig

Similar to the Baseline Test 1 full-scale seat cushion materials, a decision was made to rotate the bottom cushion 90°, so that the flat surface of the front of the cushion would face the test burner flames (figure B-19). This would prevent the burner flames from protruding under the contoured cushion, which would not typically occur if the samples were the proper shape and size. The back cushions were clamped to the vertical test frame to prevent collapse during the test (figures B-20 through B-22).

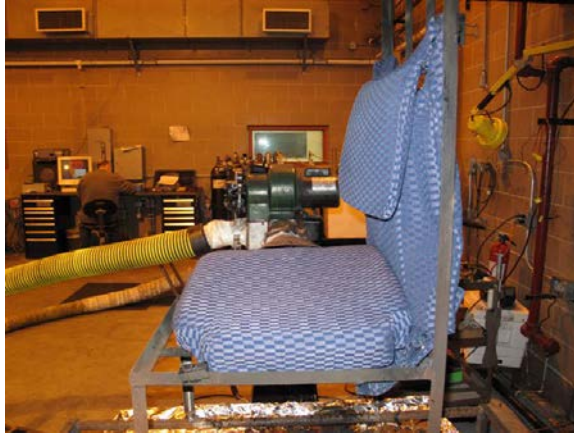
Figure B-20. Side View of Baseline Test 2 Cushions Prepared for Testing in Laboratory-Scale Test Rig

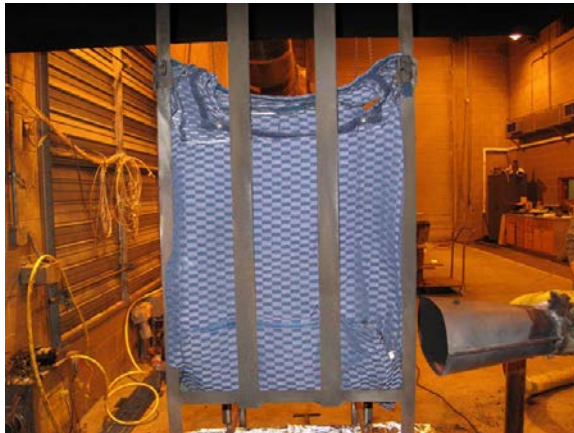
Figure B-21. Rear View of Baseline Test 2 Cushions Prepared for Testing in Laboratory-Scale Test Rig

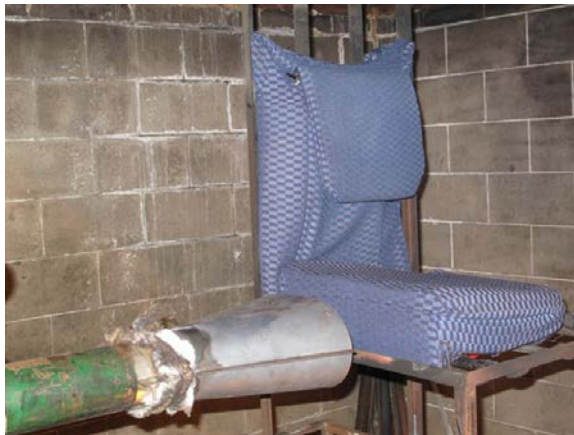
Figure B-22. Side View of Baseline Test 2 Cushions Prepared for Testing in Laboratory-Scale Test Rig

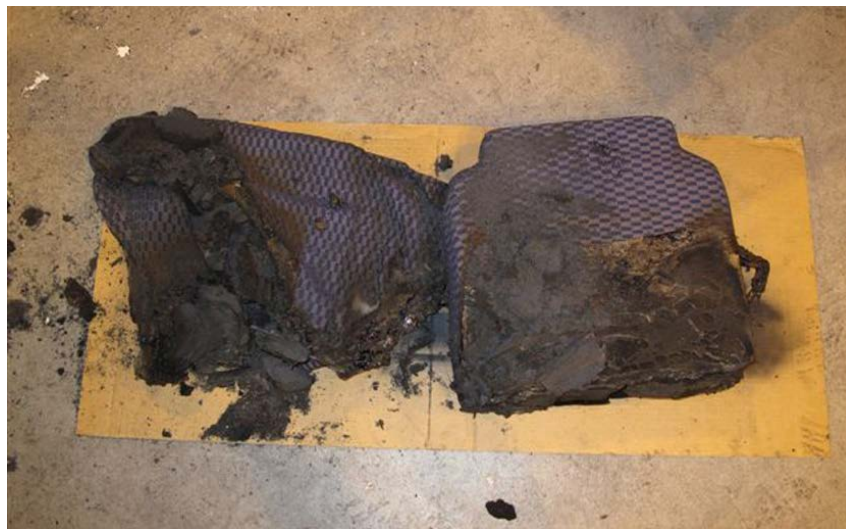
Figure B-23. Baseline Test 2 Cushion Samples Following Laboratory-Scale Test

Following the 2-minute burner warm-up, the seat cushion test assembly was rolled in front of the burner flames to begin the test. As in the Baseline Test 1 oil burner test, the back cushion was largely consumed, with remnant material slumped onto the remaining bottom cushion. Figure B-23 shows the cushion remnants of one of the tests. The tabulated results, including weight percentage losses are included in table B-2. The results again indicated high weight losses associated with the back cushion system, ranging from 30% to 42% of the initial weight. Although the bottom cushions performed much better when compared to the seatback cushions, the results still far exceeded the 14 CFR 25.853c Appendix F, Part II pass-fail requirement, which required 10% or less weight percentage loss. It should be noted again that these tests were not run in accordance with the seat cushion flammability test specified in 14 C FR 25.853c Appendix F, Part II, due to the lack of standardized test samples. However, the tests were at least an indication of the general fire performance of the materials and confirmed the poor performance of the back cushion.
