**DOT/FAA/TC-14/8**

# **Review and Assessment of Transport Category Airplane Ditching Standards and Requirements**

May 2015

Final Report

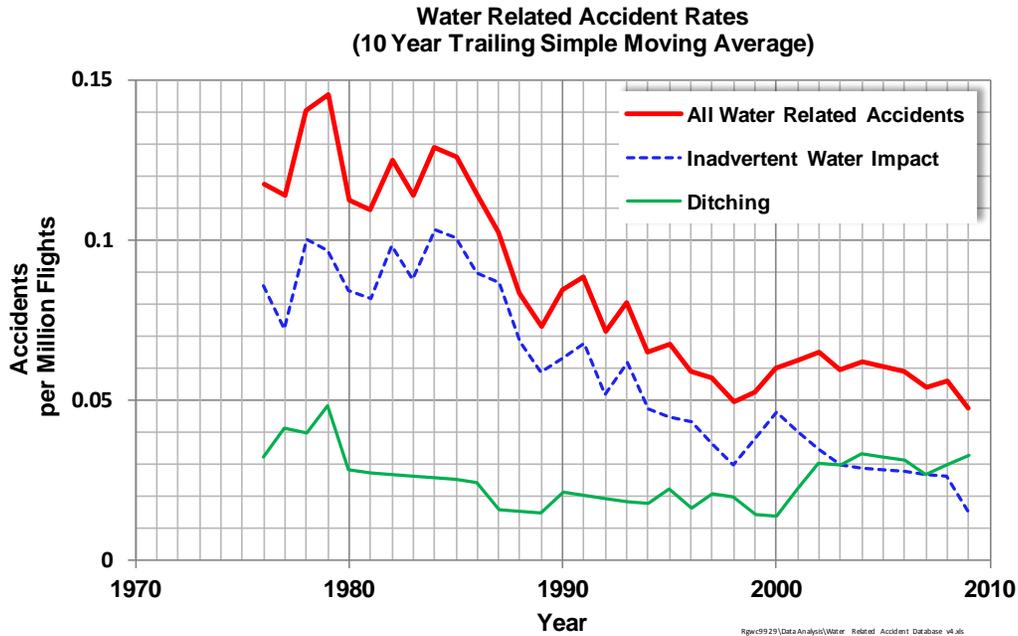
Figure 1 shows the 10-year Trailing Simple Moving Average<sup>3</sup> accident rate (accidents per million flights<sup>4</sup>) for ditching, inadvertent water impact and all water-related accidents involving airplanes meeting the criteria defined in section 6.1.

Figure 1. Trends in Water Related Accident Rates

It may be seen in Figure 1 that, based on a 10 year moving average, the accident rate for ditching accidents is relatively constant at around 0.03 accidents per million flights. It may be inferred from this that there has been no appreciable improvement in the ditching accident rate over the period 1967 through 2009. A possible explanation for this might be that the primary cause of ditching accidents is the loss of power from all engines. This type of occurrence is often attributable to fuel exhaustion, but also includes other causes such as bird strike and ingestion of water/hail/ice. These occurrences are unlikely to have benefited from the technological and operational improvements in aviation safety over the last few decades.

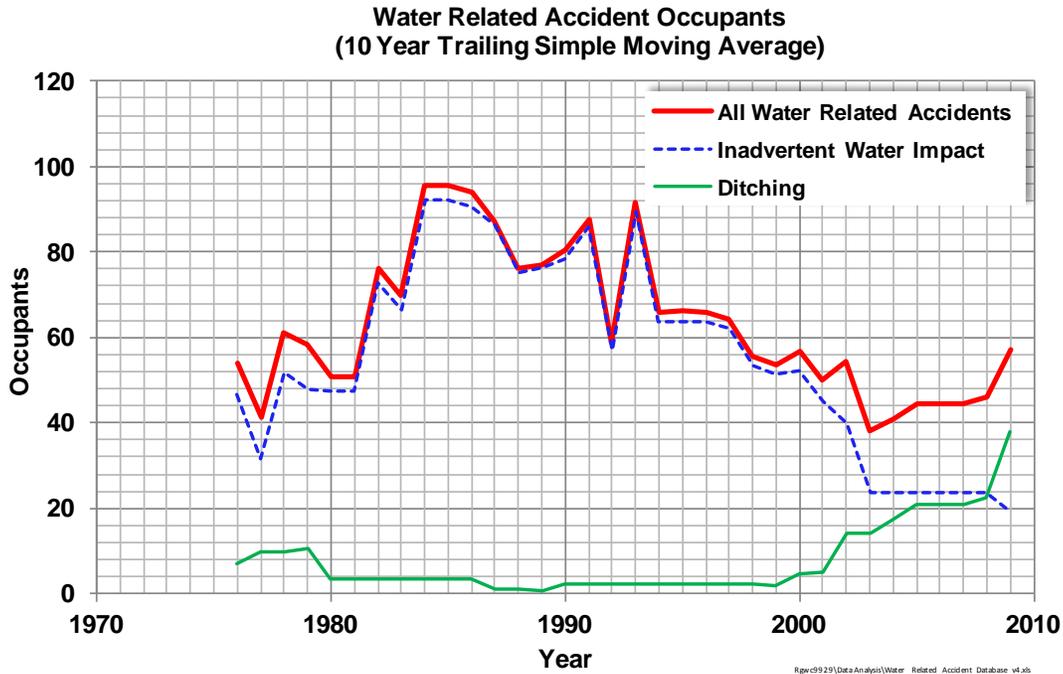
Figure 2 shows the 10 year Trailing Simple Moving Average for the annual number of occupants involved in ditching and inadvertent water impact accidents involving airplanes defined in section 6.1.

Figure 2. Trends for the Number of Occupants Involved in Water Related Accidents

It may be seen in Figure 2 that the number of occupants involved in inadvertent water impact accidents rose annually throughout the 1970s and early 1980s followed by a marked reduction over the following two decades until present. A possible explanation for this is that the number of accidents and occupants initially rose in line with air transport growth, but then declined consistent with the reduction in the overall accident rate in the latter period.

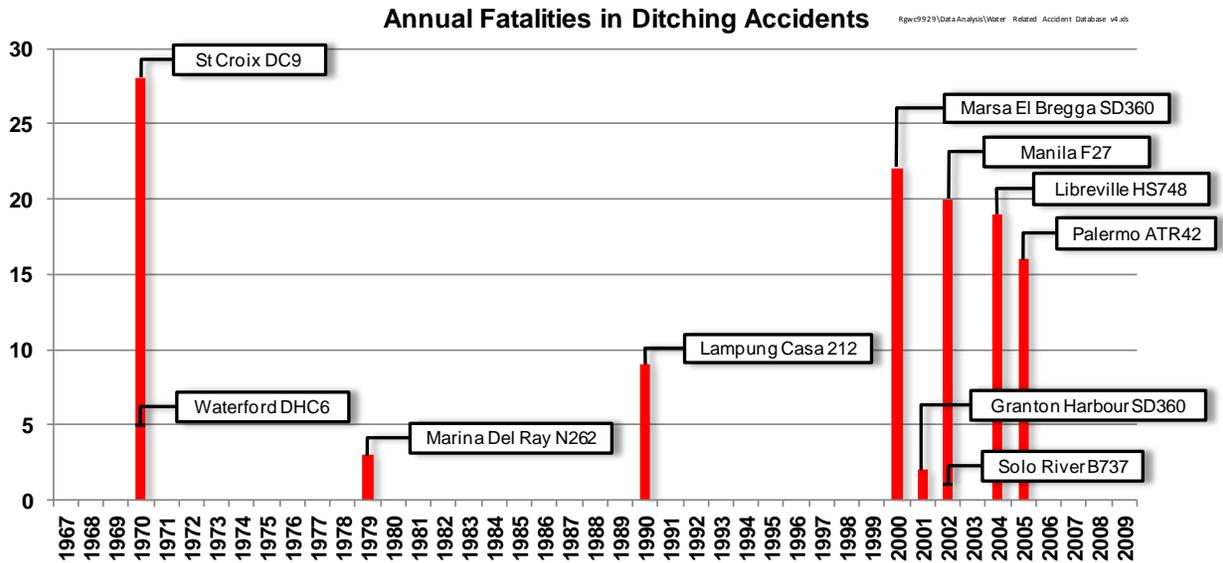
Fatalities occurred in 10 of the 19 ditching accidents identified within the water related accident database involving airplanes meeting the criteria defined in section 6.1. The number of fatalities for each of these ten accidents is shown in Figure 3.

Figure 3. Ditching Accident Fatalities

There are insufficient data to identify a trend in the number of ditching accident fatalities. However, it would appear that the majority of fatalities involve accidents with turboprop airplanes with a significant number occurring since 2000. Over the period 1967 to 2009, there were 95 fatalities in turboprops as opposed to 24 in turbojets. Over the period 1967 to 2009 inclusive, only three ditching accidents involved jet airplanes and that two of these three involved ditching into rivers as opposed to the sea. Over the same period no wide body<sup>5</sup> airplanes were ditched.

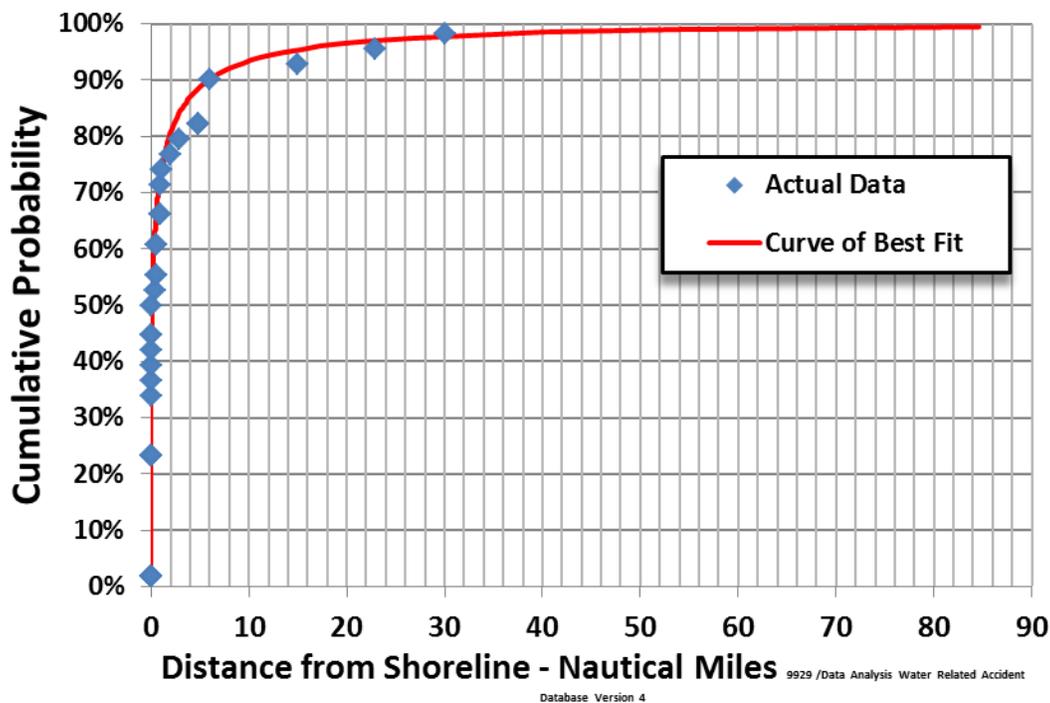
Thirty-nine accidents were selected that met the above criteria. Of these a determination could be made for 37 accidents of the point at which the airplane alighted on the water in relation to the shoreline. The cumulative probability distribution for the distance from the shoreline, based on these data, is shown in Figure 4. Much of the data used to derive the cumulative probability distribution is based on estimations made from the available data. However, these estimates are considered sufficiently accurate to provide a reasonable assessment of the distribution.

Figure 4. Cumulative Probability Distribution of Distance from Shoreline

The Curve of Best Fit for the data illustrated in Figure 4 is based on a Weibull Distribution with a  $\gamma$  value of zero, a  $\beta$  value of 0.313, and an  $\eta$  value of 0.411 nautical miles.

Based on Figure 4 it may be concluded that the majority of water related accidents occur within 50 nautical miles of a shoreline with probably less than 2 percent being greater than this distance. It is also likely that more than 80 percent occur within 3 miles of a shoreline.

<sup>14</sup> Since the 50 nautical miles criteria relates to the carriage of passengers, only passenger airplanes were considered in the distance from shoreline analysis. Furthermore, inspection of the accident data suggests inclusion of other airplane operations would make a negligible difference to the curve illustrated in Figure 4.

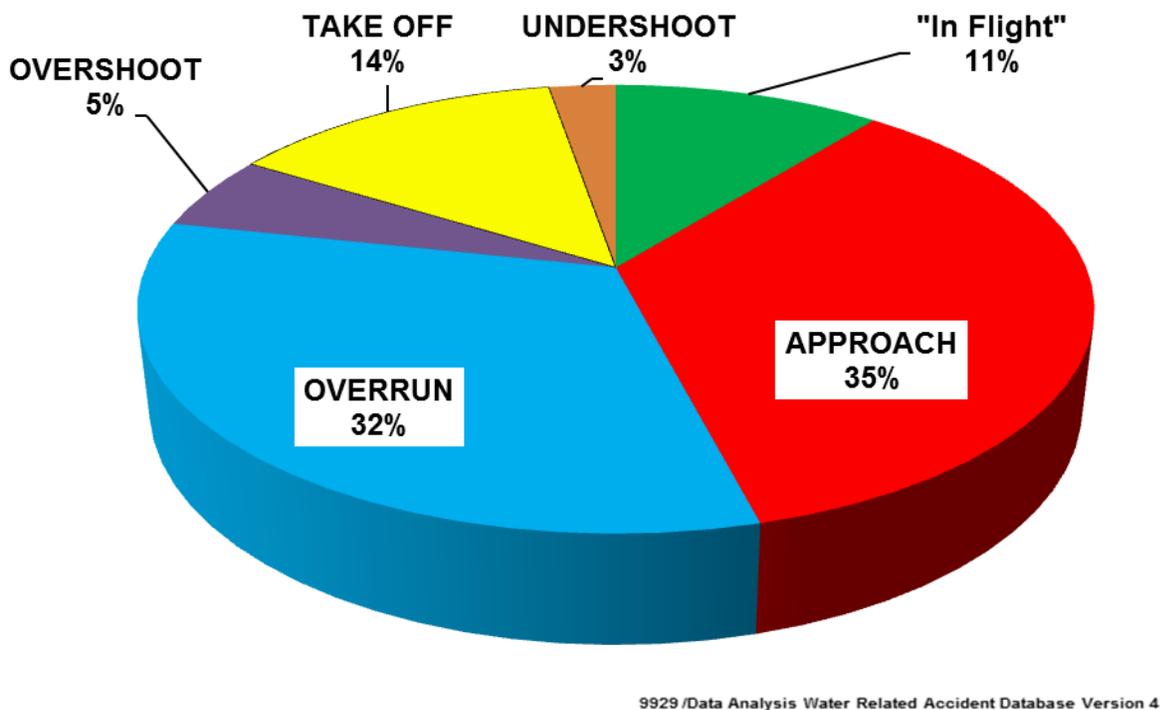
Of the 39 accidents there was sufficient data on 37 occurrences to make a determination of the phase of flight in which the airplane impacted with the water. The disposition of these flight phases is illustrated in Figure 5. It may be seen that approximately 89 percent (100 percent – 11 percent) occurred while the airplane was approaching an airfield, landing or taking-off.

Figure 5. Water Related Accident Occurrences by Phase of Flight
