DOT/FAA/TC-16/42

A Comparison of the Performance of OSU-Compliant Versus Non-OSU-Compliant Thermoplastics Used in the Lower Area of Aircraft Seats During a Simulated Post-Crash Fire Scenario

Final Report

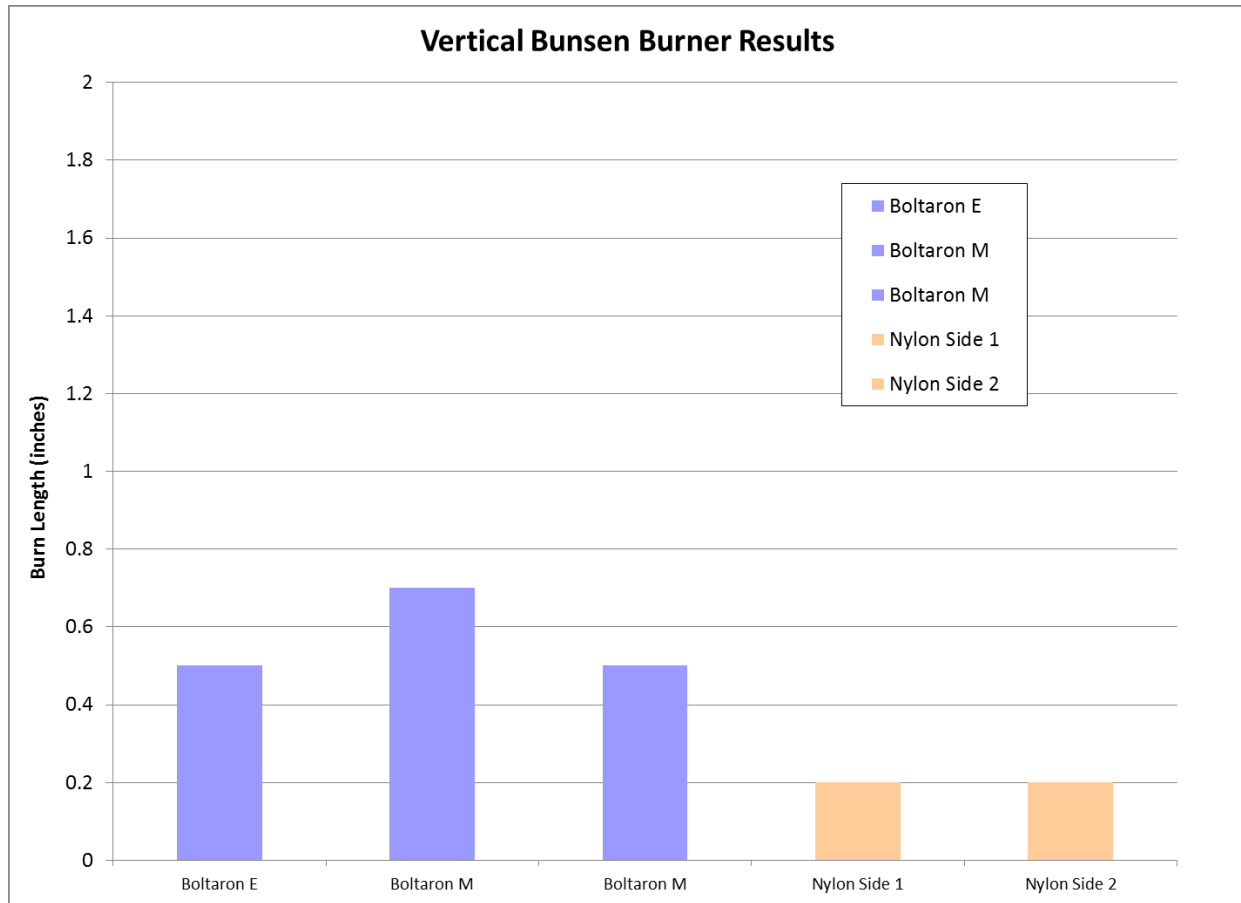
Figure 1. Thermoplastic burn length results using 12-second Bunsen burner method

Figure 1 shows the vertical Bunsen burner test results for burn length of the two sets of materials. The results indicate that both sets of materials easily met the burn length requirement of 8-inch maximum.

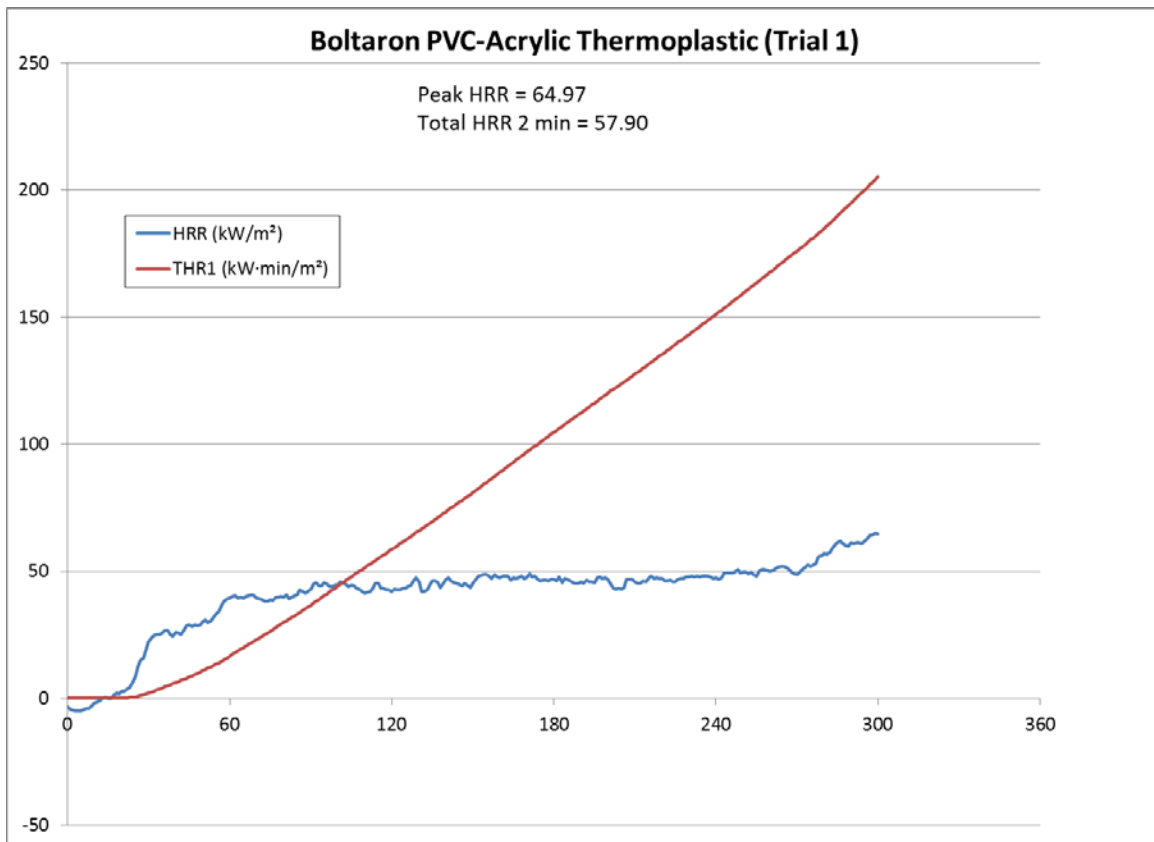
Figure 2. OSU test results for Boltaron thermoplastic material, Trial 1

The FAA Fire Safety Branch had the benefit of operating two independent heat-release apparatuses at two of its facilities to offer more than a singular data point. Two test trials of the aircraft-grade thermoplastic were conducted in the primary apparatus, and a third test was conducted in a secondary apparatus for comparison. The test results yielded a peak heat-release rate of between 52 and 65 kW/m² and total heat-release values between 44 and 58 kW-min/m² (figures 2, 3, and 4). These results confirmed that this material met the current heat-release allowable requirements of 65 kW/m² and 65 kW-min/m² for peak and total heat-release, respectively.

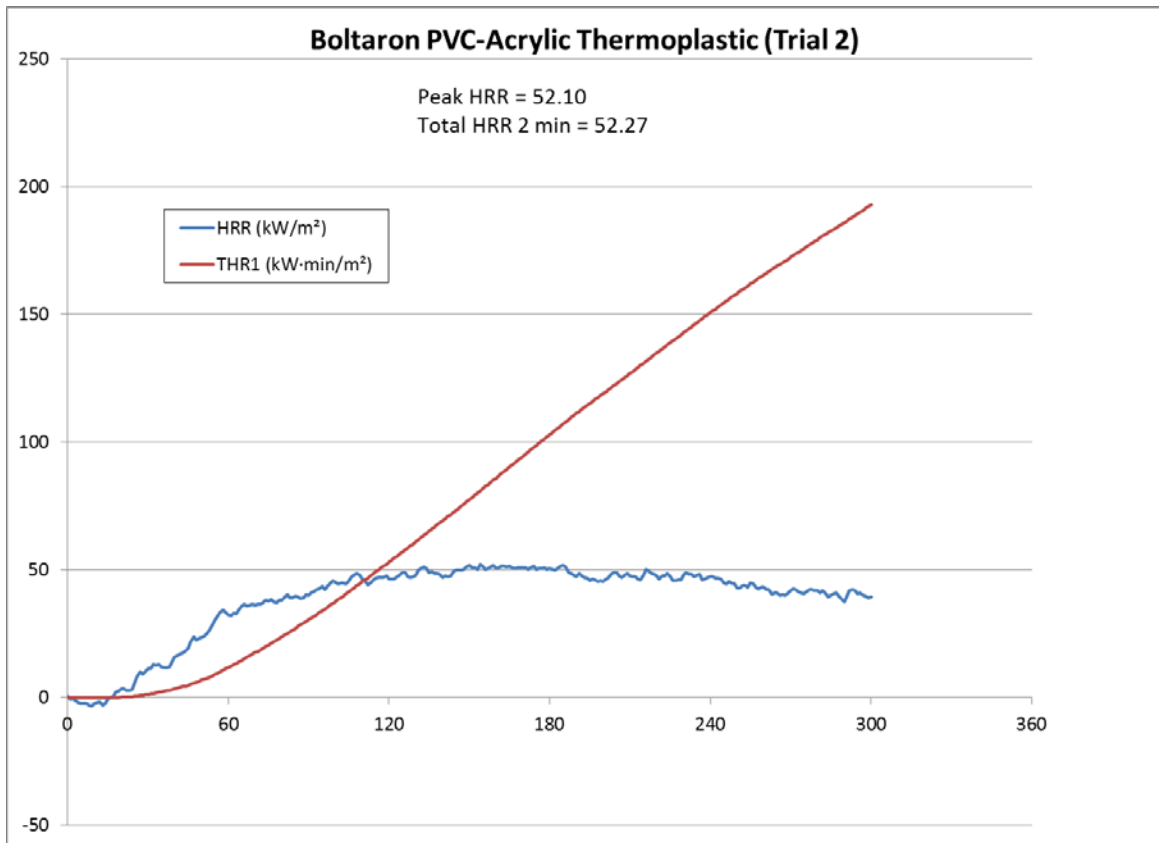
Figure 3. OSU test results for Boltaron thermoplastic material, Trial 2

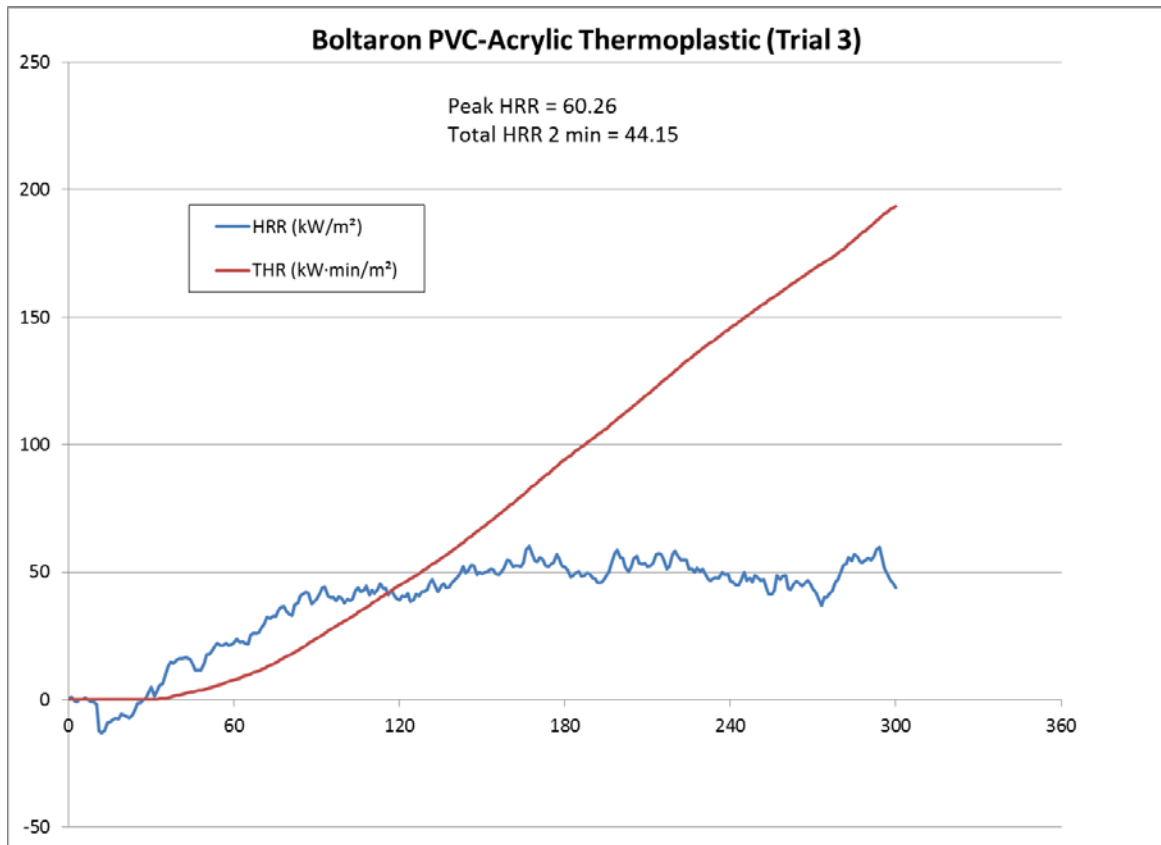
Figure 4. OSU test results for Boltaron thermoplastic material, Trial 3

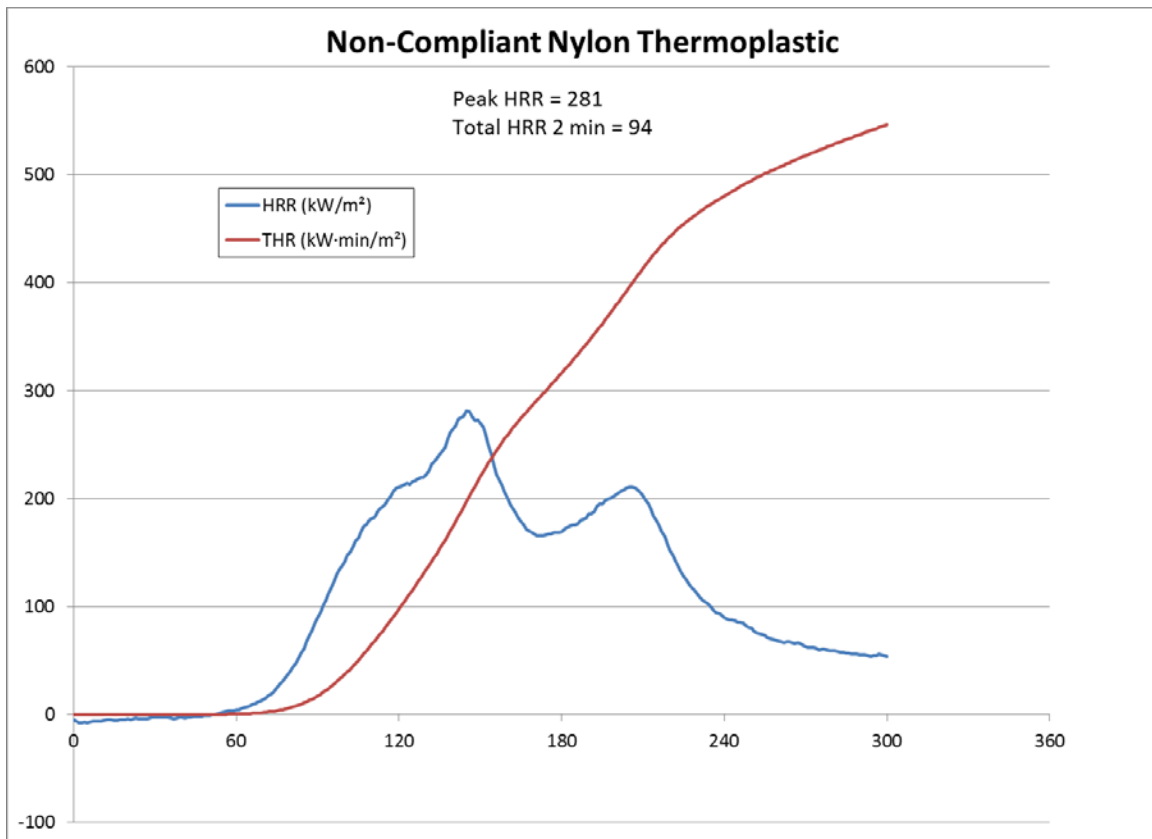
Figure 5. OSU test results for nylon thermoplastic material, primary apparatus

The nylon thermoplastic material was also tested in each of the apparatuses. In the primary apparatus, the material yielded a peak heat-release rate of 281 kW/m² and a total heat-release value of 94 kW·min/m² (figure 5). In the secondary apparatus, the material yielded a peak heat-release rate of 221 kW/m² and a total heat-release value of 71 kW·min/m² (figure 6). These results confirmed that this material clearly did not meet the current heat-release allowable requirements of 65 kW/m² and 65 kW·min/m² for peak and total heat-release, respectively.

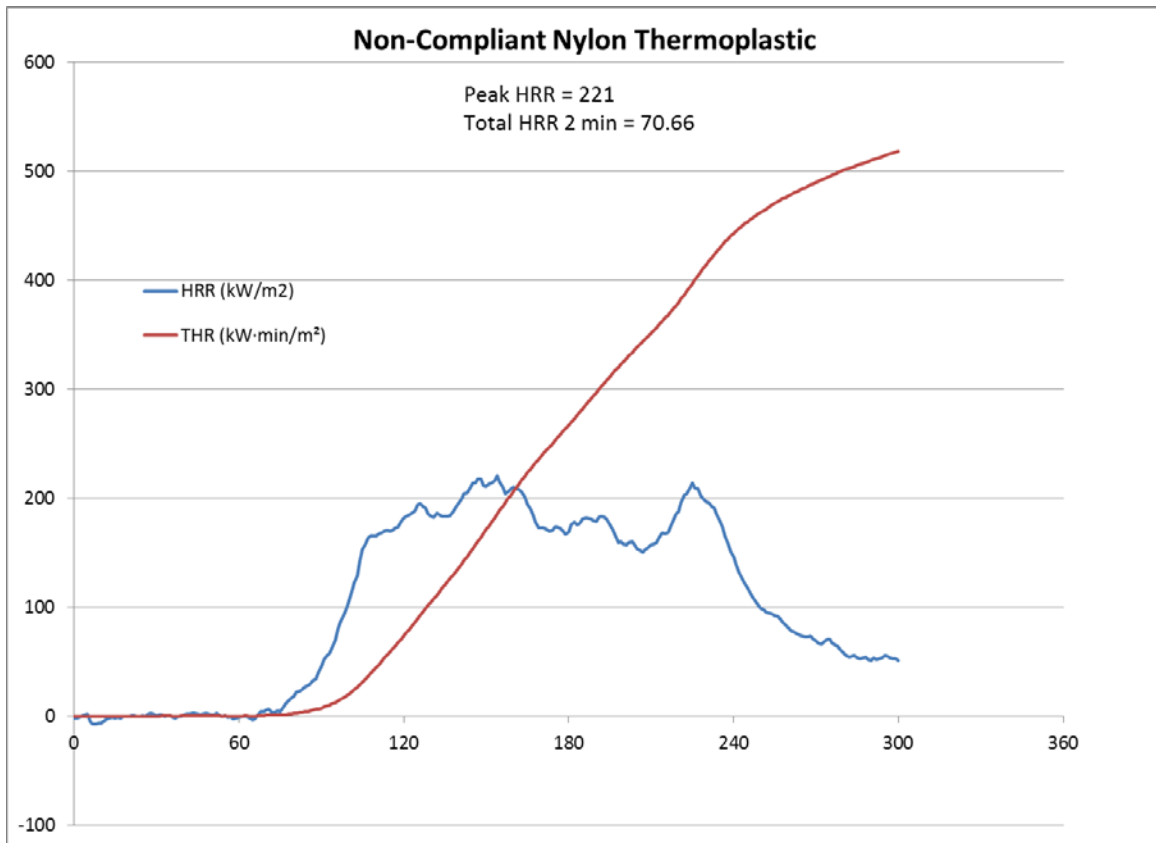
Figure 6. OSU test results for nylon thermoplastic material, secondary apparatus

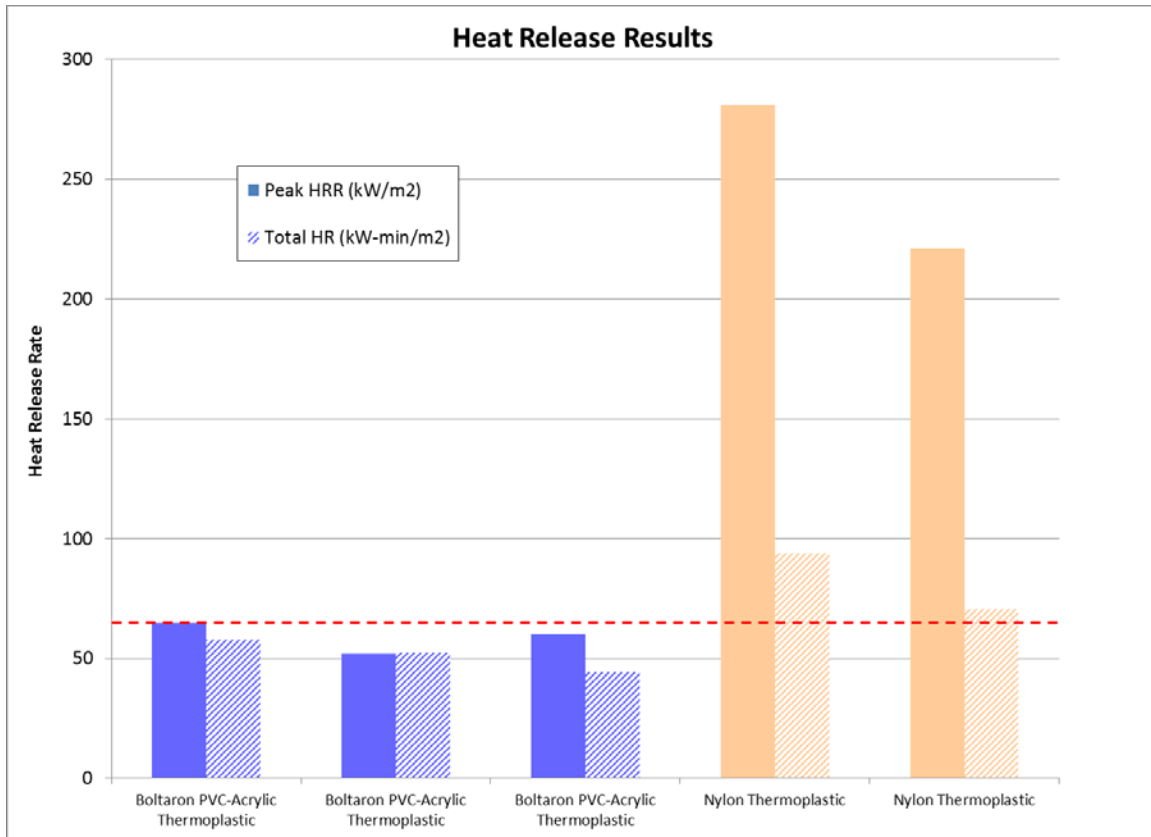
Figure 7. Summary of OSU test results for thermoplastic materials

The heat-release results are summarized in figure 7. As shown, the aircraft-grade thermoplastic met the heat-release requirements, whereas the nylon thermoplastic did not. Because both materials met the 12-second vertical Bunsen burner requirements, the materials were suitable for a more realistic full-scale comparison.

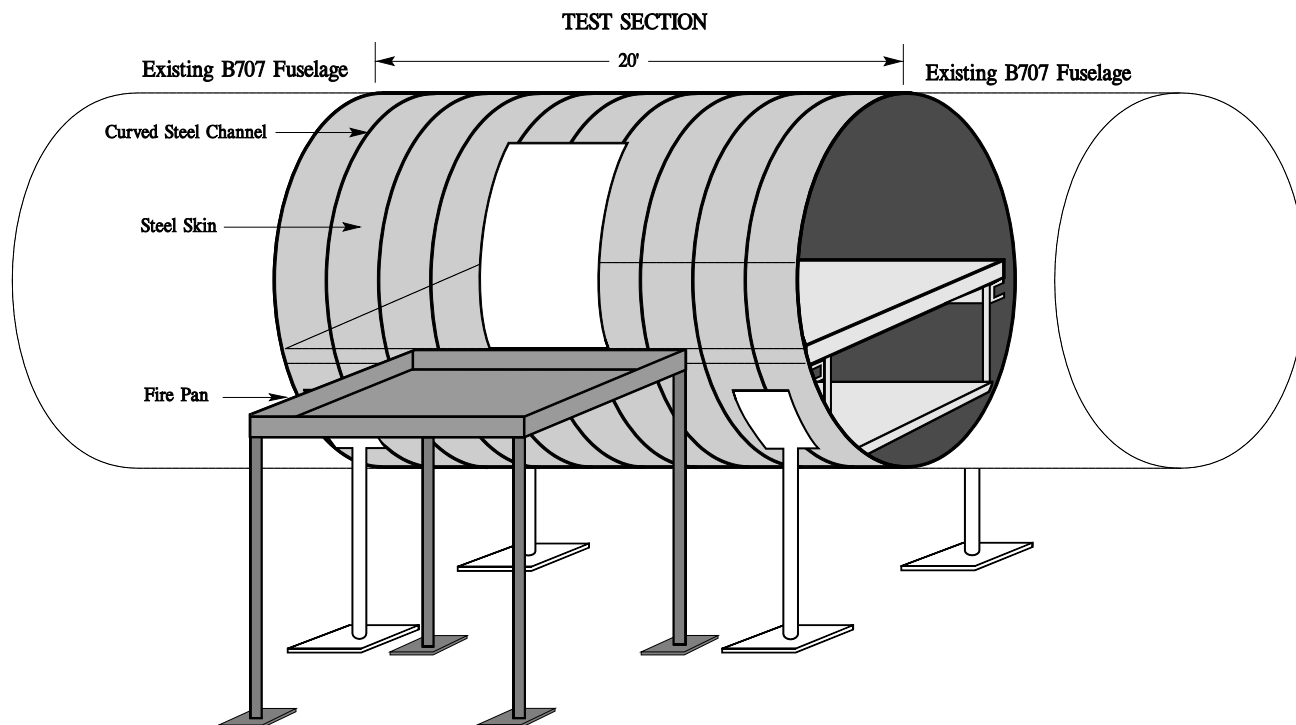
Figure 8. Full-scale test fuselage

The FAA Fire Safety Branch used this post-crash test scenario to investigate the impact of using non-heat-release-compliant materials in the lower portions of seats. A B-707 fuselage was fire-hardened to allow repetitive testing of cabin materials without damage to the fuselage structure. The test section consisted of a 20' long steel cylinder fabricated from curved steel channels, which was then inserted between two halves of the B-707 fuselage. An 8' x 10' fuel pan was situated adjacent to a 40" x 80" opening in the fuselage representing a large rupture (figure 8). In this configuration, flames from the external fuel fire impinged directly on one of the seats positioned in the opening. The pan fire was fueled by 55 gallons of Jet-A fuel, which was manually ignited with a flaming boom. The mocked-up section of the test fuselage included seats

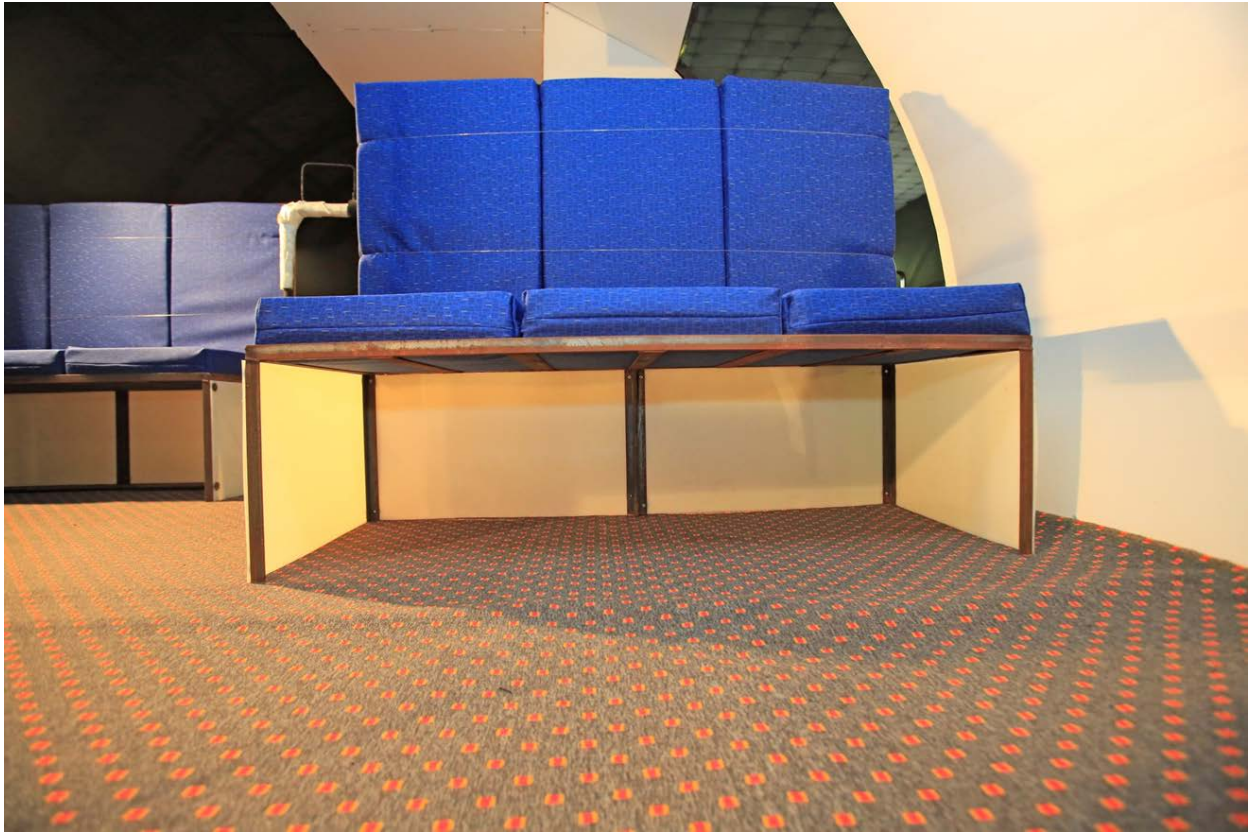
Figure 10. Mock-up triple seats used in full-scale tests

lower area of aircraft seats (i.e., 15" or less above the cabin floor). To best accomplish the objective, a baseline hazard level had to be established during a test using materials that met the current heat-release requirements. The baseline test used mocked-up triple coach seats fabricated from steel angle. The mock-up design allowed not only the cushion material, but also the thermoplastic materials tested previously, to be mounted to the seat frames (figure 10).

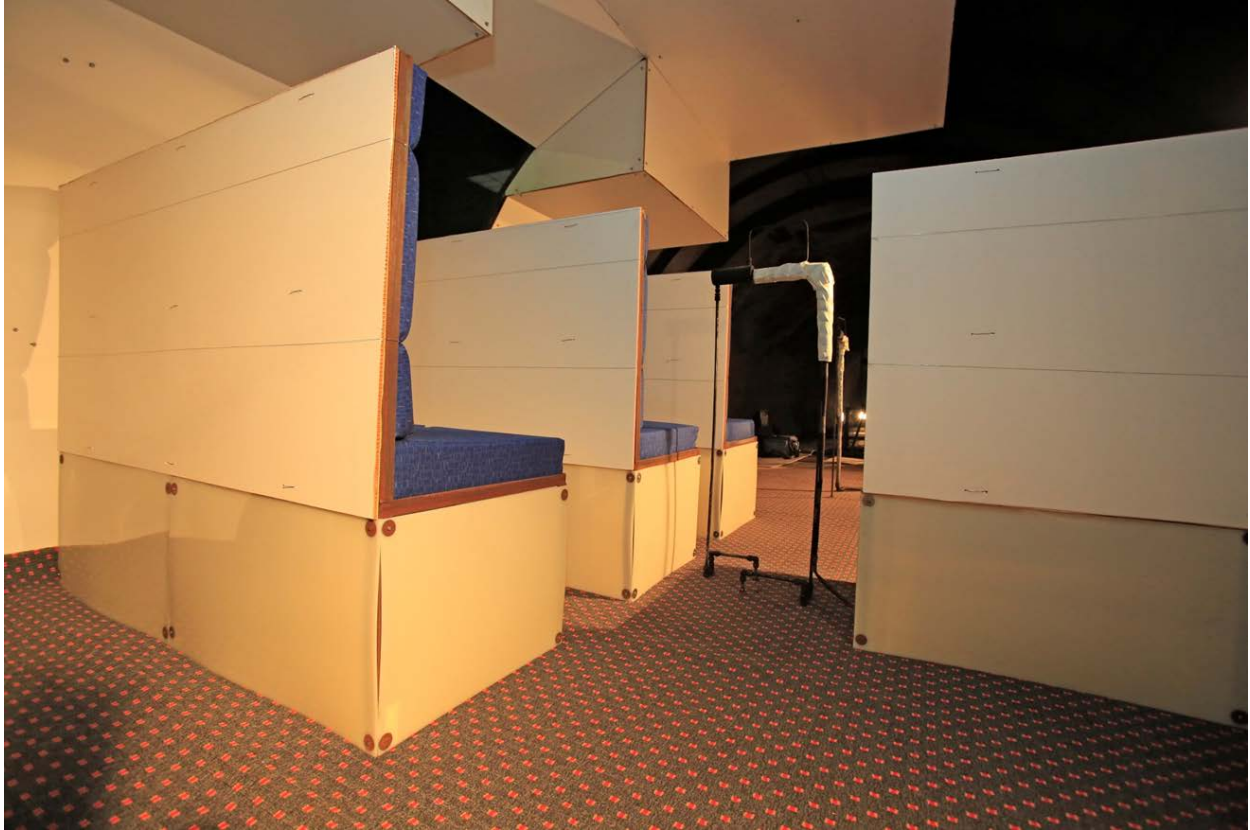
Figure 11. Mock-up seats with thermoplastic paneling mounted to sides and rear

As shown, the thermoplastic paneling was secured to the rear of the triple seat frame and to each side. The paneling was attached with screws and large-area washers to prevent the paneling from separating from the frame during the test. The thermoplastic paneling measured 15" high x 20" deep on each side and 15" high by 56" wide on the rear, for a total of 10 square feet of paneling per seat. The seat cushions were the standard size used in the FAA-required laboratory-scale flammability test. The seat cushions were fabricated from DAX® fire-hardened foam with a wool/nylon dress cover. Heat-release-compliant honeycomb paneling was also secured to the rear of all seat frames to simulate the large surface-area panels that are common on business and first-class seats (figure 11).

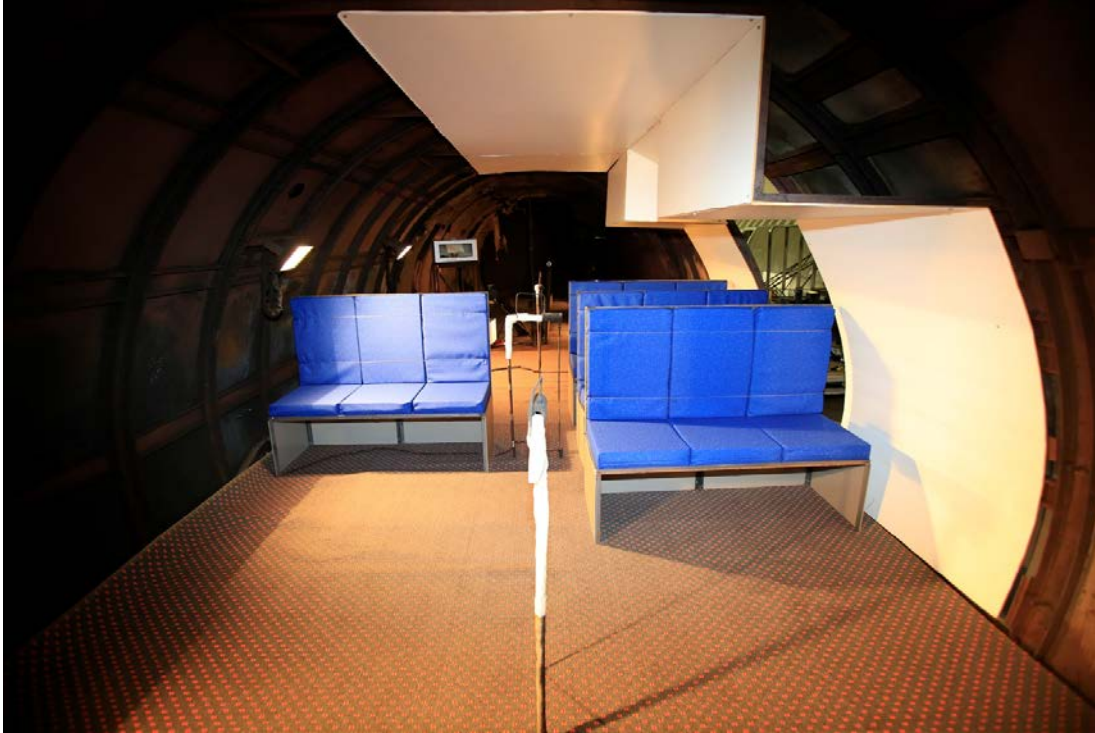
Figure 12. Mock-up seats positioned inside full-scale test fuselage

During the initial full-scale test, four of the mock-up triple seats were situated in the test fuselage to form a row of three seats on the rupture-side (port-side) of the fuselage, with one triple seat located across the aisle on the non-rupture starboard side (figures 12 and 13). Heat-release-compliant honeycomb core paneling was installed in the sidewall area of the rupture side and in the ceiling and stowage-bin areas to complete the test area. Aircraft-grade carpeting extended beyond the immediate test area by several feet; however, past testing had shown carpeting to contribute minimally during these types of experiments.

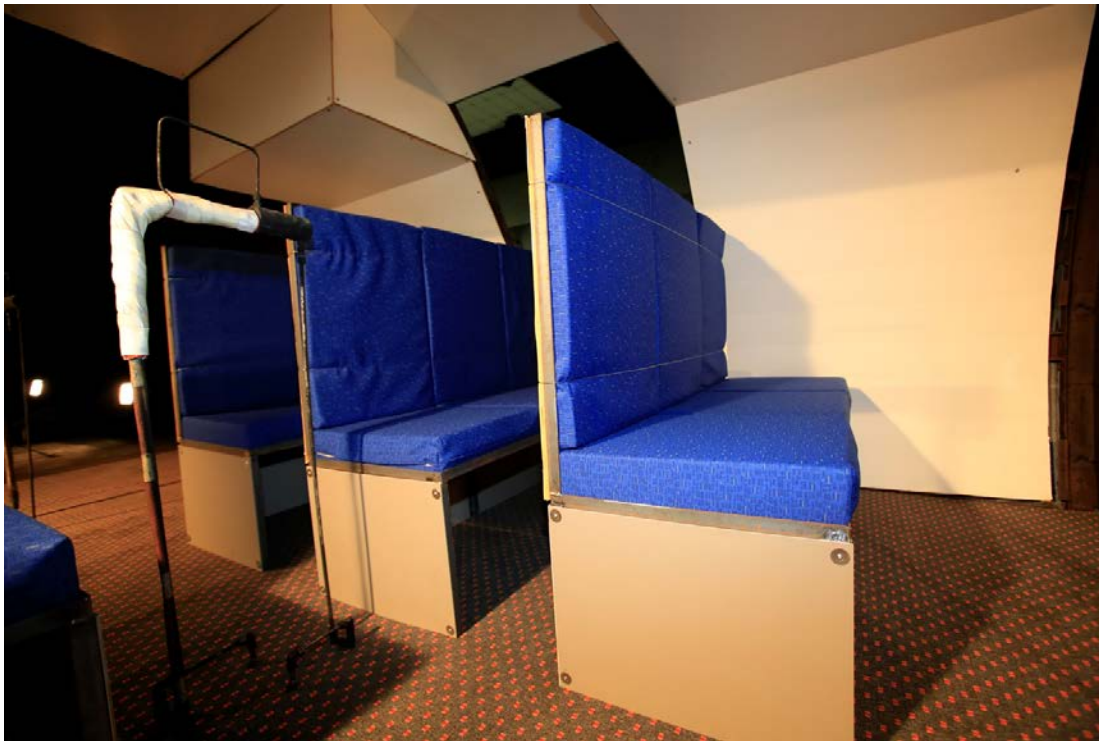
Figure 13. Alternate view of mock-up seats positioned inside full-scale test fuselage

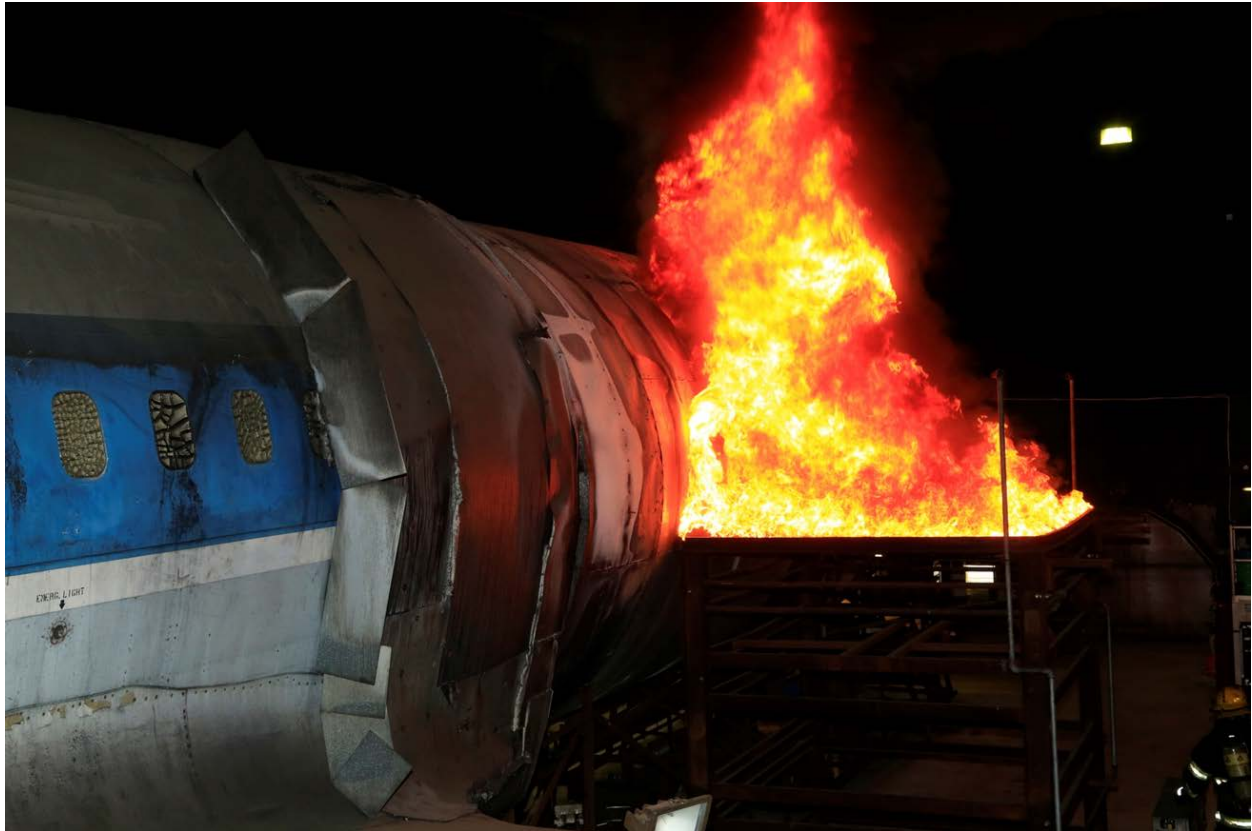
Figure 14. External view of fully developed fuel fire adjacent to test fuselage

Prior to the test, 55 gallons of Jet-A fuel were loaded into the fire pan adjacent to the fuselage. One gallon of regular gasoline was then poured over the Jet-A fuel to facilitate easy ignition and rapid development of the external fire. After a final instrumentation check, the fuel pan was ignited manually using a flaming rag attached to the end of a length of conduit (figure 14).

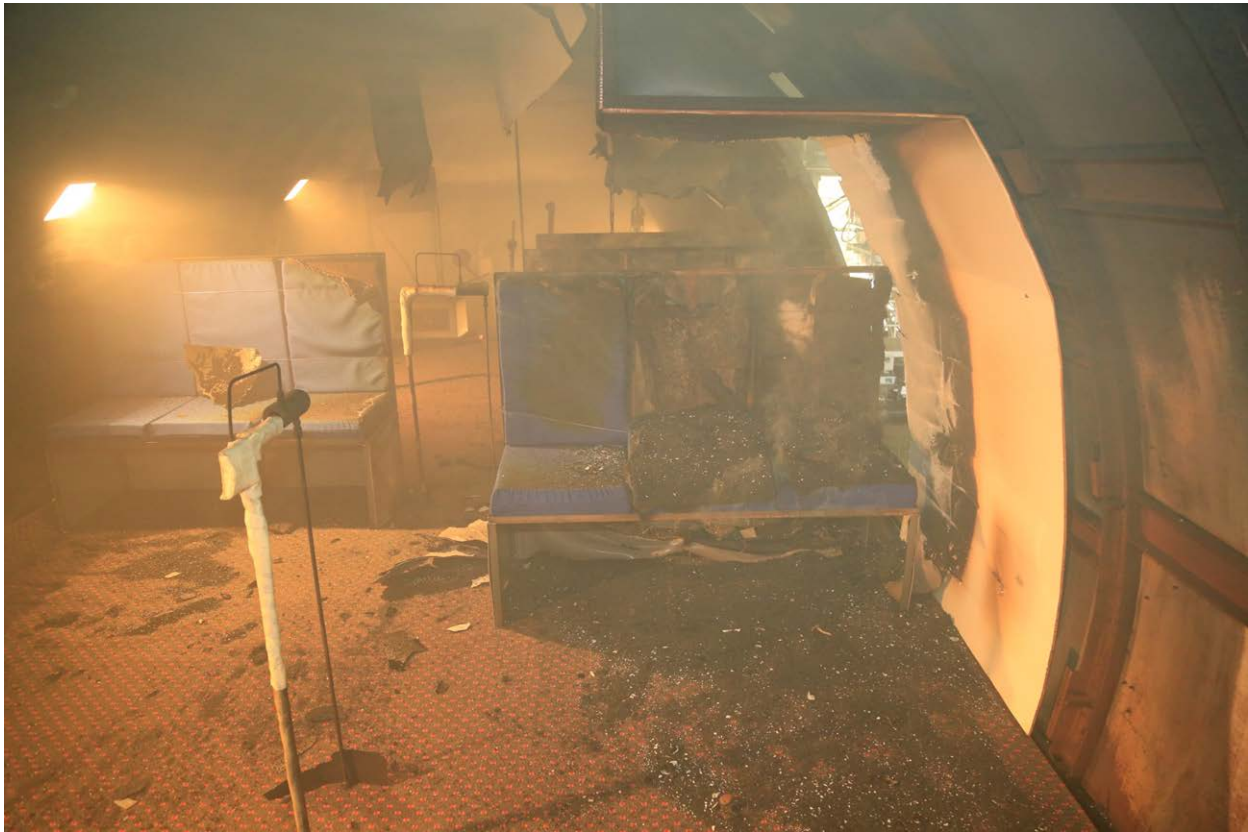
Figure 15. Post-test view of fuselage interior, facing aft

fire opening were also heavily damaged, as were the mocked-up stowage bins (figure 15). The seat-cushion materials on the seat located directly in the fire opening were also mostly consumed, with only charred remnants remaining. The cushion material in the seats forward and aft of the seat in the fire opening was also heavily damaged by the interior fire. Although these seats on the port (fire opening) side of the fuselage were largely consumed, the fire did not fully cross over the aisle to the starboard side seat. Only a small percentage of the upper dress cover of the starboard seat sustained any fire damage, along with some charring of the exposed face of the bottom cushion (figure 16).

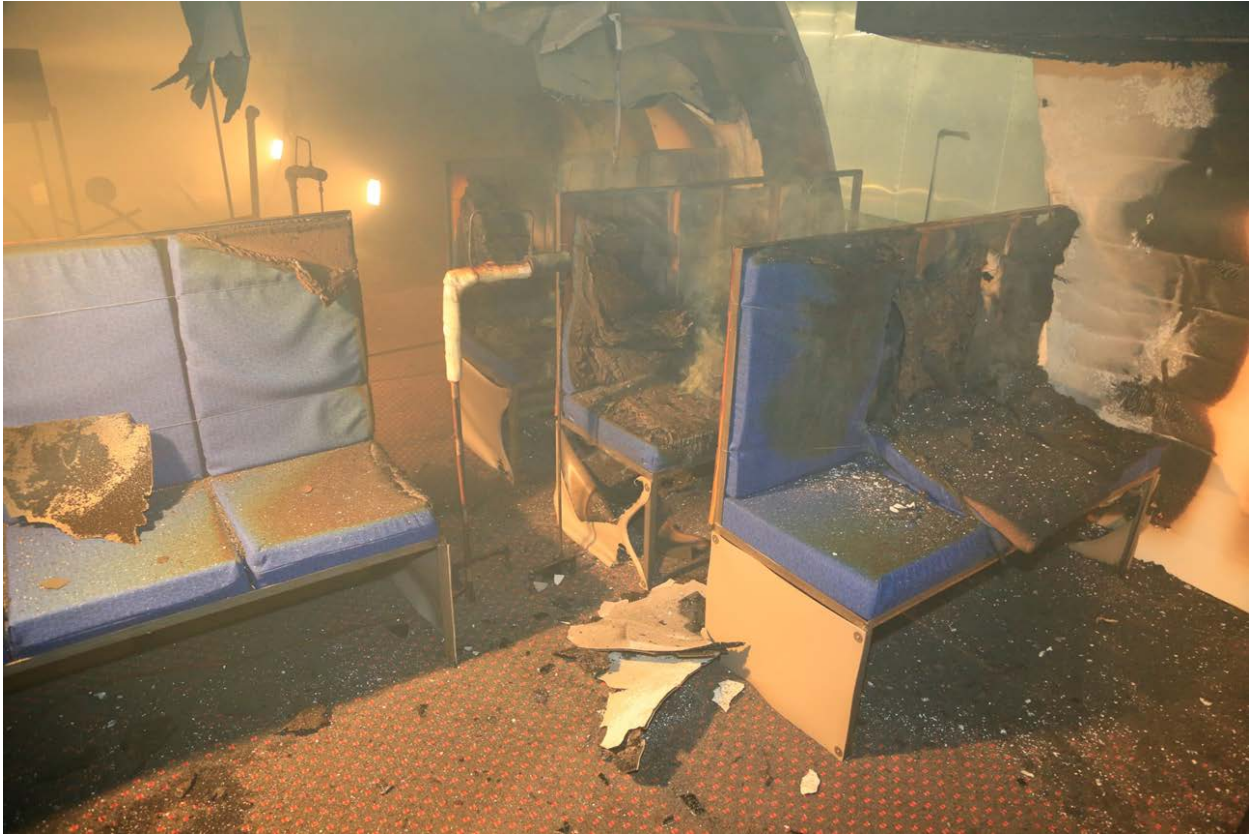
Figure 16. Post test view of fuselage interior, facing fire opening

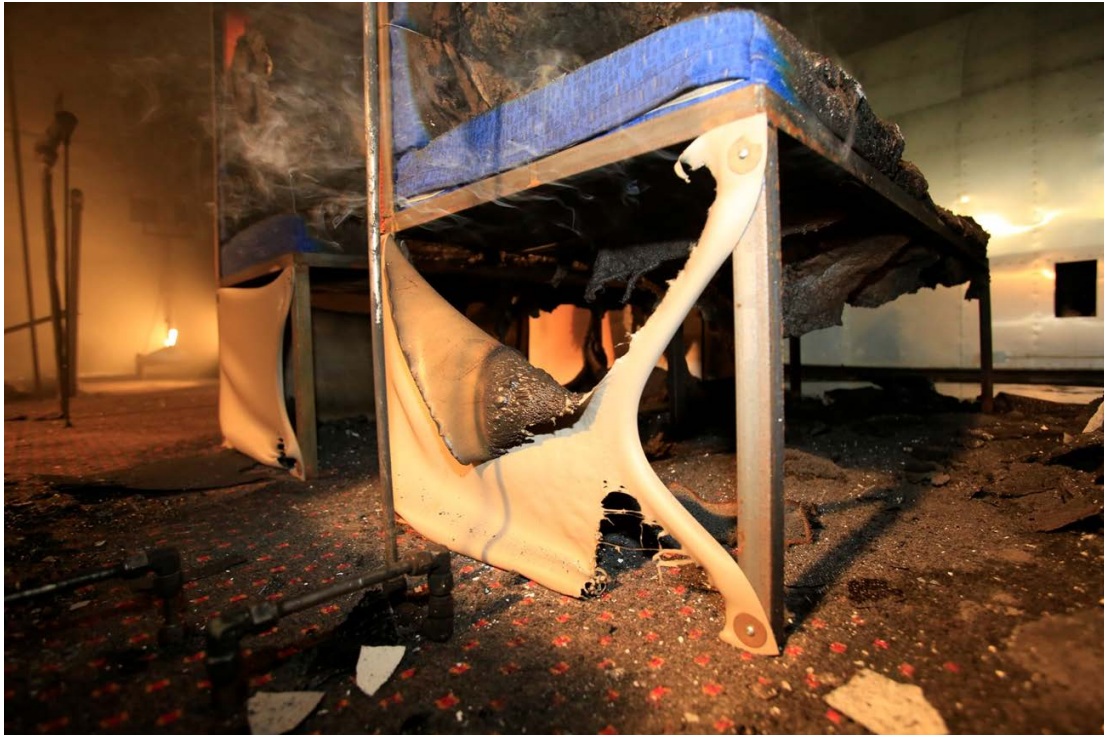
Figure 17. Post-test view of thermoplastic paneling on port-side seats

As expected, the thermoplastic materials mounted on the seat positioned in the fire door had melted significantly. One concern prior to the test was that the thermoplastics would melt and fall completely to the floor and, therefore, not become a factor during the test. However, the post-test inspection revealed that the bolts and large-head washers were effective in keeping these materials secured in place (figure 17). Although the thermoplastic rear and side panels were almost completely consumed in the seat positioned in the fire opening, the thermoplastics located on seats forward and aft of this area were not nearly as consumed. The side panels of the forward seat were fairly intact, whereas the sides and rear panels in the aft seat showed some melting and charring, although they were still largely intact (figure 18). The thermoplastics mounted on the starboard-side seat were undamaged, except for some minor warping on the side facing the fire.

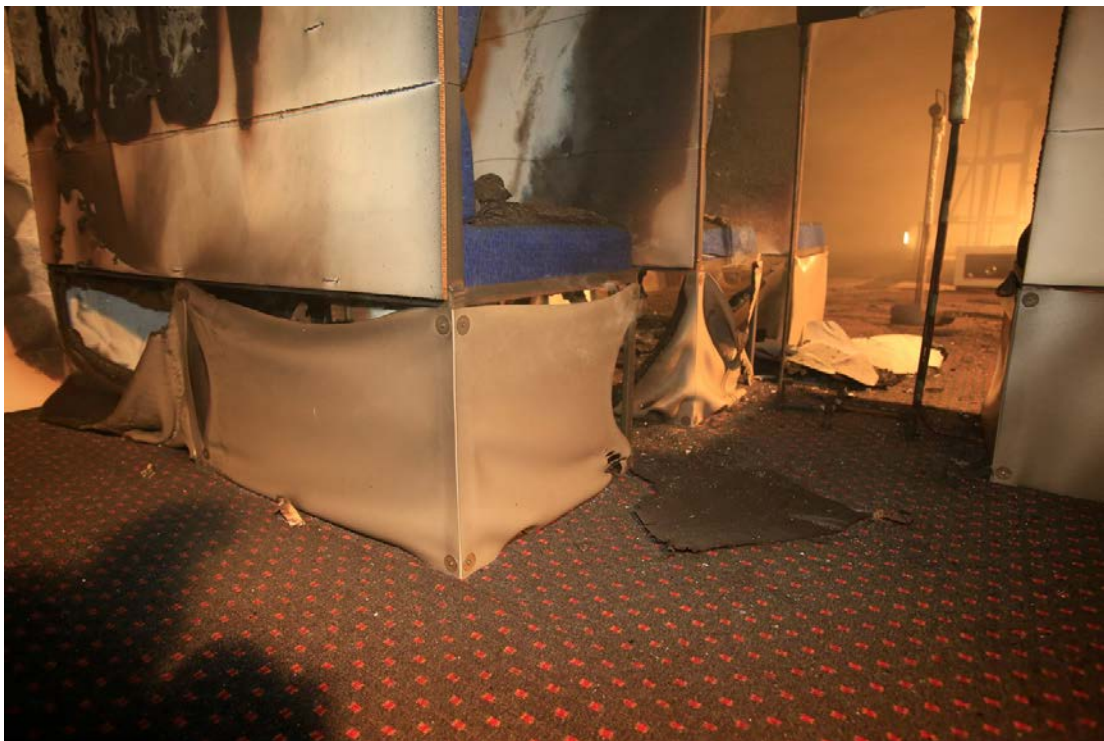
Figure 18. Post-test view of thermoplastic paneling on rear of port-side seat

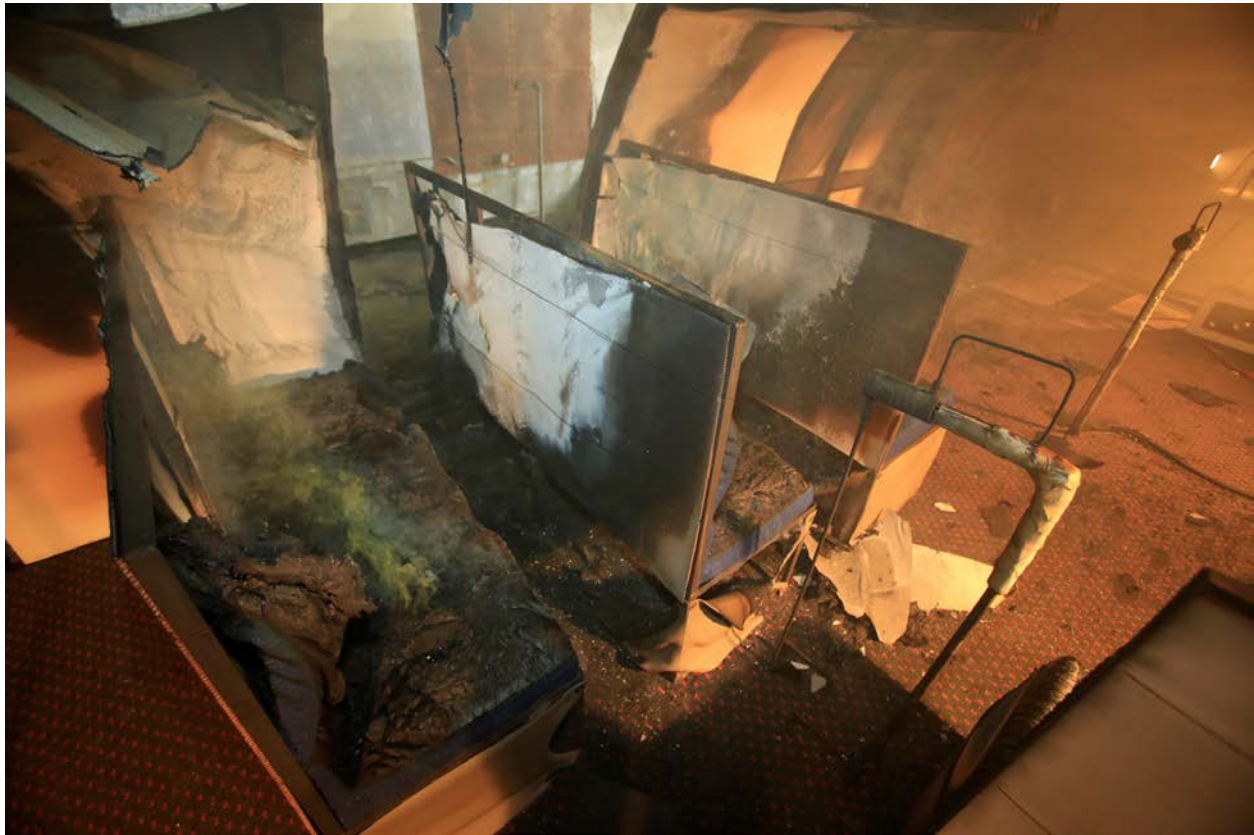
Figure 19. Post-test view of seat-mounted honeycomb paneling

The honeycomb panels located on the backs of the seats exhibited varying degrees of damage consistent with the thermoplastic damage (figure 19).

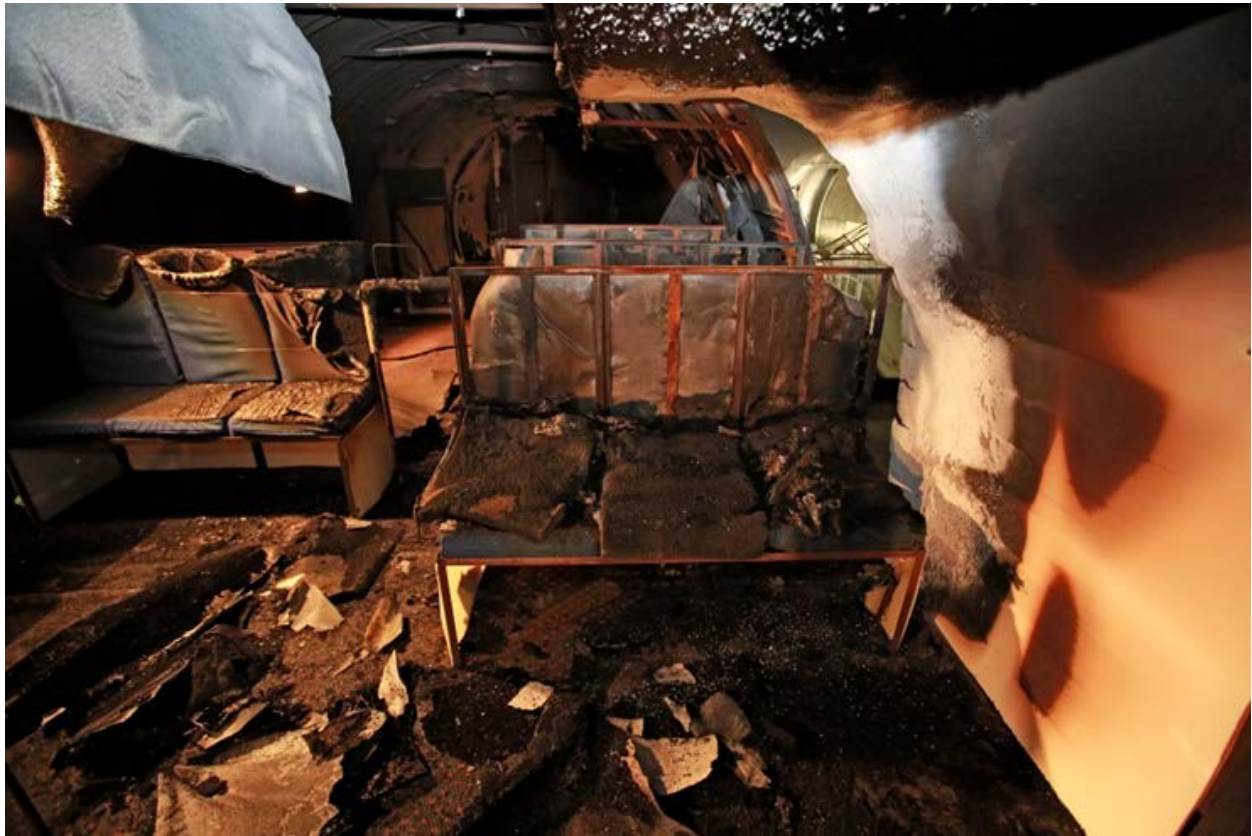
Figure 20. Post-test view of fuselage interior during non-heat-release-compliant test

sidewall panels next to the fire opening were also heavily damaged, as were the mocked-up stowage bins (figures 20–22). The seat-cushion materials on the seat located directly in the fire opening were almost completely consumed, with only charred remnants remaining. The seat-back cushion materials appeared to fall forward onto the seat bottom cushions despite each seat place being restrained with safety wire to prevent or minimize this occurrence (figure 23). The cushion materials in the seats forward and aft of the seat in the fire opening were also heavily damaged, with the forward seat-back cushions again falling onto the seat-bottom cushions (figure 24).

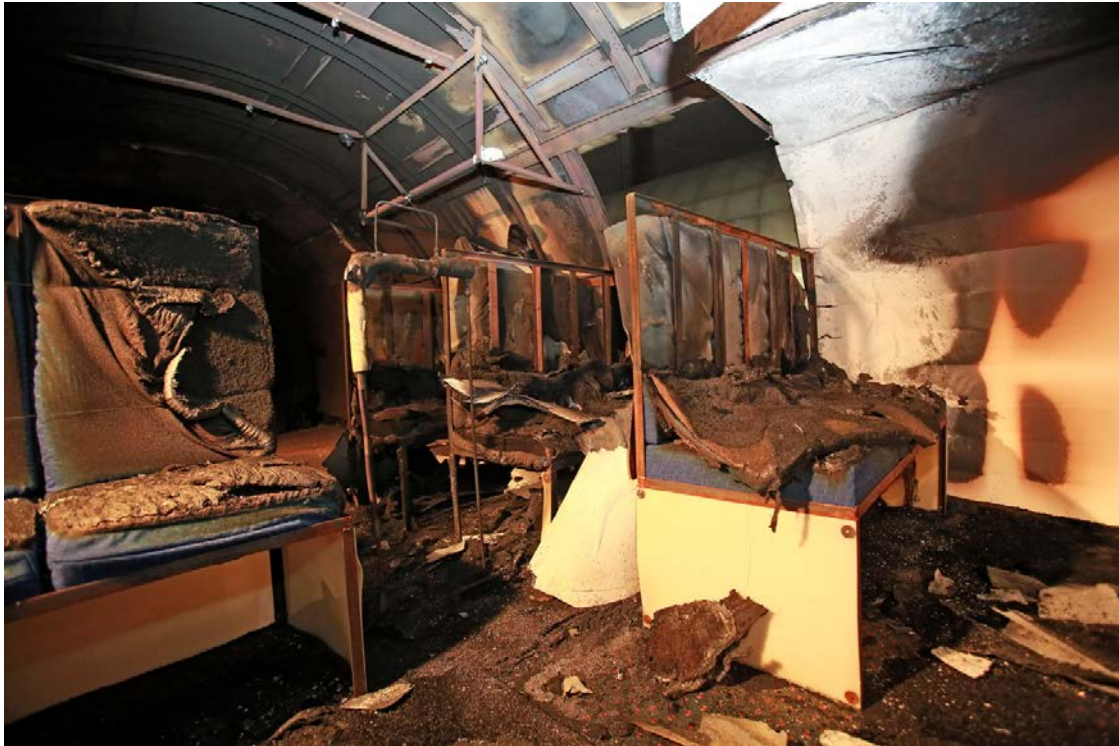
Figure 21. Post-test view of seating materials during non-heat-release-compliant test

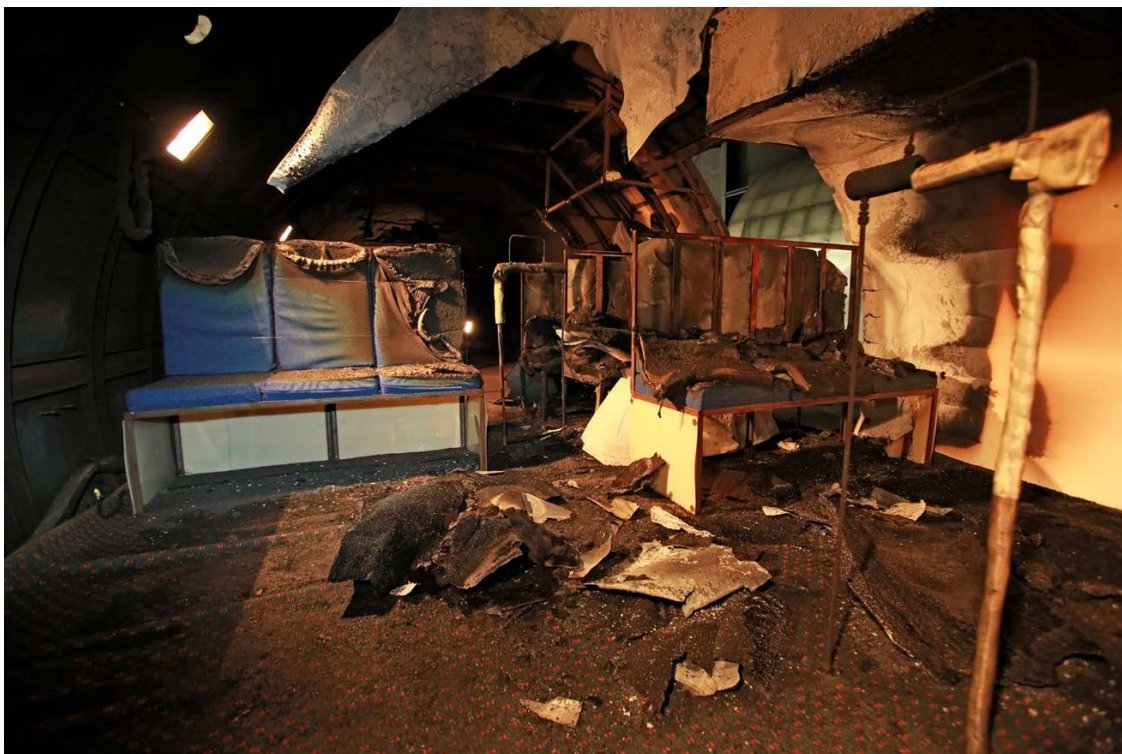
Figure 22. Post-test view of seating materials during non-heat-release-compliant test, view looking aft
