DOT/FAA/TC-16/42

A Comparison of the Performance of OSU-Compliant Versus Non-OSU-Compliant Thermoplastics Used in the Lower Area of Aircraft Seats During a Simulated Post-Crash Fire Scenario

Final Report

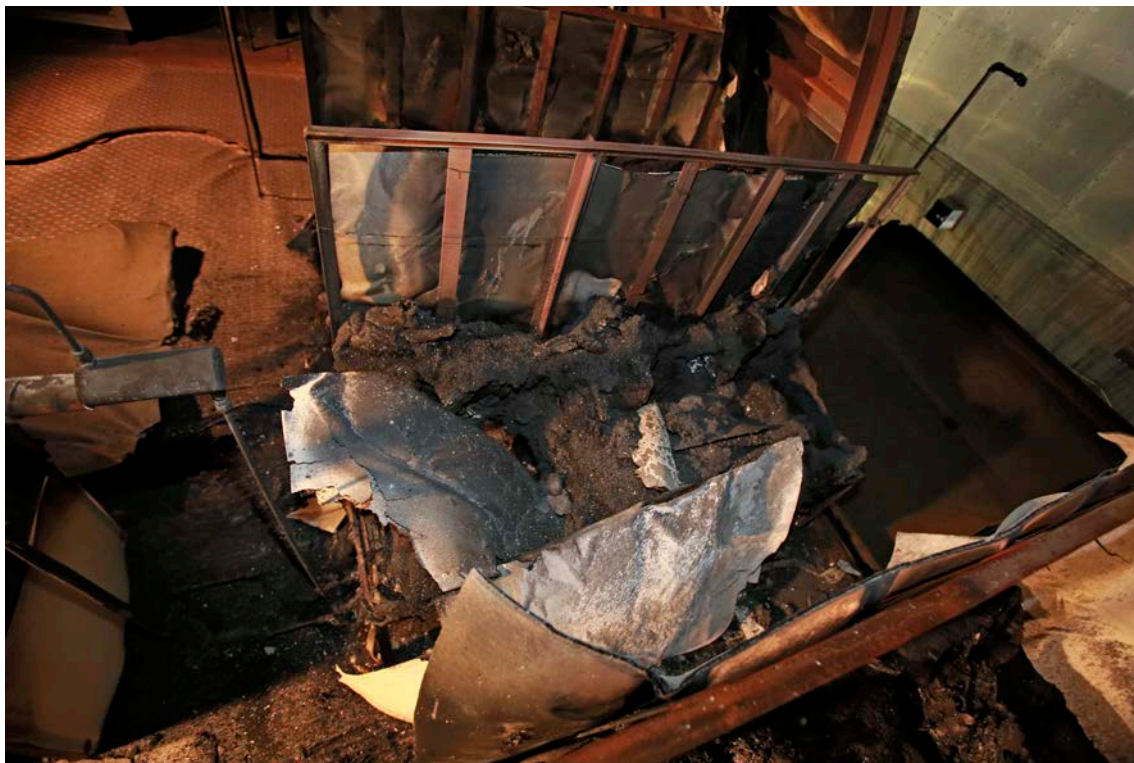
Figure 23. Post-test view of fuselage interior showing seat in fire opening

sidewall panels next to the fire opening were also heavily damaged, as were the mocked-up stowage bins (figures 20–22). The seat-cushion materials on the seat located directly in the fire opening were almost completely consumed, with only charred remnants remaining. The seat-back cushion materials appeared to fall forward onto the seat bottom cushions despite each seat place being restrained with safety wire to prevent or minimize this occurrence (figure 23). The cushion materials in the seats forward and aft of the seat in the fire opening were also heavily damaged, with the forward seat-back cushions again falling onto the seat-bottom cushions (figure 24).

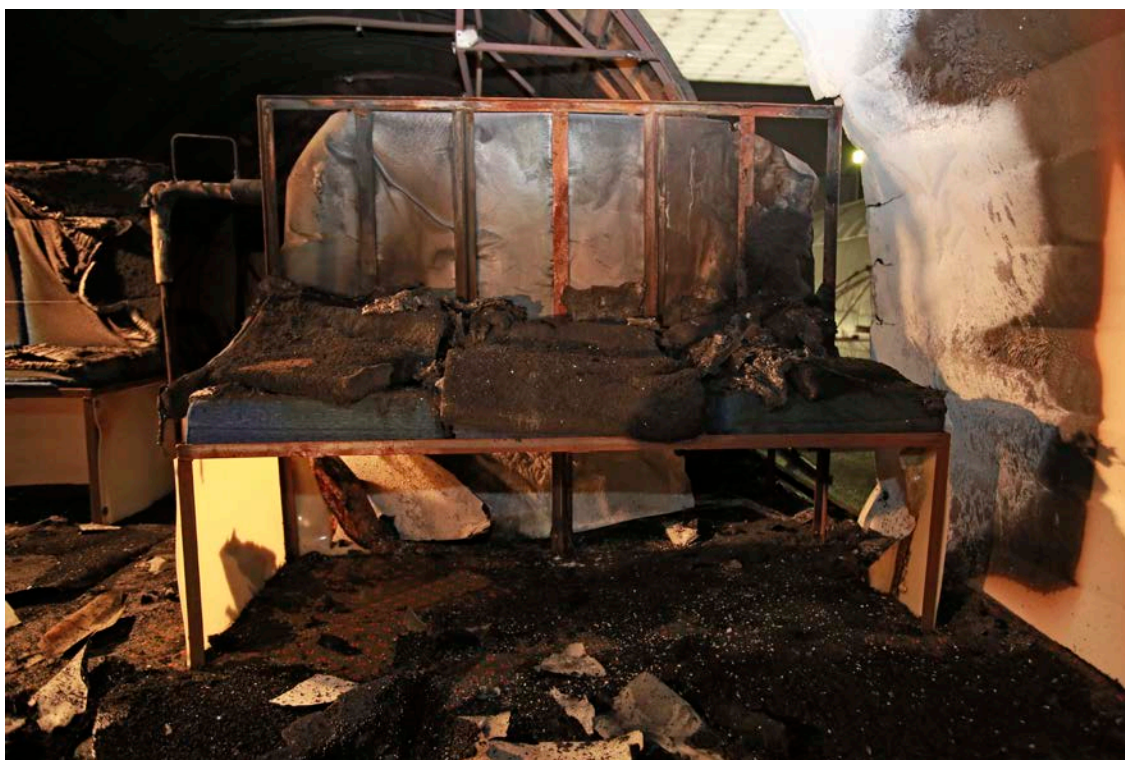
Figure 24. Post-test view of fuselage interior showing forward port side seat

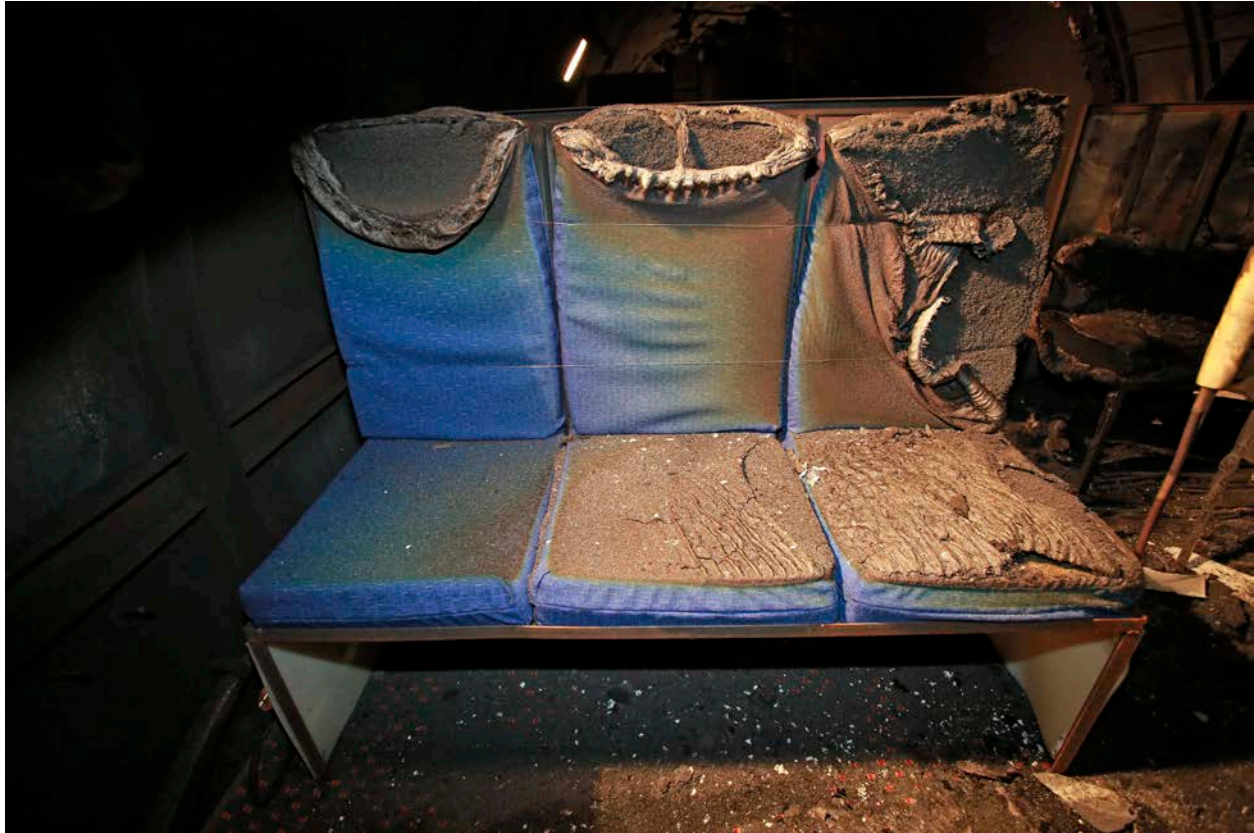
Figure 25. Post-test view of fuselage interior showing damage to starboard-side seat

In addition to the port-side (fire opening) seats being largely consumed, there was also evidence the fire crossed over the aisle to the starboard side seat. The starboard side seat was significantly fire damagedmoderately , with the seat back closest to the fire door nearly consumed (figure 25). This was a noticeable difference from the previous test, in which the fire caused only minor charring of the starboard seat.

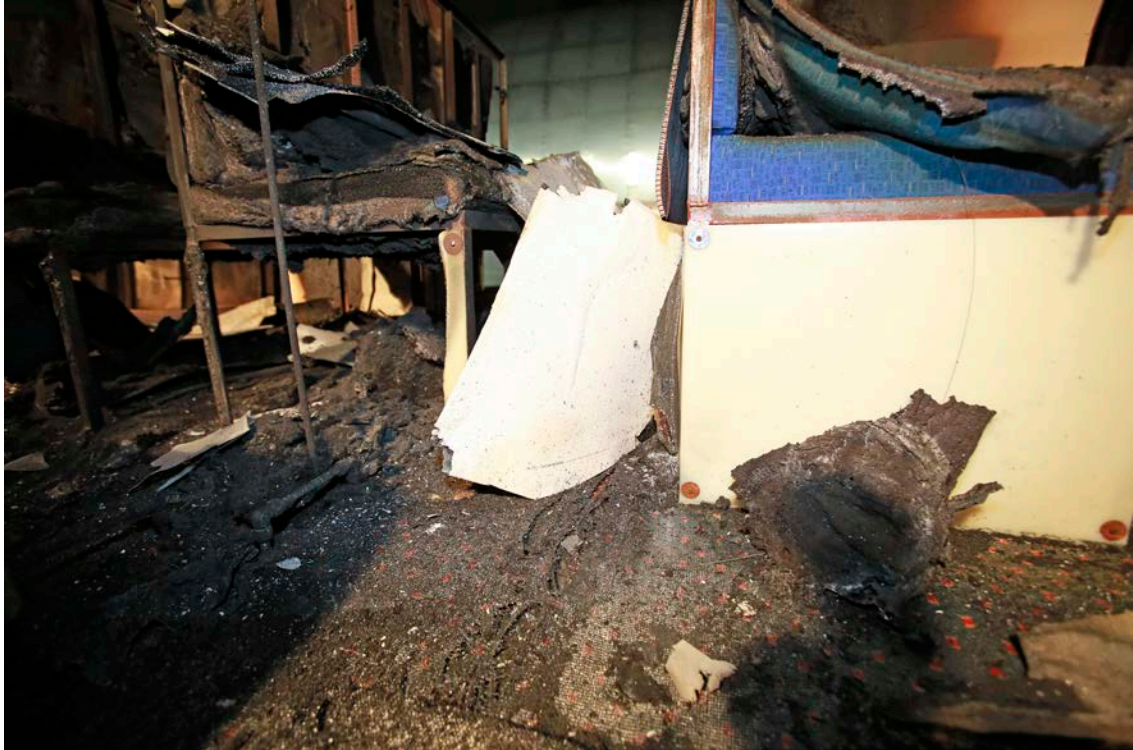
Figure 26. Post-test view of fuselage interior showing damage to thermoplastic paneling

The fastening method employing the bolts and large-head washers was again effective in preventing the thermoplastic materials from falling to the floor (figure 26). However, the side and rear panels of the aft seat were also completely consumed (figure 27). This represented a noticeable difference from the previous test, in which the thermoplastics located in these areas were still somewhat intact. The thermoplastics mounted on the starboard-side seat were undamaged, except for some minor warping on the side facing the fire (figure 28).

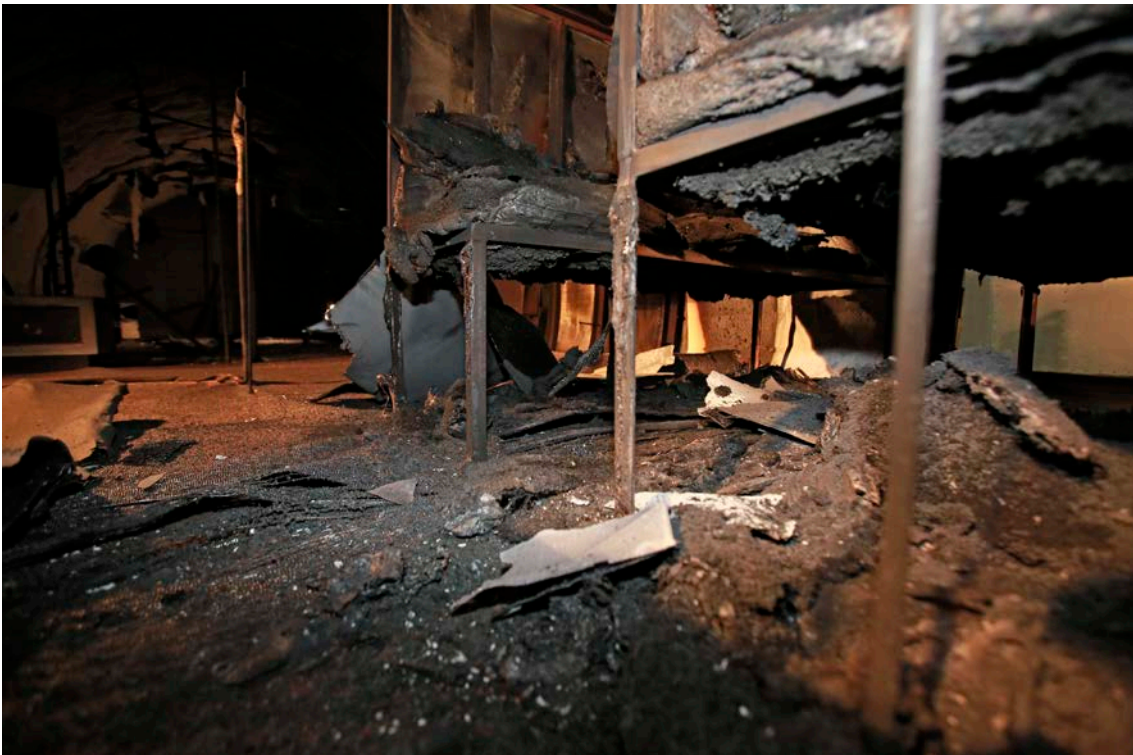
**Figure 27. Post-test view showing damage to thermoplastic paneling
on seat positioned in fire opening**

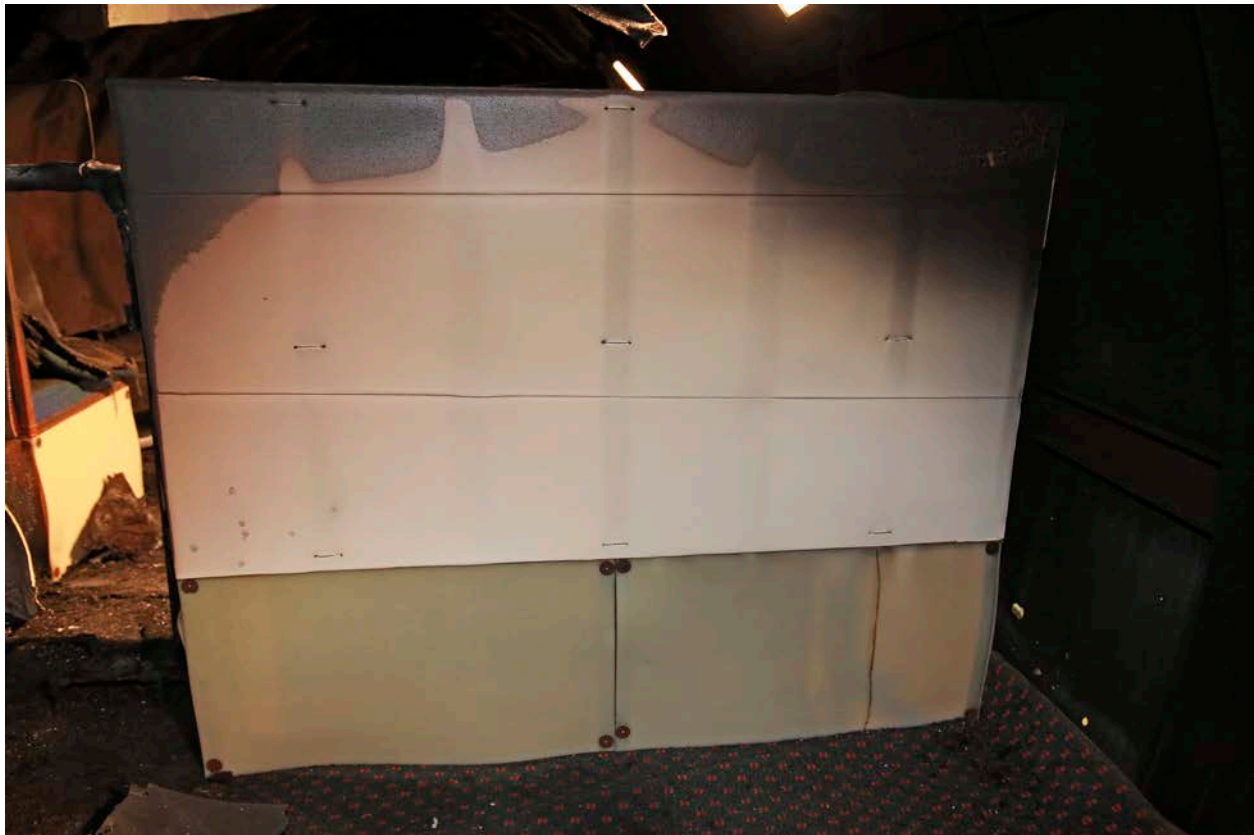
Figure 28. Post-test view showing damage to thermoplastic paneling on starboard-side seat

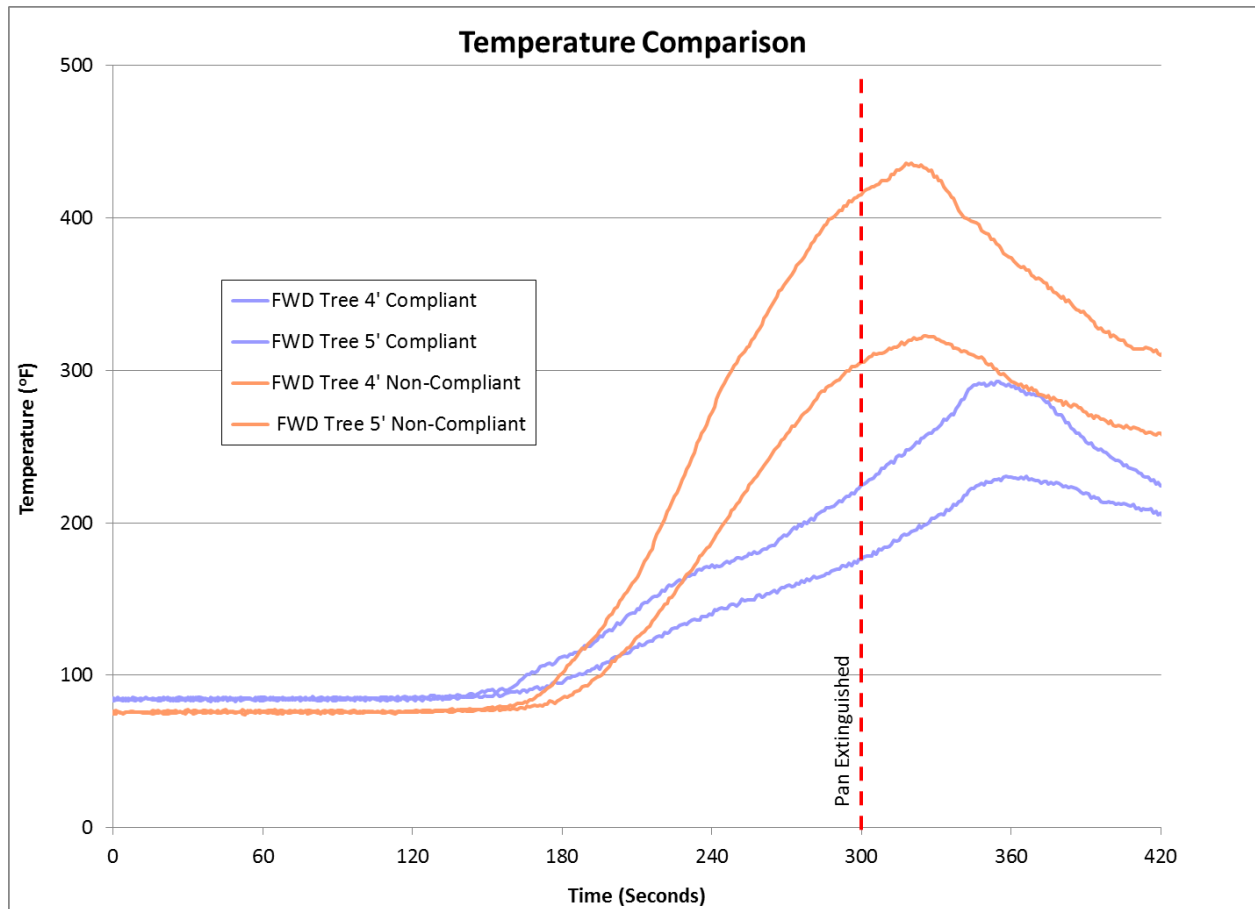
Figure 29. Temperature comparison at the forward cabin area

The forward cabin temperatures, measured at heights between 4' and 5' above the floor, indicated similar temperatures up until approximately 180 seconds into the test. Shortly after this point, the temperatures at this location increased markedly during the test using the non-heat-release-compliant materials (figure 29). At the 5' elevation, the temperatures exceeded 400°F at the point of pan fire extinguishment, whereas the compliant material test reached only 220°F. A similar trend was observed at the mid-cabin temperature tree, which was located closer to the burning materials (figure 30). The temperature separation between the two tests was even more pronounced, with the noncompliant material test reaching more than 600°F and the compliant material test only slightly exceeding 300°F.

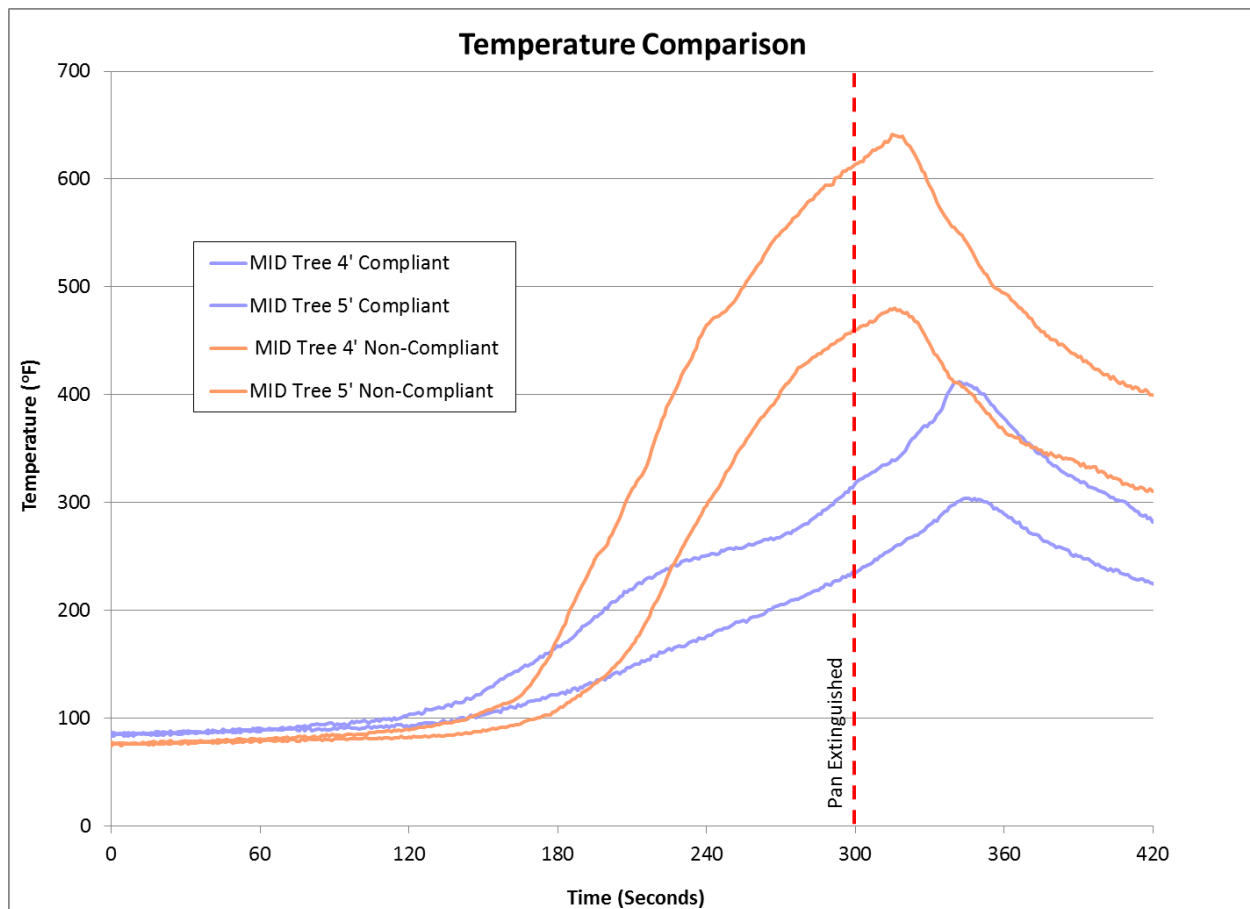
Figure 30. Temperature comparison at the mid-cabin area

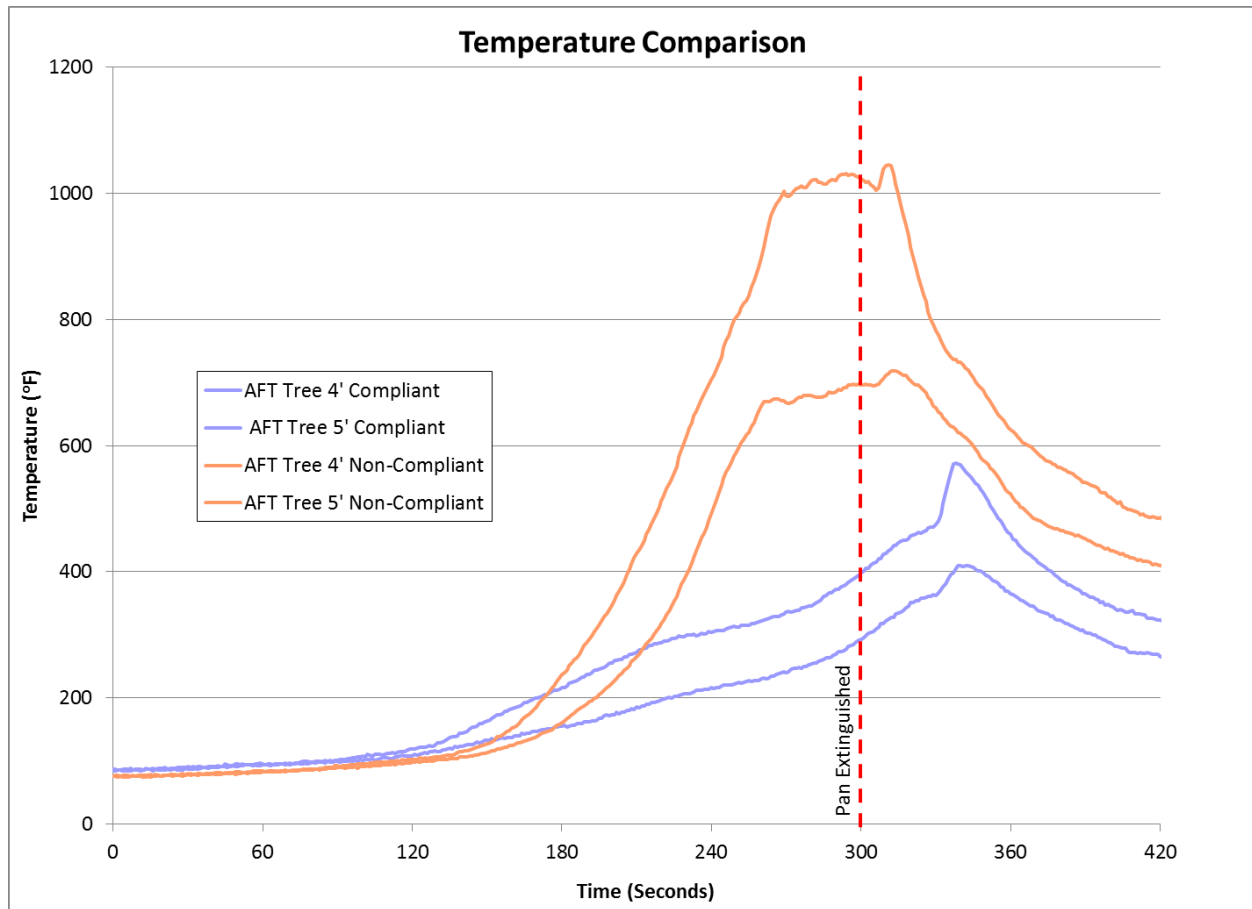
Figure 31. Second temperature comparison at the mid-cabin area

Air temperatures were also measured in the aft cabin (figure 31), where a similar trend was observed with the temperatures measured in the forward and mid-cabin locations. At approximately 180 seconds, the cabin air temperatures increased rapidly for the non-heat-release-compliant test. The rapid climb in temperatures eventually slowed after 240 seconds, but they reached a peak of more than 1000°F, whereas during the heat-release-compliant test, they were approximately 400°F. In all cases, the thermocouple tree measurements indicated a stratified environment inside the fuselage, with temperatures increasing as the height from the floor increased.

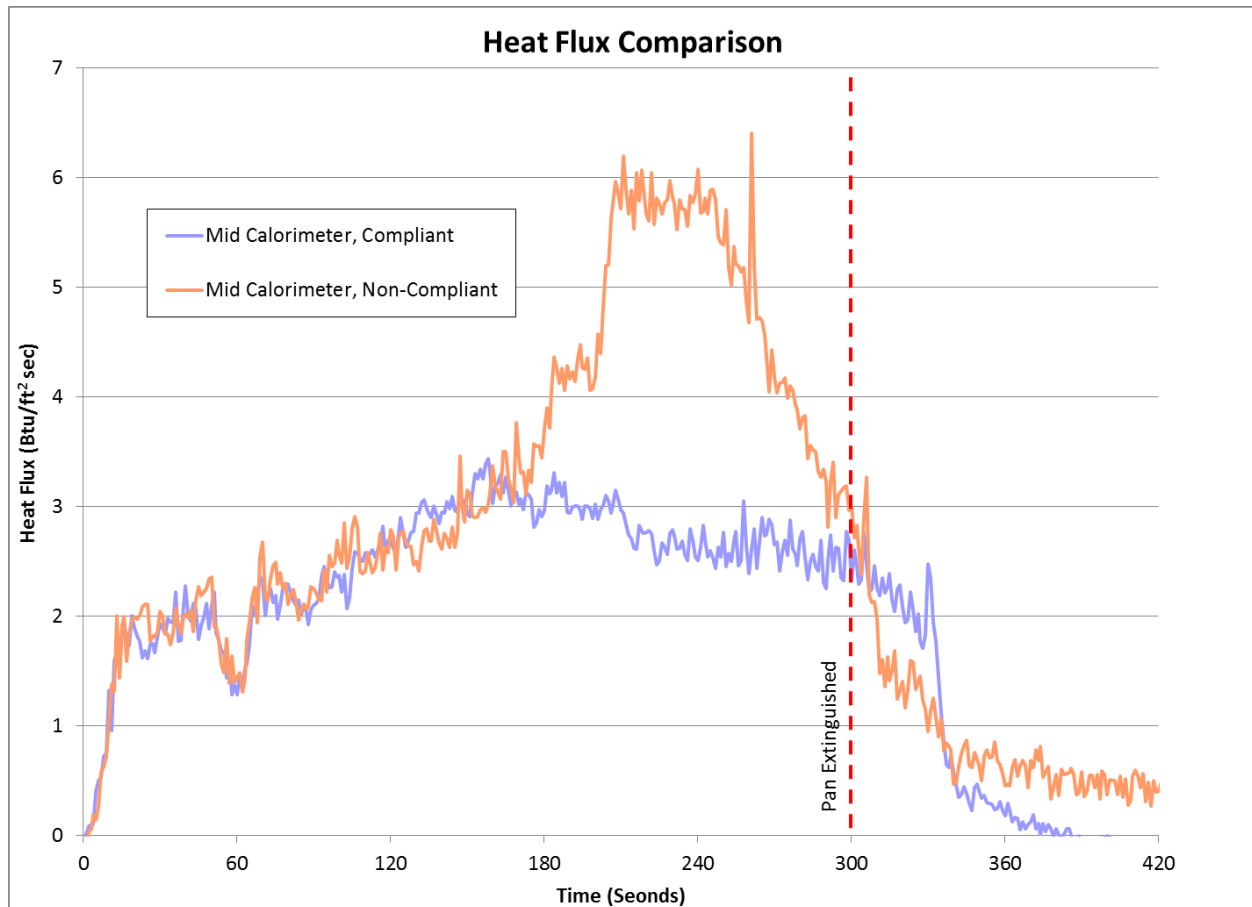
Figure 32. Heat flux comparison in test section

Heat flux measurements were taken in the immediate area of the seats and paneling via three water-cooled heat flux transducers. The transducers were positioned horizontally at a height of 42" above the floor. This provided a good comparative measurement of the conditions in the test section. One transducer was in front of the seats, facing aft, and another was aft of the seats, facing forward. A third instrument faced directly out toward the fire entry opening. Similar to the temperature profiles measured from the thermocouple trees, the heat flux measurements were nearly identical for the first 180 seconds of the test. At the 180-second point, the heat flux shows a marked rise during the test of the non-heat-release-compliant material, as measured by the mid-calorimeter facing the fire (figure 32). The heat flux at this location reached a maximum of approximately 6 Btu/ft² sec, whereas it reached only 3 Btu/ft² sec during the heat-release-compliant test.

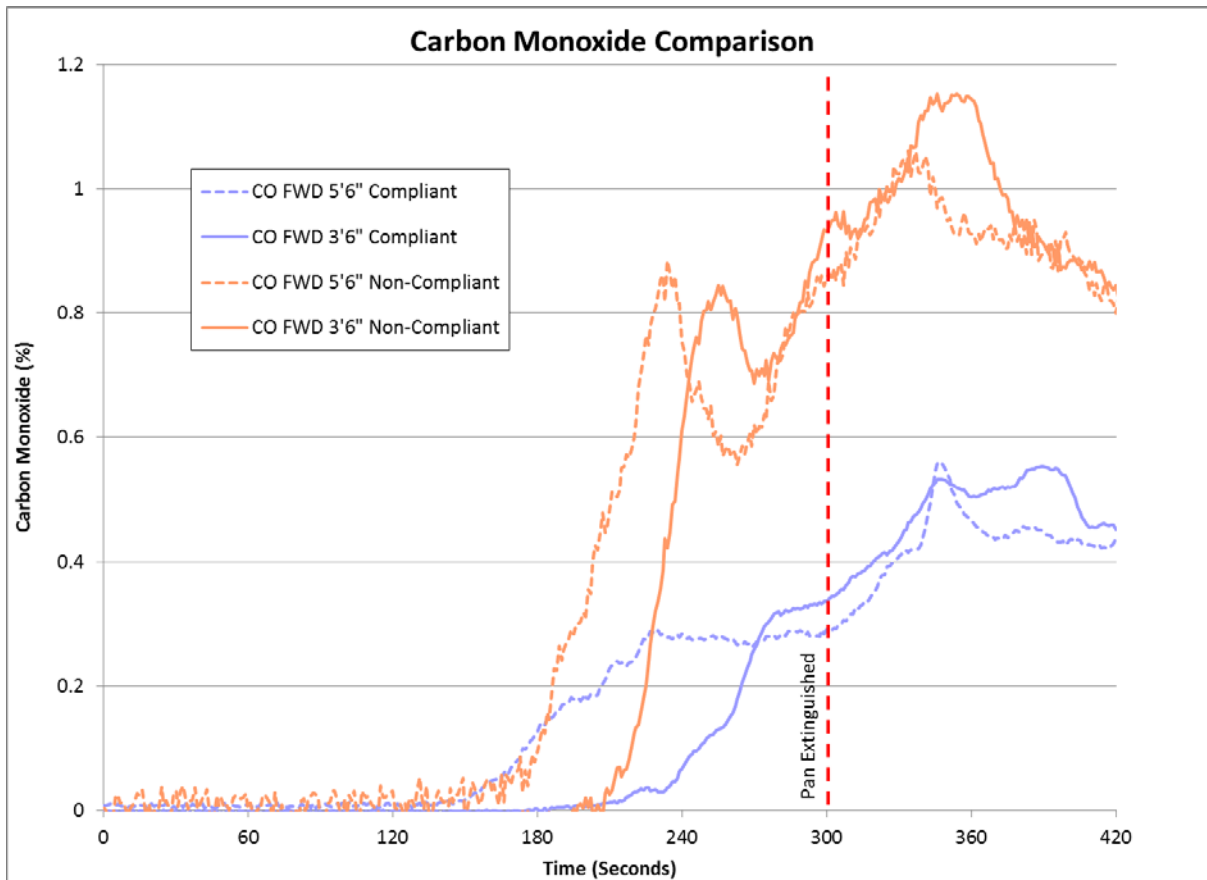
The data obtained for the carbon monoxide (CO) levels followed the same trend as the temperature and heat flux data. The forward cabin area CO levels (measured at 3'6" and 5'6") began to increase above trace levels between 140 and 200 seconds into the test, with the 5'6" level rising before the 3'6" level in both tests (figure 33). This was expected because the stratified layer of gases filled the upper section of the fuselage and then progressed downward. At the 5'6" level, the gas measurements were nearly identical for both tests until the 180-second point. After this, the CO level increased rapidly for the non-heat-release-compliant material, reaching a level of approximately 0.9% at the 5-minute mark. During the test using heat-release-compliant materials, the level reached only 0.3% at the 5-minute mark. Similar results were also obtained at the 3'6" level.

Figure 33. CO level comparison at forward cabin area

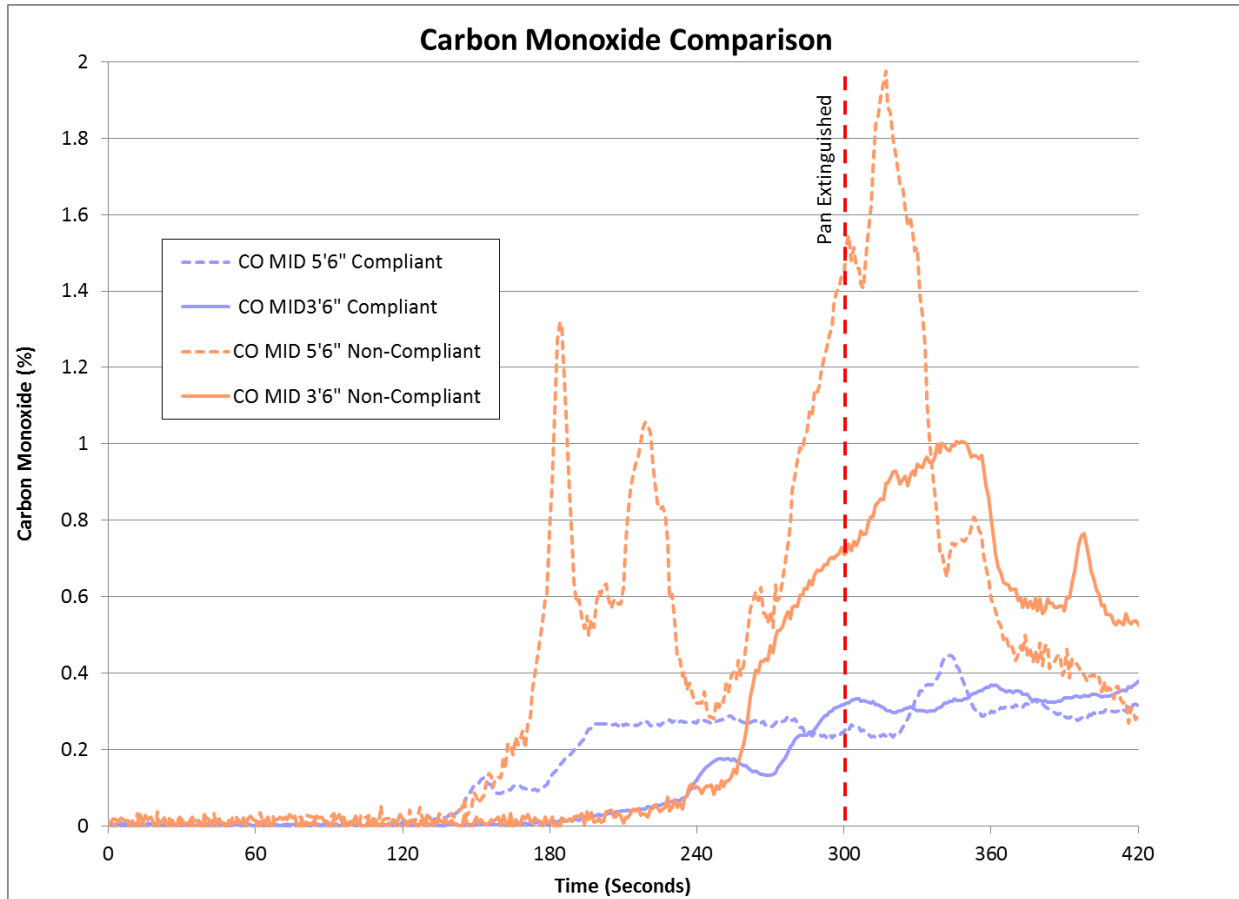
The mid-cabin area CO levels (measured at 3'6" to 5'6") showed a much more erratic behavior, indicating greater turbulence in the cabin air at this location (figure 34). This was anticipated because there is typically more air movement closer to the fire. Although less clear than the forward cabin station, the CO levels began to increase above trace levels between 130 and 180 seconds into the test, with the 5'6" level again rising before the 3'6" level in both tests because of stratification. At the 5'6" level, the gas measurements were nearly identical for both tests until the 150-second point. After this, the CO level increased and decreased rapidly for several iterations for the non-heat-release-compliant material, reaching a level of approximately 1.5% at the 5-minute mark. During the test using heat-release-compliant materials, the level reached only 0.3% at the 5-minute mark. At a height of 3'6" above floor, the non-heat-release-compliant materials reached a maximum of 0.7%, whereas the heat-release-compliant material reached a maximum of approximately 0.3%.

Figure 34. CO level comparison at mid-cabin area

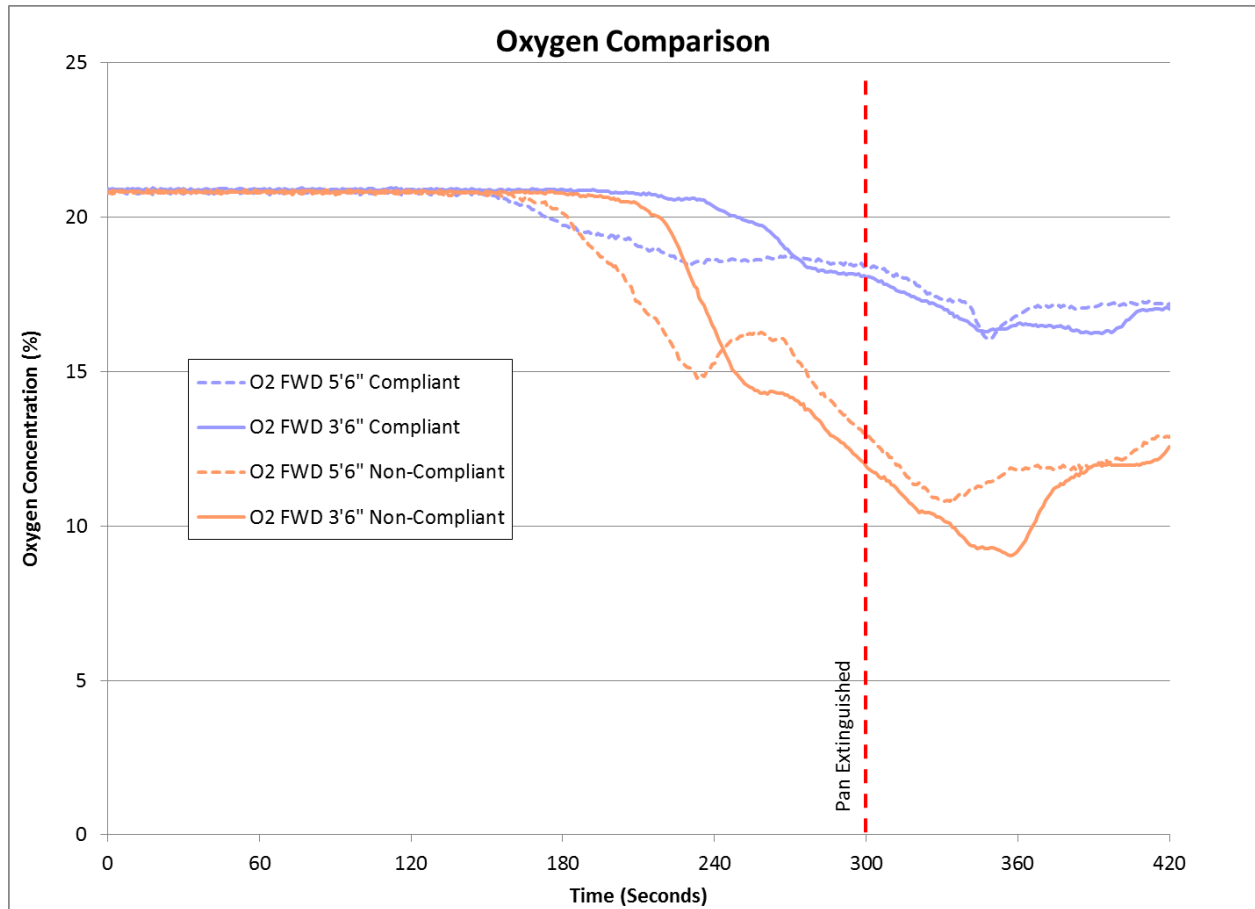
Oxygen depletion was also recorded and showed much the same delay and trending between the two tests compared (figures 35 and 36). At the forward cabin area, the oxygen levels dropped to between 12% and 18% at the point where the external fuel fire was being extinguished (figure 35). As with the CO measurements, the oxygen depletion was recorded at the 5'6" height before occurring at the 3'6" height. The oxygen depletion began at approximately 160 seconds at the upper measuring level, and 200 seconds at the lower level.

Figure 35. Oxygen level comparison at forward cabin area

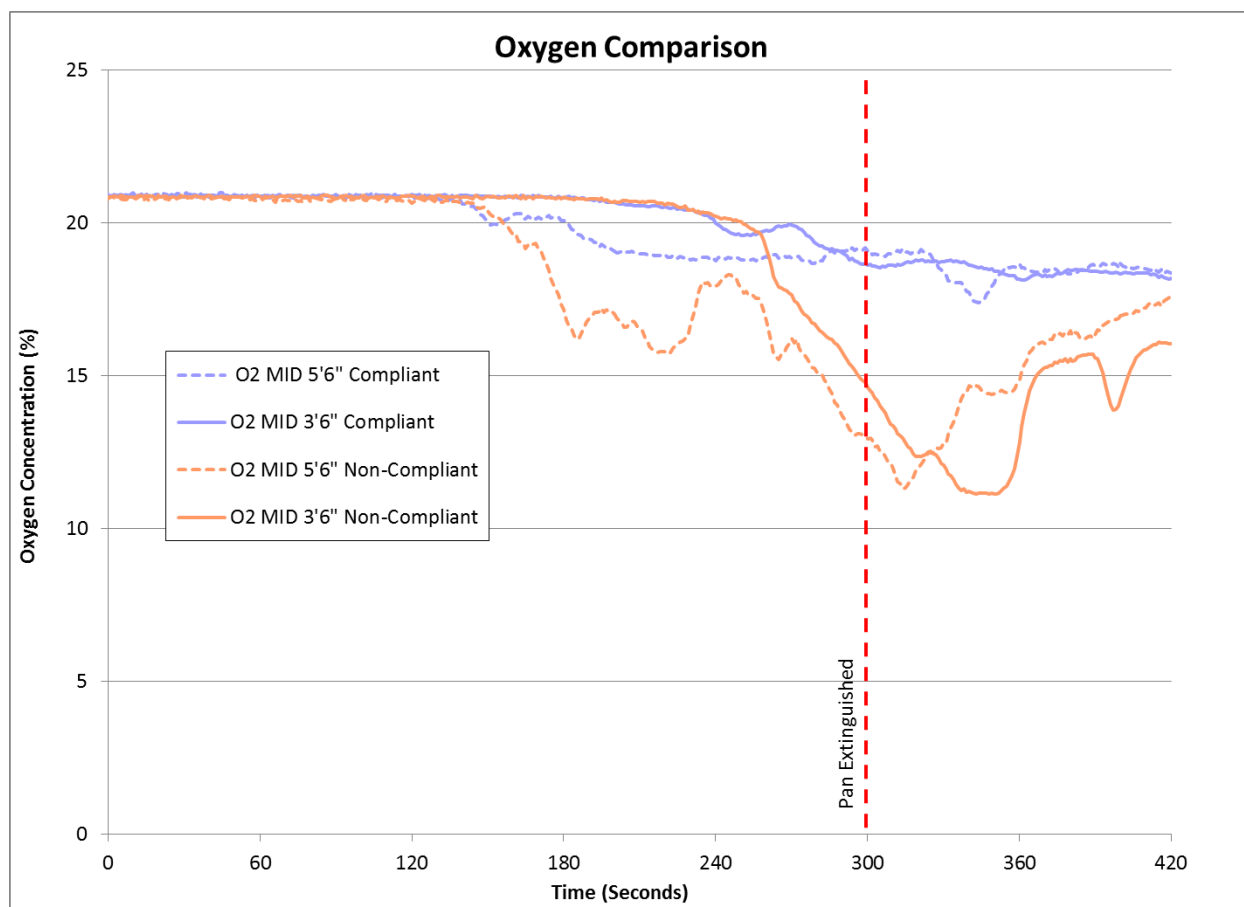
Figure 36. Oxygen level comparison at mid-cabin area

At the mid-cabin location, closer to the fire, the oxygen depletion began to occur at 150 seconds at the 5'6" level and 190 seconds at the 3'6" level. At the point of extinguishment of the external fuel fire, the oxygen levels had dropped to between 13% and 15% for the non-heat-release-compliant materials and approximately 18%–19% for the heat-release-compliant materials. As expected, the mid-cabin oxygen levels were not as uniform (figure 36), indicating less stratification and more mixing because of this area's closer proximity to the burning materials.

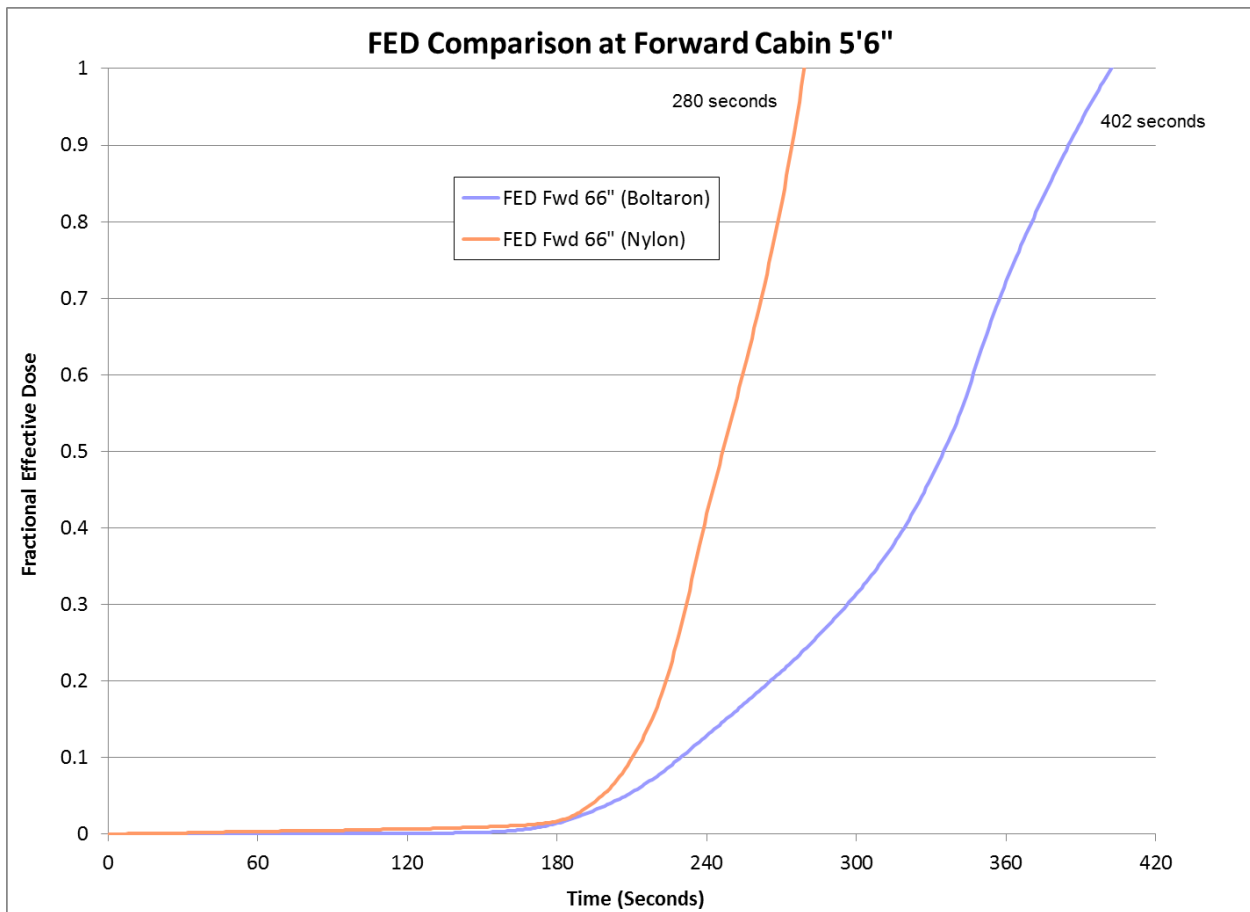
The results from this two-test comparison showed a marked decrease in survivability when the non-compliant thermoplastic materials were used. At the forward cabin area, theoretical incapacitation was reached in 402 seconds for the heat-release-compliant material test, but only 280 seconds for the non-heat-release-compliant materials (figure 37). Although the initial increase in hazard level within the fuselage was nearly identical for the two tests (3 minutes 40 seconds for the compliant materials, and 3 minutes 35 seconds for the non-compliant materials) this was a significant (122-second) difference between the two tests. This indicates the non-heat-release-compliant materials produced more substantial fire growth, resulting in reduced time until incapacitation. Likewise, at the mid-cabin location, the non-heat-release-compliant materials resulted in incapacitation 94 seconds earlier than when using heat-release-compliant materials (figure 38).

Figure 37. Survivability comparison of heat-release-compliant and heat-release-non-compliant tests at the forward cabin area

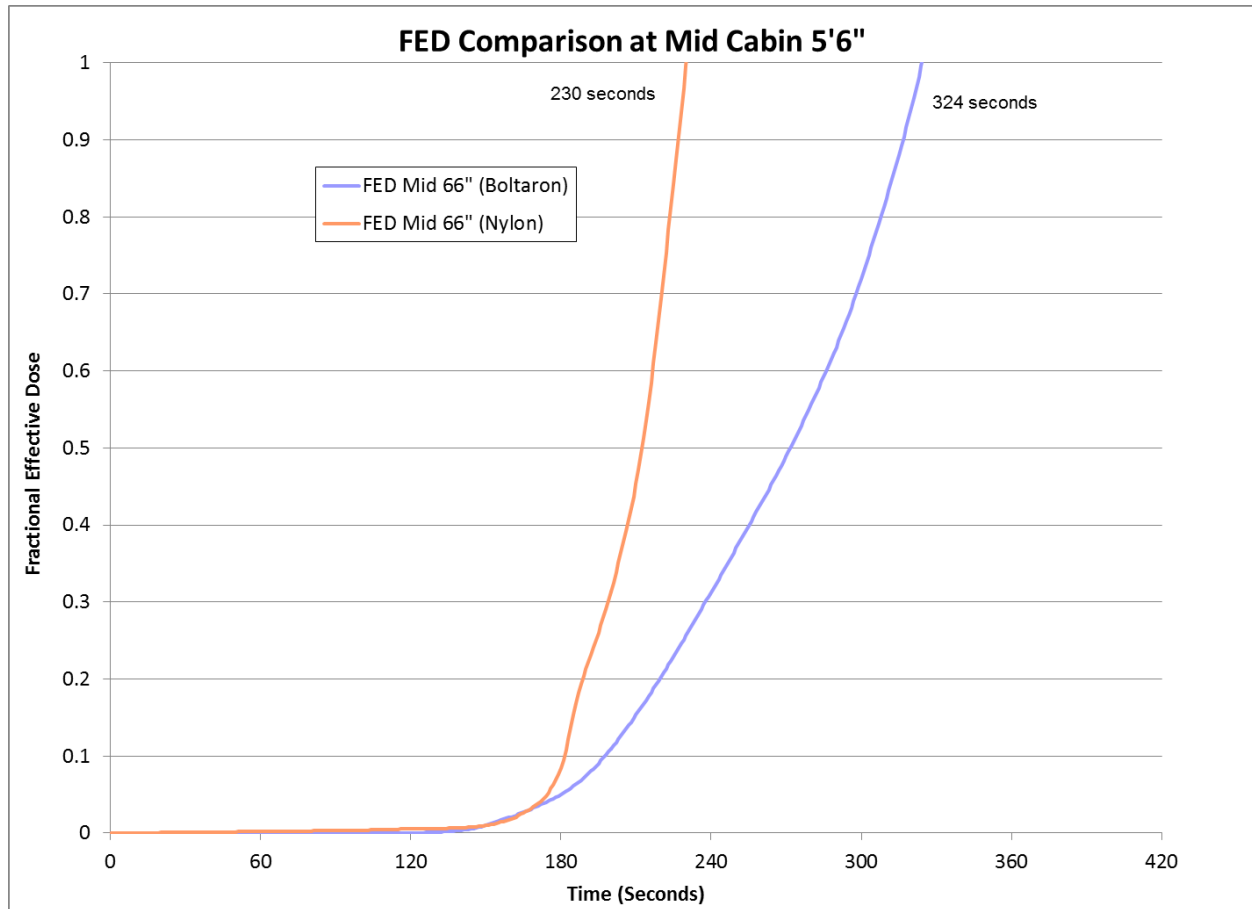
Figure 38. Survivability comparison of heat-release-compliant and heat-release-non-compliant tests at the mid-cabin area
