A Preliminary Examination of the Effectiveness of Hand-Held Extinguishers Against Hidden Fires in the Cabin Overhead Area of Narrow-Body and Wide-Body Transport Aircraft

July 2007

DOT/FAA/AR-TN04/33

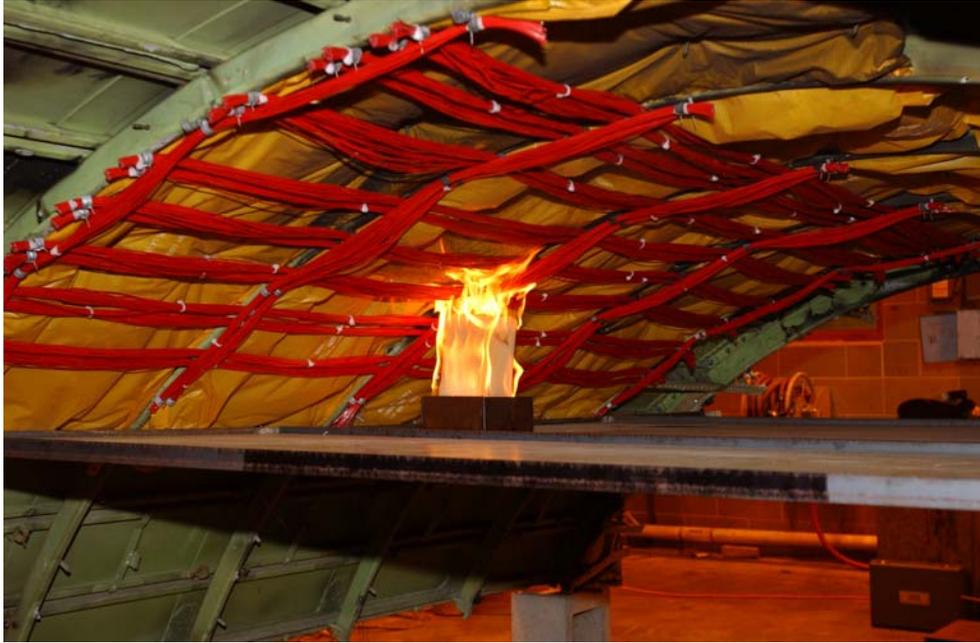
Current Federal Aviation Administration (FAA) research is aimed at the development of more stringent fire test methods for materials located in hidden areas such as the ceiling overhead areas, cheek areas, and electronics and electrical (E/E) bays. This research targets the flammability of materials such as ducts, wires, panel closeouts, clamps, and other hardware located in the hidden and inaccessible areas to upgrade these materials to an equivalent level of fire resistance as recently adopted for thermal acoustic insulation [1]. The objective is to passively reduce the likelihood of an in-flight fire from occurring by substantially improving the fire resistance of materials in hidden areas. The research is coordinated with a subgroup of the International Aircraft Materials Fire Test Working Group, a government/industry group chaired by the FAA. Full-scale tests have been completed in which various types of wiring insulation were evaluated against a realistic fire threat (figure 1) [2].

Figure 1. Wiring Test in a Simulated Cabin Overhead Area

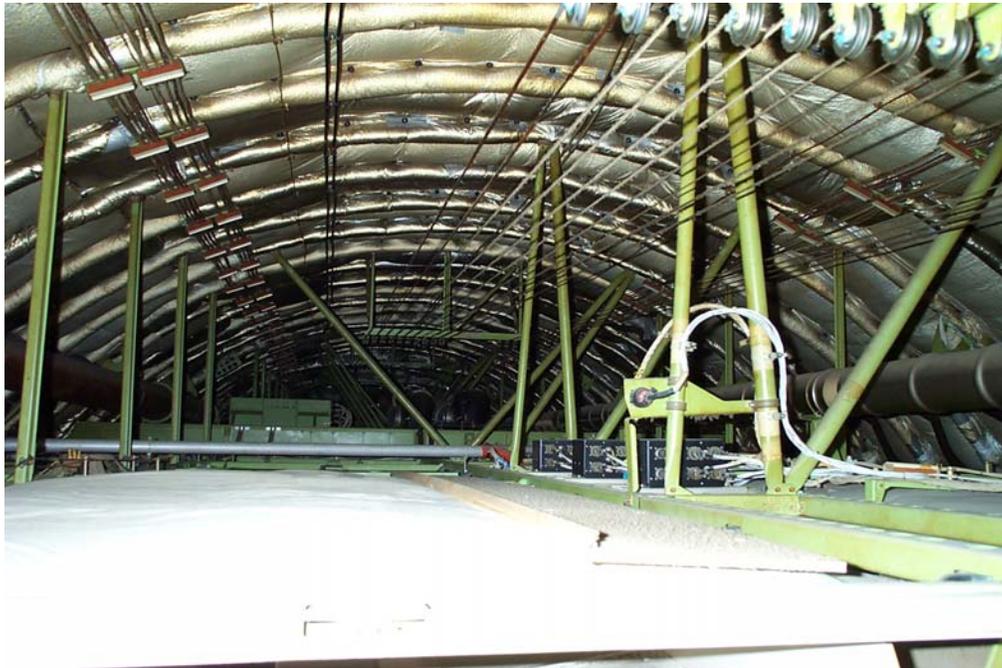
Although a majority of the cabin overhead volume is devoid of combustible materials, the periphery contains insulation blankets and adjacent wire bundles. There are also several wire bundles that run along the centerline, just above the ceiling panels. The aft overhead section of the B-747SP wide-body aircraft is shown in figure 4.

Figure 4. B-747SP Wide-Body Aircraft Aft Cabin Overhead Area

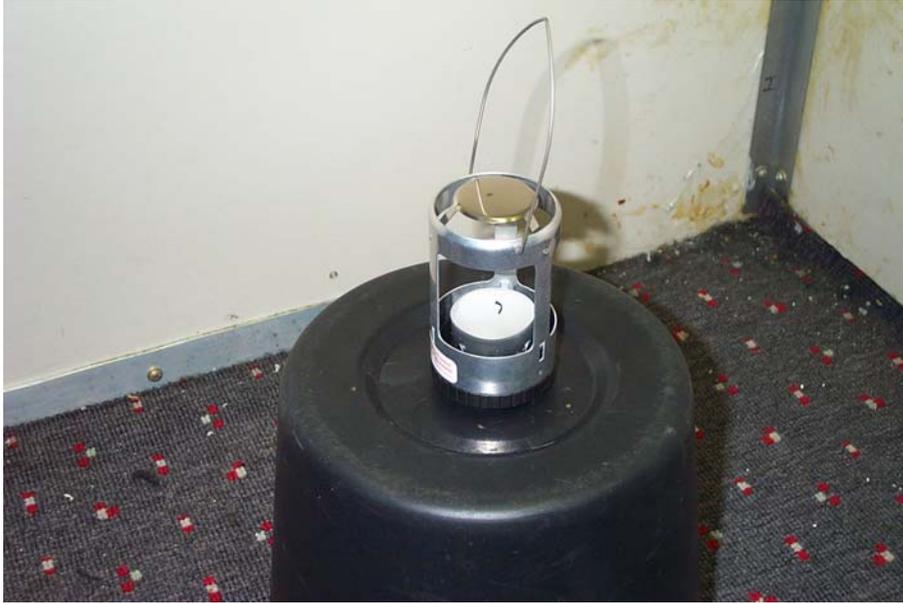
Since the B-747SP was an operational test aircraft, as opposed to a true fire test article, care had to be taken not to cause damage to the interior during live fire tests. To create a realistic yet safe fire scenario, small candle lanterns were incorporated to measure the range and volume of fire extinguishant. The candles were paraffin-based discs, enclosed in a protective metal shroud to prevent wax spillage and ignition in the event that the candle tips over (figure 5). The candle lanterns were equipped with glass cylinders that shrouded the flames, making it somewhat difficult to extinguish them. For this reason, the glass shrouds were removed for all tests performed in the cabin overhead area. Once lit, the candle lanterns could burn continuously for 4 hours, making them ideal for this type of hidden space test.

Figure 5. Candle Lanterns Used in Cabin Overhead Area Tests

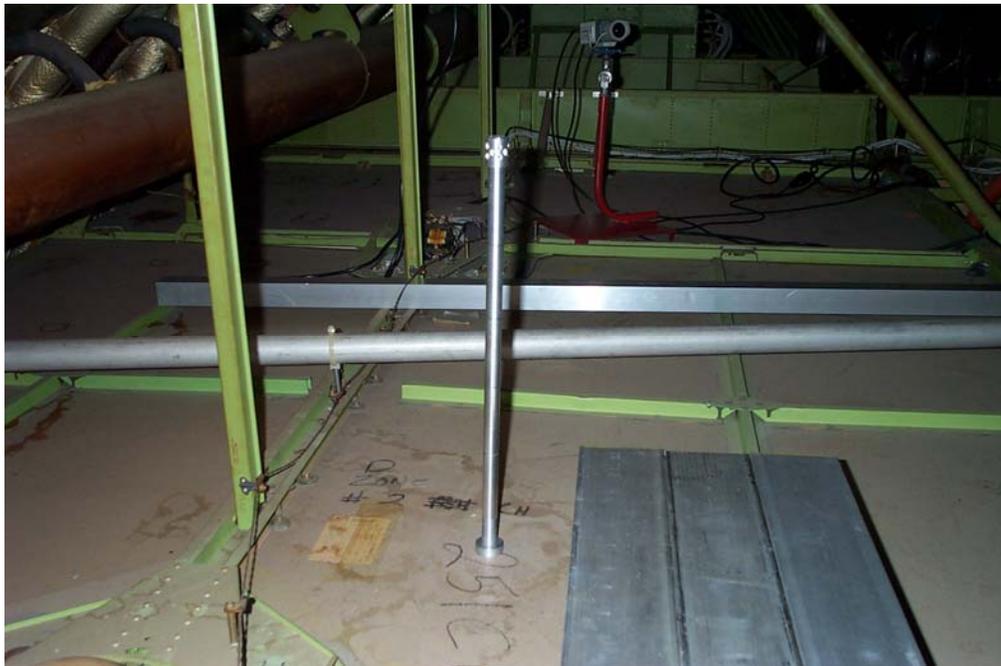
To use the available extinguishing agent most efficiently, the initial ceiling-mounted port was designed to extend above the cabin ceiling to promote extinguishing agent transport to the combustible materials near the crown of the aircraft. The port and discharge head contained a series of threaded extension tubes, each measuring approximately 6 inches long. When five extension tubes were used in conjunction with the head, the discharge point was situated 30 inches above the cabin ceiling. The discharge head was designed to propel the agent radially (figures 7 and 8).

Figure 7. Ceiling-Mounted Port Extension Tube Mounted in Cabin Ceiling

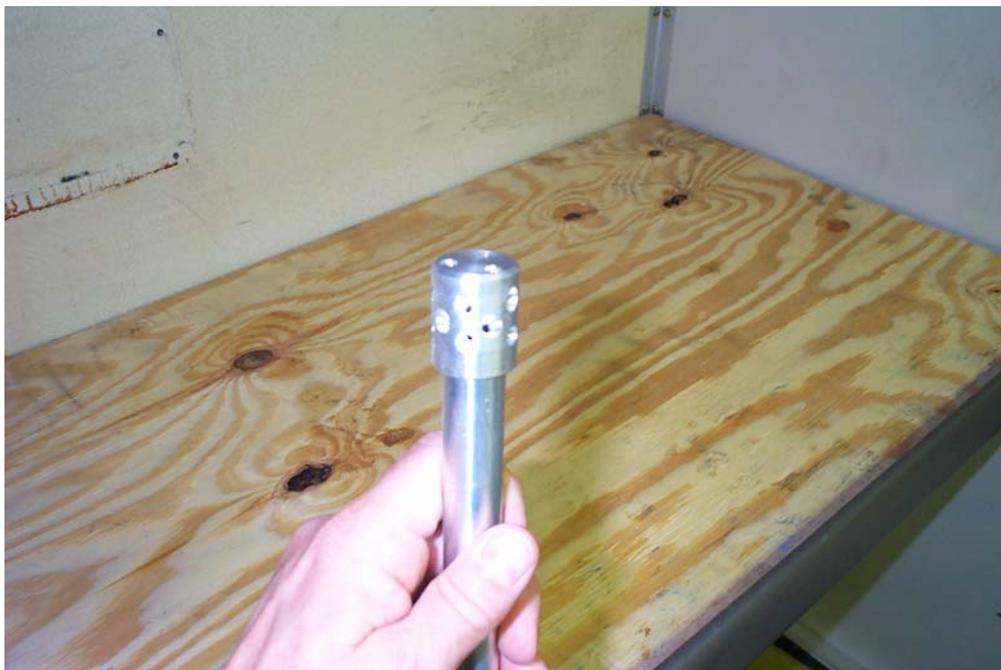
Figure 8. Ceiling-Mounted Port Prototype Discharge Head

Test 2 was run using the prototype discharge head (figure 8) attached to the end of the ceiling-mounted port. This configuration provided extinguishment of four of the six candles, a much better result than test 1. Although the overall thrust of the extinguisher was restricted with this design, it did convey the extinguishing agent far enough radially to give this outcome.

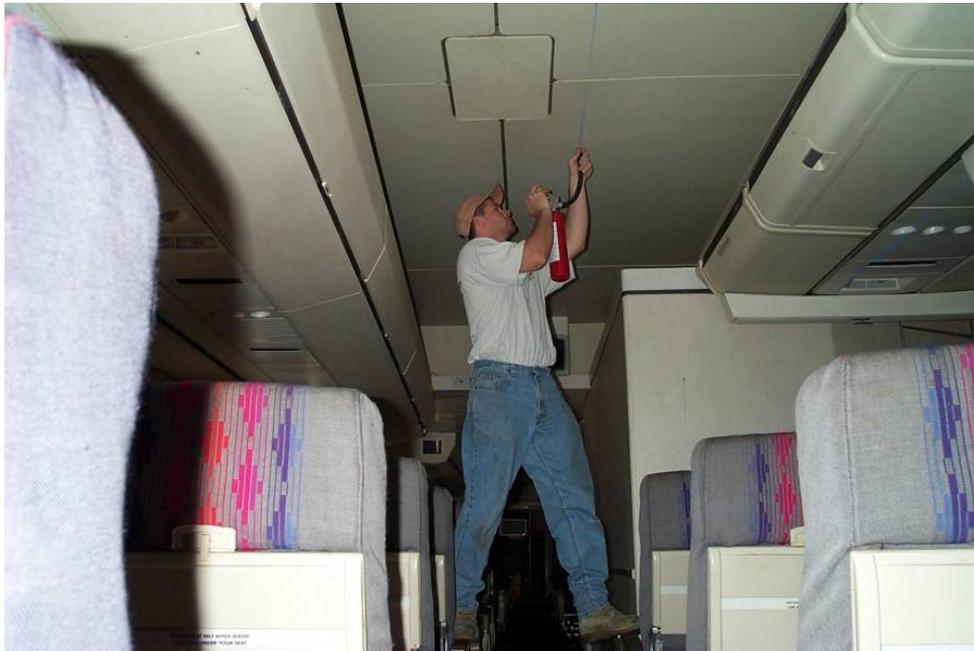
The ceiling-mounted port and associated tubes and head were centered over the left aisle, just aft of the crew rest area, which was converted into a control room for these tests. Cameras were mounted in the cabin overhead area to capture the sequence of events during extinguishing agent discharge. One important note was that all extinguishers incorporated a flexible discharge hose, allowing the extinguisher to remain perfectly upright during discharge. This enabled full expulsion of the extinguisher contents, which would not be possible otherwise, since the extinguisher would need to be held horizontally to engage the ceiling-mounted port. Also of note was the requirement that the person discharging the extinguishing agent needed to stand on the armrests of the seats to reach the ceiling-mounted port (figure 9).

Figure 9. Extinguishing Agent Discharged Through the Port in the Wide-Body Aircraft

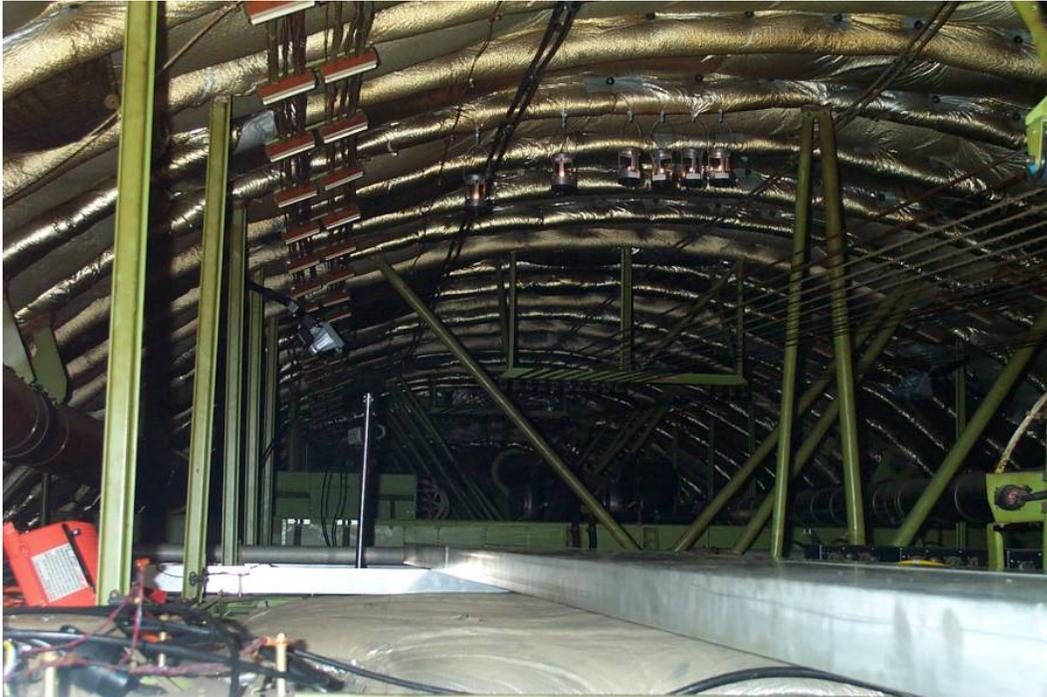
Using this arrangement, the candles were hung closer to the discharge head, perpendicular to the axis of the aircraft (figures 11 and 12). The distance from the first candle situated directly over the port to the last candle was approximately 42 inches.

Figure 12. Modified Candle Lantern Test Configuration in Cabin Overhead Area

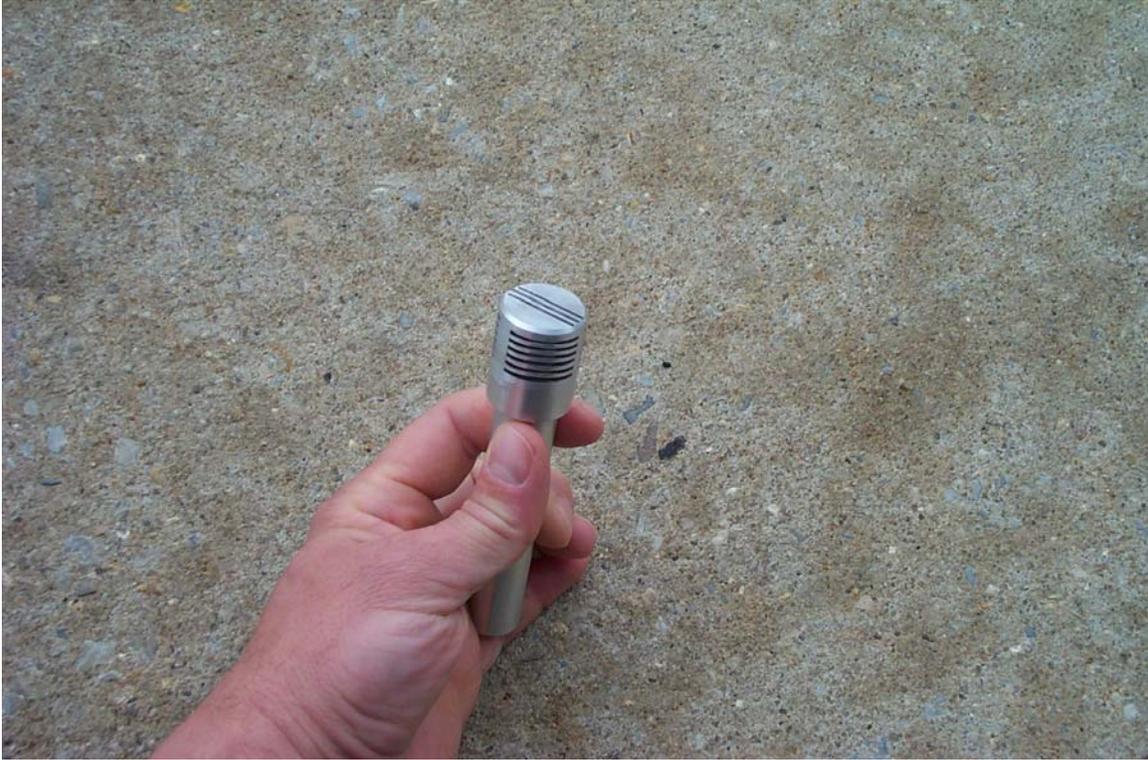
As a result, a second discharge head was designed and fitted to the ceiling-mounted port. The new discharge head featured a grill design and was much less restrictive than the previous discharge head with holes (figure 13).

Figure 13. Grill Design Discharge Head

Using the identical perpendicularly placed candle lantern test configuration, a 2.5-lb Halon 1211 extinguisher was discharged through the ceiling-mounted port containing the grill design discharge head with no additional extension tubes (test 4). This resulted in five of the six candle lanterns being extinguished. Interestingly, the lantern directly above the ceiling-mounted port location was not extinguished, indicating the upward thrust of agent was still somewhat inhibited.

During test 3, the prototype discharge head was replaced with the grilled design discharge head (figure 13). In earlier wide-body aircraft tests, this grill discharge head proved to be less restrictive, giving a slight advantage in performance over the prototype discharge head. However, the wide-body aircraft tests were run with the candle lanterns mostly vertical in relation to the discharge head, whereas the narrow-body aircraft tests were run with the candles nearly horizontal to the discharge head. Following full discharge, only three of the six candles were extinguished. Although the grill discharge head was less restrictive, it appeared slightly vertically biased, allowing more vertical discharge than radial. Given this characteristic, the

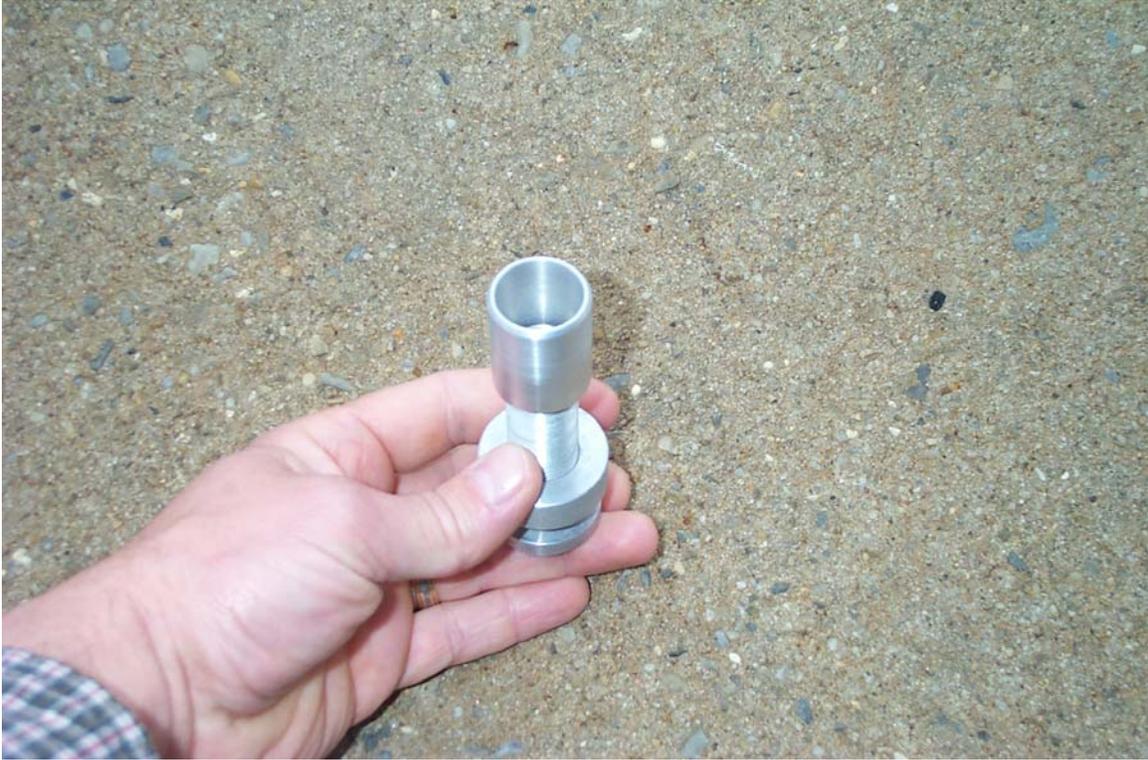
To substantiate this theory, in test 5, a feedthrough design discharge head was attached to the end of the ceiling-mounted port (figure 14). This, again, resulted in five of the six candle lanterns being extinguished. In this case, the nonextinguished lantern was farthest from the discharge location, indicating good upward thrust, but slightly reduced radial range.

Figure 14. Feedthrough Design Discharge Head

The last test in this series (test 7) used the feedthrough discharge head in conjunction with one 6-inch extension. This resulted in extinguishing all six candle lanterns. Although this result was promising, it was important to consider that the actual location of a fire may not be precisely known, and that optimization based on a specific fire location may yield misleading results. It is entirely possible that a fire could also occur directly on the top surface of the ceiling panels, either directly as the result of a wire bundle fire in this area or indirectly from a wire bundle fire above that had produced flaming drips to the ceiling surface below. For this reason, an additional candle lantern test scenario was devised in which the lanterns were placed just slightly above the ceiling panel (figure 15).

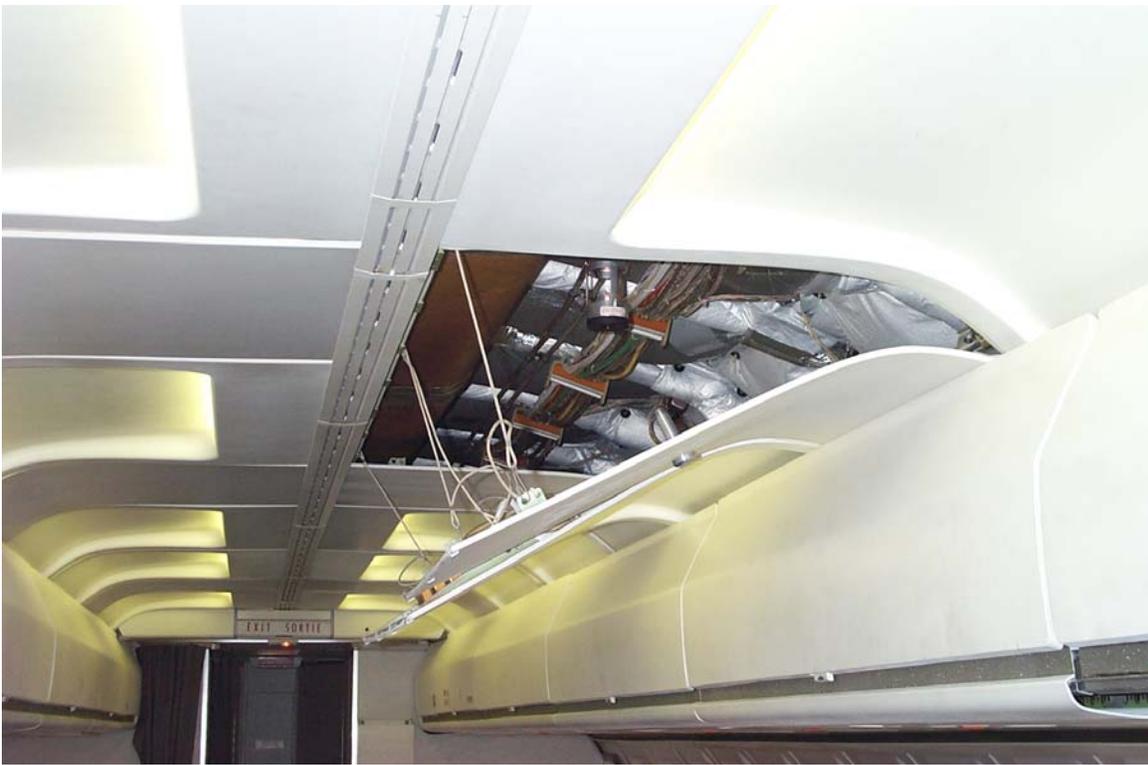
During the pretest inspection of the narrow-body aircraft, it was determined that the cabin overhead panels could be unfastened and rotated downward, giving nearly unlimited access to the cabin overhead area (figure 17). Although the locking mechanism for the panels was hidden in the overhead stowage bins and was somewhat difficult to activate, it became much easier to perform once the operator became familiar with it. This was a significant finding in that, given the proper training, a fire in the hidden overhead area of this type of aircraft with this particular panel attachment scheme could easily be accessed and extinguished. This was not true for the wide-body aircraft, in which the ceiling height was much greater and the ceiling panels were significantly larger.

Figure 17. Narrow-Body Aircraft Showing Cabin Overhead Area Access

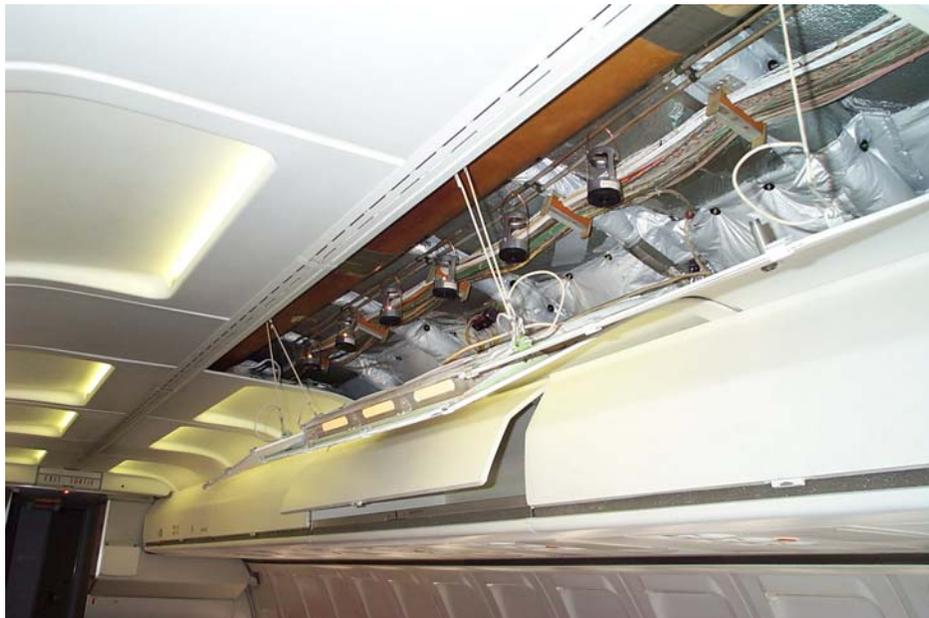
Since the cabin overhead area of the narrow-body aircraft was relatively small and cluttered in comparison with the wide-body aircraft, there were only a few possibilities in terms of the location of the candle lantern fire sources. As such, the lanterns were hung from a hydraulic line that was mounted to the fuselage formers in the cabin overhead area (figure 18). This resulted in the lanterns being very close to a large wire bundle that ran forward to aft, which was a realistic simulation in terms of fire location (figure 19). The ceiling-mounted port was installed 15 inches from the centerline of the aircraft, which was approximately aligned with the candle lanterns.

Figure 19. Narrow-Body Aircraft Test Configuration Showing Location of Candle Lanterns

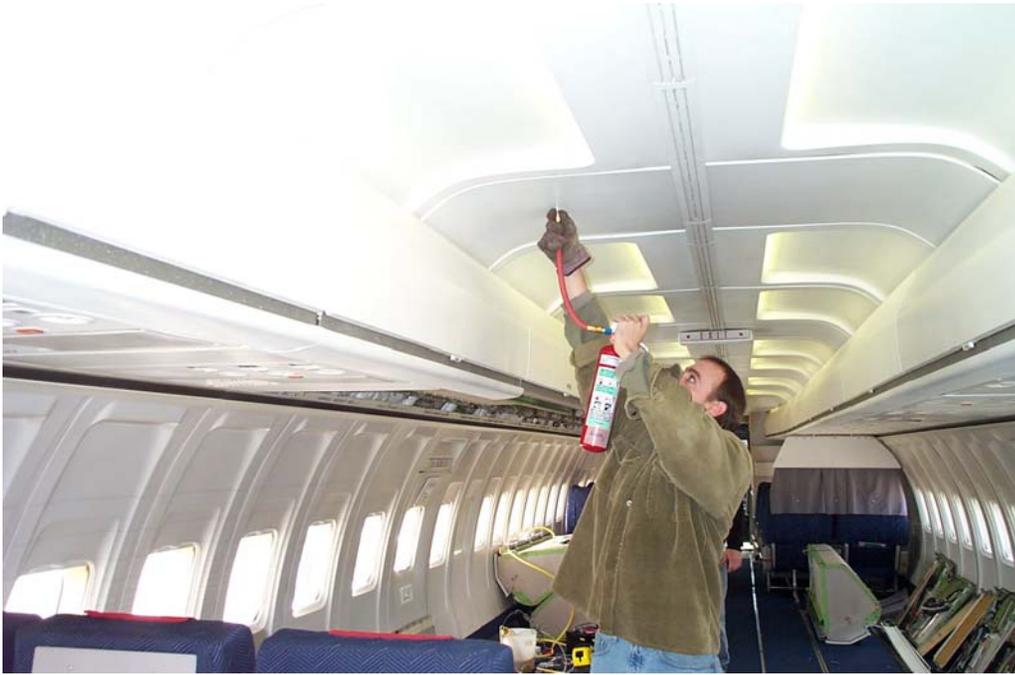
After lighting all six candle lanterns, the ceiling panels were quickly reinstalled to their proper position. The 2.5-lb Halon 1211 extinguisher was then fully discharged through the ceiling-mounted port, followed by a brief 1-minute settling period to allow the extinguishing agent to fully disperse in the cabin overhead area (figure 21). The ceiling panels were then unfastened to allow inspection of the candle lanterns. This procedure was followed for all tests.

Figure 21. Halon 1211 Discharged Through Ceiling-Mounted Port
