[Docket No. 99-NM-162-AD; Amendment 39-11750; AD 2000-11-02]

#### **Airworthiness Directives; McDonnell Douglas Model DC-10-10F, DC-10-15, DC-10-30, DC-10-30F, and DC-10-40 Series Airplanes, and Model MD-11 and -11F Series Airplanes**

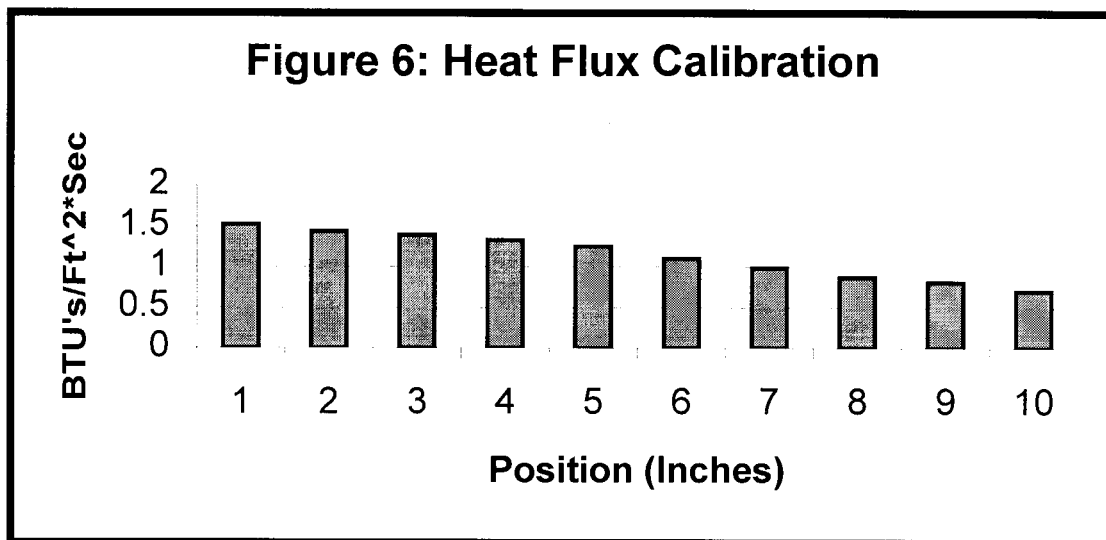
(3) After steady-state conditions have been reached, move the calorimeter 2 inches (51 mm) from the "zero" position

and record the heat flux. Allow a minimum of 30 seconds at each position for the calorimeter to stabilize. Record at

least 10 positions. (Figure 6 depicts a calibration profile.)
