DOT/FAA/CT-86/26

# **Halon Extinguishment of Small Aircraft Instrument Panel Fires**

December 1986

Final Report

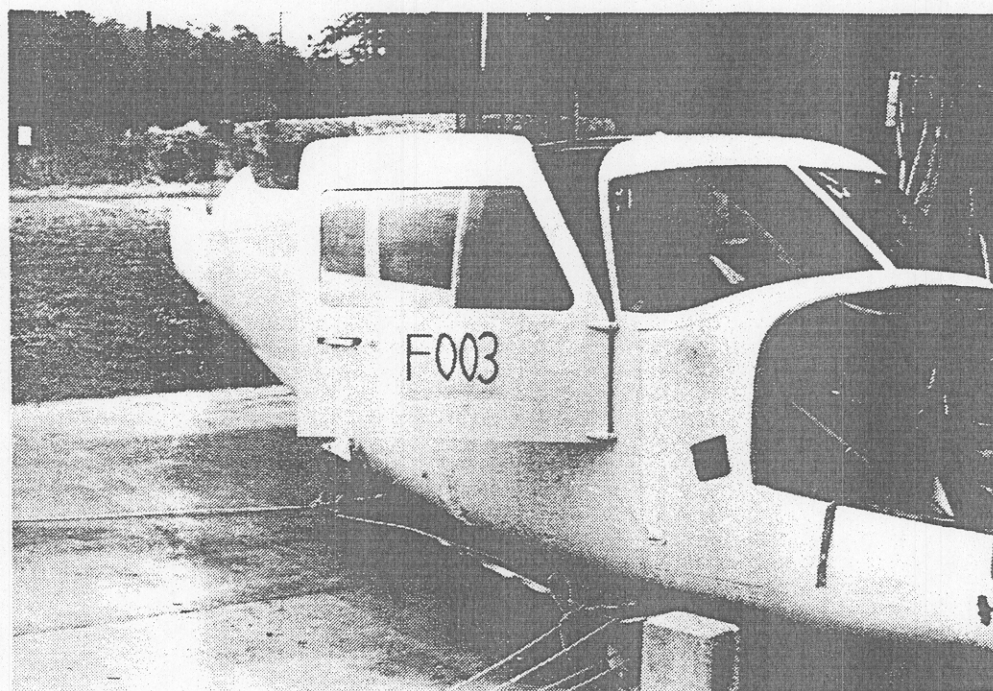
FIGURE 1. PIPER MODEL PA-30 TWIN COMANCHE FUSELAGE

simulated by the addition of compressed air through the aircraft vent system. In this specific aircraft, a ram air port in the nose forces air through ducts in the forward baggage compartment into the cabin. The aircraft test article is shown in figure 1.

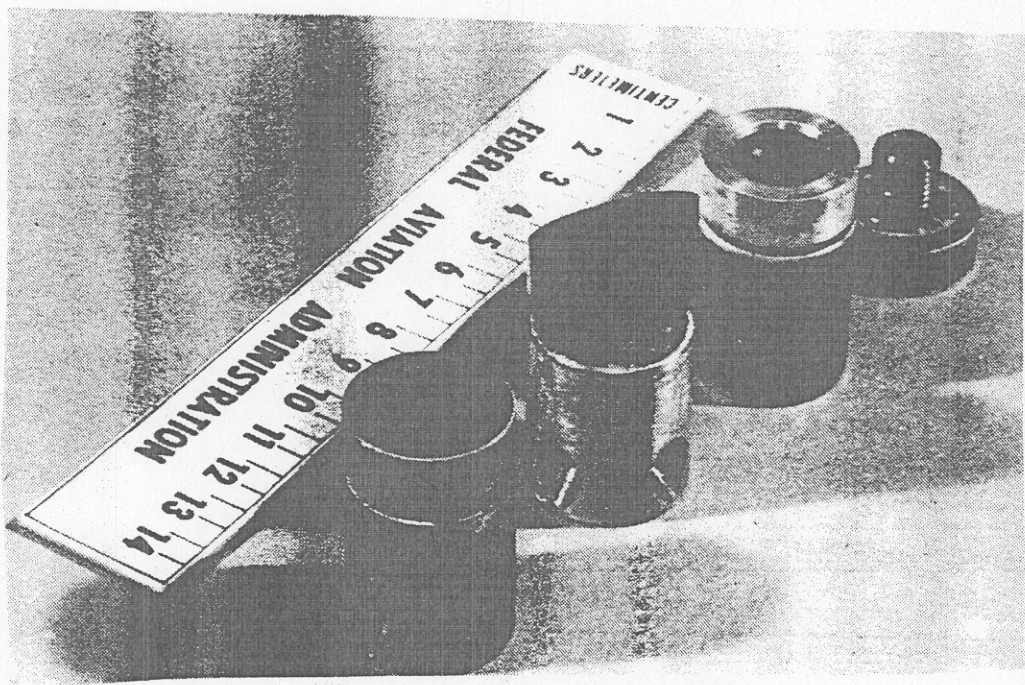
FIGURE 4. FIREPORTS - REAR VIEW

Fire extinguishers charged with Halon 1211 of 2.5-pound capacity and Halon 1301 of 3-pound capacity were tested. Two types of application of the extinguishers were employed; (1) the extinguishers were discharged directly up under the instrument panel and (2) the extinguishers were discharged through Fireports (provided by White Manufacturing Marketing, Inc., of Omaha, Nebraska) mounted directly through the instrument panel. Fireports were installed as a means to provide direct fire extinguisher agent access to an inaccessible area. The Fireports were of two types. One type consisted of five exit or distribution ports. Four distribution ports were located radially on a cylinder barrel, directing agent in the radial directions, and the fifth port was located in the cylinder barrel cap end, directing agent directly toward the firewall (figures 2, 3, and 4). The second type Fireport was a single port design and directed agent to a specific location. The Fireports incorporated a plastic insert in the front section through which the extinguisher nozzle was inserted to discharge agent through the Fireport into an inaccessible area. A special nozzle adaptor had to be installed on Halon 1301 extinguishers to provide a proper fit with the Fireports. This was a Teflon™ bodied orifice assembly that was used as a substitute for the hand extinguishers discharge horn. It must be noted that use of such a replacement assembly in practice will nullify the basis for the extinguisher's approval status.
