DOT/FAA/CT-86/5

Halon Extinguisher Agent Behavior in a Ventilated Small Aircraft

Final Report

U.S. Department of Transportation
Federal Aviation Administration
Technical Center
Atlantic City Airport, N.J. 08405

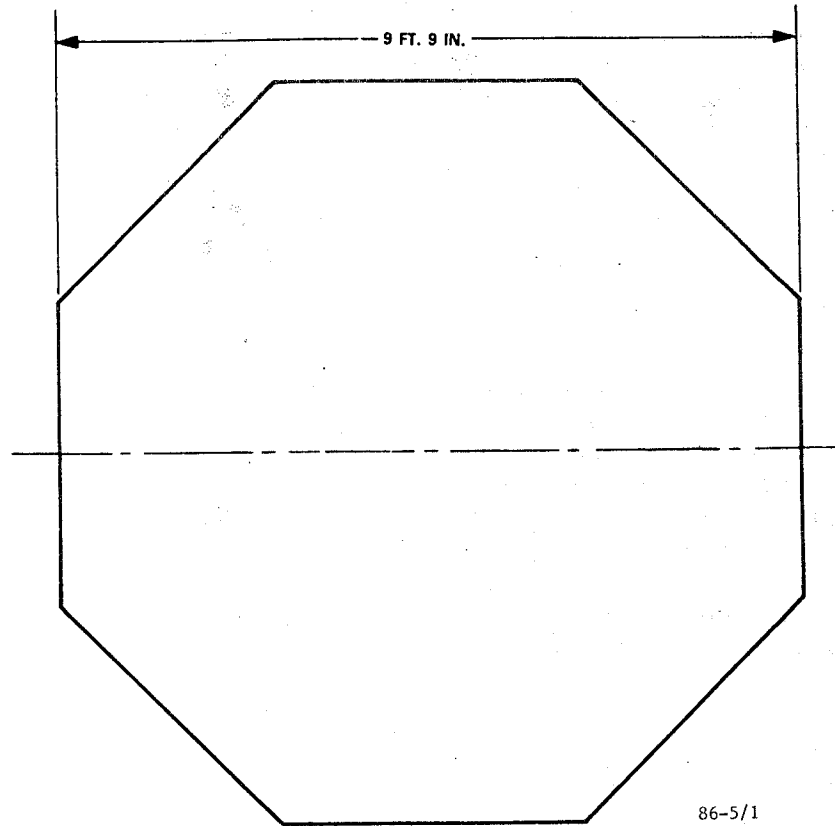
FIGURE 1. GENERAL AVIATION AIRFLOW FACILITY TEST SECTION - CROSS SECTION

A 10-foot diameter by 24-foot-long airflow facility was designed and constructed from flat 4-foot by 8-foot sheets of low carbon steel. The cross section, figure 1, is octagonal in shape. The entrance is a bellmouth design with a 5-foot radius. This extension is attached to an existing 5-foot diameter airflow facility, figures 2 and 3. Performance of the 5-foot facility is near Mach 1 airspeed. Two J57 turbo jet engines provide power to drive the facility by ejector action. The 10-foot

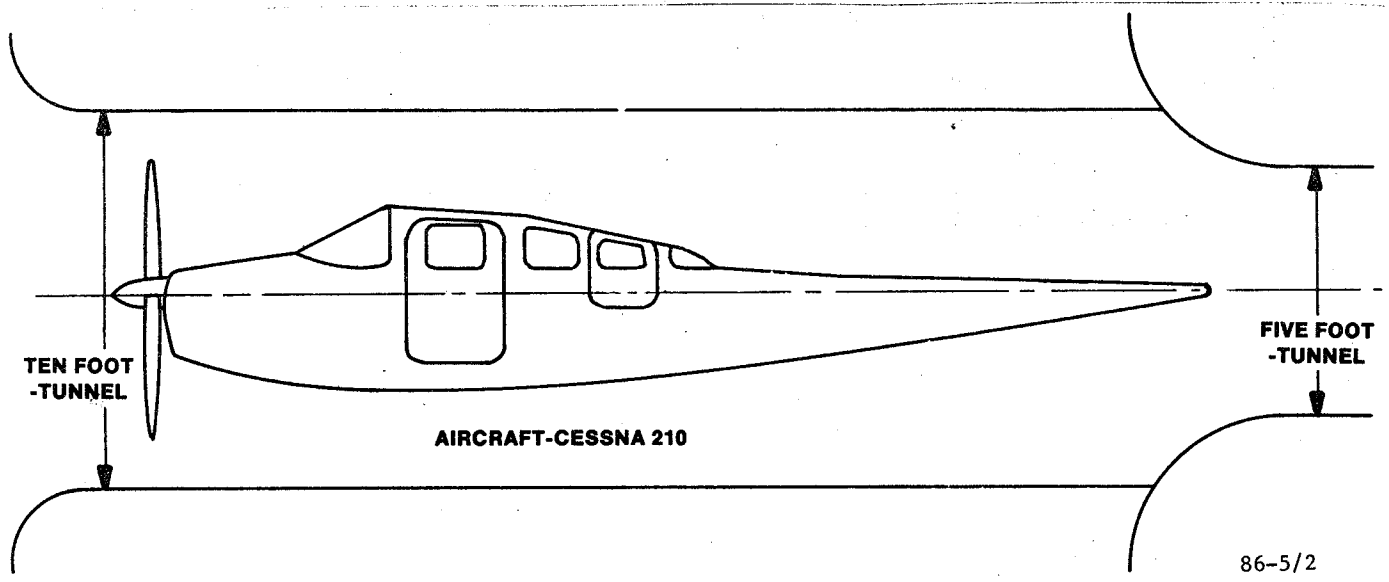
FIGURE 2. GENERAL AVIATION AIRFLOW FACILITY TEST SECTION - PROFILE

The test article is a 1963 model Cessna 210C with retractable landing gear (figures 2 and 3). The airplane is a four-place high-wing monoplane, powered by a single six-cylinder, horizontally-opposed fuel injection Continental IO470 engine. For installation in the facility, mounts were designed, fabricated, and installed at the wing spar attachment points and at the wing strut attachment points. The fuselage was installed in the tunnel with 3/4-inch high carbon steel rods connected to the mounts and to the tunnel walls. The wings were cut at the 32-inch section and then were installed on the fuselage in the tunnel. The sections were installed to provide the cabin ventilation air inlet ports located in the wings. It was necessary to move the ports inboard for inclusion in the 32-inch wing root sections.

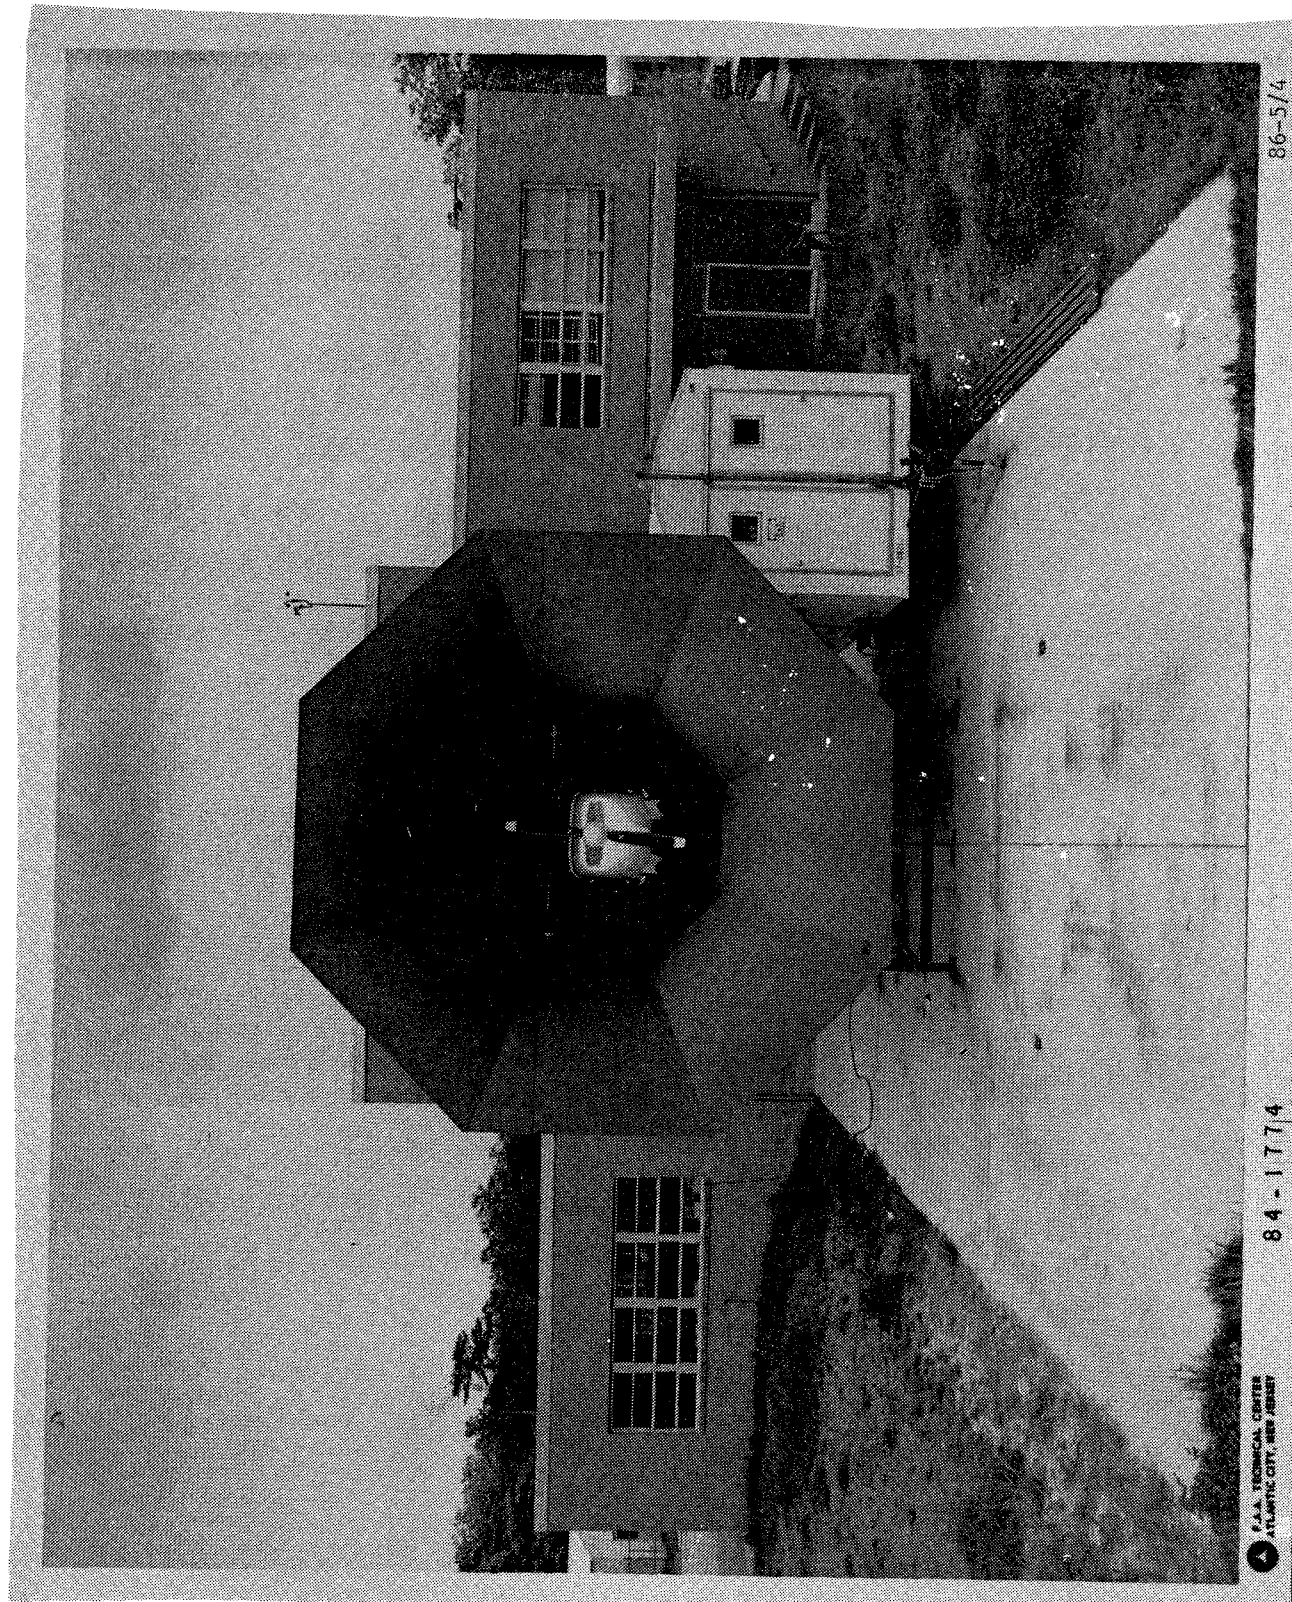
FIGURE 3. CESSNA 210C AIRPLANE WITHIN AVIATION FLOW FACILITY TEST SECTION

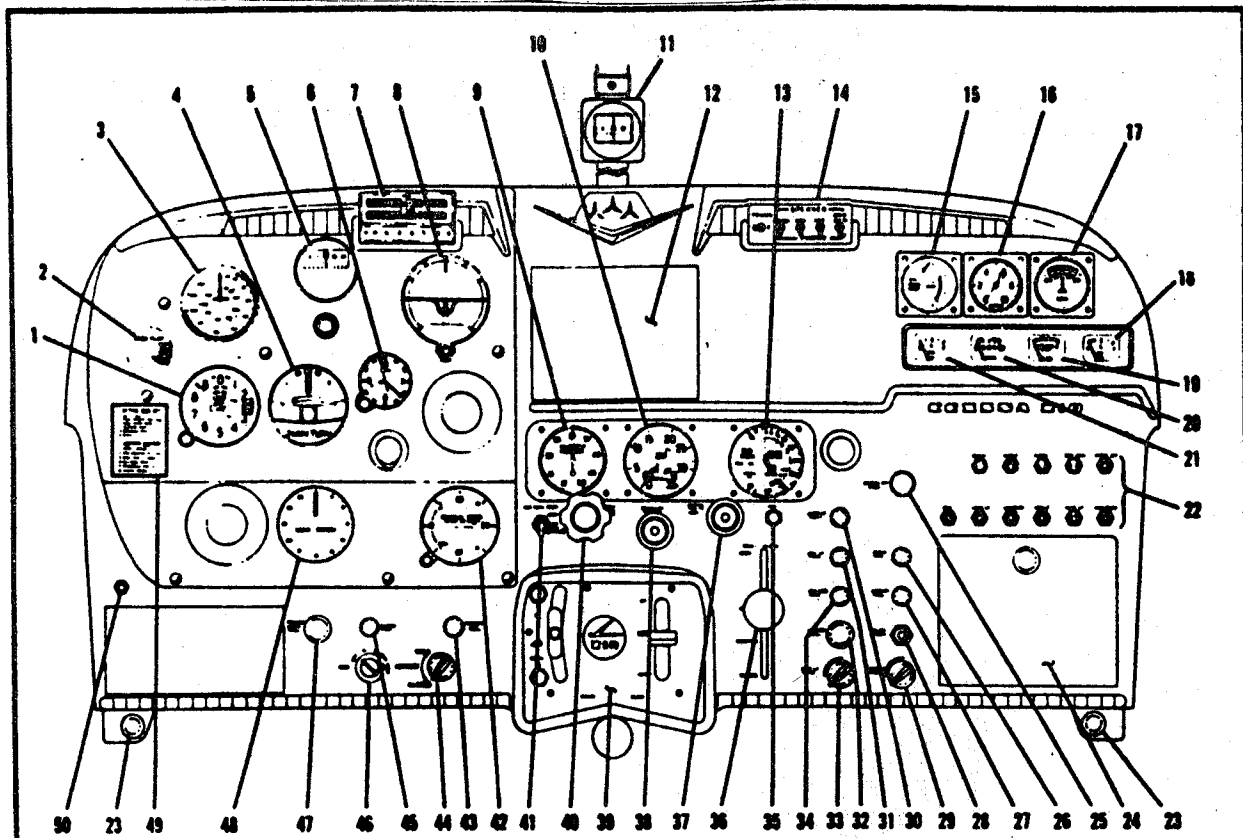
If shockmount has unequal thread length, install shorter threads through stationary panel.

FIGURE 4. INSTRUMENT PANEL - CESSNA MODEL 210C AIRPLANE

The electrical and electronic components are primarily located in and under the instrument panel. The instrument panel for the test aircraft (Cessna 210) is shown in figure 4. Identification of the equipment is also listed. Electrical power for the aircraft is supplied by a 12-volt direct current, negative ground electrical system. A single 12-volt battery supplies power for starting and provides reserve power in the event of a generator or alternator failure. On the extreme left side of the instrument panel, one item that could be involved in a fire is the master switch. Operation of the switch connects the battery solenoid coil and the generator field coil to ground, thereby, activating the power system.

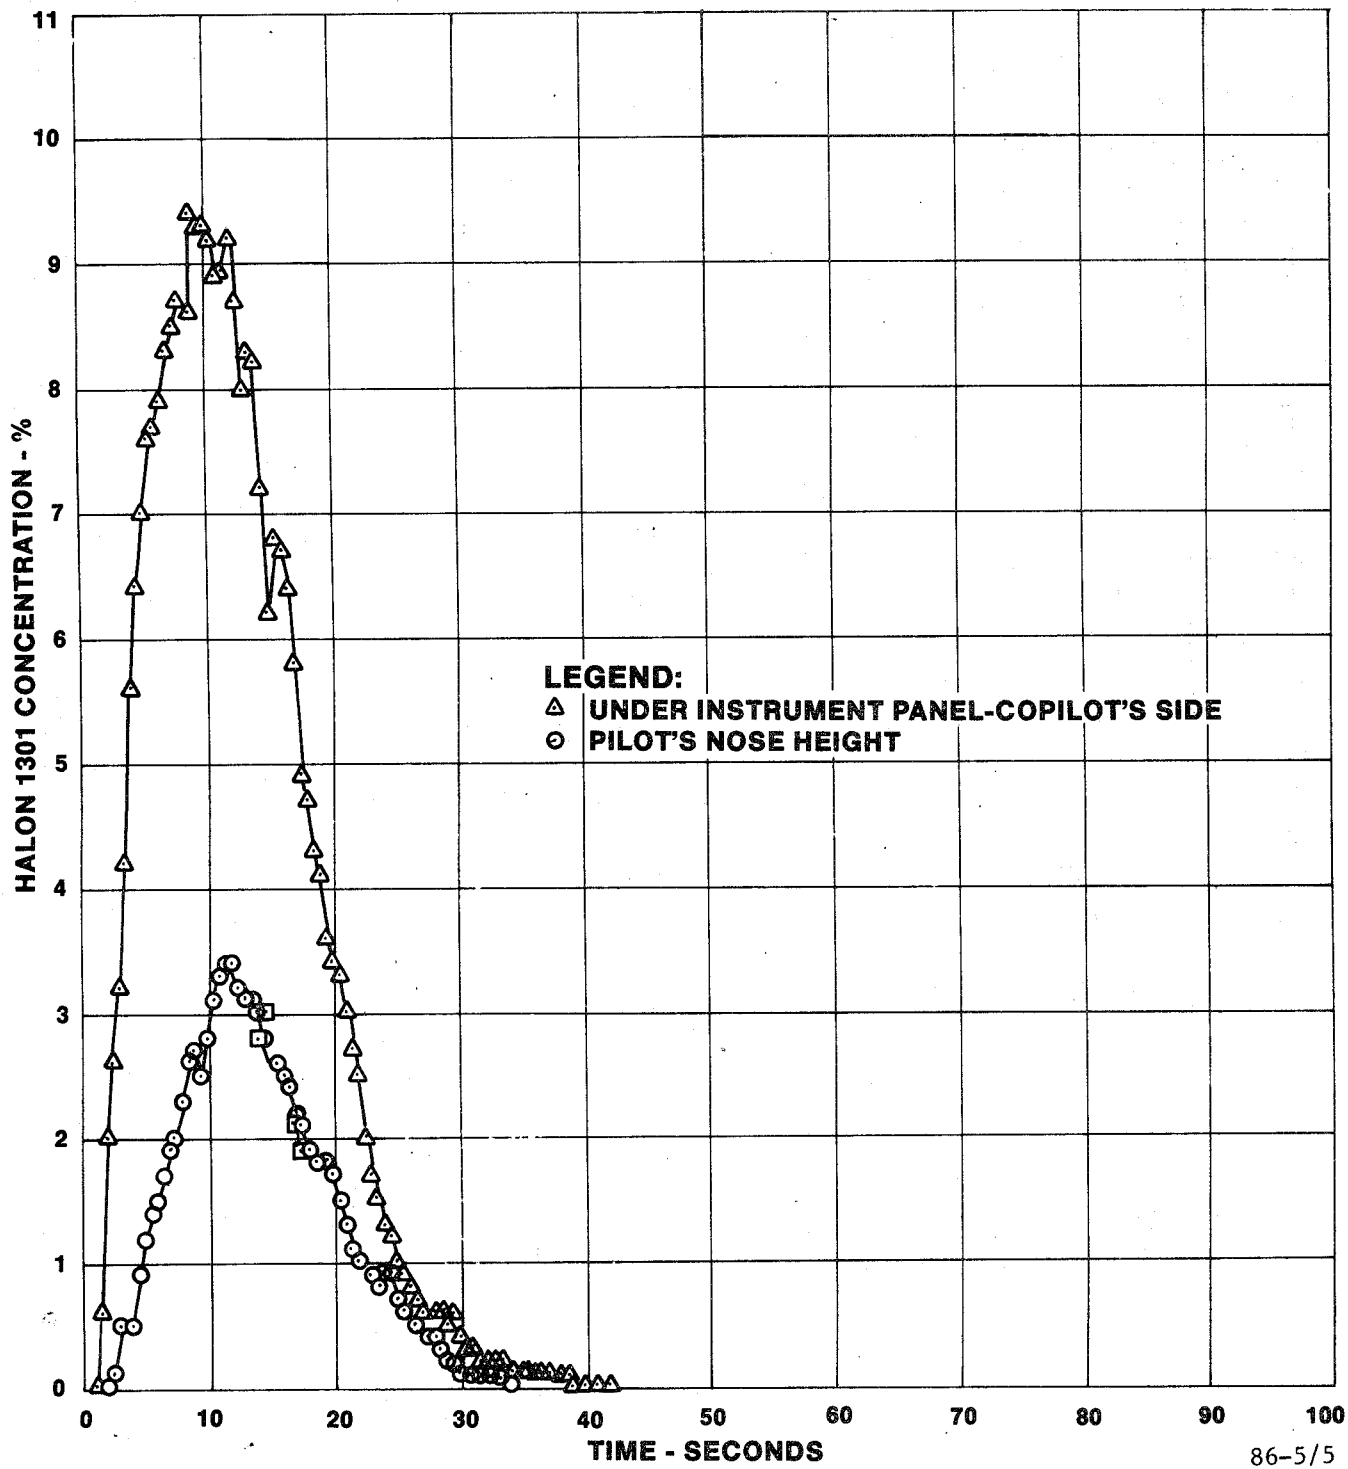
FIGURE 5. HALON 1301 CONCENTRATIONS - 3-POUND EXTINGUISHER DIRECTED UNDER INSTRUMENT PANEL - COPILOT'S SIDE - OVERHEAD VENTS OPEN

The gas measurements for the tests conducted with extinguishers discharged under the instrument panel were plotted against time in seconds and are presented in figures 5 through 12, and certain selected values were tabulated in table 2.

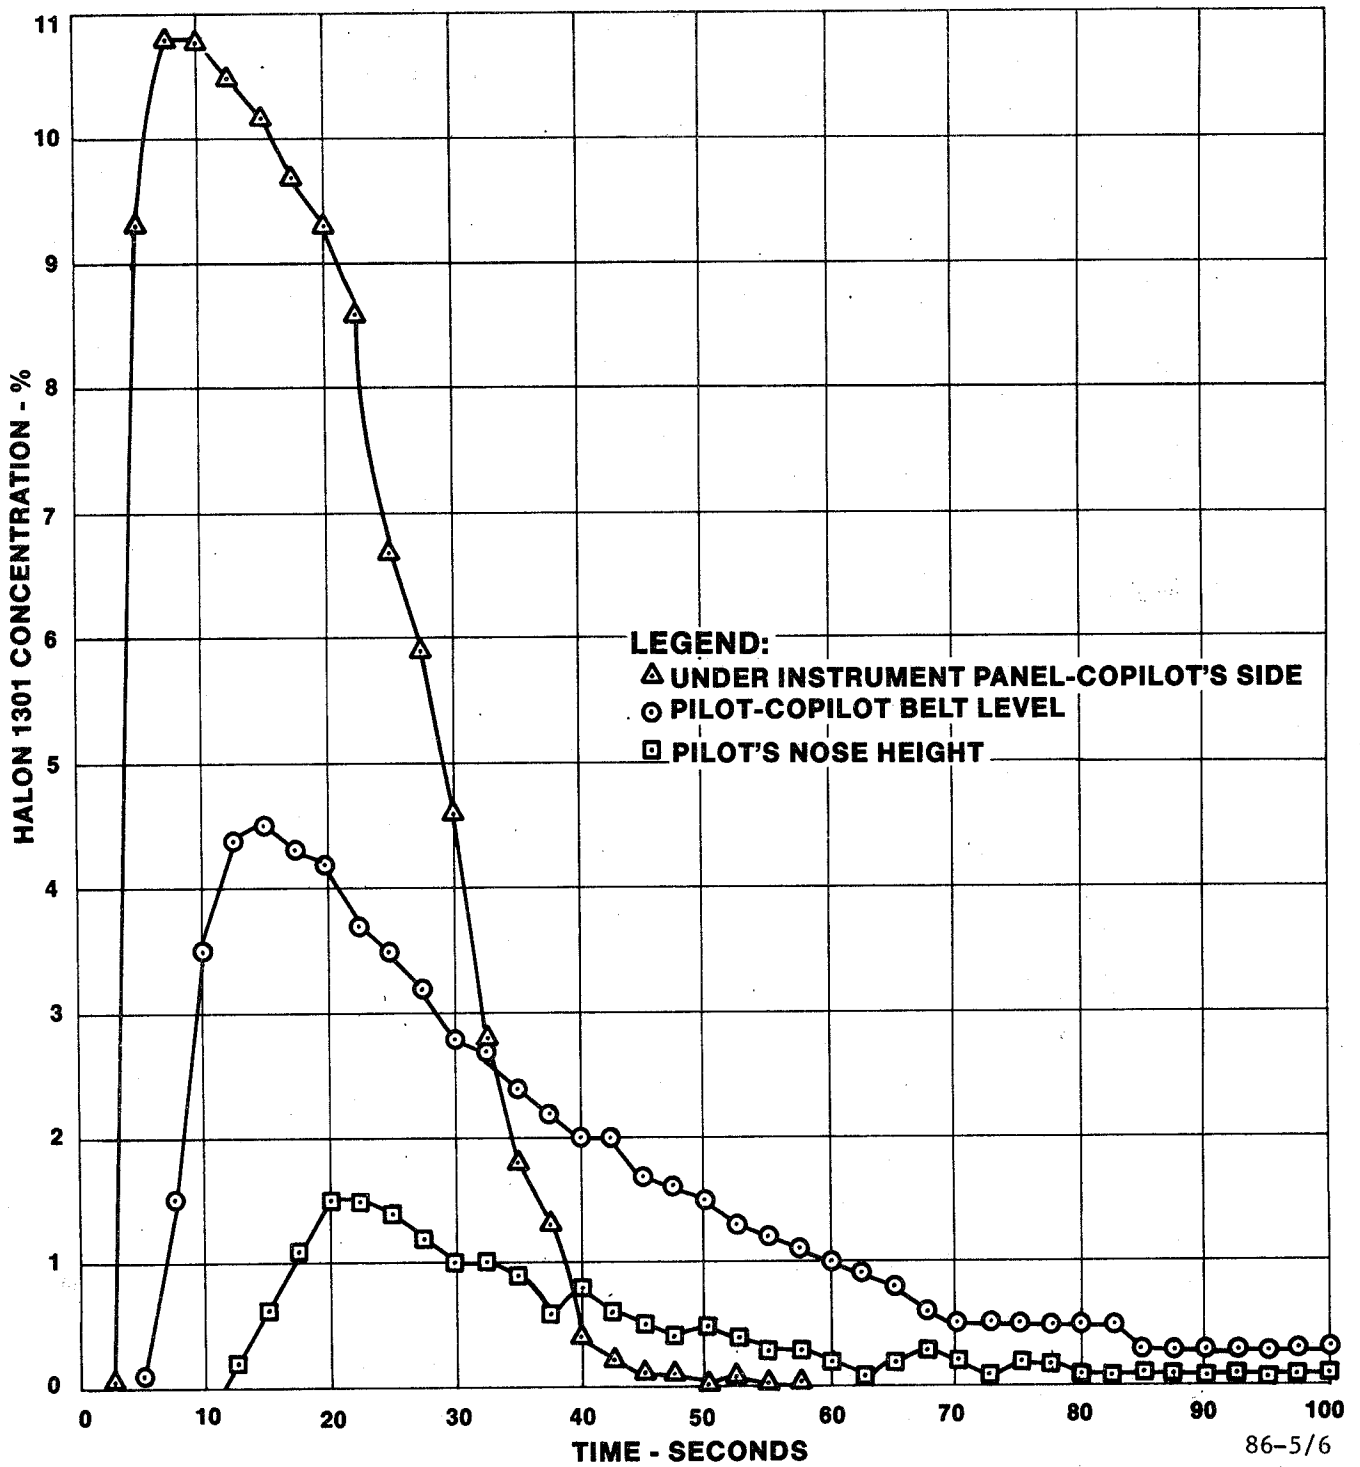
FIGURE 6. HALON 1301 CONCENTRATIONS - 3-POUND EXTINGUISHER DIRECTED UNDER INSTRUMENT PANEL - COPILOT'S SIDE - OVERHEAD VENTS CLOSED

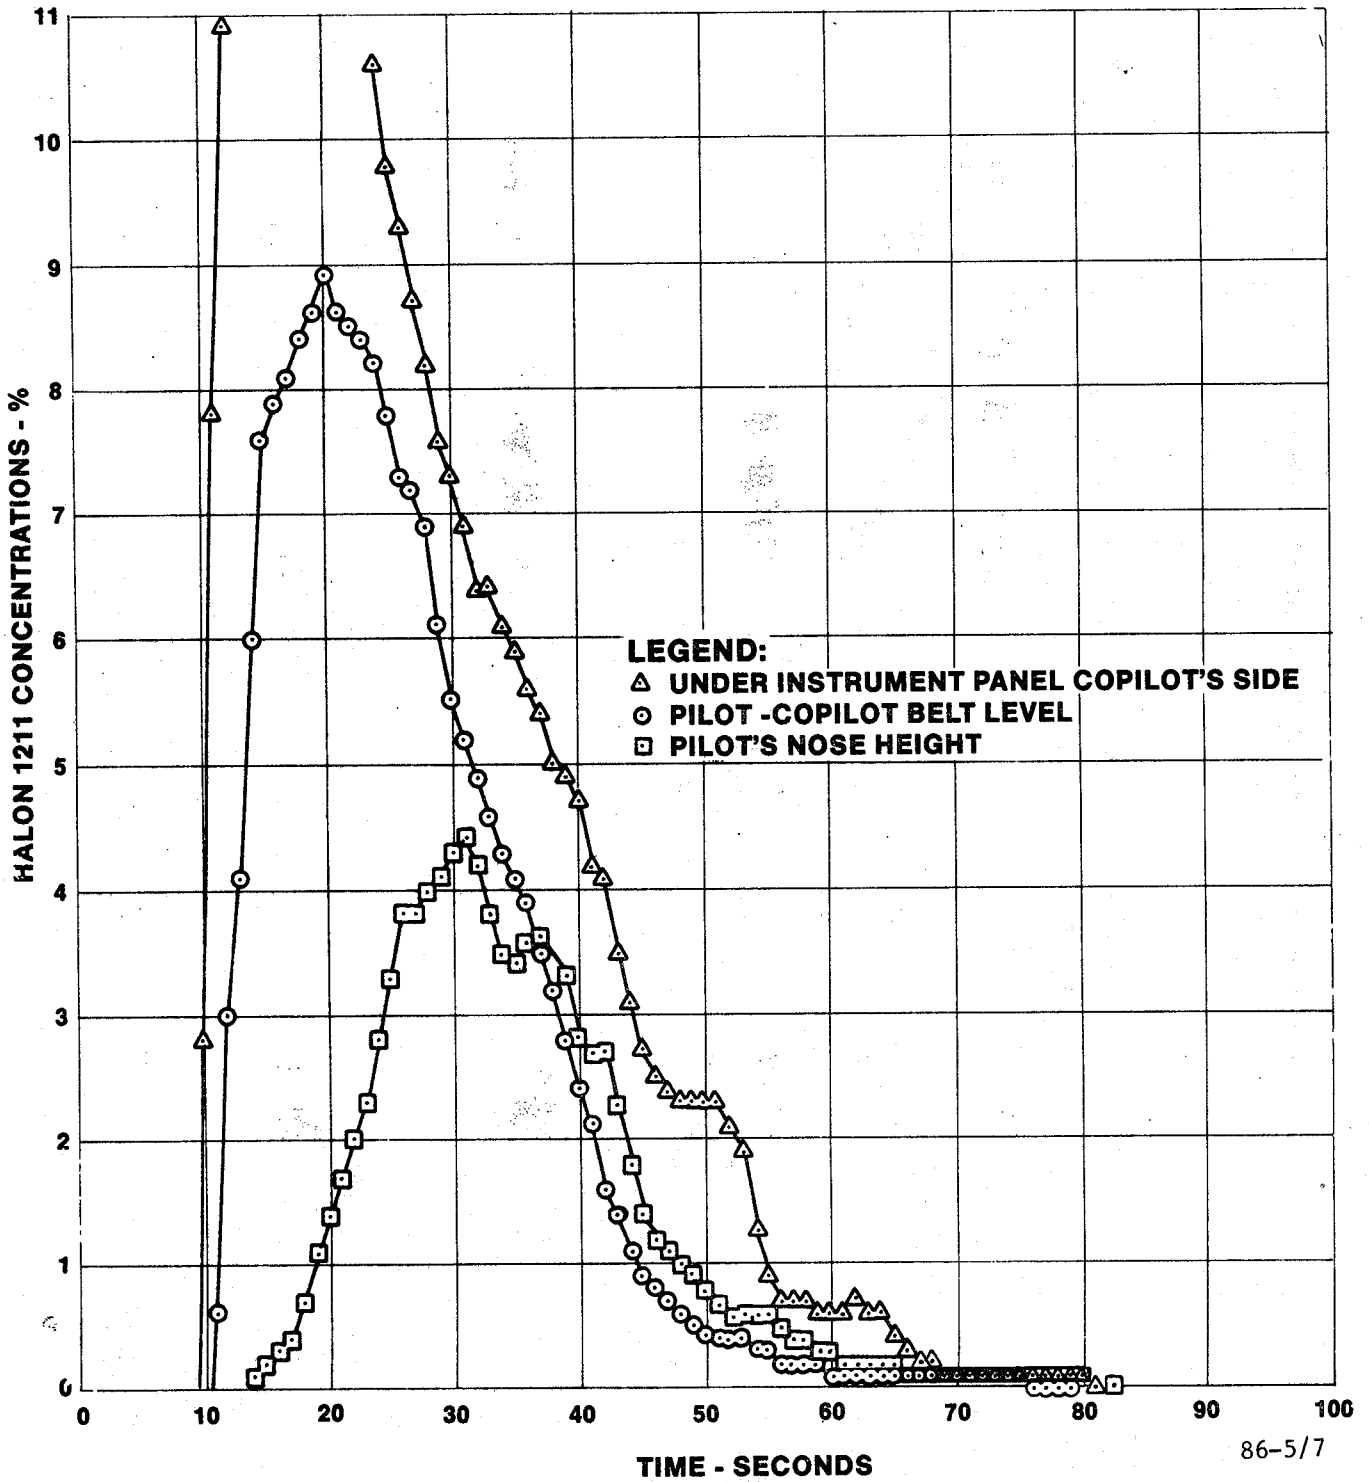
FIGURE 7. HALON 1211 CONCENTRATIONS - 2.5-POUND EXTINGUISHER DIRECTED UNDER INSTRUMENT PANEL - COPILOT'S SIDE - OVERHEAD VENTS OPEN

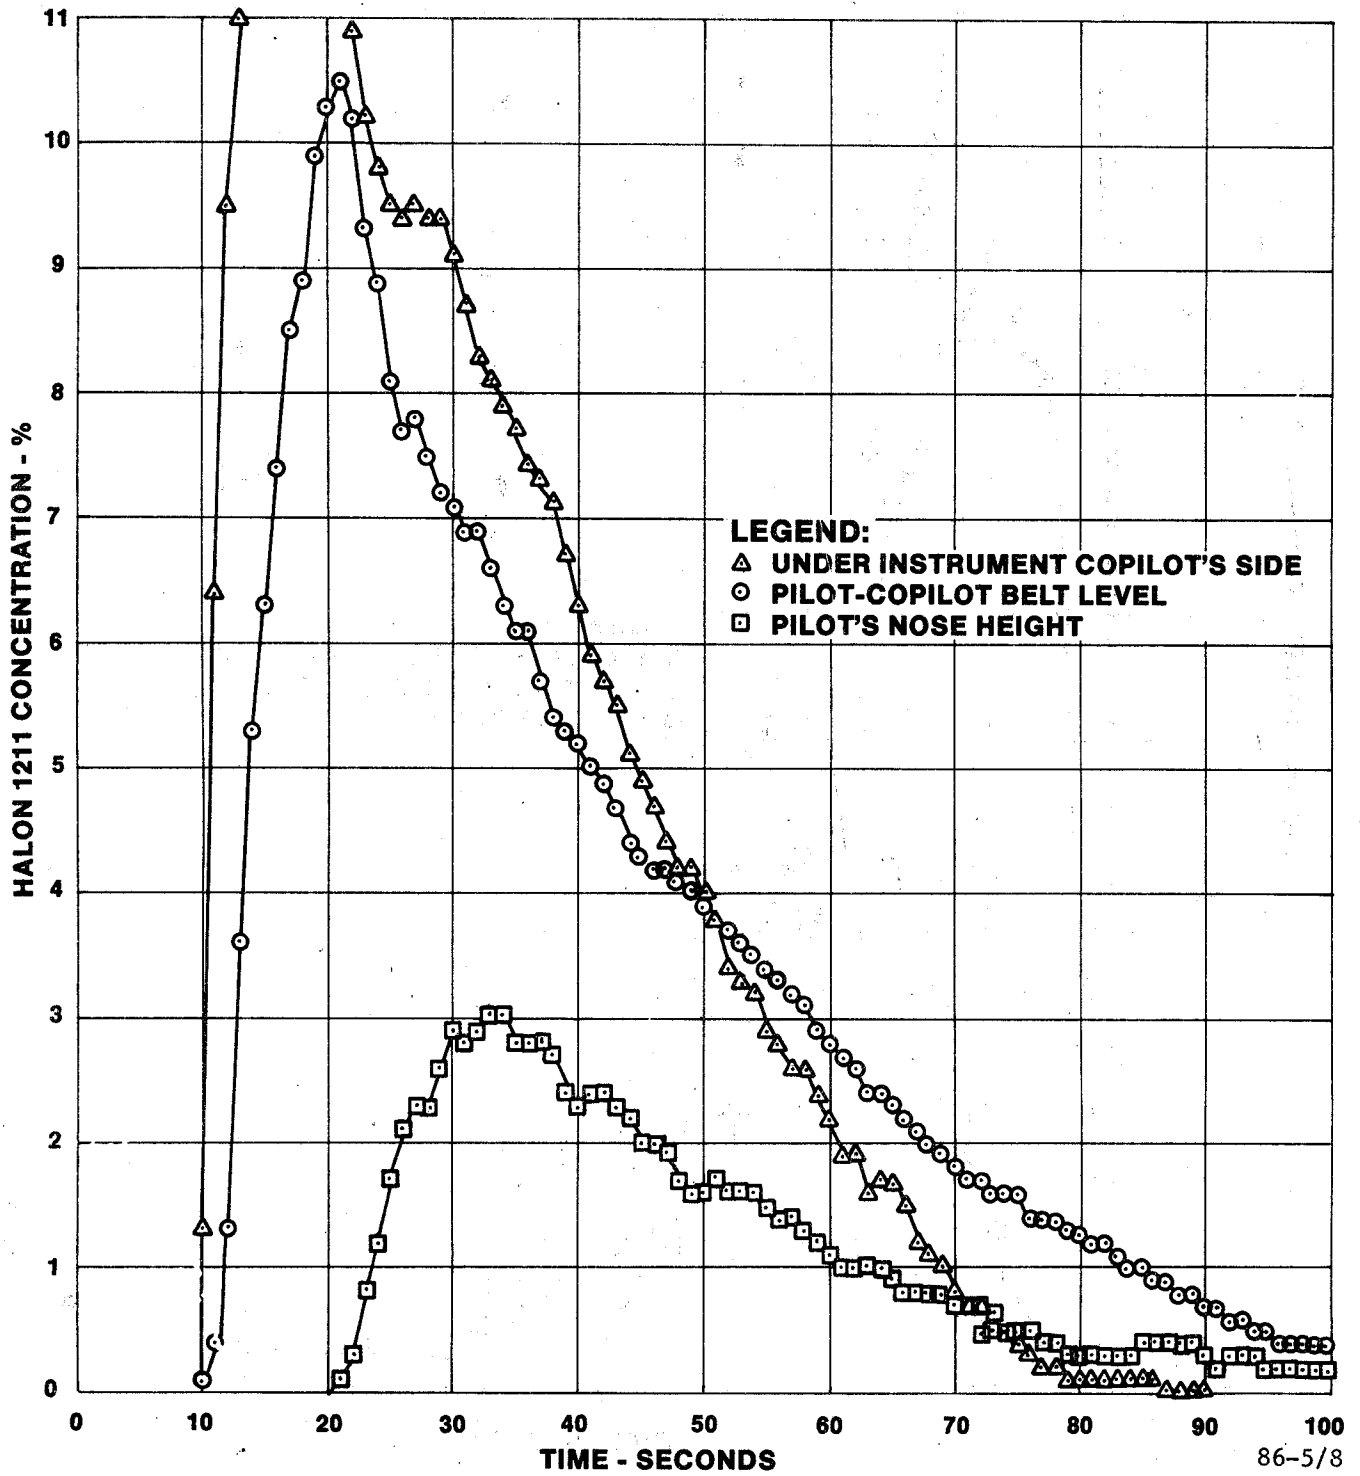
FIGURE 8. HALON 1211 CONCENTRATIONS - 2.5-POUND EXTINGUISHER DIRECTED UNDER INSTRUMENT PANEL - COPILOT'S SIDE - OVERHEAD VENTS CLOSED

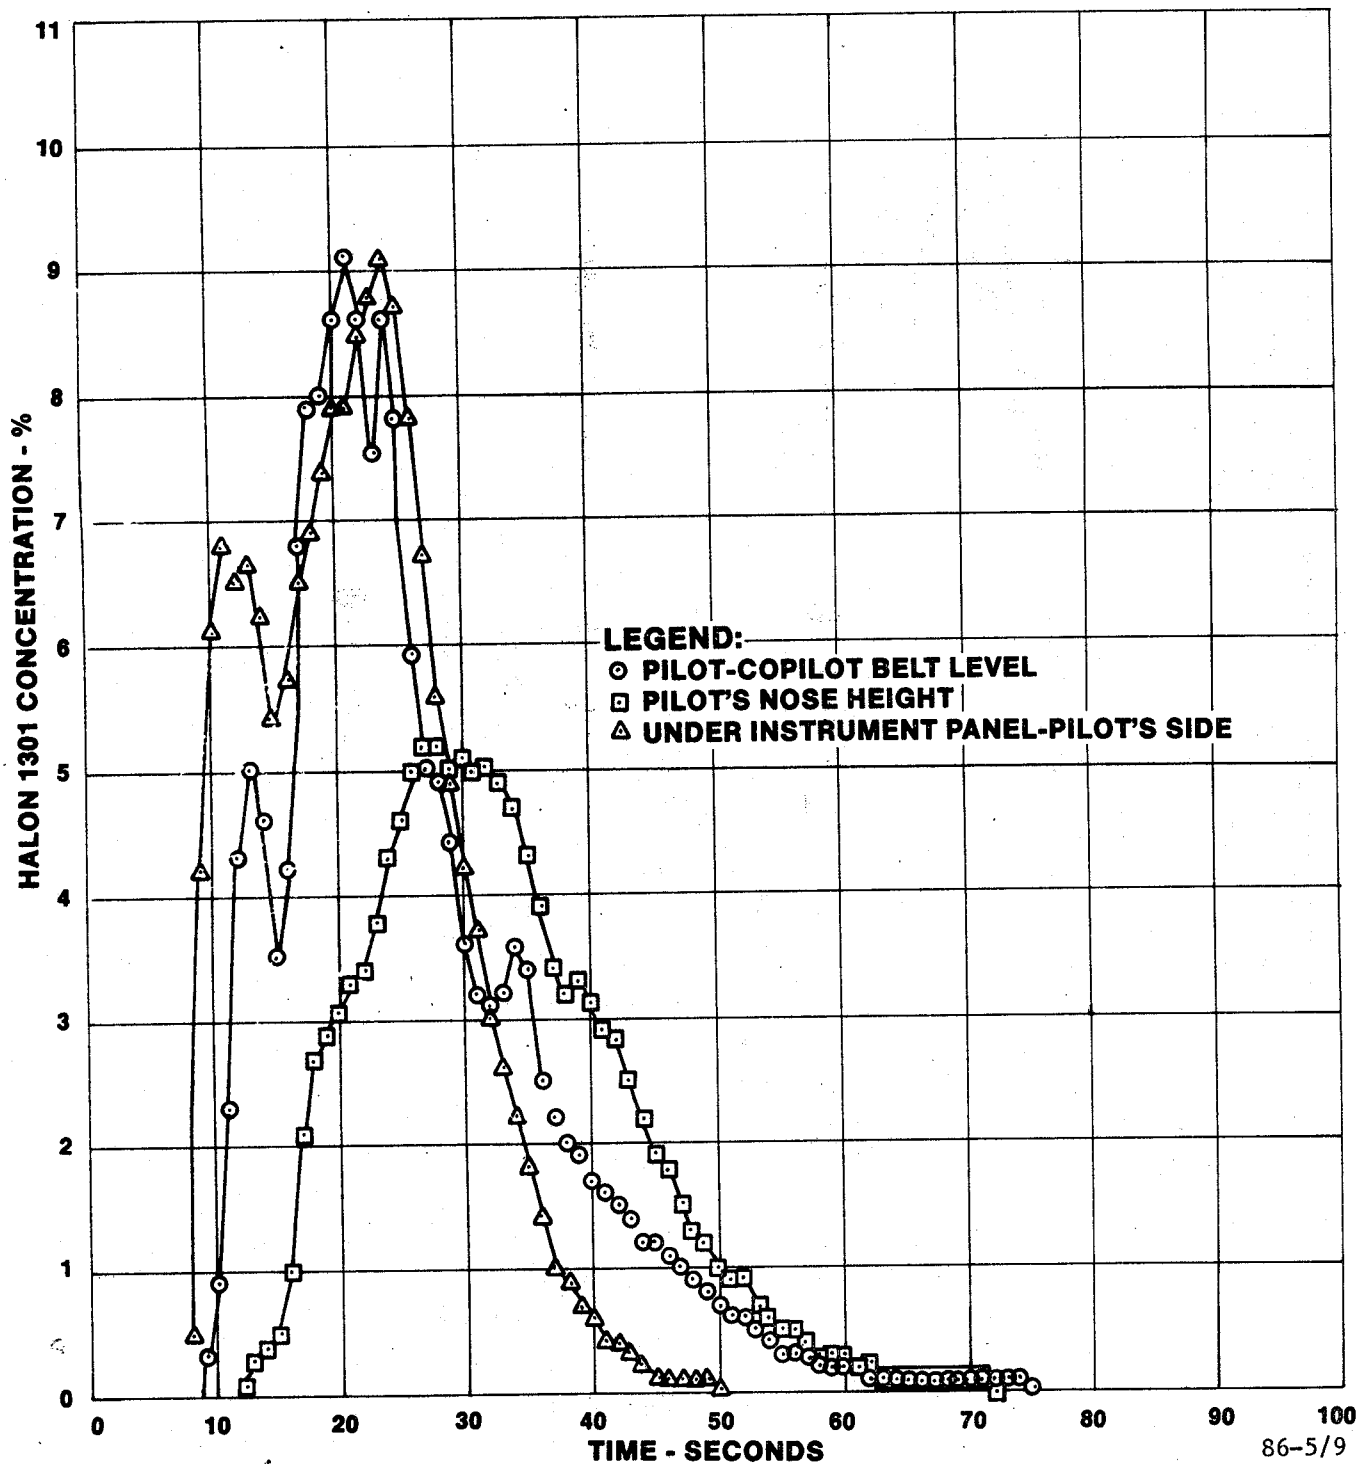
FIGURE 9. HALON 1301 CONCENTRATIONS - 3-POUND EXTINGUISHER DIRECTED UNDER INSTRUMENT PANEL - PILOT'S SIDE - OVERHEAD VENTS OPEN

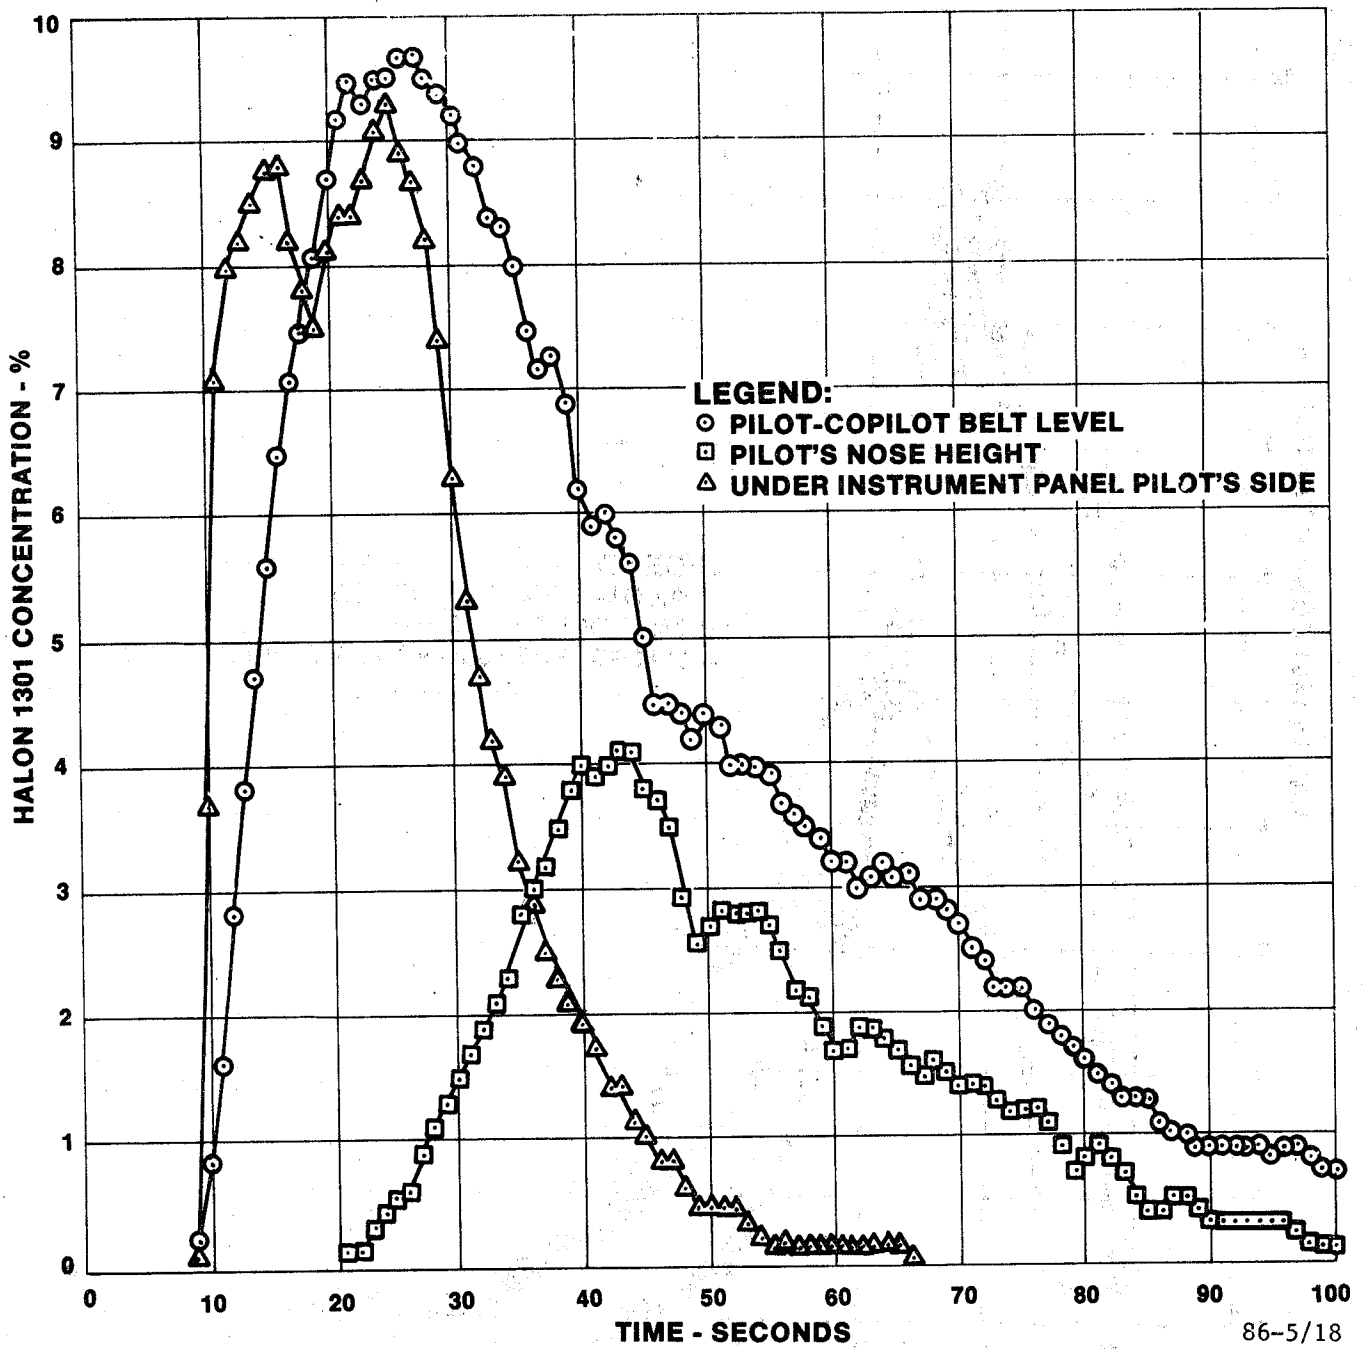
FIGURE 10. HALON 1301 CONCENTRATIONS - 3-POUND EXTINGUISHER DIRECTED TO THE COPILOT'S DOOR - OVERHEAD VENTS CLOSED

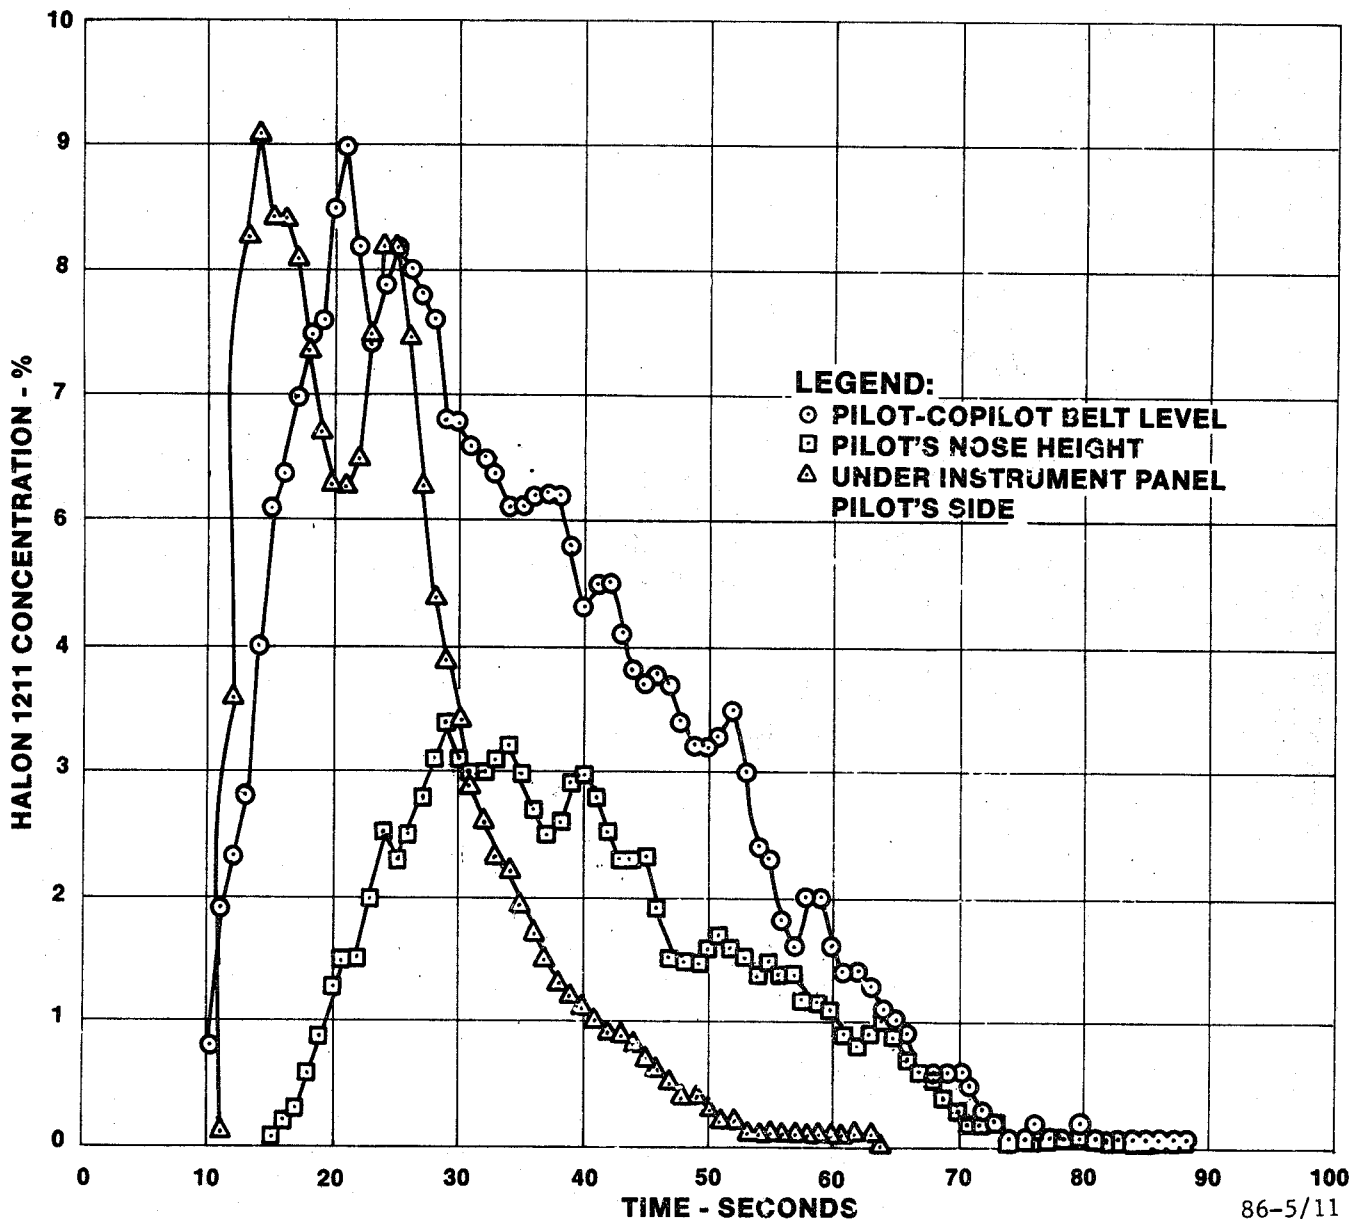
FIGURE 11. HALON 1211 CONCENTRATIONS - 2.5-POUND EXTINGUISHER DIRECTED UNDER INSTRUMENT PANEL - PILOT'S SIDE - OVERHEAD VENTS OPEN

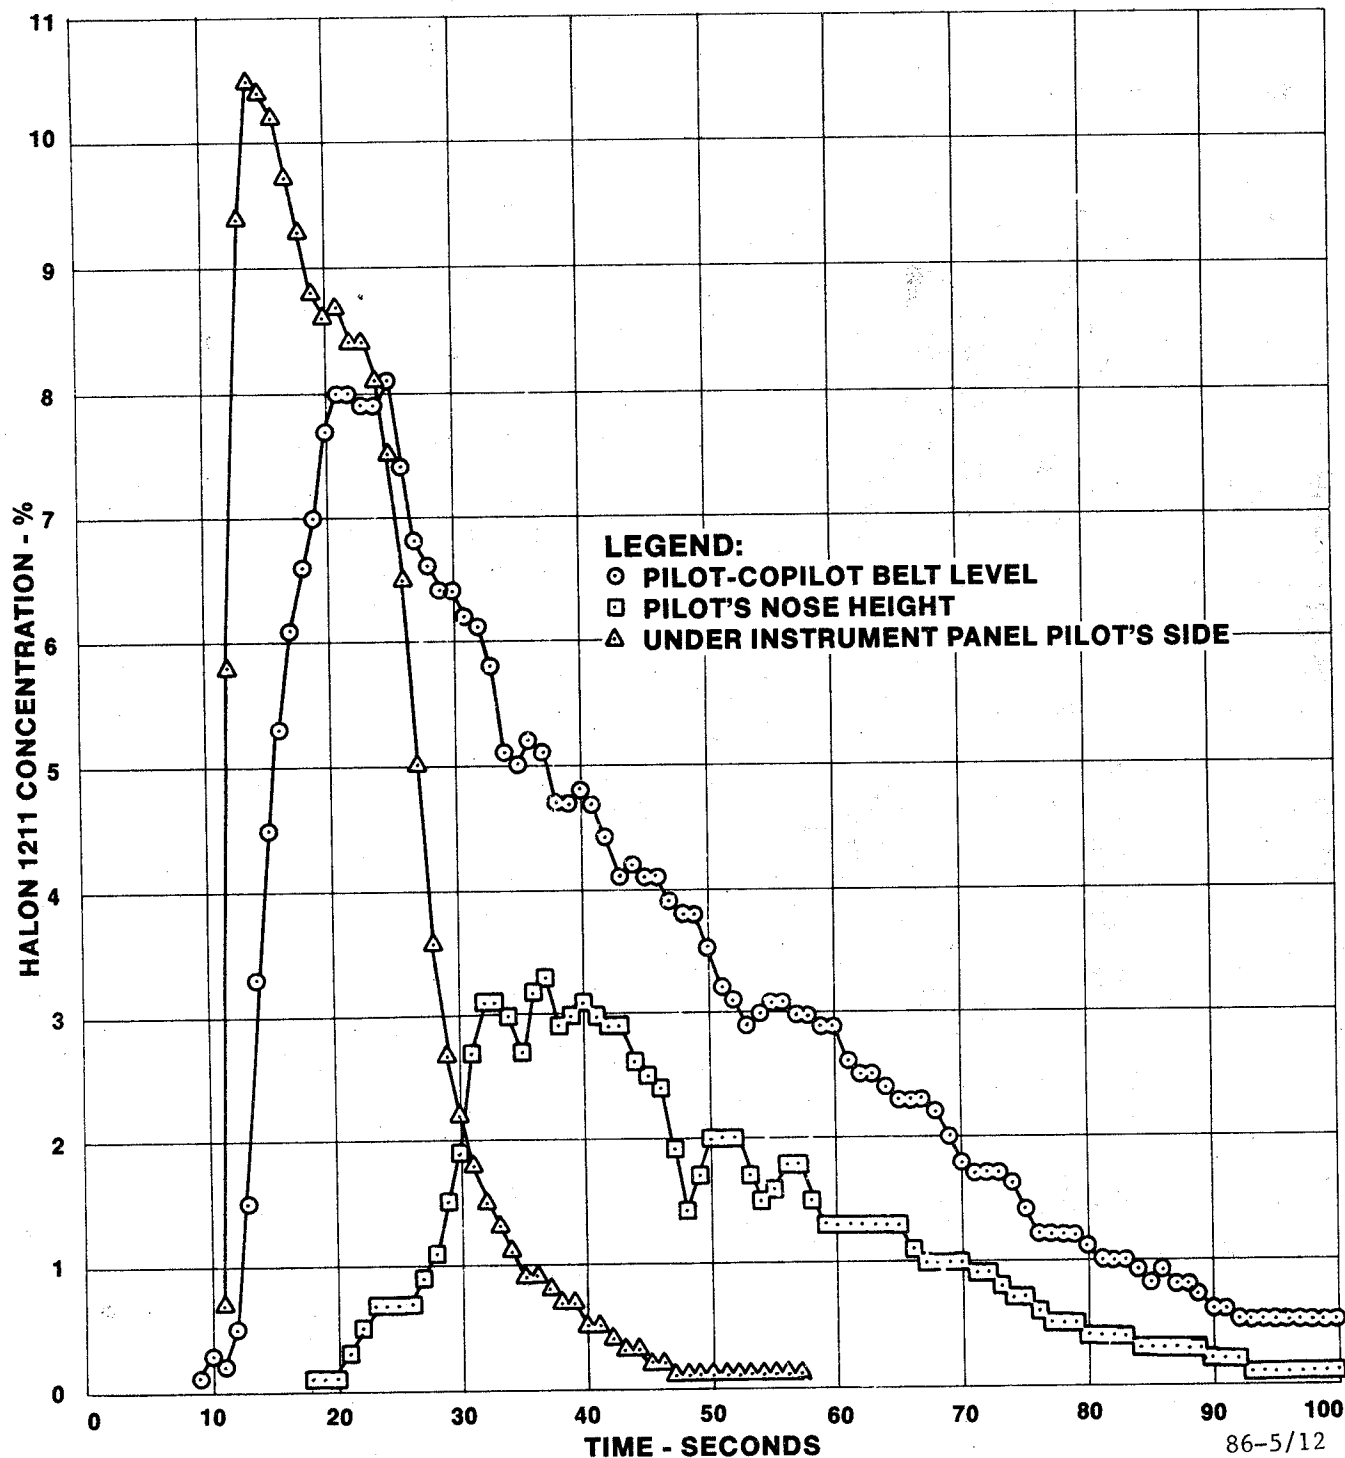
FIGURE 12. HALON 1211 CONCENTRATIONS - 2.5-POUND EXTINGUISHER DIRECTED UNDER INSTRUMENT PANEL - PILOT'S SIDE - OVERHEAD VENTS CLOSED
