DOT/FAA/CT-86/5

Halon Extinguisher Agent Behavior in a Ventilated Small Aircraft

Final Report

U.S. Department of Transportation
Federal Aviation Administration
Technical Center
Atlantic City Airport, N.J. 08405

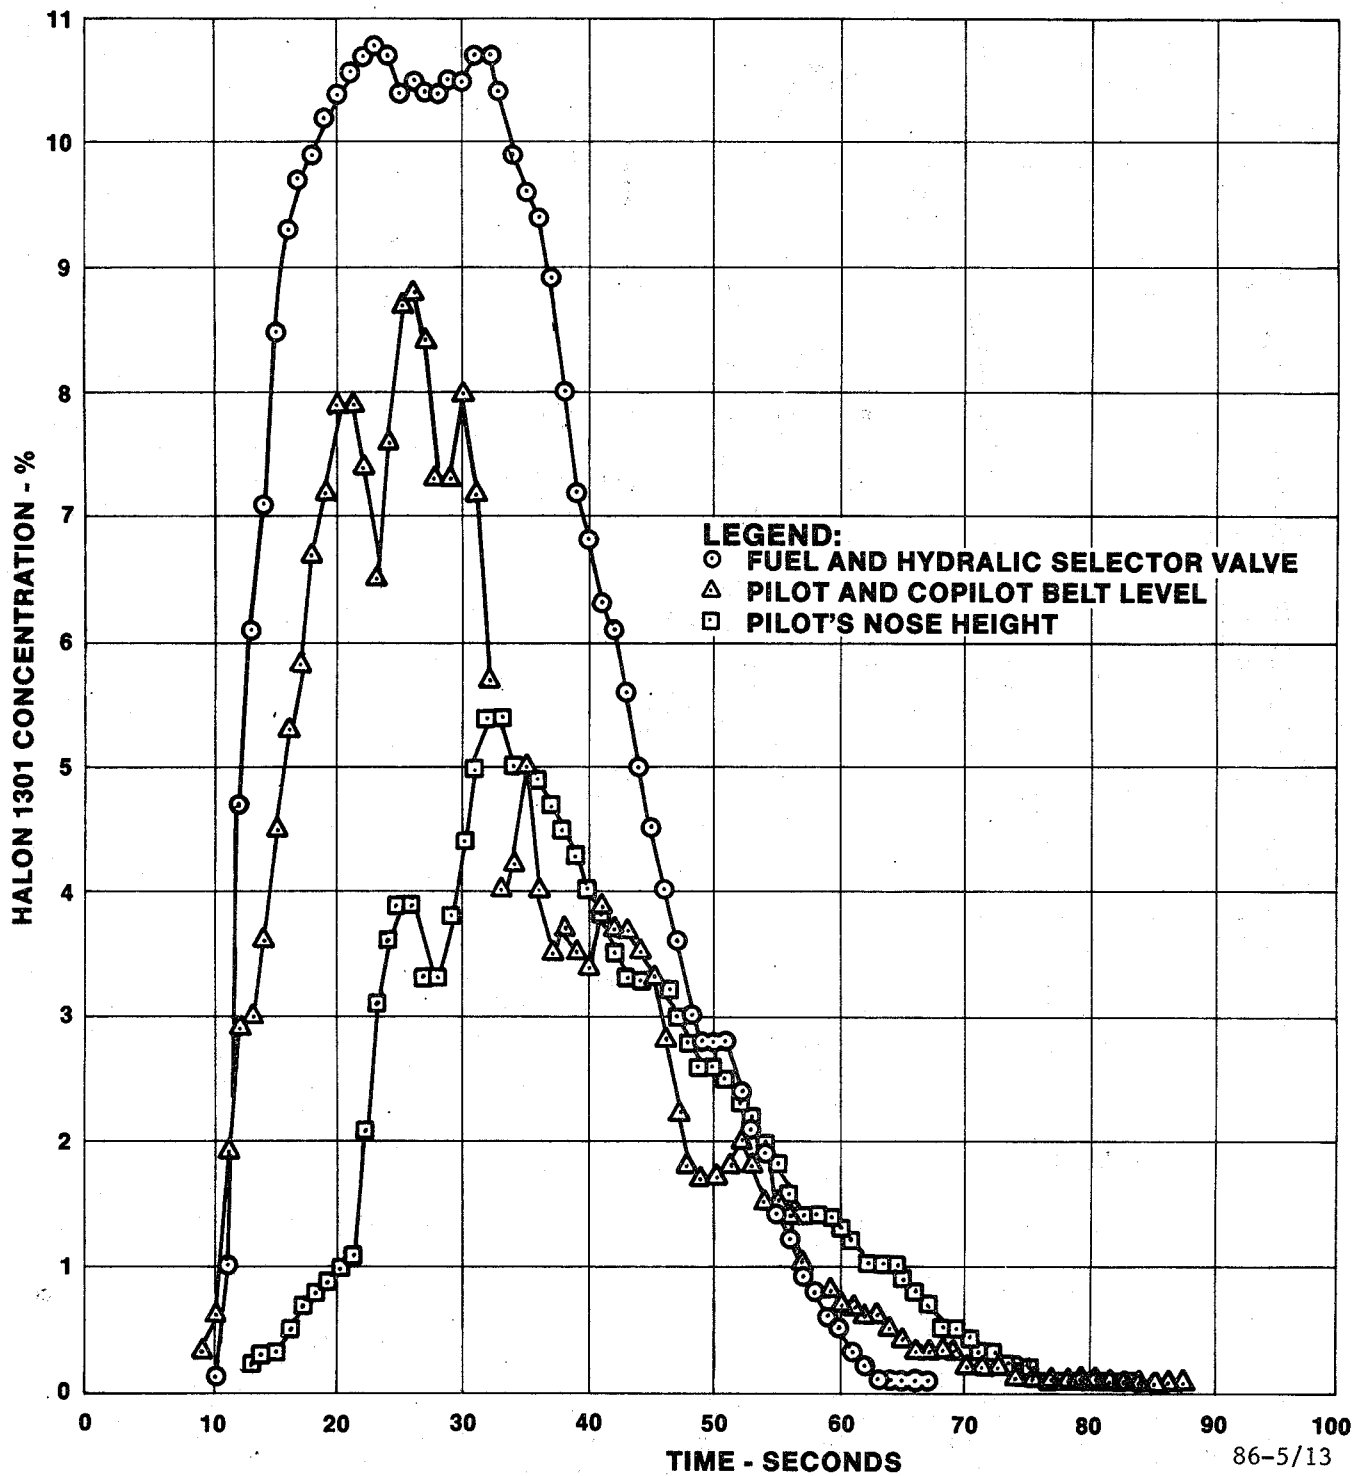
FIGURE 13. HALON 1301 CONCENTRATIONS - 3-POUND EXTINGUISHER DIRECTED TO THE FUEL AND HYDRALIC SELECTOR VALVES - OVERHEAD VENTS OPEN

The extinguishers were directed to the fuel and hydraulic selector valves located on a console raised approximately 6 inches from floor between the pilot and copilot. Two 2.5-pound Halon 1211 extinguishers and two 3.0-pound Halon 1301 extinguishers were tested with identical ventilation conditions as previously described. The gas measurements are plotted in figures 13 through 16 and selected data are tabulated in table 2. Dose calculated for the pilot's nose was 1.72 and 2.56 percent minutes and is up to 64 percent of the limit for Halon 1211 and 2.69 and 3.10 for Halon 1301 which is 31 percent of the limit dose. Maximum dose at the pilot's and copilot's belt level was 4.88 and 5.78 percent minutes for Halon 1211 and 5.82 and 6.53 of Halon 1301. The pilot could bend over the 10 seconds without exceeding the limit dose when discharging Halon 1211 and could bend over indefinitely after discharging Halon 1301.

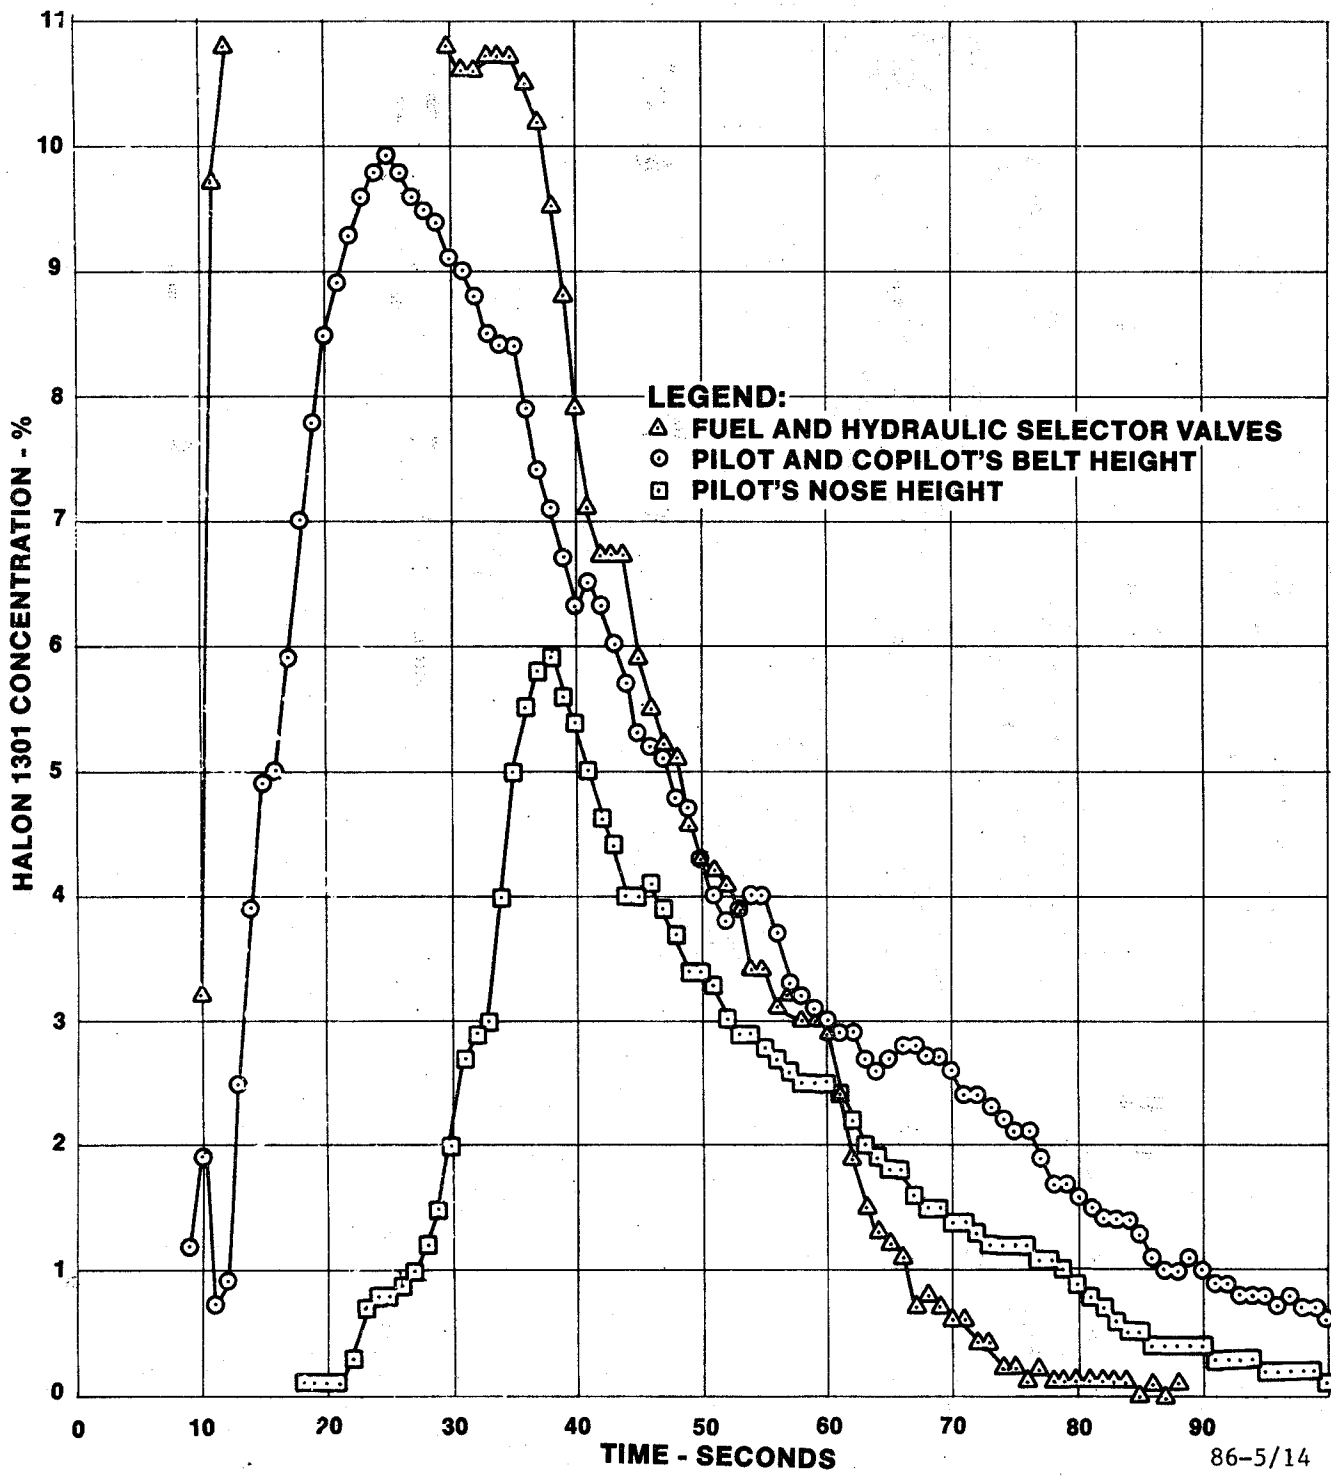
FIGURE 14. HALON 1301 CONCENTRATIONS - 3-POUND EXTINGUISHER DIRECTED TO THE FUEL AND HYDRAULIC SELECTOR VALVES - OVERHEAD VENTS CLOSED

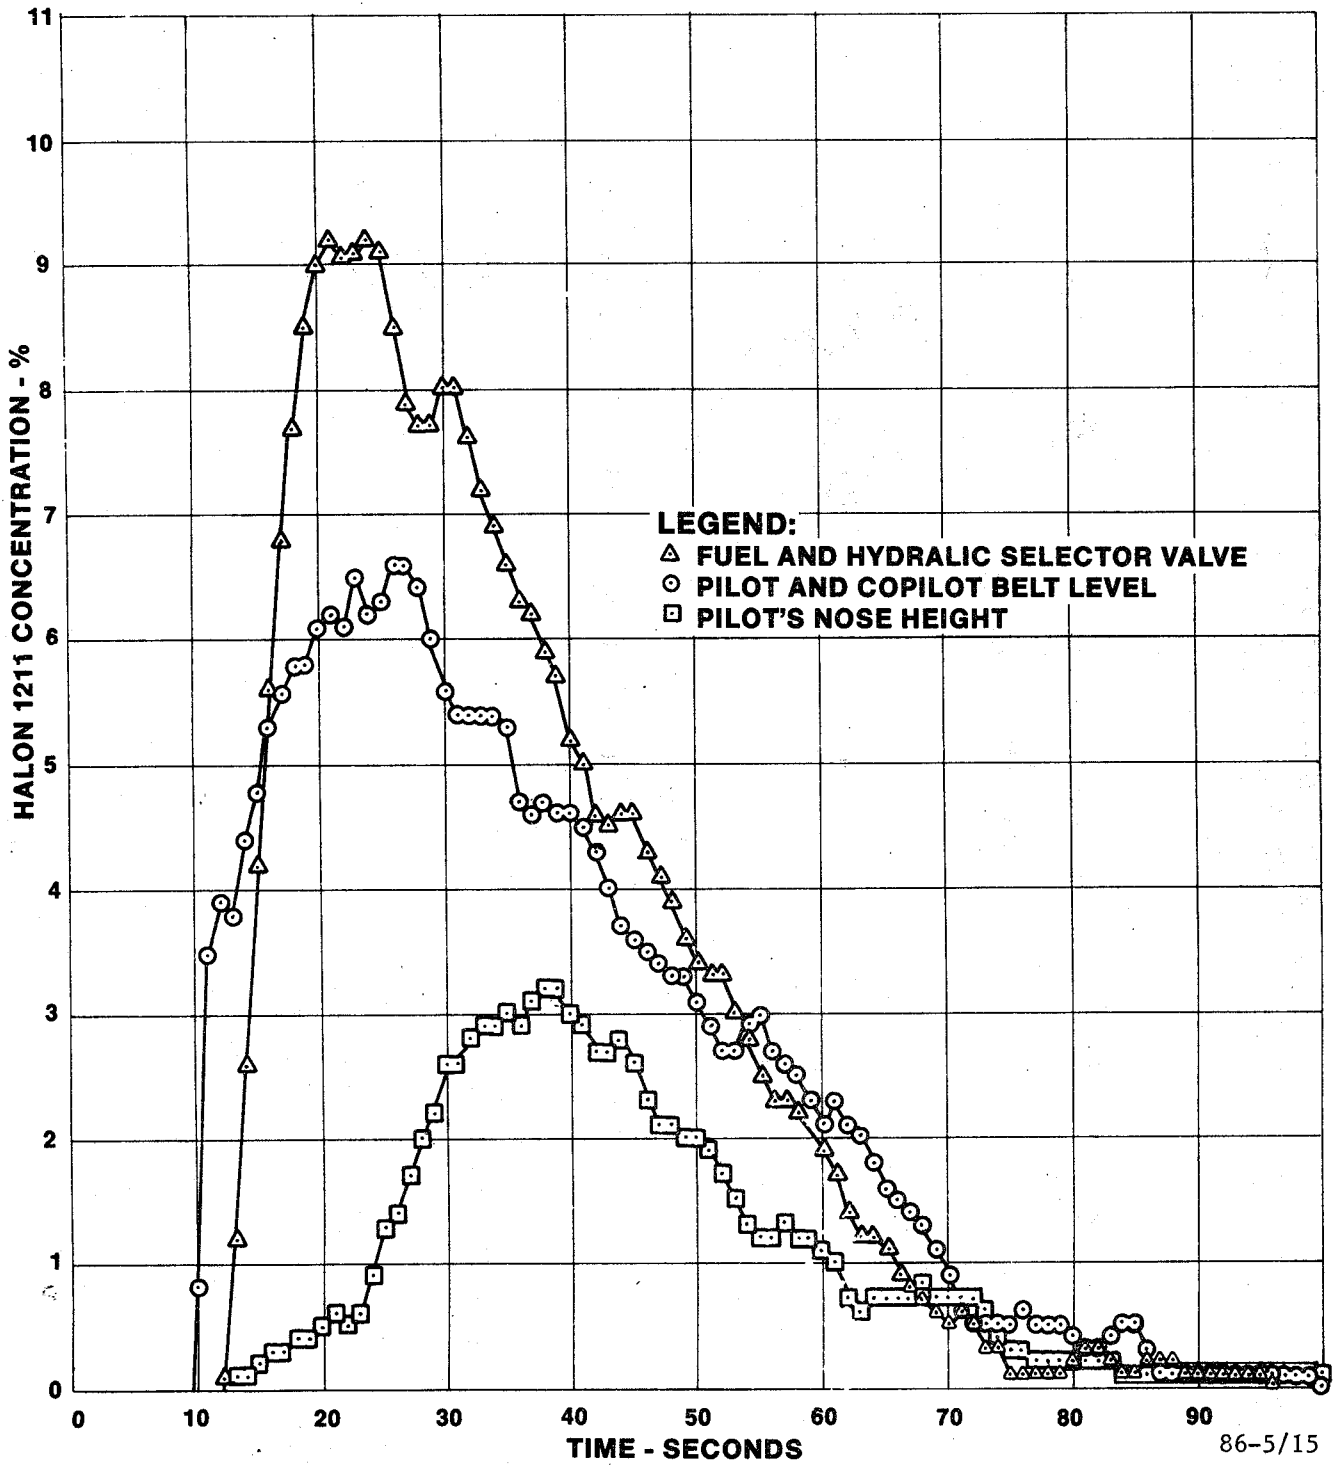
FIGURE 15. HALON 1211 CONCENTRATIONS - 2.5-POUND EXTINGUISHER DIRECTED TO THE FUEL AND HYDRAULIC SELECTOR VALVES - OVERHEAD VENTS OPEN

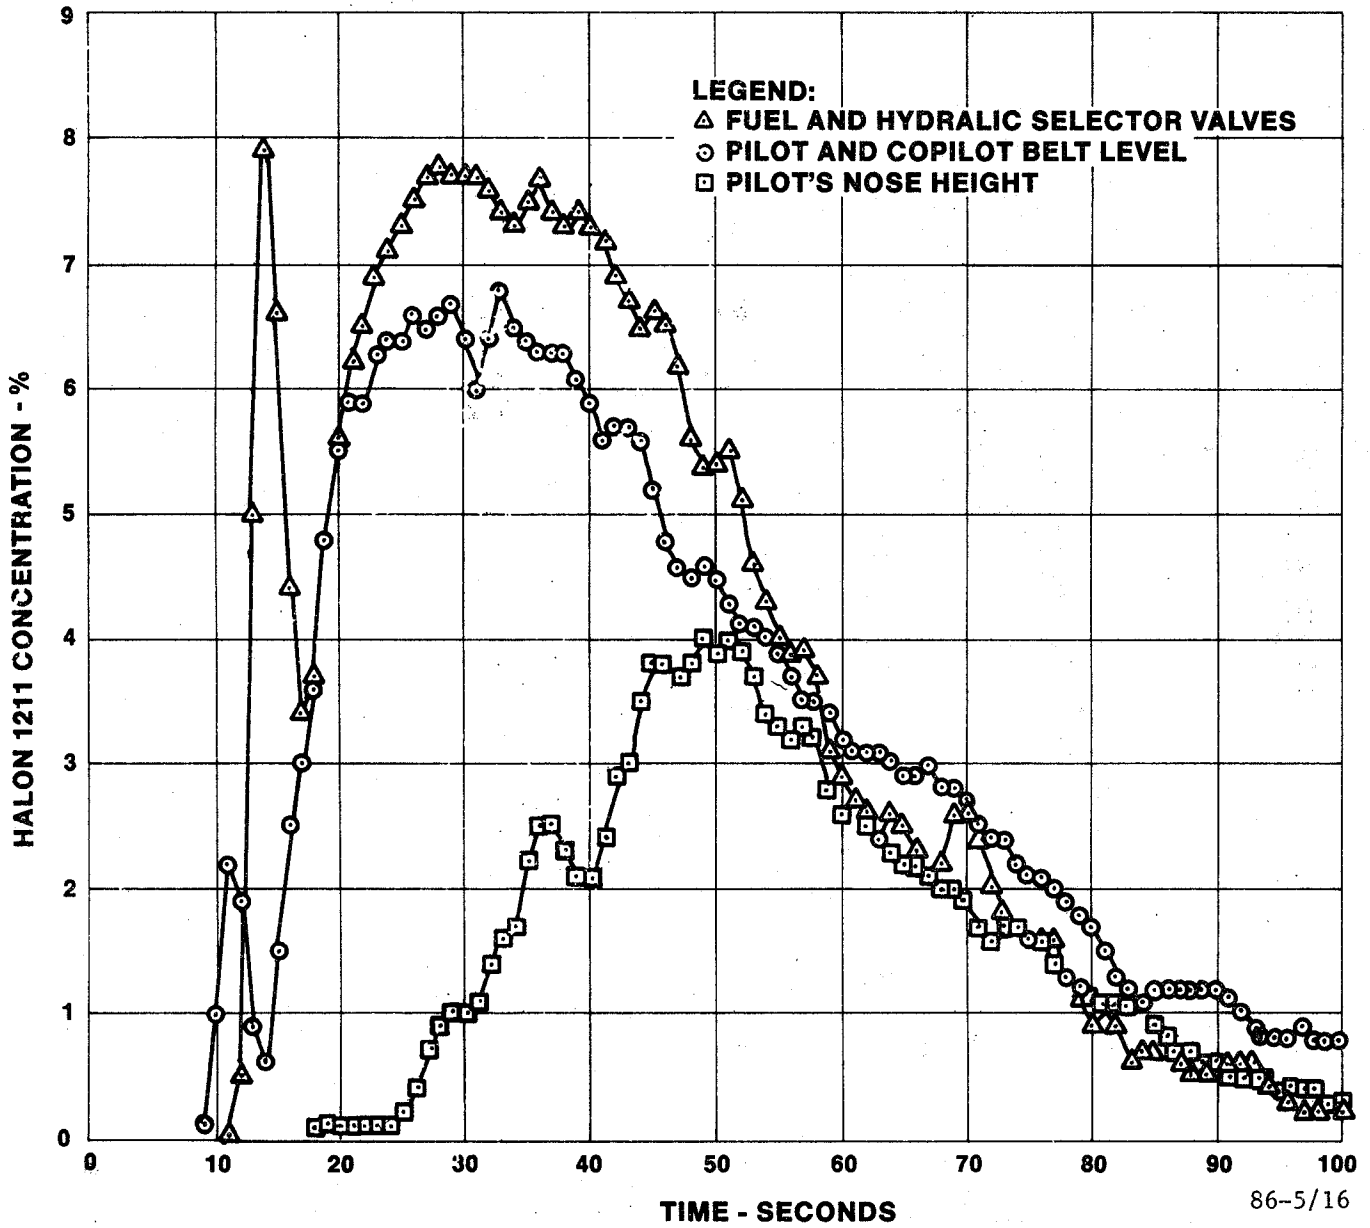
FIGURE 16. HALON 1211 CONCENTRATIONS - 2.5-POUND EXTINGUISHER DIRECTED TO THE FUEL AND HYDRALIC SELECTOR VALVES - OVERHEAD VENTS CLOSED

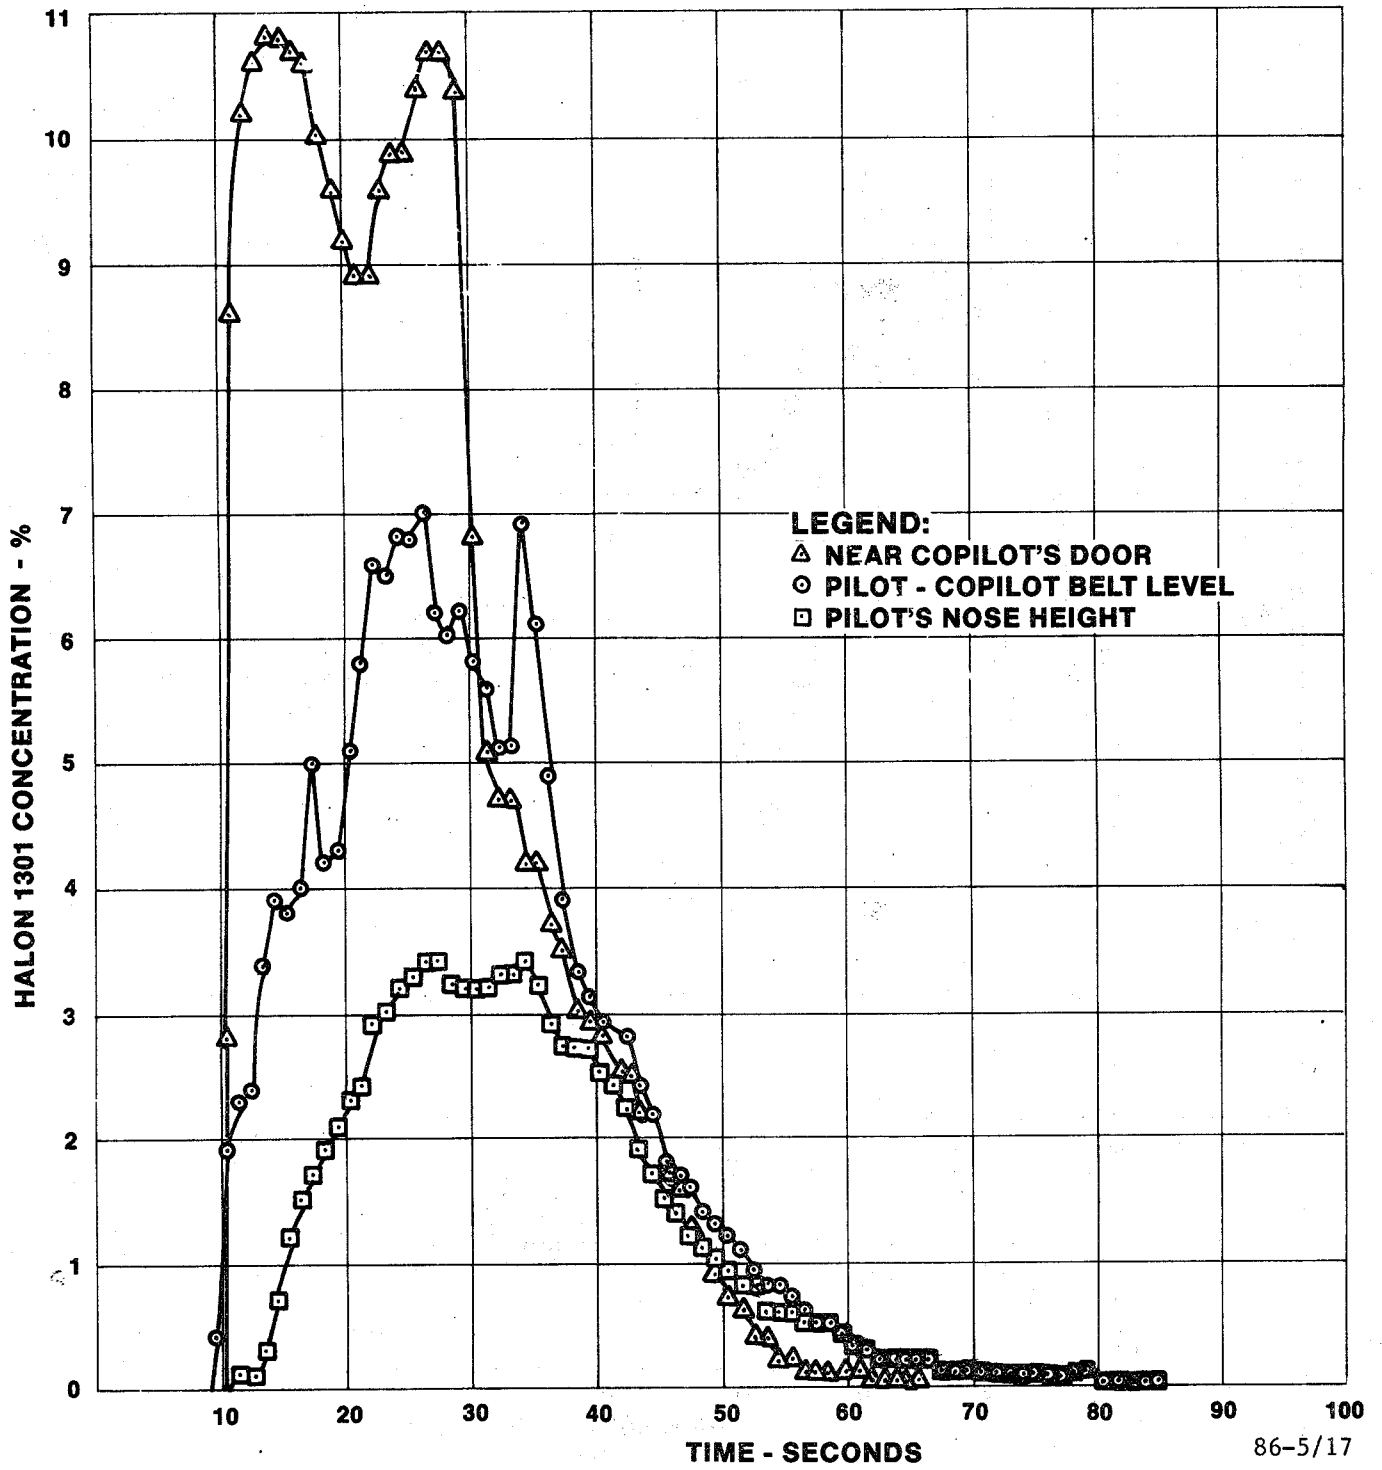
FIGURE 17. HALON 1301 CONCENTRATIONS - 3-POUND EXTINGUISHER DIRECTED TO THE COPILOT'S DOOR - OVERHEAD VENTS OPEN

Two Halon 1211 and two Halon 1301 extinguishers were discharged to the copilot's door at a point below the arm rest. Figures 17 through 20 show the agent concentrations plotted against time. As the discharge location was moved in relation to the pilot, dose calculations are less. The dose for the pilot was only 19 percent of the limit for Halon 1211, and 17 percent of the limit for Halon 1301.

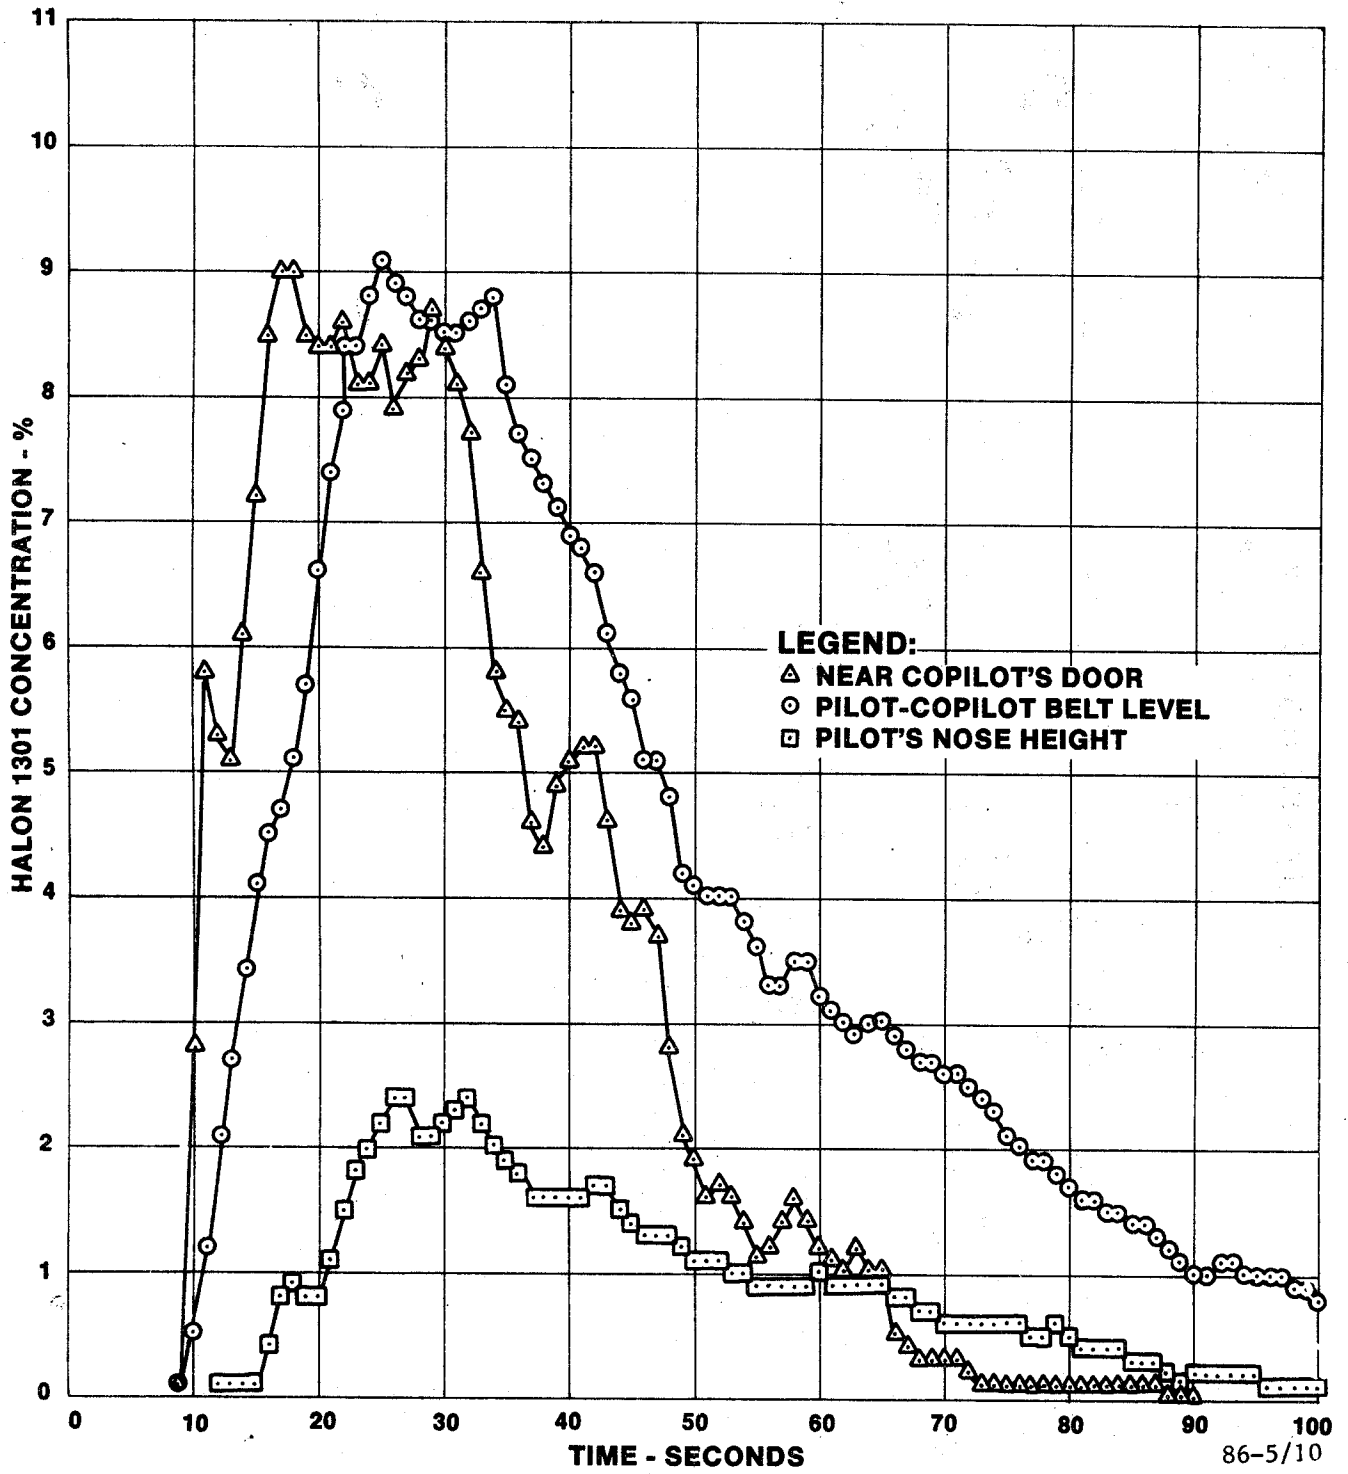
FIGURE 18. HALON 1301 CONCENTRATIONS - 3-POUND EXTINGUISHER DIRECTED UNDER INSTRUMENT PANEL - PILOT'S SIDE - OVERHEAD VENTS CLOSED

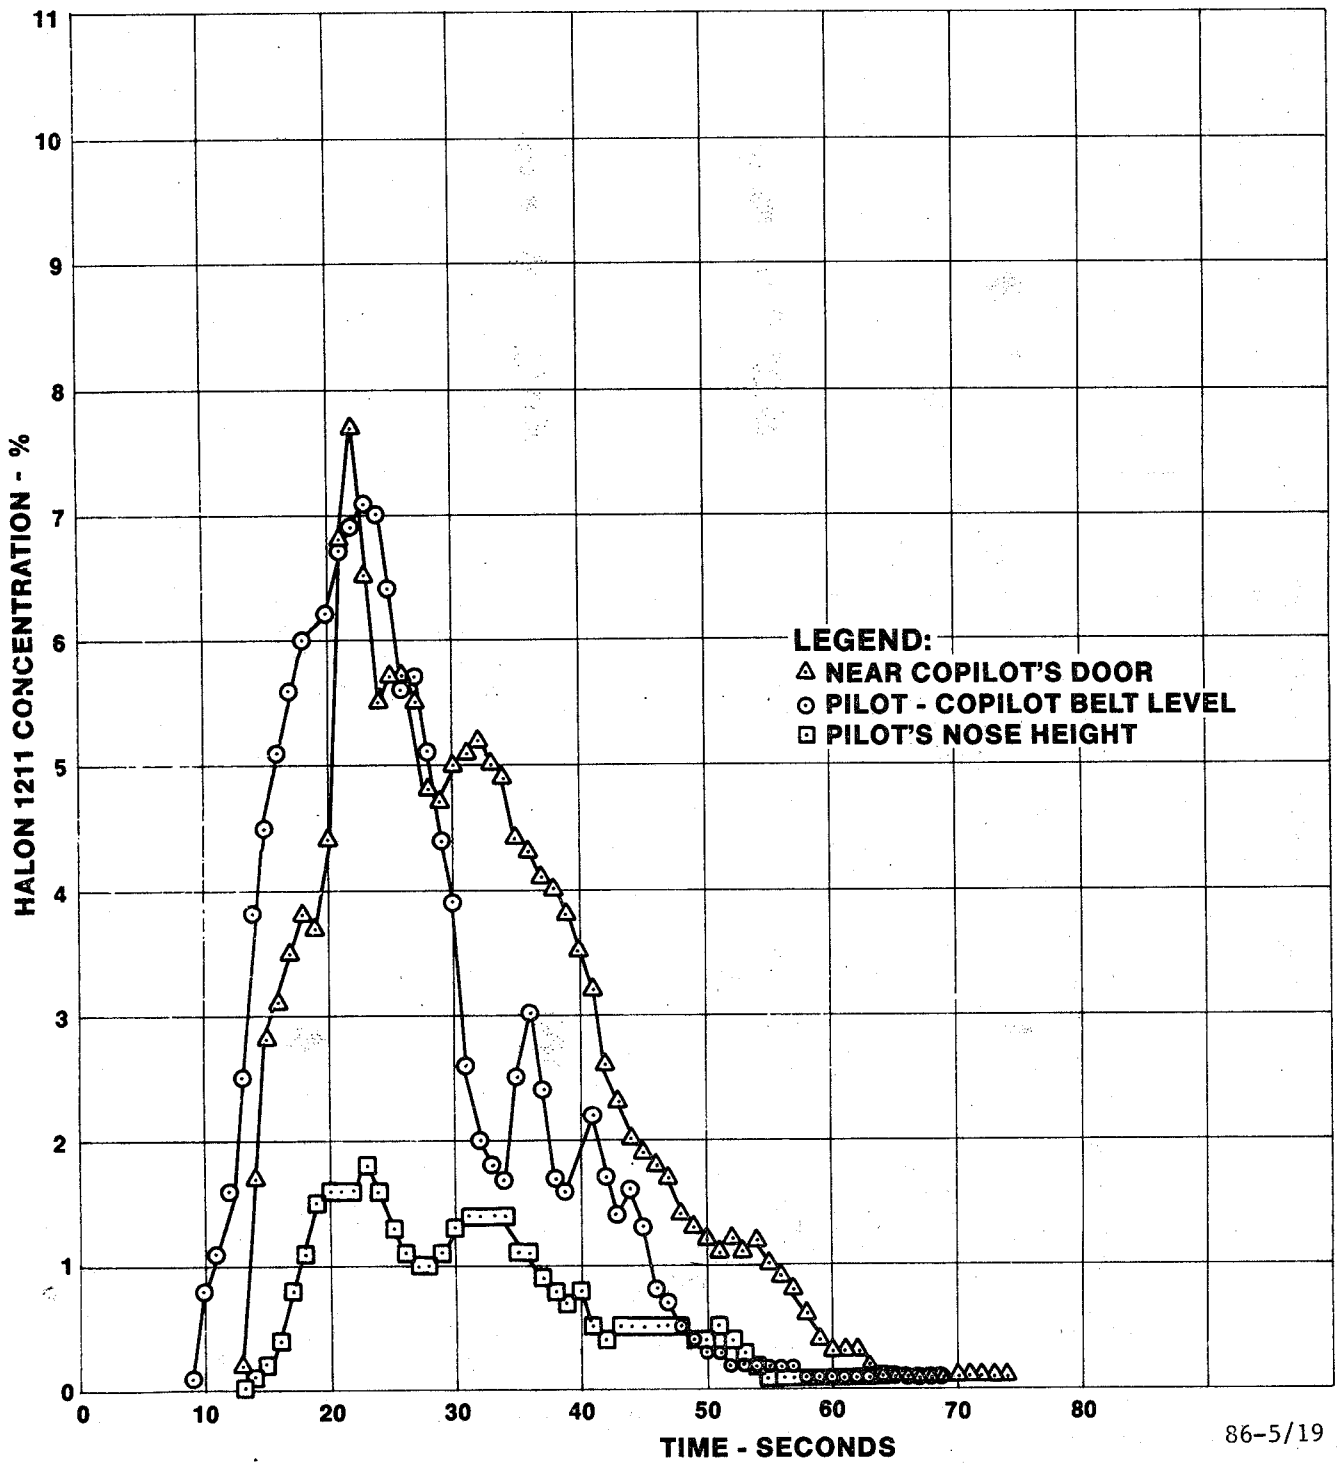
FIGURE 19. HALON 1211 CONCENTRATIONS - 2.5-POUND EXTINGUISHER DIRECTED TO THE COPILOT'S DOOR - OVERHEAD VENTS OPEN

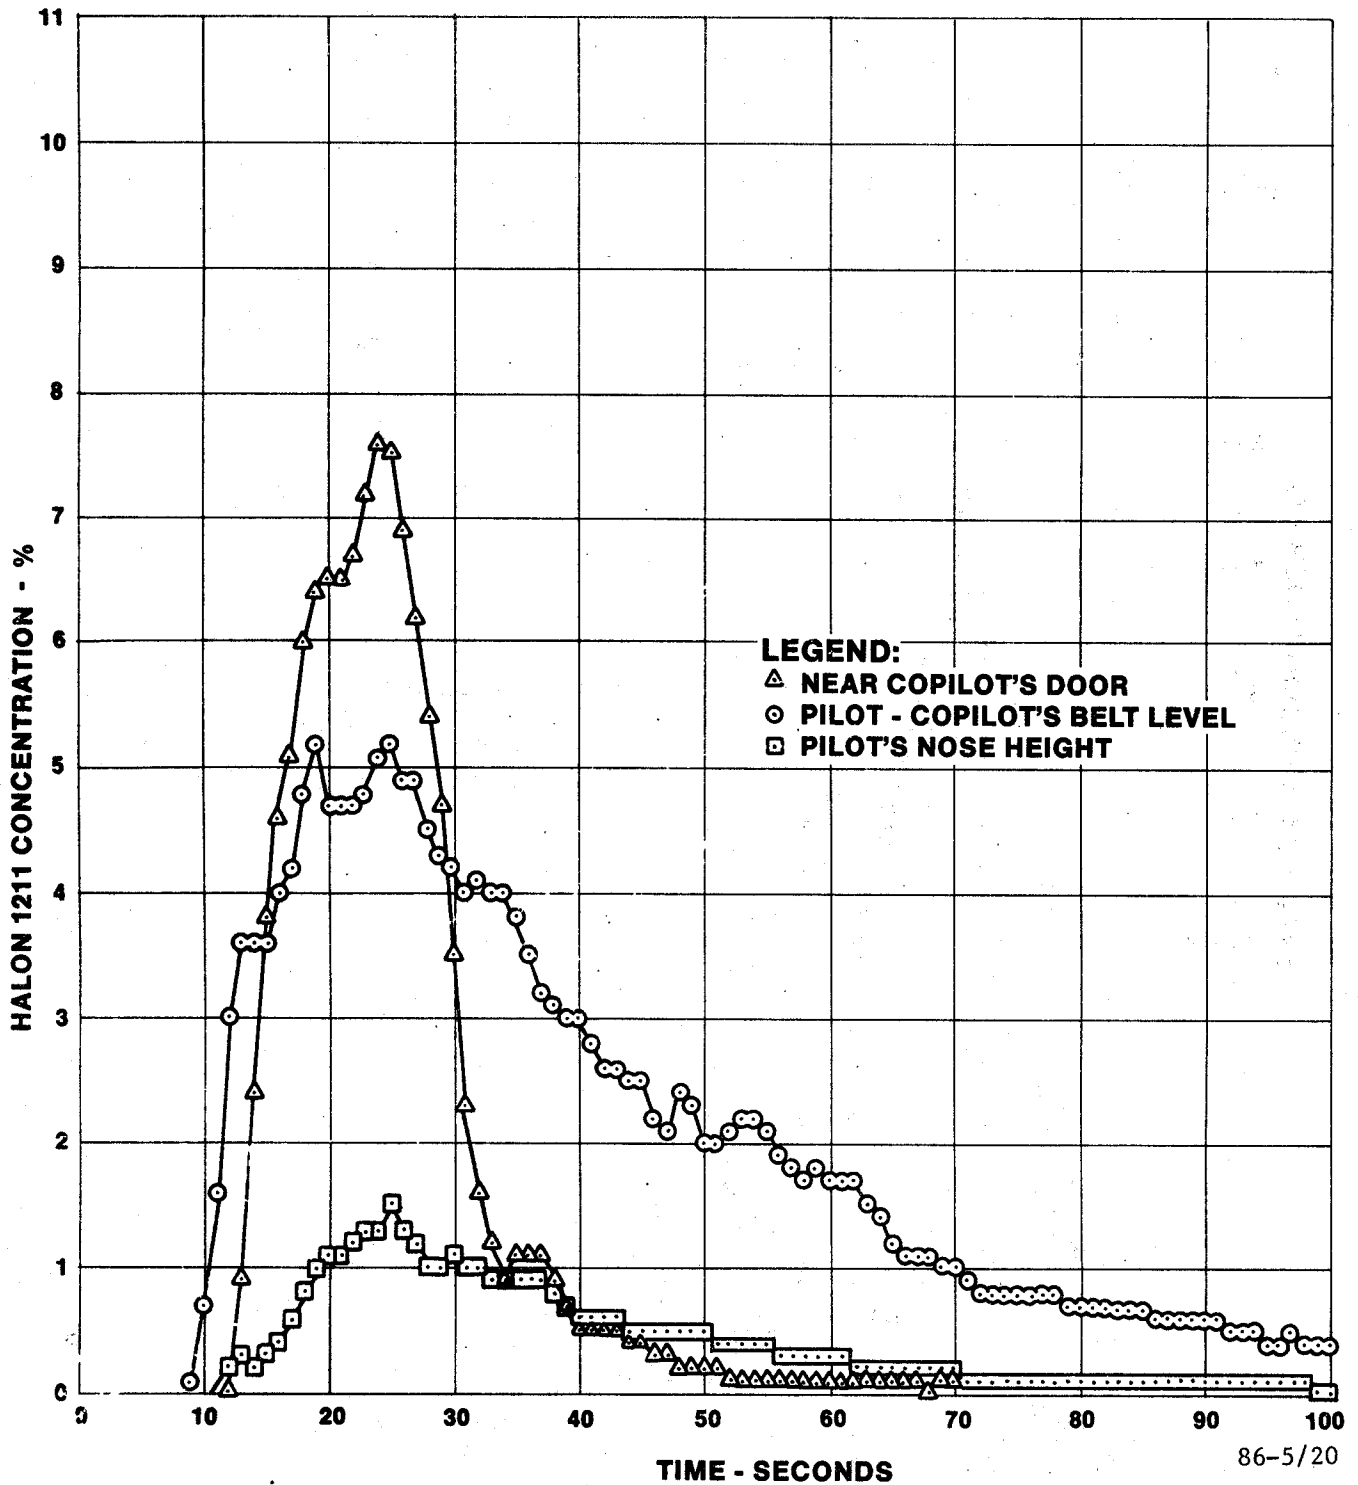
FIGURE 20. HALON 1211 CONCENTRATIONS - 2.5-POUND EXTINGUISHER DIRECTED TO THE COPILOT'S DOOR - OVERHEAD VENTS CLOSED

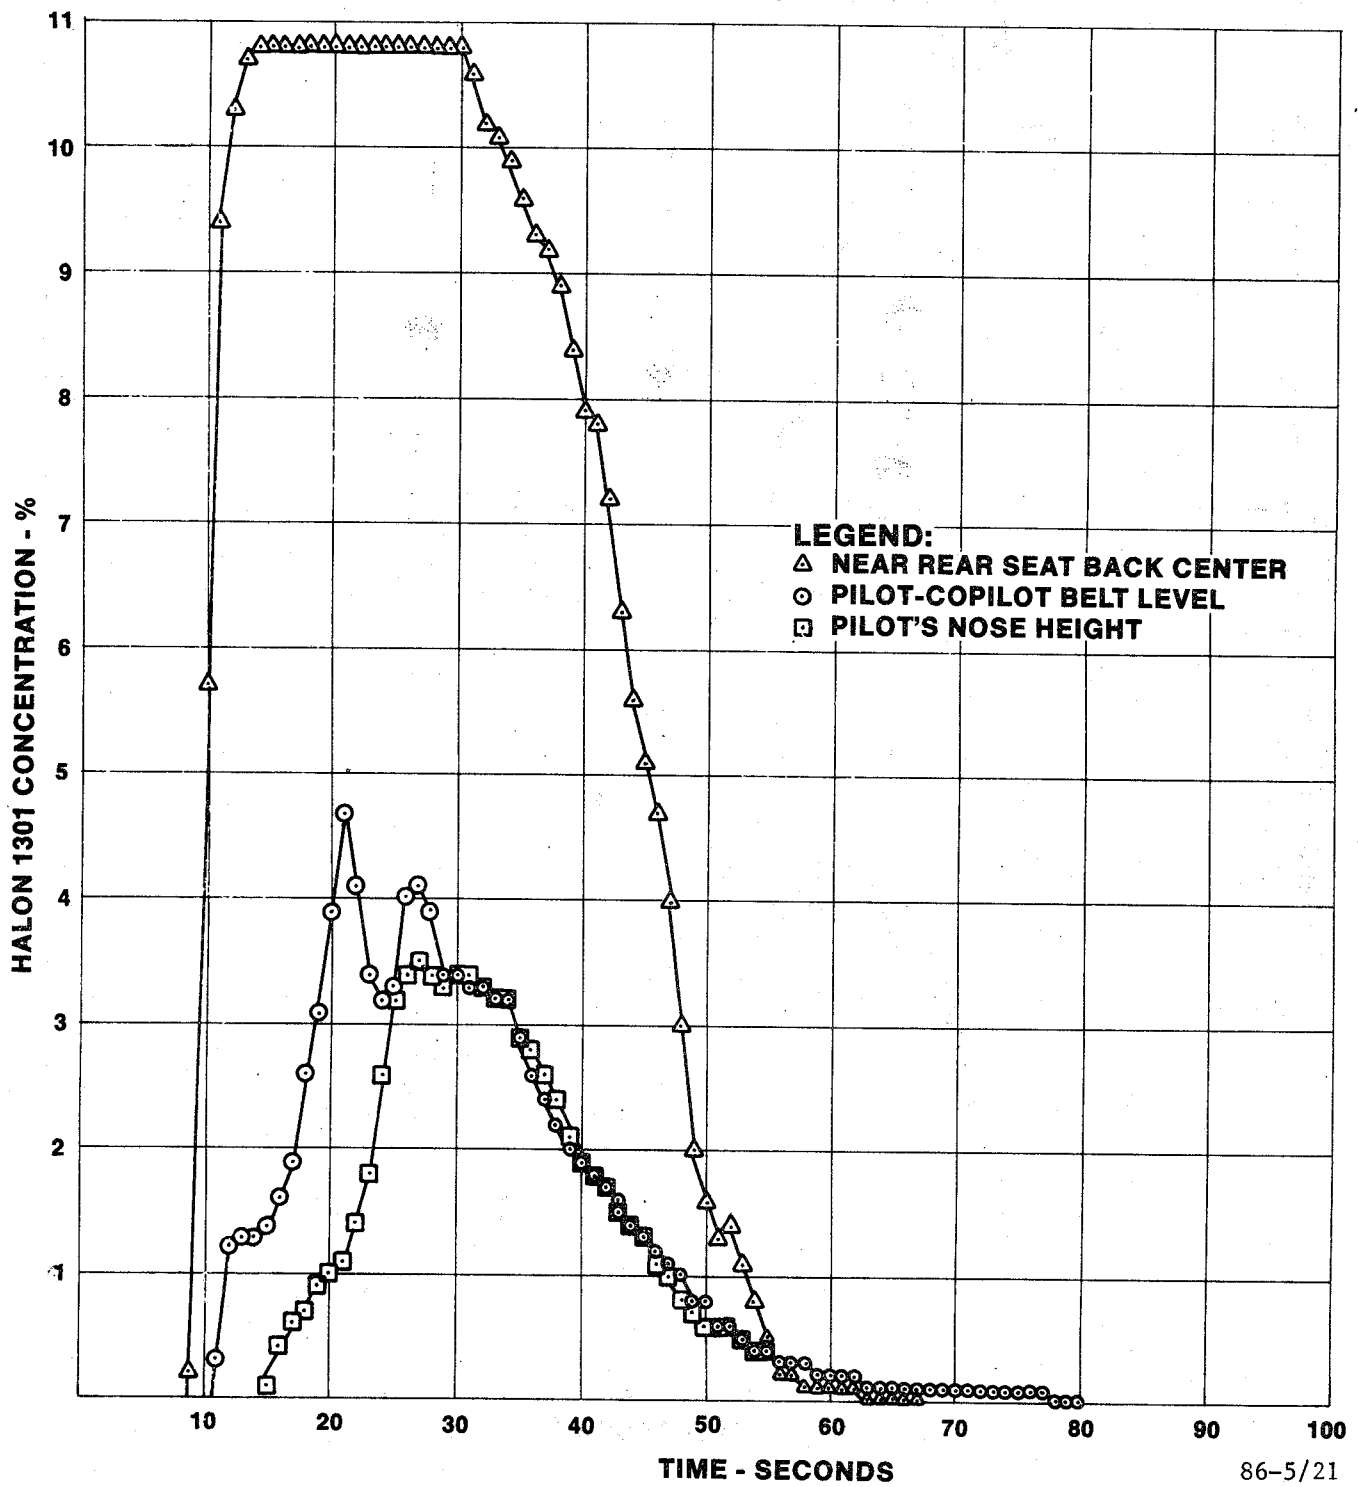
FIGURE 21. HALON 1301 CONCENTRATIONS - 3-POUND EXTINGUISHER DIRECTED TO THE REAR SEAT - OVERHEAD VENTS OPEN

Two Halon 1211 and two Halon 1301 bottles were discharged to the center of the rear seat back. The measurements plotted versus time are in figures 21 through 24 and values are tabulated in table 2. Dose calculations for the pilot's nose was only up to 33 percent of the limit for Halon 1211 and up to 23 percent of the limit for Halon 1301. Dose for the pilot's belt level was also low and was below the limit dose for both agents.

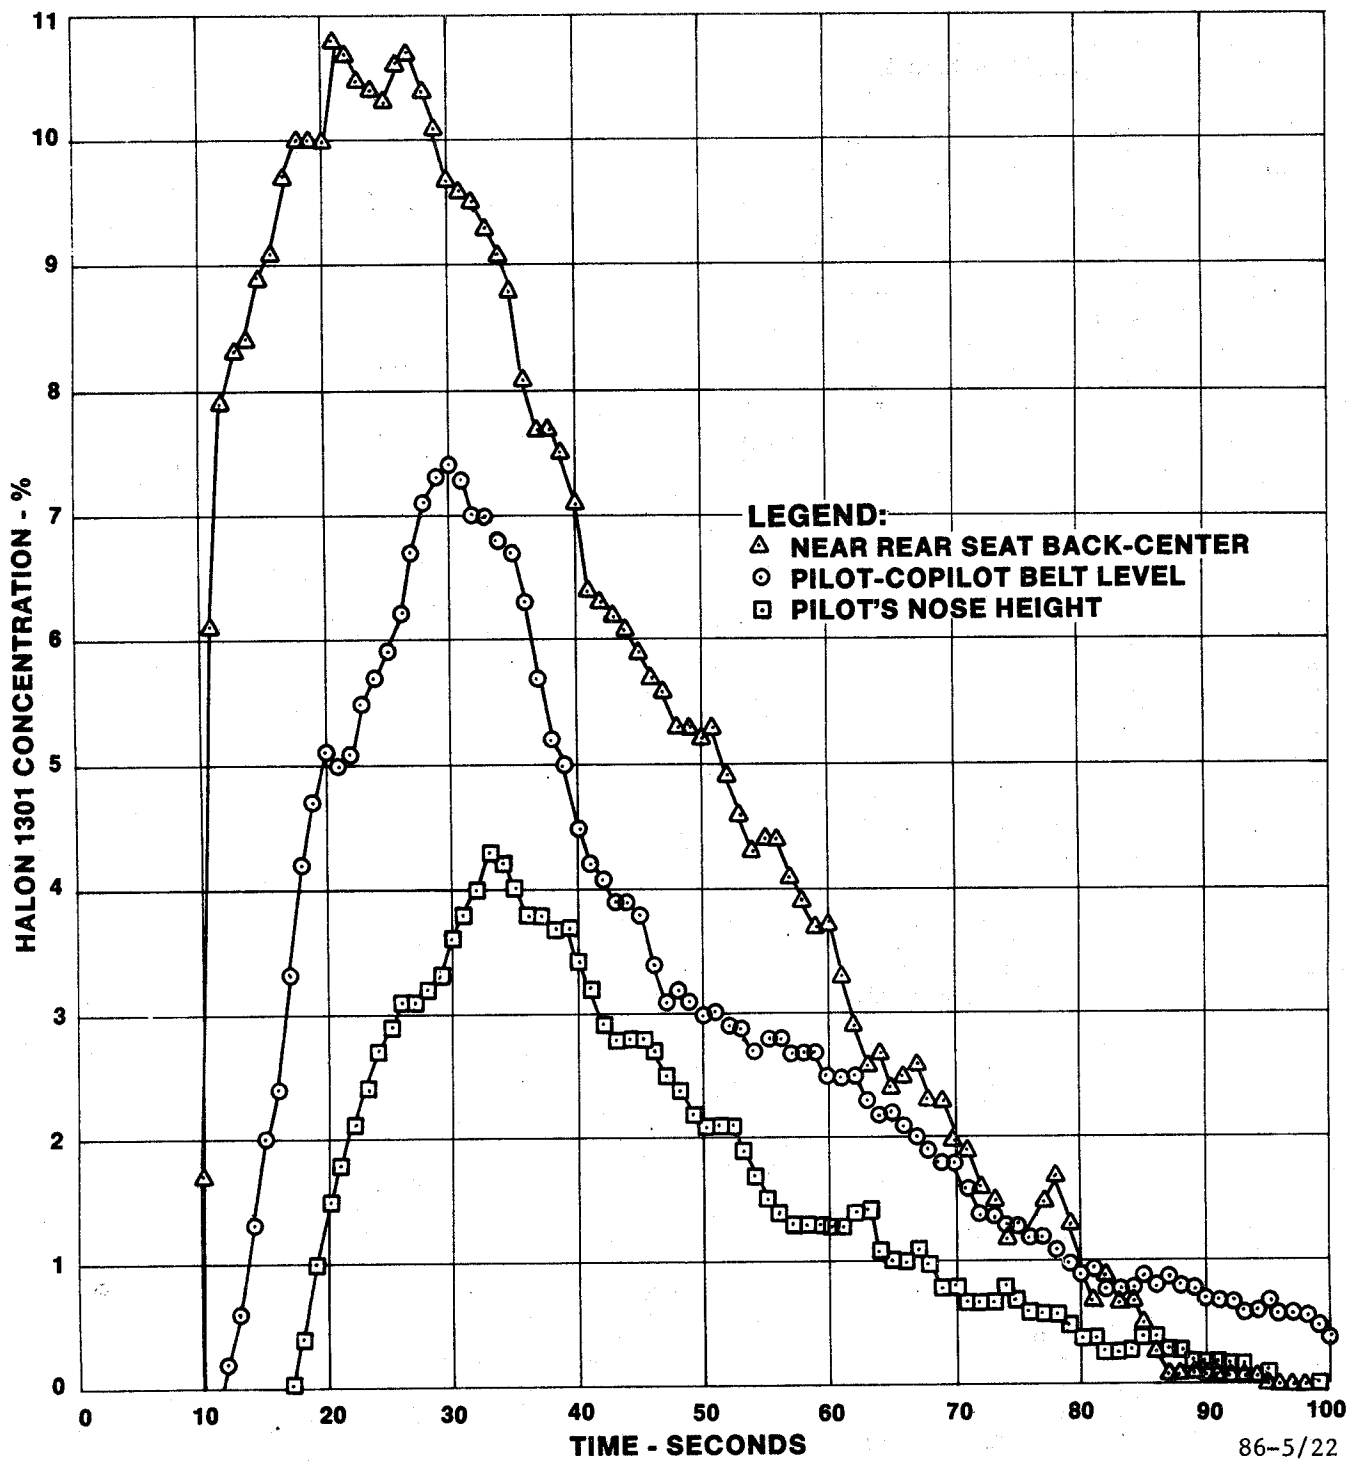
FIGURE 22. HALON 1301 CONCENTRATIONS - 3-POUND EXTINGUISHER DIRECTED TO THE REAR SEAT - OVERHEAD VENTS CLOSED

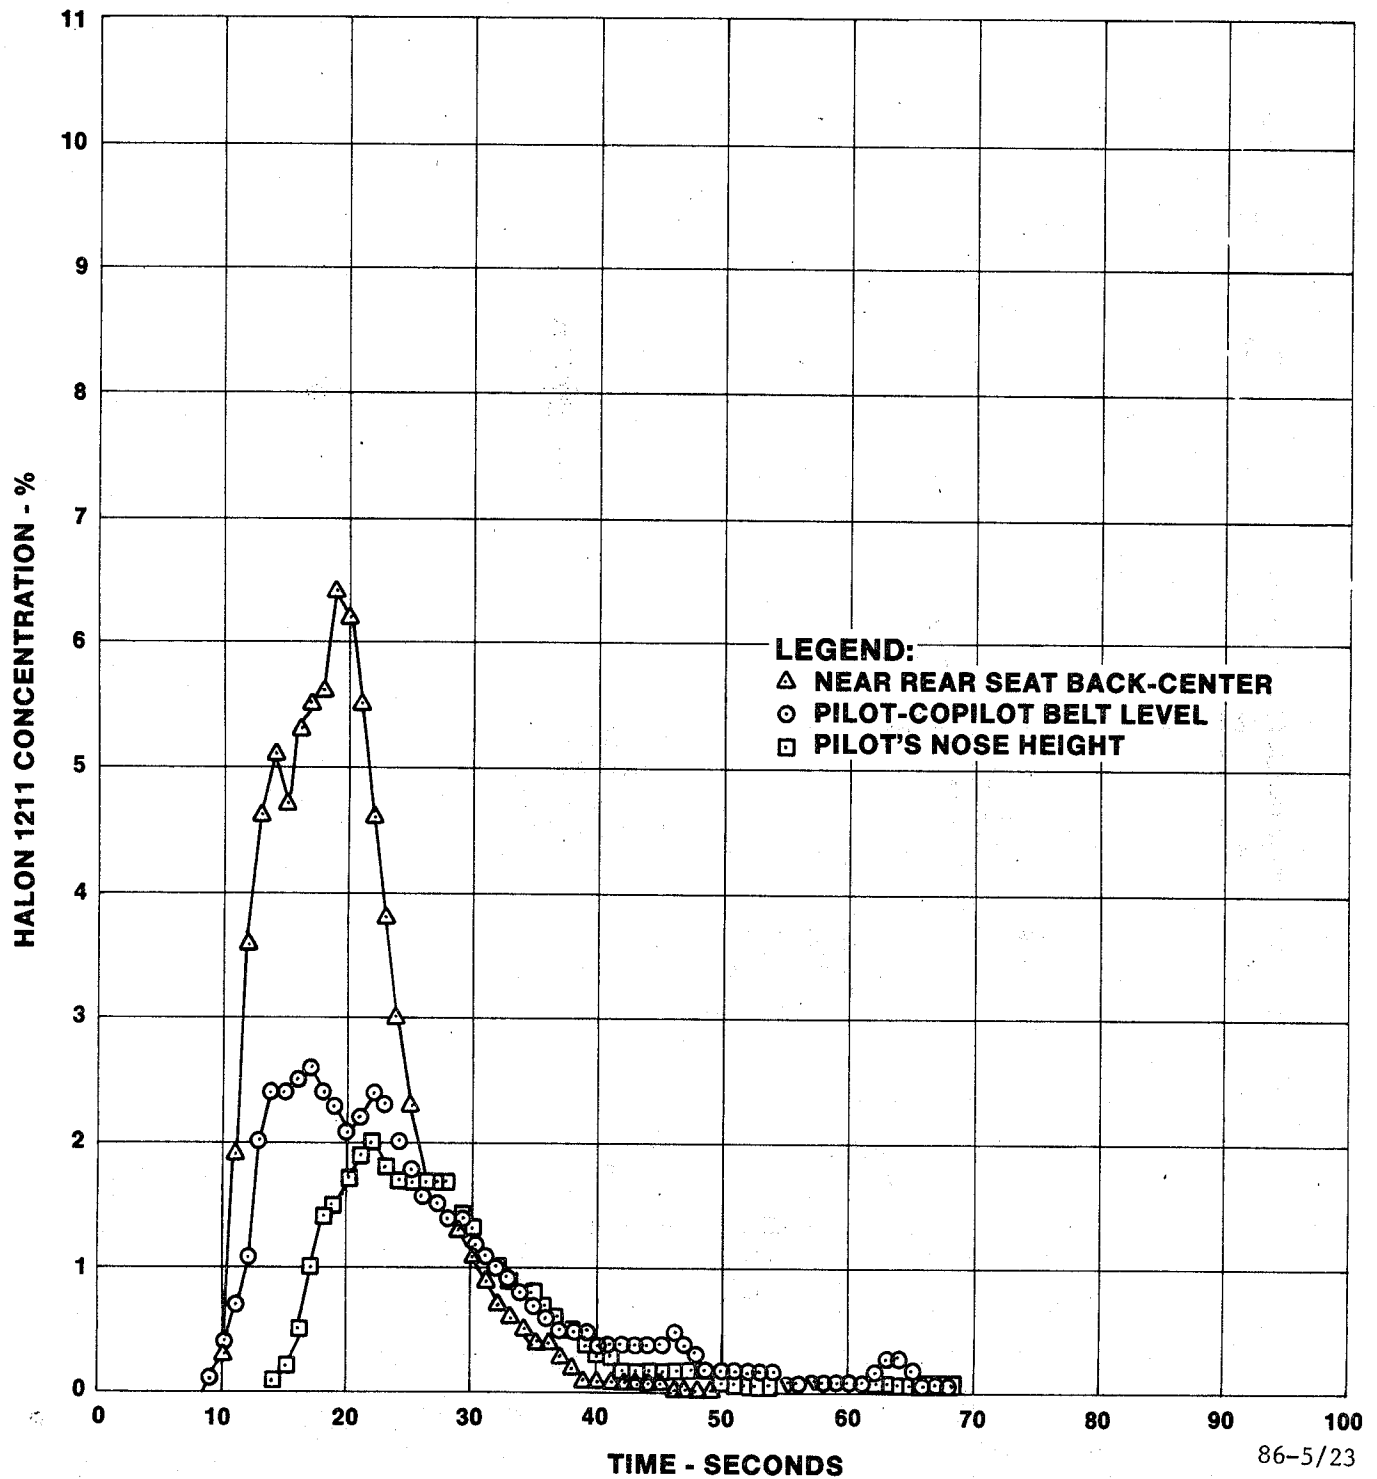
FIGURE 23. HALON 1211 CONCENTRATIONS - 2.5-POUND EXTINGUISHER DIRECTED TO THE REAR SEAT - OVERHEAD VENTS OPEN
