DOT/FAA/CT-86/5

Halon Extinguisher Agent Behavior in a Ventilated Small Aircraft

Final Report

U.S. Department of Transportation
Federal Aviation Administration
Technical Center
Atlantic City Airport, N.J. 08405

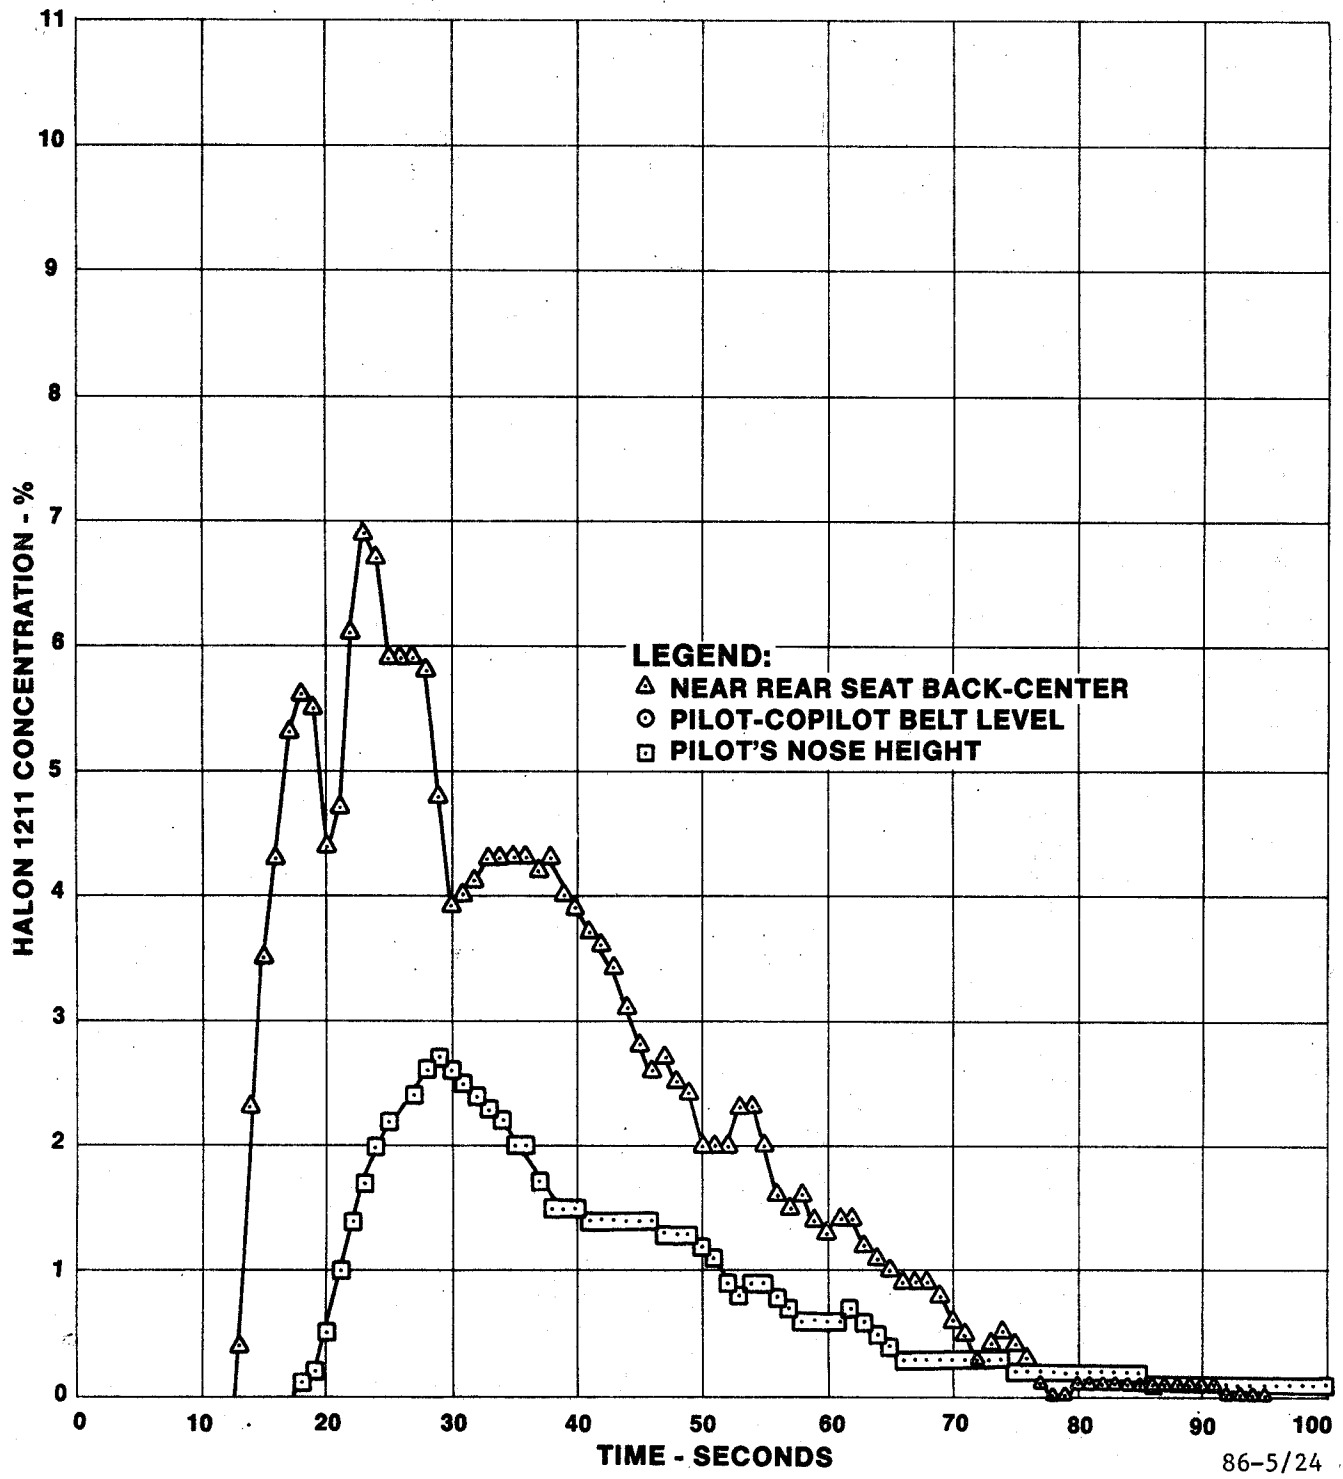
FIGURE 24. HALON 1211 CONCENTRATIONS - 2.5-POUND EXTINGUISHER DIRECTED TO THE REAR SEAT - OVERHEAD VENTS CLOSED

Two Halon 1211 and two Halon 1301 bottles were discharged to the center of the rear seat back. The measurements plotted versus time are in figures 21 through 24 and values are tabulated in table 2. Dose calculations for the pilot's nose was only up to 33 percent of the limit for Halon 1211 and up to 23 percent of the limit for Halon 1301. Dose for the pilot's belt level was also low and was below the limit dose for both agents.

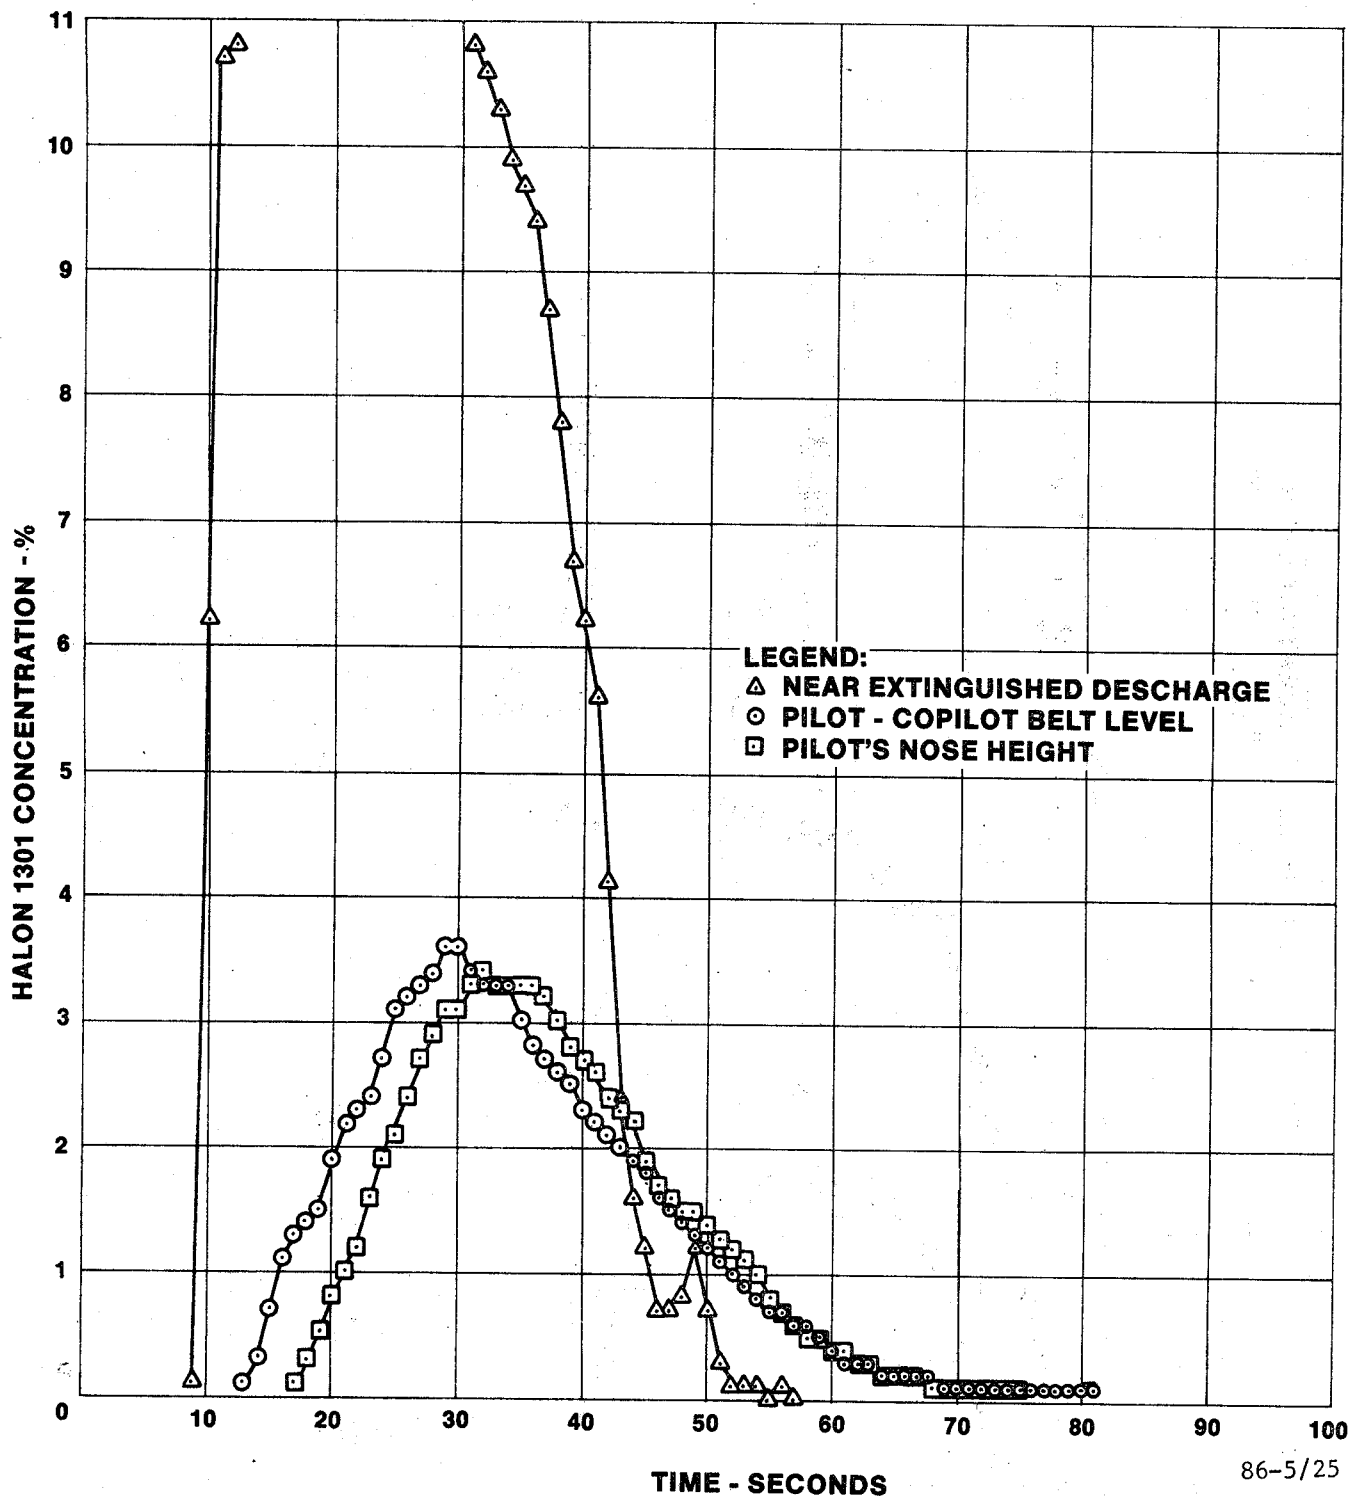
FIGURE 25. HALON 1301 CONCENTRATIONS - 3-POUND EXTINGUISHER DIRECTED TO THE BAGGAGE COMPARTMENT - OVERHEAD VENTS OPEN

Extinguishers were directed to the center section of the baggage compartment. Tests of both Halon 1211 and Halon 1301 extinguishers were completed. The measurements are plotted in figures 25 through 28 and selected values are tabulated in table 2. The dose calculations for the pilot's nose was only 16 percent of the limit for Halon 1211, and only up to 15 percent of the limit for Halon 1301. Dose for the pilot's belt level was also low and was below the limit dose for both agents.

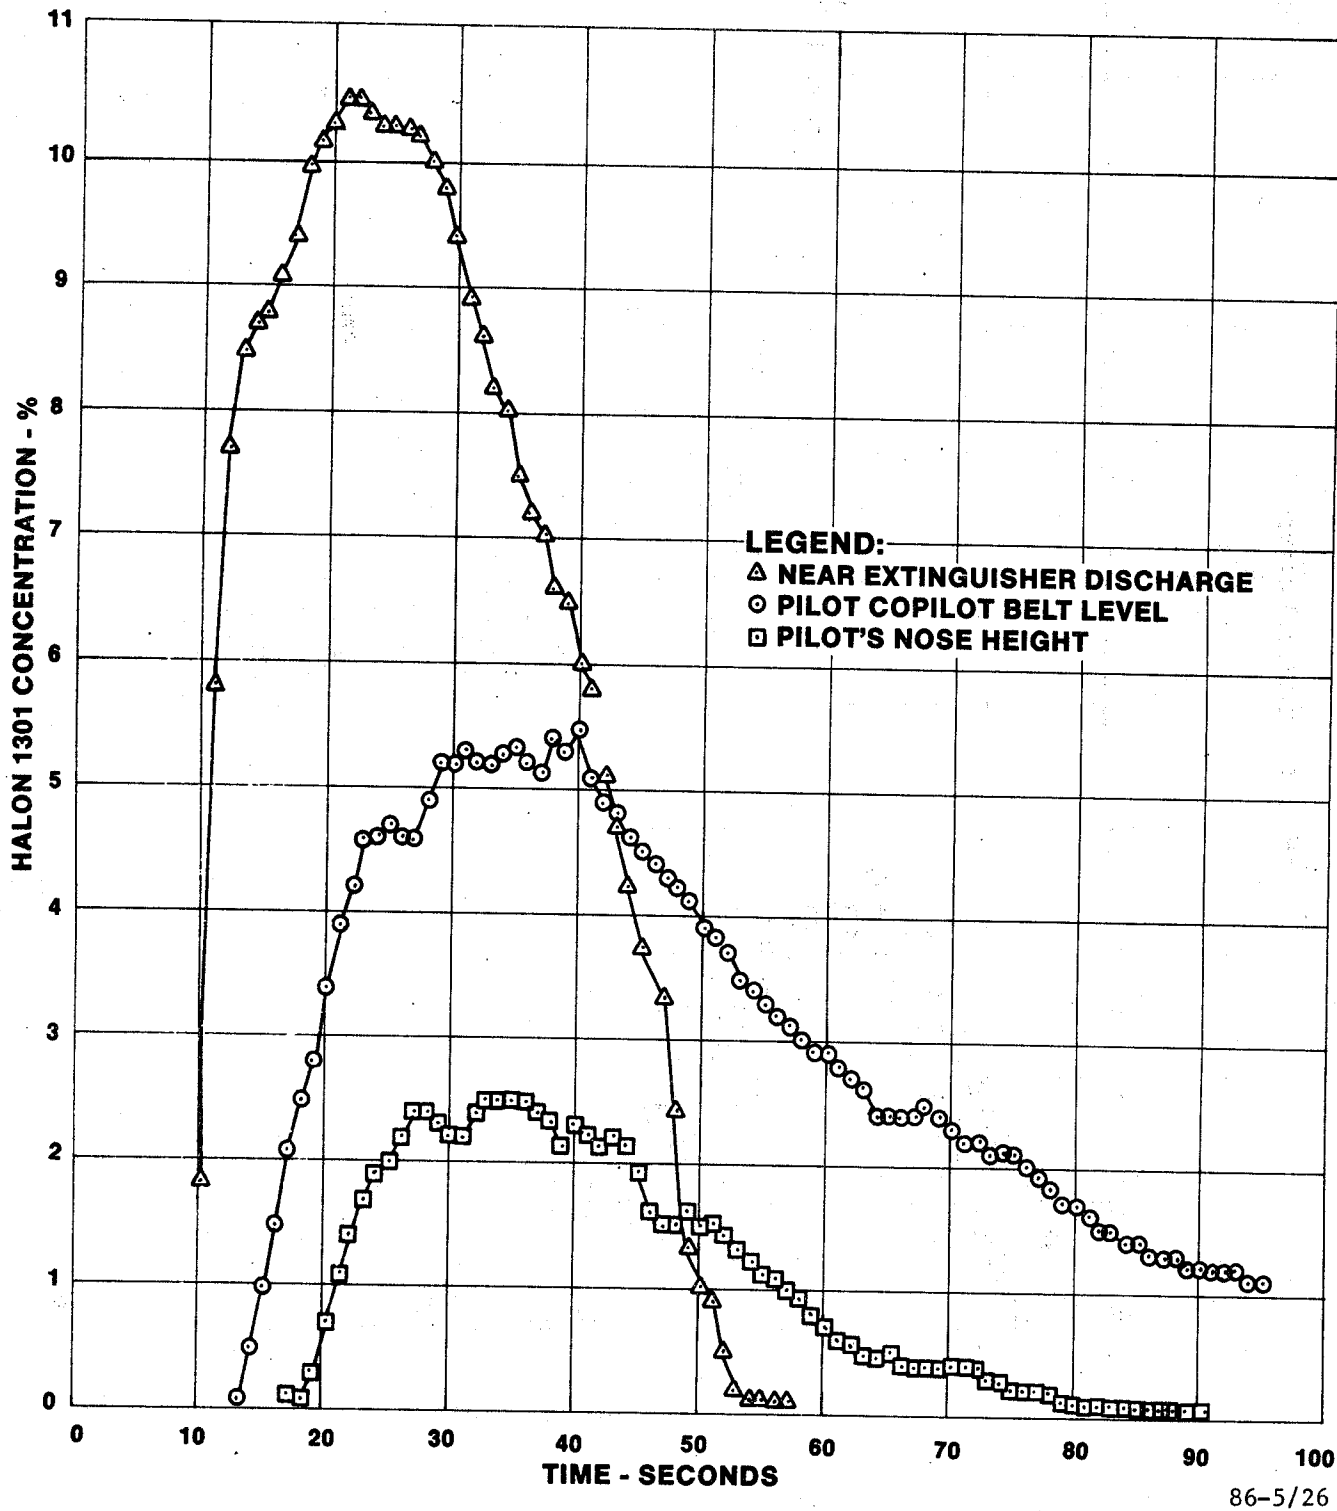
86-5/26

FIGURE 26. HALON 1301 CONCENTRATIONS - 3-POUND EXTINGUISHER DIRECTED TO THE BAGGAGE COMPARTMENT - OVERHEAD VENTS CLOSED

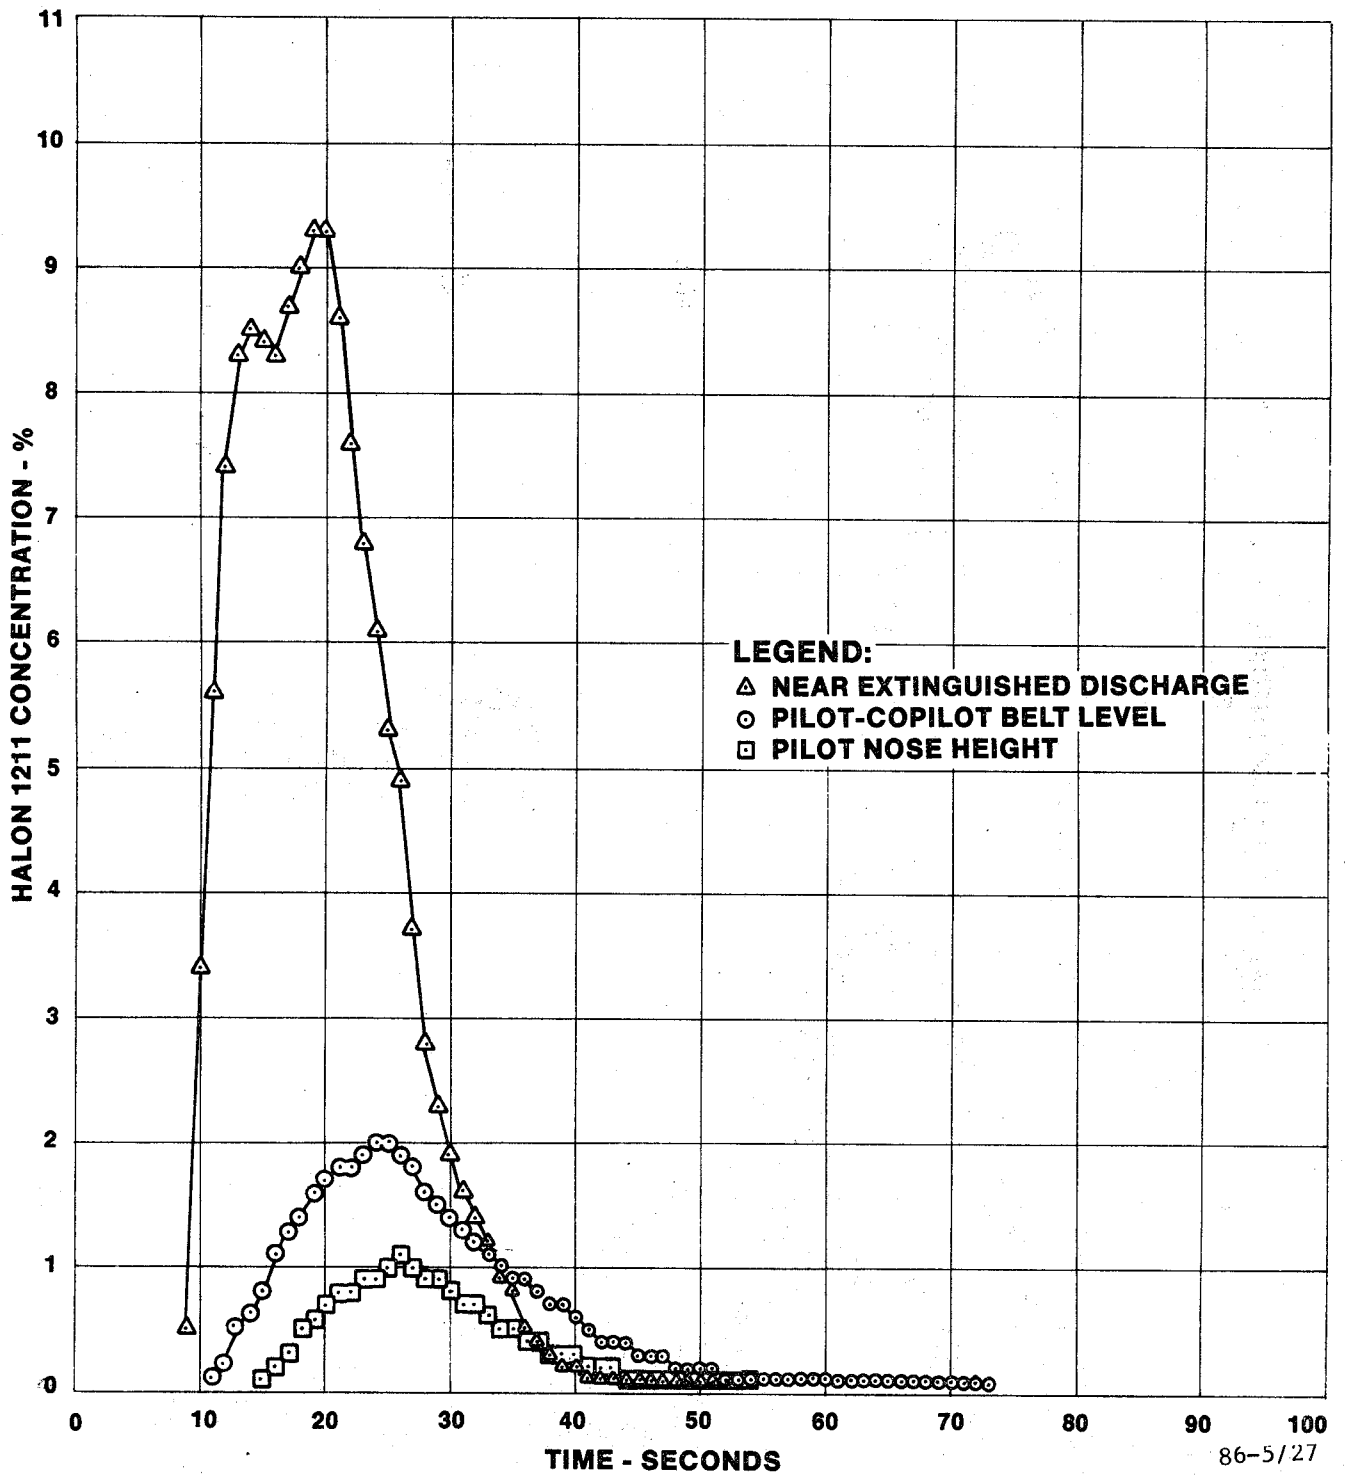
FIGURE 27. HALON 1211 CONCENTRATIONS - 2.5-POUND EXTINGUISHER DIRECTED TO THE BAGGAGE COMPARTMENT - OVERHEAD VENTS OPEN

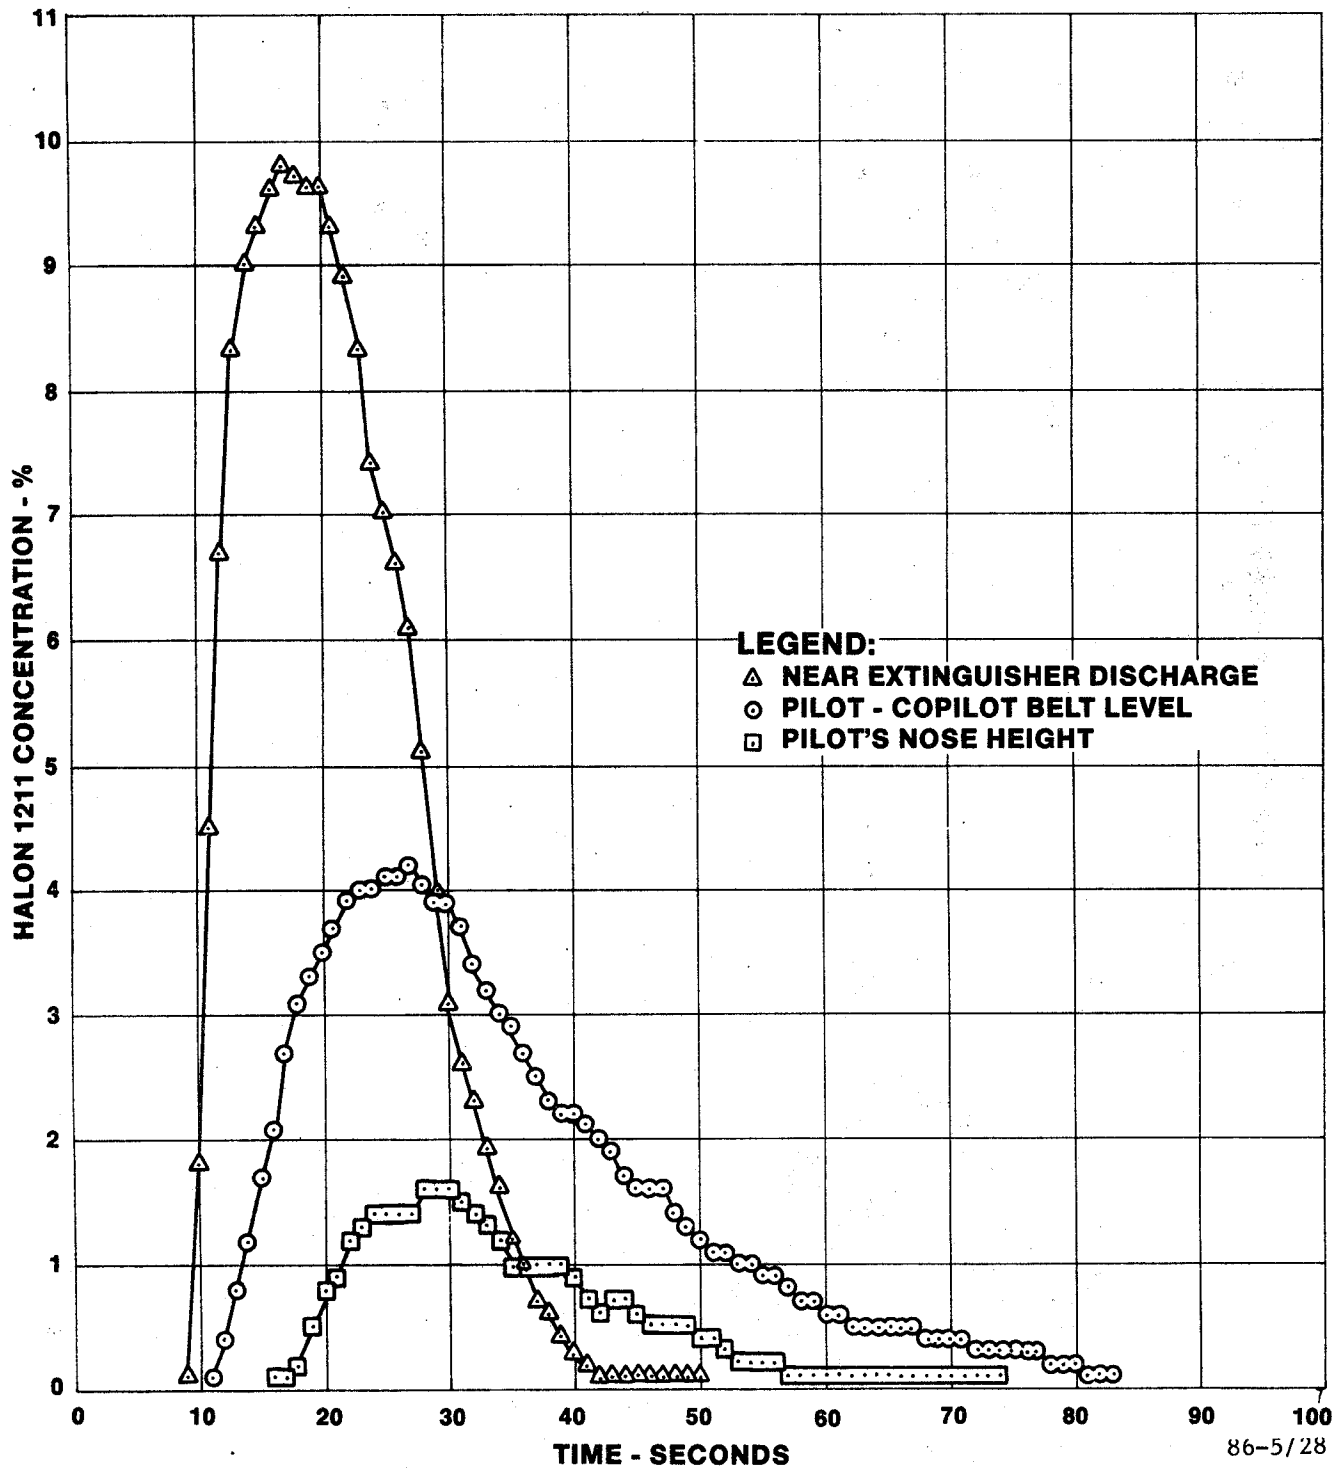
FIGURE 28. HALON 1211 CONCENTRATIONS - 2.5-POUND EXTINGUISHER DIRECTED TO THE BAGGAGE COMPARTMENT - OVERHEAD VENTS CLOSED

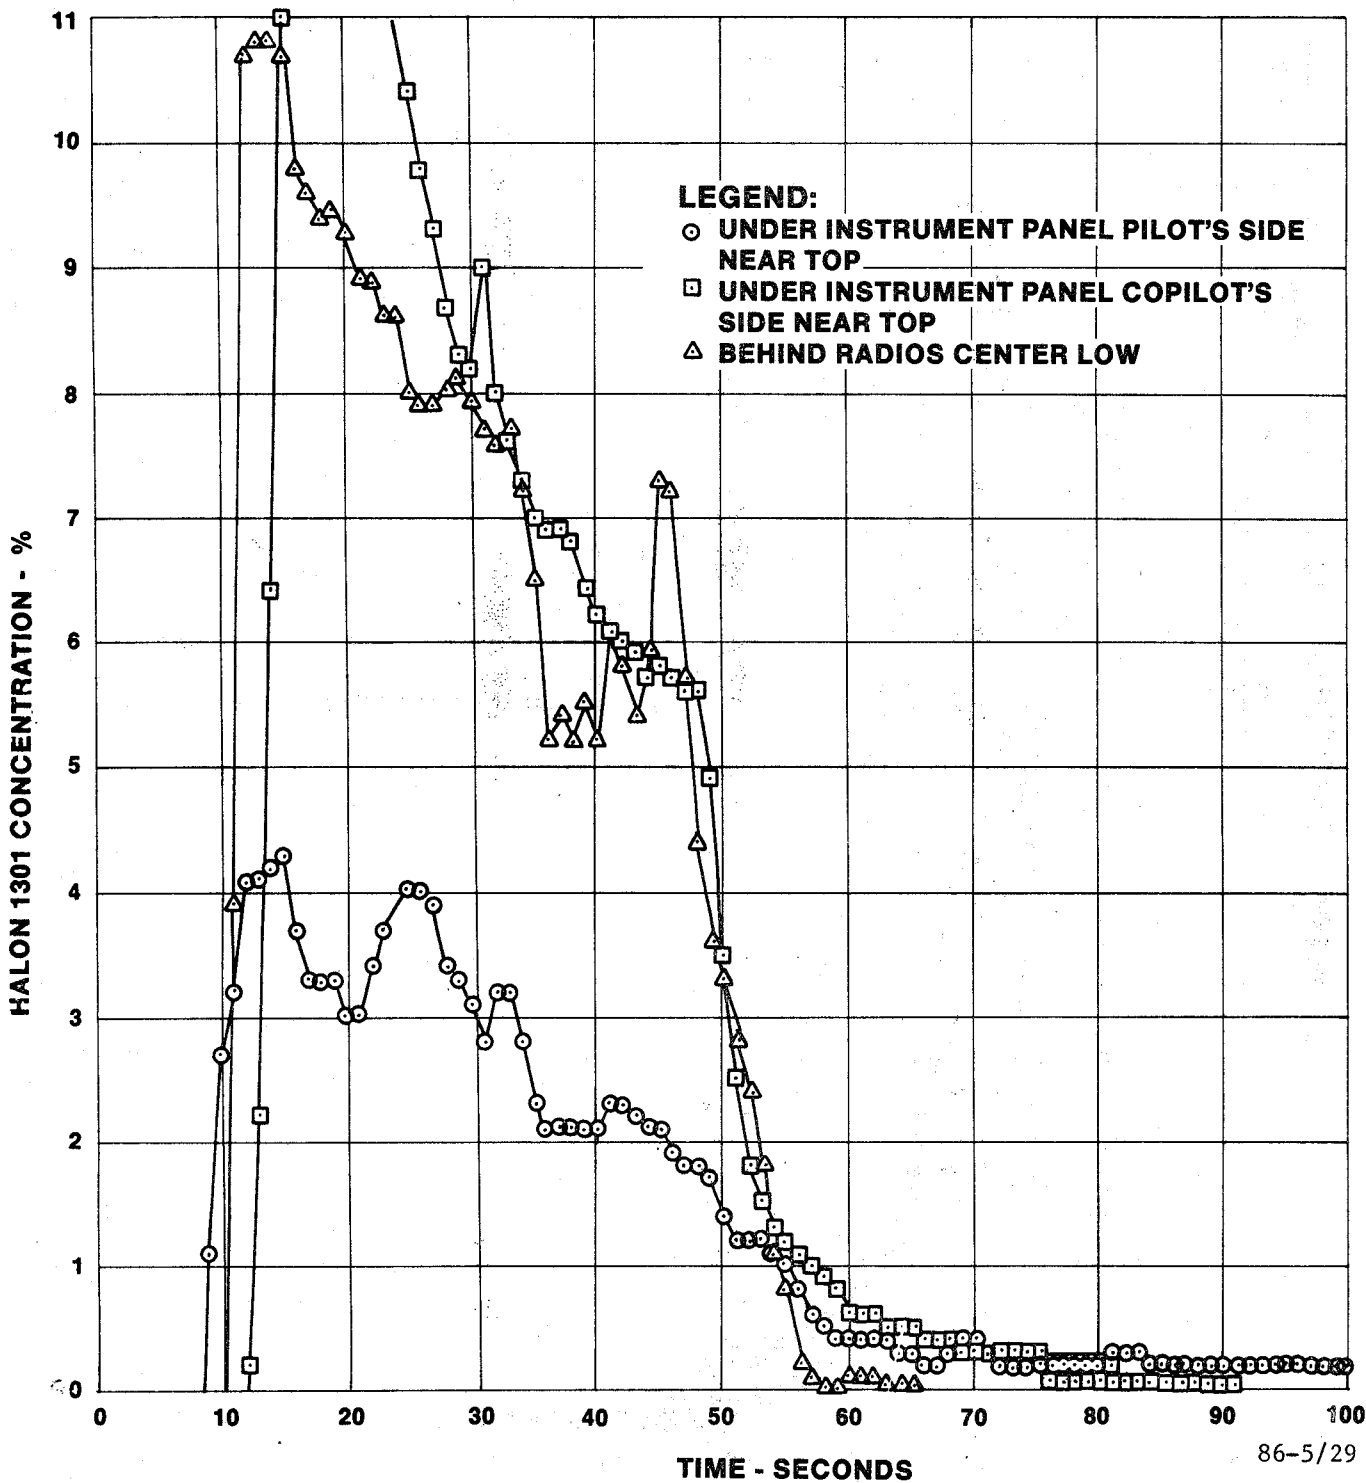
FIGURE 29. HALON 1301 CONCENTRATIONS - 3-POUND EXTINGUISHER DIRECTED UNDER THE INSTRUMENT PANEL - COPILOT'S SIDE - ALL SAMPLE LINES UNDER INSTRUMENT PANEL

An investigation was conducted to determine the distribution of extinguisher agents under the instrument panel. The gas sample lines were arranged to sample near the top of the instrument panel (pilot's side), near the top of the instrument panel (copilot's side), and at the very low center section under the stack of radios and direction finding electronics. The measurements are plotted versus time, figures 29 through 32, and selected values are listed in table 4. One Halon 1211 extinguisher and one 1301 extinguisher were discharged under the instrument panel on the copilot's side and identical testing was completed by discharging the extinguishers under the instrument panel pilot's side. High levels of agent (10 to 11 percent) were measured under the instrument panel on the side where the extinguishers were discharged. On the opposite side of the instrument panel, extinguisher gas concentrations ranged from 3.8 percent to 4.5 percent. Under the stack of radios located in the center section, concentrations ranged from high levels to low levels of 3.8 percent. Thus, both agents exhibited good distribution throughout the sampled area beneath the instrument panel.

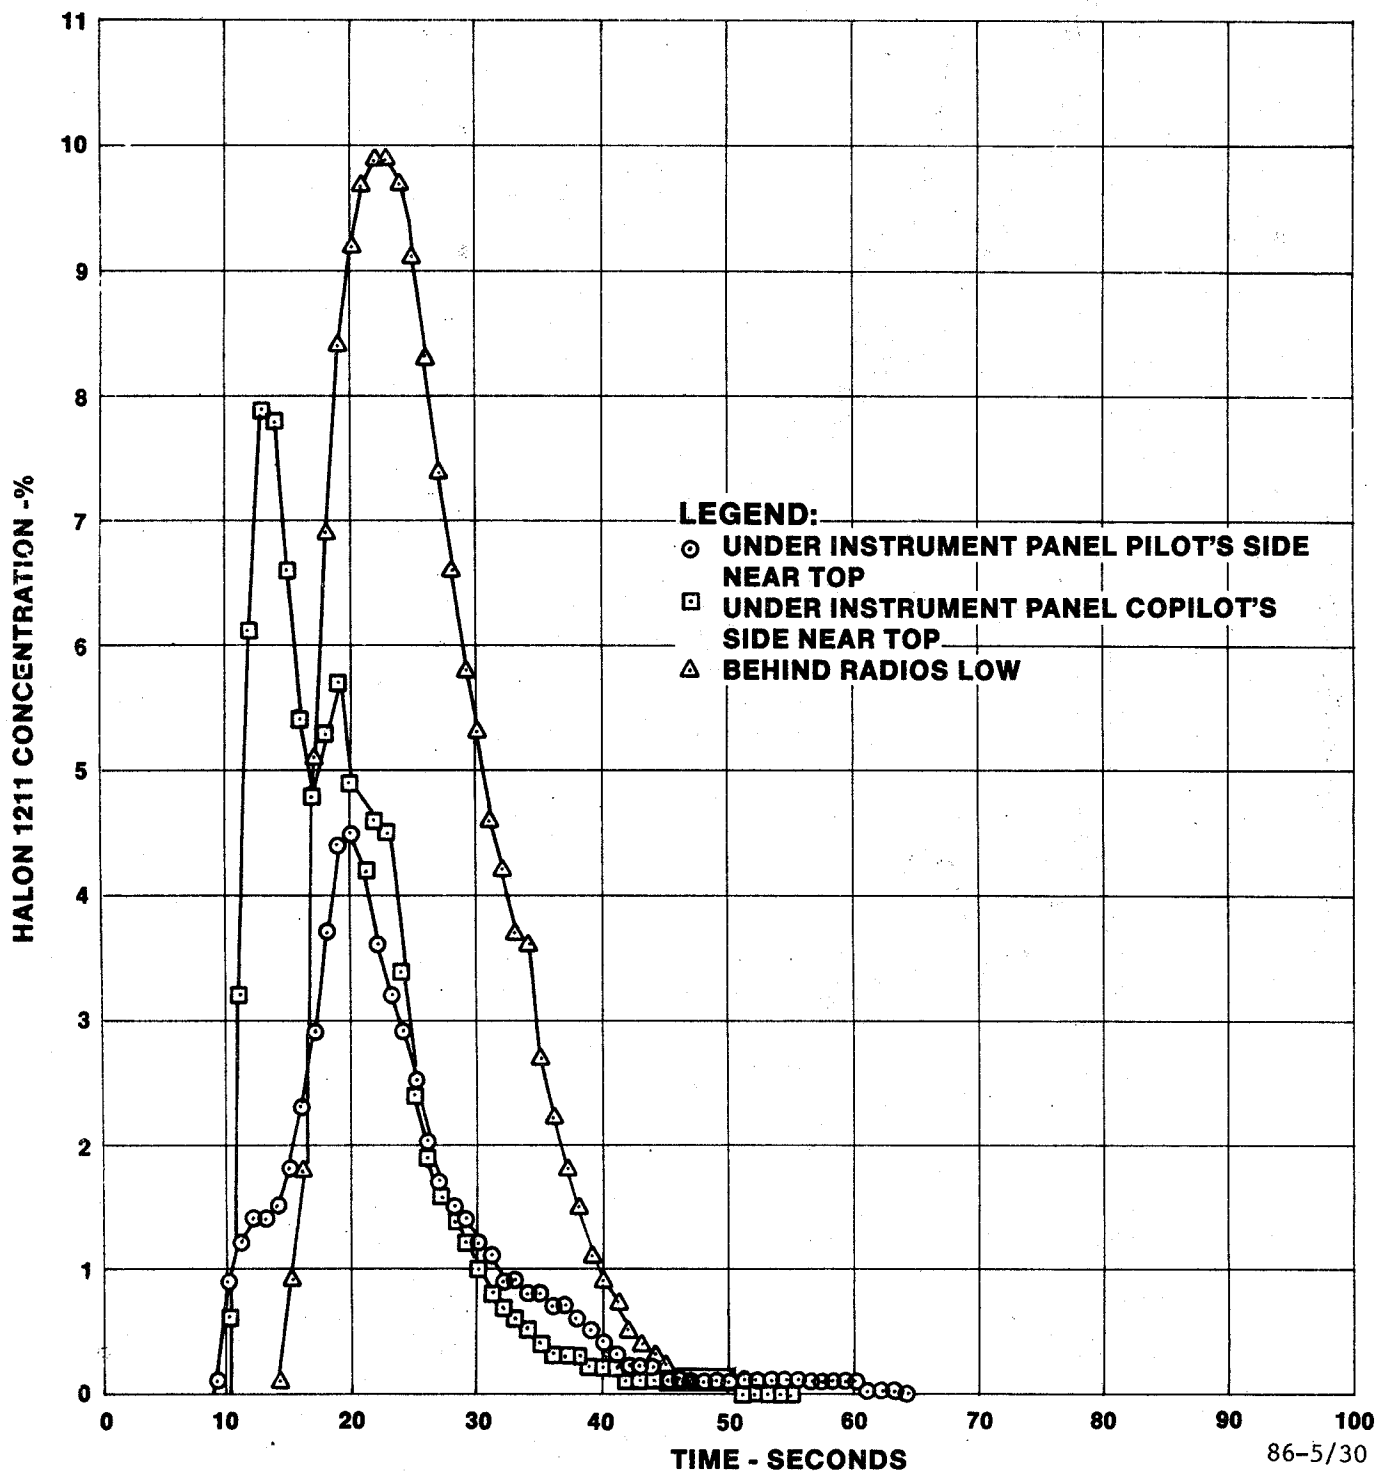
FIGURE 30. HALON 1211 CONCENTRATIONS - 2.5-POUND EXTINGUISHER DIRECTED UNDER THE INSTRUMENT PANEL - COPILOT'S SIDE - ALL SAMPLE LINES UNDER INSTRUMENT PANEL

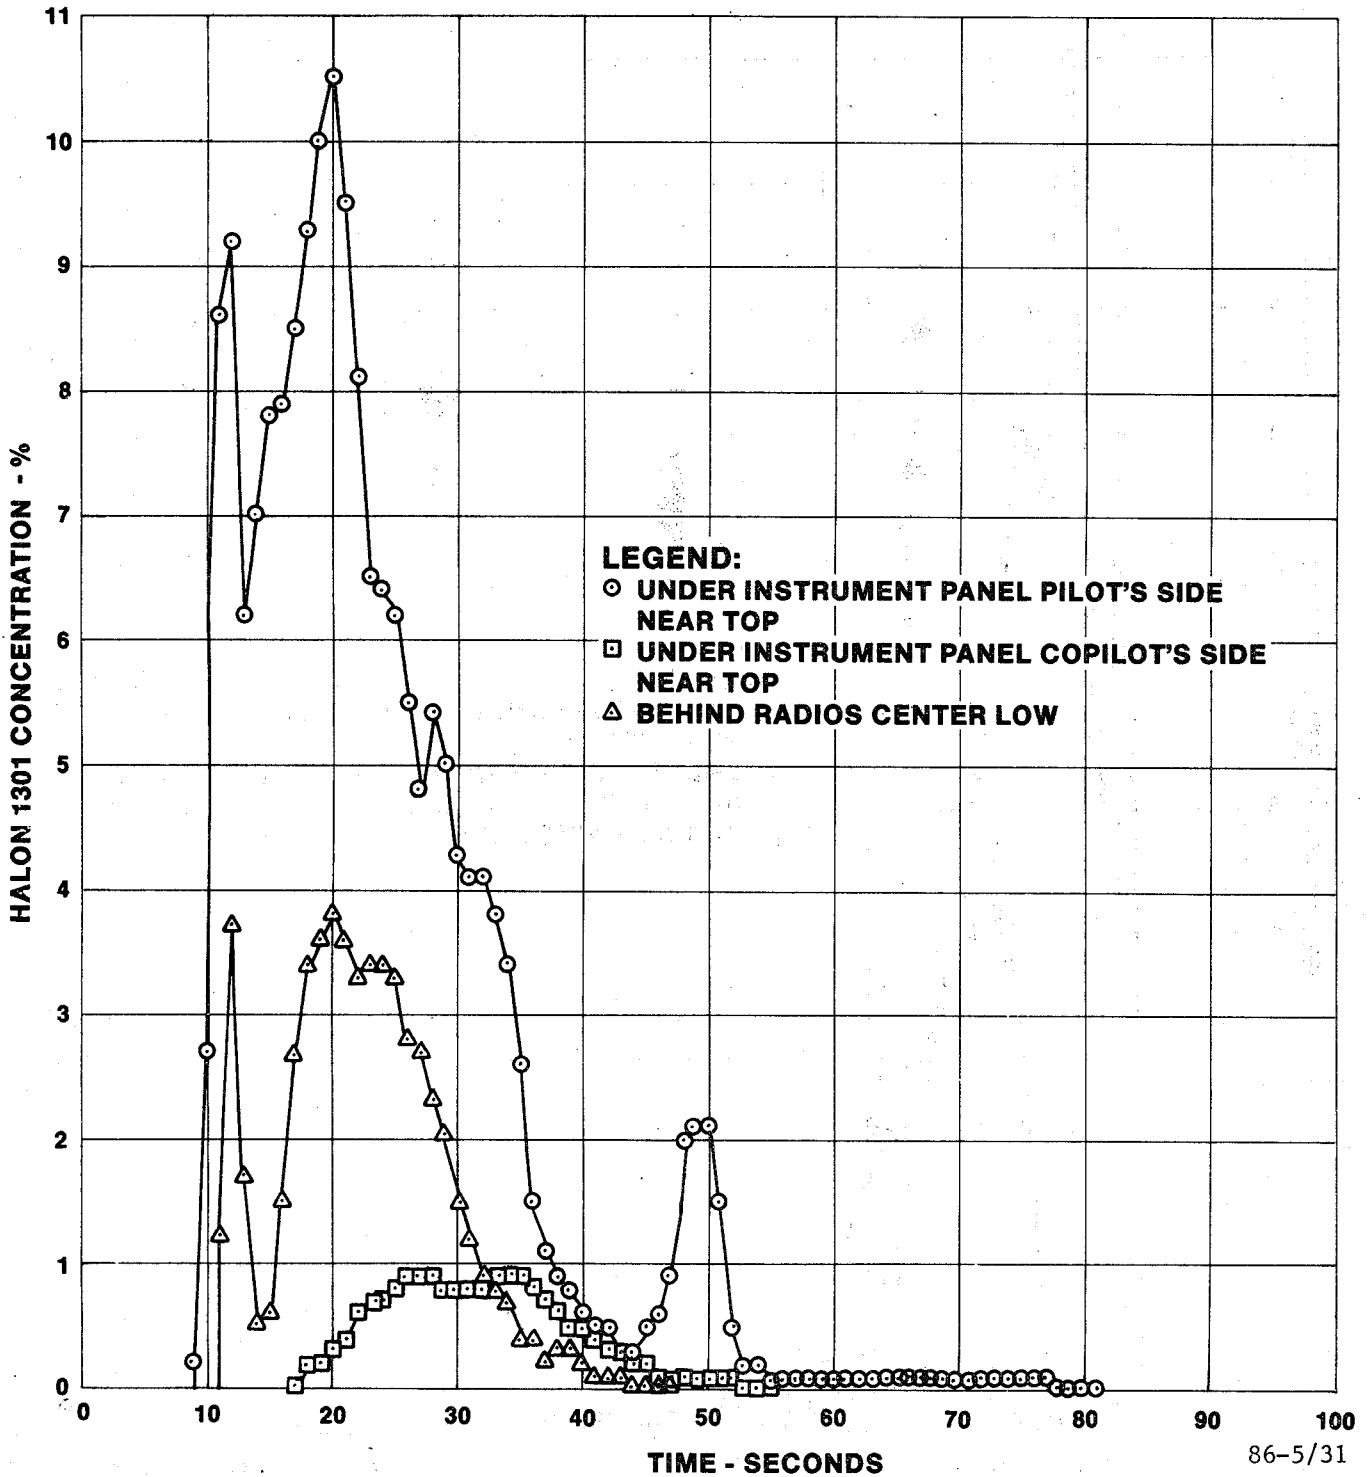
FIGURE 31. HALON 1301 CONCENTRATIONS - 3-POUND EXTINGUISHER DIRECTED UNDER THE INSTRUMENT PANEL - PILOT'S SIDE - ALL SAMPLE LINES UNDER THE INSTRUMENT PANEL

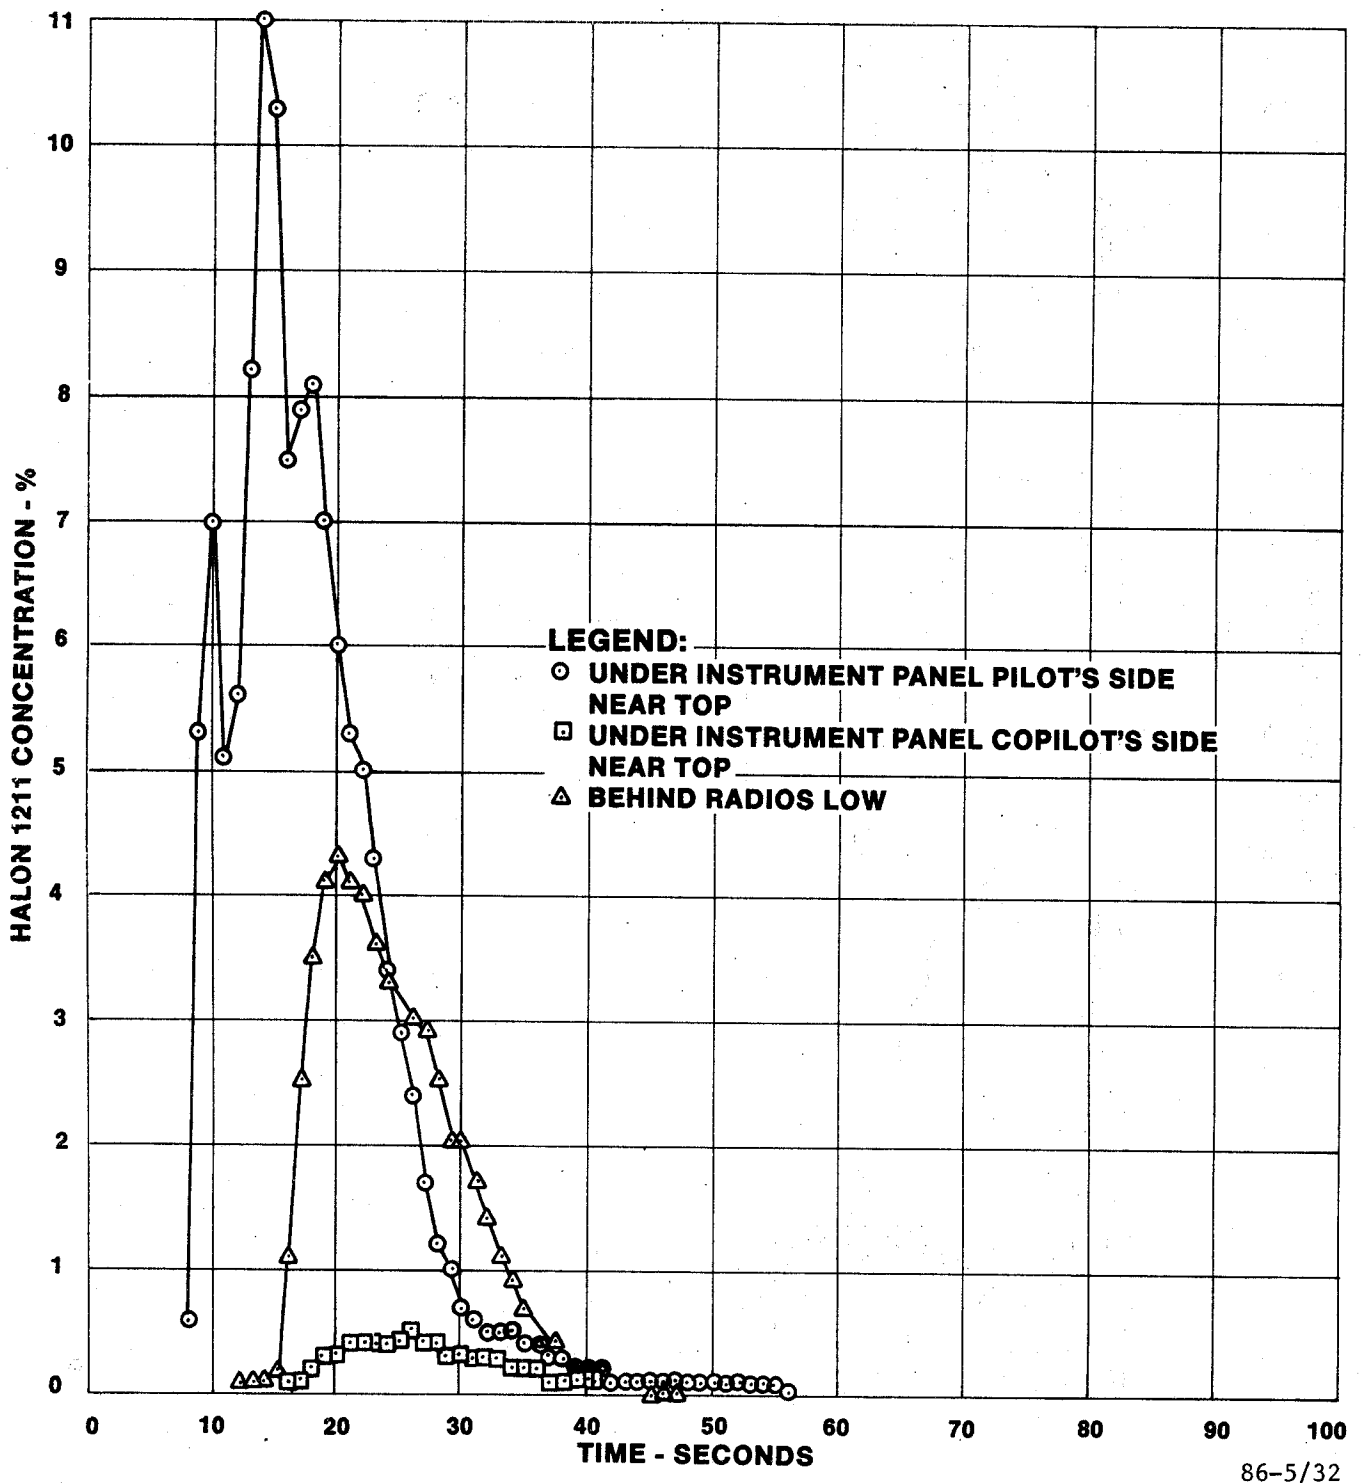
86-5/32

FIGURE 32. HALON 1211 CONCENTRATIONS - 2.5-POUND EXTINGUISHER DIRECTED UNDER THE INSTRUMENT PANEL - PILOT'S SIDE - ALL SAMPLE LINES UNDER THE INSTRUMENT PANEL

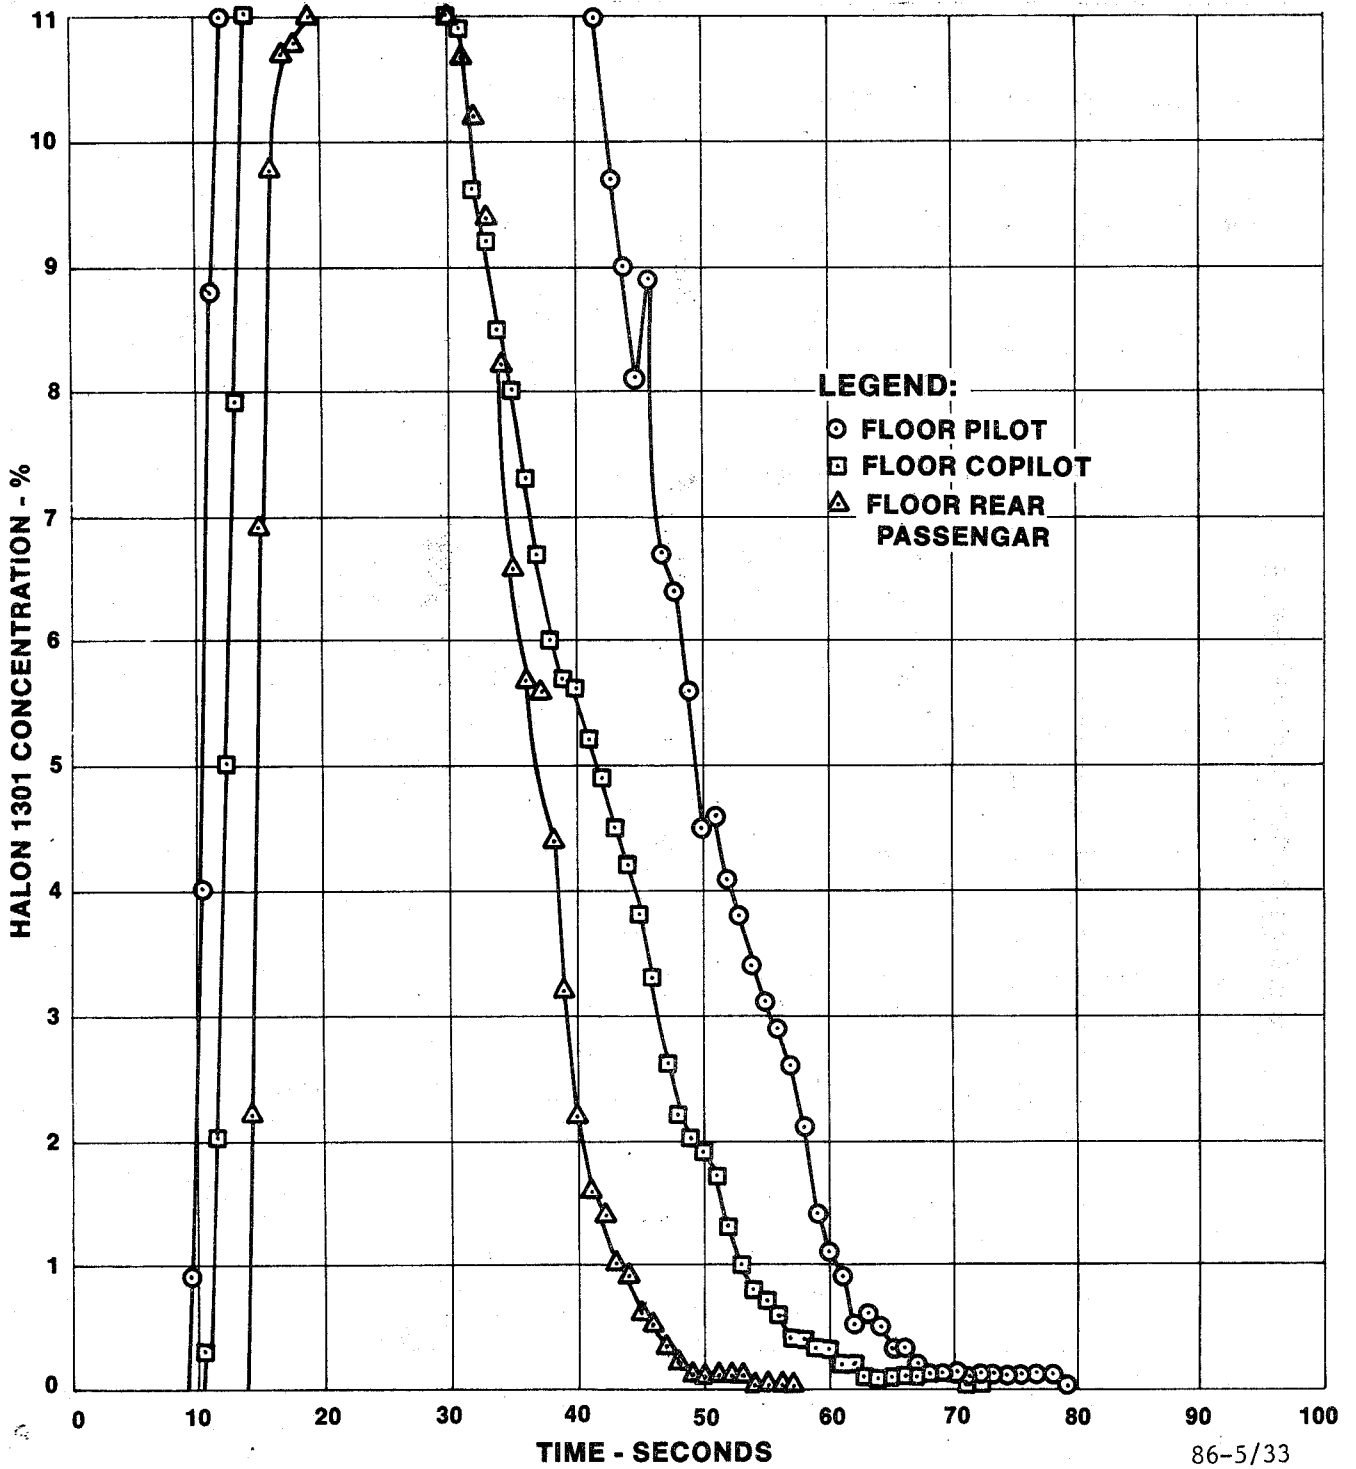
FIGURE 33. HALON 1301 CONCENTRATIONS - 3-POUND EXTINGUISHER DIRECTED TO THE FUEL AND HYDRAULIC SELECTOR VALVES - ALL SAMPLE LINES LOCATED ON THE FLOOR.

Testing was designed to measure extinguisher agent stratification within the cabin. The three sample lines were placed on the cabin floor. Single sample lines were placed on the floor both near the pilot and the copilot and on the floor by the rear passenger behind the pilot. The measurements are in figures 33 and 34 and selected values are listed in table 5. The highest Halon extinguisher gas concentrations are located on the floor. In all cases, the gas measurement capability was overwhelmed and exceeded the maximum measurement level of 11 percent. Stratification of the Halon agents are presented in figure 35. Average gas measurements were plotted for the pilot-copilot belt level and for the pilot's nose location. As noted, only one test with each Halon was conducted for measurement of the agents for the floor. Stratification of the Halons is significant as they vary from over 11 percent on the floor to 2.65 percent and 4.03 percent at the pilot's nose and it appears that this relationship is near linear, figure 35.
