DOT/FAA/CT-86/5

Halon Extinguisher Agent Behavior in a Ventilated Small Aircraft

Final Report

U.S. Department of Transportation
Federal Aviation Administration
Technical Center
Atlantic City Airport, N.J. 08405

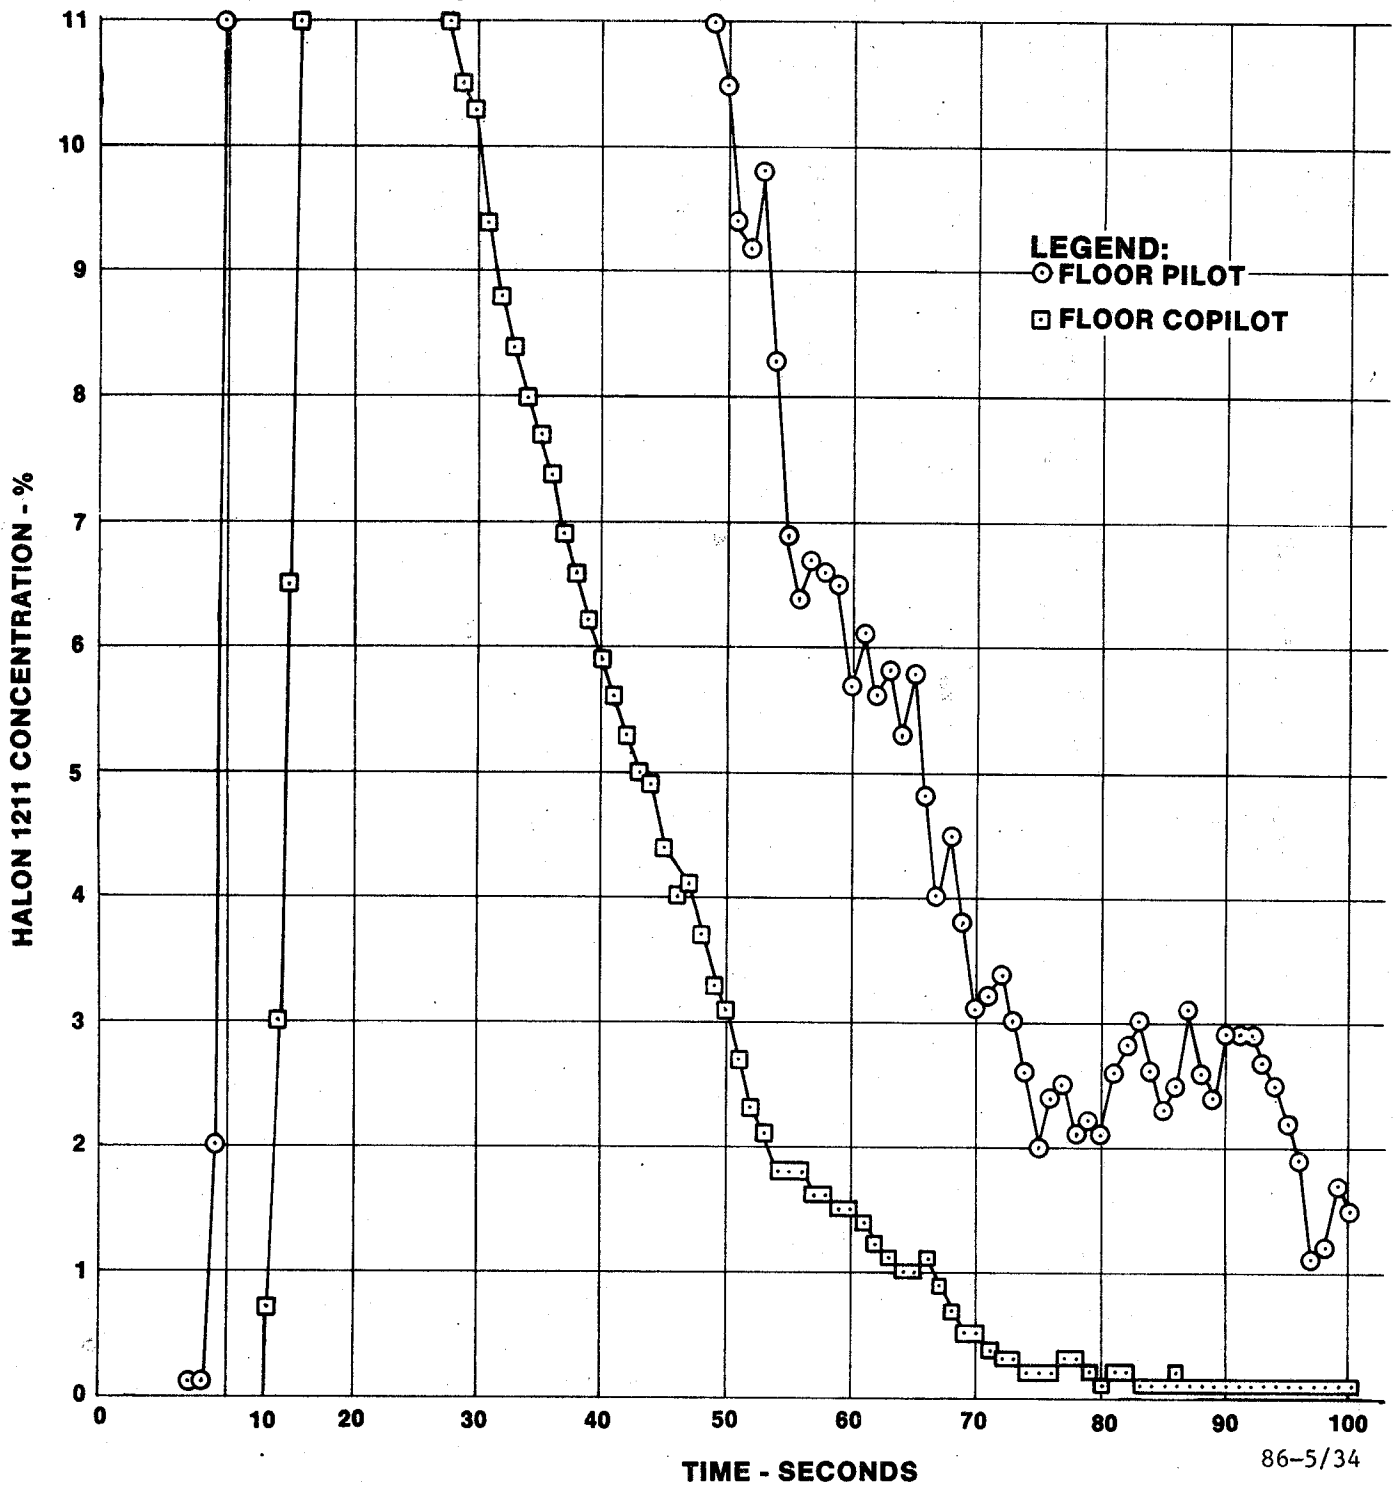
FIGURE 34. HALON 1211 CONCENTRATIONS - 2.5-POUND EXTINGUISHER DIRECTED TO THE FUEL AND HYDRAULIC SELECTOR VALVES - ALL SAMPLE LINES LOCATED ON THE FLOOR

Testing was designed to measure extinguisher agent stratification within the cabin. The three sample lines were placed on the cabin floor. Single sample lines were placed on the floor both near the pilot and the copilot and on the floor by the rear passenger behind the pilot. The measurements are in figures 33 and 34 and selected values are listed in table 5. The highest Halon extinguisher gas concentrations are located on the floor. In all cases, the gas measurement capability was overwhelmed and exceeded the maximum measurement level of 11 percent. Stratification of the Halon agents are presented in figure 35. Average gas measurements were plotted for the pilot-copilot belt level and for the pilot's nose location. As noted, only one test with each Halon was conducted for measurement of the agents for the floor. Stratification of the Halons is significant as they vary from over 11 percent on the floor to 2.65 percent and 4.03 percent at the pilot's nose and it appears that this relationship is near linear, figure 35.

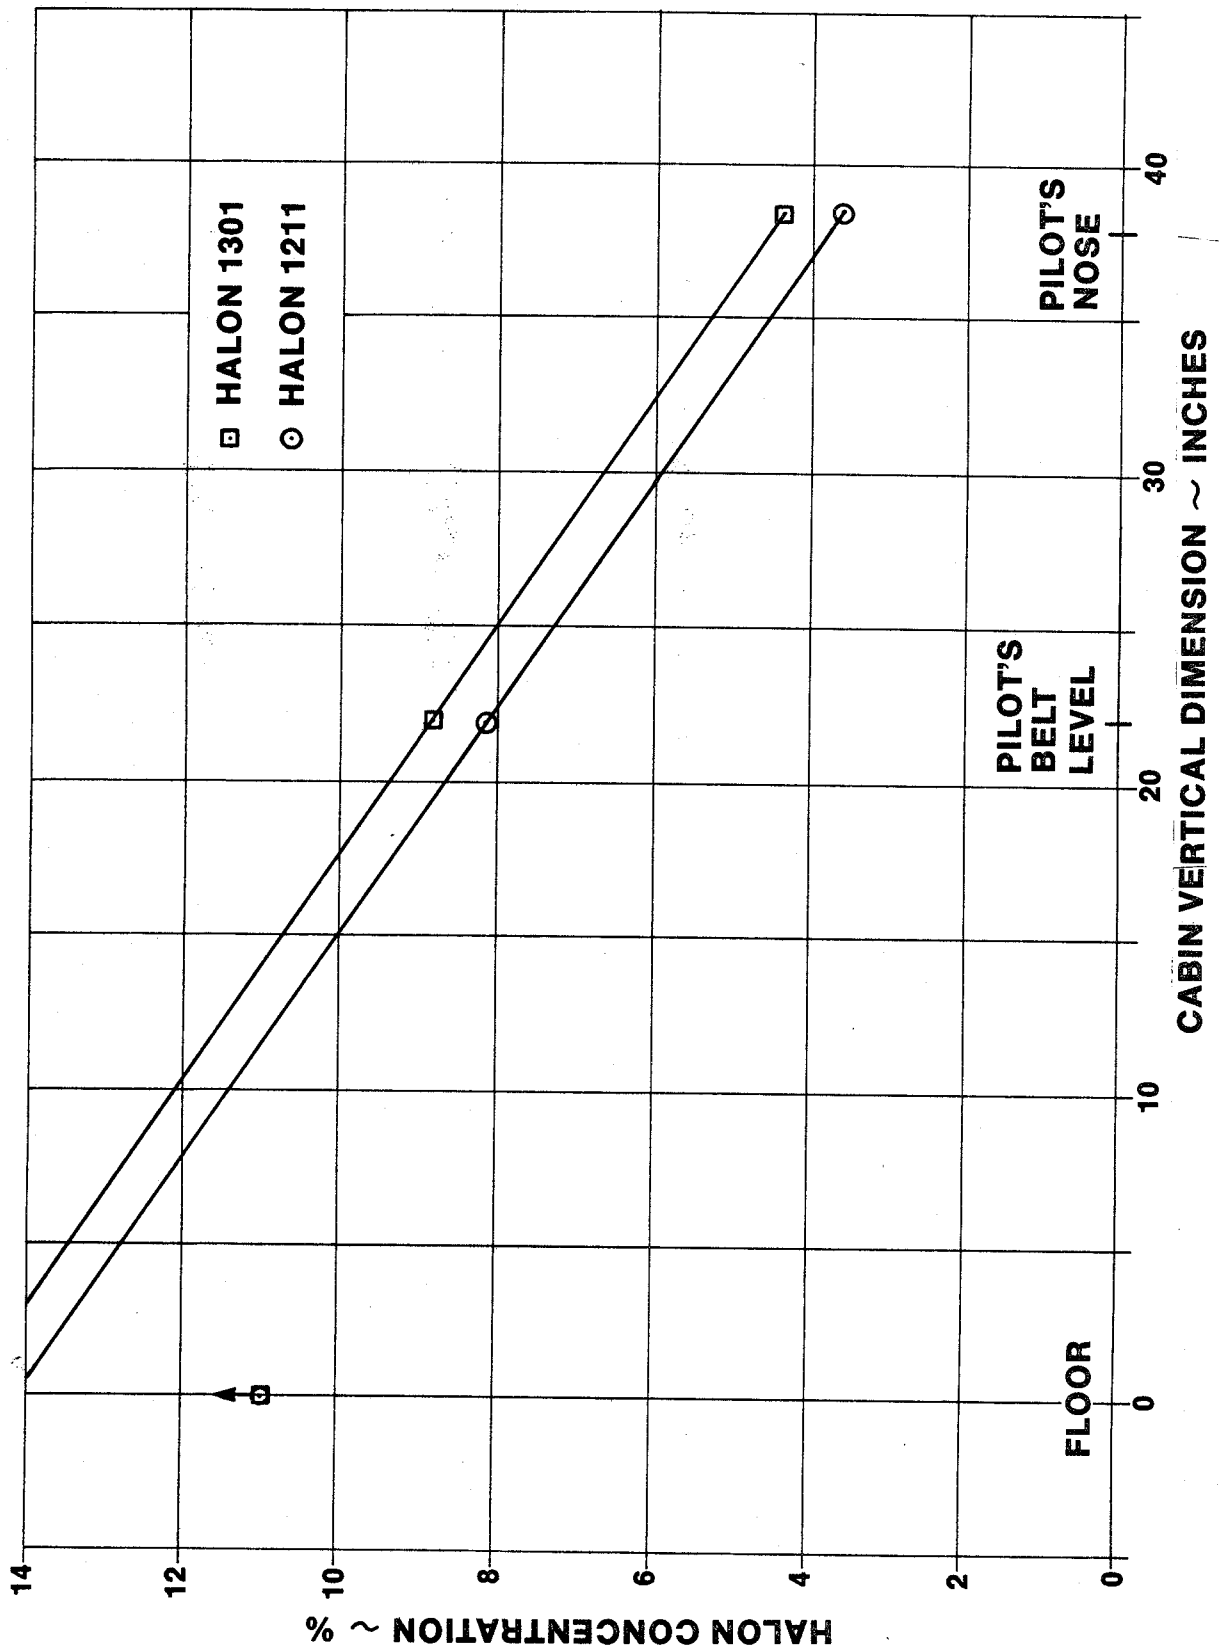
FIGURE 35. STRATIFICATION OF HALON EXTINGUISHING AGENTS
