DOT/FAA/CT-88/03

Study of Benefits of Passenger Protective Breathing Equipment From Analysis of Past Accidents

March 1988

Final Report

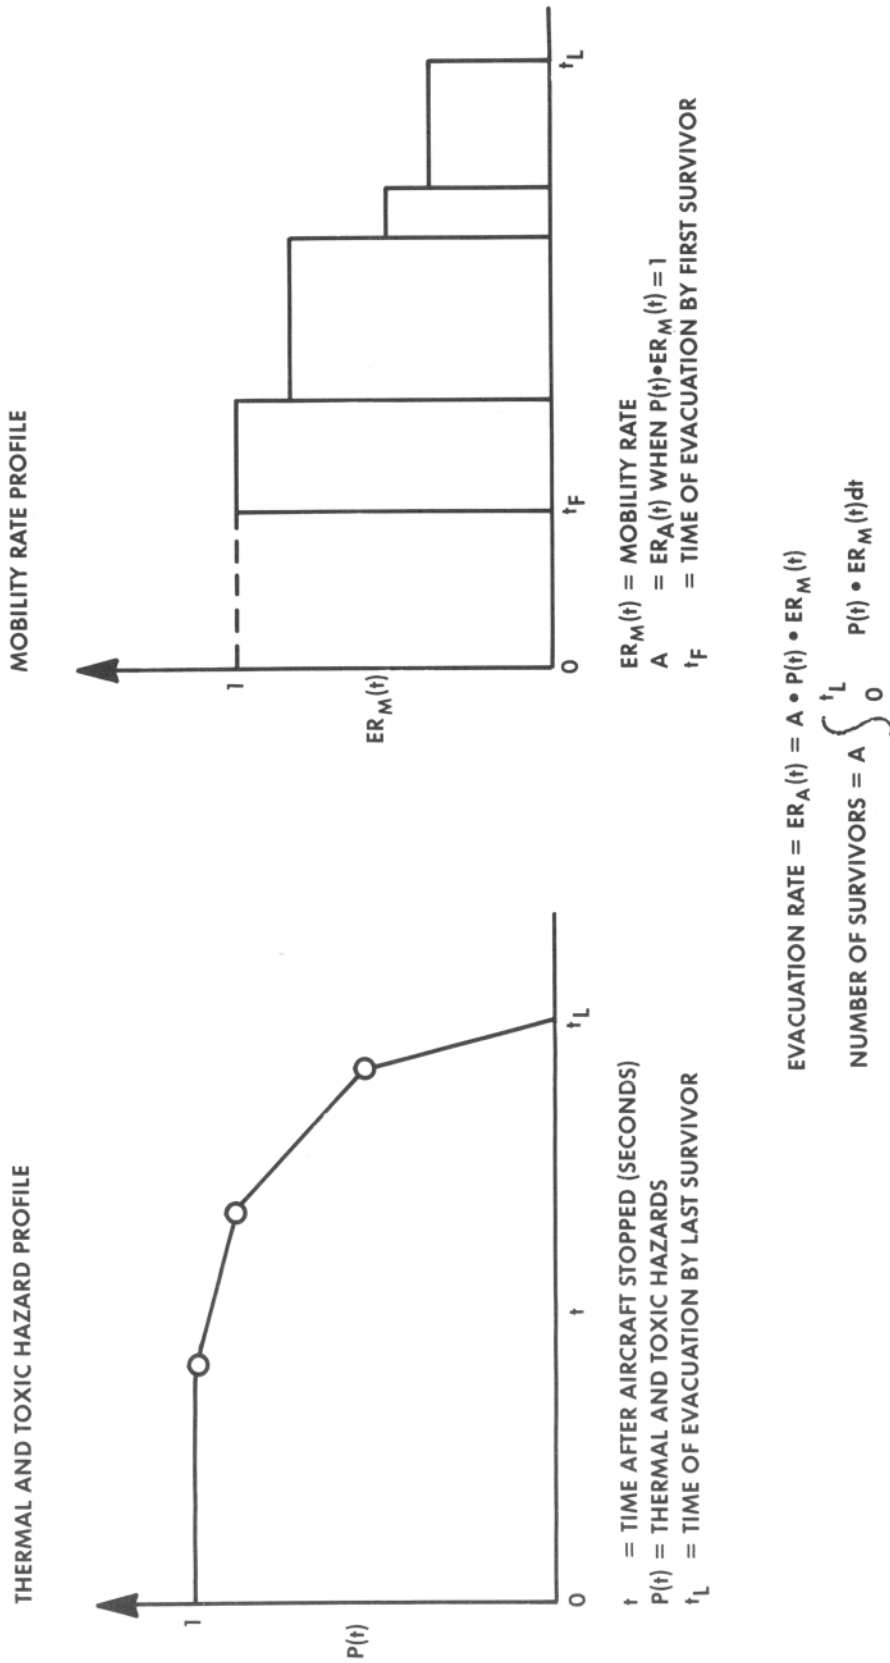
FIGURE 1. METHOD OF APPROACH

- SOLVE FOR A FROM NUMBER OF SURVIVORS
- COMPARE A WITH EVACUATION DEMONSTRATION DATA
- MODIFY ASSUMPTIONS, IF NECESSARY, TO MAKE A CONSISTENT WITH EVACUATION DATA
- A FIRE SAFETY IMPROVEMENT WILL CHANGE THE PROFILES, BUT NOT A
- CALCULATE THE NUMBER OF SURVIVORS FOR EACH IMPROVEMENT

A simple model was developed to predict the number of survivors in an aircraft fire scenario, based on mobility and fire hazard profiles. The model is one-dimensional in that time is the only independent variable. Thus, the model requires that the two profiles be described as a function of time ($f(t)$). In the case of an accident, the profiles are a numerical, subjective reconstruction of the relative decrease in occupant mobility and relative increase in fire hazards, both as $f(t)$, from a review of accident reports and information from accident investigators. Inevitably, many assumptions must be made to exercise the model, due to lack of complete information. Figure 1 illustrates these two profiles and how they are utilized to determine evacuation rates. The time of evacuation by the first survivor is t_F . The time the last survivor exits the aircraft is t_L .

Thermal and toxic hazard profile: $P(t)$ versus time after aircraft stopped. As can be seen from figure 1, if $P(t) = 1$, no toxic or thermal hazards exist. If $P(t) = 0$, sufficient hazards exist to result in the incapacitation of all passengers. If all survivors were to successfully evacuate with time to spare, $P(t)$ would exceed 0 at the time the last passenger exited the aircraft. Hazards that cause incapacitation include heat, toxic gases, oxygen depletion, smoke inhalation, and direct exposure to fire.

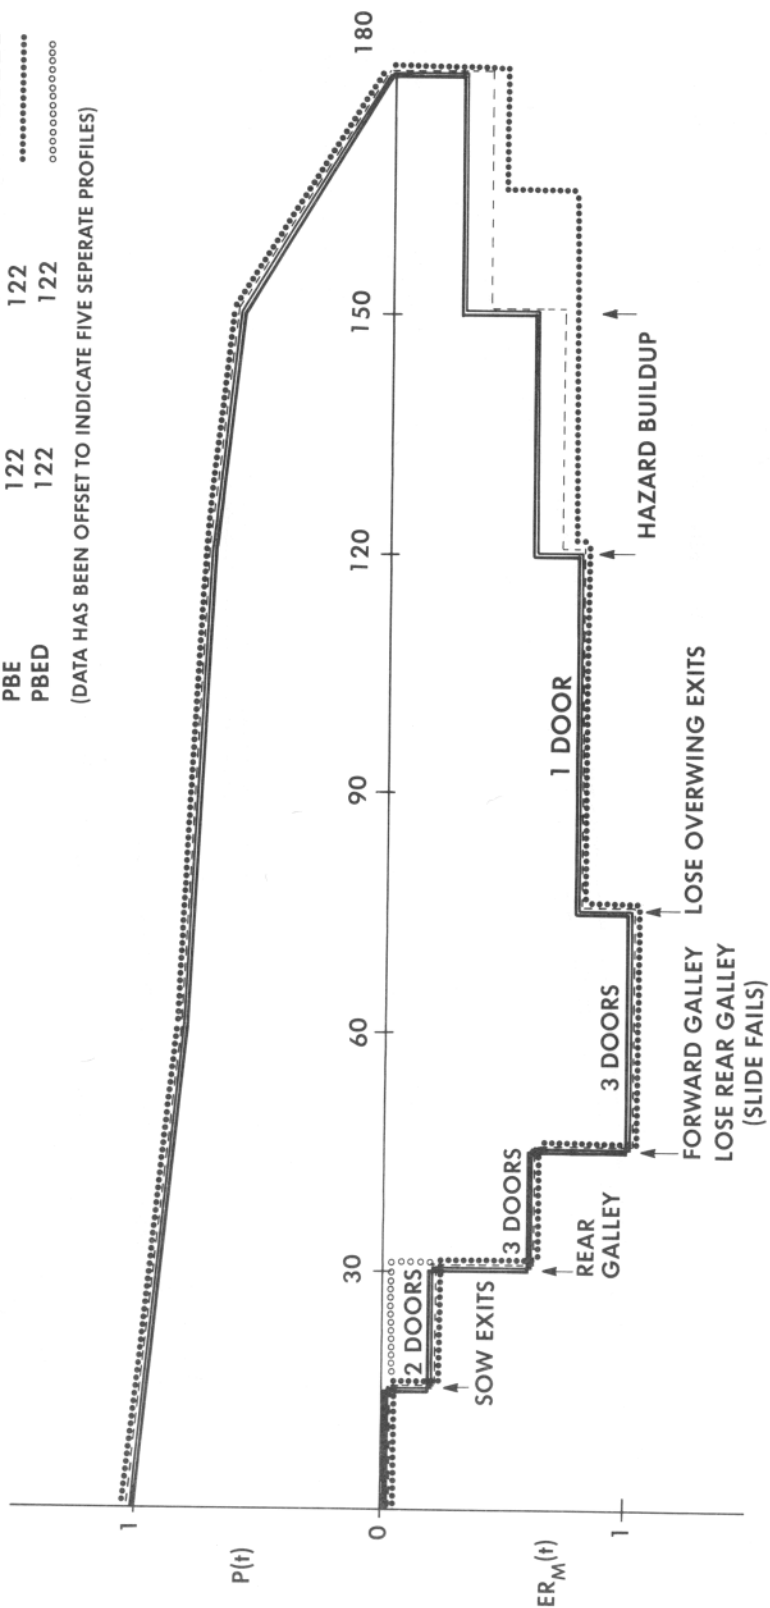
FIGURE 6. ACCIDENTS PROFILES FOR B-707 4/8/68

EVACUATION RATE = 1.548 PEOPLE/SECOND

2. 4/8/68 British Overseas B-707 (Figure 6)

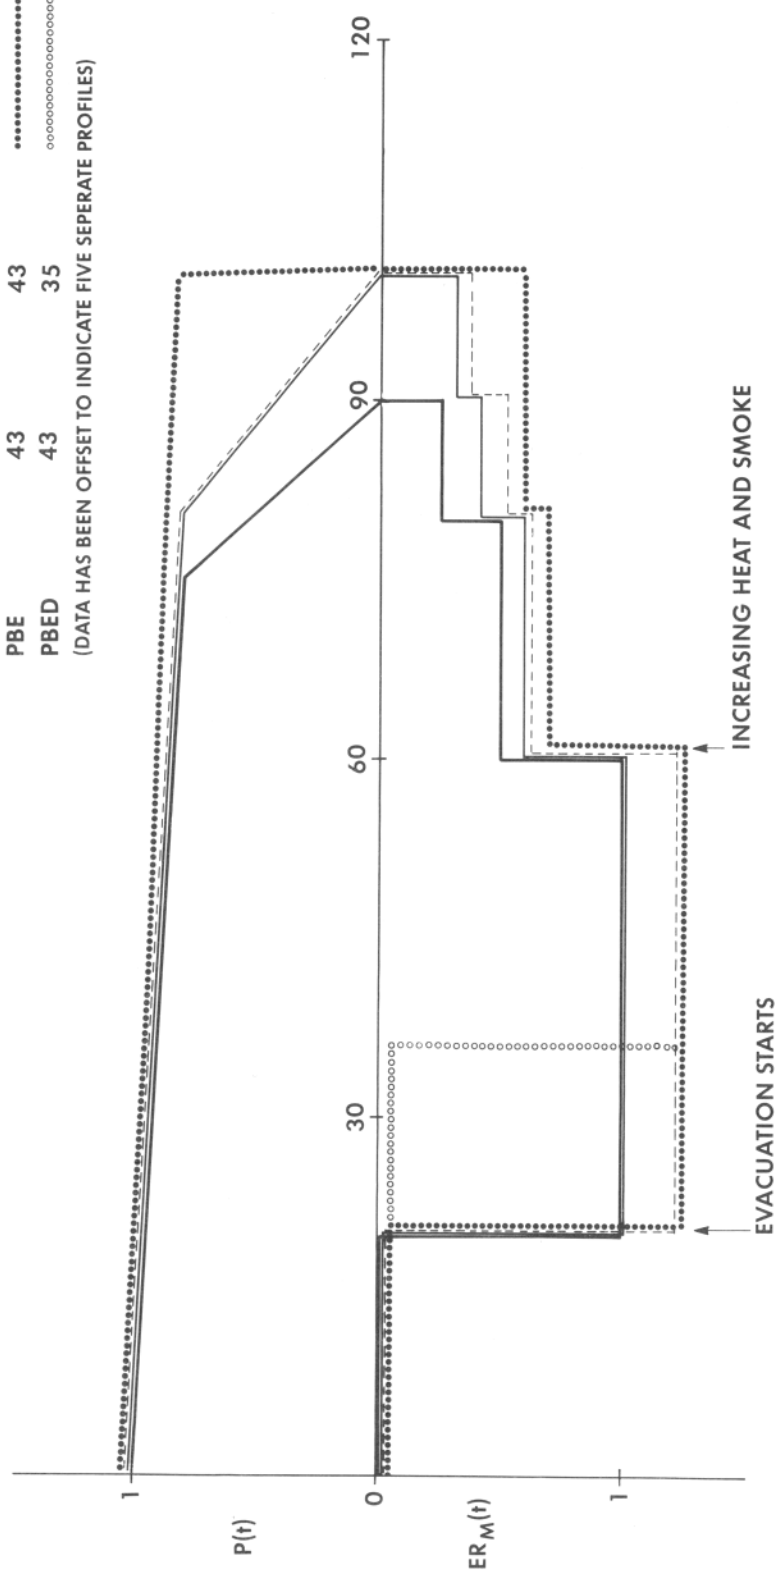
FIGURE 10. ACCIDENT PROFILES FOR NORTH CENTRAL DC-9 12/20/72

EVACUATION RATE = 0.750 PEOPLE/SECOND

7. 12/20/72 North Central DC-9 (Figure 10)

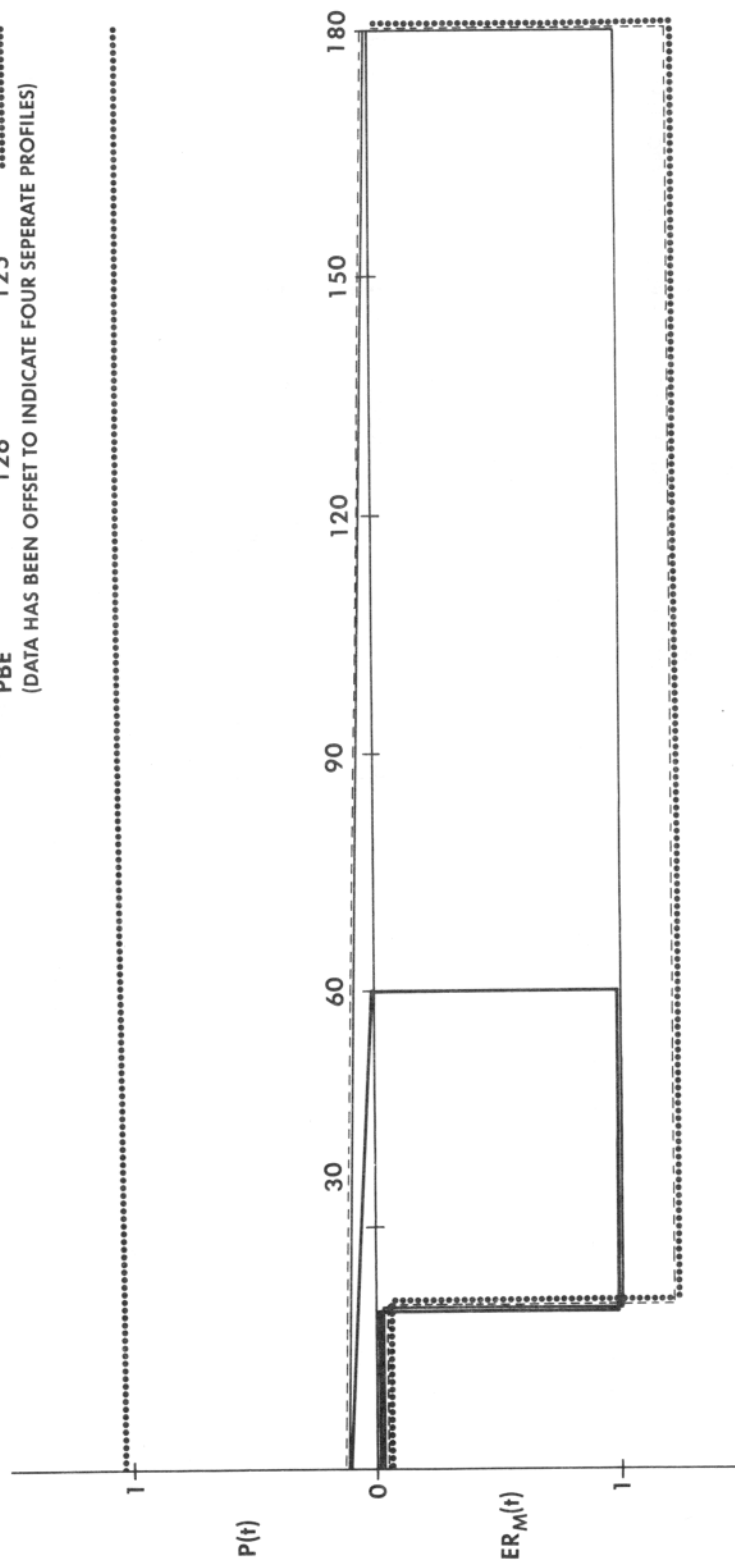
FIGURE 11. ACCIDENT PROFILES FOR VARIG B-707 7/11/73, NO EXTINGUISHERS

IMPROVEMENT	PASSENGERS	SURVIVORS
NONE	126	4
FB	126	22
FPL	126	26
PBE	126	125

(DATA HAS BEEN OFFSET TO INDICATE FOUR SEPERATE PROFILES)

EVACUATION RATE = 3.077 PEOPLE/SECOND

8. 7/11/73 Varig B-707 (Figures 11, 12)

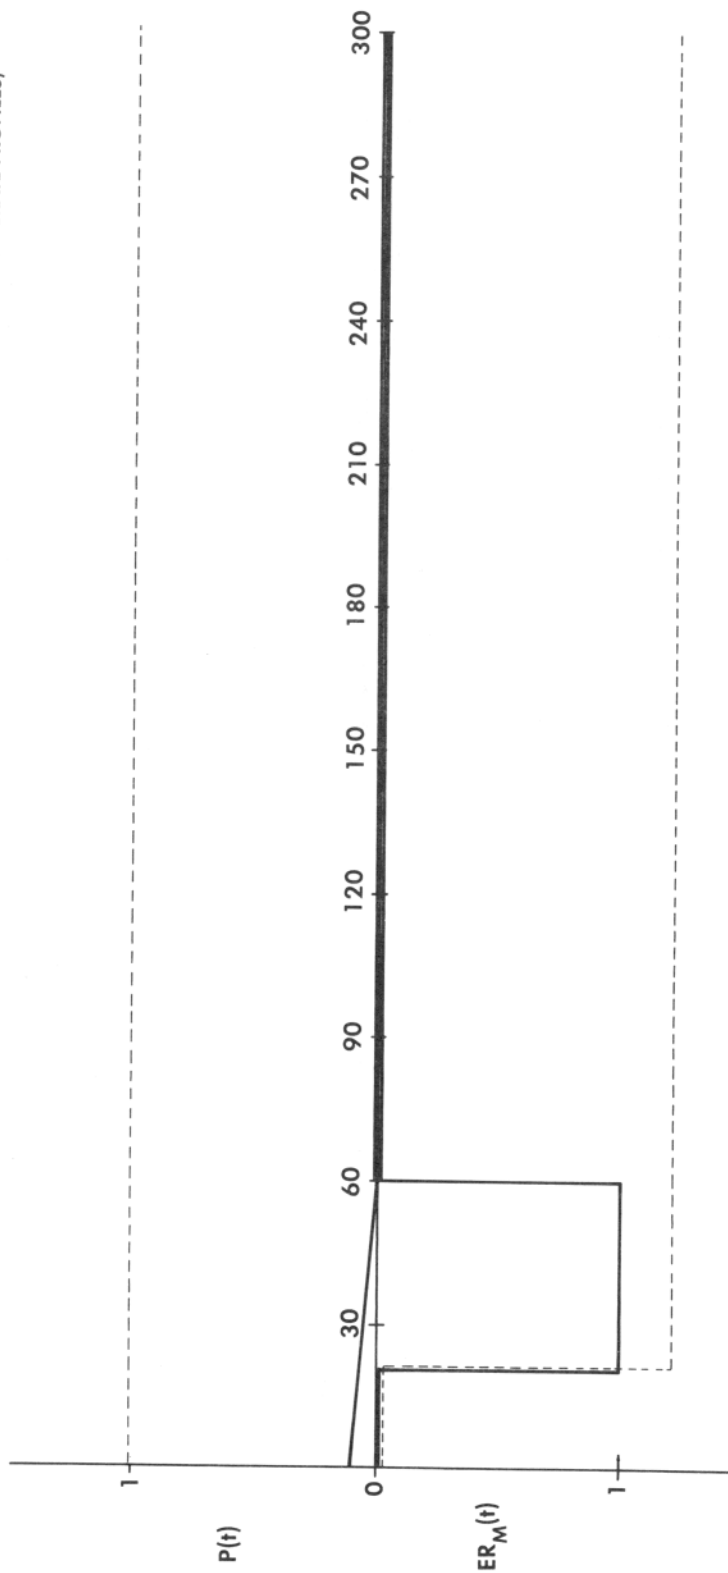
FIGURE 12. ACCIDENT PROFILES FOR VARIG B-707 7/11/73, WITH EXTINGUISHERS

IMPROVEMENT	PASSENGERS	SURVIVORS
NONE	126	4
EXT	126	125

(DATA HAS BEEN OFFSET TO INDICATE TWO SEPERATE PROFILES)

EVACUATION RATE = 3.077 PEOPLE/SECOND

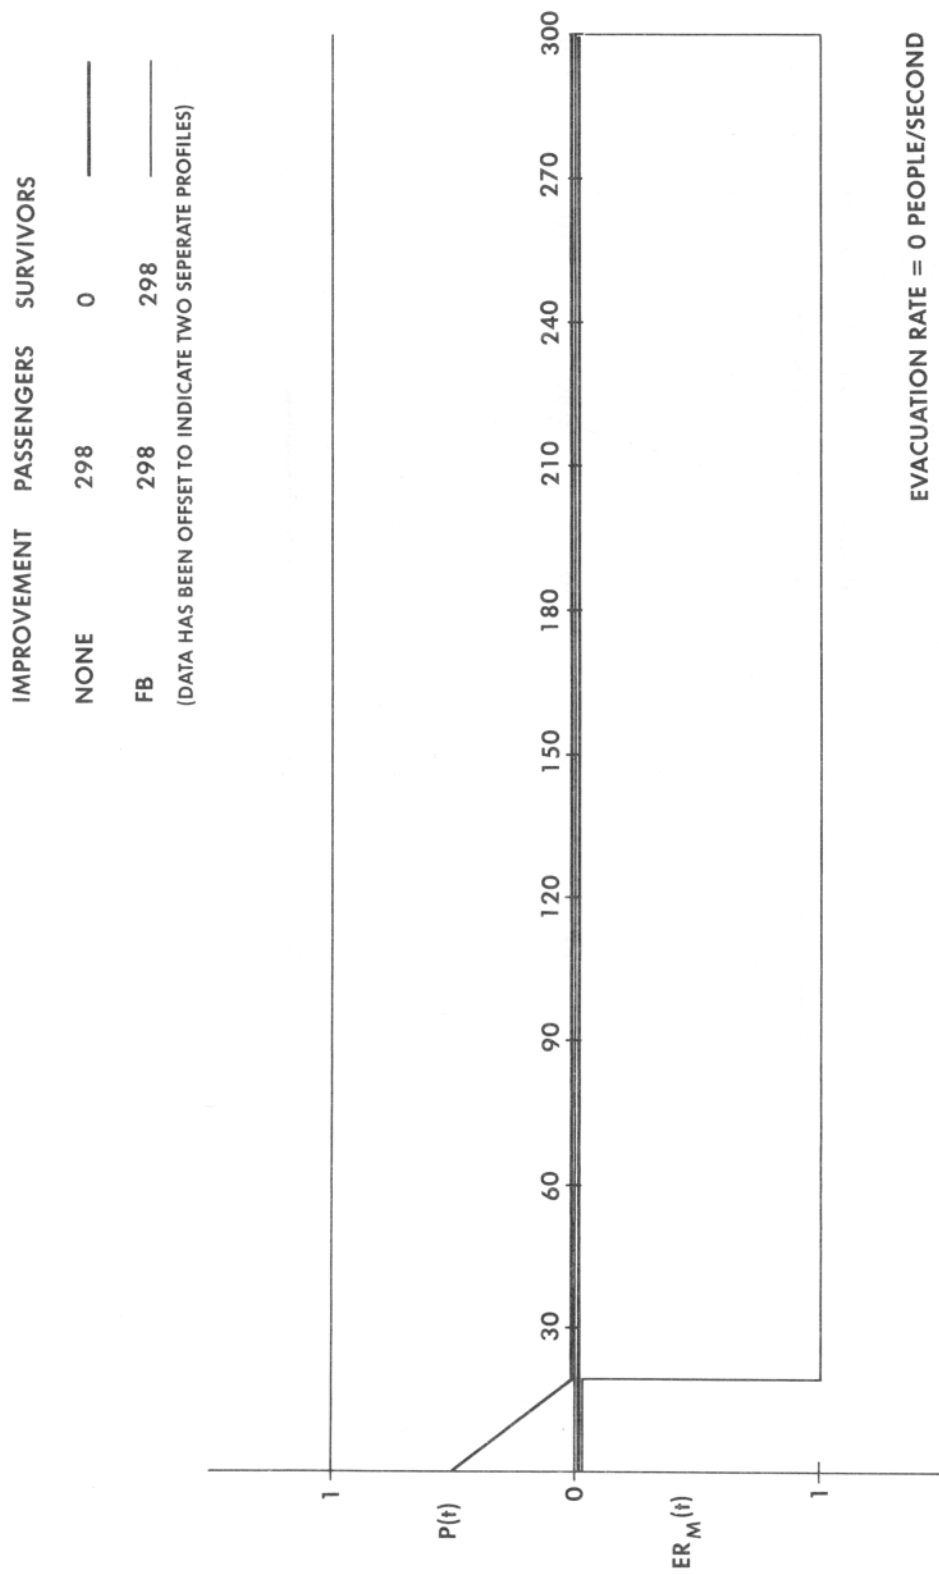
FIGURE 16. ACCIDENT PROFILES FOR SAUDI L1011 8/19/80

IMPROVEMENT	PASSENGERS	SURVIVORS
NONE	223	211
FB	223	223
FPL	223	223
PBE	223	223
PBED	223	223

(DATA HAS BEEN OFFSET TO INDICATE FIVE SEPERATE PROFILES)

14. 8/19/80 Saudi Air L-1011 (Figure 16)

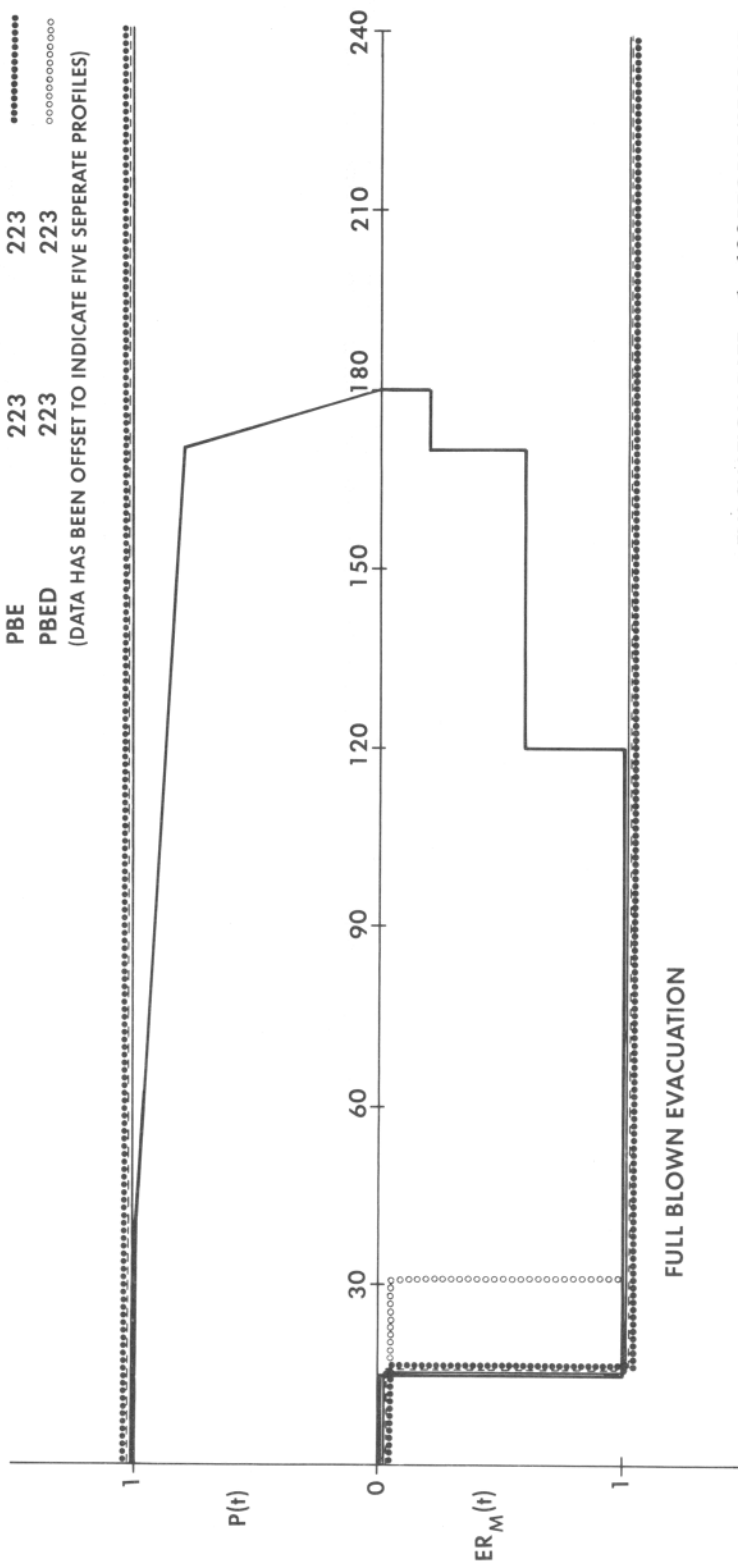
FIGURE 17. ACCIDENT PROFILES FOR KOREAN AIRLINES B-747 11/19/80

EVACUATION RATE = 1.689 PEOPLE/SECOND

15. 11/19/80 Korean Airlines B-747 (Figure 17)

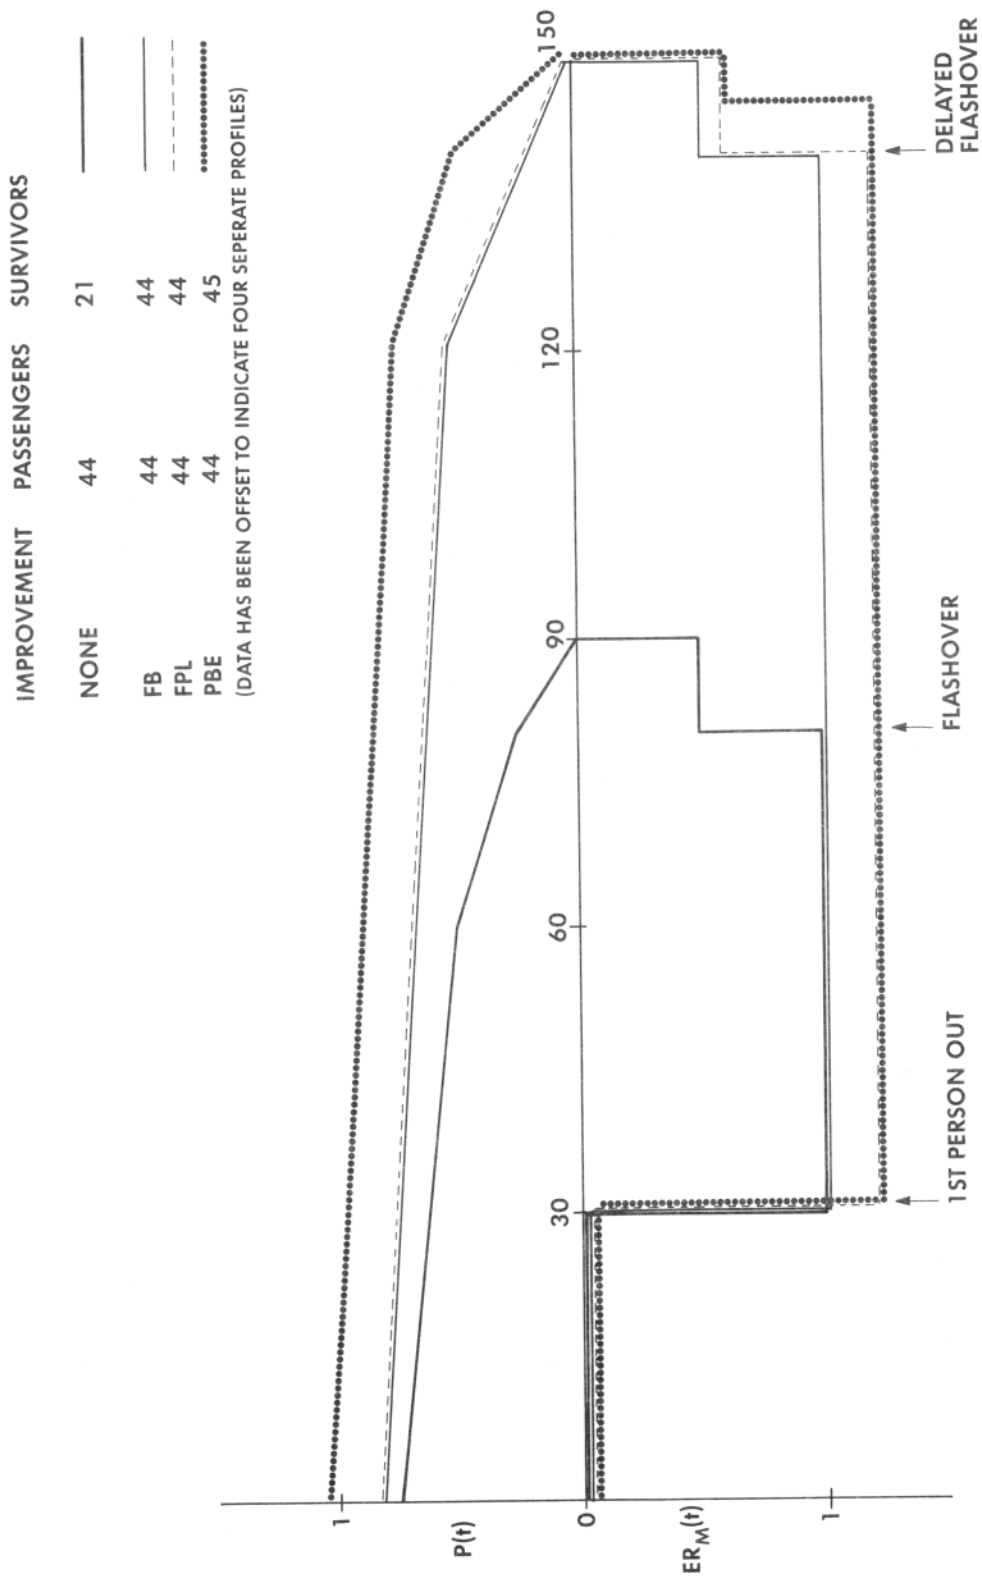
FIGURE 19. ACCIDENT PROFILES FOR AIR CANADA DC-9 6/2/83

EVACUATION RATE = 0.848 PEOPLE/SECOND

18. 6/2/83 Air Canada DC-9 (Figure 19)
