DATA REPORT NO. 99
SMALL-SCALE FIRE TESTS ON SECTIONS OF
AIRCRAFT LOADING WALKWAY

Project No. 184 732 02X

DEPARTMENT OF TRANSPORTATION
Federal Aviation Administration
Aircraft Safety Division
Propulsion and Fire Protection Branch
National Aviation Facilities Experimental Center
Atlantic City, New Jersey

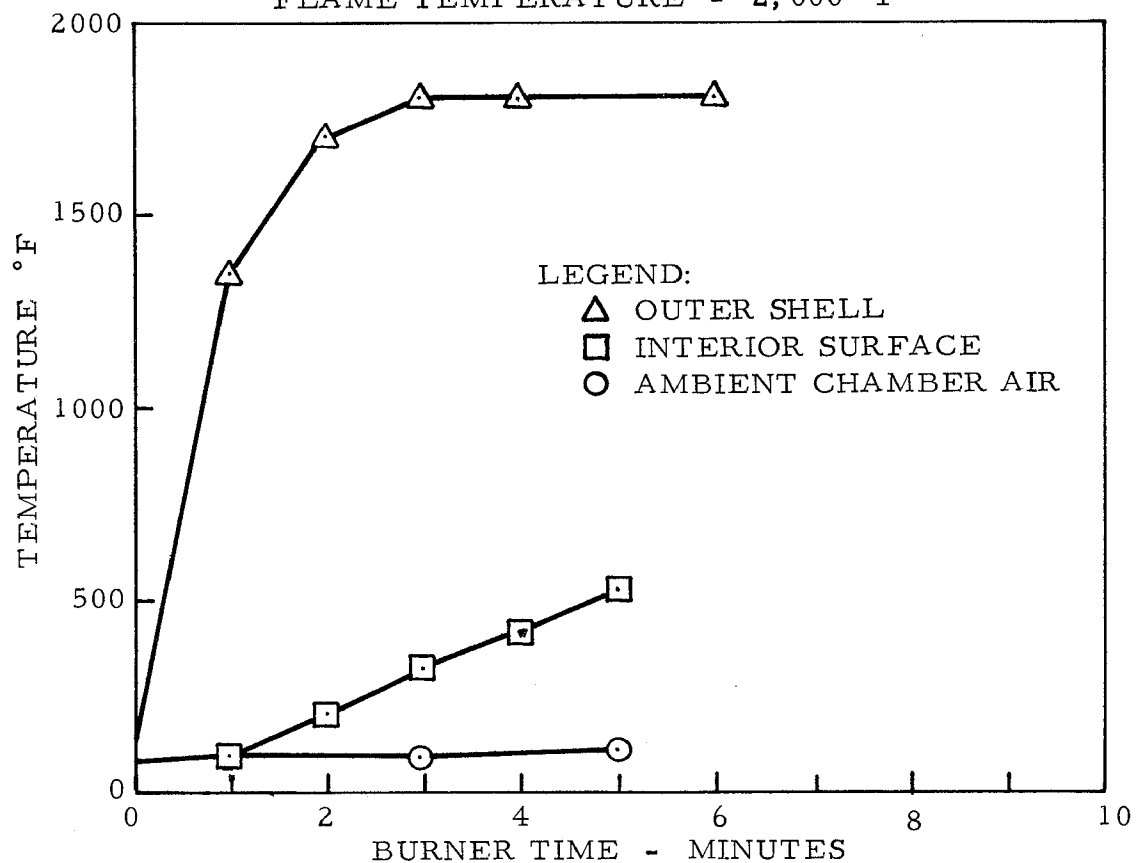
TEST CONDITIONS:

HEAT SOURCE - 2 GPH KEROSENE BURNER

HEAT FLUX - 16.3 BTU/FT²/SEC

FLAME TEMPERATURE - 2,000 °F

FIGURE 10. TEMPERATURE DATA FOR PANEL NO. 1 - WALL SECTION OF AIRCRAFT LOADING WALKWAY

Panel No. 1 - This panel was exposed to the burner flame for the minimum required time of 5 minutes. Temperature data for this panel is shown in Figure 10. Outer shell temperature exceeded the specified 1000°F for principal structural steel parts at 33 seconds. Interior surface temperature exceeded the specified 320°F for interior surfaces after 3 minutes of flame exposure. Ambient air temperature, due to the small exposure surface and relatively large air volume for the test configuration, did not exceed 95°F for the duration of the test. However in a full-scale test, with the structure surrounded on all sides by flame, this temperature could be expected to be higher.

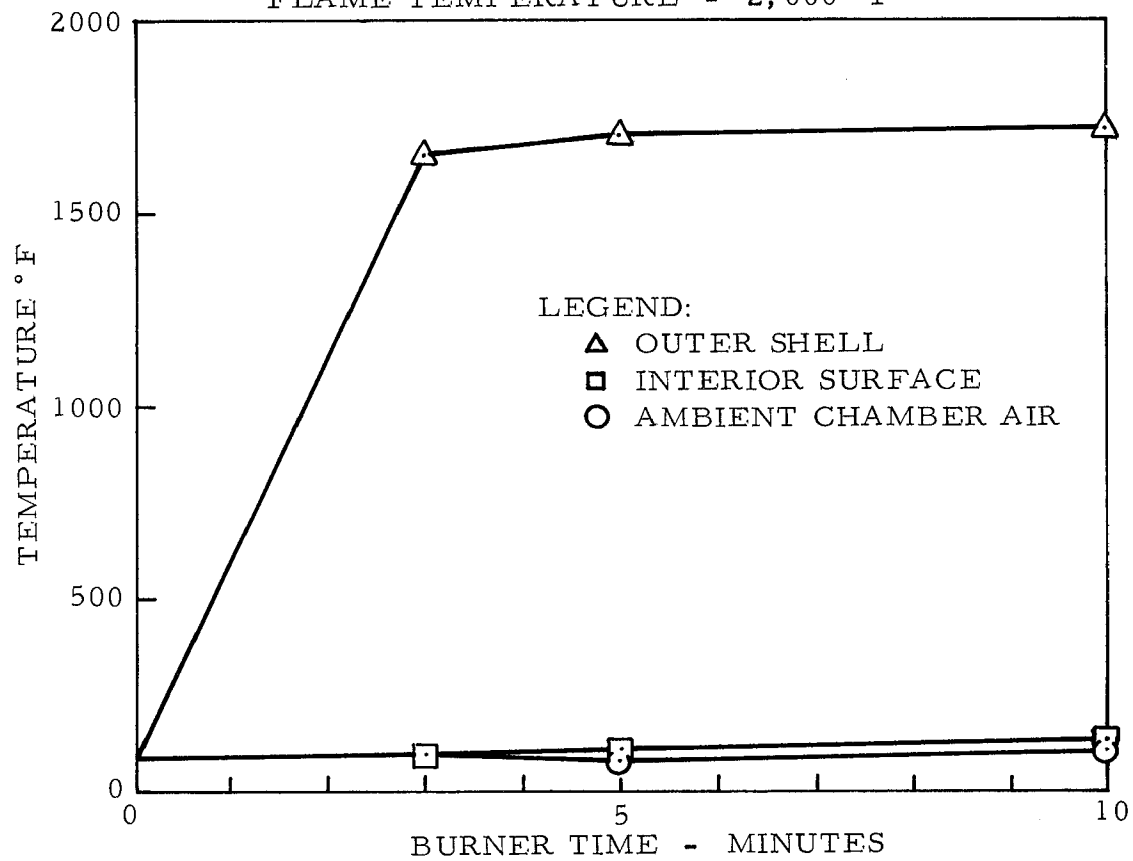
TEST CONDITIONS:

HEAT SOURCE - 2 GPH KEROSENE BURNER

HEAT FLUX - 16.3 BTU/FT²/SEC

FLAME TEMPERATURE - 2,000 °F

FIGURE 16. TEMPERATURE DATA FOR PANEL NO. 2B -
MODIFIED FLOOR SECTION OF AIRCRAFT
LOADING WALKWAY

As shown in Figure 16, interior temperature for this panel reached 100°F at 5 minutes with ambient chamber temperatures reaching 95°F. During the first 5 minutes of the test no smoke entered the chamber. Only a small amount of smoke indicated by less than 5-percent light obscuration developed during the latter half of the test. Figure 17 shows no rug damage after the 10-minute test.

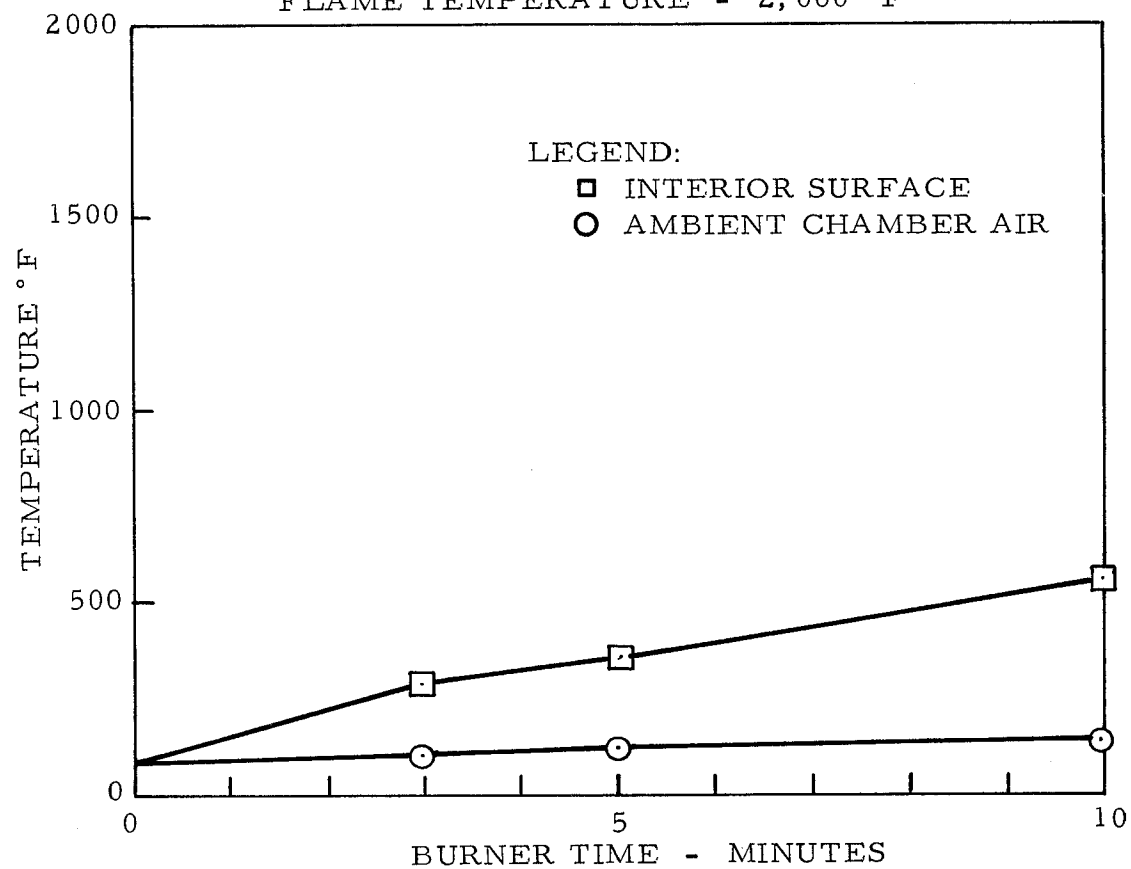
TEST CONDITIONS:

HEAT SOURCE - 2 GPH KEROSENE BURNER

HEAT FLUX - $16.3 \text{ BTU/FT}^2/\text{SEC}$

FLAME TEMPERATURE - $2,000^\circ\text{F}$

FIGURE 20. TEMPERATURE DATA FOR PANEL NO. 3 - FLEXIBLE CLOSURE CANOPY OF AIRCRAFT LOADING WALKWAY

Panel No. 3 - Front and rear views of the panel, after flame exposure, are shown in Figures 18 and 19. This panel was exposed to the burner flame for 10 minutes. Temperature data for this test is shown in Figure 20.
