Difficult Areas For Burnthrough Implementation

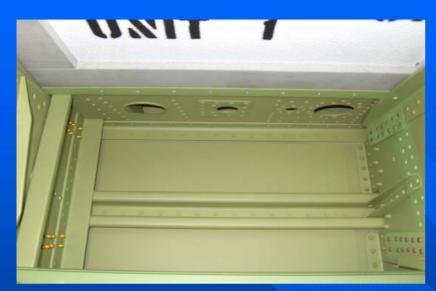
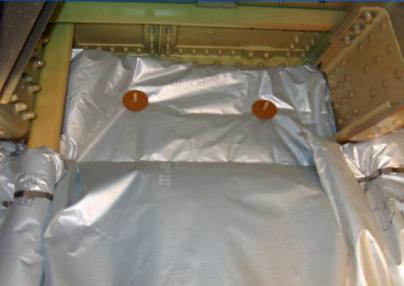
- Upper cheek Main deck floor beam and frame intersection
- Situation:
 - Not able to clamp over frames due to floor beams
 - No other attachment method known that meets rule
 - No method for testing

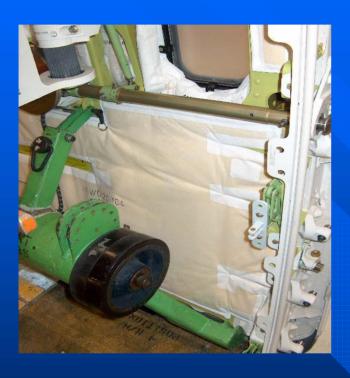
- Main Deck Entry Doors and Hatches
- Situation:
 - Contain blankets that are installed into pockets, retained with bond-on pins or hook and loop
 - No overlap possible must maintain door functionality.
 - Cannot add holes for screw though pins
- Allow burnthrough materials with best design solution no testing required

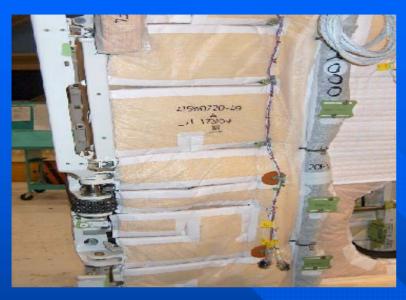
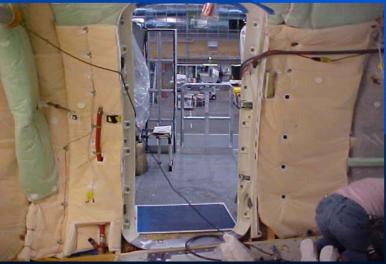
- Blankets Surrounding MainDeck Entry Doors
- Situation:
 - Unique structure around doorways does not allow for use of screw-through pins or clamps
 - Blankets are attached to structure with hook and loop
 - Overlap of blankets is not possible must maintain door functionality.

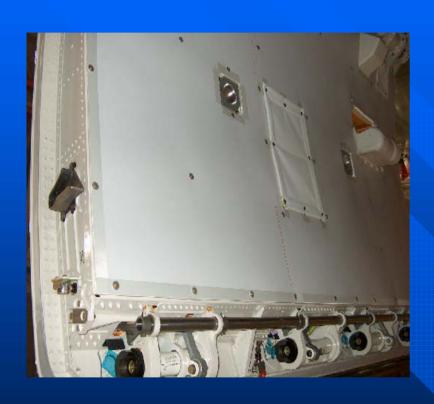
- Lower Lobe Cargo Door
- Situation:
 - Foam is attached to outboard side of cargo liner with adhesive.
 - Insulation attached to door with hook & loop
 - No method for testing

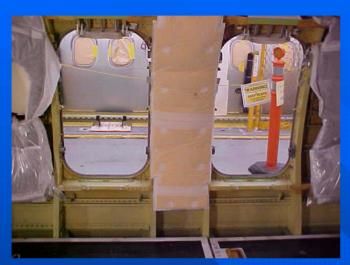
- Automatic Over-wing Exit(AOE) doors and linings
- Situation:
 - Unique structure around doorways does not allow for use of screw-through pins or clamps
 - Blankets installed on liner with double back tape.

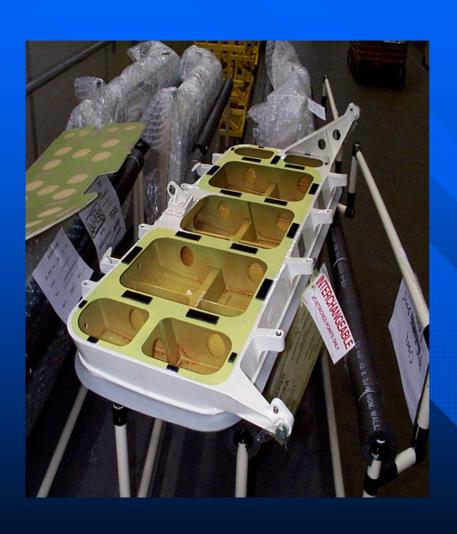
- Airstair Door
- Situation:
 - Unique structure around doorways does not allow for use of screw-through pins or clamps
 - Foam pad glued to aluminum skin (shown left of door) and is attached to inboard surface of door using velcro.

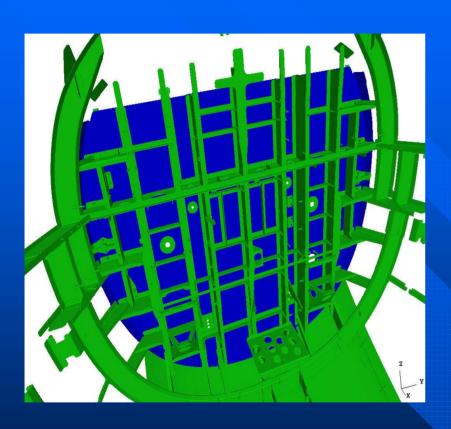
- Nose Bulkhead
- Situation:
 - Blankets are attached using hook and loop or bond on attachments
 - Not able to use clamps around perimeter locations

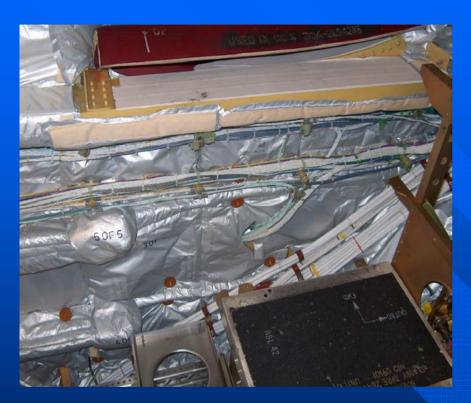
- Cargo Bulkhead
- Situation:
 - Blankets are attached using hook and loop or bond on attachments
 - Not able to use clamps around perimeter locations

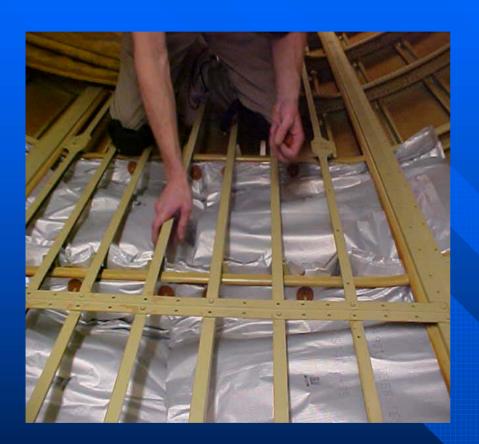
- Nose wheel well bulkhead/Bilge
- Situation:
 - Unique structure does not allow for use of screw-through pins or clamps
 - No testing method known

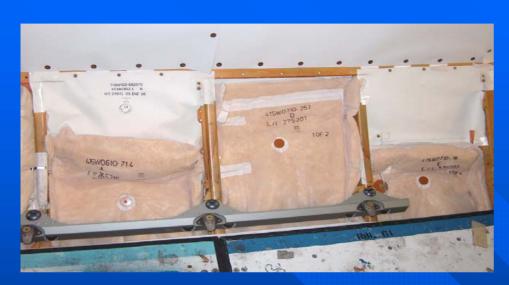
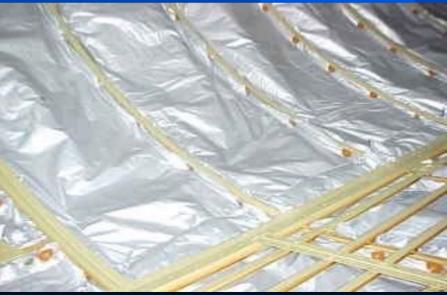
- Over-frame support beams
- Situation:
 - Certification is undefined due to slits needed to overlap frame.

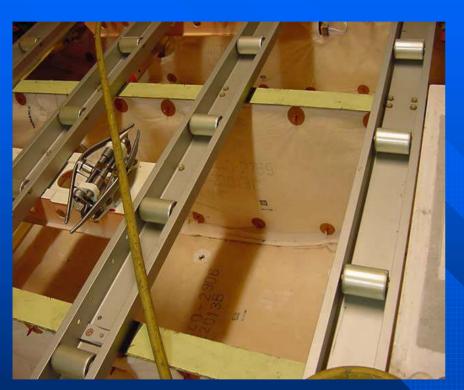
- Sloping sidewall
- Situation:
 - Blankets do not overlap frame because of cargo liner attachment
- Allow cargo liner as part of the burnthrough configuration

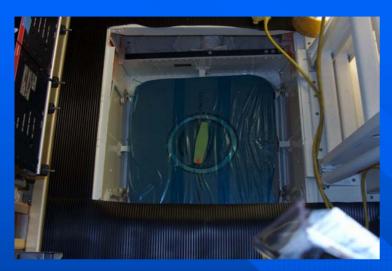
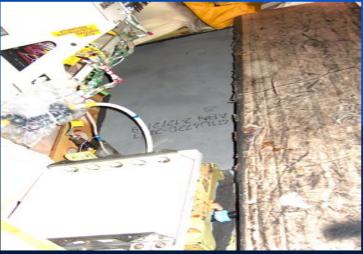
- Bilge
- Situation:
 - Blankets do not overlap frame
 - Airplane geometry requires splice at frame skin intersection
 - Bilge frame up to 2' deep
 - No method for testing

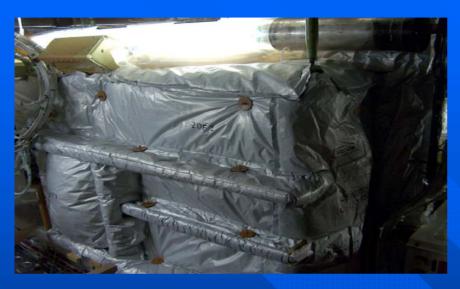
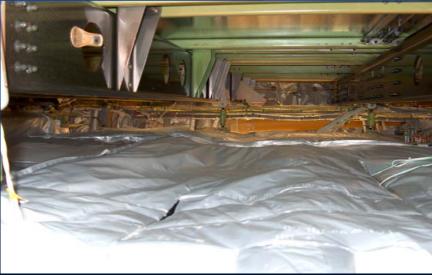
- EE Bay Hatch and walkway
- Situation:
 - Unique structure around hatches does not allow for use of screw-through pins or clamps
 - Foam bonded or attached with velcro to interior surface of EE bay hatch and walkway
