**Federal Aviation
Administration**

Update on Flammability Testing of Magnesium Alloy Components

By: Tim Marker, FAA Technical Center

Date: June 23, 2010

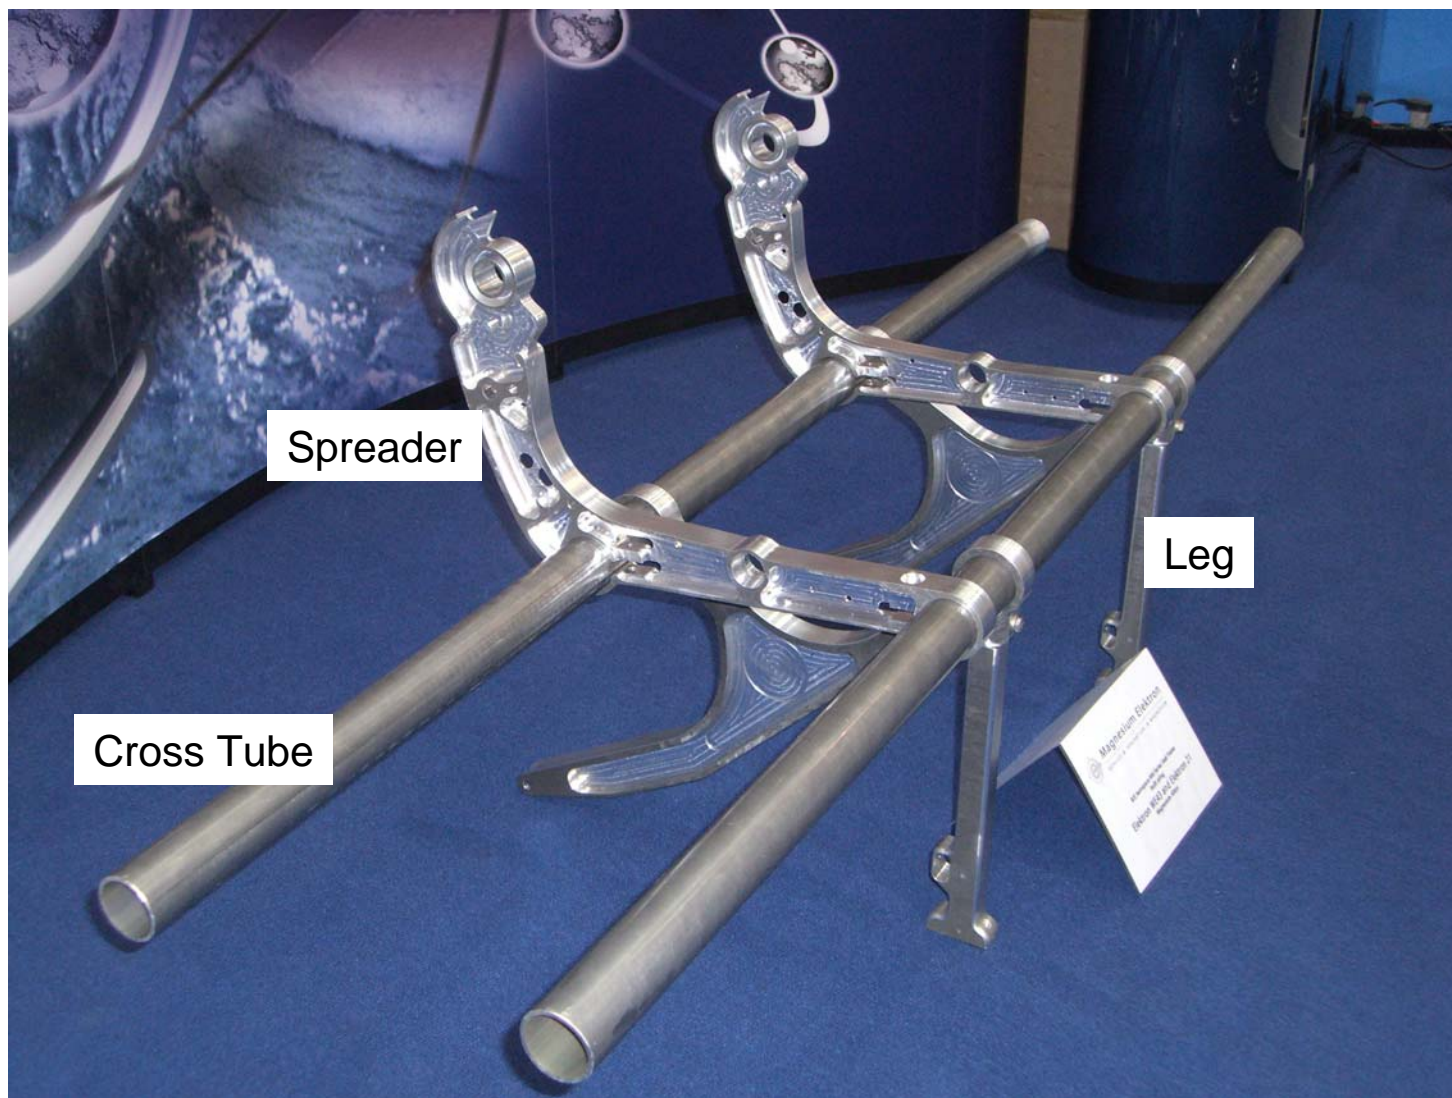
Primary Seat Components

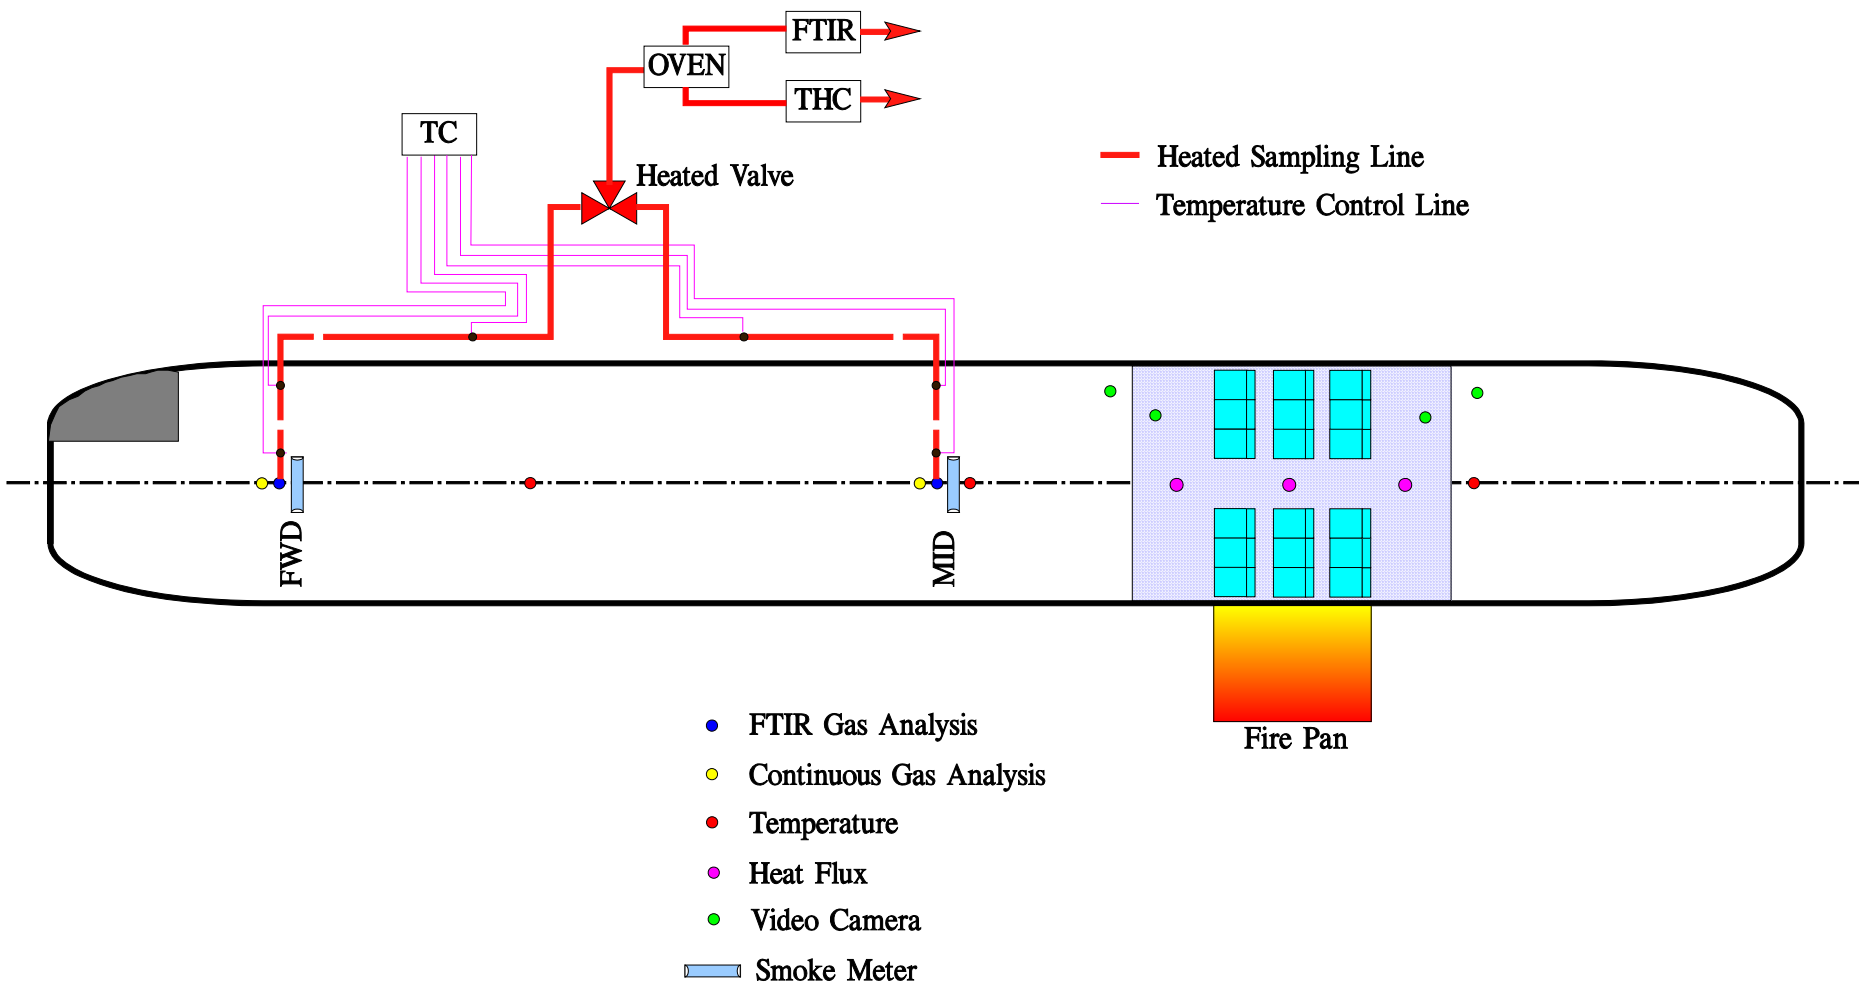
Full-Scale Test Apparatus

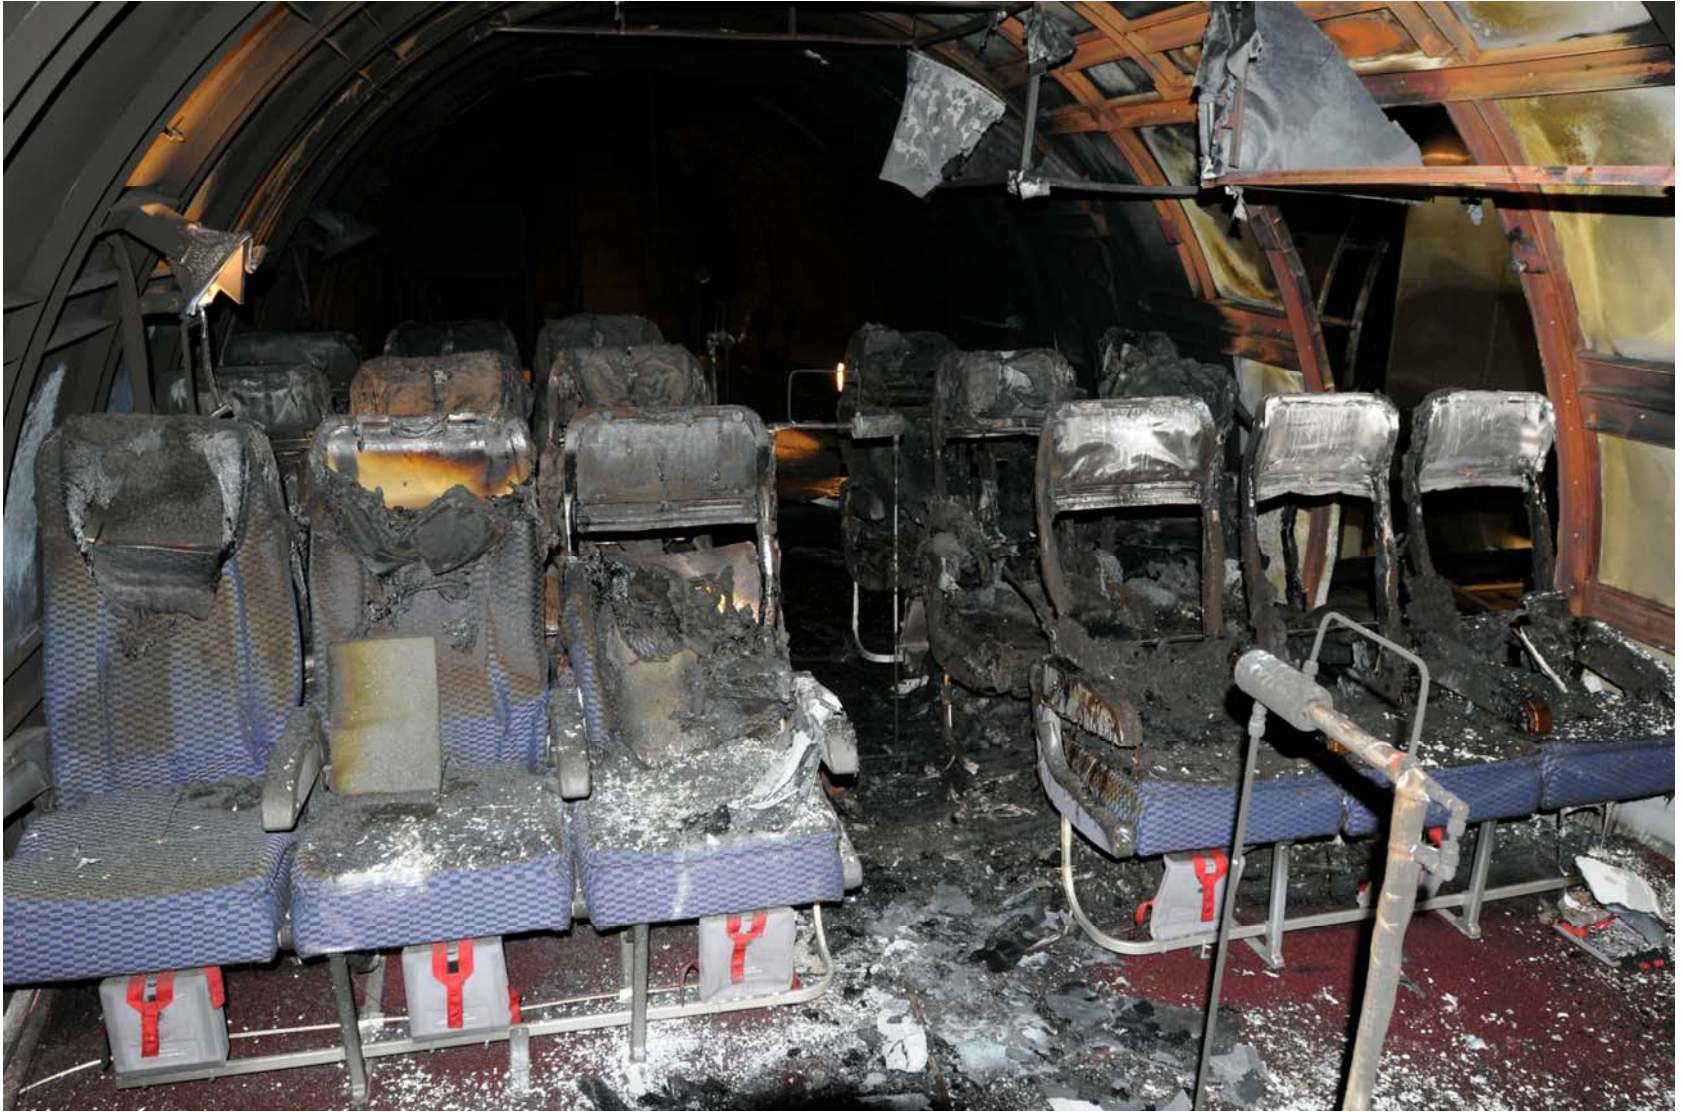
Initial 2 Baseline Tests Highlighted Seat Back Flammability

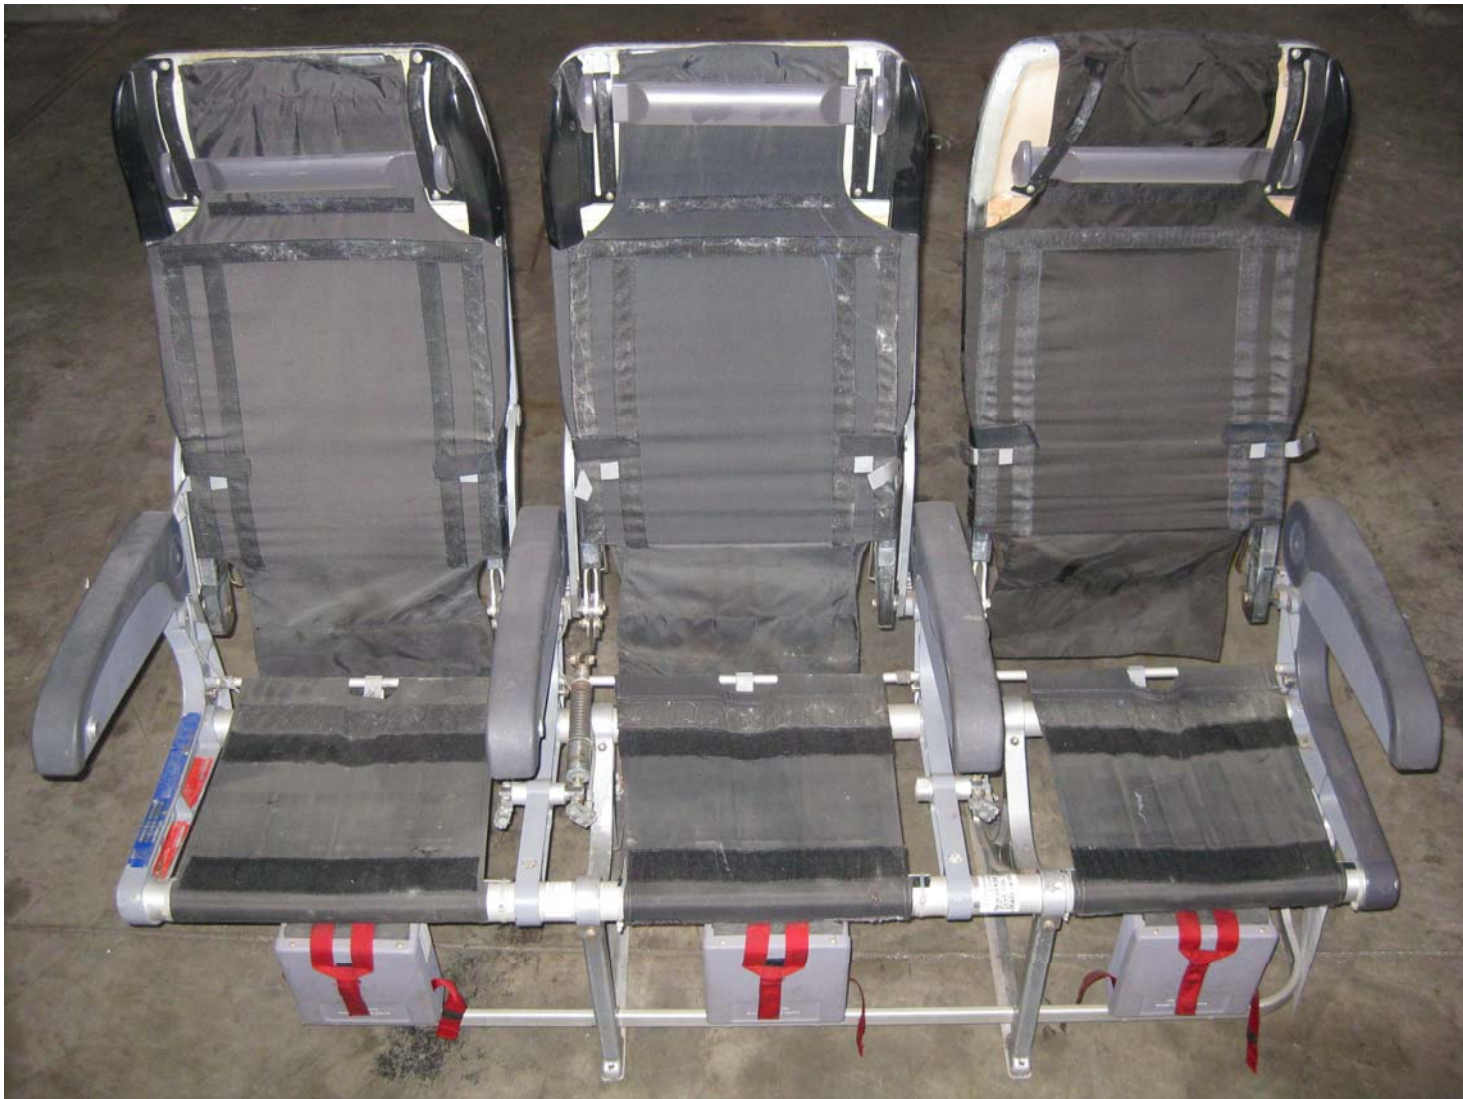
Back Rest Construction of B/E 990 Seats

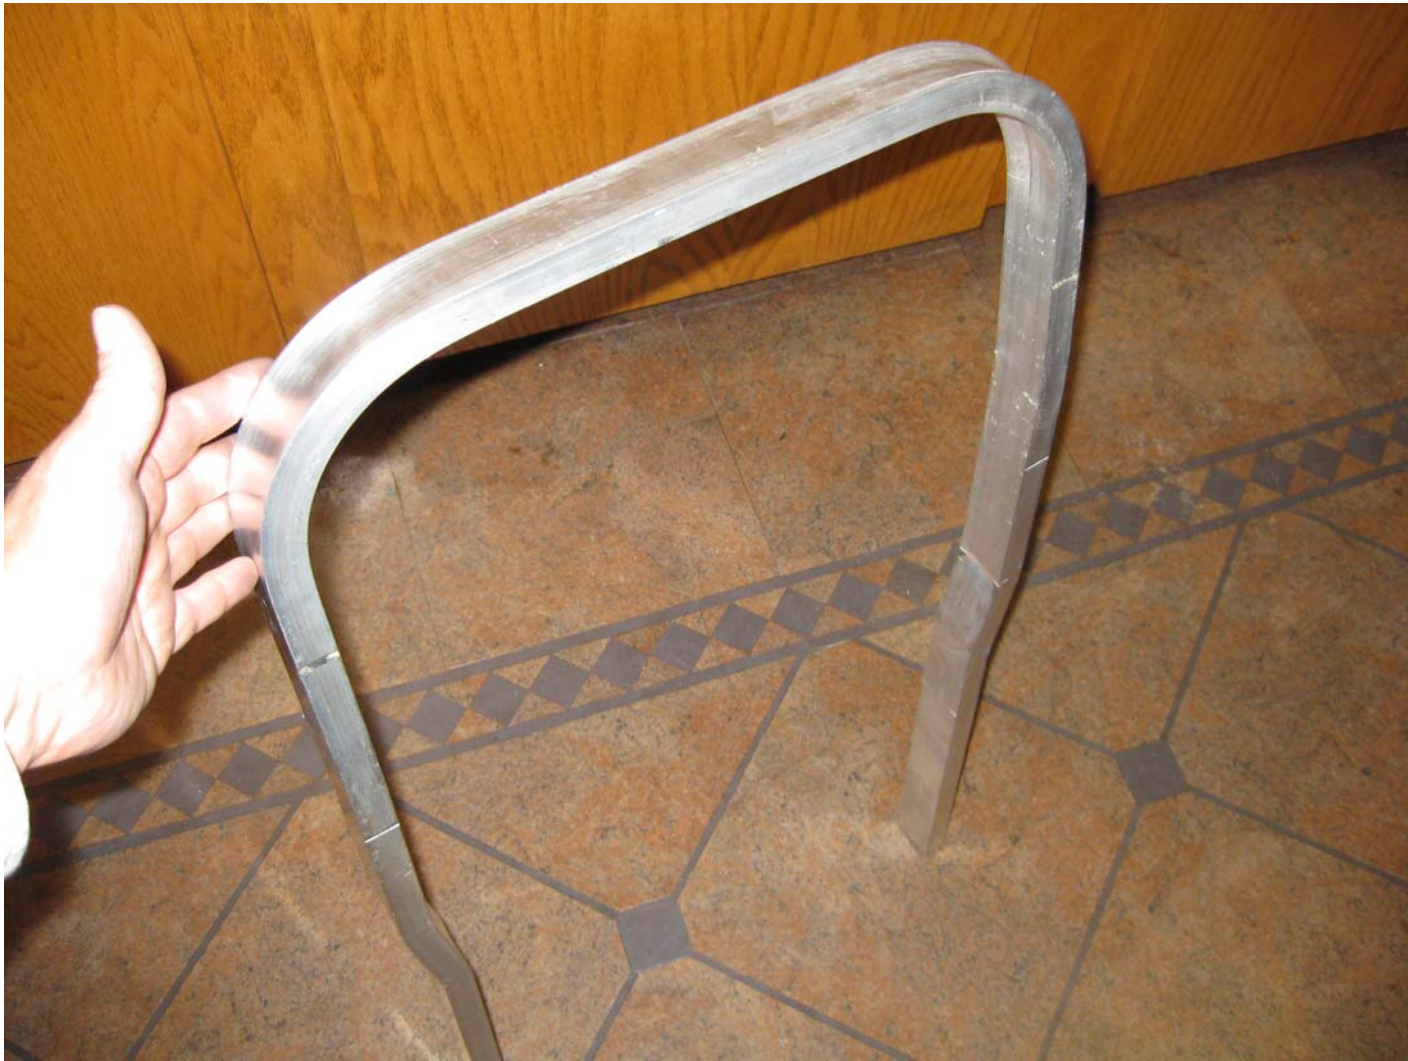
New Seat Back Frame Design

2024 alum box frame, 0.75-inch by 1.5 inch

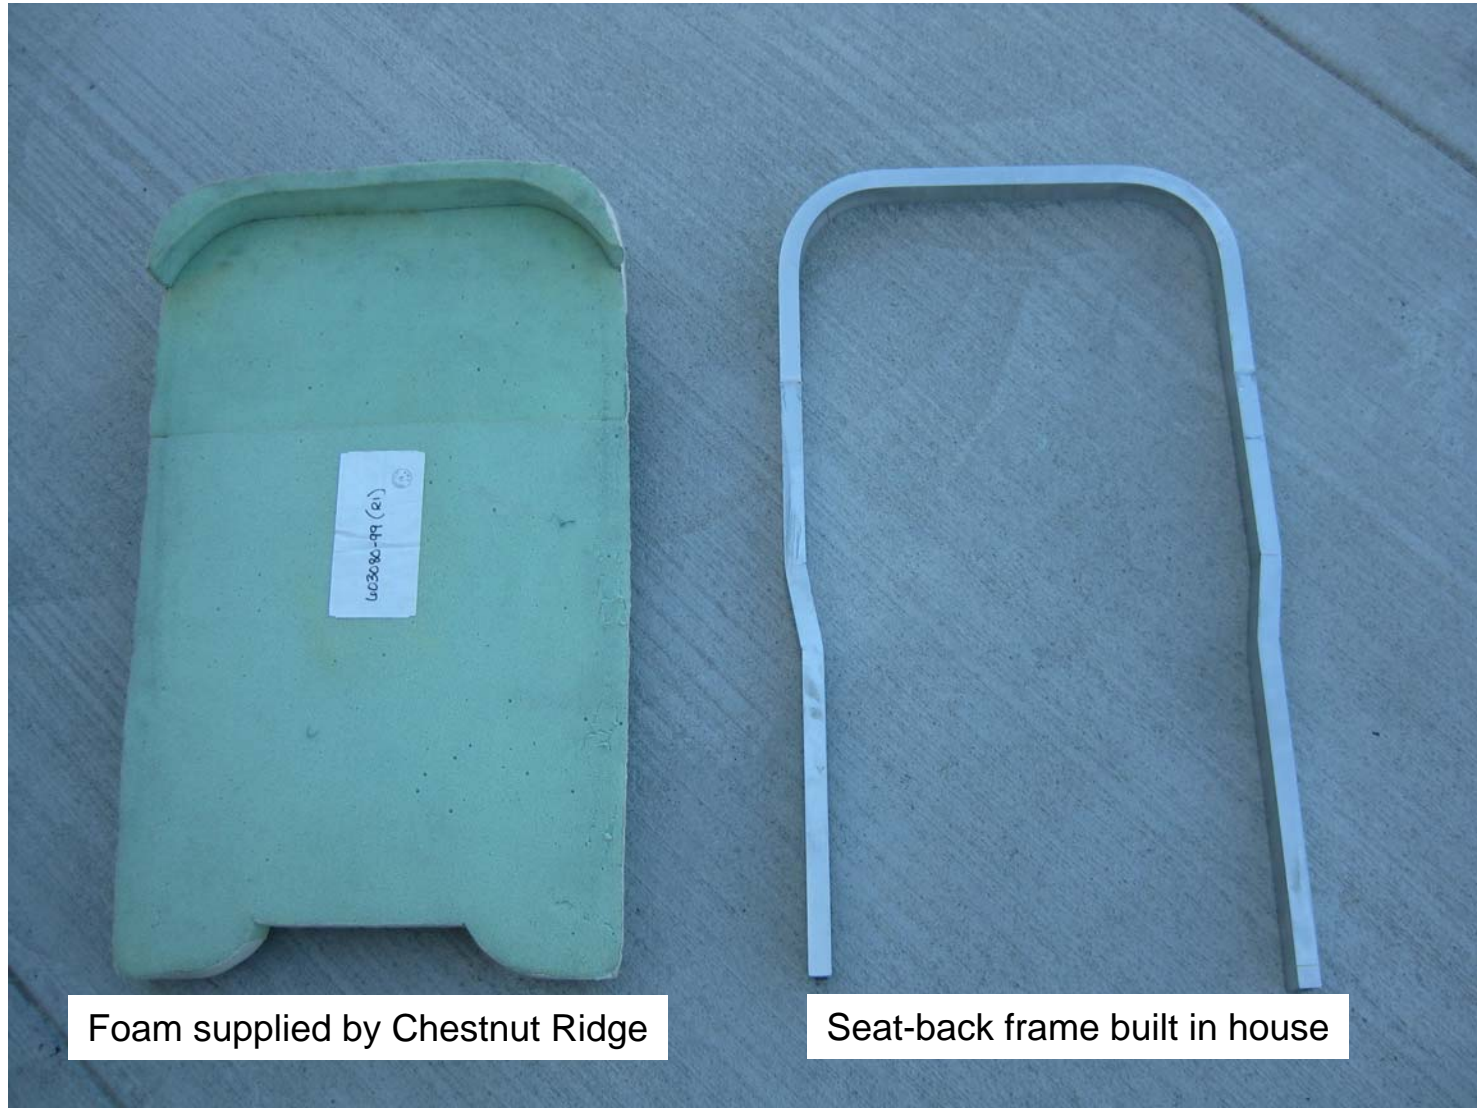
New Fire Hardened Foam for Seat Back

Foam supplied by Chestnut Ridge

Seat-back frame built in house

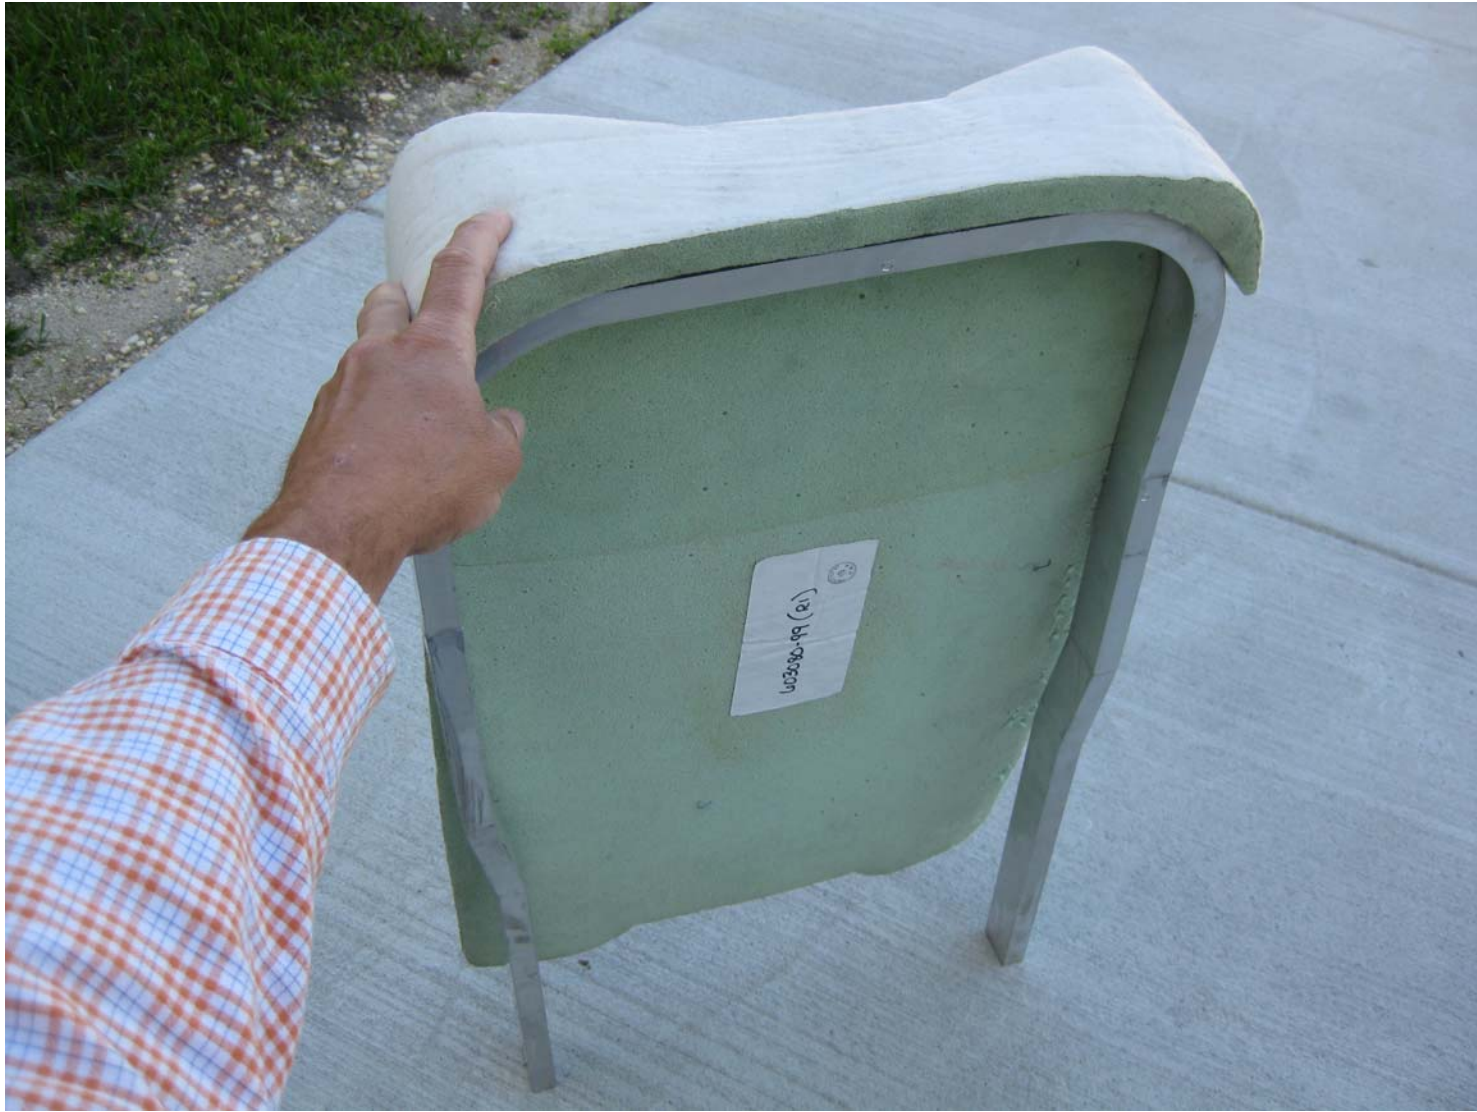
New Fire Hardened Foam for Seat Back

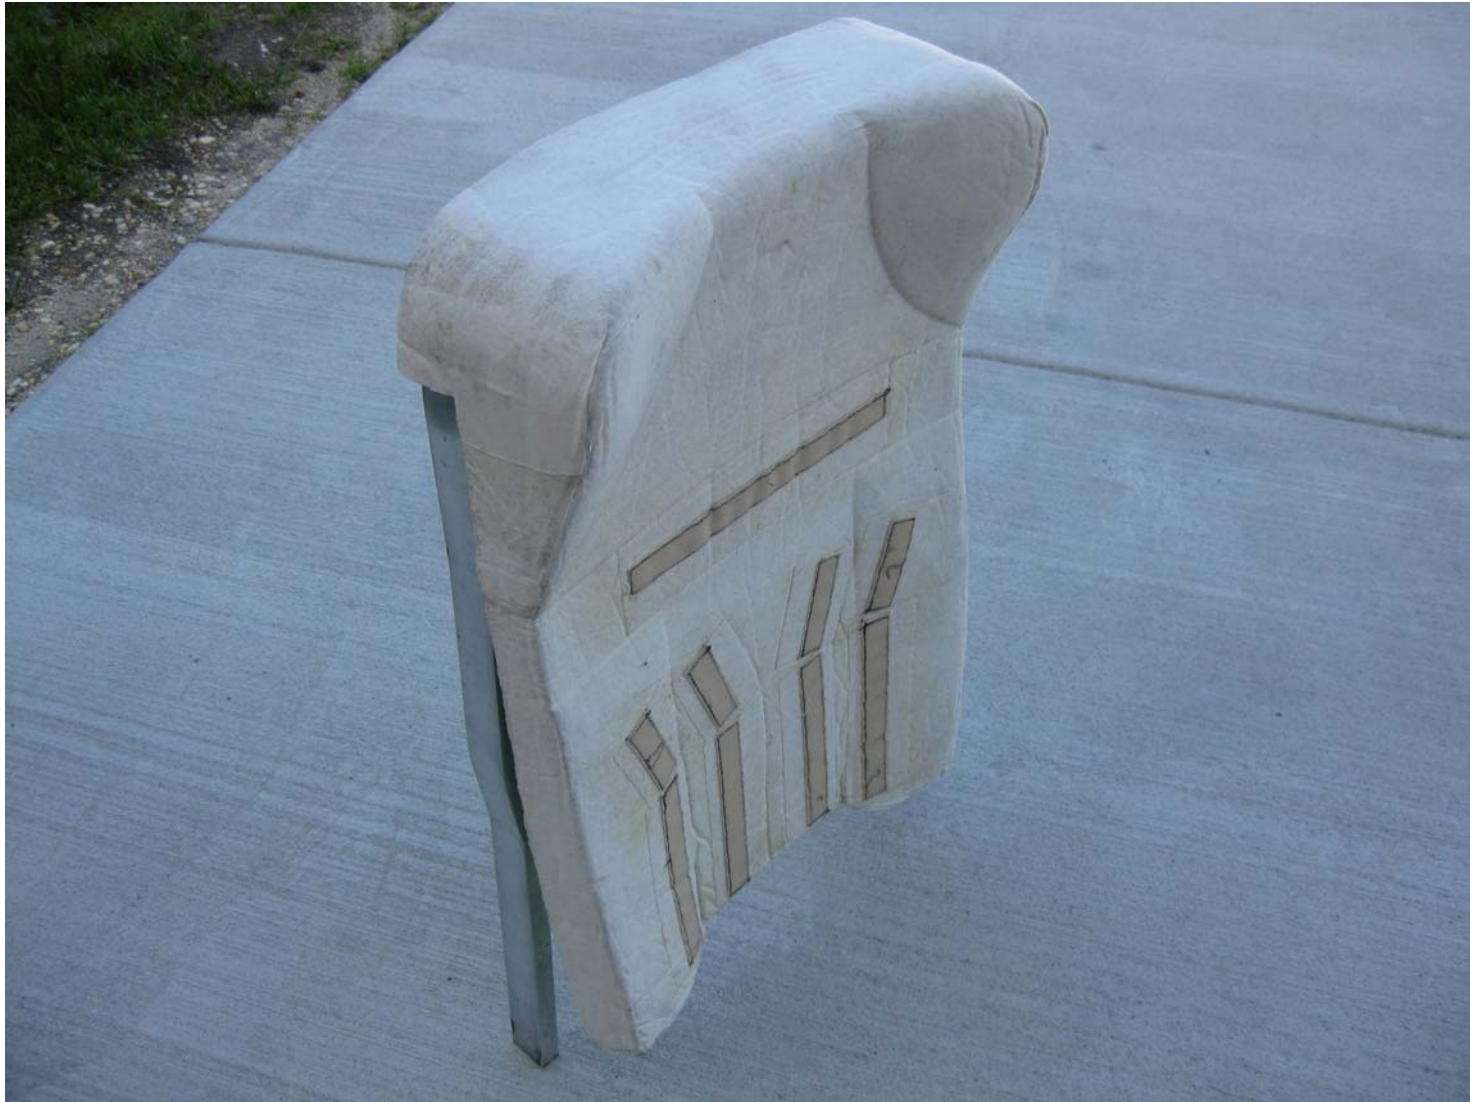
New Seat Back

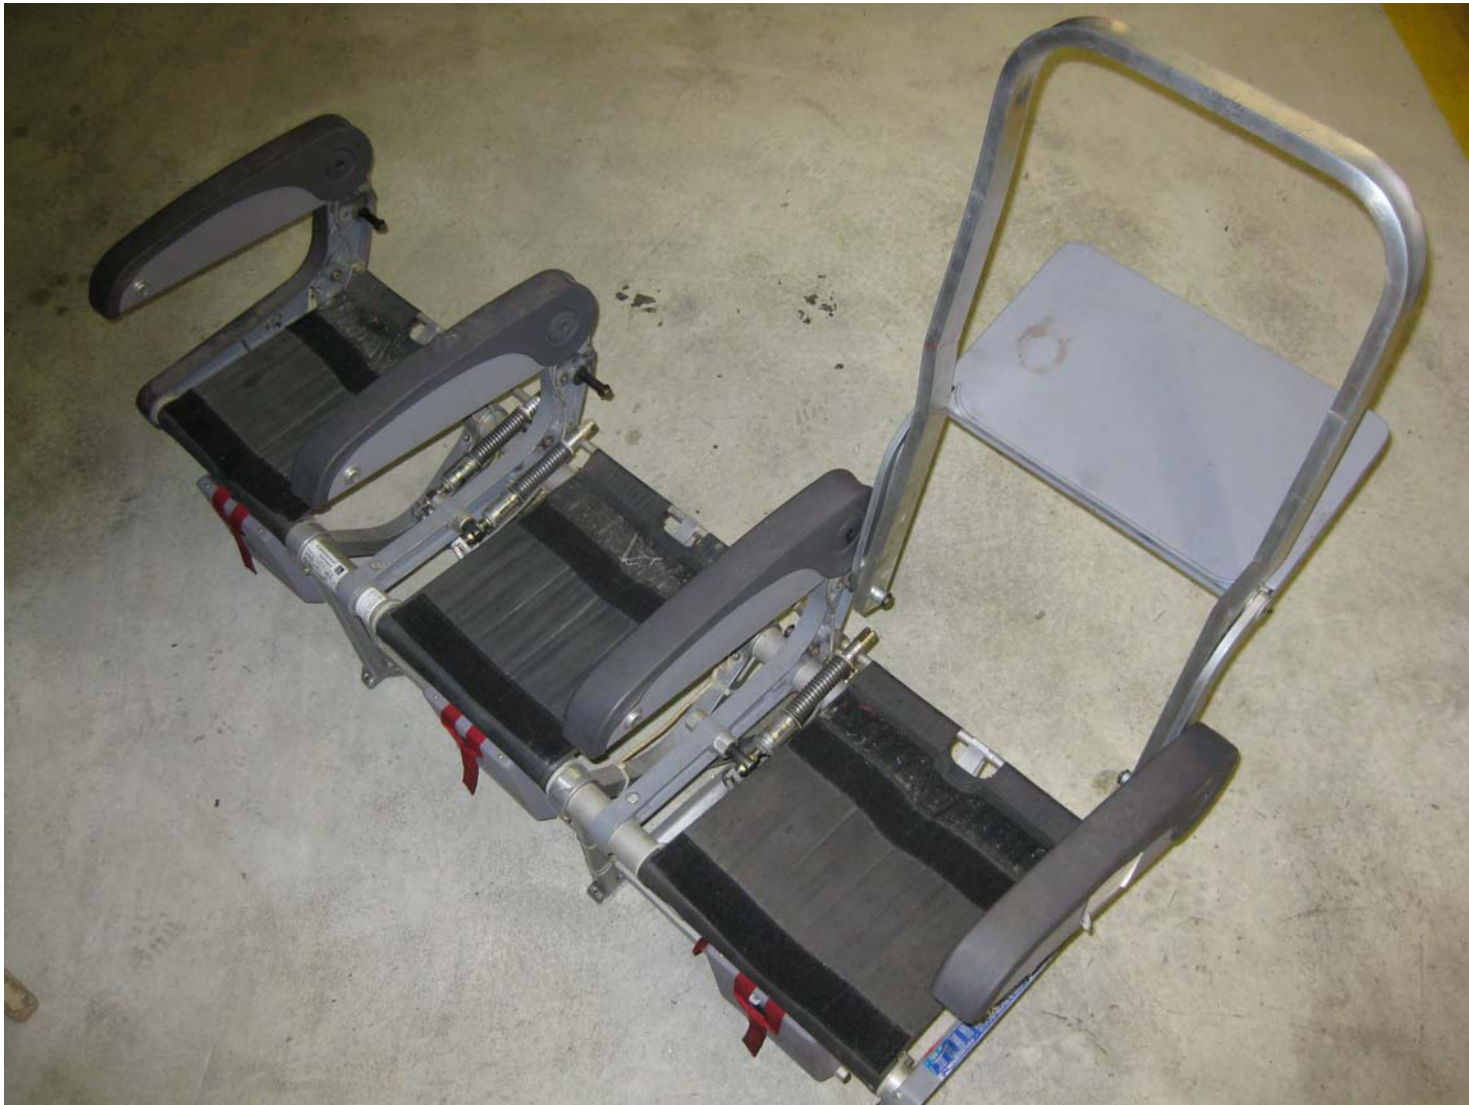
New Back Frame Installed

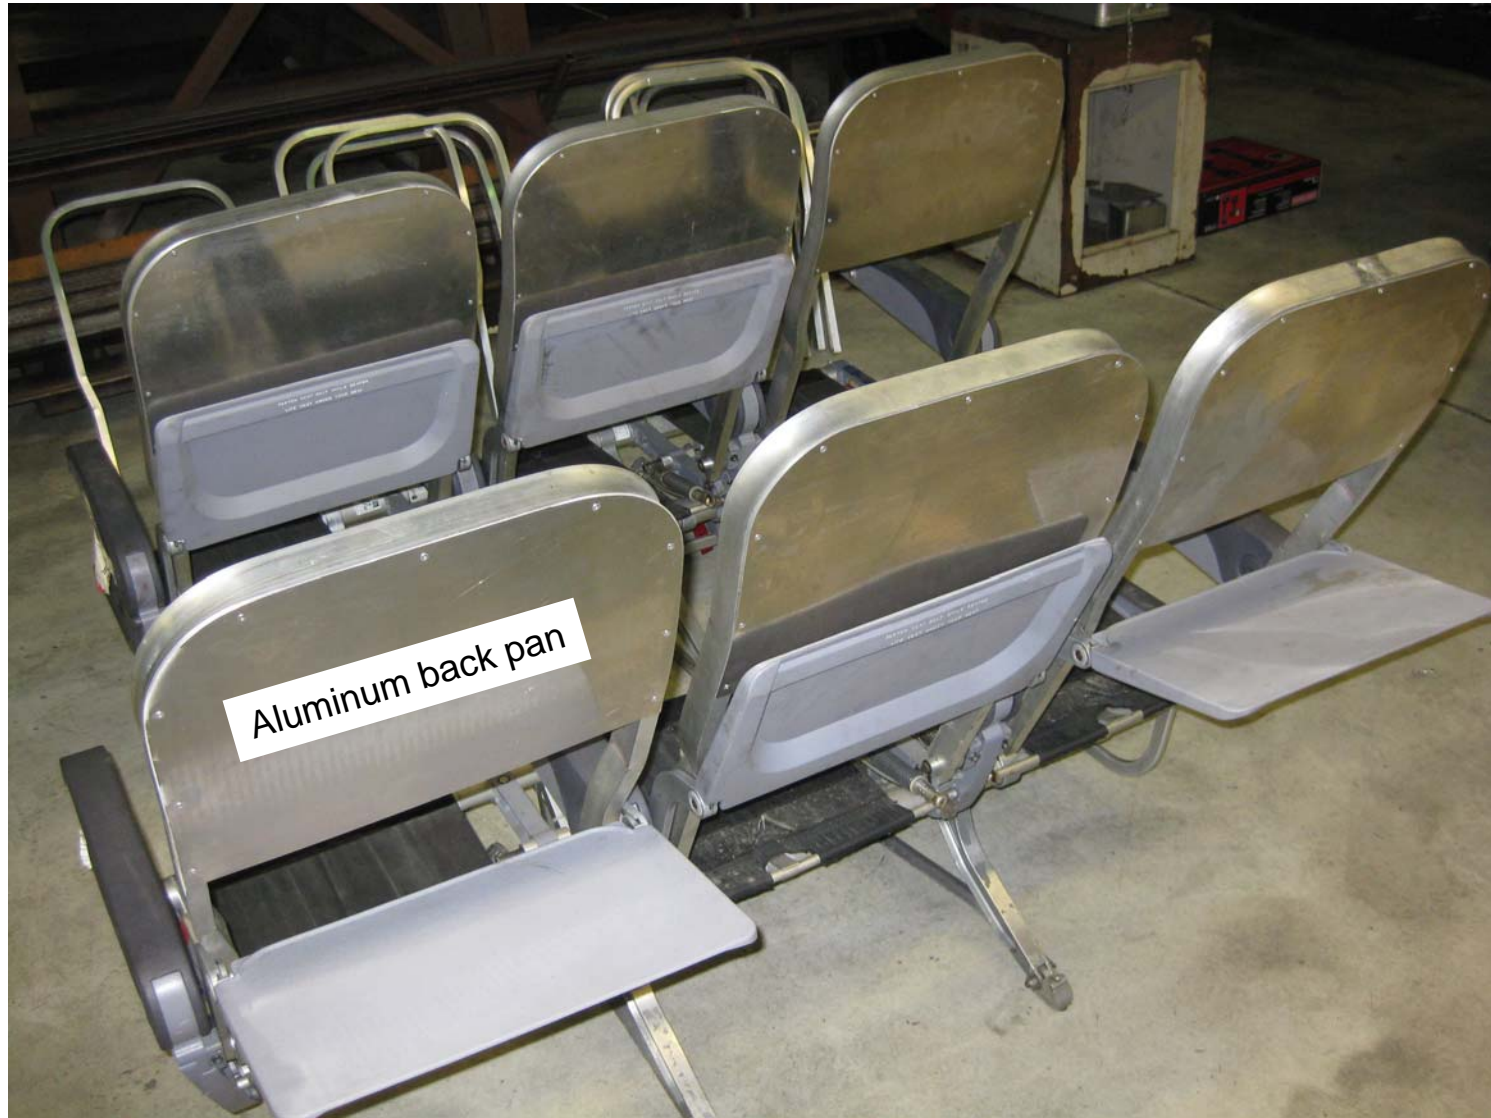
Mass Production of Seat Back Frames

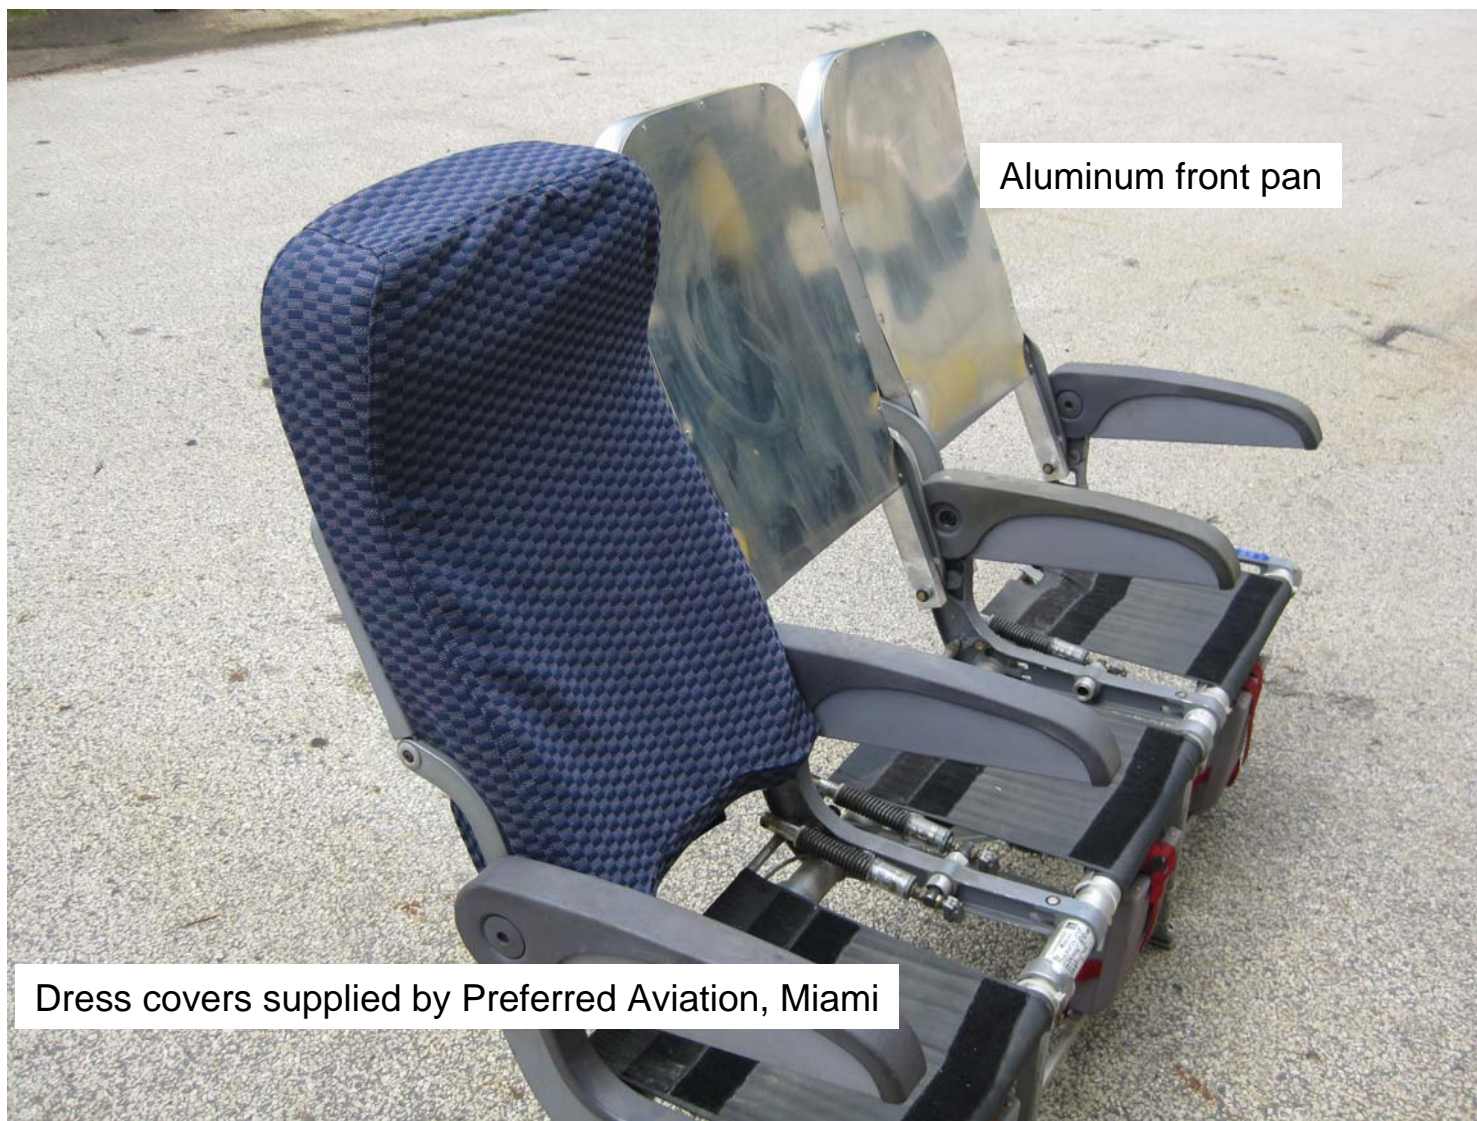
Dress Cover Installed Over New Back Frame

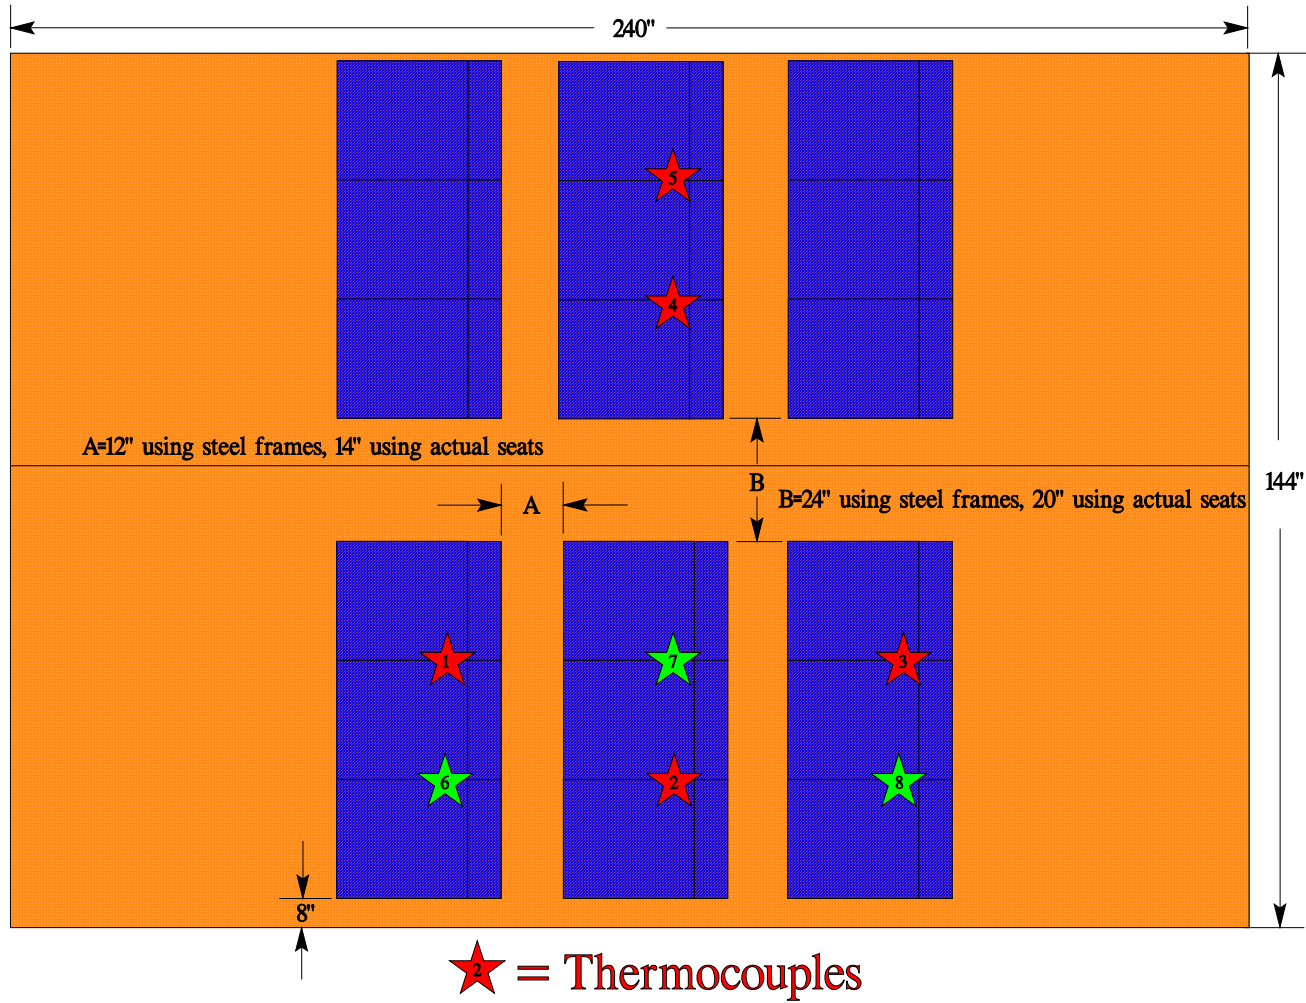
Seat Thermocouples

Additional thermocouples installed in seat leg frames

Additional thermocouples in seat frames

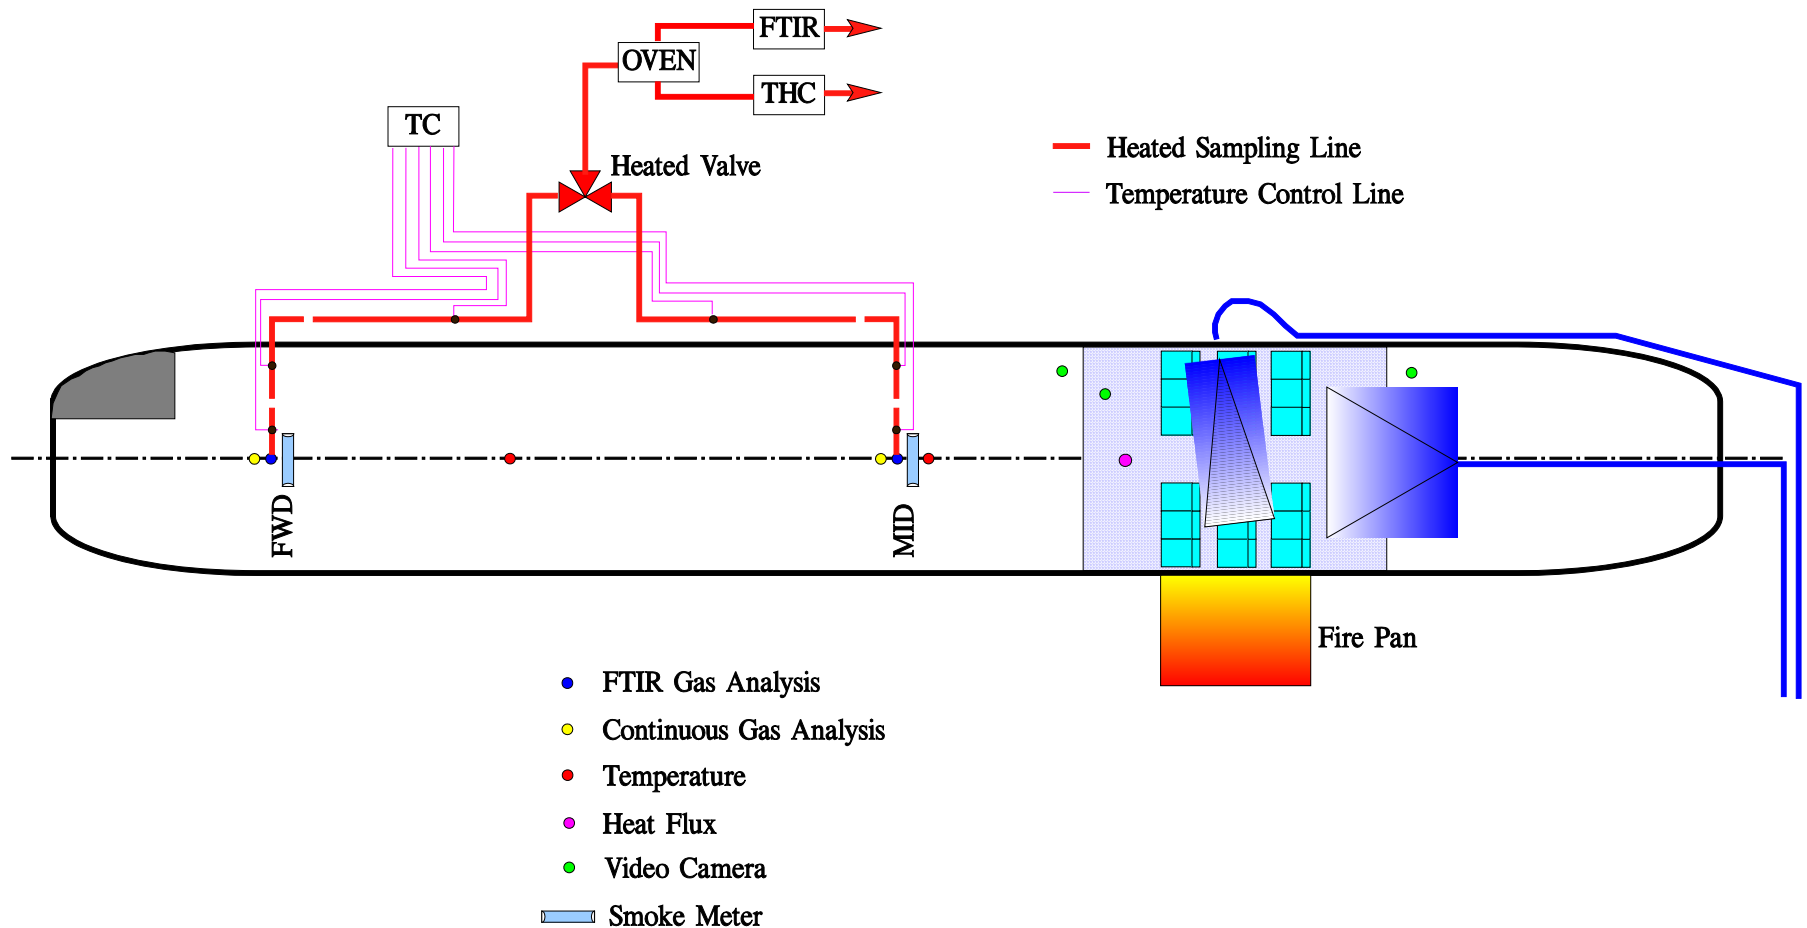
Application of Water Post-Test

water applied at end of all tests (not just magnesium), for similarity

Application of water at set time for all remaining tests

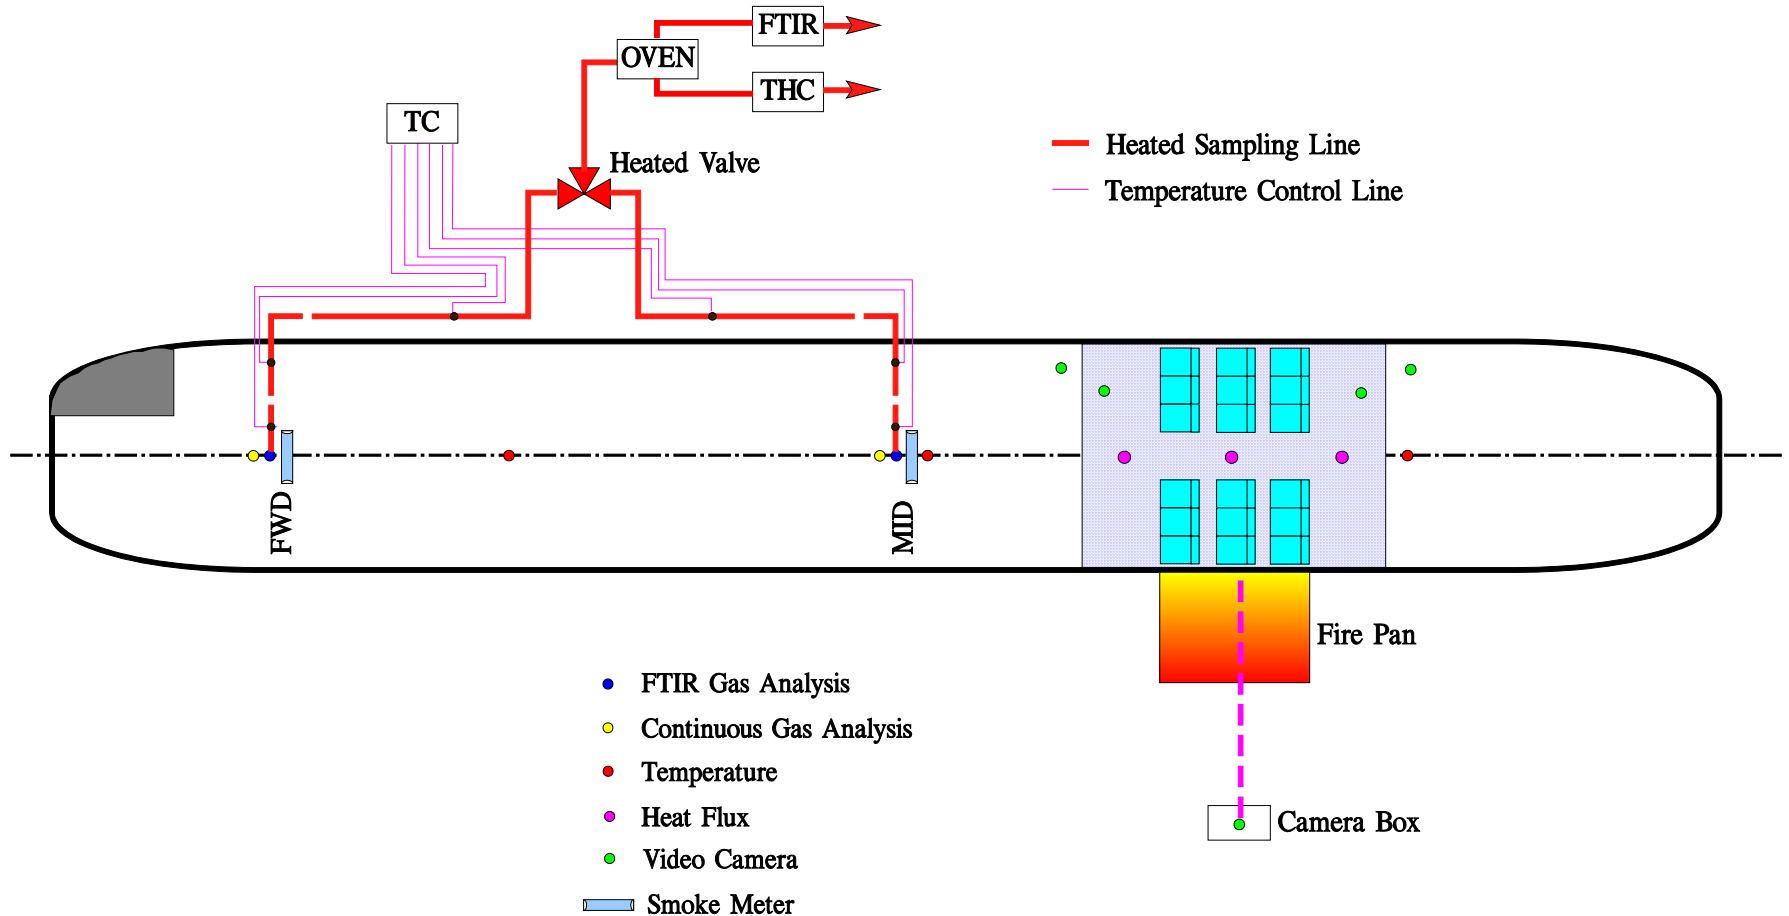
Camera Location

Additional 'unobscurable' video camera used for accurate application of water post test

Additional camera that will not become obscured during test
