**Federal Aviation
Administration**

Update on Flammability Testing of Magnesium Alloy Components

By: Tim Marker, FAA Technical Center

Date: June 23, 2010

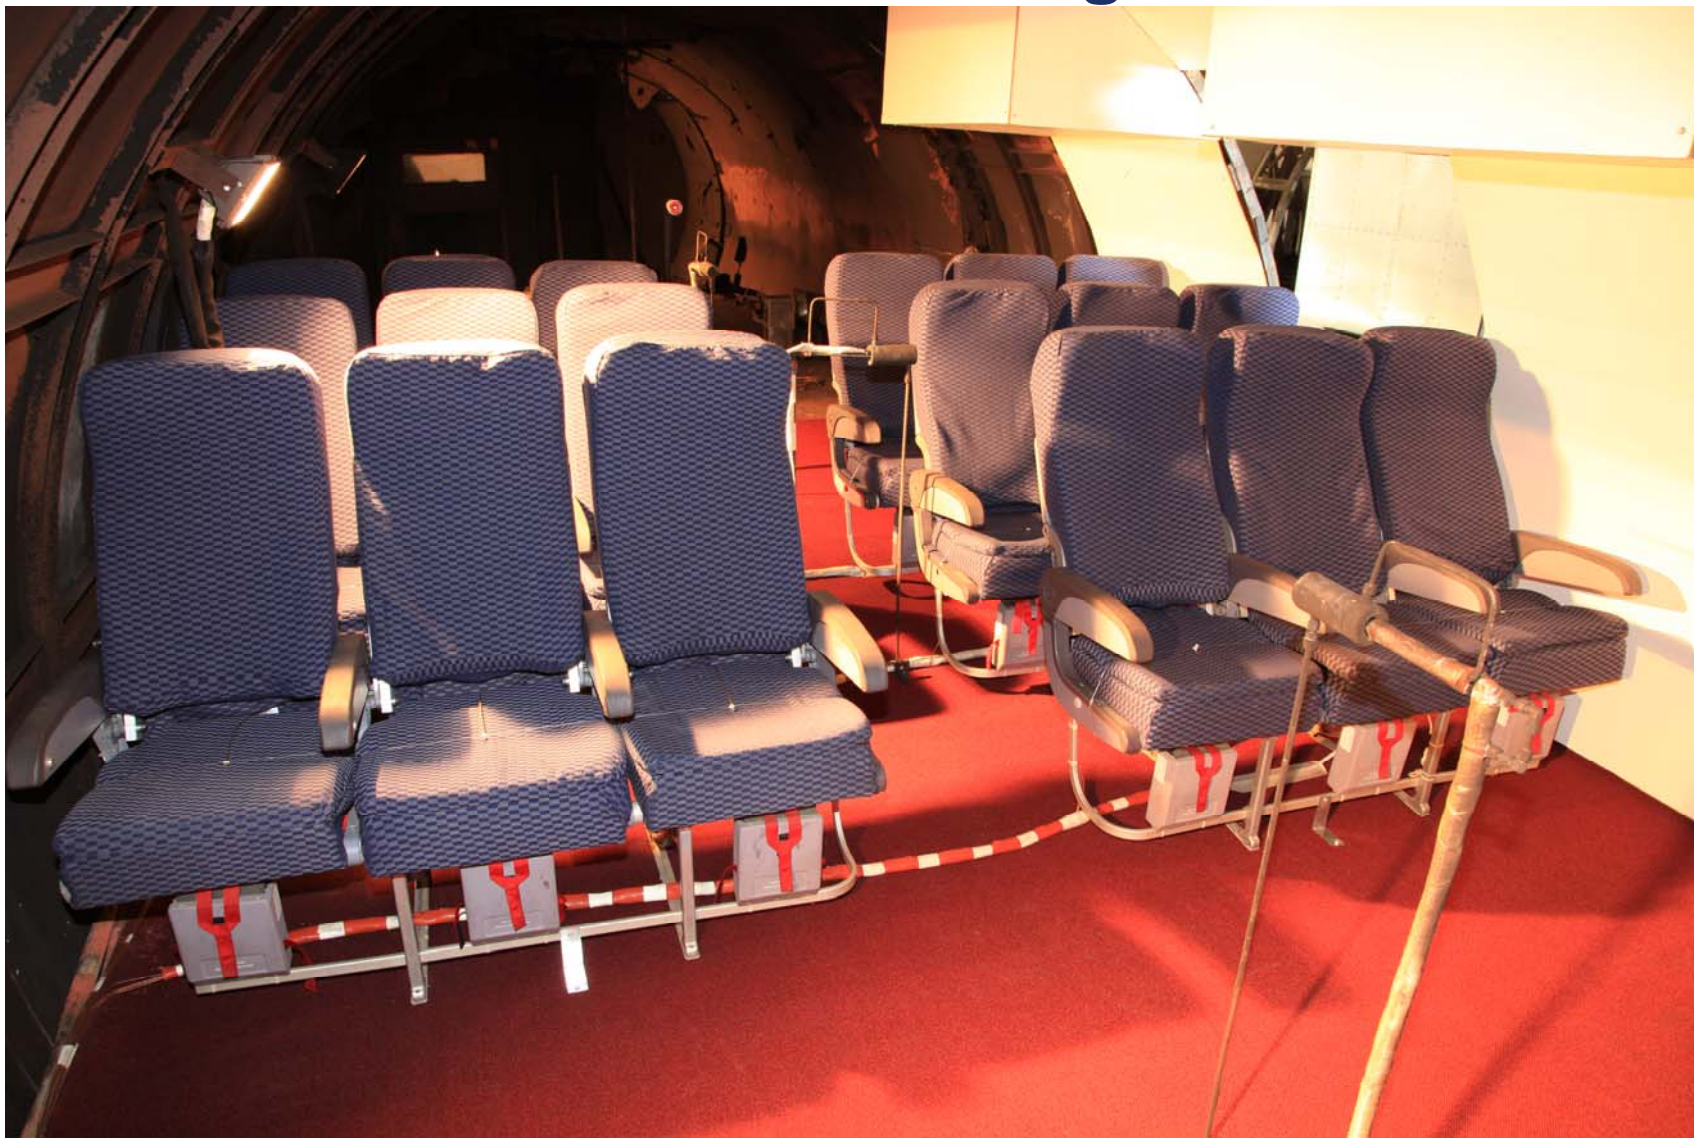
Baseline 3 Test Configuration

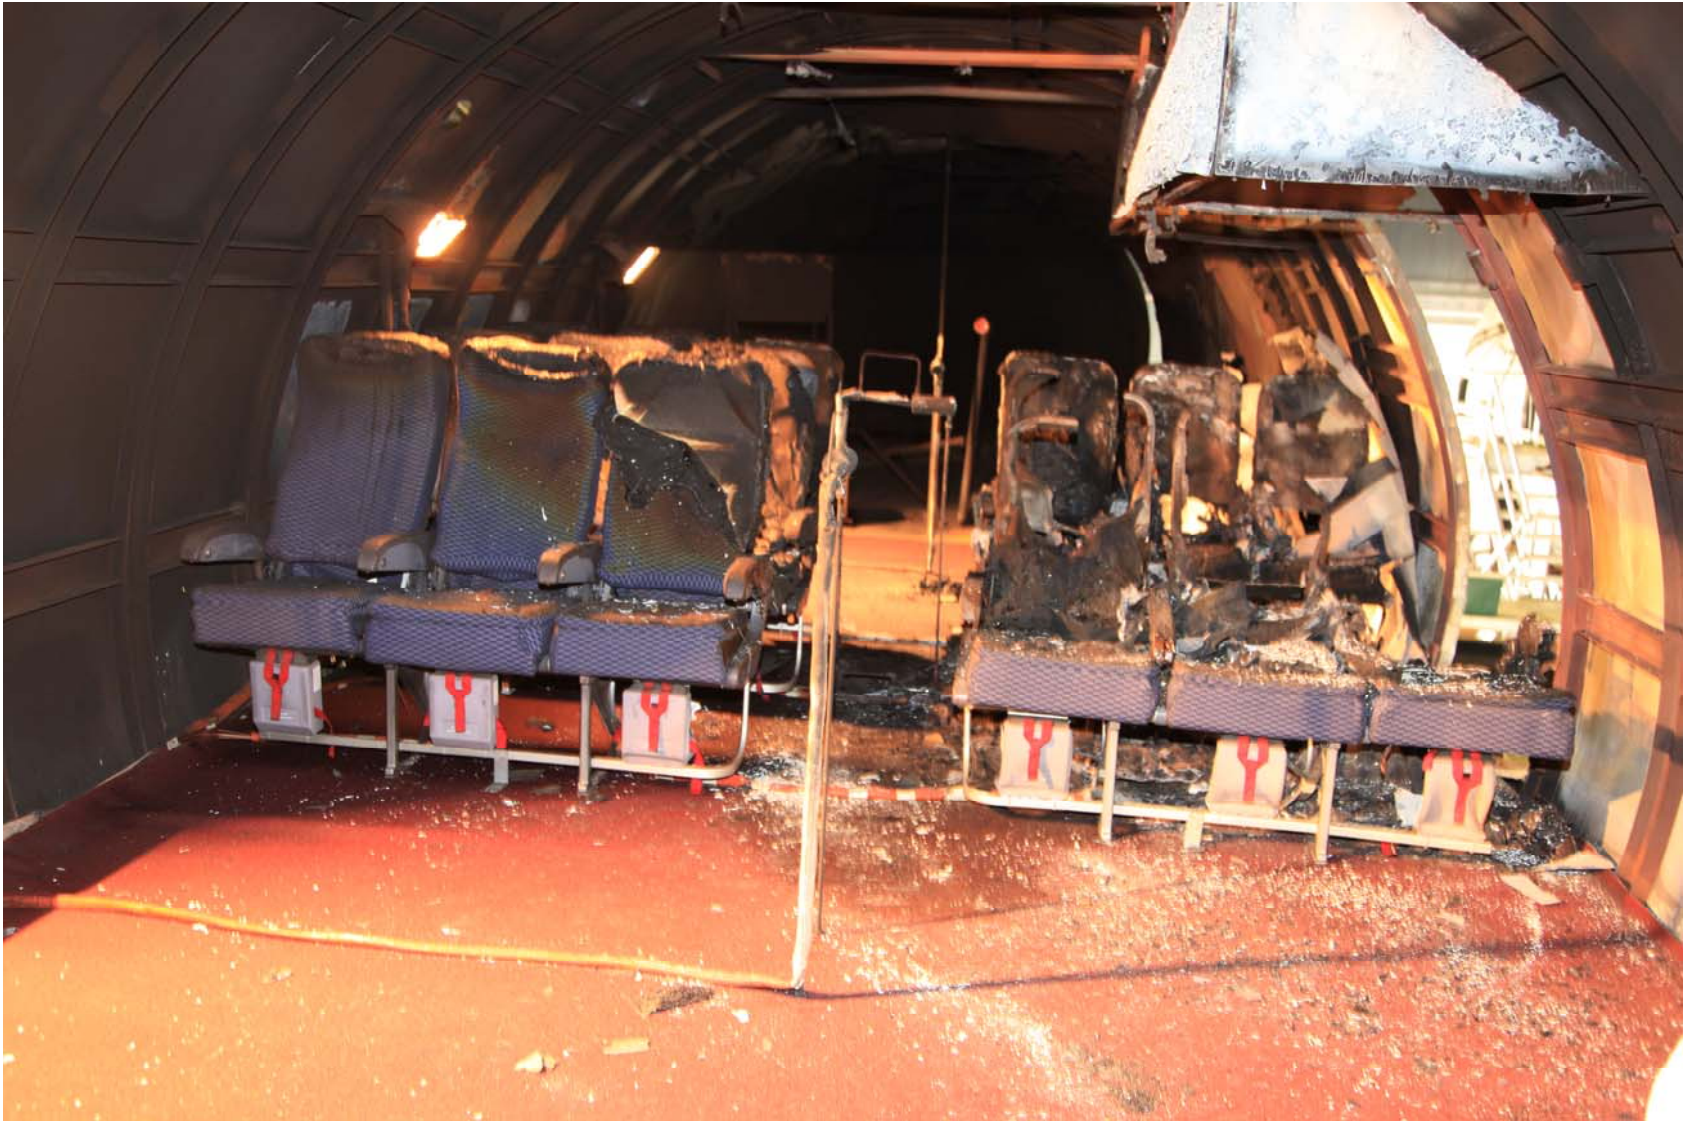
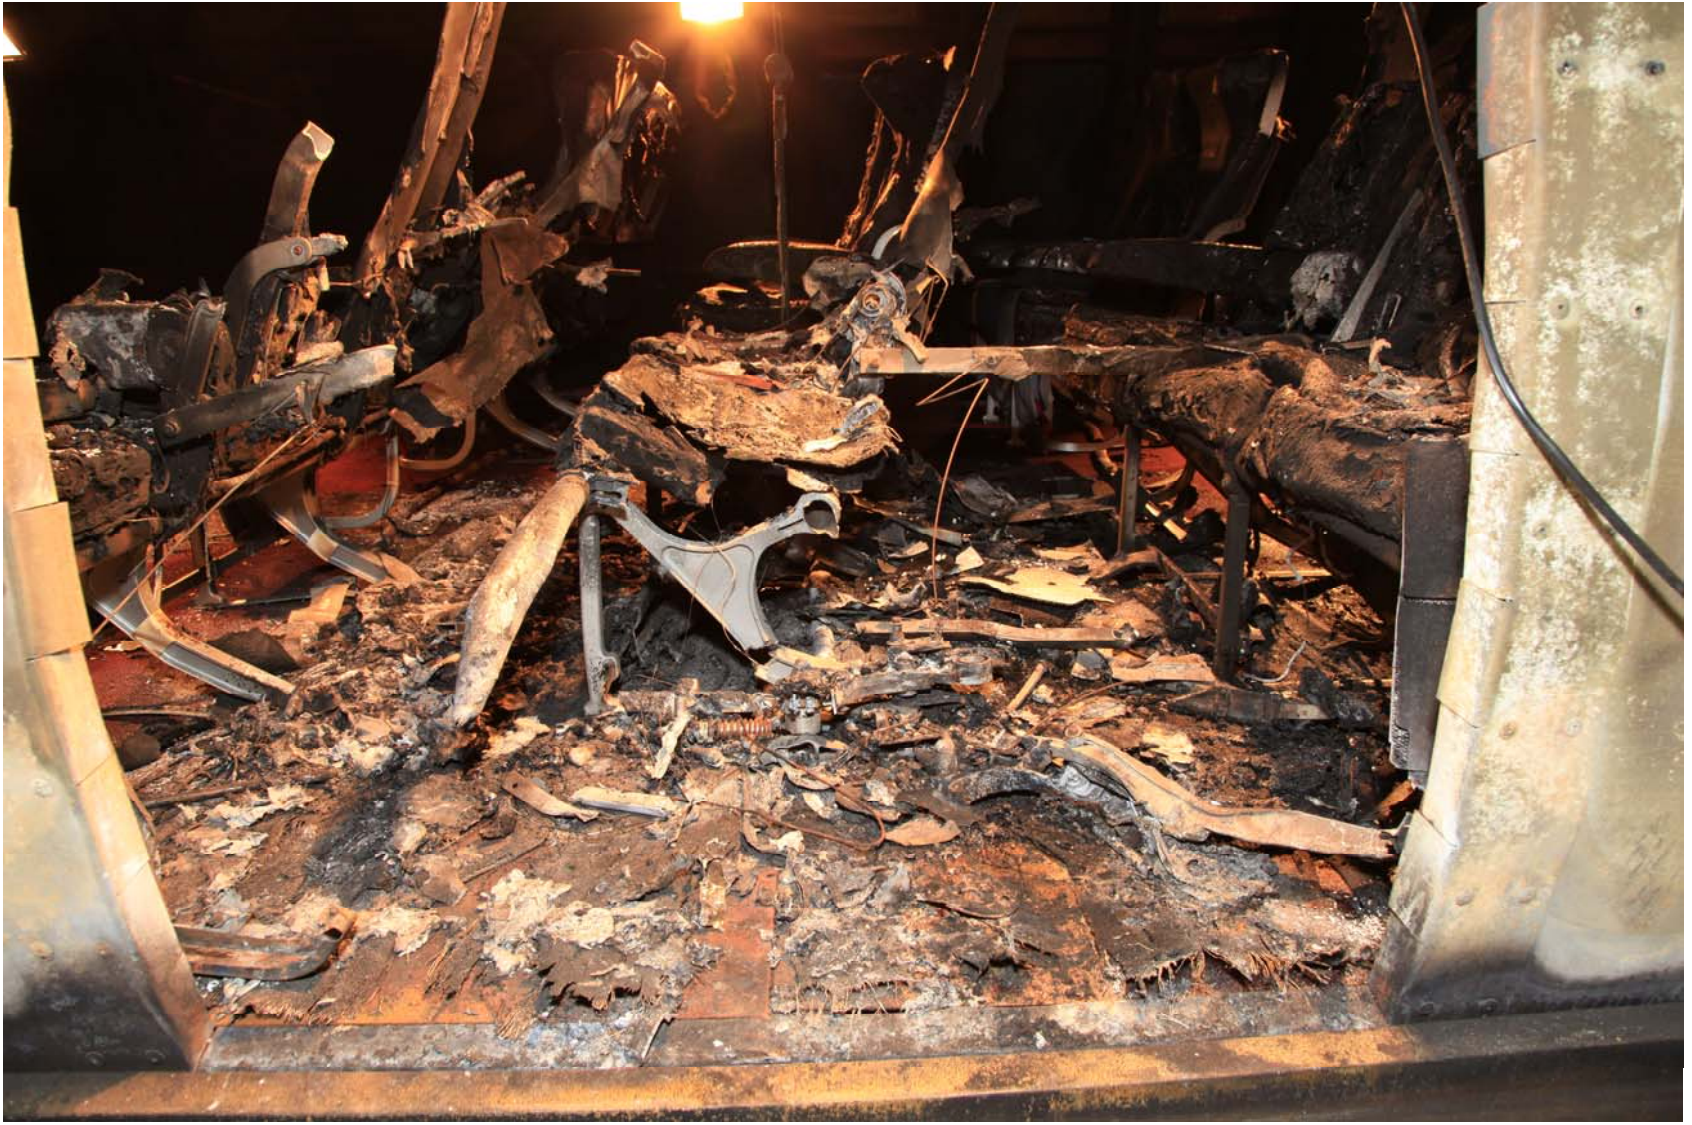
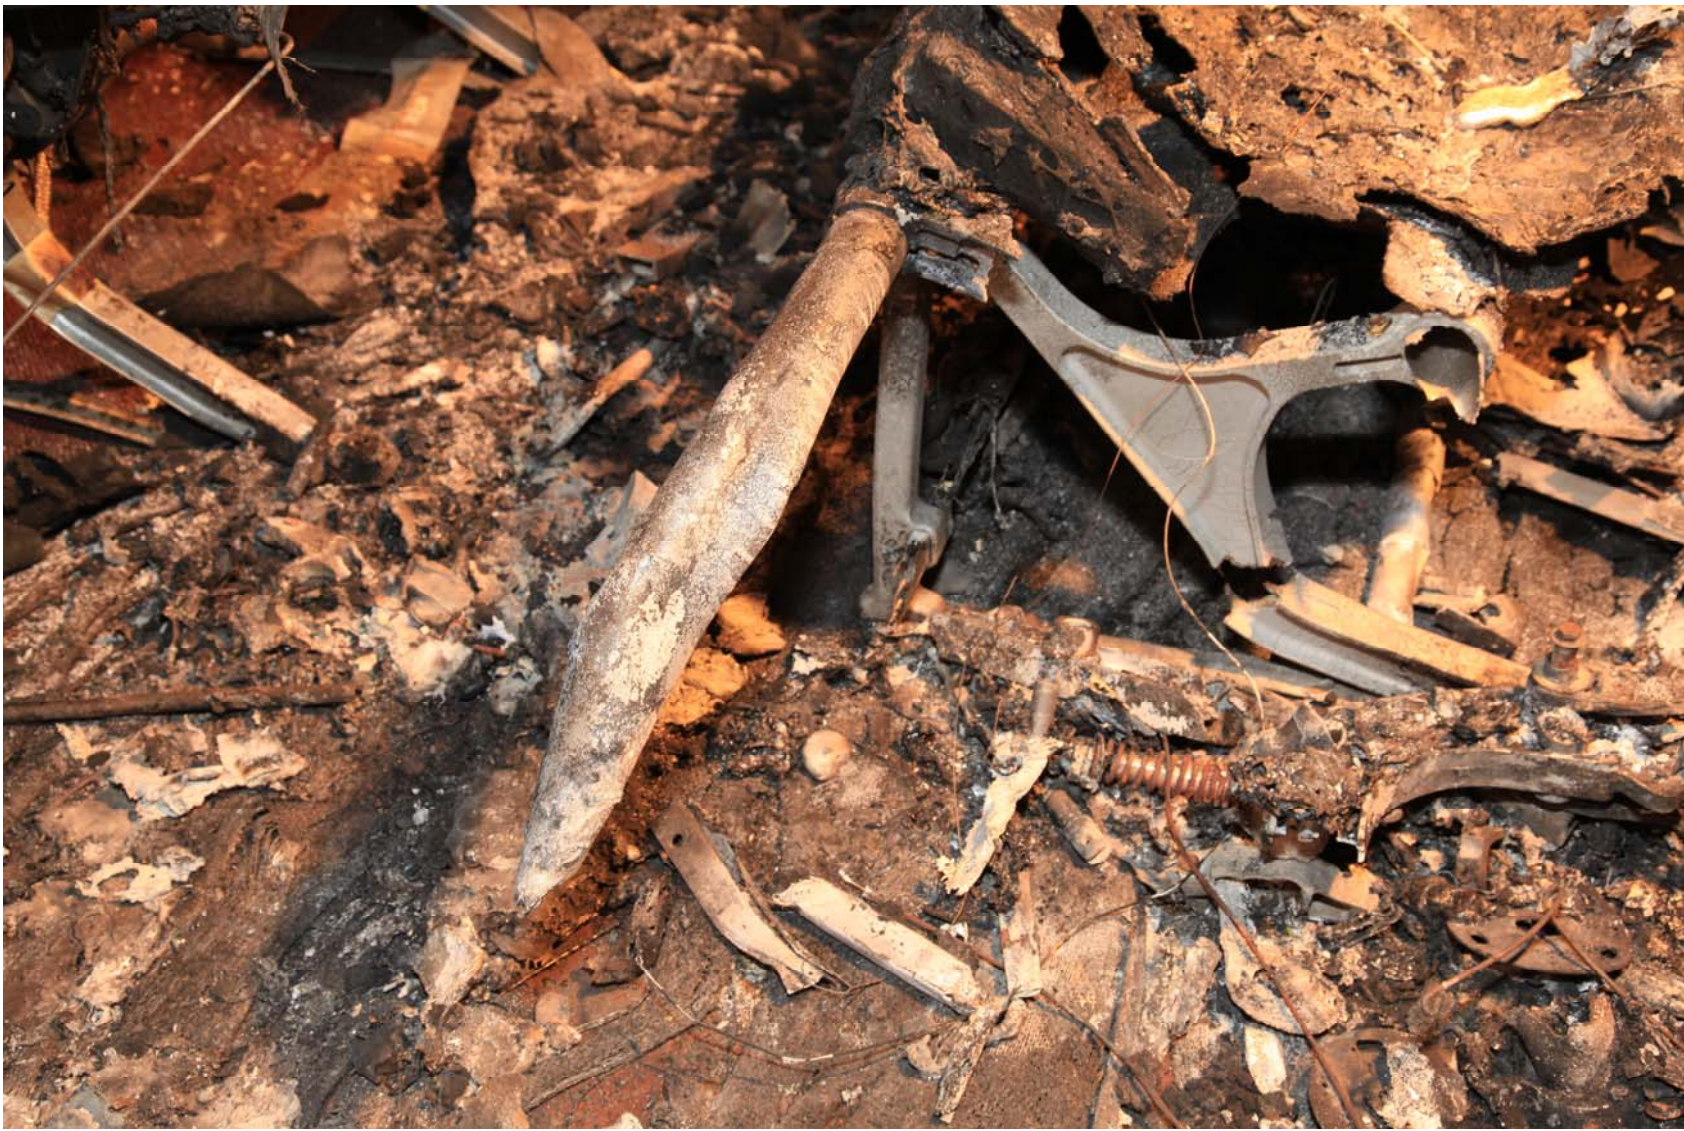
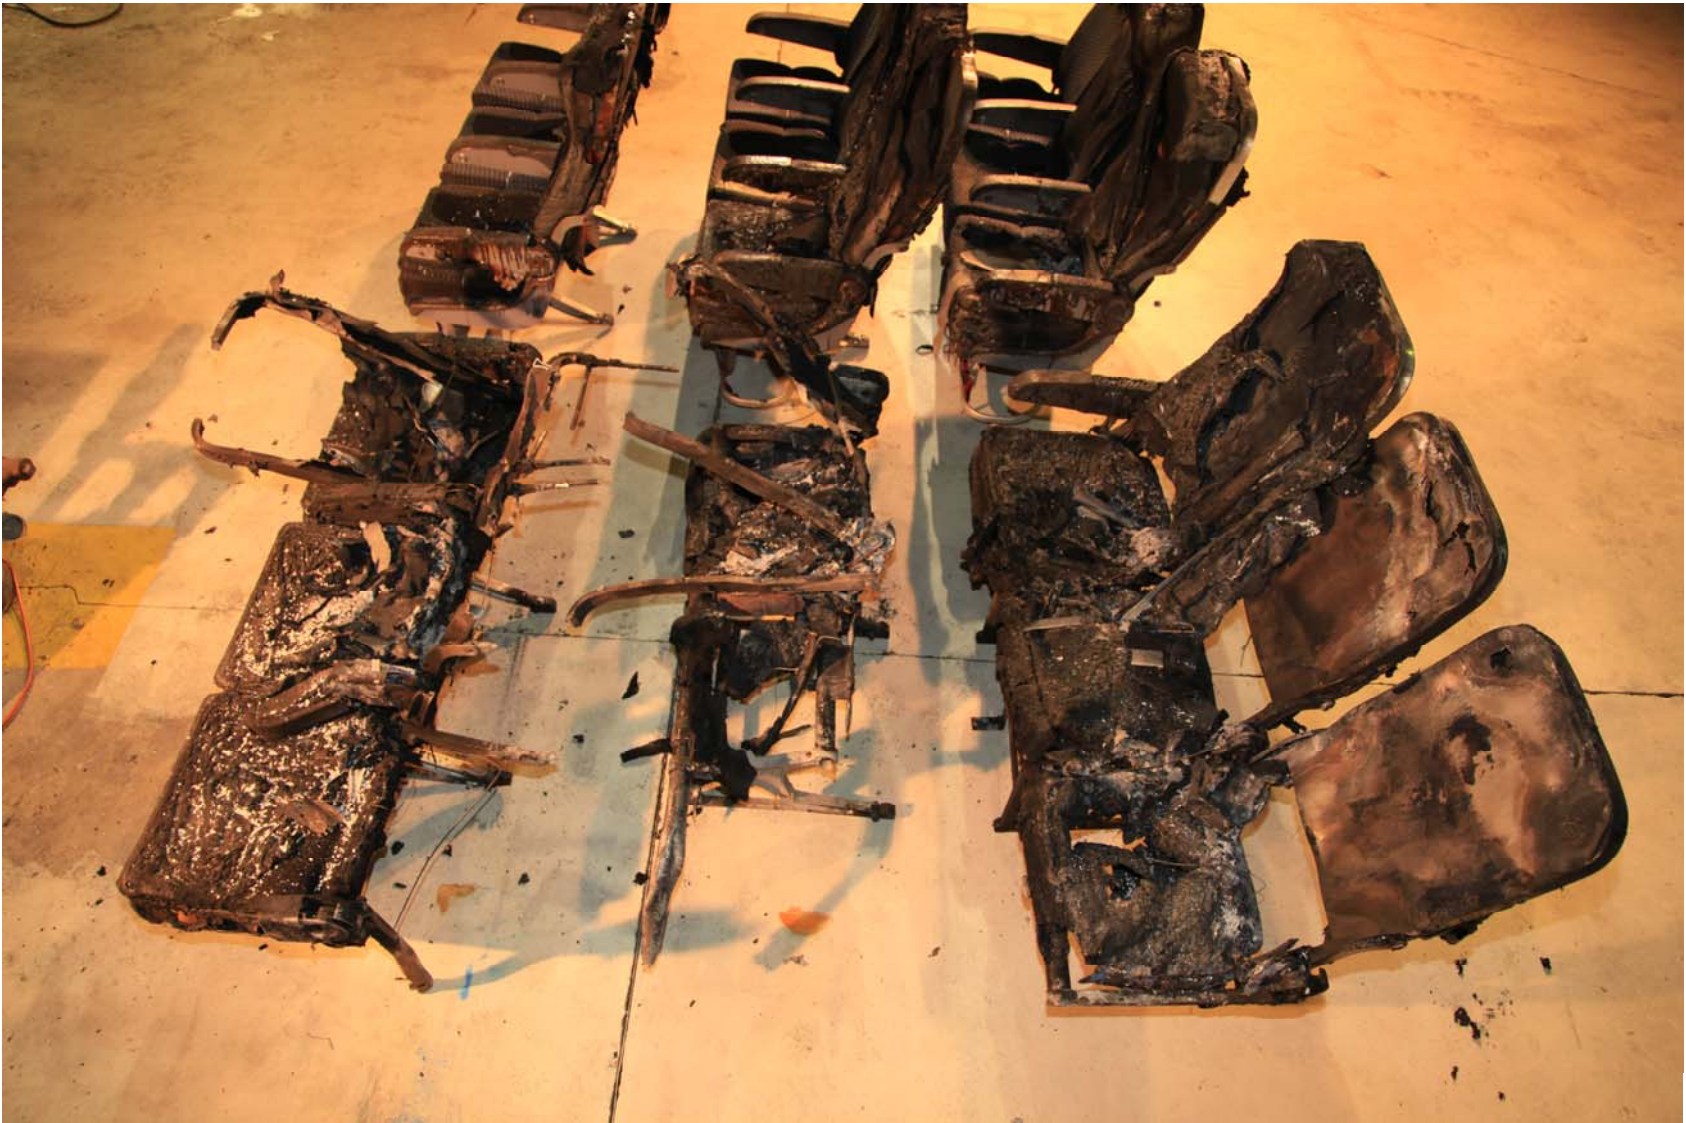
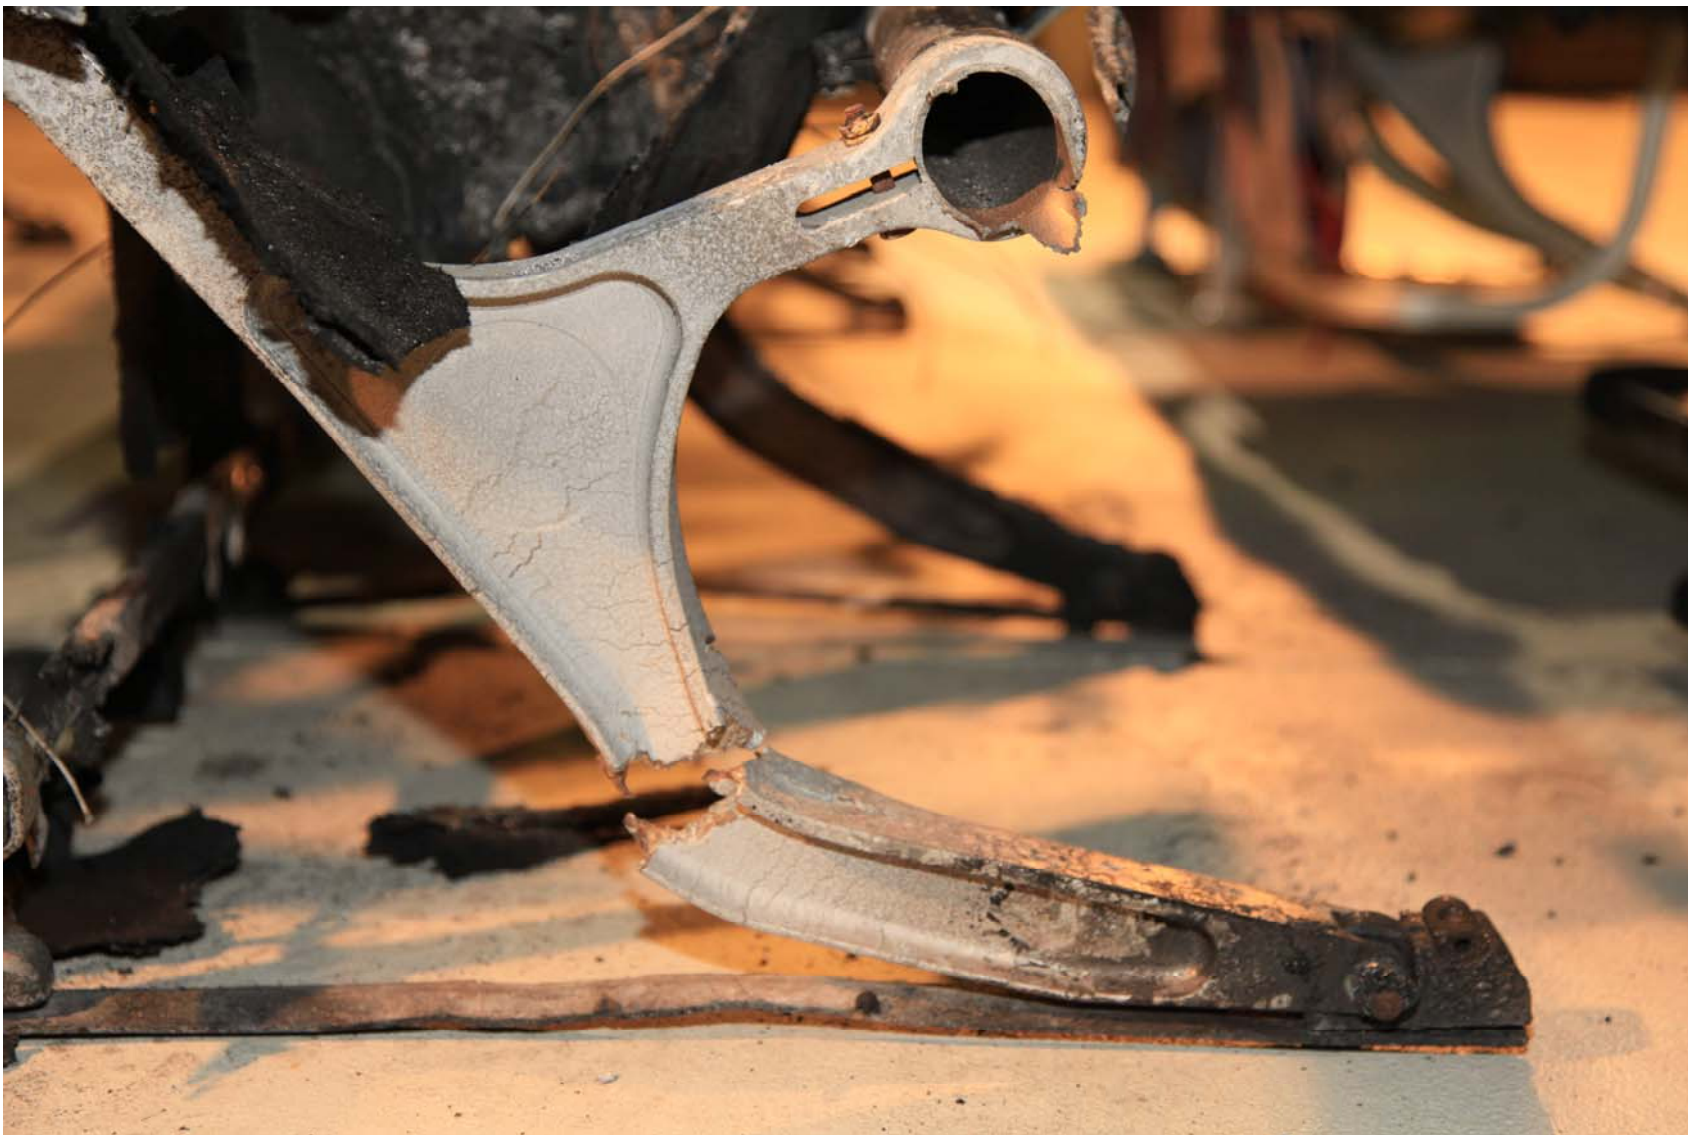
Baseline 3 Test Results

Summary of Findings

Pan fire extinguished at 5 minutes using AFFF

Interior fire extinguished at 10 minutes using water

Incapacitation reached in 4 min 10 sec at forward location

Seat backs (cushions, covers, plastics) mostly consumed on port side; largely intact on starboard side

Seat bottom cushions on port side heavily involved in fire

Increased melting of primary seat structure compared to previous baseline tests

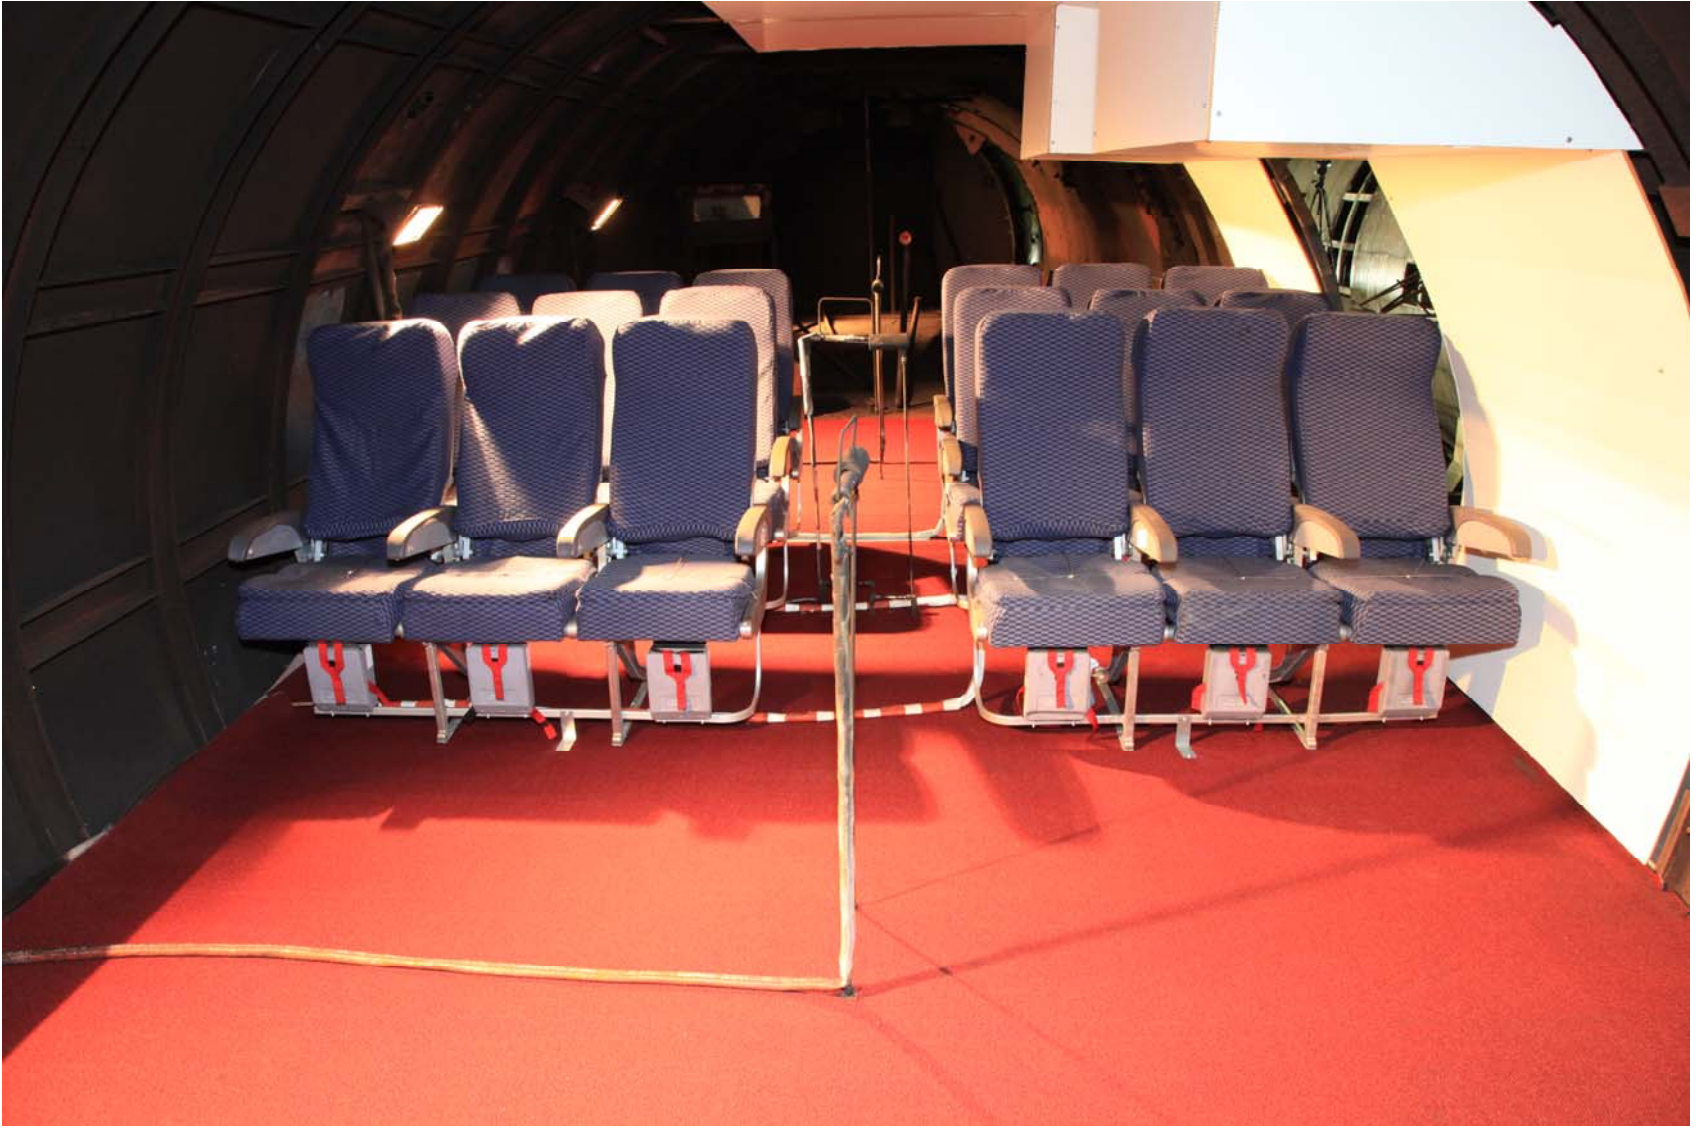
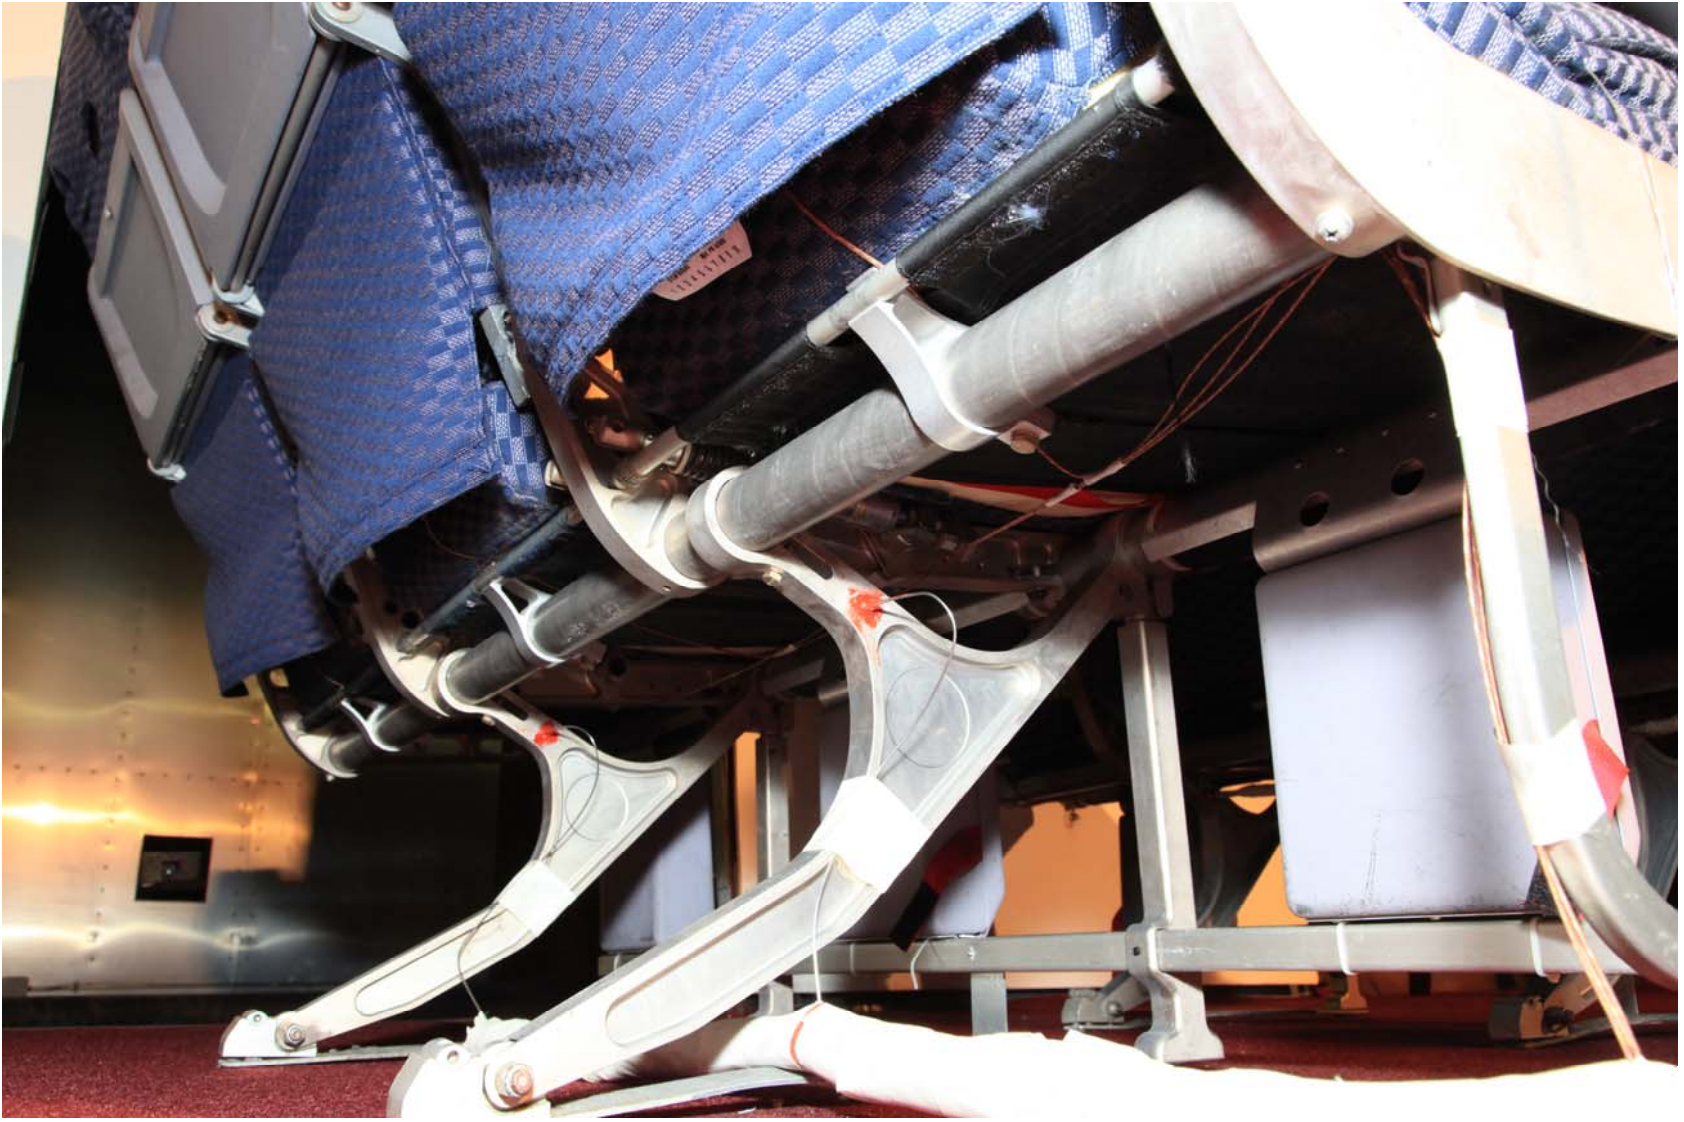
WE-43 Test Configuration

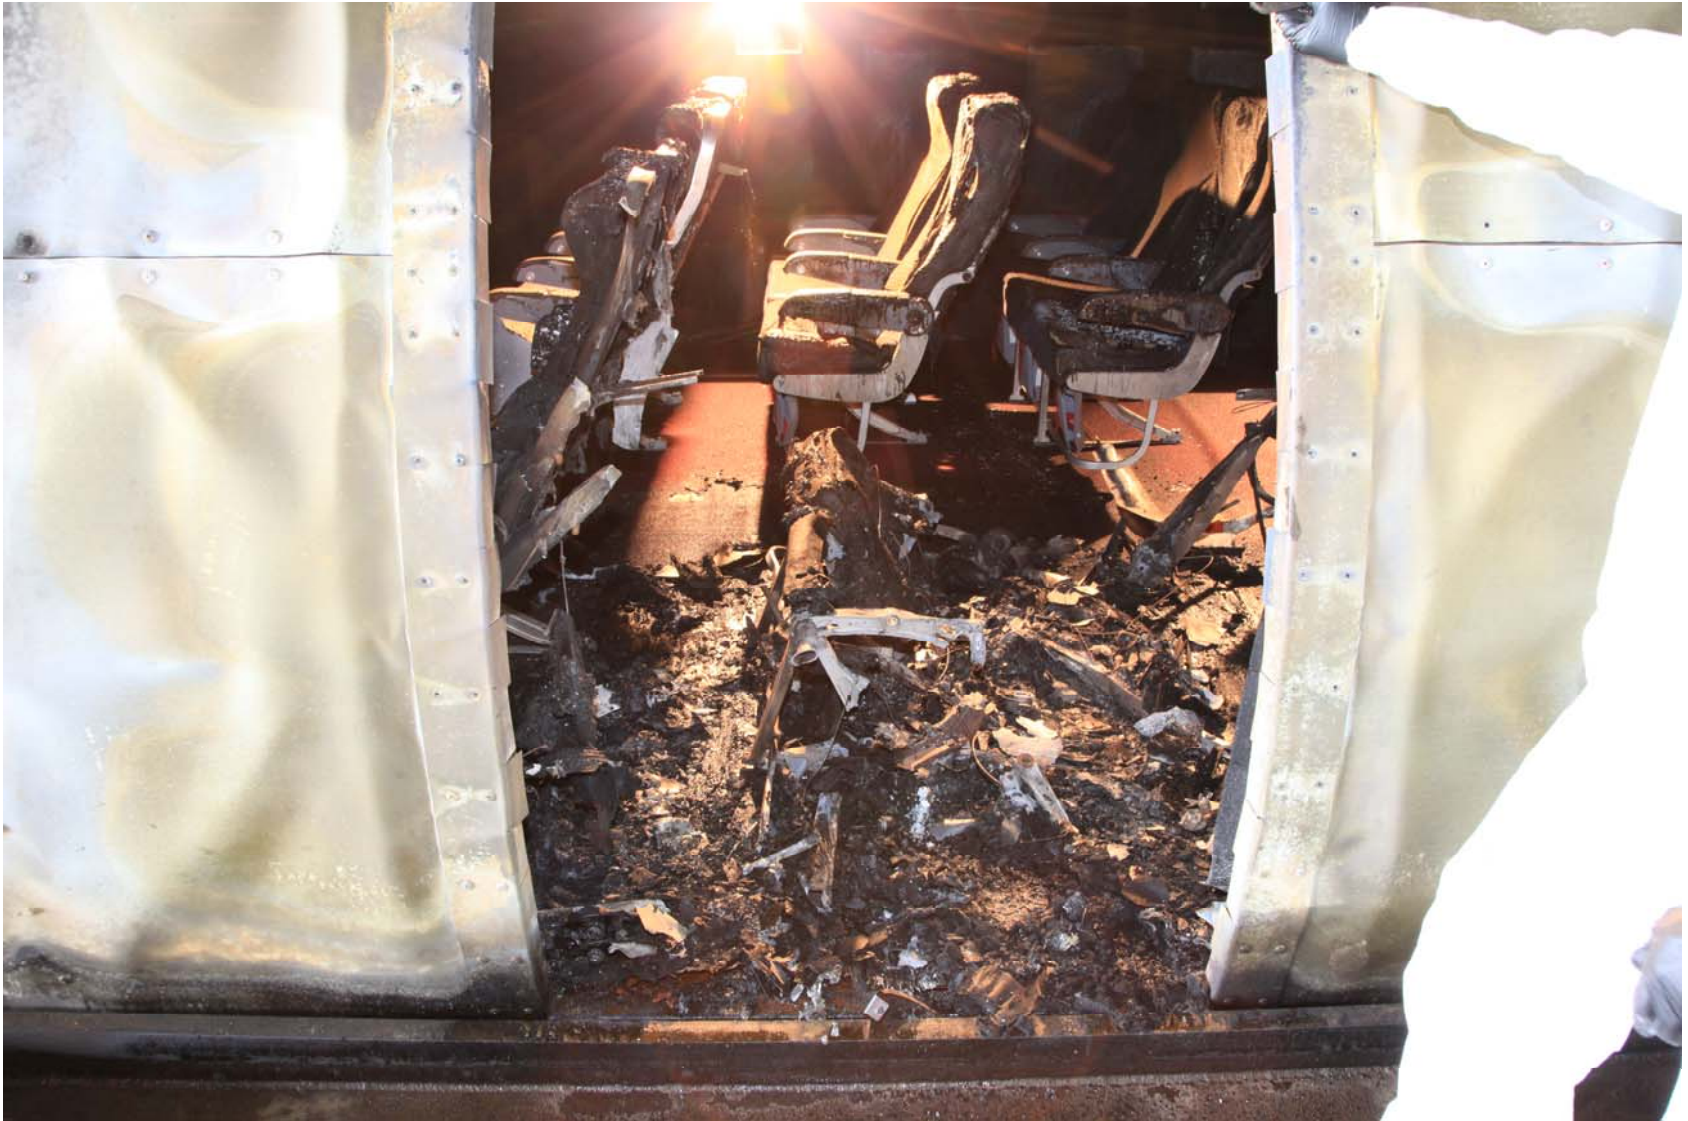
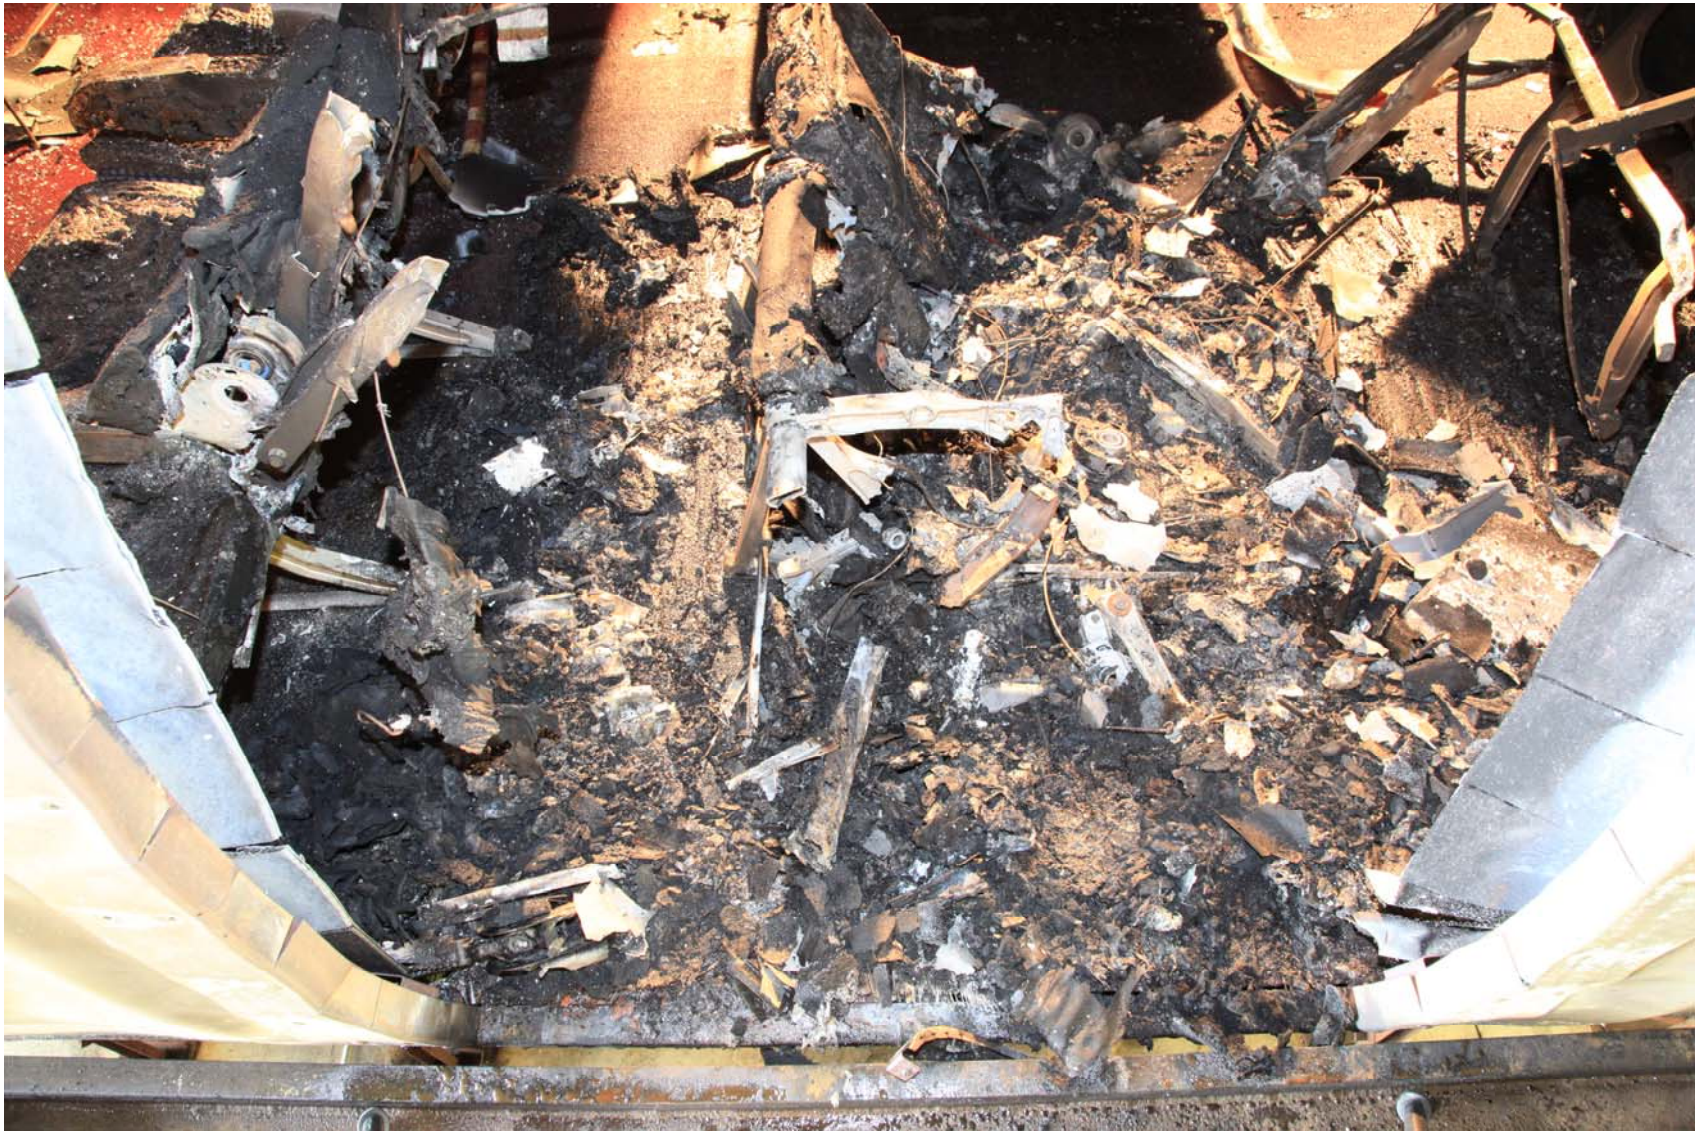
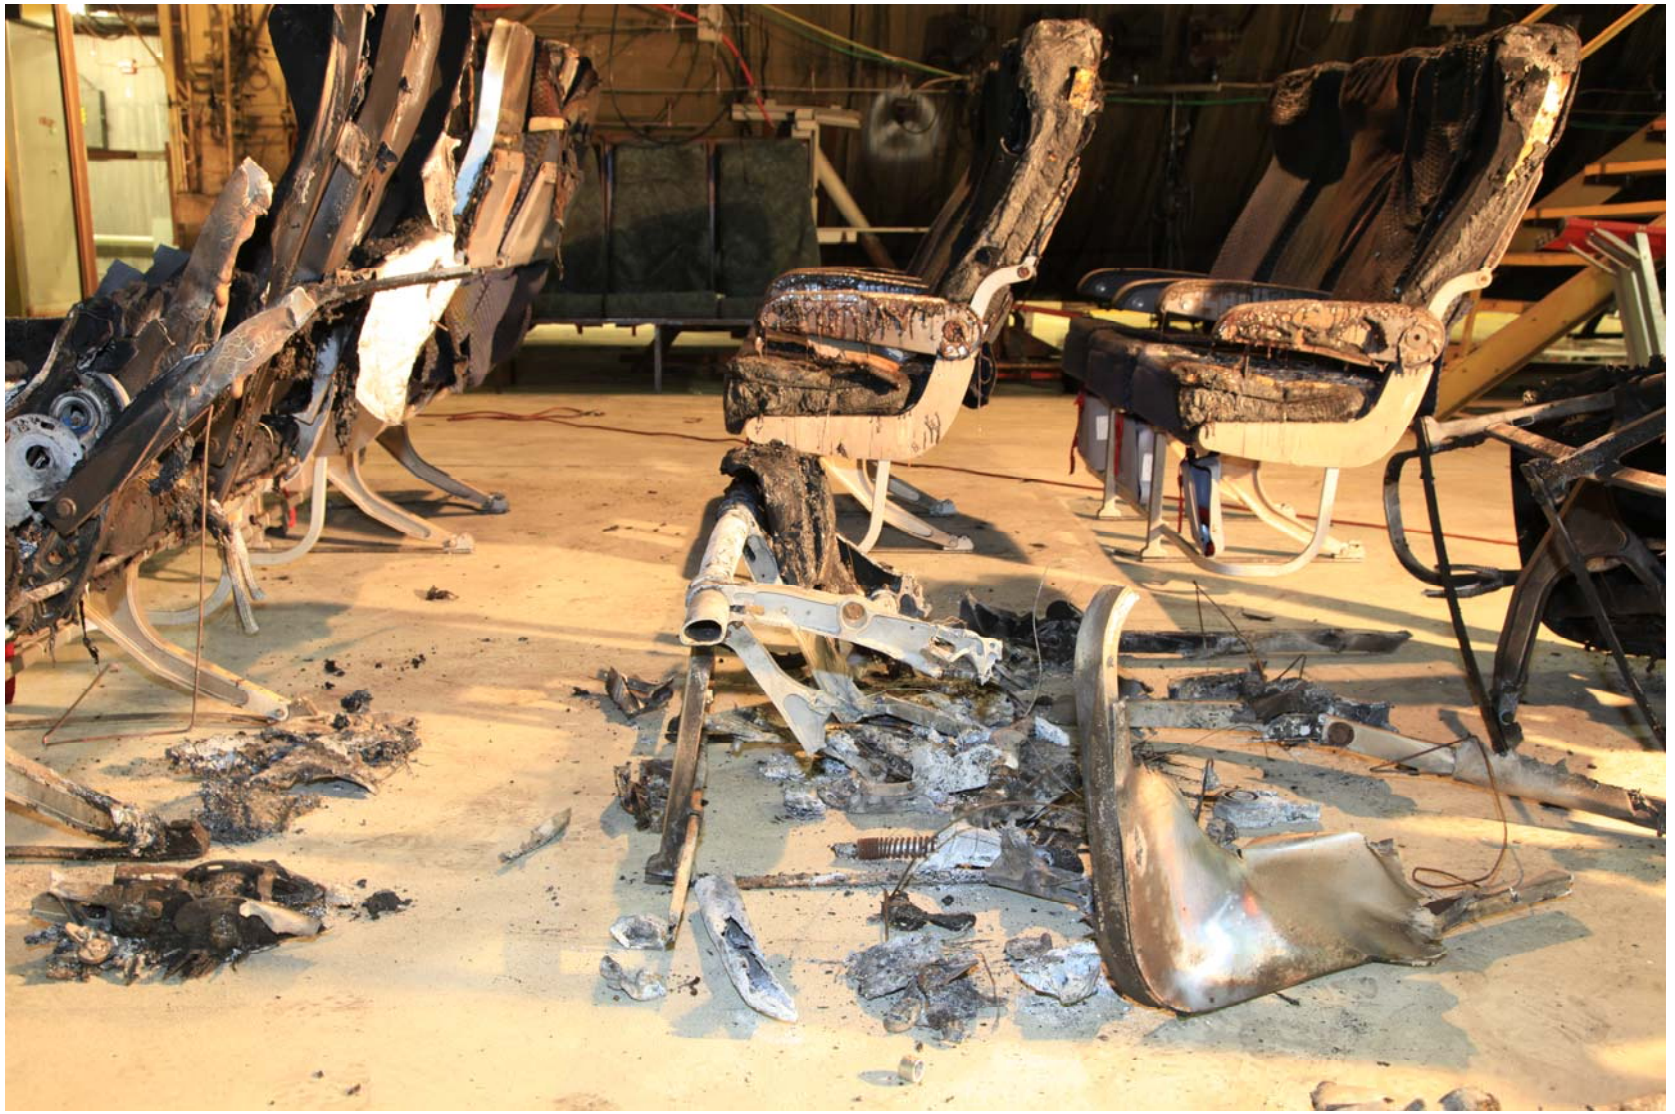
WE-43 Test Results

Summary of Findings

Pan fire extinguished at 5 minutes using AFFF

Interior fire extinguished at 10 minutes using water

Incapacitation reached in 4 min 38 sec at forward location

Seat backs (cushions, covers, plastics) mostly consumed on port side; largely intact on starboard side

Seat bottom cushions on port side heavily involved in fire

Increased melting of primary seat structure compared to baseline 3 test
