**Federal Aviation
Administration**

Update on Flammability Testing of Magnesium Alloy Components

By: Tim Marker, FAA Technical Center

Date: June 23, 2010

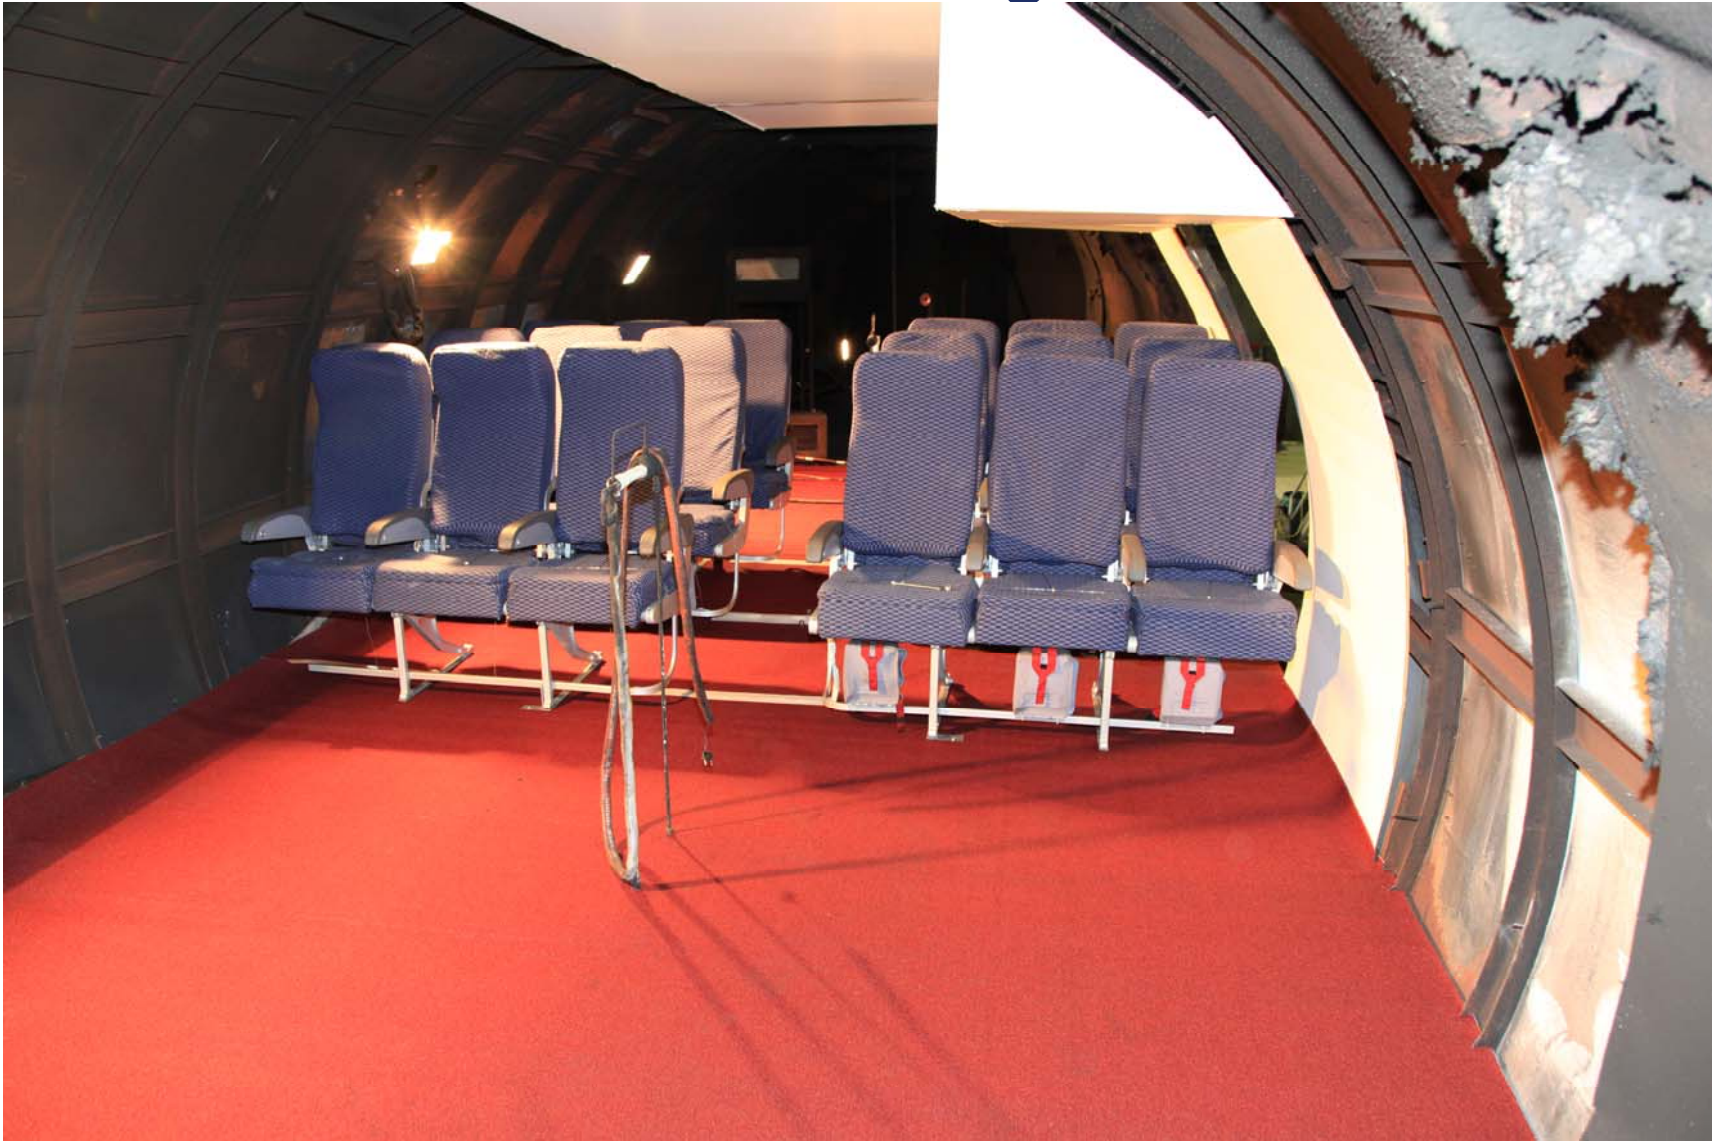
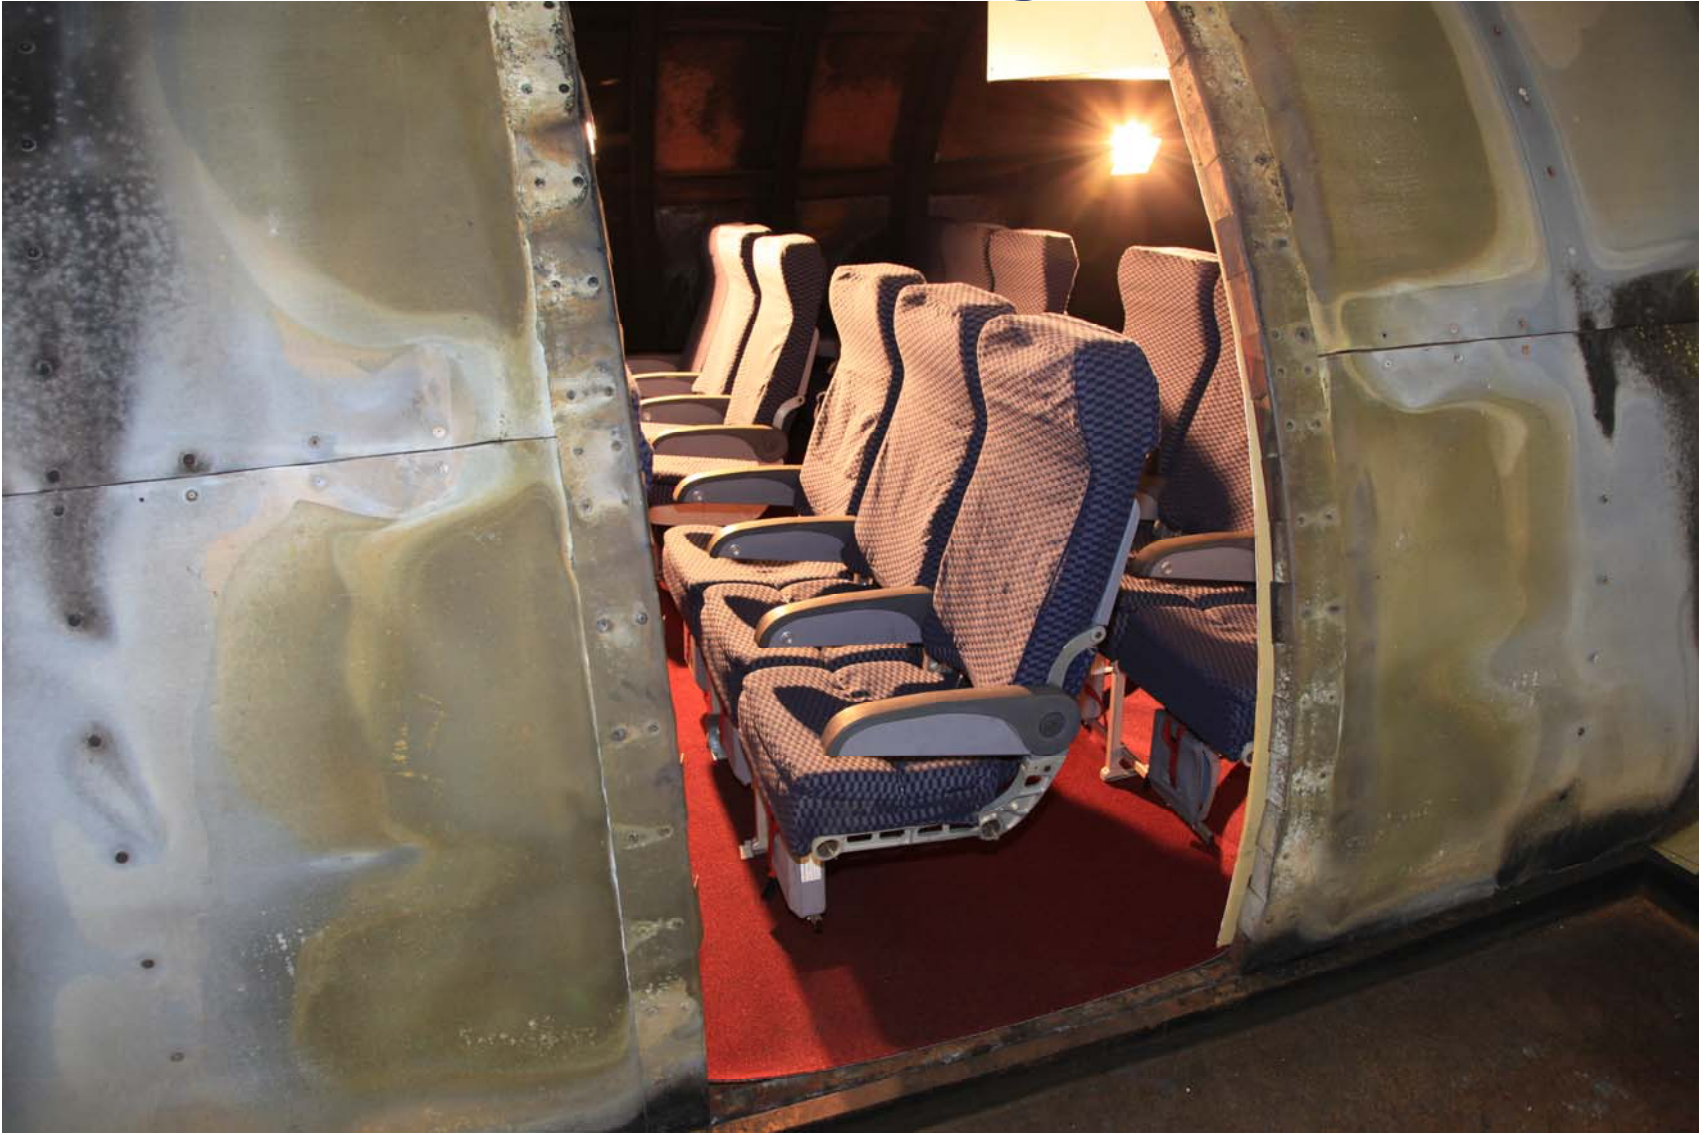
AZ-31 Test Configuration

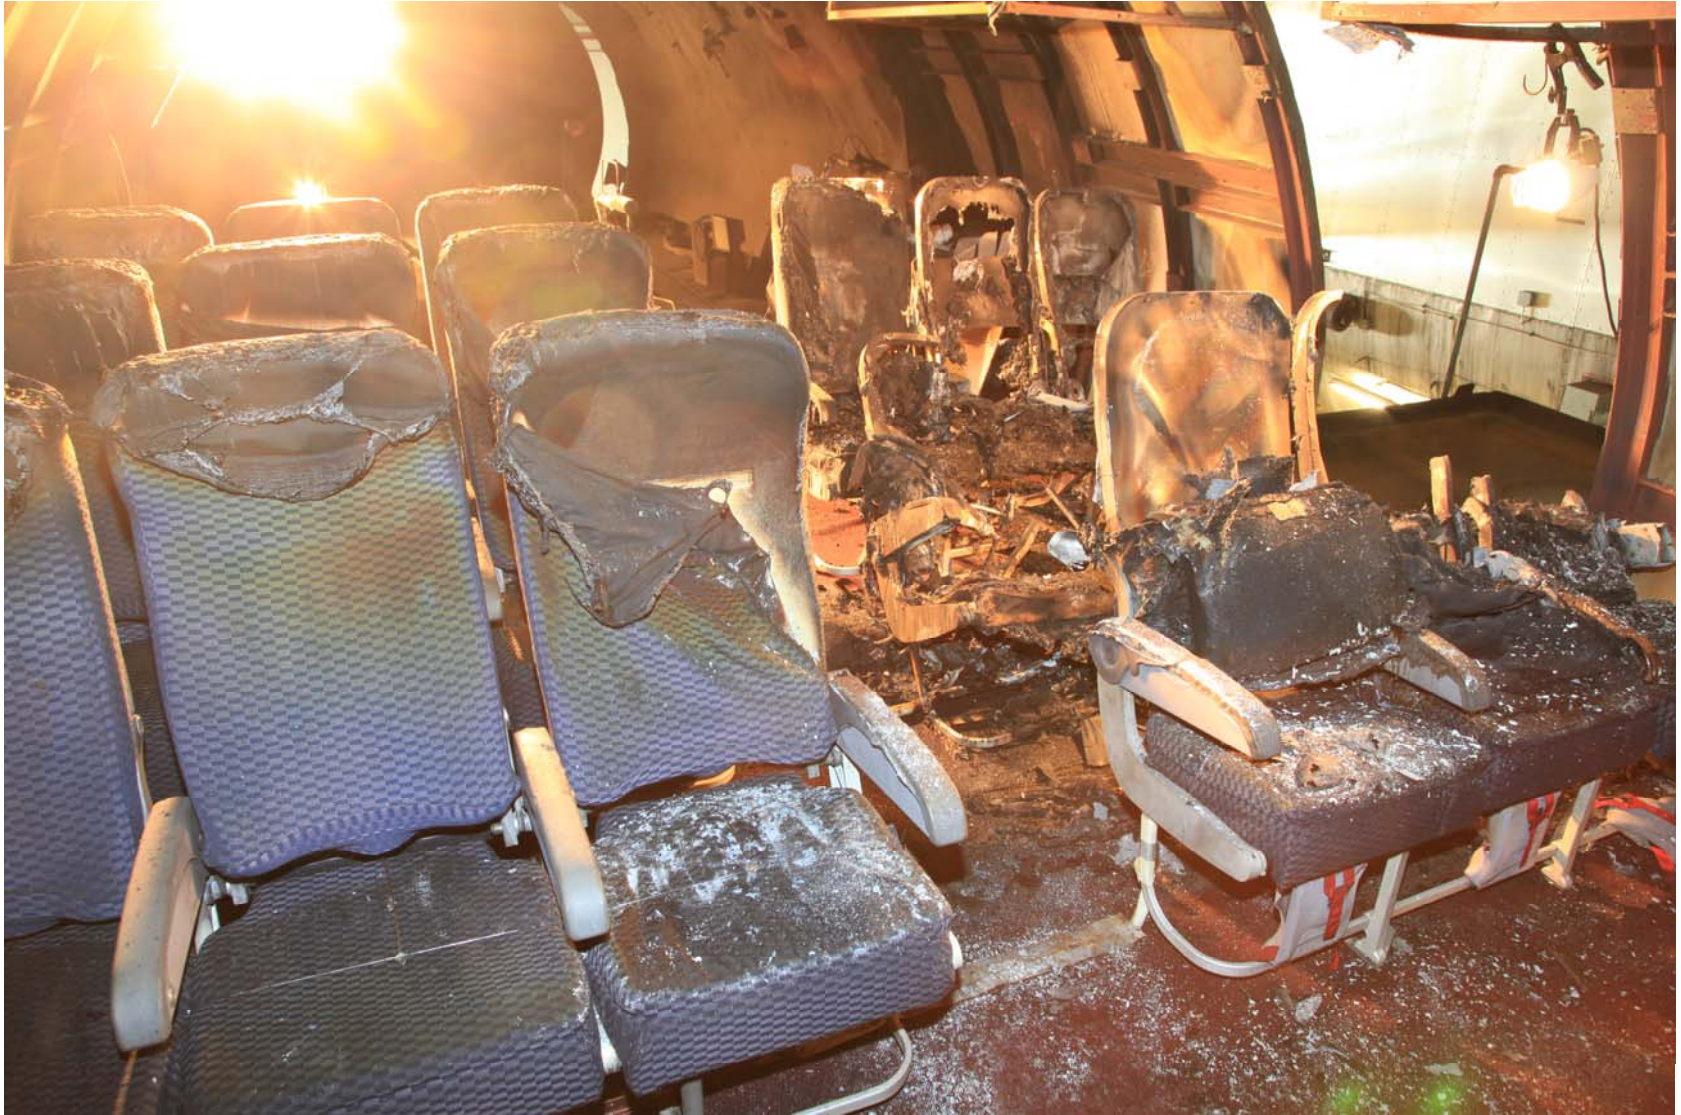
AZ-31 Test Results

Summary of Findings

Pan fire extinguished at 5 minutes using AFFF

Interior fire extinguished at 10 minutes using water

Incapacitation reached in 4 min 33 sec at forward location

Seat backs (cushions, covers, plastics) mostly consumed on port side; largely intact on starboard side

Seat bottom cushions on port side heavily involved in fire

Increased melting of primary seat structure compared to baseline 3 test

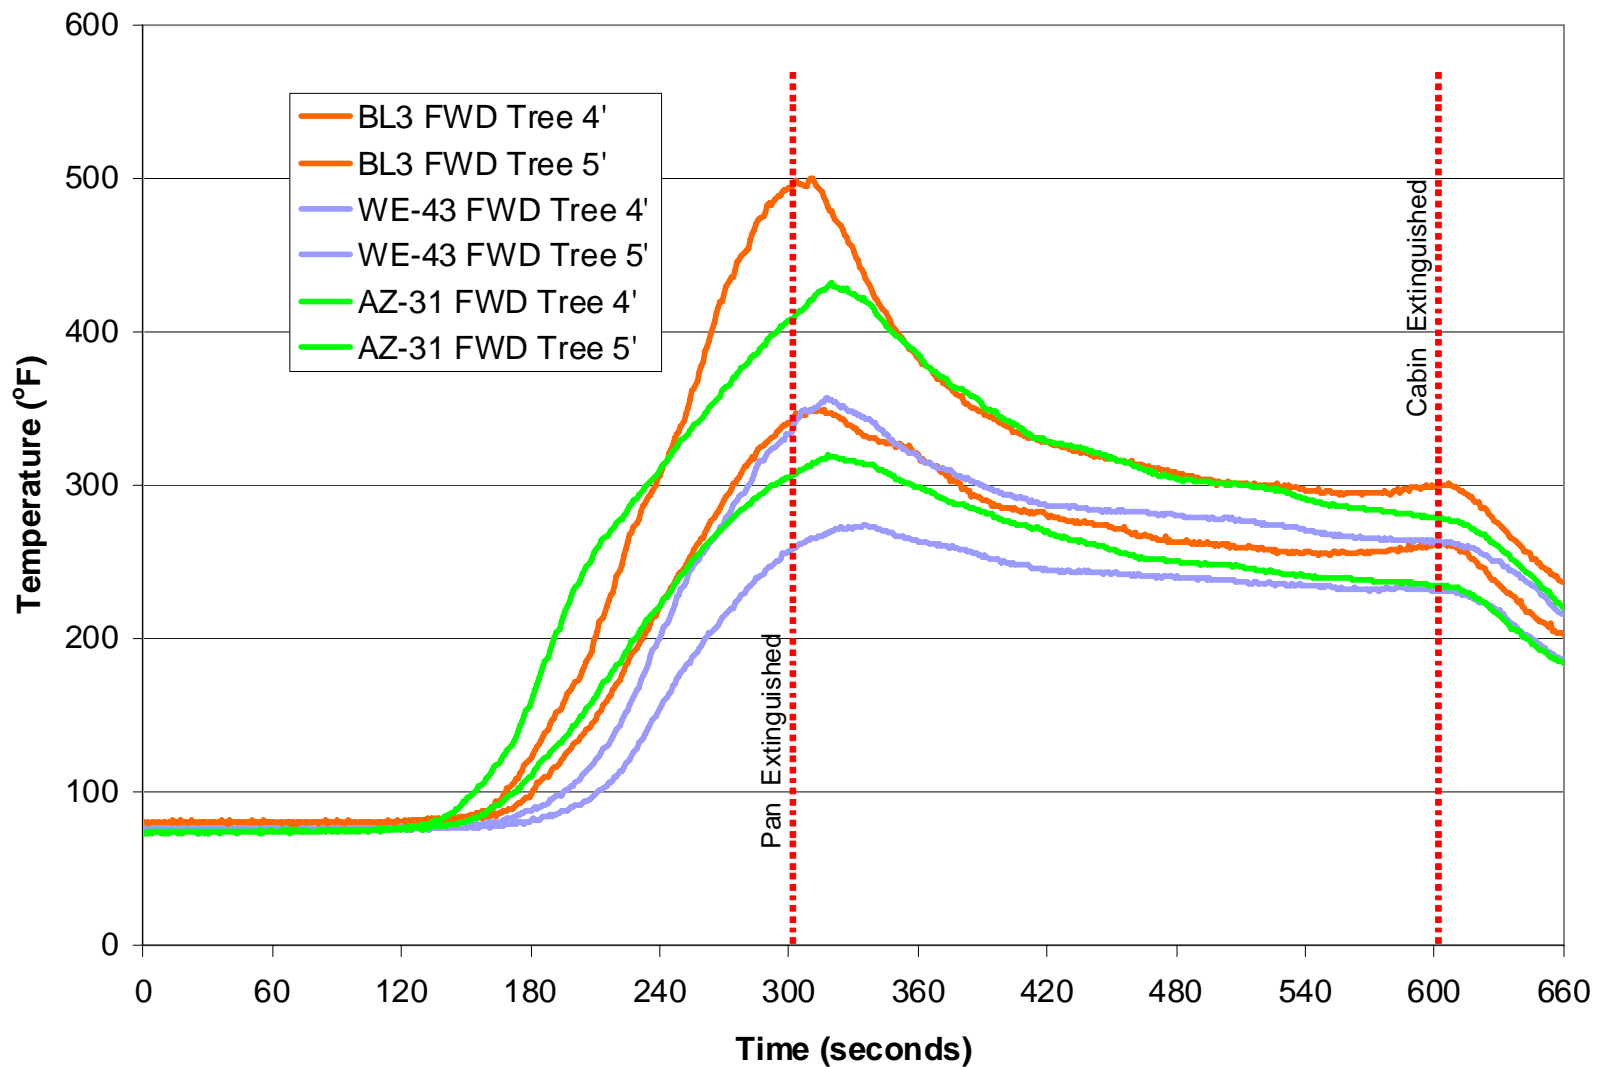
Test Comparison Temperature 4' to 5' in Forward Cabin

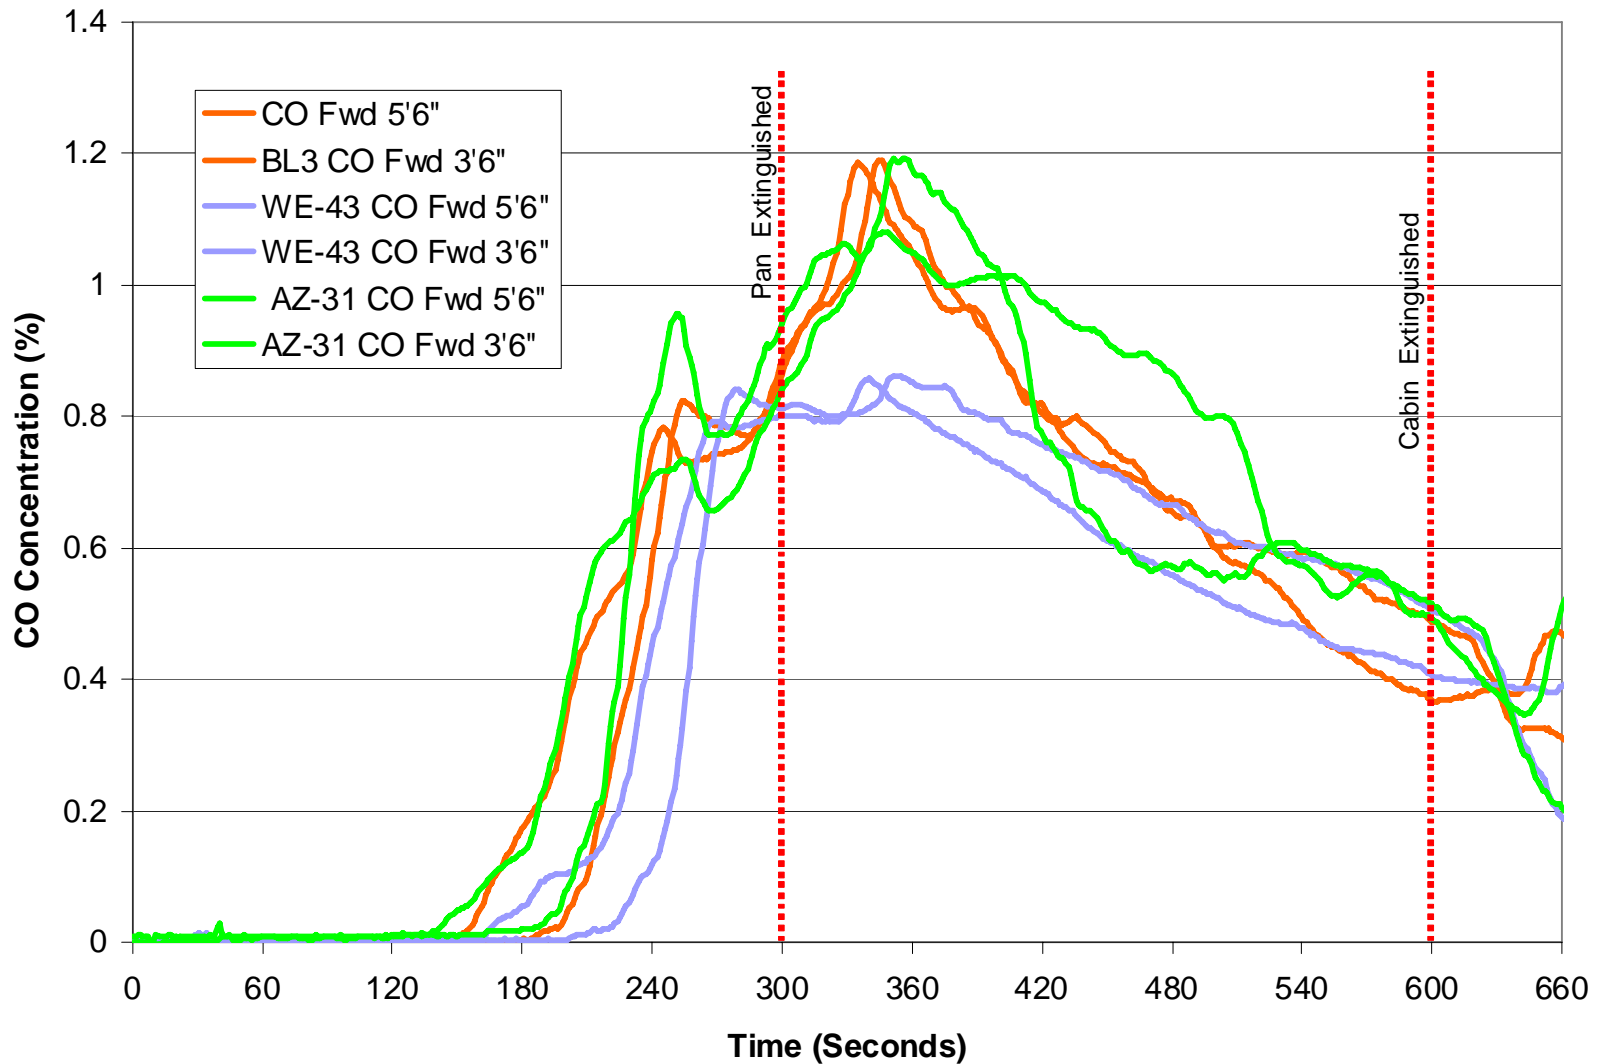
Test Comparison Carbon Monoxide at Forward Cabin

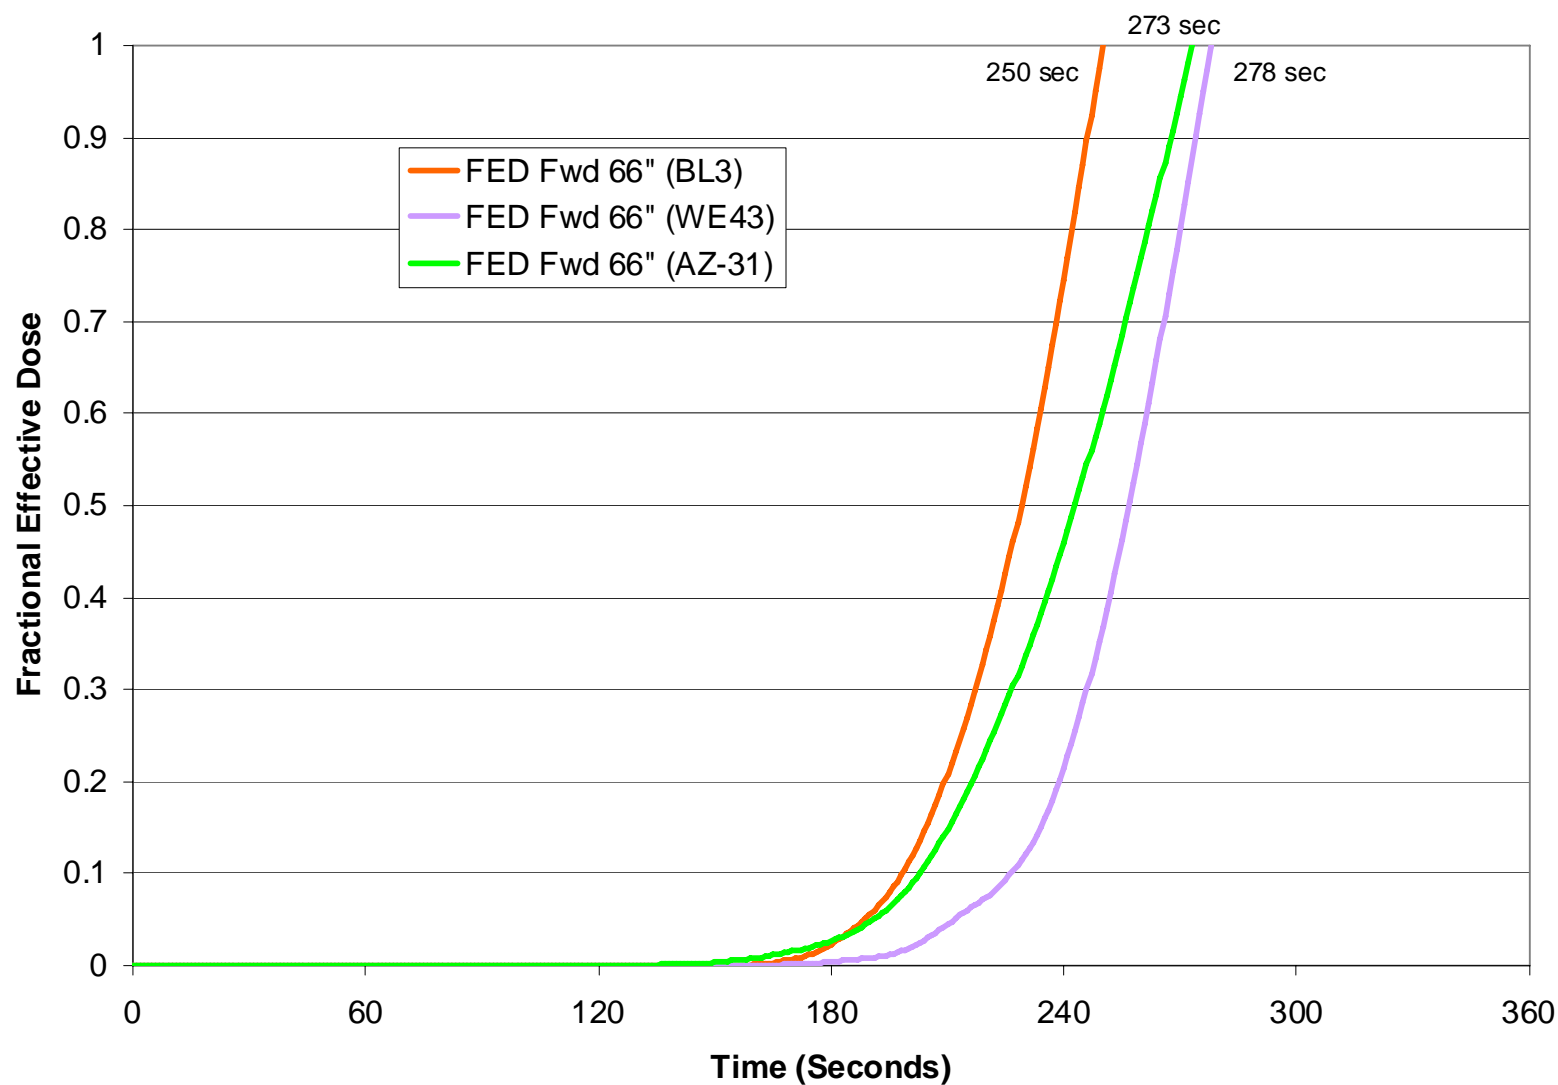
FED Comparison at Forward Station

Incapacitation results very similar for baseline and mag-alloy tests

- slightly better for mag-alloys at forward location
- slightly worse for mag-alloys at mid location
- More severe fire condition caused more rapid incapacitation during “all-mag” tests

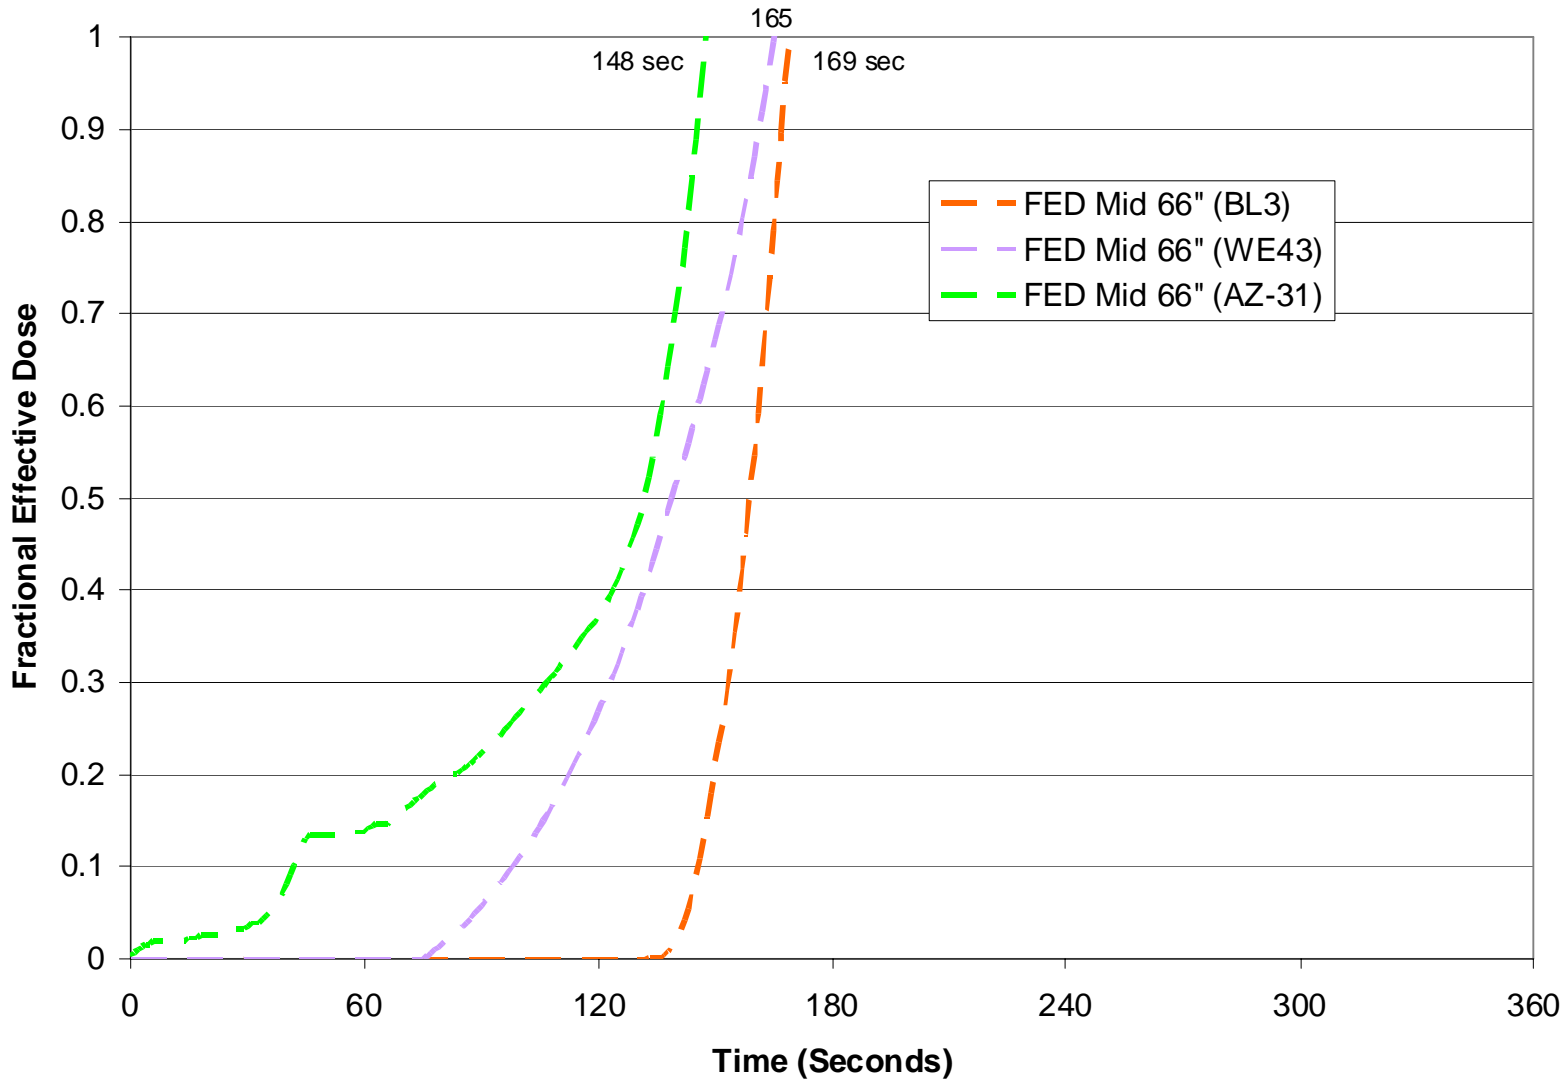
FED Comparison at Mid Station

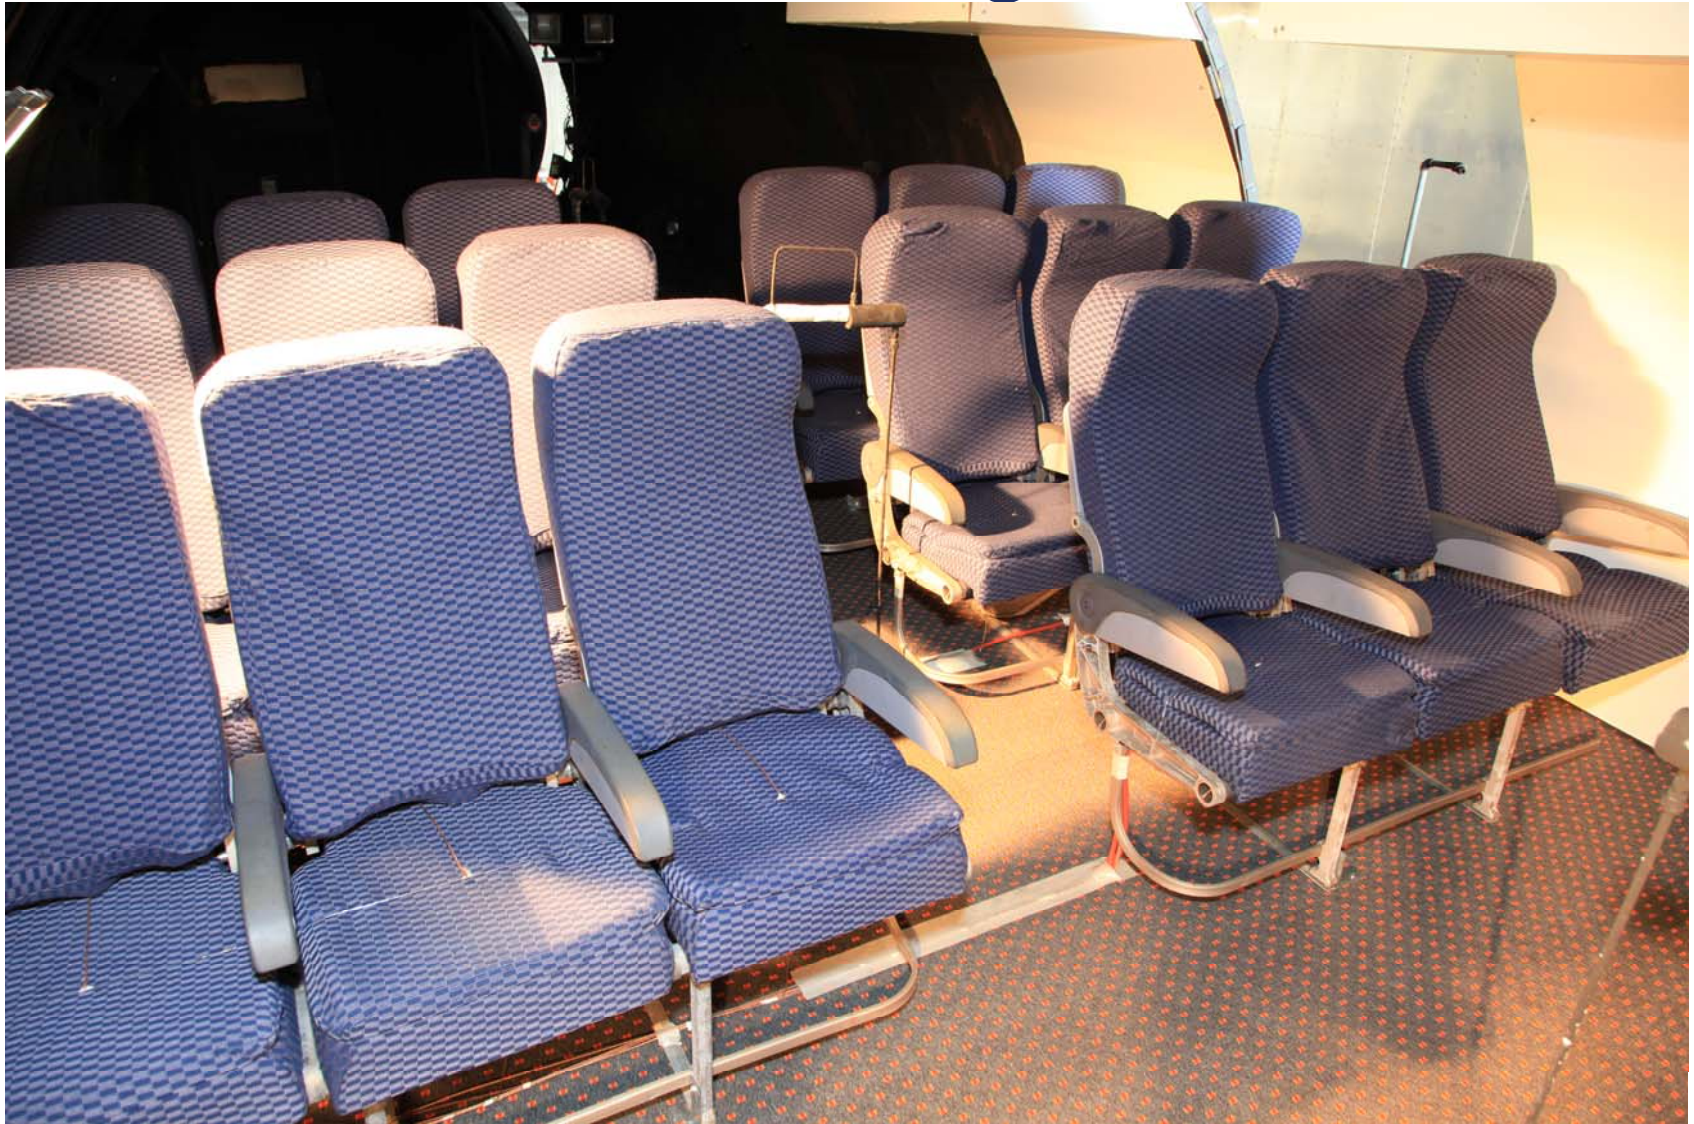
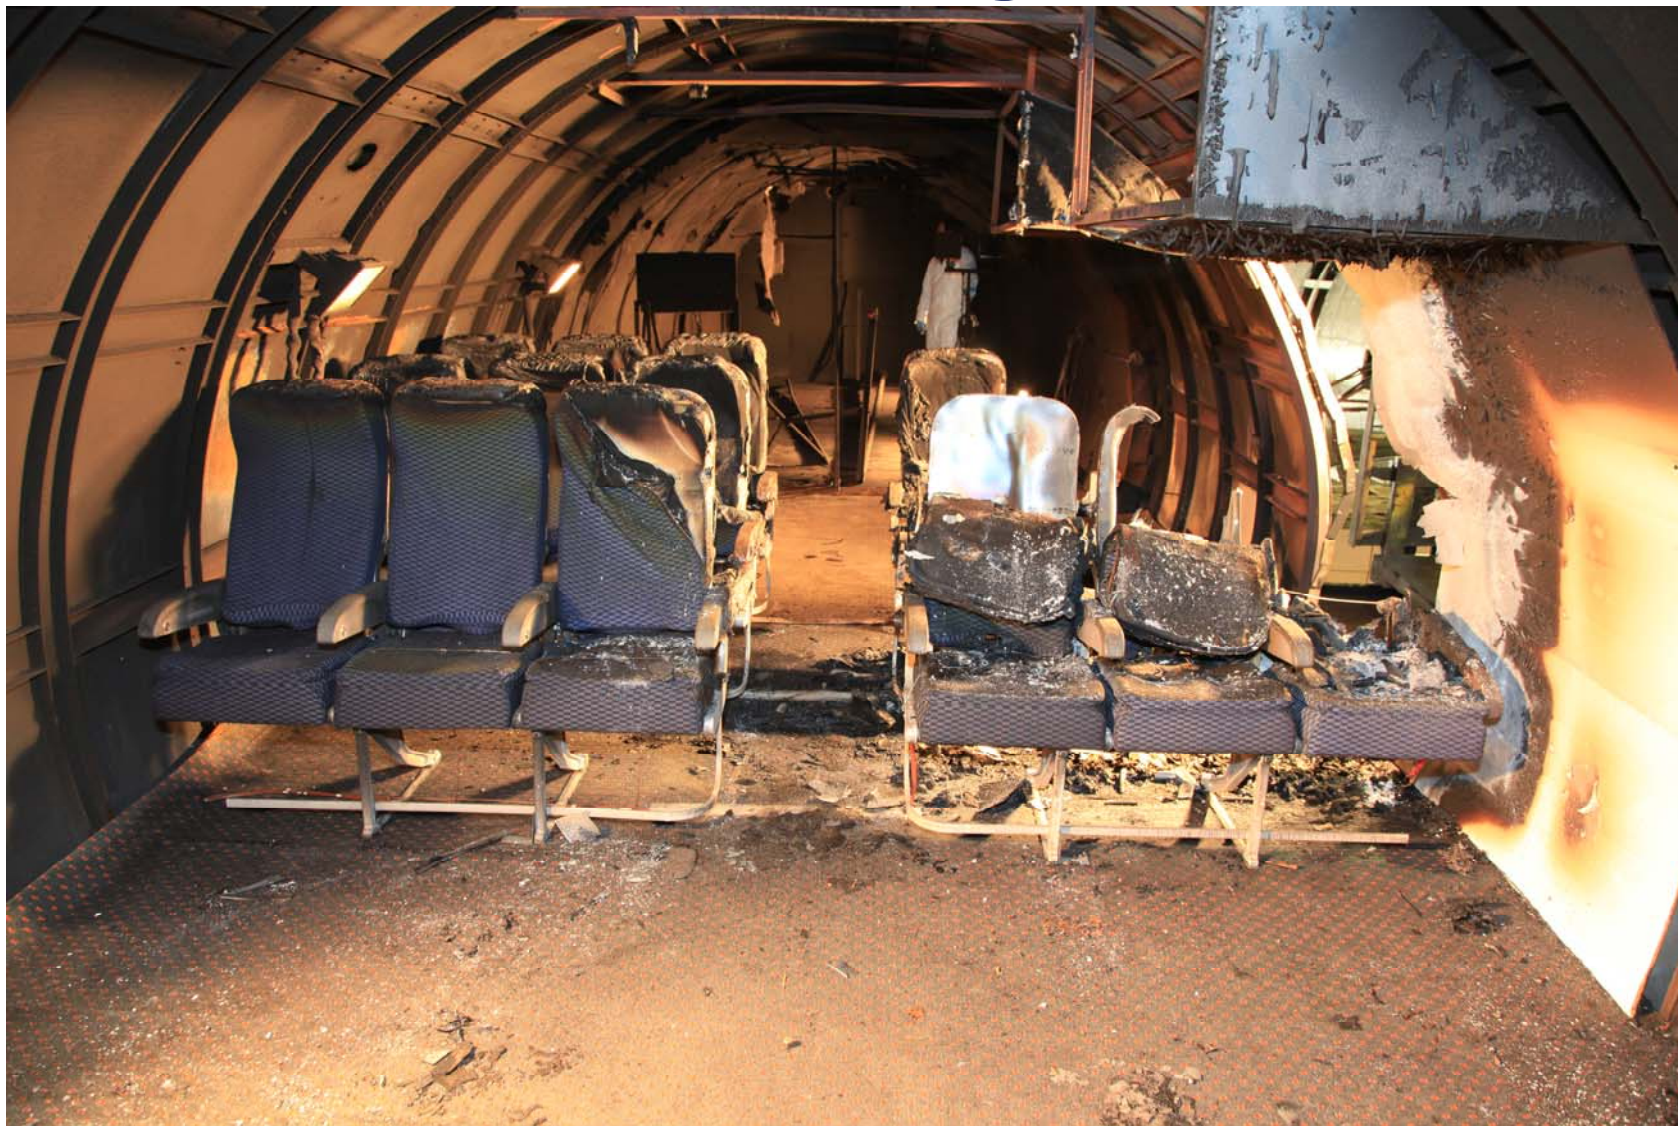
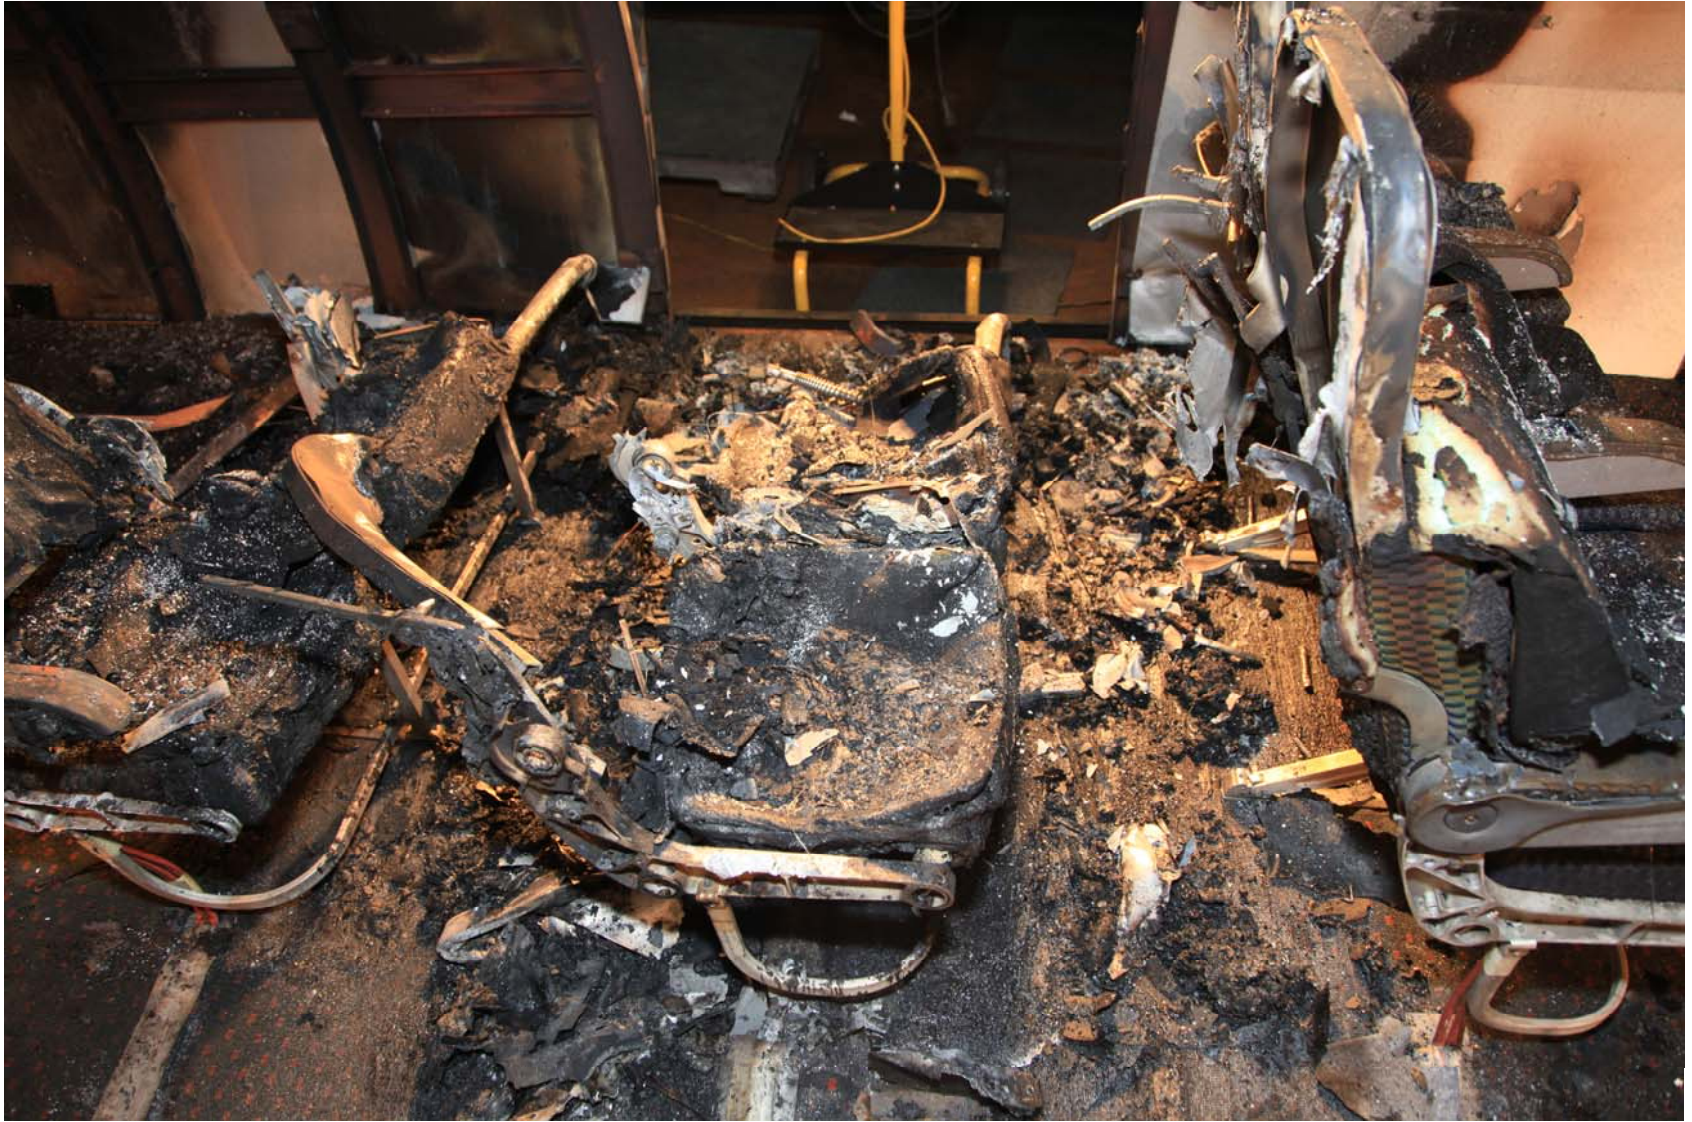
WE-43 All-Mag Test

Conducted test with seats using WE-43 extrusions in back frame and baggage bar on 4/20/10
