**Federal Aviation
Administration**

Update on Flammability Testing of Magnesium Alloy Components

By: Tim Marker, FAA Technical Center

Date: June 23, 2010

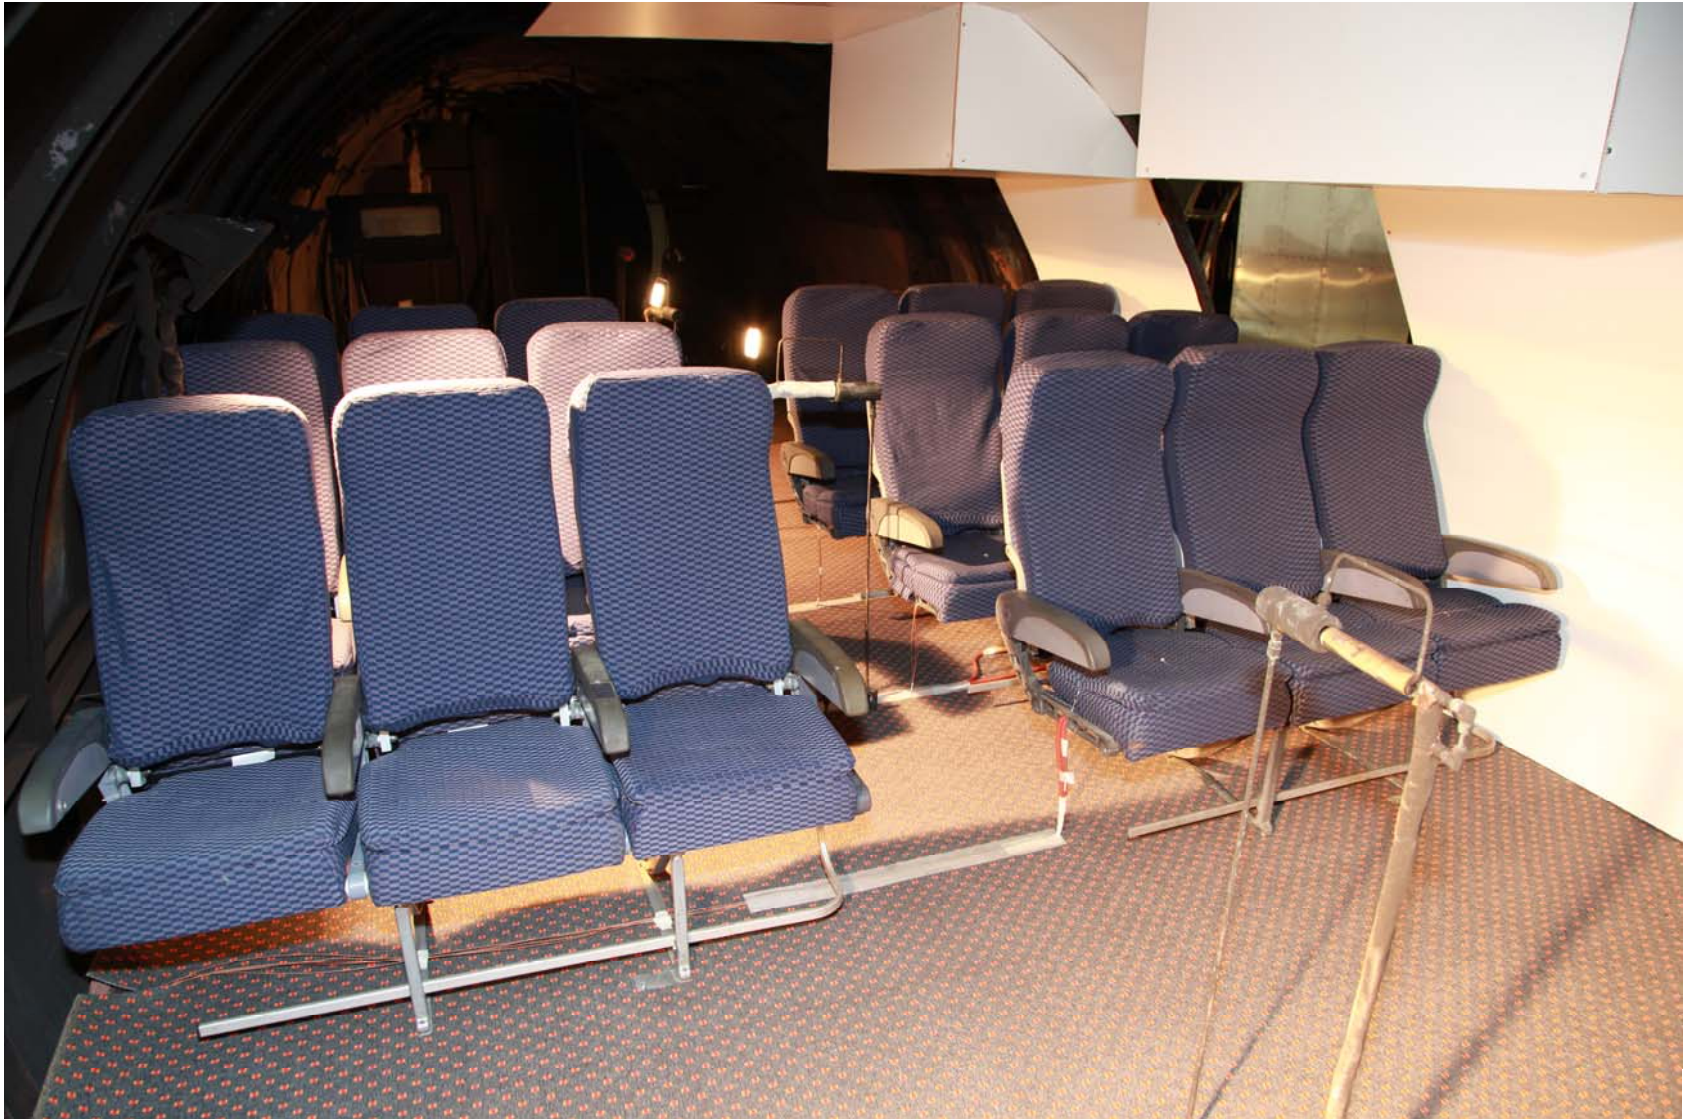
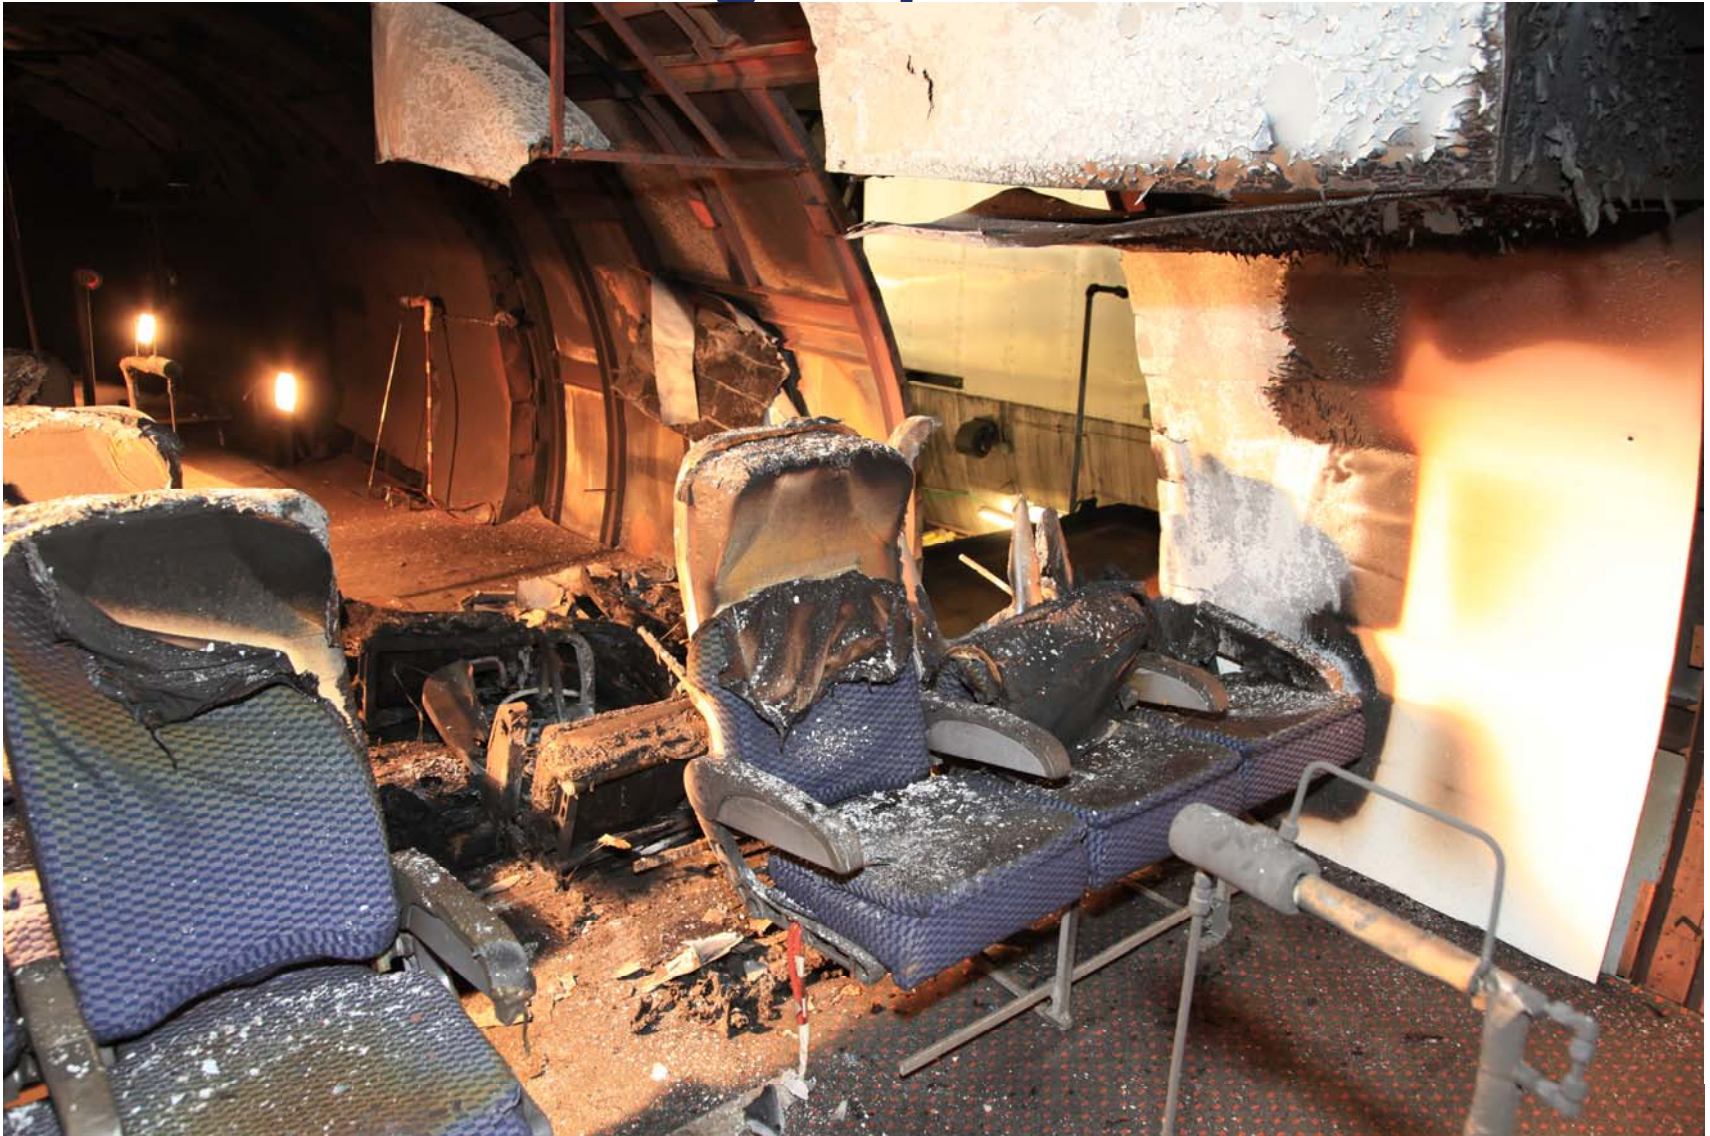
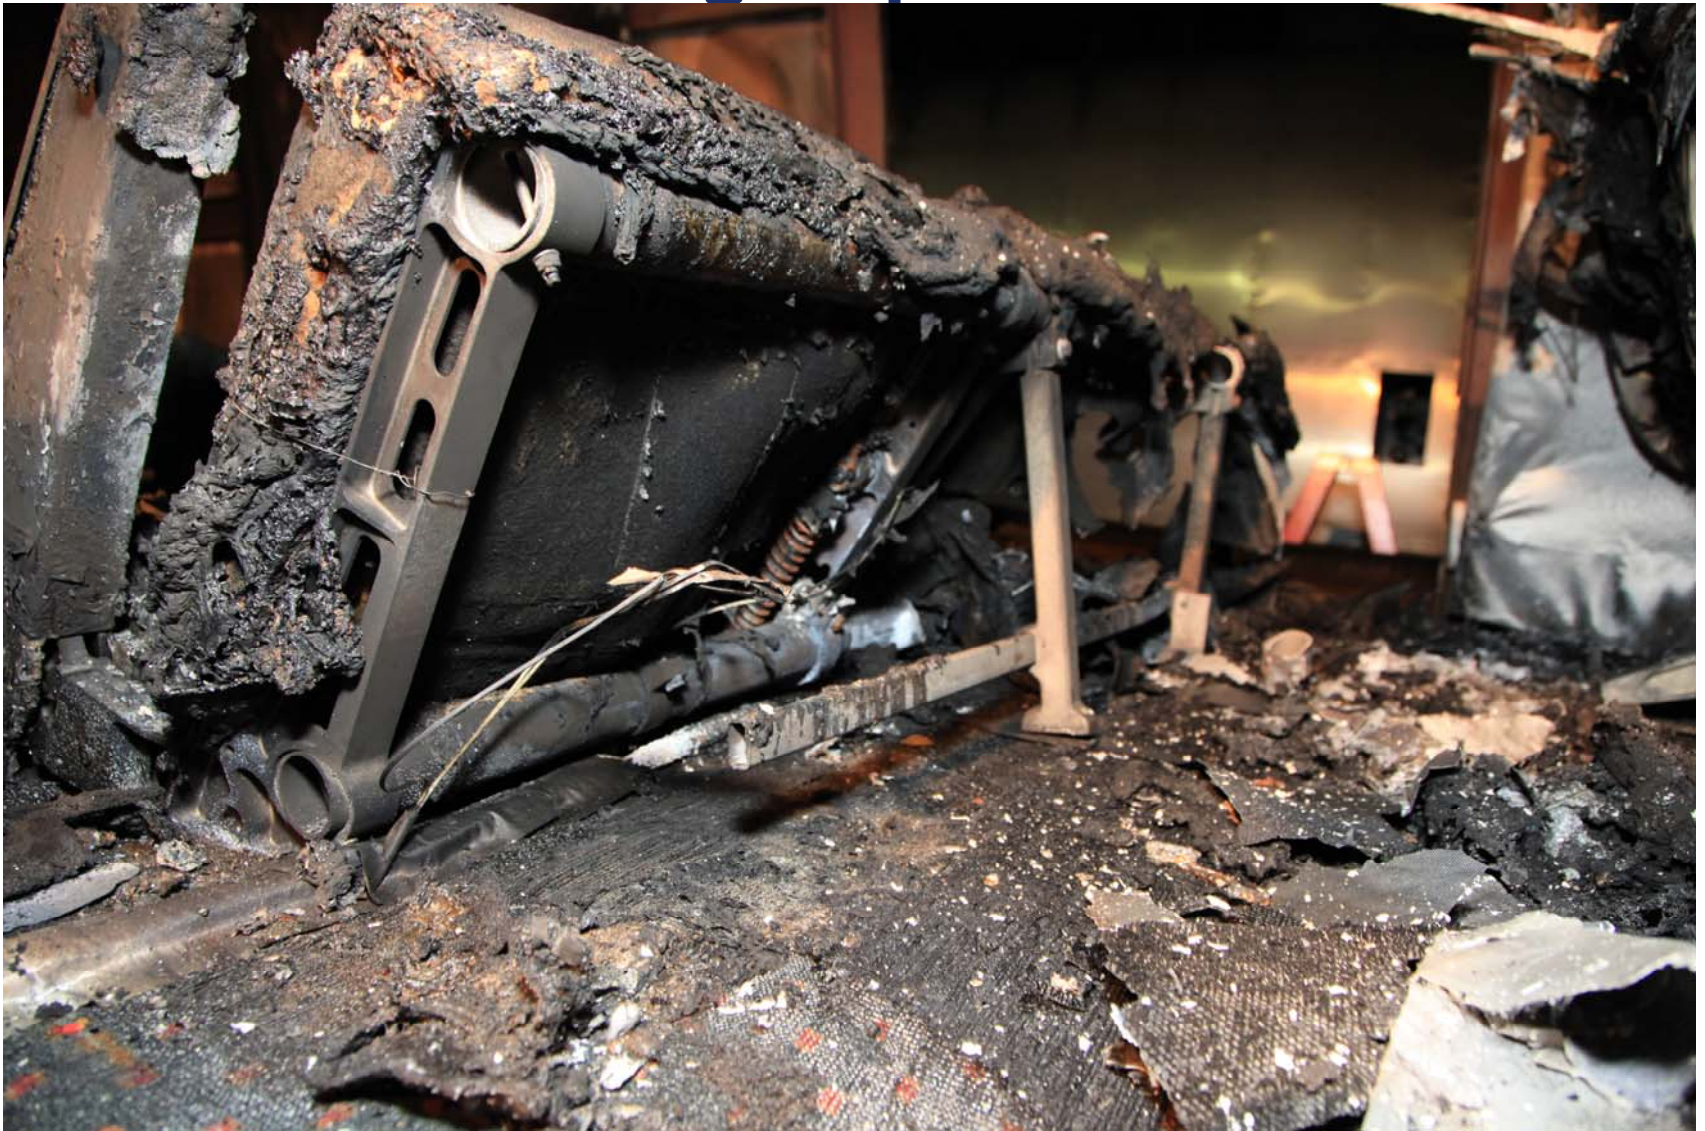
All-Mag Repeat Test

Conducted test with seats using WE-43 extrusions in back frame and baggage bar on 5/13/10 (repeat)

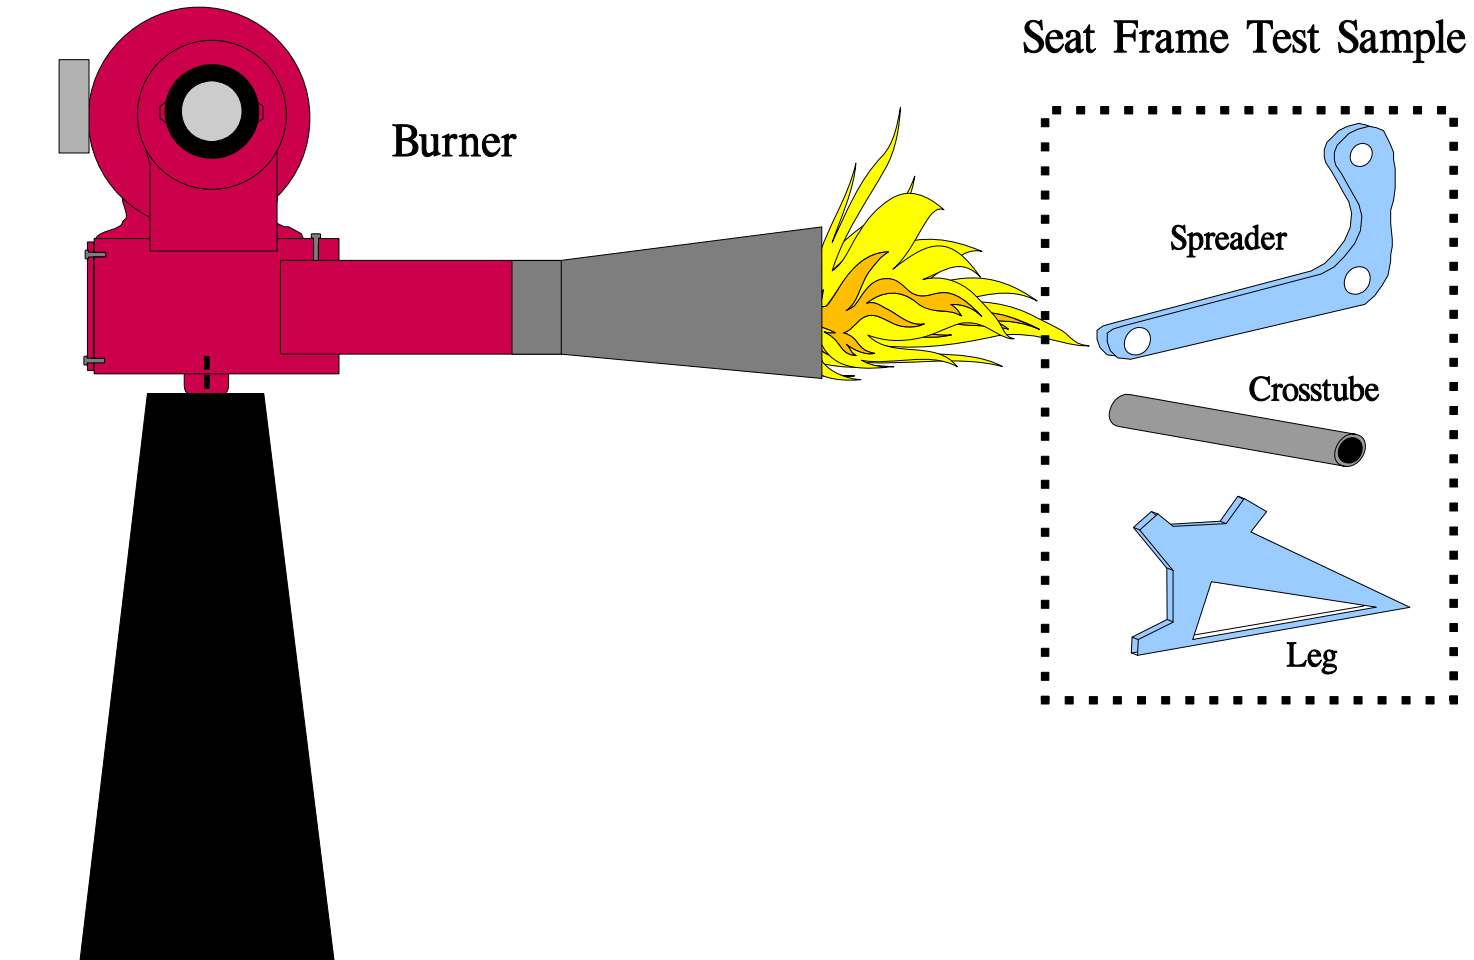
Test Method Development
