Cargo Liner Flame Penetration and Insulation Burnthrough Test Hierarchy Study

Presented to: IAMFTWG

By: Robert I Ochs

Date: March 7 2017

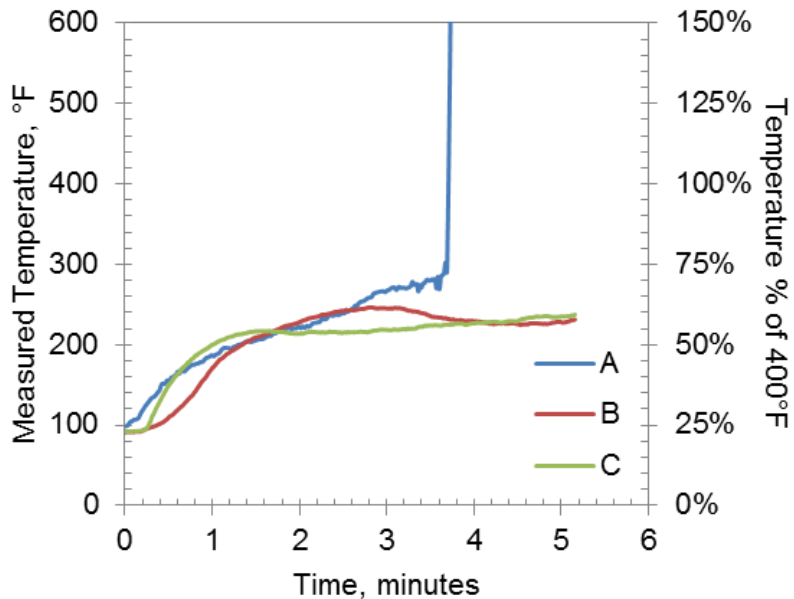
Cargo Test Results

A is a single test
B, C are average of 5 tests

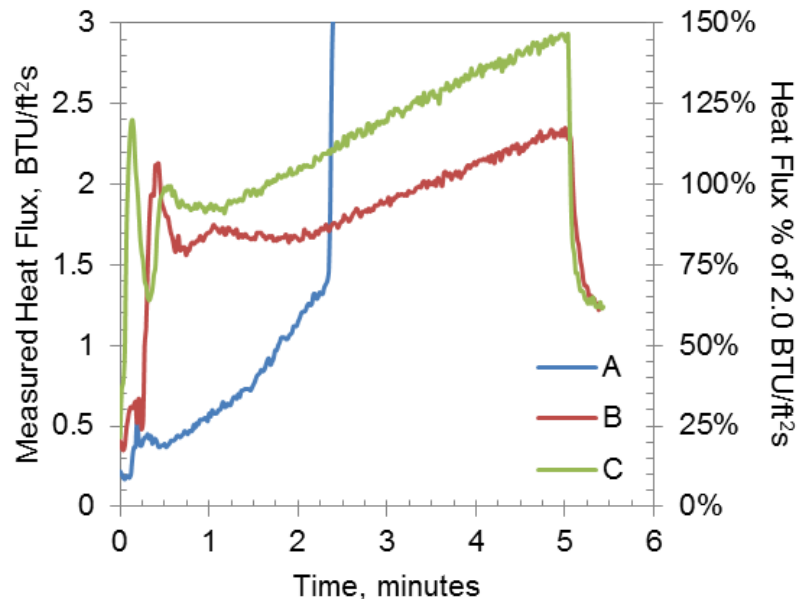
Insulation Test Results (Picture Frame)

A, B, C all individual tests (non-averaged)

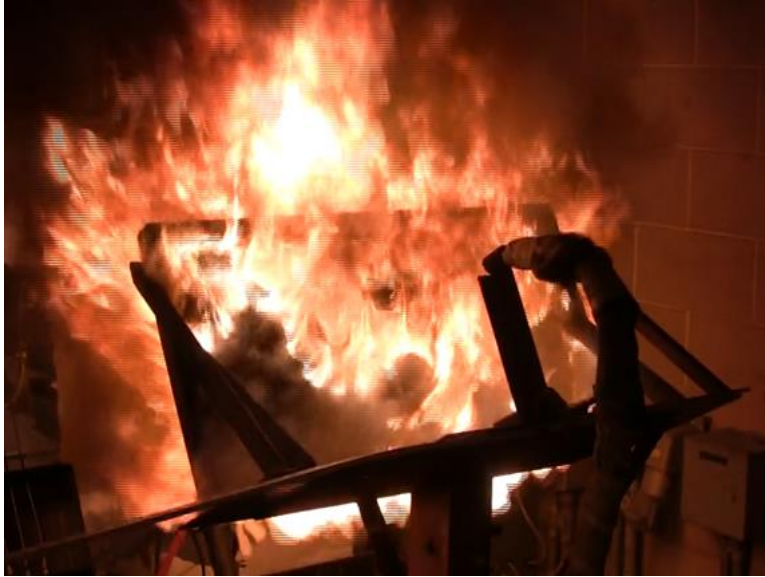
Material B

Insulation Burnthrough Test – Picture Frame

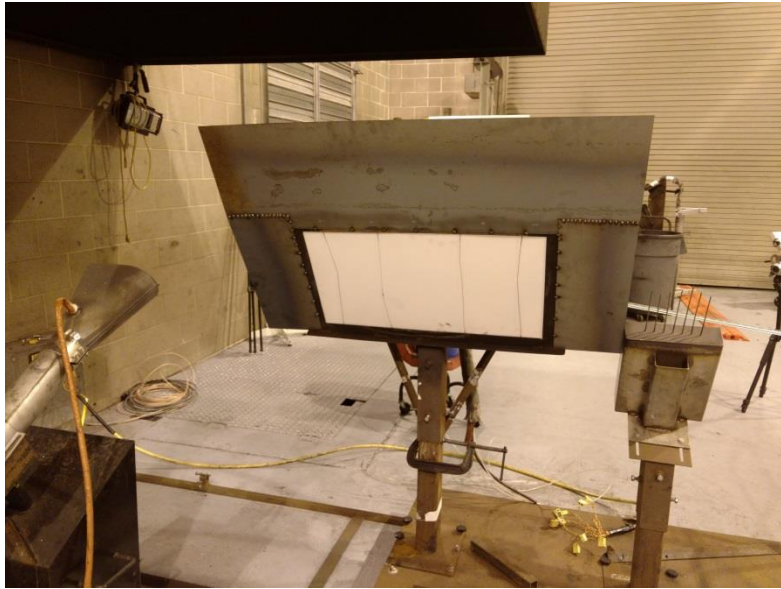
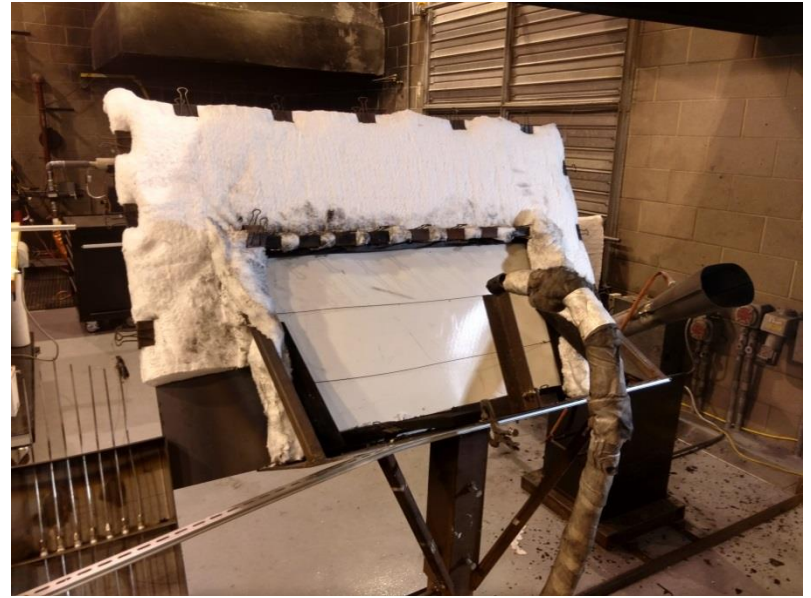
Picture Frame Shield

- Shield constructed to prevent flames from igniting vapors on back side
- 48 inches wide by 32 inches tall
- Insulated with ceramic fiber insulation to prevent metal surface from radiating towards heat flux gauge

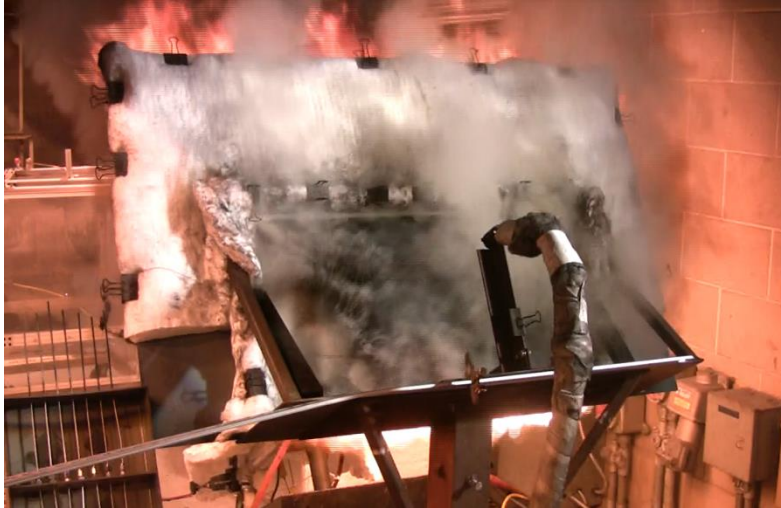
Insulation Test – Picture Frame w/Shield

Test Sample	Failure Time, sec.	Failure Time w/Shield, sec.
Material B	23	45
Material C	5	46

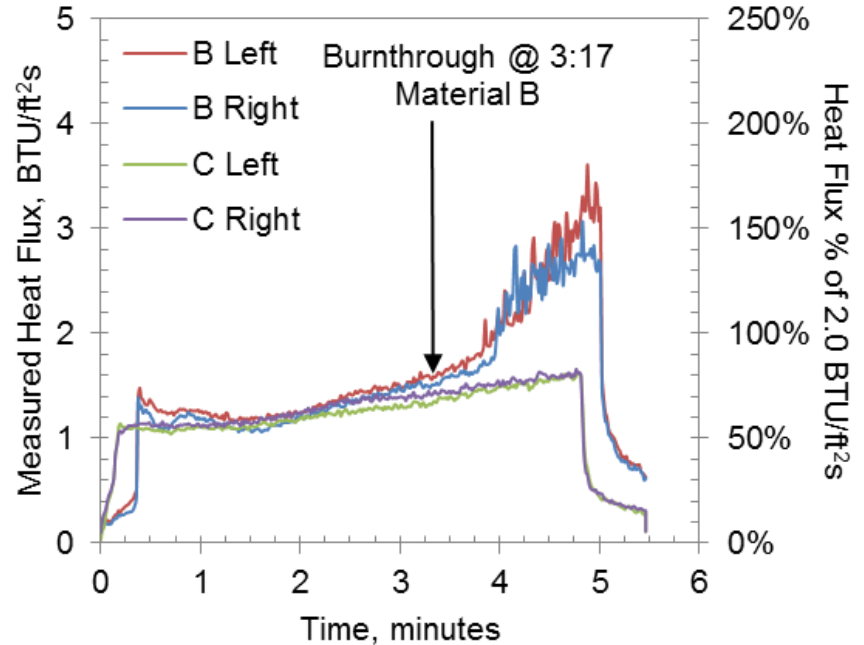
Burnthrough Rig Test Results

- **Material B** burned through at 3:17
- **Material C** passed for burnthrough and heat flux
- Influence of test rig significant on heat flux measurements

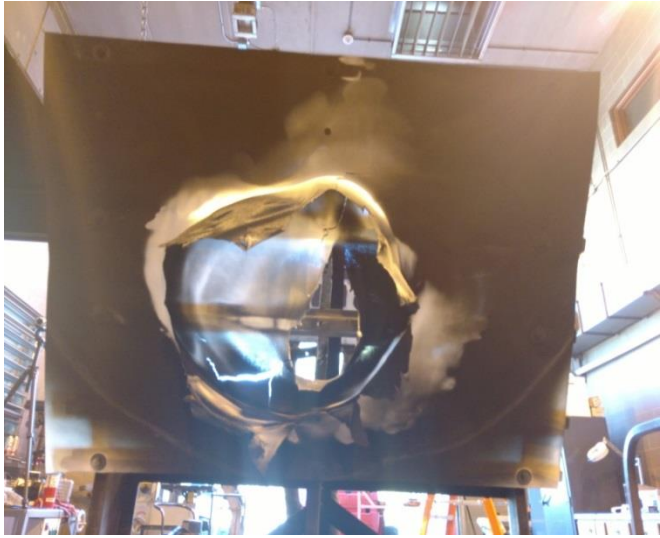
Material B

Insulation Test – Burnthrough Rig
