COMPOSITE MATERIAL FIRE FIGHTING

**Federal Aviation
Administration**

**Presented to: International Aircraft Materials Fire Test Working
Group
Atlantic City, New Jersey, USA**

Composite Aircraft Fire Fighting

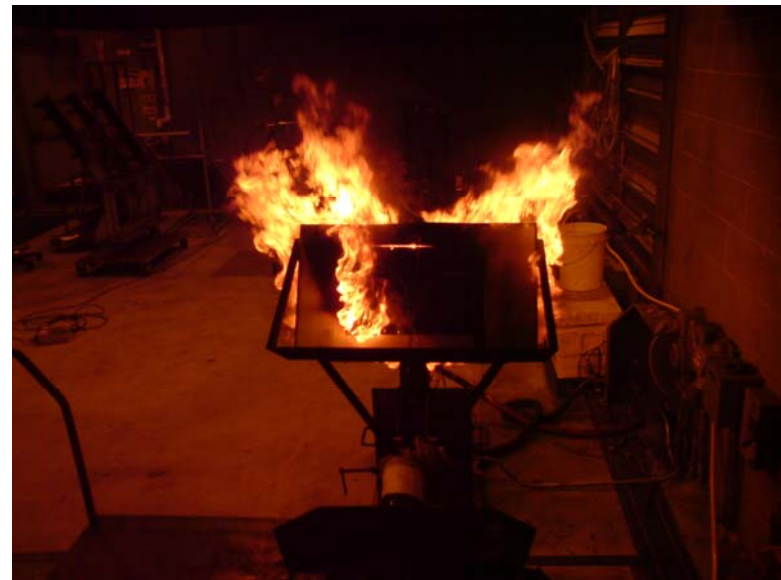
Test 1, Holder Failure

- The first several tests identified necessary adjustments to refine our methodology.
 - Attachment of thermocouples
 - Method to secure panel in place
 - Placement of thermocouples
 - FLIR camera settings

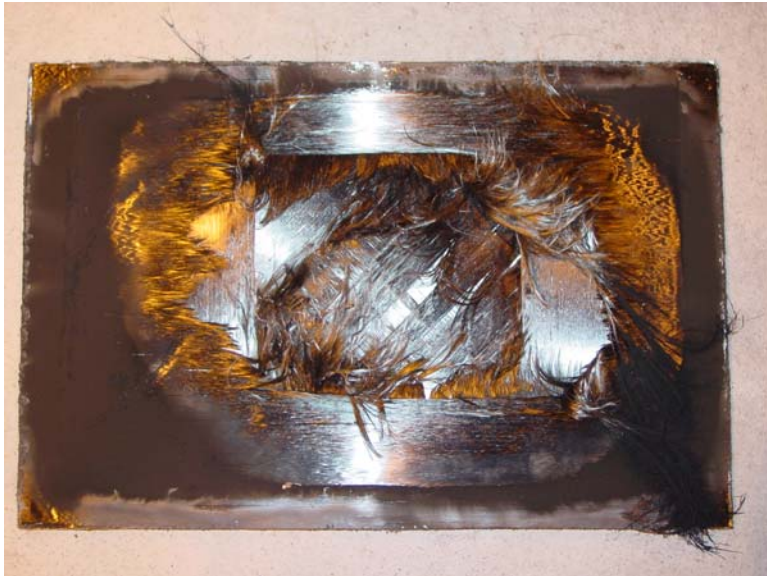
Test 6, 10 minute exposure

- **Longer exposure times inflicted heavy damage on the panels.**
 - Longer exposures burned out almost all of the resin.
 - Backside has “hard crunchy” feel.
 - Edges however, seem to have most of the resin intact. Edge area matched 1 inch overlap of Kaowool.

Front (fire side)

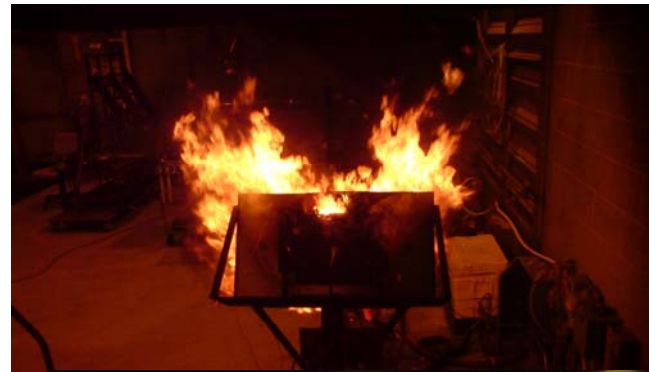
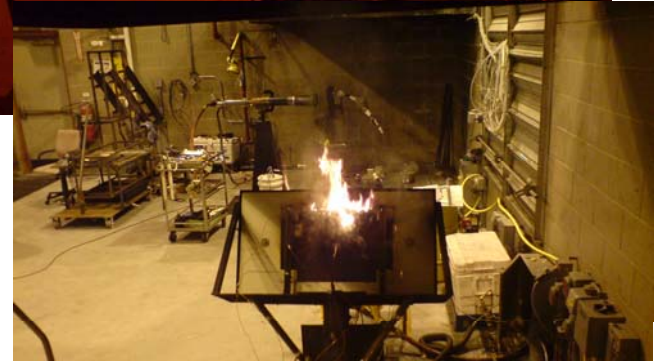
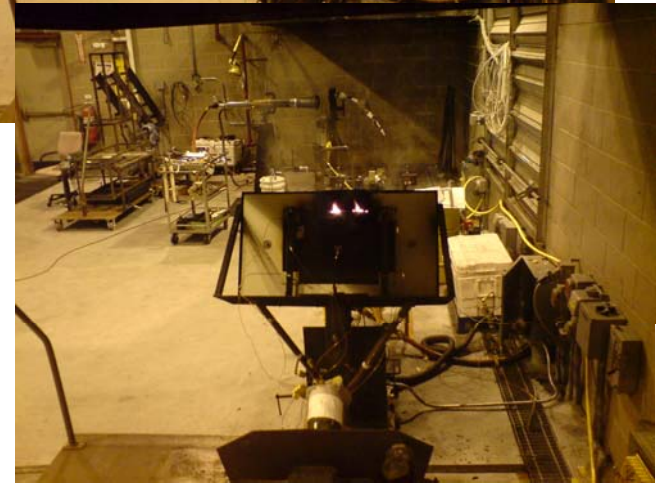
- **Shorter pre-burns showed some flaming combustion after exposure.**
 - 1 minute pre-burn seemed to offer the most post-exposure burning.
 - Continued burning for 1:17 min
 - Separate Air Force testing currently underway has shown a similar result at 1 minute.
 - However only 1 test, Test 12, has been conducted by us with 1 minute pre-burn.
 - Test 12 had flame initiate on the back top of the panel due to a crack in the Kaowool board.
 - Post-exposure the panel was burning on both the front and back sides which may account for why slight propagation of flame was noted on back.
