Electrical Short Circuit and Current Overload Tests on Aircraft Wiring

March 1995

DOTIFAA/CT-TN94/55

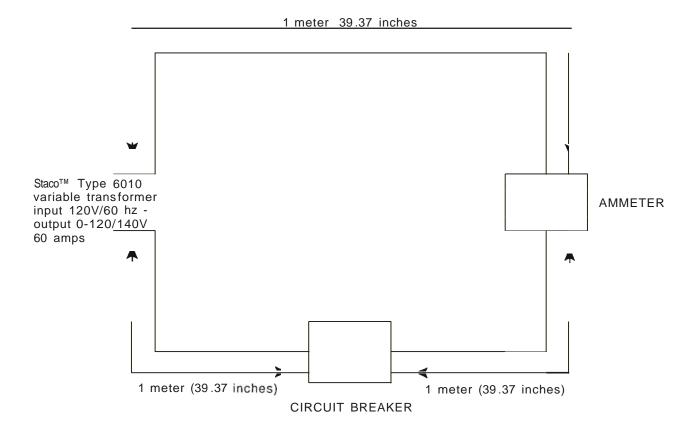
FIGURE 1. TEST CIRCUIT

All wires were 20 American Wire Gauge (AWG). This gauge was chosen because it is one of the most commonly used sizes. In this test, a 7.5-,10-, and a 15-amp circuit breaker (all standard aircraft thermal breakers) were subjected to 135 percent of their current rating and time-monitored when the breaker tripped. All tests were conducted at room temperature (23°C, 73°F). Figure 1 shows a diagram of the test circuit. Each wire segment rested on thermal/acoustic insulation (fiber glass with polyester film cover). This test, which is a calibration test used by circuit breaker manufacturers, references the International Electrotechnical Commission (IEC) 934, Circuit Breakers for Equipment, and the Underwriters Laboratories Incorporated (UL) 1077. Supplementary Protectors for use in Electrical Equipment. This test calls for wire rated at 600V and 105°C (221°F). The following is a section of the wire gauge table derived from IEC 934 for this test:
