Propulsion Halon Replacement Activity at the FAA WJ Hughes Technical Center

Presented to: 5TH Triennial International Fire and Cabin Safety Research Conference

Date: 30Oct2007

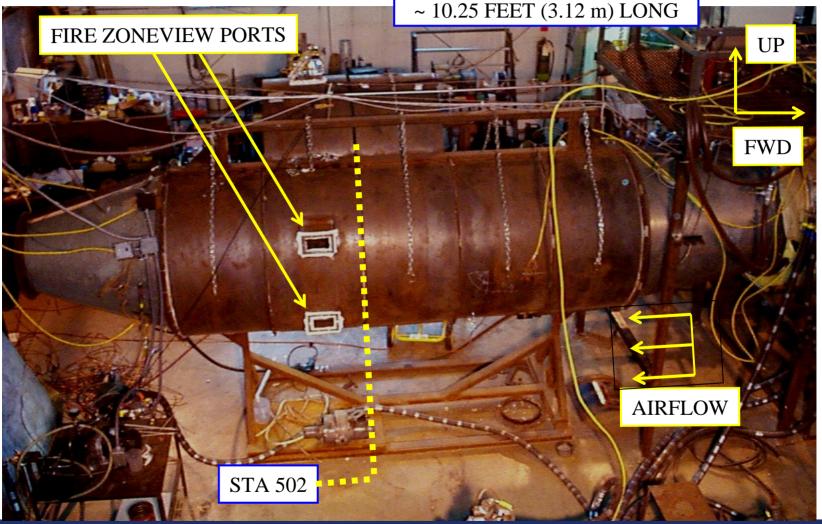
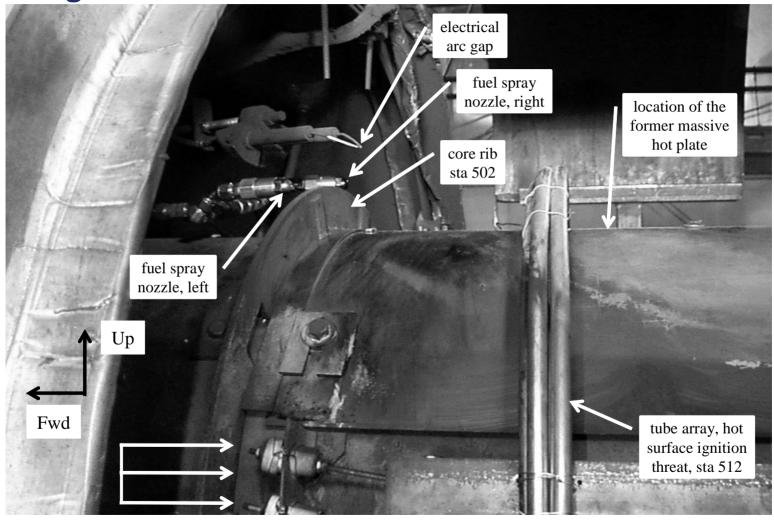
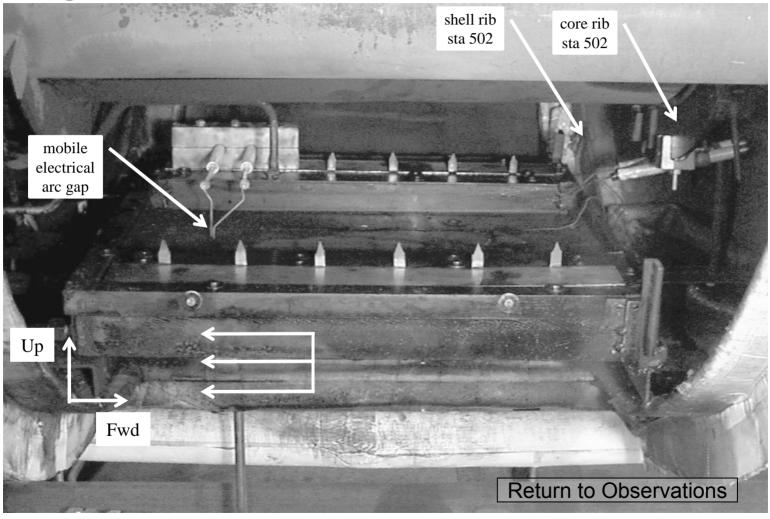
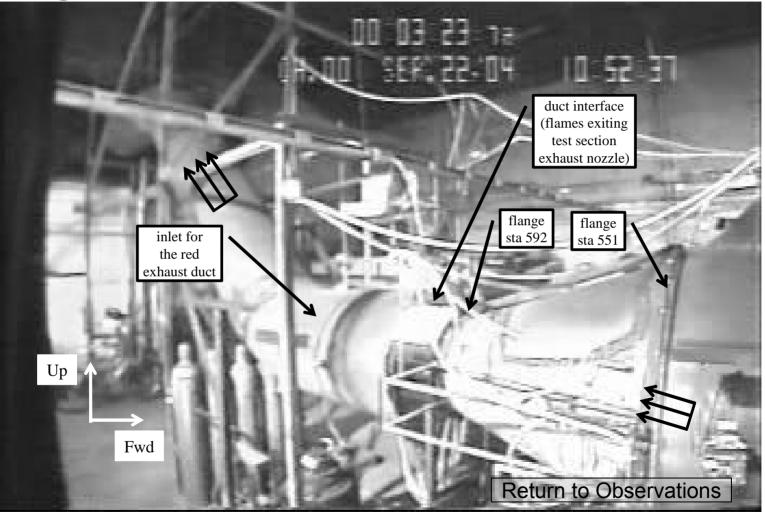
TEST SECTION DIMENSIONS 48 INCH (1.22 m) OD SHELL 24 INCH (0.61 m) OD CORE

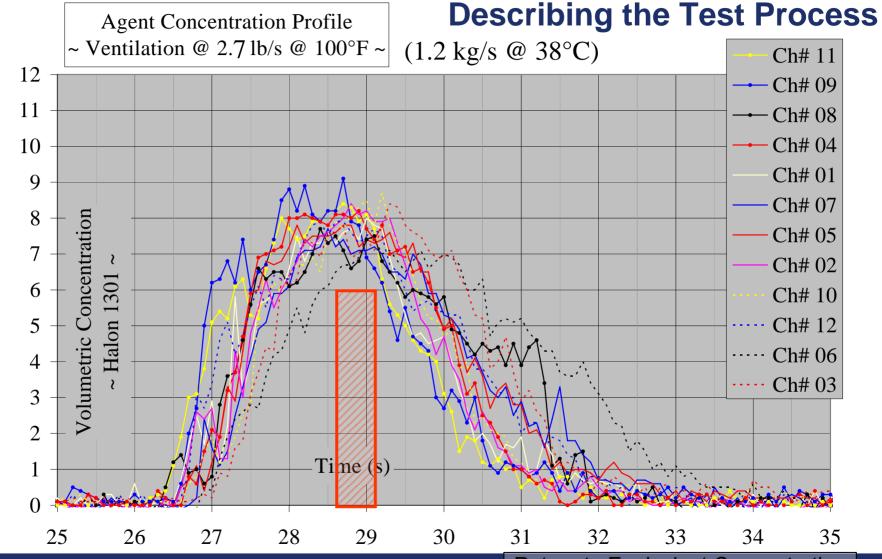
Halon 1301 delivered to test fixture meeting the intent of FAA certification

- Measured by Statham-derivative gas analyzer, 12 sampling points
- 3 ring sampling arrangement, middle ring centered at flame front

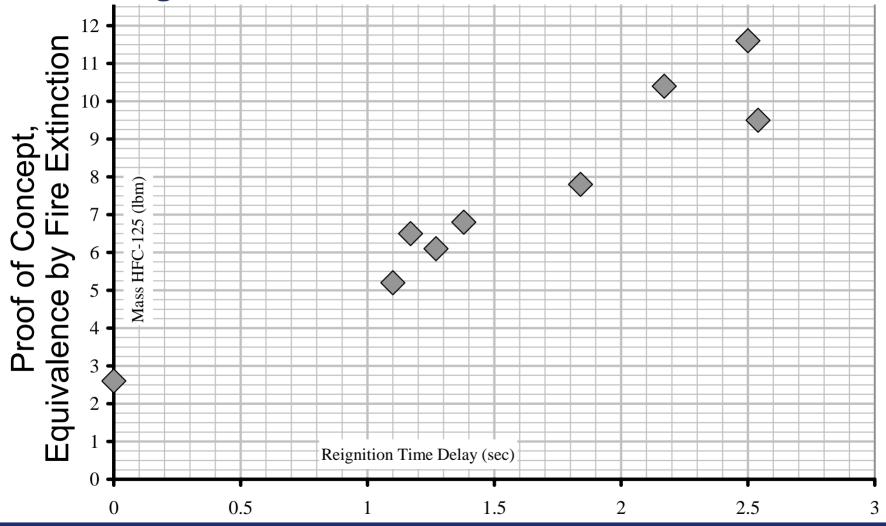
- Reignition Time Delay (RTD)
 - A visually observed duration of suppressed combustion
 - Occurs during the presence of forced ventilation, a transient agent pulse, and persistent ignition/fuel sources
 - RTD = t fire reignition t fire extinction
- Desired conditions :
 - RTD(Replacement quantity 01) ≥ RTD(H1301)
 - $\sigma(\text{Replacement quantity 01}) \approx \sigma(\text{H1301})$

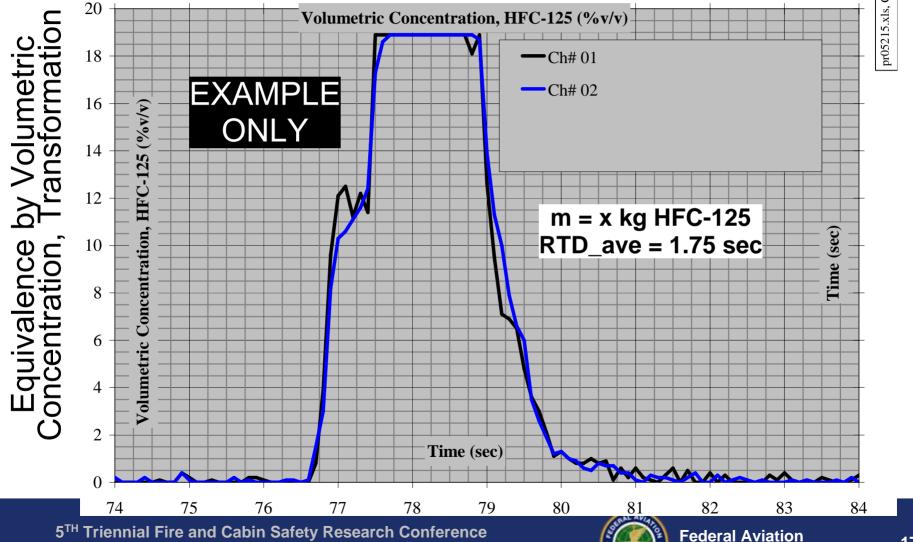
- Fire testing ceases; equivalence by fire extinction is established
- Agent distribution captured for the established agent delivery
- Data pool composed of recorded concentration behavior :
 - 2 flame front locations
 - 3 repeated tests
- Data pool is transformed :
 - From elapsed/historical time to durational behavior
 - Described by a best-fit least squares polynomial
- Equivalence by concentration is calculated by :
 - Using the related average RTD in the best-fit relationship
 - Solving for a volumetric concentration

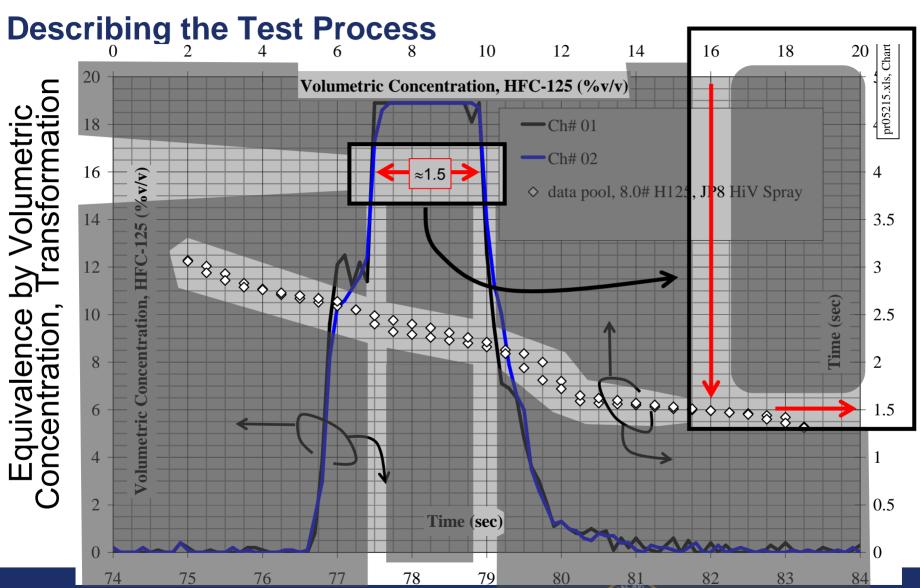
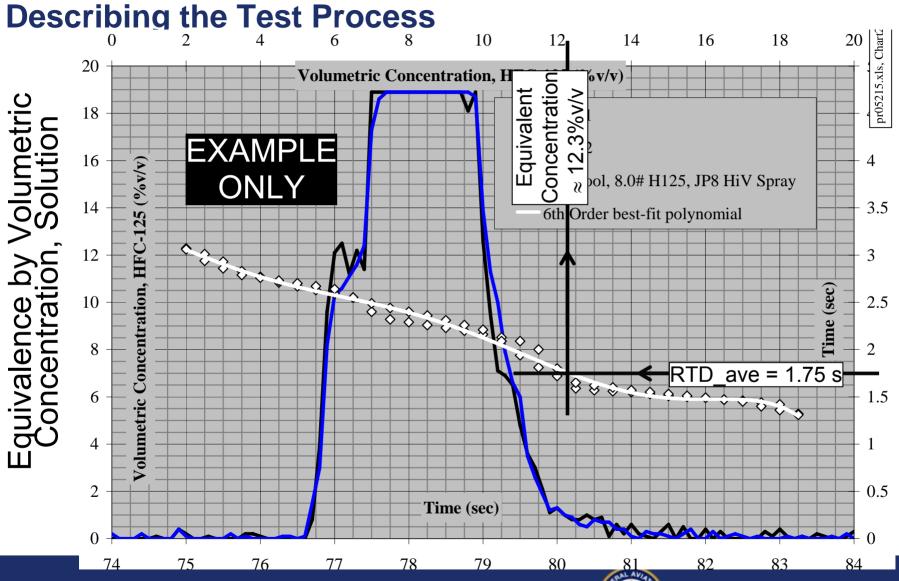
Explaining equivalence by "concentration"

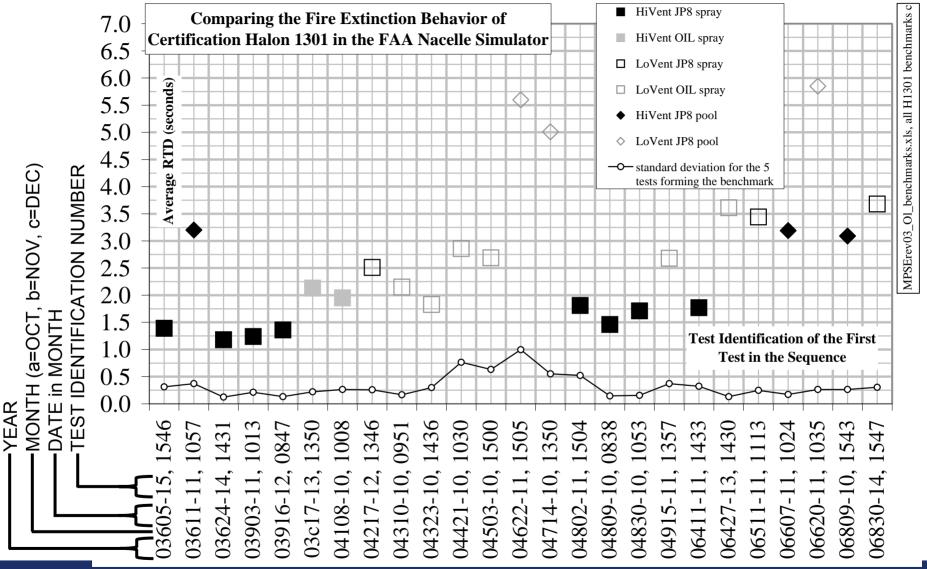
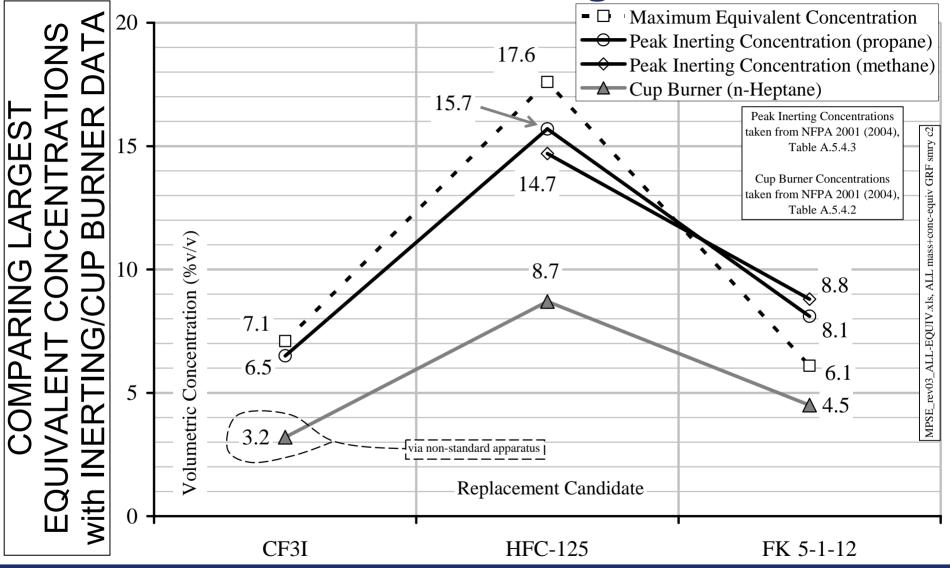
- Test histories include Halon 1301, HFC-125, CF₃I, 2-bromotrifluoropropene (2-BTP), & FK-5-1-12
- Variation in test process & environment
 - If all is operating normally, test outcome is reasonably consistent
 - Anomalous behavior indicates fault
- Have determined equivalent concentrations for HFC-125, CF₃I, FK-5-1-12
 - Relative relationship of equivalent concentrations are reasonable
 - Compare reasonably with reported inerting and cup burner data

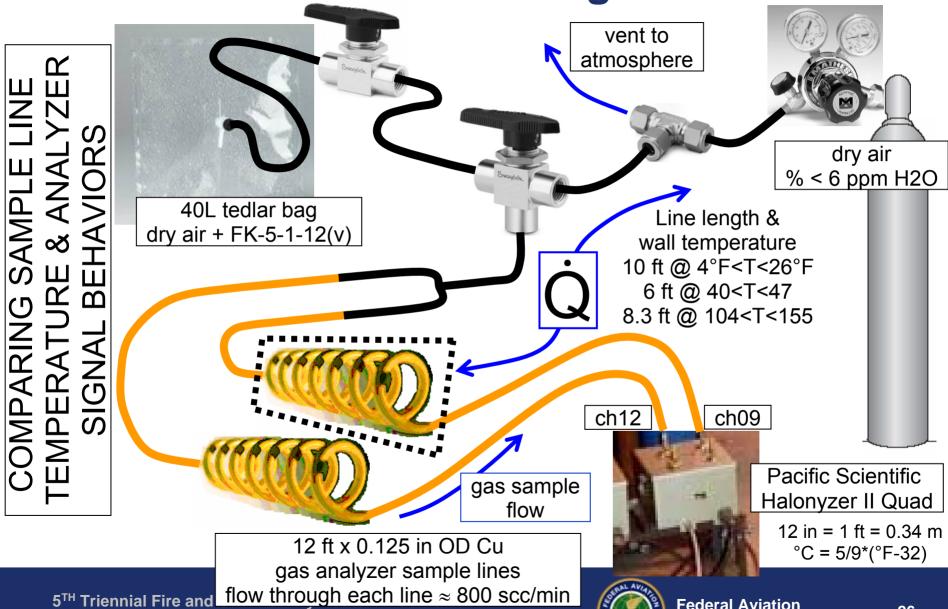
- Initially not suspected as a region of interest
- 2004, 2-BTP observed to be reactive
- Temperature, pressure, & optical instrumentation added after 2004 testing
- H1301 & candidates demonstrate different behaviors during reignition
 - H1301 does not force any visible smoke into test bay
 - ALL successful replacement candidates forced visible smoke (NOT fire) into the test bay in some configuration
 Refresh memories about duct interface

- FK-5-1-12 condensed in analyzer sample lines during bench scale investigations
- Flame attachment more evident with increasing normal BP (CF3I, FK-5-1-12)
 - anecdotal observations during pool fire testing
 - photoconductive photodiodes

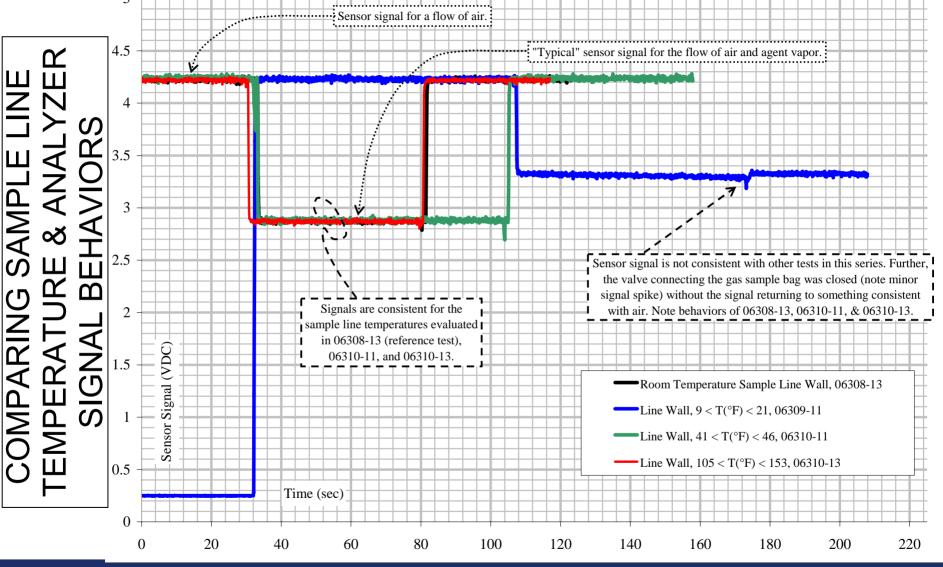
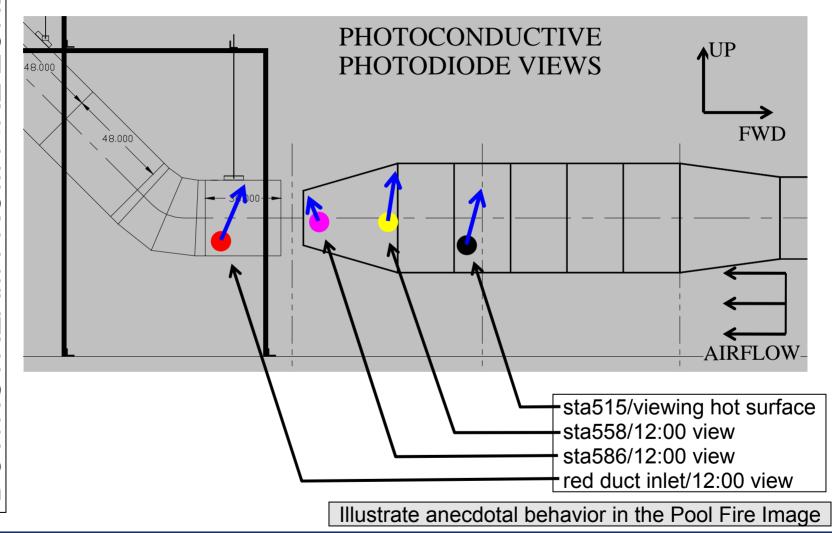
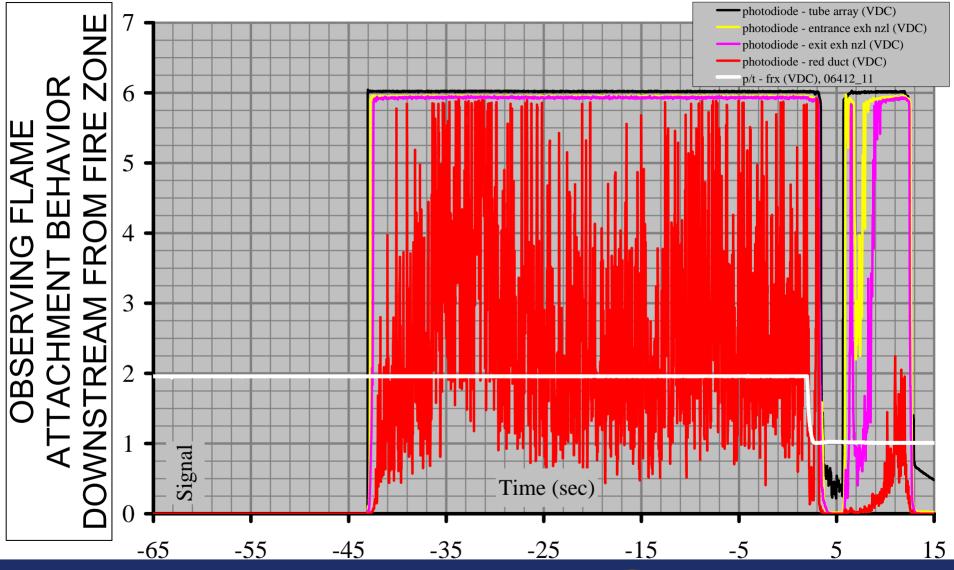
Observations at the duct interface

Observations associated with normal boiling point (BP)

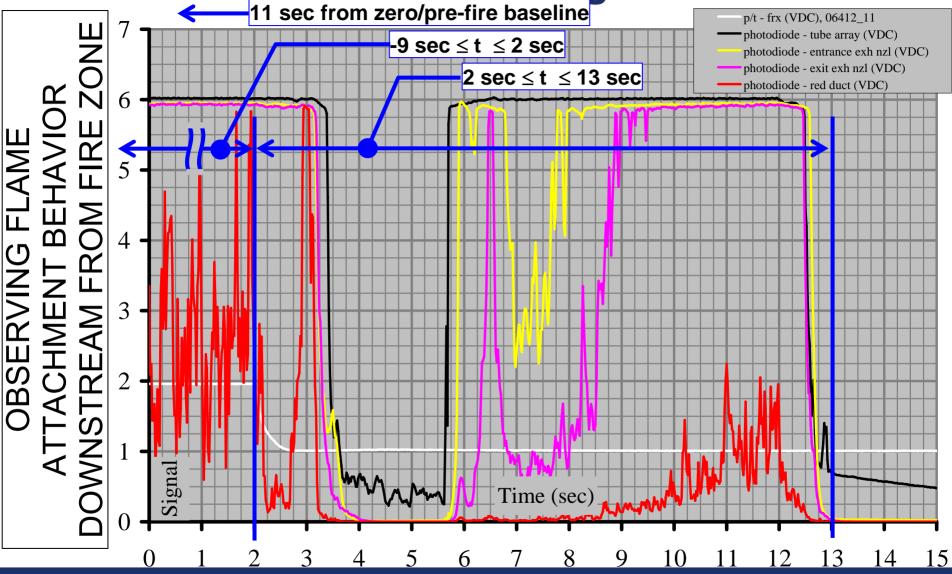
11 sec from zero/pre-fire baseline
