5th Triennial International Fire and Cabin Safety Research Conference

The Use of Magnesium in Aircraft Interiors

By: Tim Marker, FAA Technical Center

Date: October 31, 2007

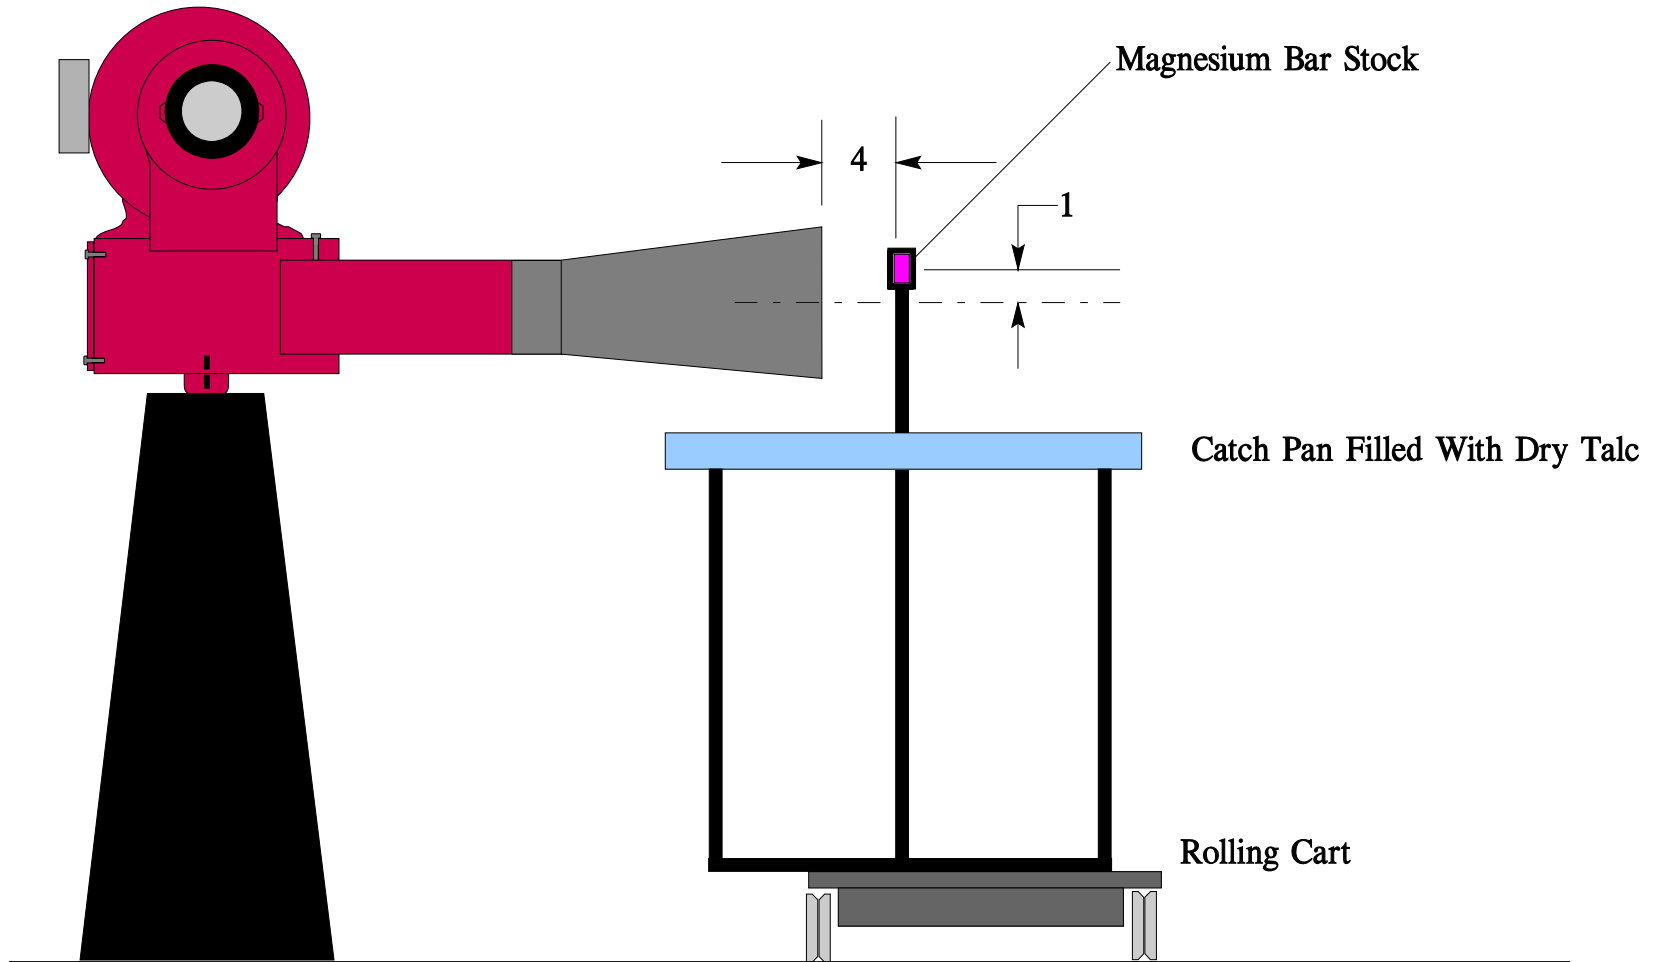
Initial Postcrash Test Configuration

- FAATC agrees to run preliminary tests on magnesium bar, to provide initial characterization of flammability of various magnesium alloys
- Tests to utilize oil burner from existing seat cushion flammability test
- Informal program, with samples provided by Magnesium Elektron

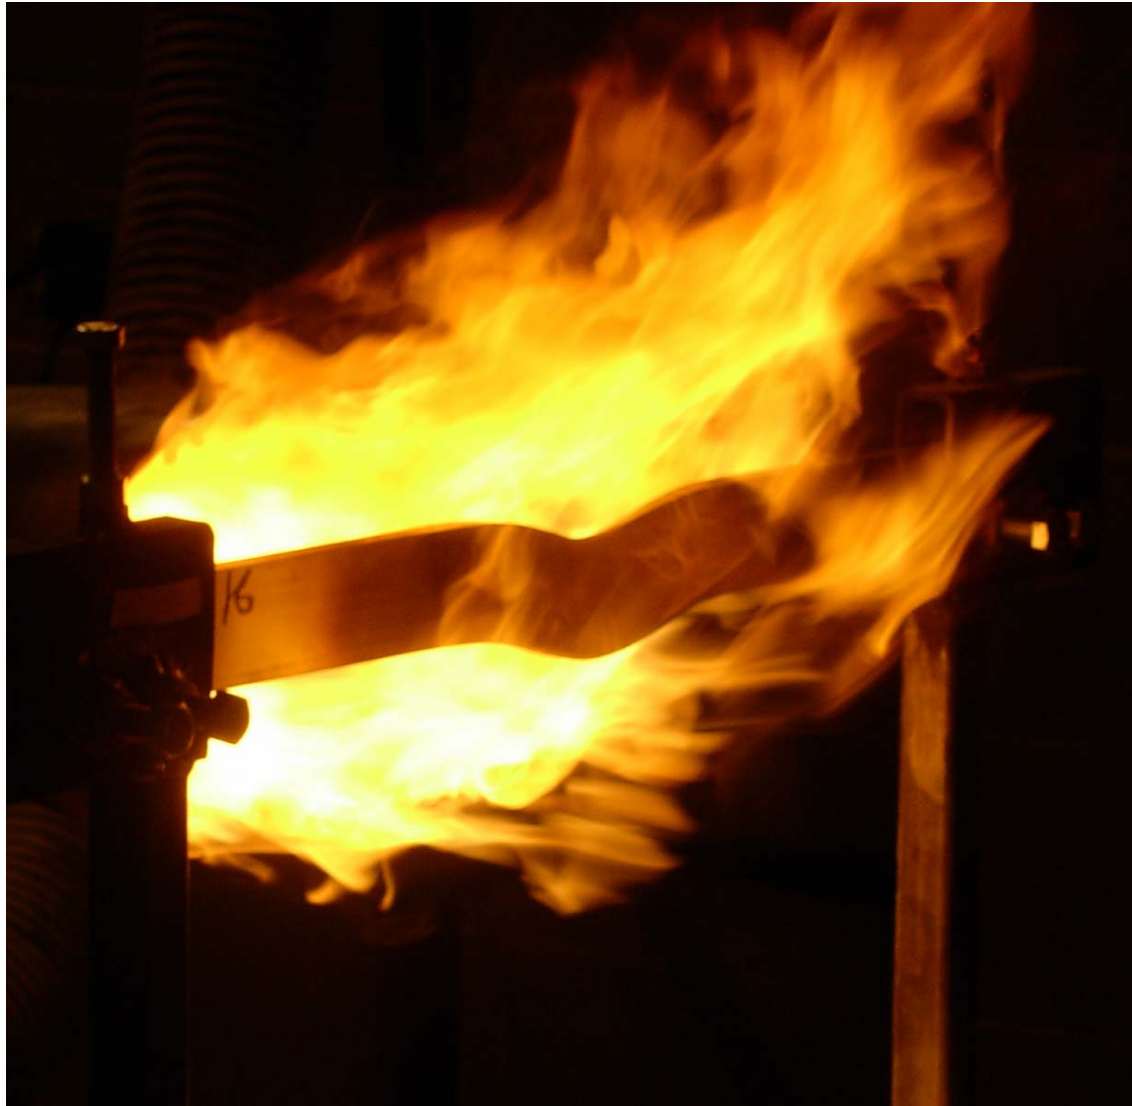
Magnesium Bar Pre-Melt

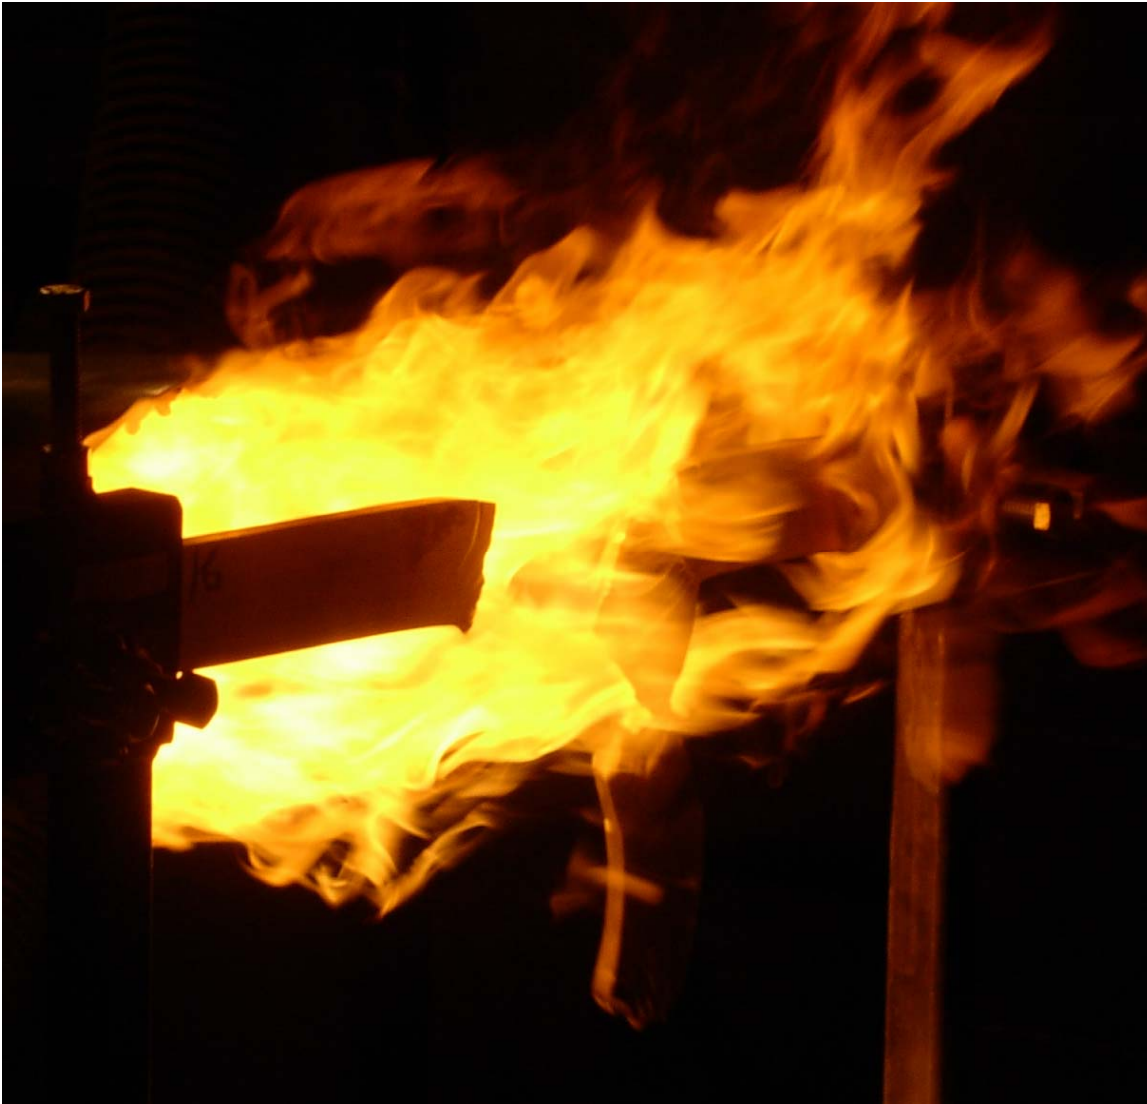
Magnesium Bar Melting

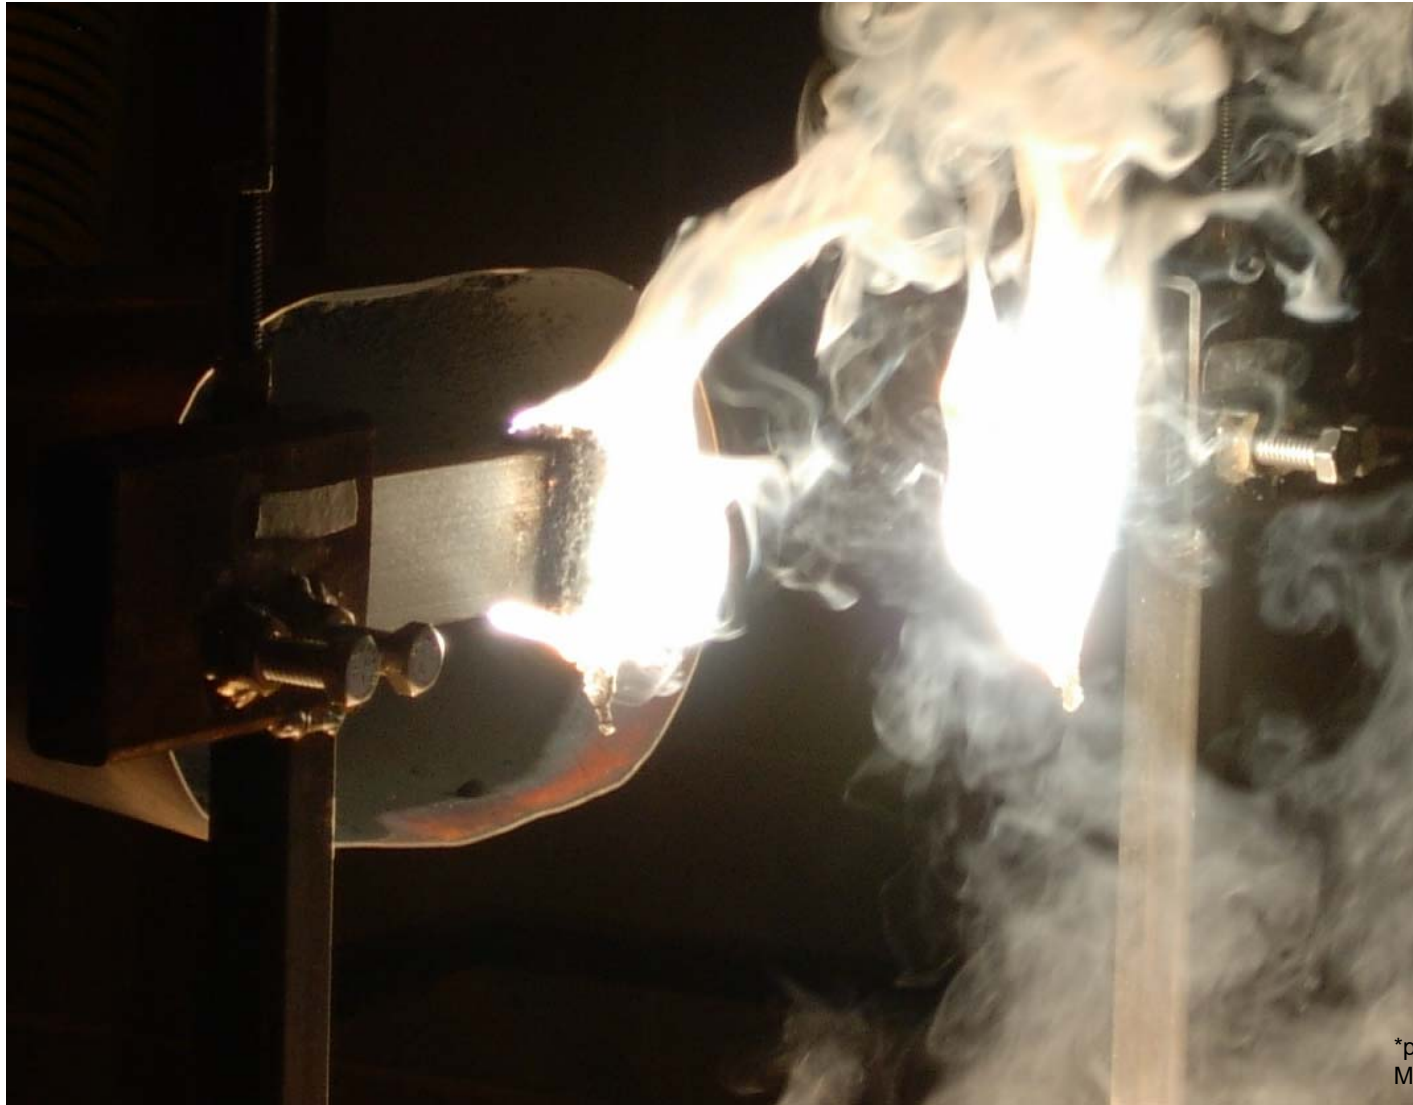
Magnesium Burning After Burner Shut Off

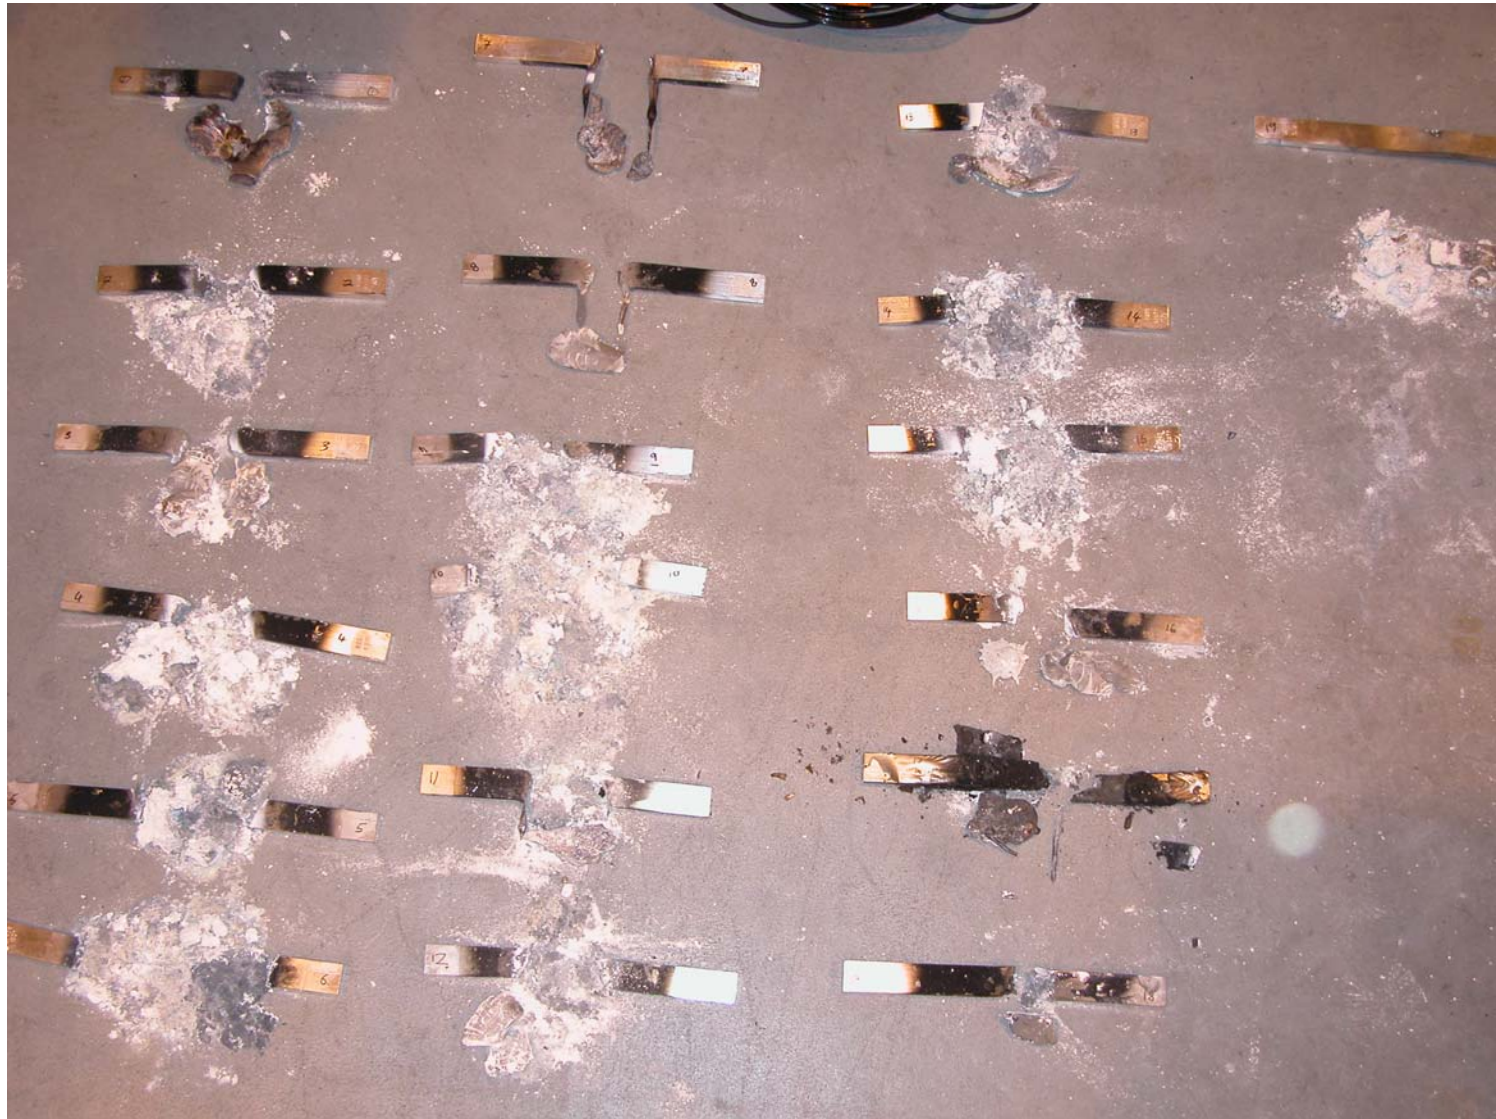
Magnesium Bar Samples Post-Test

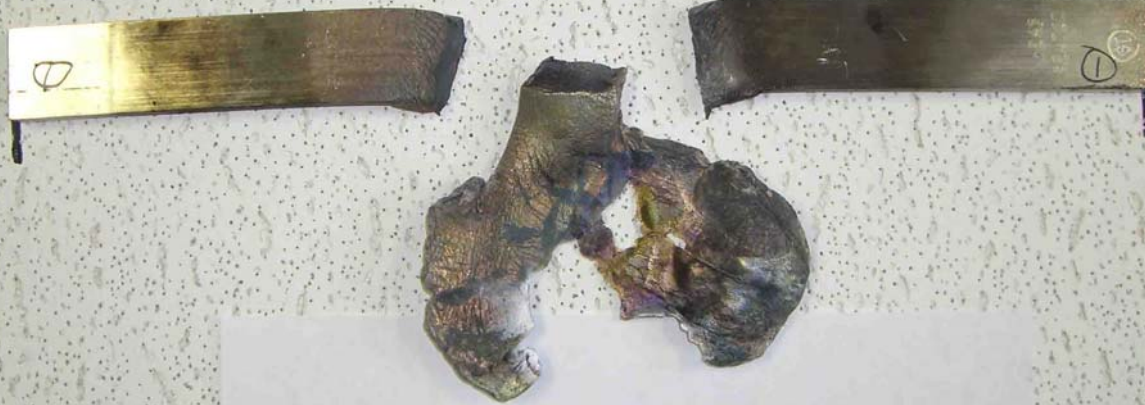
Magnesium Bar Samples Post-Test

example of minimal burning following sample melting

<u>Exp</u>	<u>Alloy</u>	<u>Section</u>
1	WE43	15 x 40

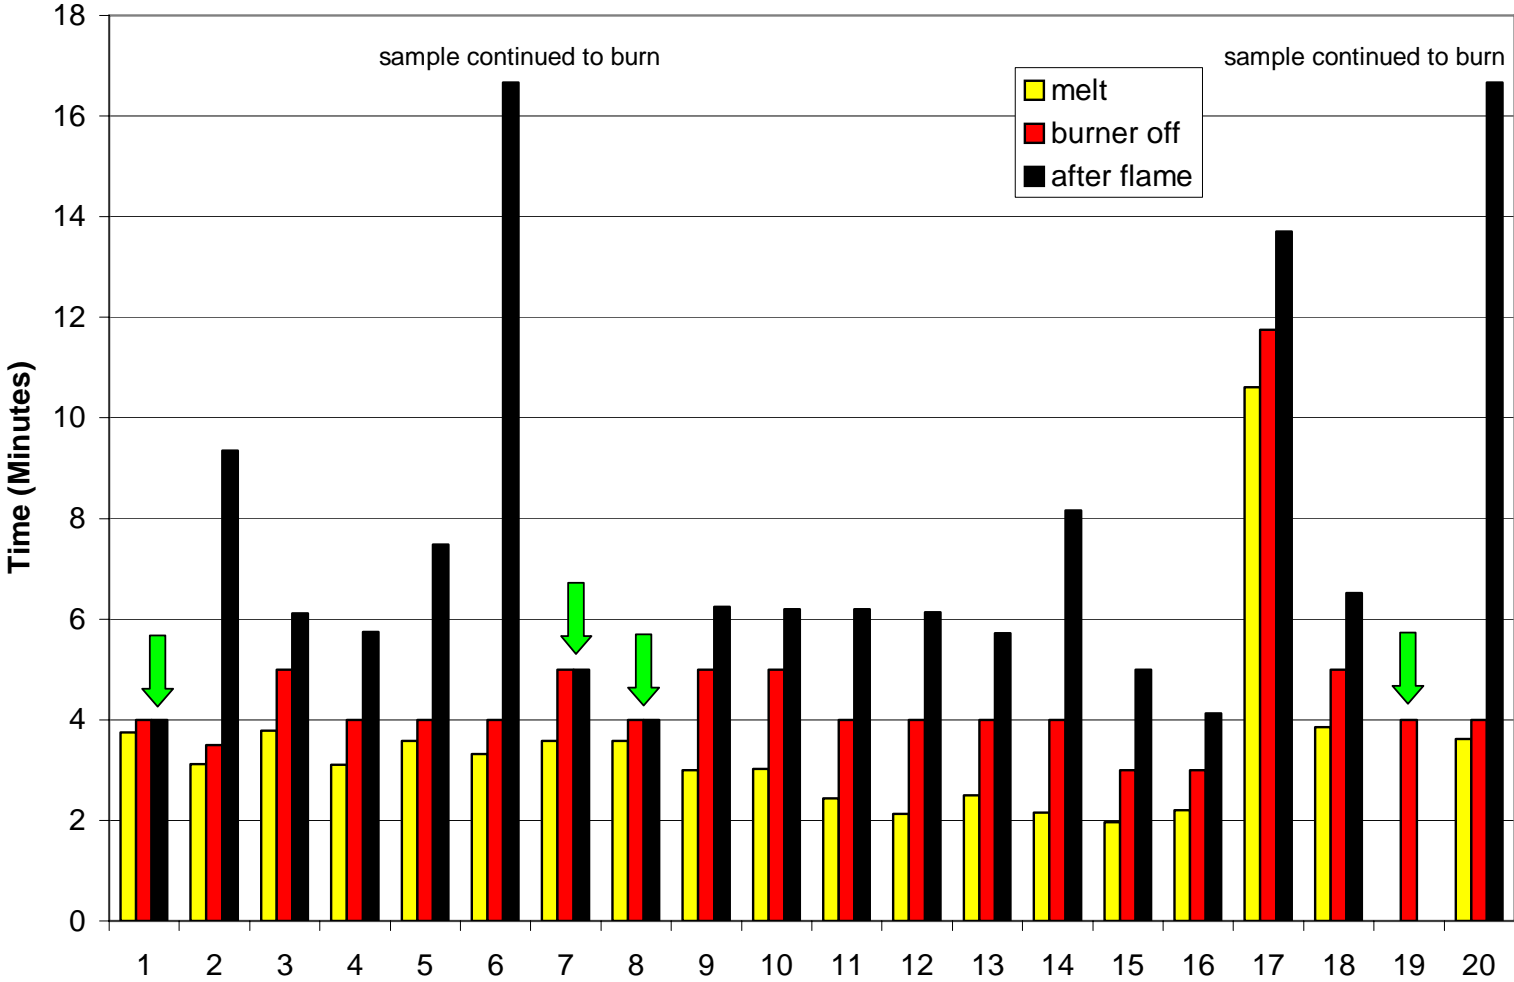
Magnesium Alloy Test Results

Summary of Burner Test Results

None of the magnesium bar samples melted prior to 2 minutes

Extending exposure time beyond 2 min caused melting and ignition

80% of samples (16 of 20) continued to burn after burner flame removed

Sample performance (i.e., flammability) largely dependent on alloy type and section thickness

WE43 and Elektron 21 more ignition resistant than other alloys tested

Vertical orientation of sample promoted continued burning

Use of intumescent coating increased time-to-melt substantially

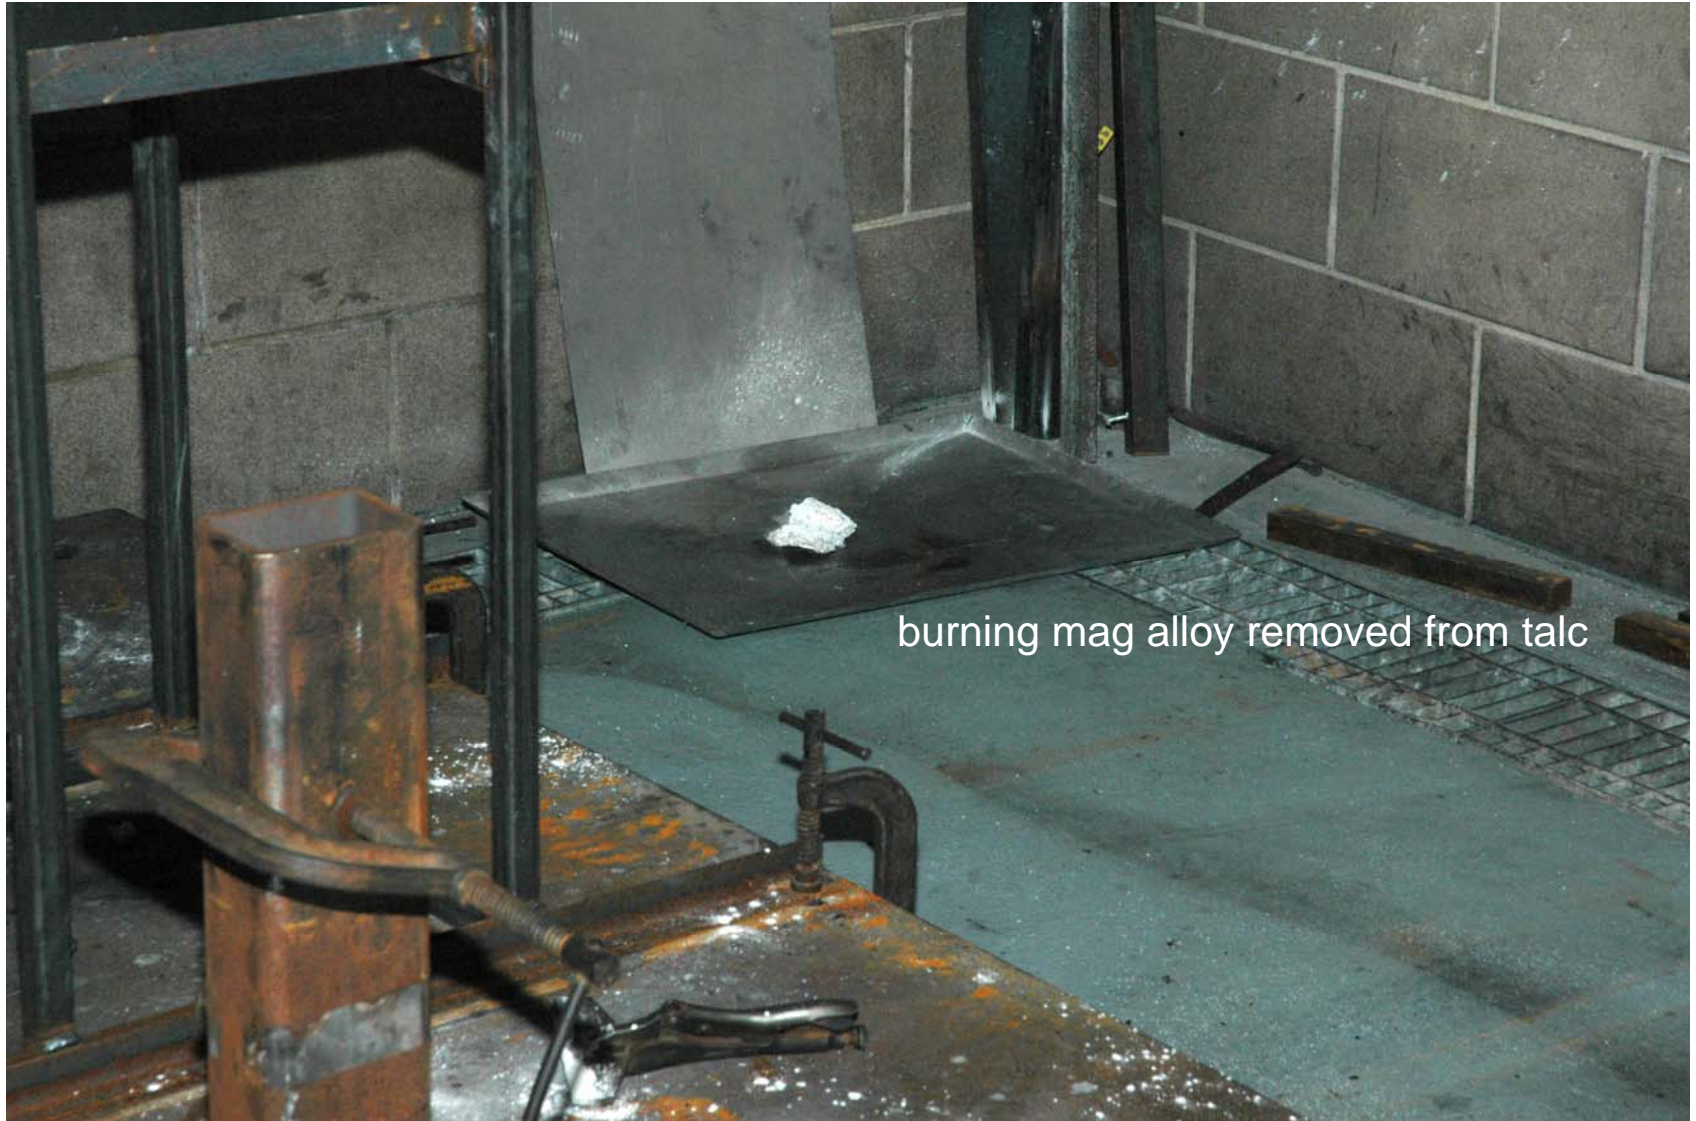
burning mag alloy removed from talc

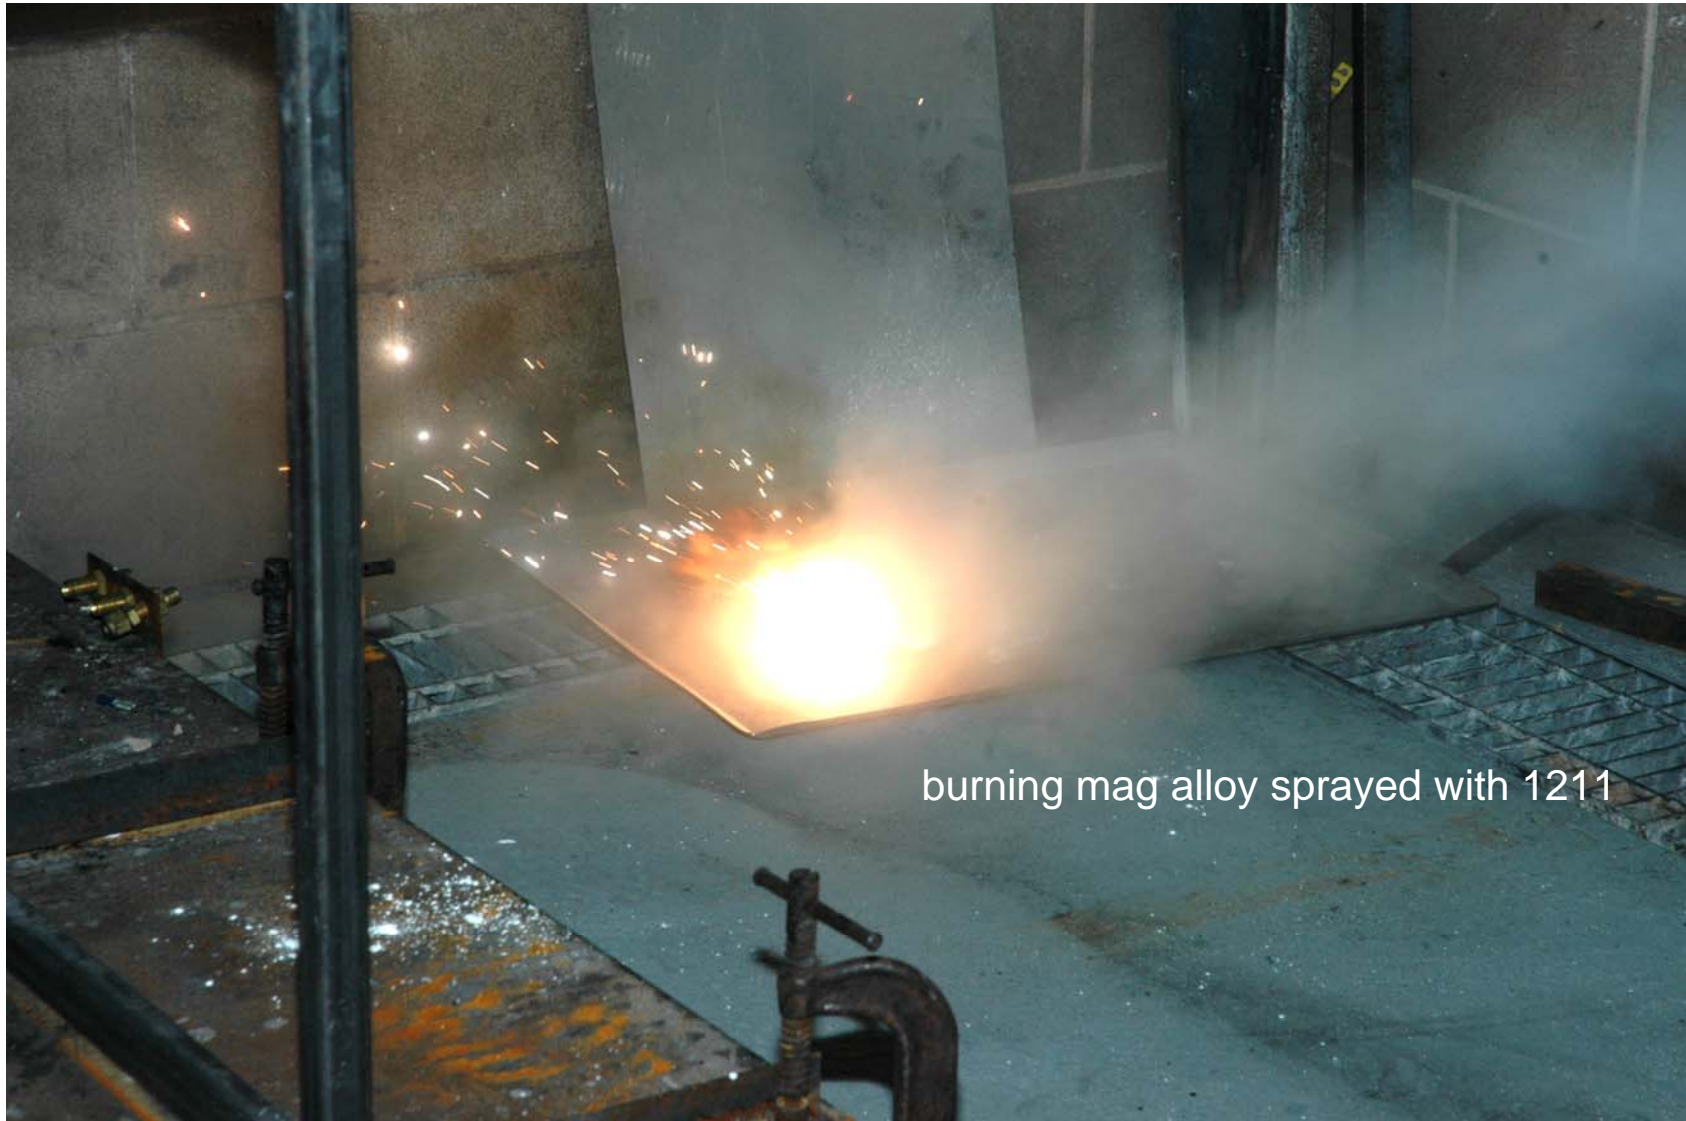
burning mag alloy sprayed with 1211

Halon-1211 least effective at extinguishing fire; water most effective

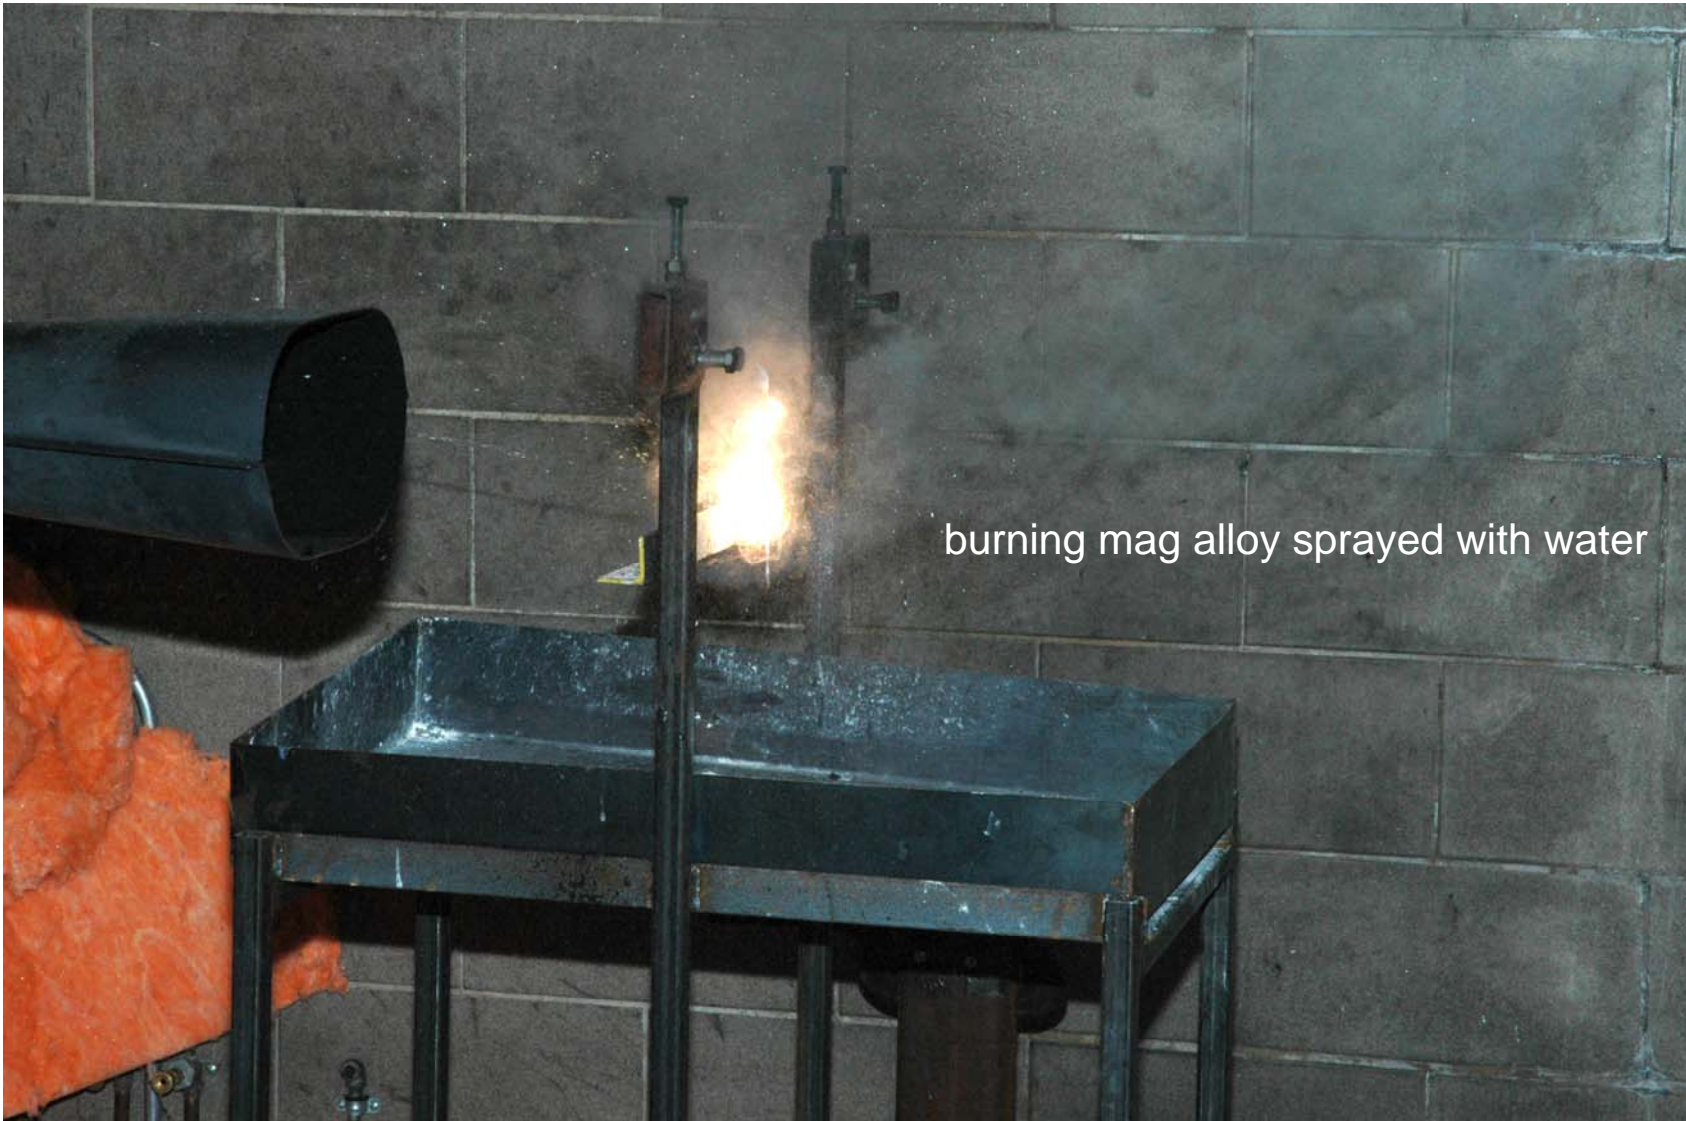
burning mag alloy sprayed with water

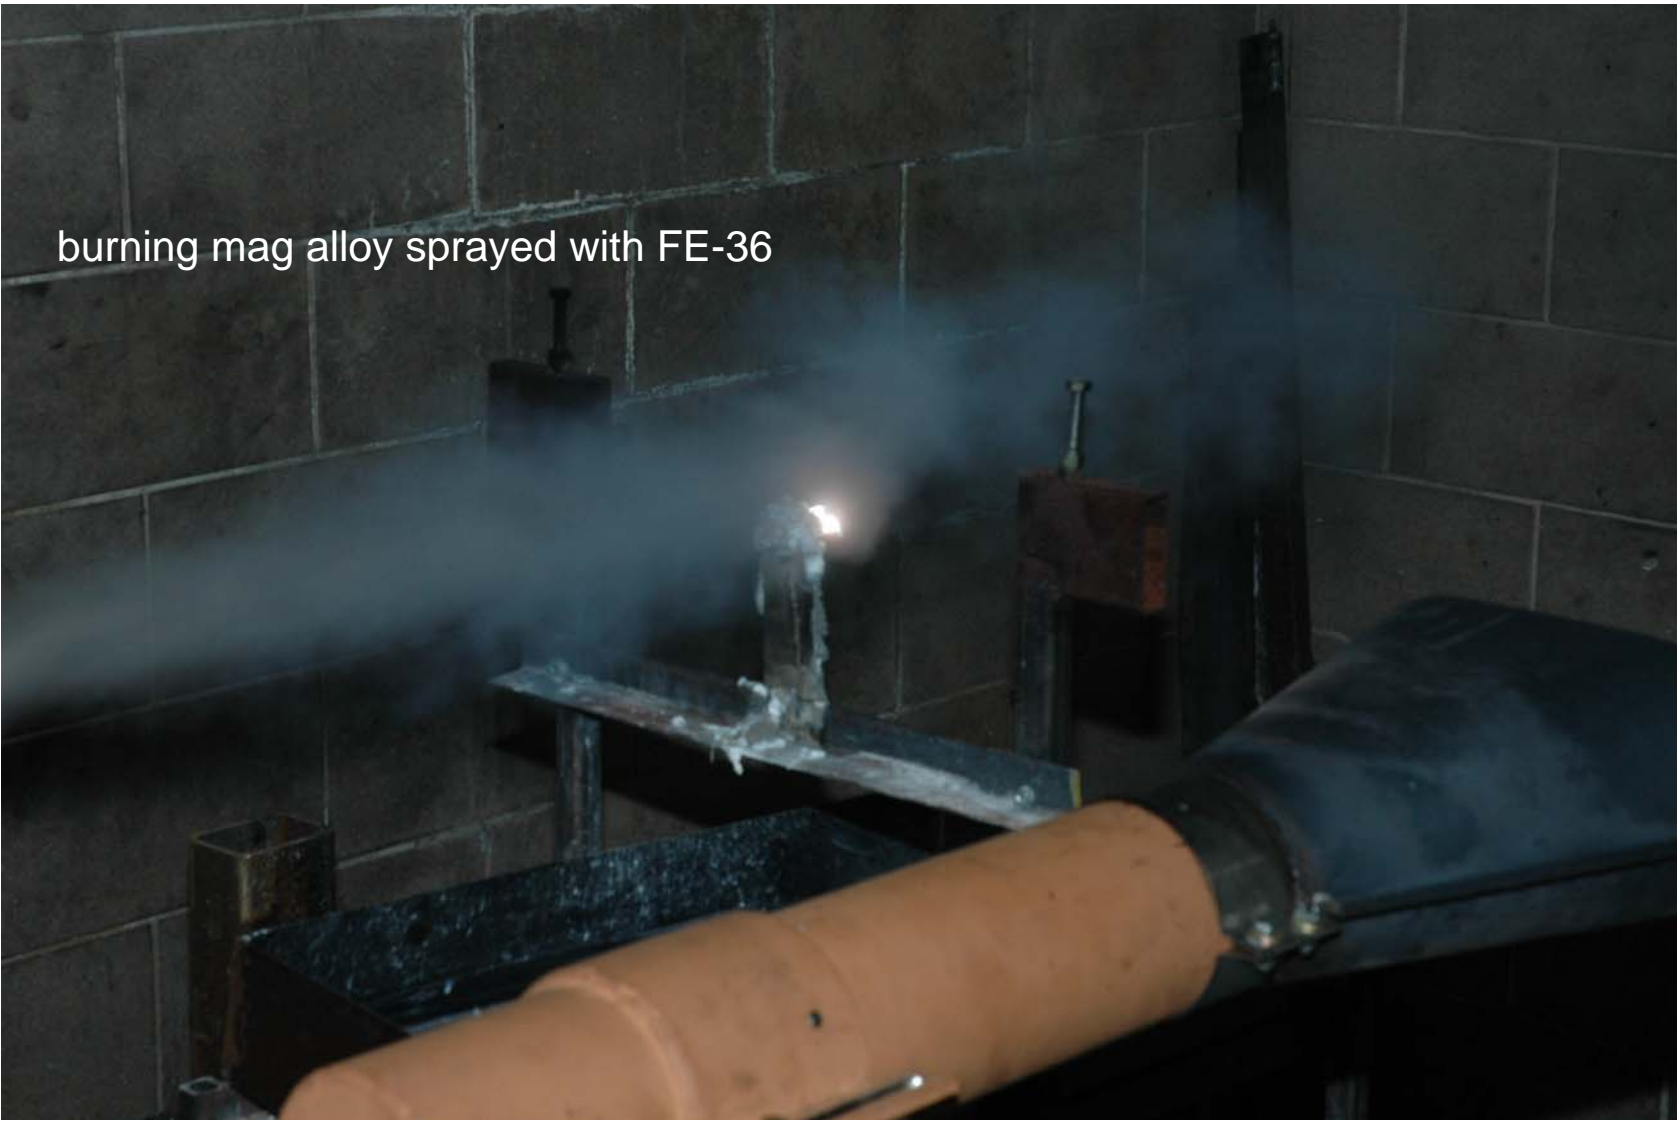
burning mag alloy sprayed with FE-36

FE-36 caused rapid oxidation of burning samples

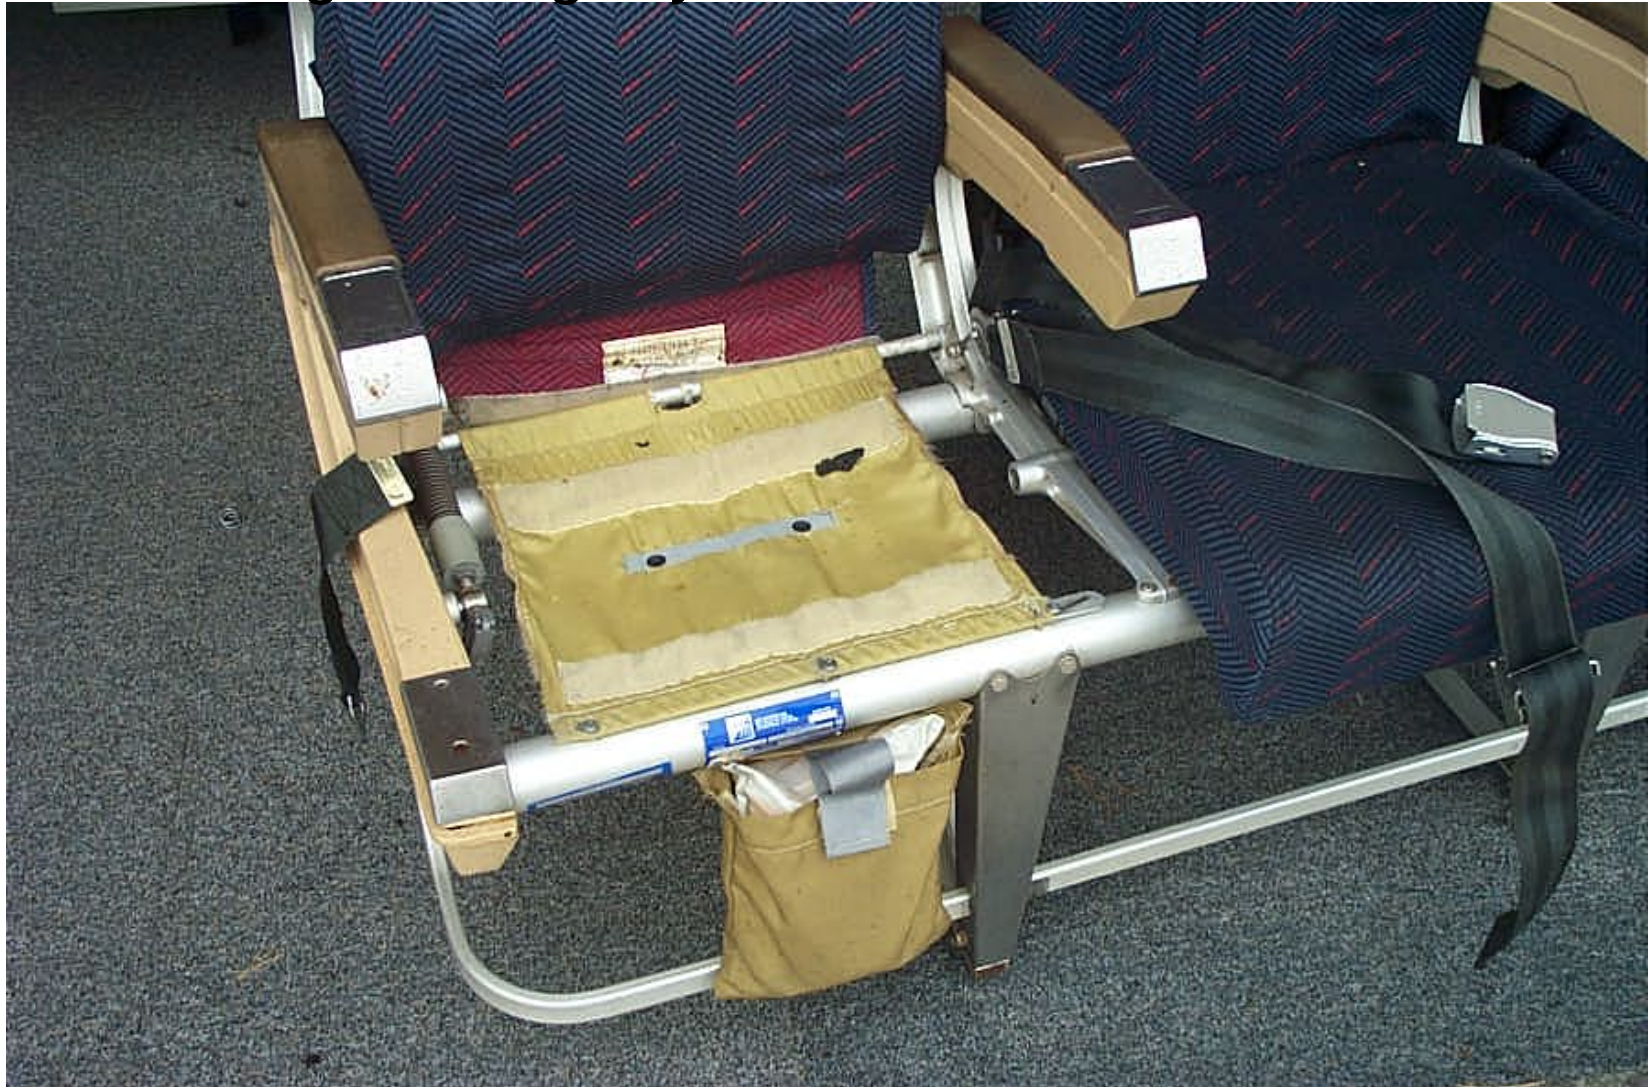
How do we ignite mag-ally without “unrealistic” fire source??
