DOT/FAA/TC-13/52

Development of a Laboratory- Scale Flammability Test for Magnesium Alloys Used in Aircraft Seat Construction

Final Report

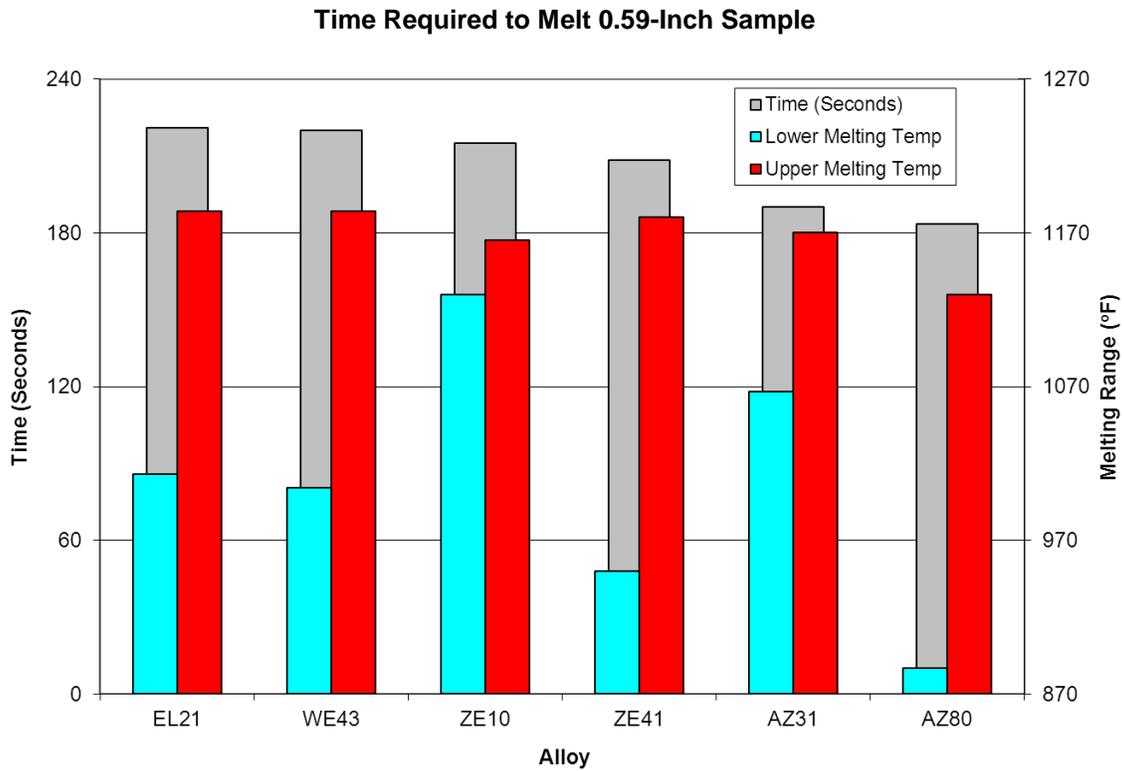
Figure 8. Various 0.59-Inch-Thick Samples and Respective Time to Reach Melting

In many cases, once the samples were subjected to the burner for a time period adequate to cause melting, the alloys ignited. Several samples were new generation alloys specifically designed to minimize flammability. As a result, a large difference in flammability was observed between the various samples tested. For example, the alloys WE43 and EL21 both showed outstanding resistance to ignition compared to the legacy alloys, such as AZ31. In two of the three AZ31 tests, the sample did not self-extinguish, regardless of time, and burned indefinitely.

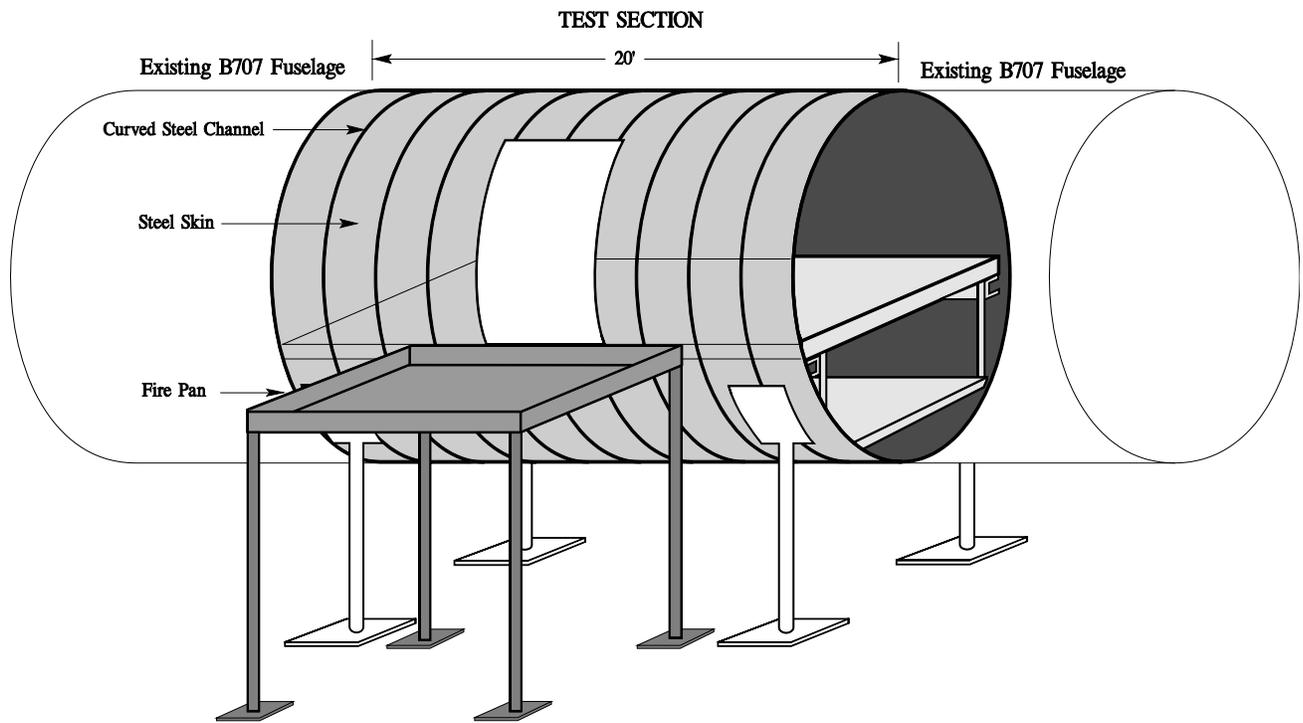
Figure 22. Full-Scale Test Fuselage

To evaluate potential hazards associated with the ignition of magnesium alloy components under more realistic conditions, a full-scale test series was conducted. Based on input from industry regarding the potential use of magnesium alloy inside a passenger cabin, it was clear that the seat structure was a primary target area. In particular, the large, machined primary components, such as the legs, spreaders, and cross tubes, were ideal for retrofitting. These aluminum components were substantial in mass and would benefit the most from substitution using a magnesium alloy. Other less massive seat components, such as the seat bottom and back pans, would not be ideal for magnesium alloy substitution and, therefore, were not considered in the full-scale study. To conduct the tests, a narrow-body test fuselage was used. Using this test fuselage was the most practical approach for repetitive tests and systematic evaluation of the various magnesium alloys. The test fuselage consisted of a 20-foot-long steel cylinder section fabricated from curved steel channels, which was then inserted between two halves of a Boeing 707 fuselage (figure 22). This test fuselage was configured with a standard-sized opening, 40 by 80 inches, representing a break in the fuselage. In this configuration, flames from an external fuel fire impinged directly on one of the seats positioned in the opening. An 8- by 10-foot fuel pan was situated adjacent to the test fuselage. The fire was produced from 55 gallons of JP-8 fuel ignited in the fuel pan. The mocked up section of the test fuselage included seats and other cabin materials, such as paneling and carpet (figure 23).

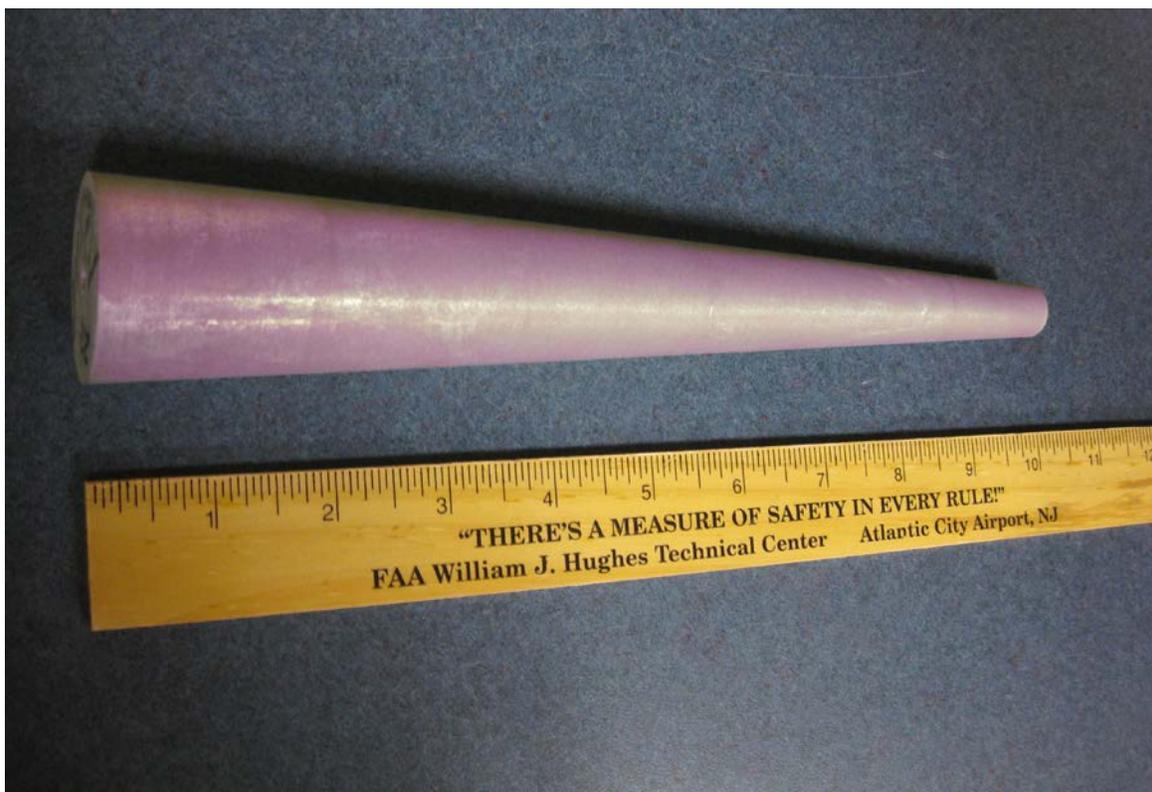
Figure 33. Initial 10-Inch-Long Truncated Cone Test Sample

(significant ignition/burning of the droppings, but little or no burning of the remaining sample). In an attempt to overcome this situation during the test development phase, the concept of orienting the sample vertically was raised, with the expectation that a sample could be ignited near its top. Once ignited, the sample could continue to burn vertically, similar to a candle, thus enabling sustained ignition for a period of time after the ignition source was removed. This burn progression could possibly eliminate the previous result, for which a large segment of the test sample melted and fell away from the ignition source (burner flames). To facilitate easy ignition of the vertical sample, it was theorized that the upper portion could be minimized in mass/size compared to the lower portion. This resulted in the concept of a cone-shaped sample in which a more massive base at the bottom formed into a less massive pinnacle near the top, where the ignition source was concentrated. The first truncated cone-shaped prototype samples were machined using AZ31 and WE43 alloys, because these materials were used in the full-scale test demonstrations and typically yielded substantially different results. Initially, two truncated cone sample configurations were produced. The samples measured approximately 10 inches in height with a base diameter of approximately 1.6 inches and a truncated top measuring either 0.4 inches or 0.6 inches in diameter (figure 33).

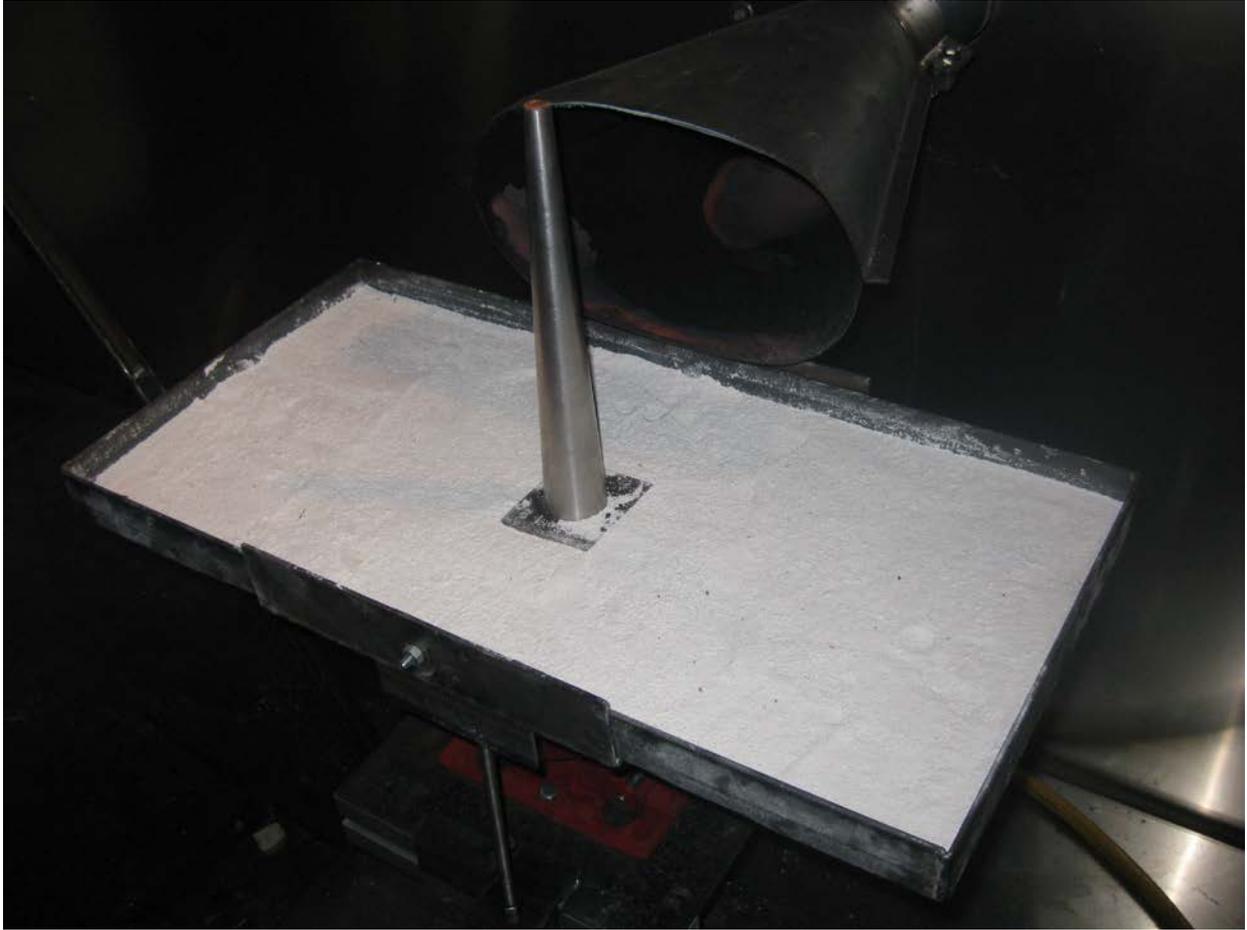
Figure 35. Truncated Cone-Shaped Test Sample Affixed in Talc-Filled Catch Pan, With Burner Shown in Background (2/8/2011)

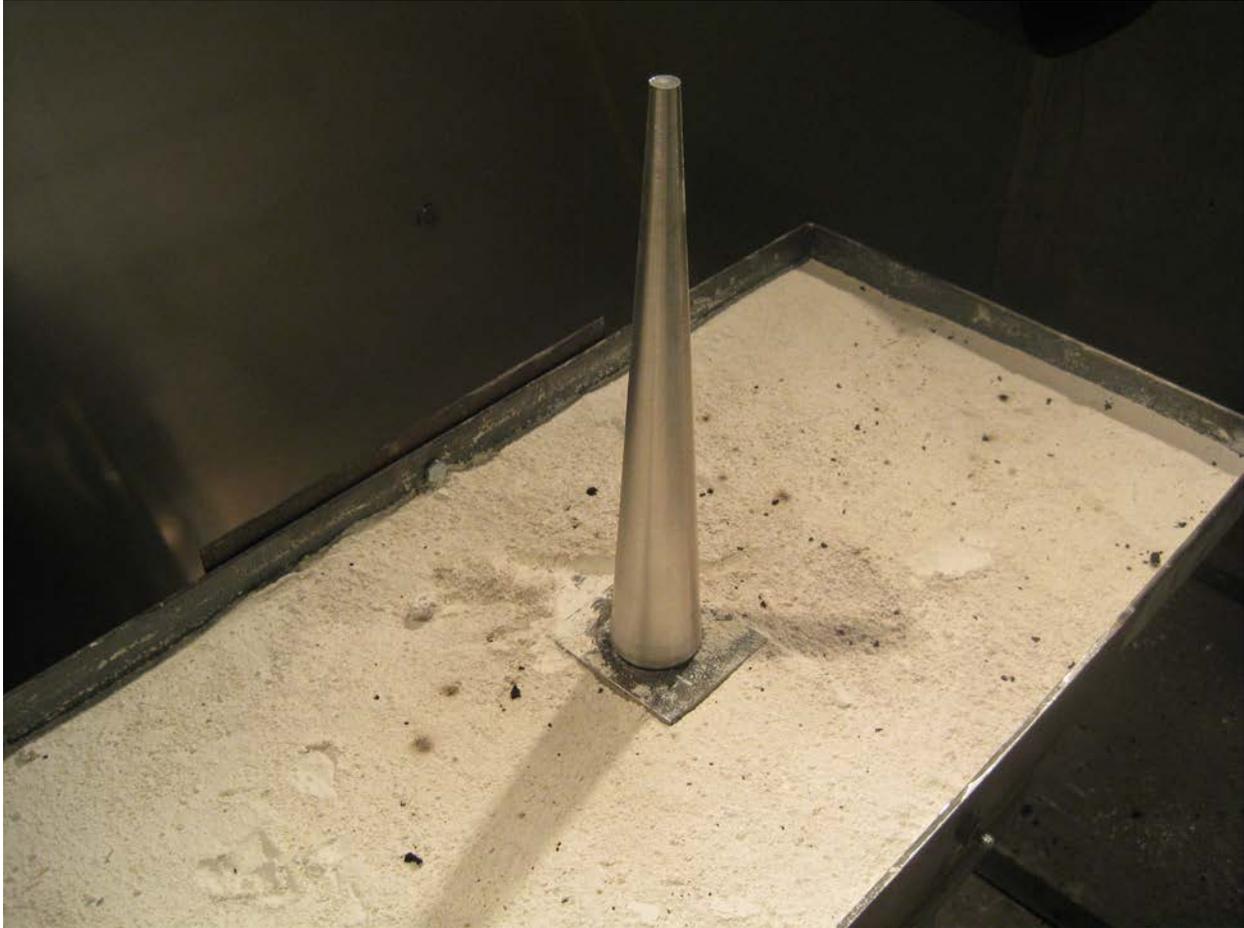
Figure 36. Truncated Cone-Shaped Test Sample Affixed in Talc-Filled Catch Pan (2/8/2011)

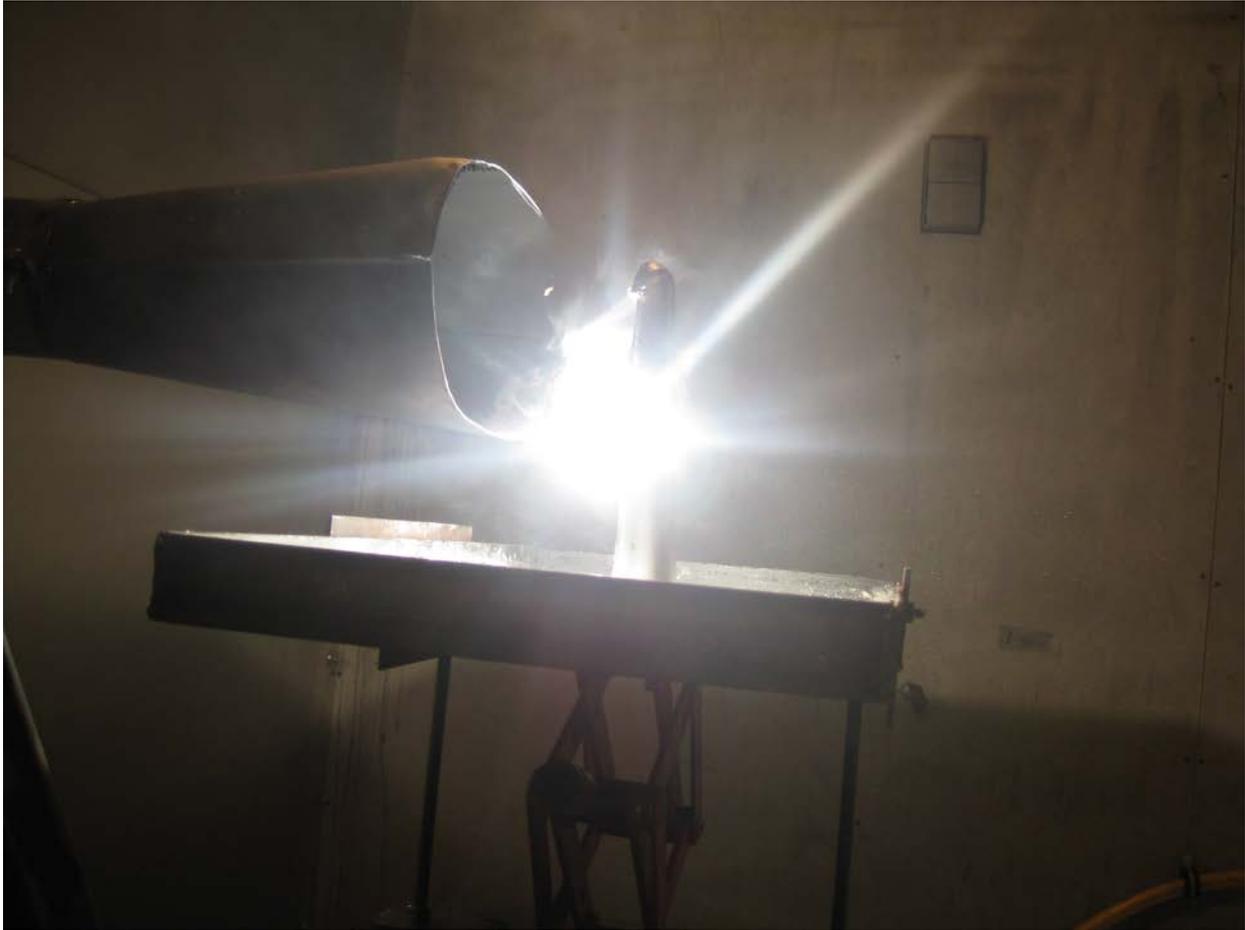
Figure 37. Typical Ignition of Truncated Cone-Shaped Test Sample (2/8/2011)

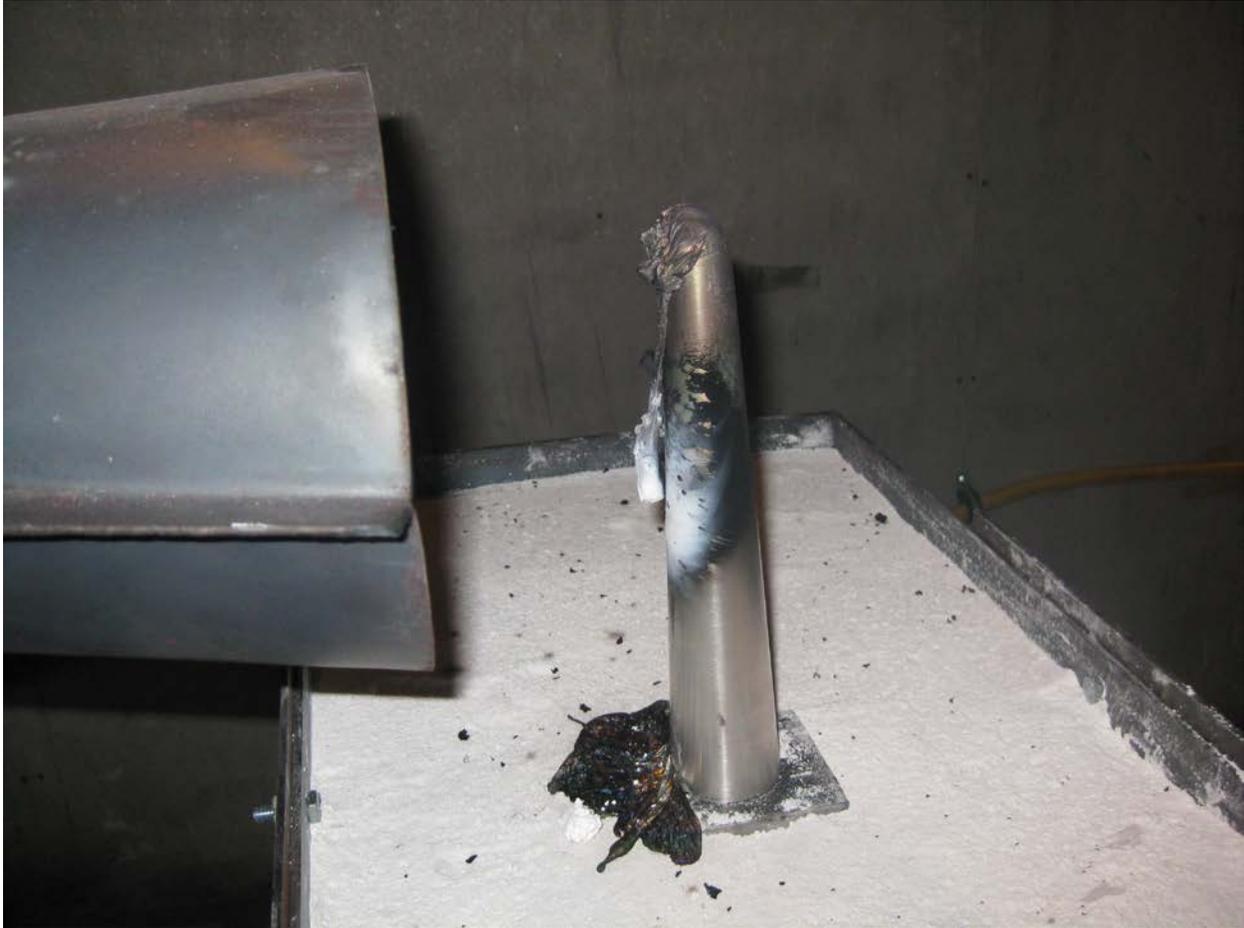
Figure 38. Post-Test Inspection of Truncated Cone-Shaped Test Sample (2/8/2011)

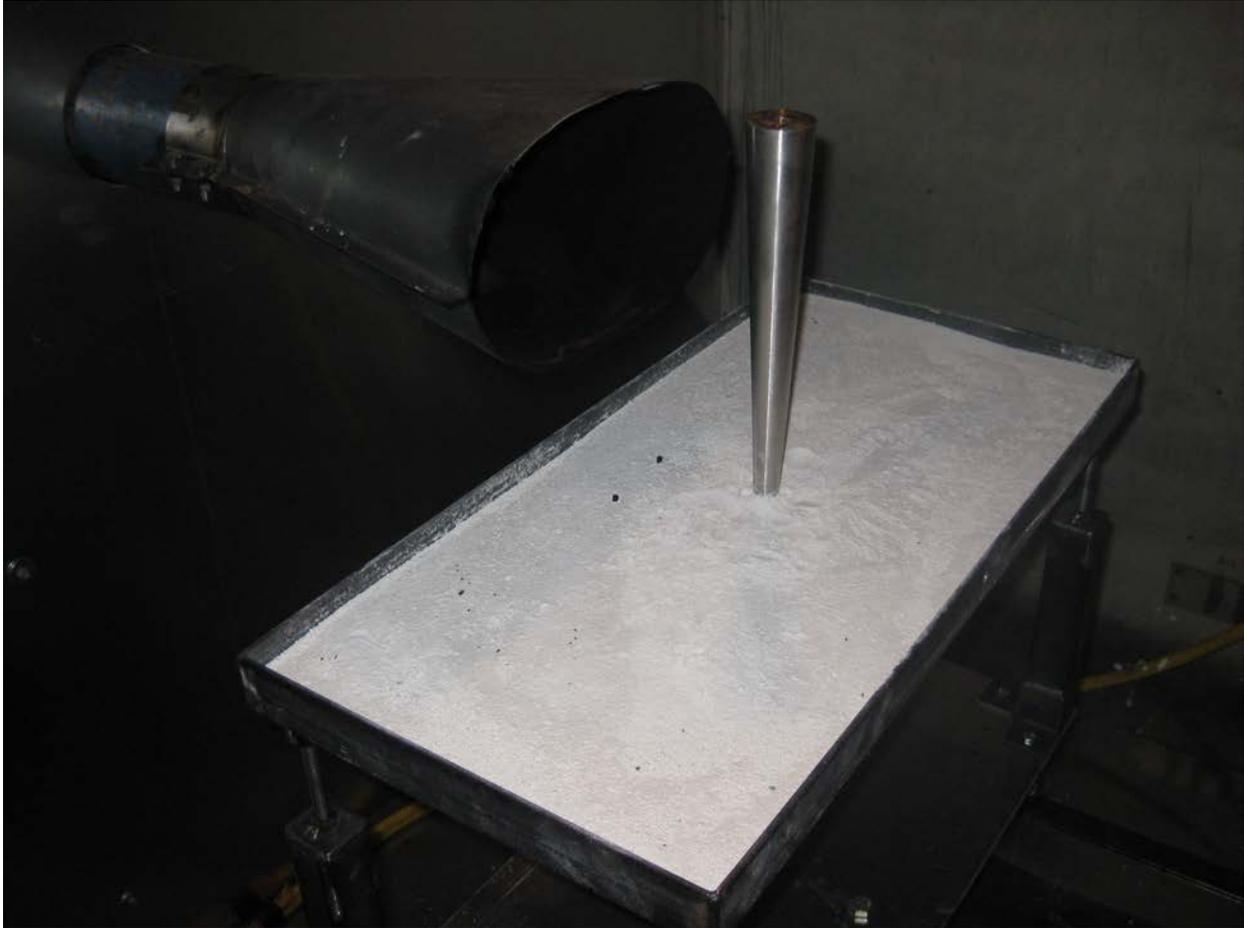
Figure 39. Inverted, Truncated Cone-Shaped Test Sample (2/16/2011)

In an effort to prevent the formation of the thin, irregular-shaped appendages during the melting process, a sixth test was conducted on an inverted, truncated, cone-shaped sample (figure 39). Because the larger mass of the conical base was now positioned in the midst of the burner flames, it was theorized that this could slow down the melting sequence, resulting in a more gradual and possibly more regular-shaped melting area.

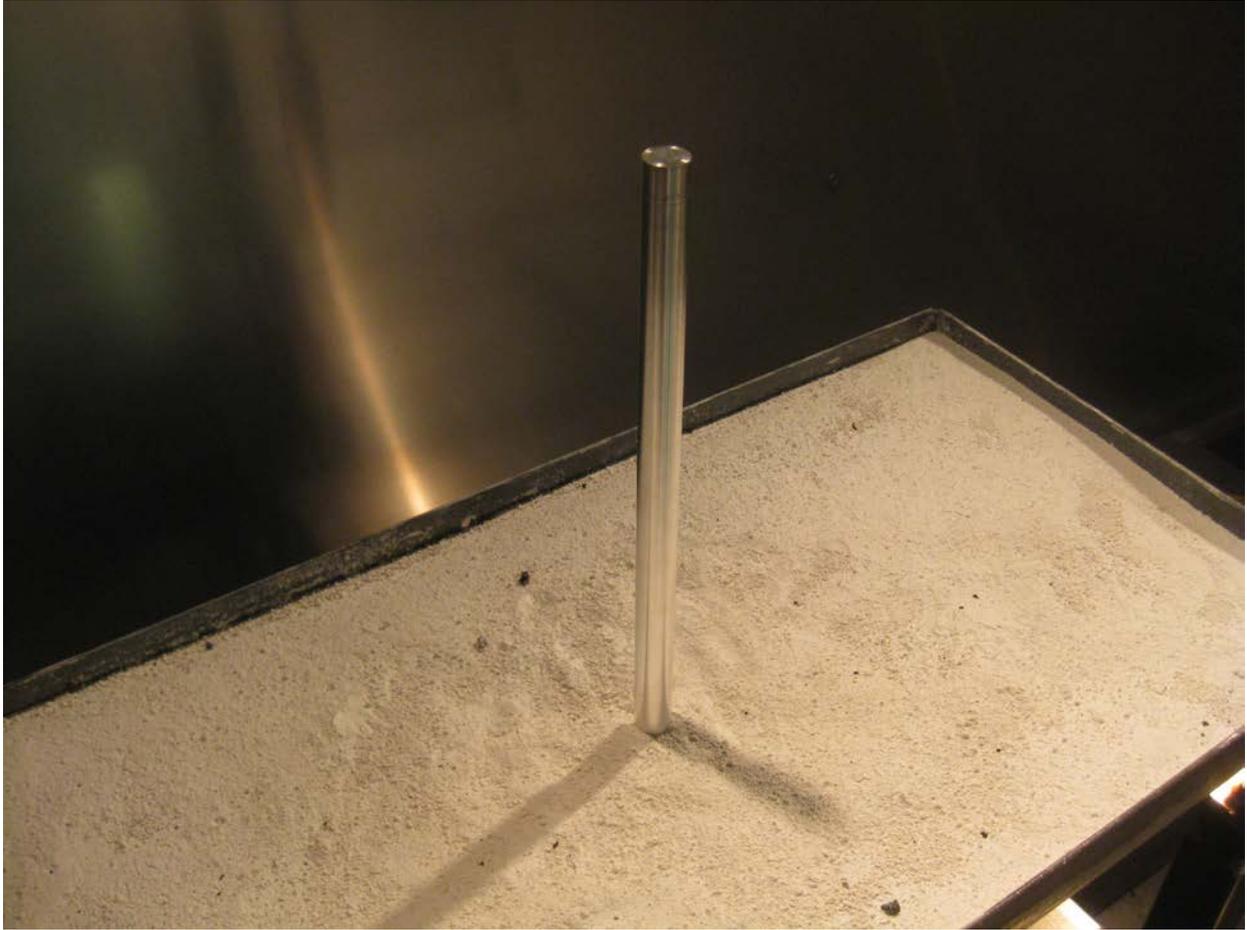
Figure 40. Cylinder-Shaped Test Sample Affixed in Talc-Filled Catch Pan (2/24/2011)

To evaluate another sample configuration, one of the original WE43 truncated cone samples was machined down on a lathe to produce a thin, upright cylinder for testing (figure 40). As expected, because of the reduction in mass, the cylindrical sample melted after 1 minute and 40 seconds of exposure to the burner flames. During the melting, a fairly large portion of the alloy separated from the sample and fell into the catch pan, igniting simultaneously. At approximately 2 minutes and 40 seconds, the remaining upright sample ignited while the molten material in the catch pan continued to burn. The burner flames were terminated 30 seconds later at 3 minutes and 10 seconds. The upright sample self-extinguished on burner flame removal, but the molten material in the catch pan continued to burn for an additional period of time (figure 41).

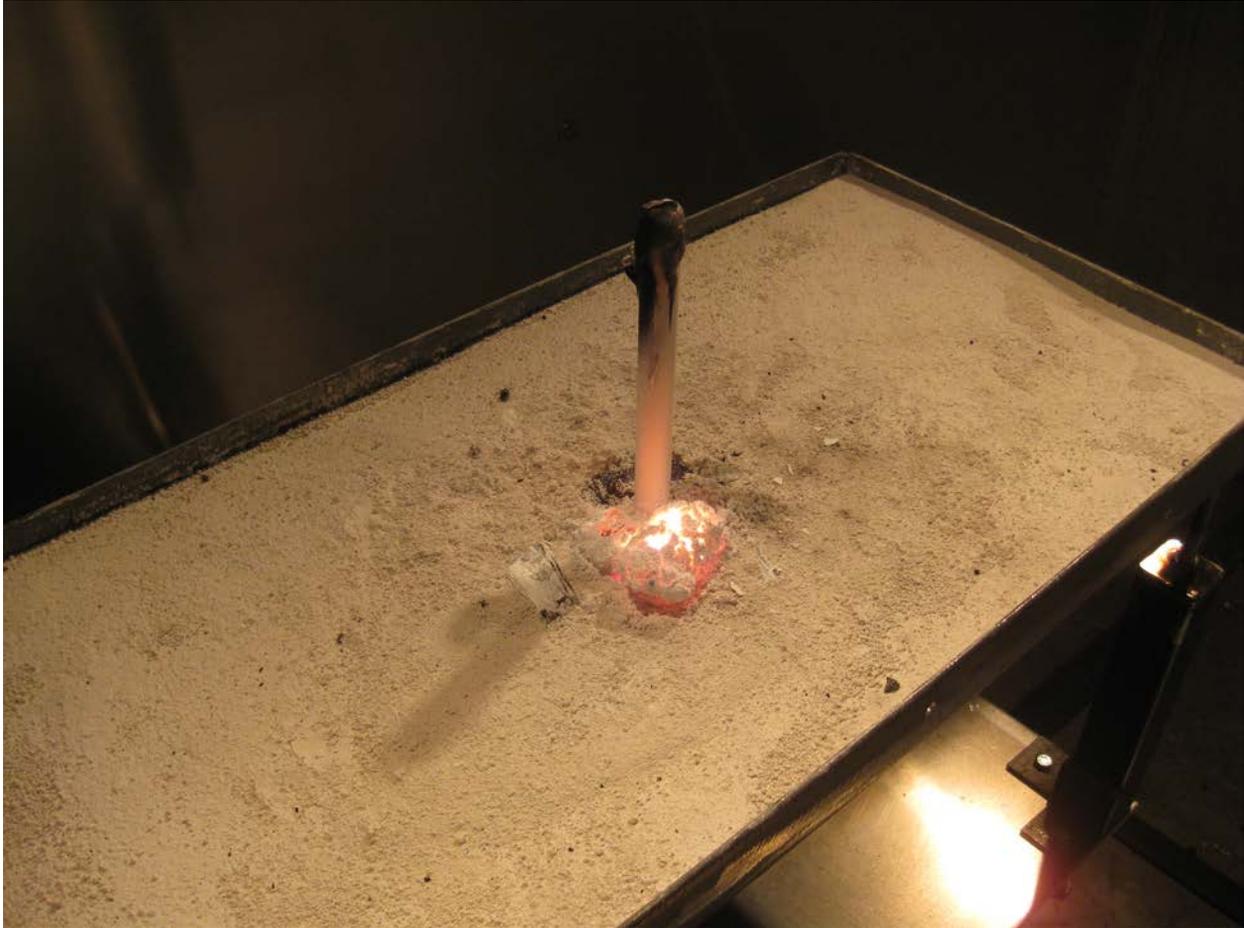
Figure 41. Cylinder-Shaped Test Sample Showing Large Segment Separating and Falling Into Talc-Filled Catch Pan (2/24/2011)

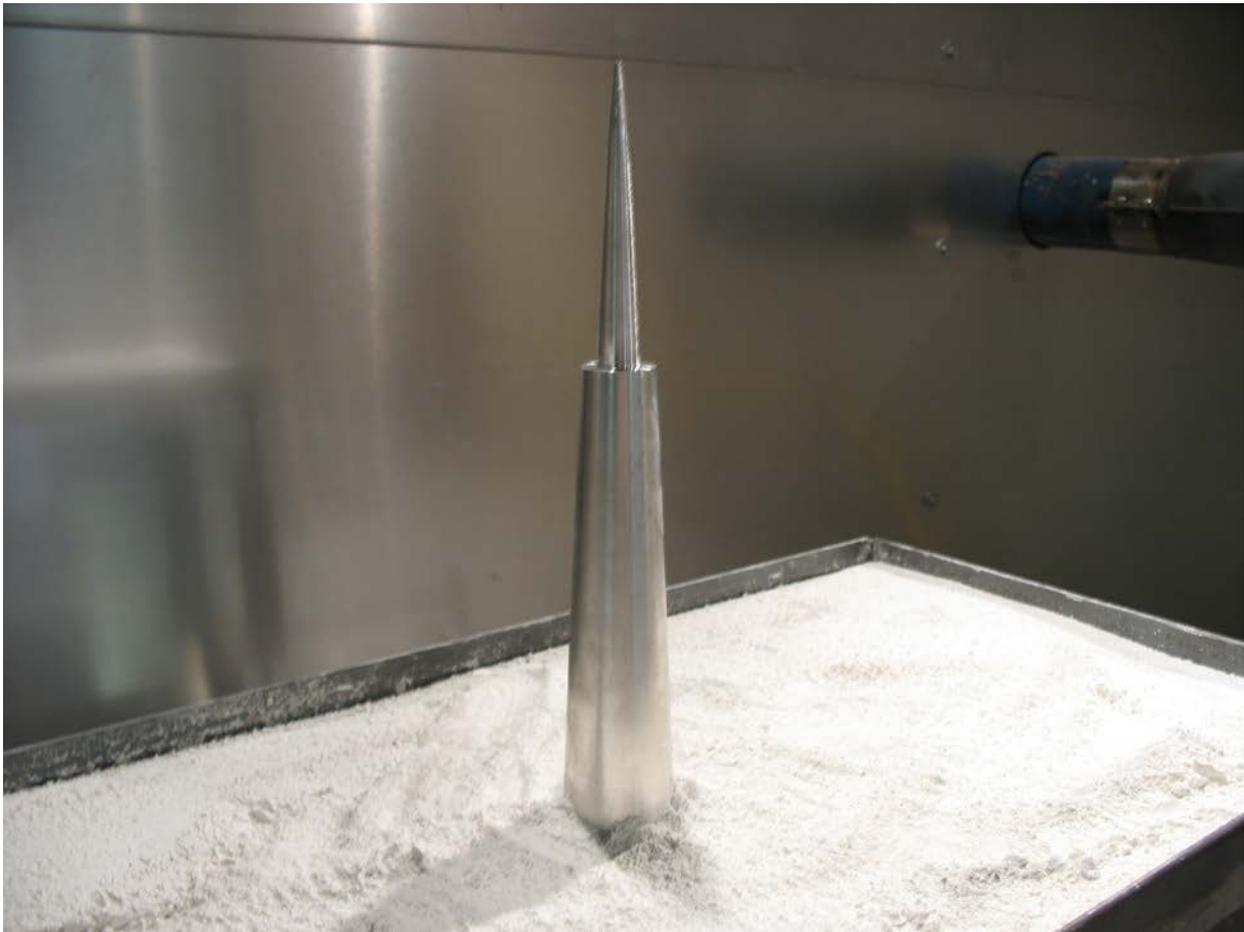
Figure 42. Conical Step-Shaped Test Sample Affixed in Talc-Filled Catch Pan (3/22/2011)

A quick review of the truncated cone-shaped sample test results indicated the melting and resolidification of material was highly random, with no set appendage formation pattern being observed. As a result, it was likely the extinguishment outcomes would not be as repeatable as desired. Furthermore, these initial tests showed that a fairly large percentage of the material continued to fall into the catch pan on melting, which was not the objective of the cone configuration. The initial intent was to have a very small mass of the sample melt at the top, ignite, and burn like a candle. In an attempt to force this condition, one of the original truncated cone samples was machined down into a thinner cone at the top, while retaining the original cone base near the bottom (figure 42). The concept of this stepped cone configuration was to allow easy ignition at the pointed tip of the cone, then subsequent ignition of the greater sample mass below. After warming up the test burner, the stepped cone was placed in front of the flames. As expected, the upper, thin portion of the sample melted in 1 minute and 24 seconds. The molten material dripped down onto the remaining sample, but did not ignite. The test progressed without ignition until 4 minutes and 37 seconds, at which point additional melting of the upper segment occurred. Immediately following this event, the sample ignited at 4 minutes and 40 seconds. The burner flames were not terminated until 1 minute later at 5 minutes and 40 seconds. The sample self-extinguished 10 seconds later at 5 minutes and 50 seconds (figure 43).

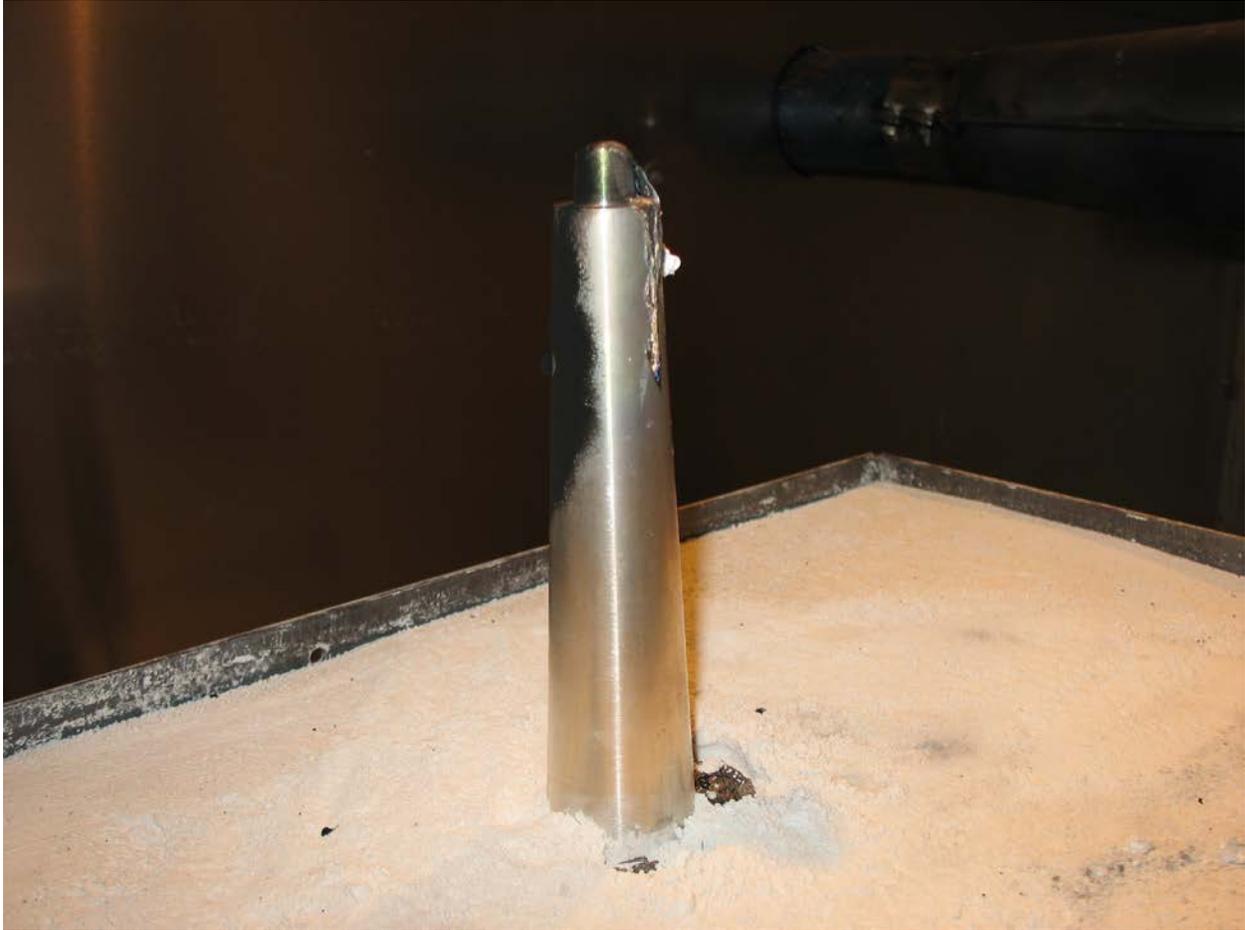
Figure 43. Post-Test Inspection of Conical Step-Shaped Test Sample (3/22/2011)

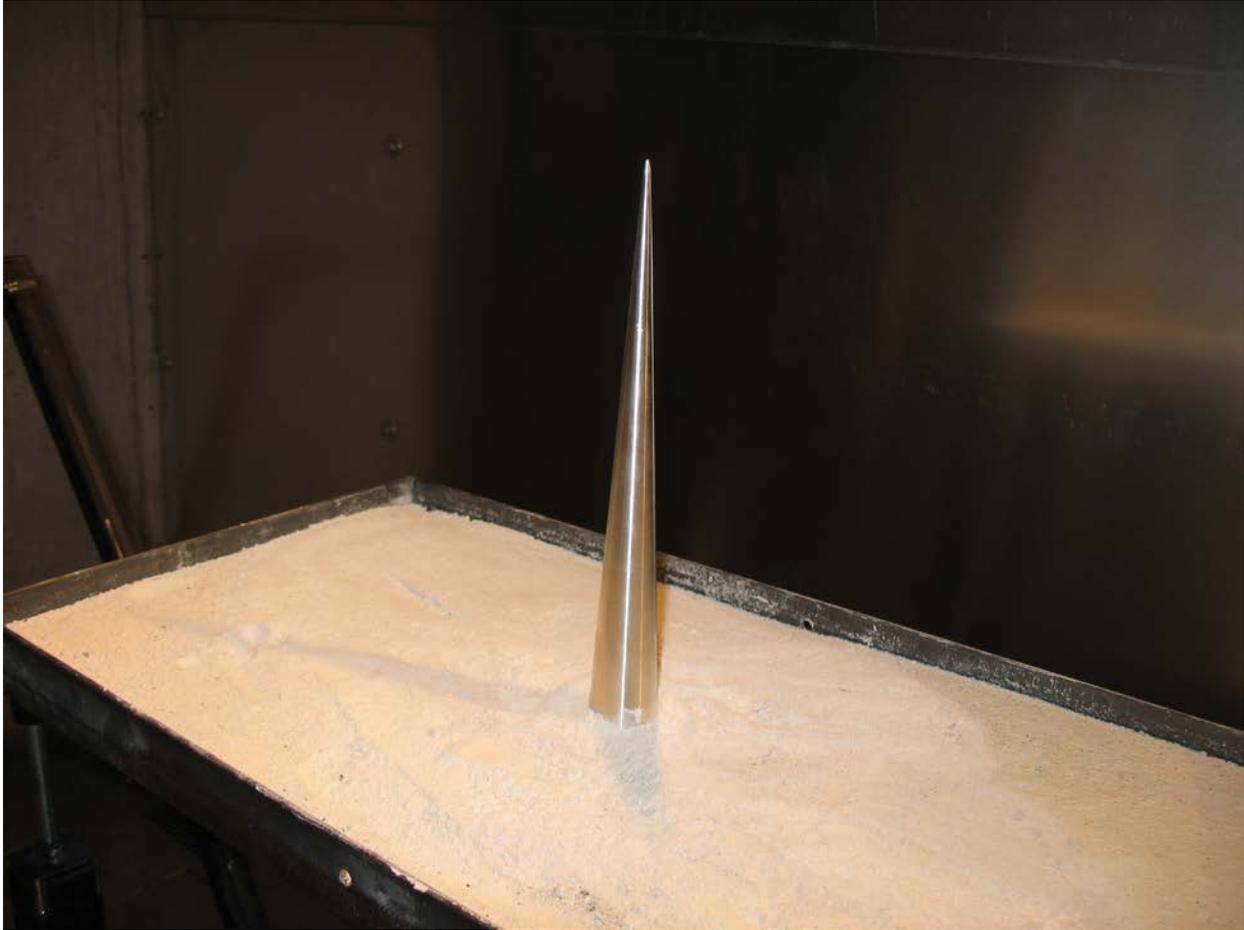
Figure 44. Cone-Shaped Test Sample Affixed in Talc-Filled Catch Pan (3/23/2011)

Although the stepped-cone sample did not burn continuously as was expected, it did show the ability of the thinner tip of the cone to melt more quickly. For this reason, one of the truncated cones was next machined down to a point, resembling a true conical shape (figure 44).

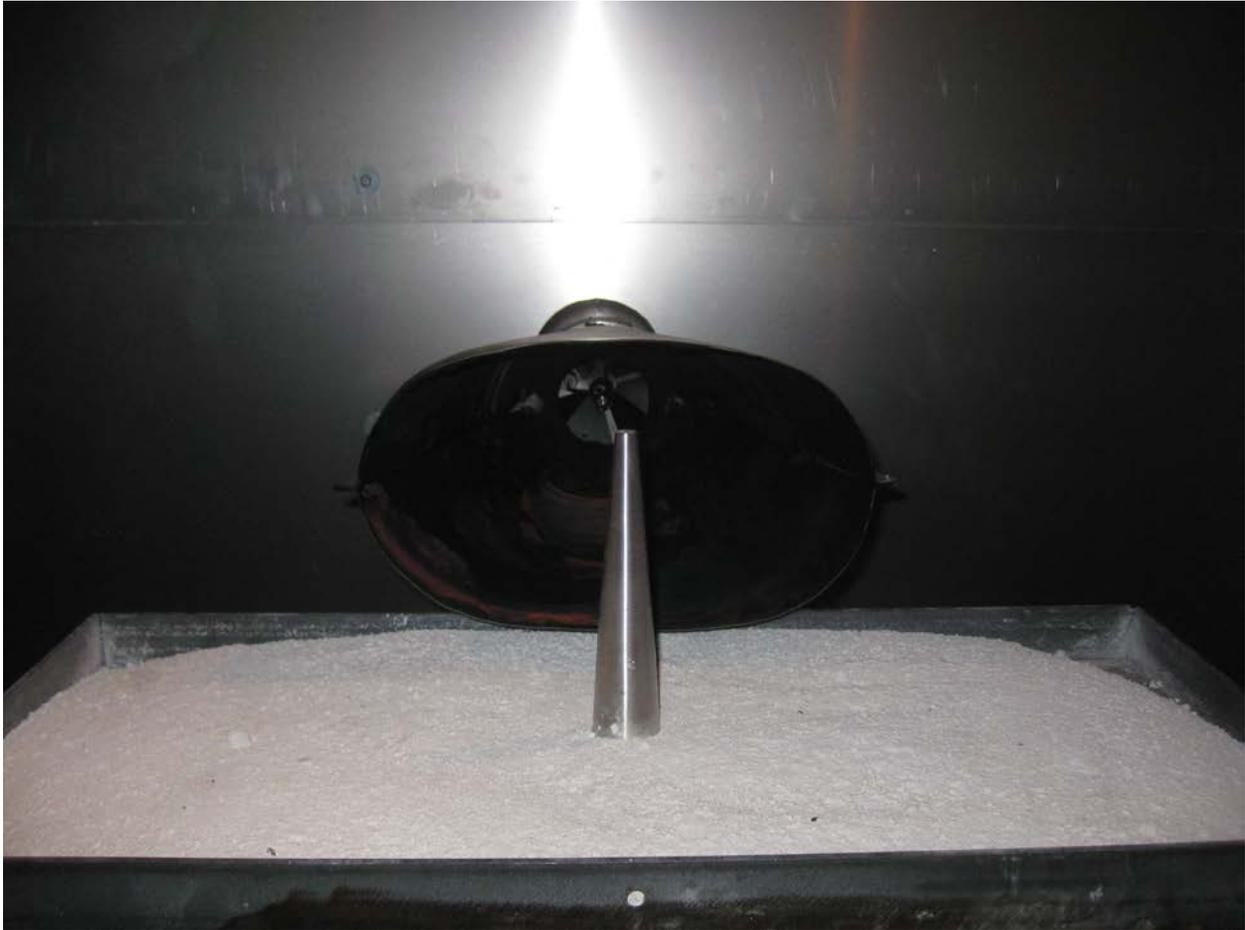
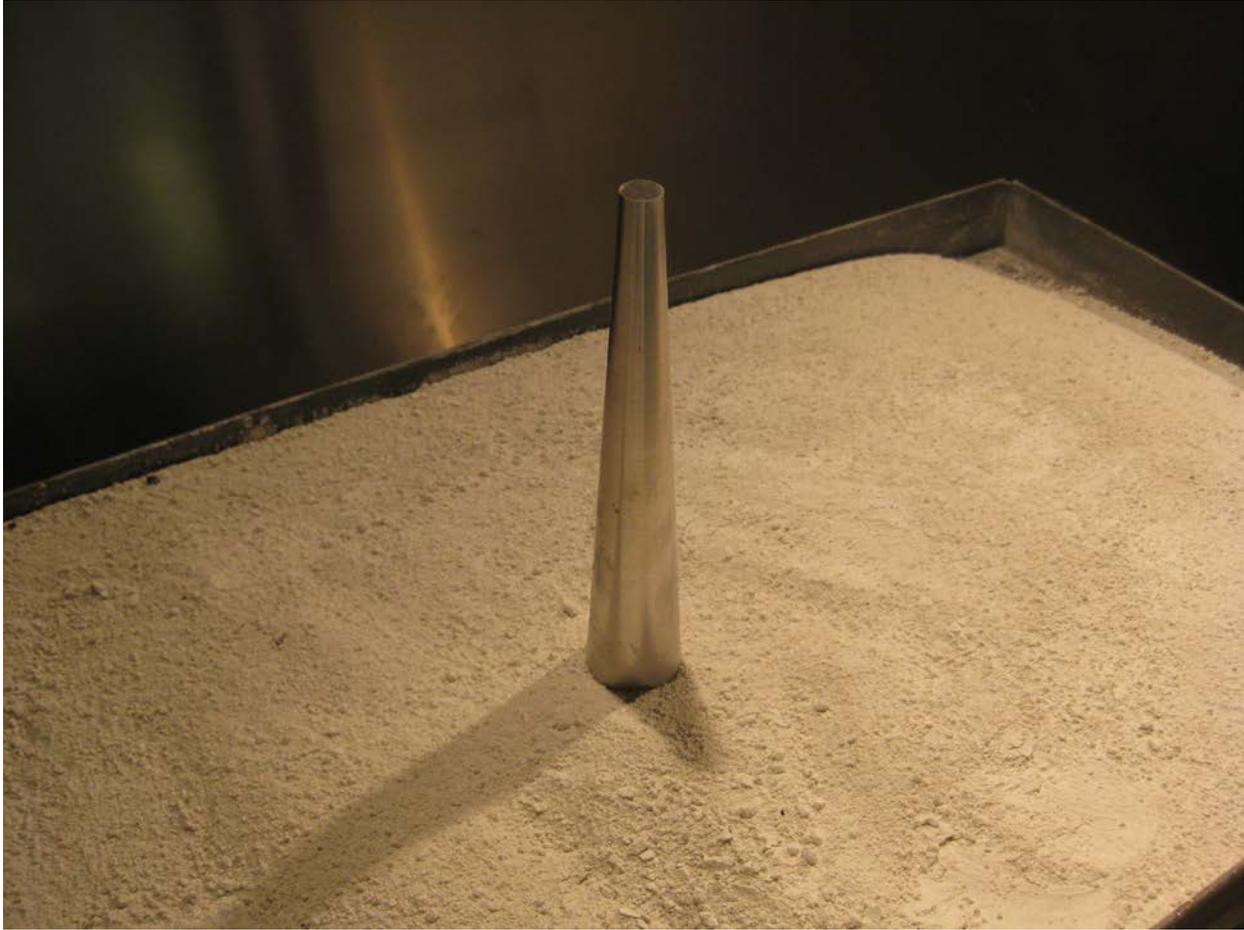
Figure 45. Shortened Truncated Cone Sample With Burner Shown in Background (3/28/2011)

Figure 46. Shortened Truncated Cone Sample (3/28/2011)

portion of the sample height melted and fell away from the burner flames, resulting in no ignition. In an attempt to keep more of the sample mass in front of the flames, the next several tests were conducted using the upper 6 inches of the original approximately 10-inch-high truncated cone samples. Essentially, the lower 4 inches of the samples were removed, resulting in a slightly smaller base diameter (figures 45 and 46).

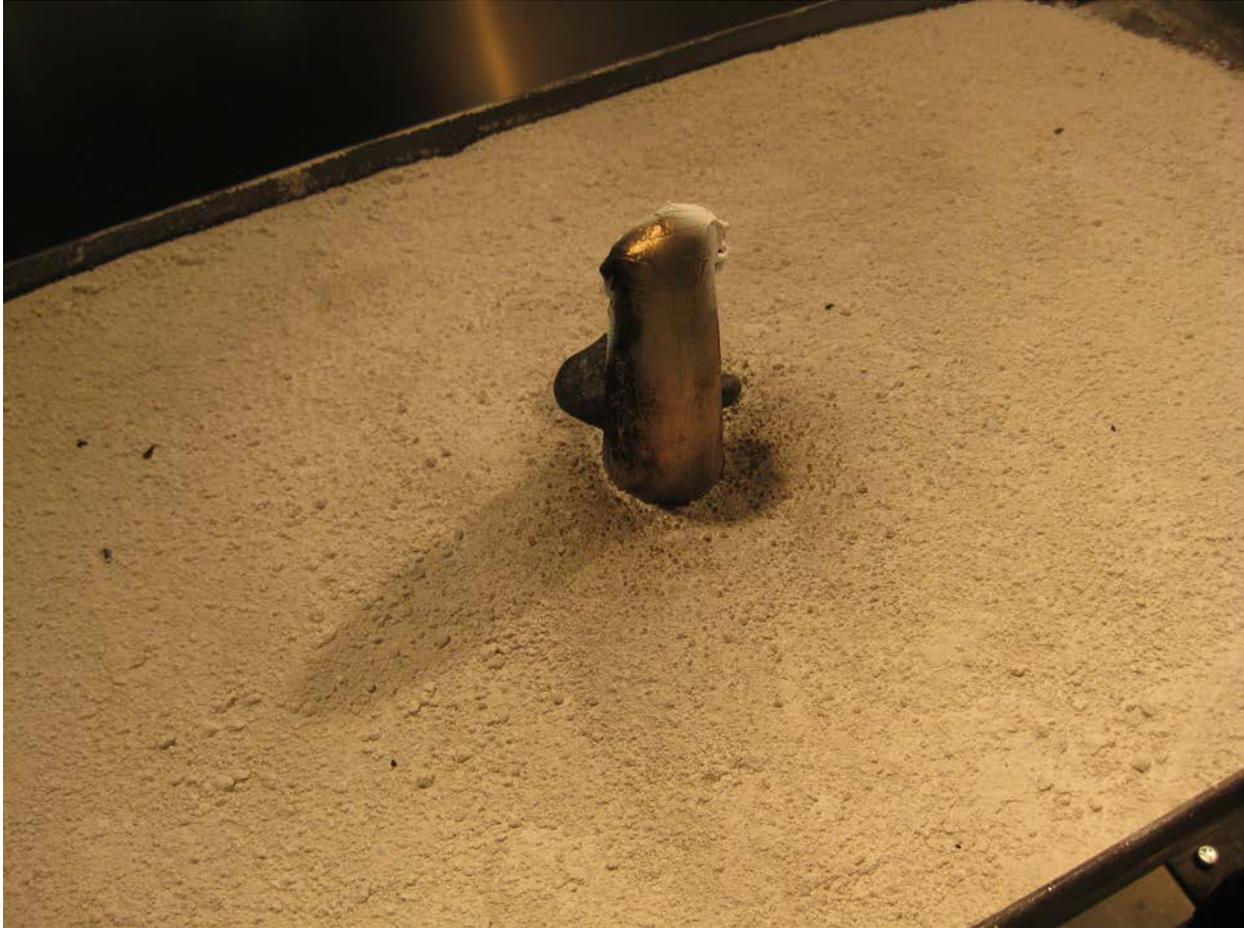
Figure 47. Post-Test Examination of Shortened Truncated Cone Sample (3/28/2011)

During the initial test of this configuration, the top of the sample was situated at 2 inches above the horizontal centerline of the burner. Following burner application, the first sample melted at 3 minutes and 55 seconds, at which point it simultaneously ignited and continued to burn. The burner flames were terminated 1 minute later at 4 minutes and 55 seconds and the sample continued to burn until 6 minutes and 20 seconds, at which point the sample self-extinguished (figure 47). The test was repeated, with melting of a small portion of the top of the sample at 2 minutes and 15 seconds. Despite the melting, the sample did not ignite, so the test was continued. At 3 minutes and 30 seconds, an additional mass of material melted; ignition occurred simultaneously. The burner flames were terminated at 4 minutes and the sample continued to burn for an additional 9 minutes and 30 seconds. As mentioned previously in this section, it was difficult to determine the exact point in time when the sample self-extinguished, because the burning was concentrated on the mass of material that separated from the sample. This accumulated mass near the base of the sample was initially burning intensely, then gradually cooled and oxidized over a period of more than 9 minutes.

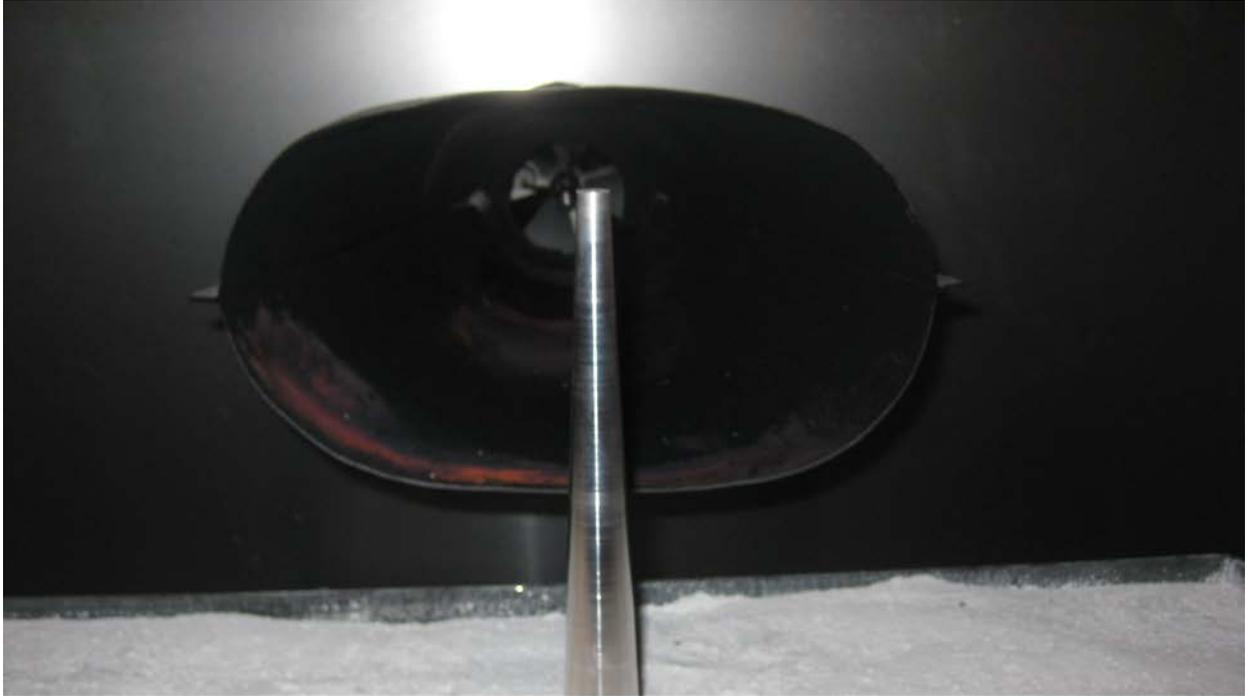
Figure 50. Truncated Cone Sample With Increased, 8-Inch Length (4/14/2011)

Two additional truncated cone samples fabricated from Elektron[®]21 were tested. The sample length was increased slightly from 6 inches to approximately 8 inches, with the smaller head diameter, to determine if this configuration yielded a shorter burn duration (figure 50). Although this alloy had not been used in any of the full-scale tests, it exhibited a high level of flame resistance during previous horizontal bar testing. The samples melted at 1 minute and 52 seconds and 1 minute and 55 seconds; secondary melt times and ignition times were comparable. However, after removal of the burner flames, both samples continued to burn for an extended period, with burn durations of over 15 minutes and 8 minutes, respectively. An increasingly large oxidation mass began to form at the top of the sample once the burner flames were removed (figure 51). Although the burning mass was initially small and burned intensely, it began to enlarge as the burning subsided and the mass cooled. This made it difficult to determine the time of extinguishment. The results of the 18 tests described in this section are summarized in table 3.

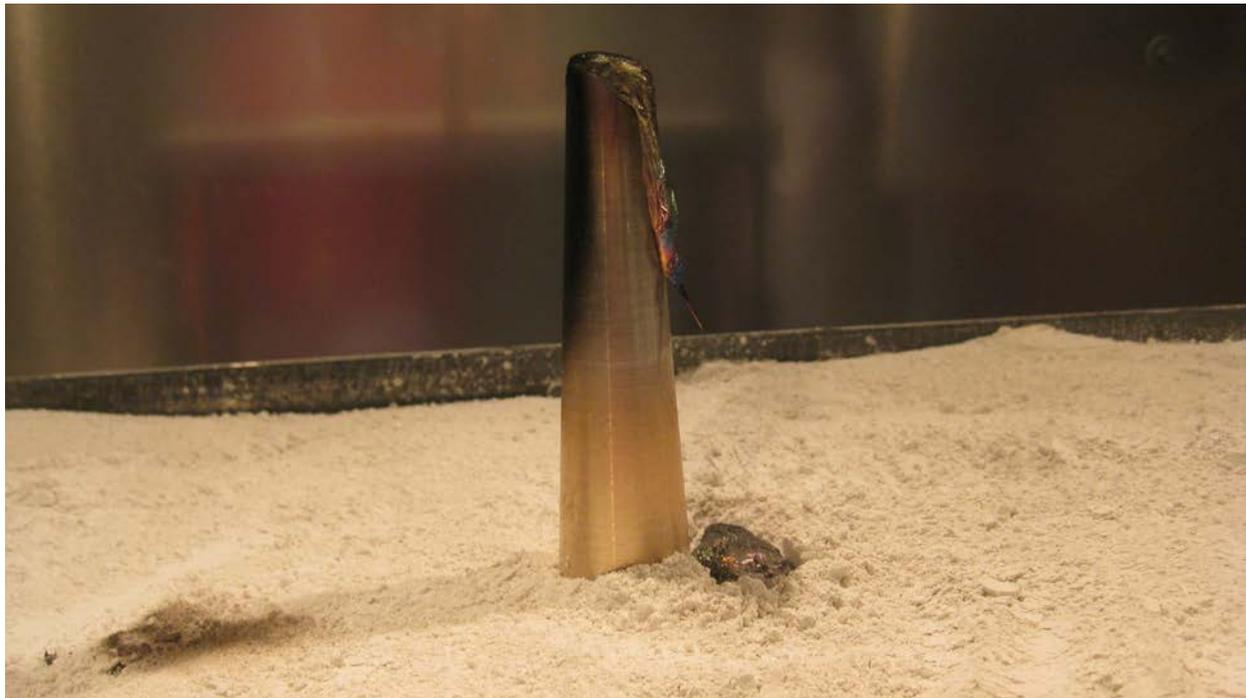
Figure 53. Pointed Conical Sample of WE43, Post-Test (5/5/2011)

The burner flames were terminated 1 minute later at 3 minutes and 45 seconds. Unexpectedly, the sample continued to burn for an additional 3 minutes and 45 seconds, which was longer than either of the two AZ31 samples had burned. Because this result was atypical, a check test was run using a 10-inch long truncated cone sample of AZ31. The sample melted at 2 minutes with ignition occurring simultaneously. The burner flames were terminated at 4 minutes and the sample continued to burn for an additional 16 minutes, completely consuming the sample. It appeared that this original truncated cone configuration was consistent in terms of AZ31 igniting and burning completely. For comparison, a final test was run on another 8-inch long WE43 pointed cone sample. During the test, the sample melted at 1 minute and 5 seconds and ignition occurred at 1 minute and 30 seconds. A secondary melting event occurred at 3 minutes and 45 seconds without disruption to the burning. The burner flames were terminated at 4 minutes and the sample self-extinguished at 5 minutes and 35 seconds. This result did not match those of either of the previous two using the pointed WE43 cones (one sample did not ignite and the other ignited and burned for 3 minutes and 45 seconds). The results indicated that this sample configuration produced inconsistent results. The pointed sample results are shown in table 4.
