DOT/FAA/TC-13/52

Development of a Laboratory- Scale Flammability Test for Magnesium Alloys Used in Aircraft Seat Construction

Final Report

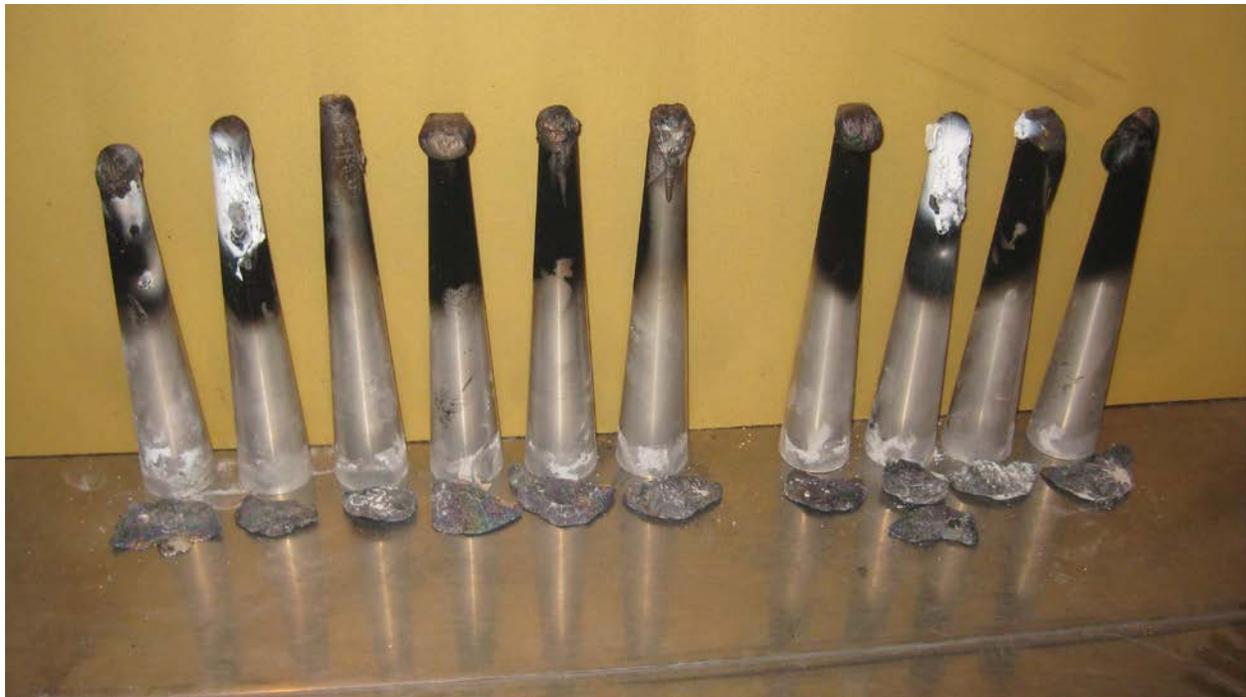
Figure 54. Post-Test Results of Truncated Cones (6/16/2011)

With the exception of four tests, the samples were positioned with the top of the sample 2 inches above the horizontal centerline of the burner cone. Beginning with test 8 of 30, the sample was positioned slightly closer to the burner so the centerline of the sample was 4 inches away from the exit plane of the burner cone (previously, the face of the sample top had been positioned 4 inches from the burner exit plane). The tests were completed over an approximate 3-month time period during a range of atmospheric conditions (e.g., external temperature, humidity, and atmospheric pressure). A quick survey of the WE43 results indicated a fairly consistent melt time in the 2-minute range with occasional excursions to more than 3 minutes and one test that required 4 minutes and 27 seconds for the sample to melt. In terms of the duration of the ignition of the WE43 samples, the results ranged from no burning (zero ignition) to complete consumption. However, a majority appeared to self-extinguish in less than 2 minutes after the burner flames terminated. Figure 54 shows a collection of post-test samples, some displaying a white, powdery residue near the top of the sample, which is indicative of oxidation/burning.

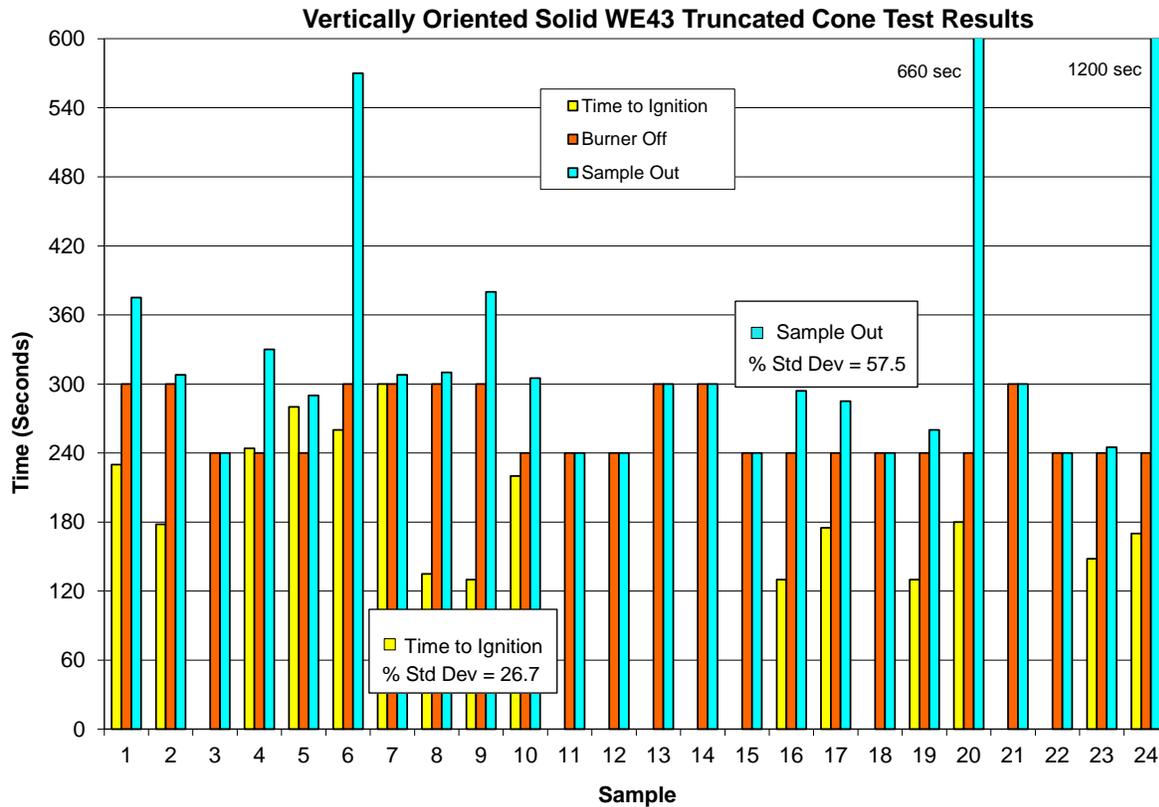
Figure 55. Charted Results of Truncated WE43 Cone Samples

The WE43 test results were charted in an effort to determine the level of test repeatability (figure 55). The chart depicts three parameters for each of the 24 tests: time to ignition, time of burner flame termination (either 4 or 5 minutes), and time of sample self-extinguishment. A cursory review indicates a lack of consistency in terms of the time required for ignition, which was problematic.

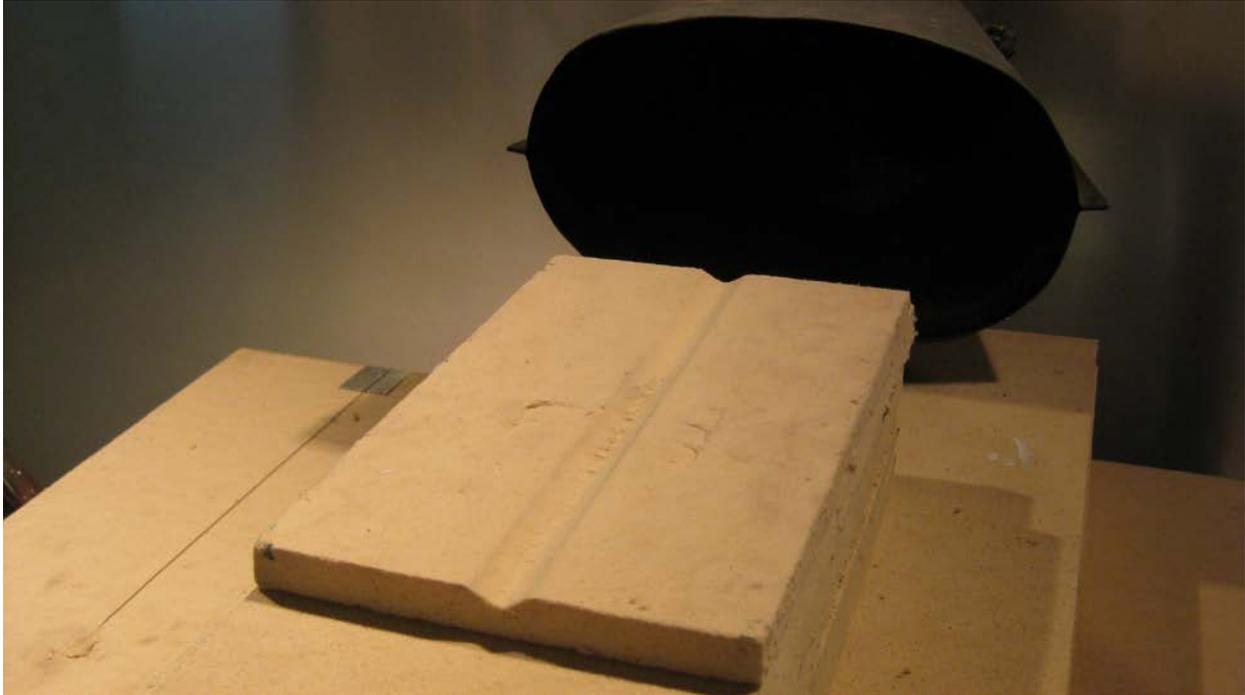
Figure 56. Test Configuration Using Grooved Ceramic Board as Sample Holder (9/20/2011)

The first concept was to orient one of the standard 10-inch-long truncated cones horizontally, resting on a grooved bed of compressed ceramic Kaowool™ boards (figure 56). The 10-inch-long horizontal sample was situated with a 1-inch section extending beyond the end of the uppermost ceramic board, allowing for this segment to melt and possibly continue to burn into the larger mass of material. An additional shelf was formed by lengthening one of the lower ceramic boards to capture any molten material that could fall below (figure 57). The tip of the sample was located 4 inches from the exit plane of the burner cone, along the horizontal axis of the burner. Following normal warmup, the sample was translated into position in front of the burner. The sample melted at 3 minutes and 25 seconds with no ignition. Additional melting also occurred at 4 minutes and 35 seconds, again without ignition. The burner flames were terminated at 6 minutes. For comparison purposes, an identical test was conducted using an AZ31 alloy sample in place of the WE43 sample. This sample melted at 3 minutes and 55 seconds and simultaneously ignited and began to burn. The burner flames were terminated at 5 minutes and the sample self-extinguished at 7 minutes and 30 seconds. This was somewhat unexpected because nearly all previous samples of AZ31 had resulted in complete consumption once ignited.

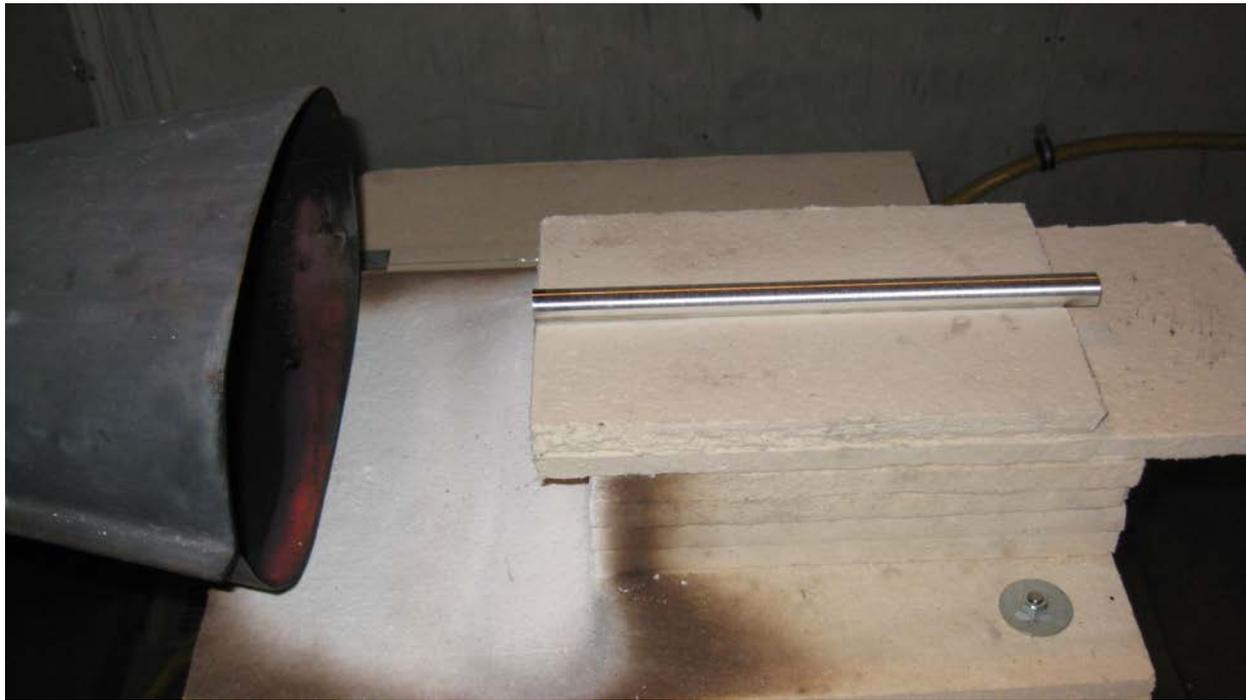
Figure 58. Thin Horizontal AZ31 Cylinder Sample on Grooved Ceramic Boards (9/21/2011)

ceramic boards (figure 58). The end face of the cylinder was situated 4 inches away from the exit plane of the burner cone. After exposing the sample to the burner flames, melting did not occur until 6 minutes and 15 seconds, at which point ignition occurred. The lengthy period of time required for melting was likely due to the small amount of material being directly exposed to the burner flames. The sample was removed from the burner flames at 7 minutes with burning continuing for an additional 15 minutes, essentially consuming the entire amount of material (figure 59).

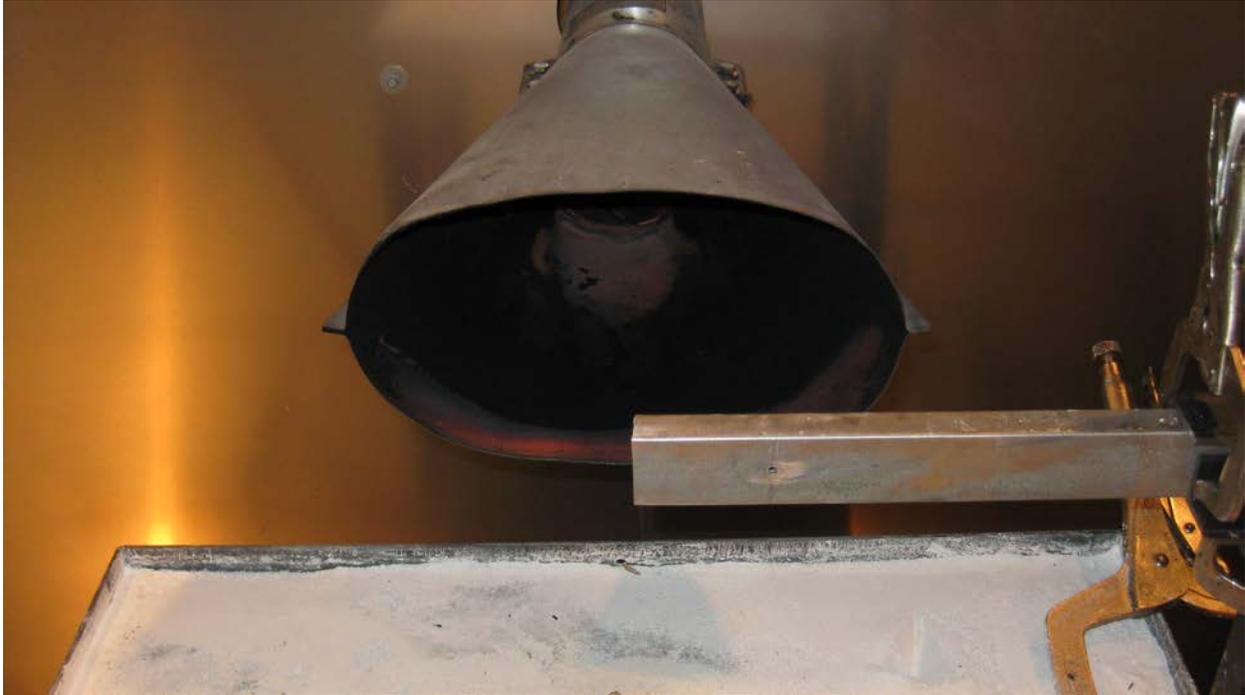
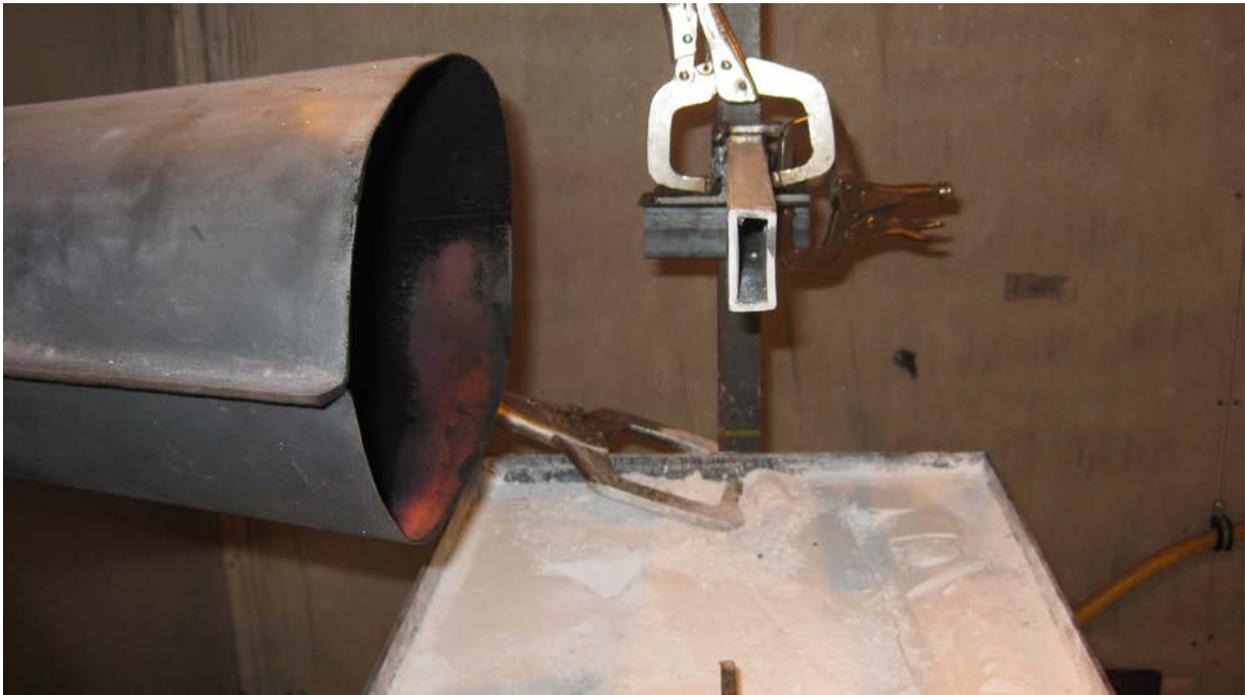
Figure 60. Rectangular WE43 Box Section Component Mounted Horizontally, Front View
(9/22/2011)

Figure 61. Rectangular WE43 Box Section Component Mounted Horizontally, Side View
(9/22/2011)

The seat-back frames used in the full-scale tests were fabricated from extruded rectangular box sections with outside dimensions of approximately 0.75 inch by 1.5 inches and a wall thickness of 0.125 inches. A 12-inch-long section of this component was cut and mounted horizontally in front of the burner with the end of the component located along the centerline of the burner, approximately 4 inches from the burner cone (figures 60 and 61).

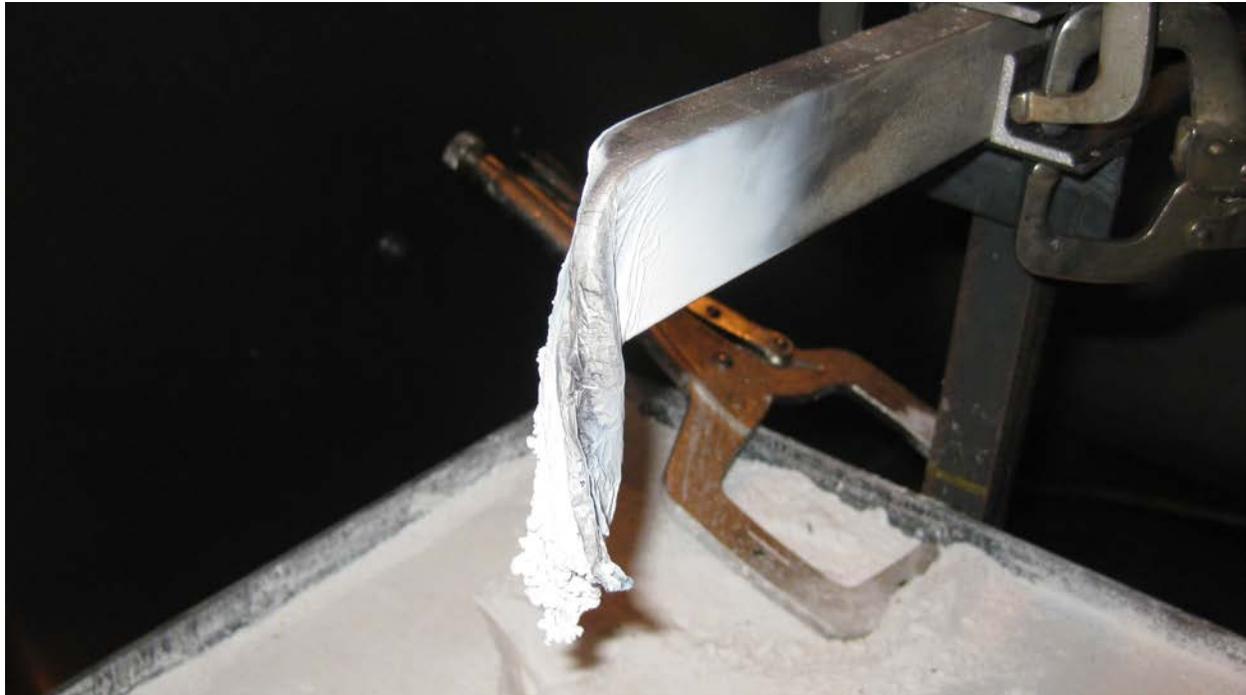
Figure 62. Rectangular WE43 Box Section Component, Post-Test (9/22/2011)

Following burner warmup, the horizontal sample was placed in front of the burner. As expected, the thin-walled sample began to yield at 2 minutes and 50 seconds, much more quickly than previous solid samples. Ignition of the material occurred simultaneously near the open end of the box sample. As the sample continued to melt and slump downward, the burning intensified. The burner flames were terminated at 5 minutes, and the sample self-extinguished at 6 minutes and 20 seconds (figure 62). This was a promising result because the original target of the project was to develop a WE43 test sample that produced an approximate 90 seconds of burning prior to self-extinguishment.

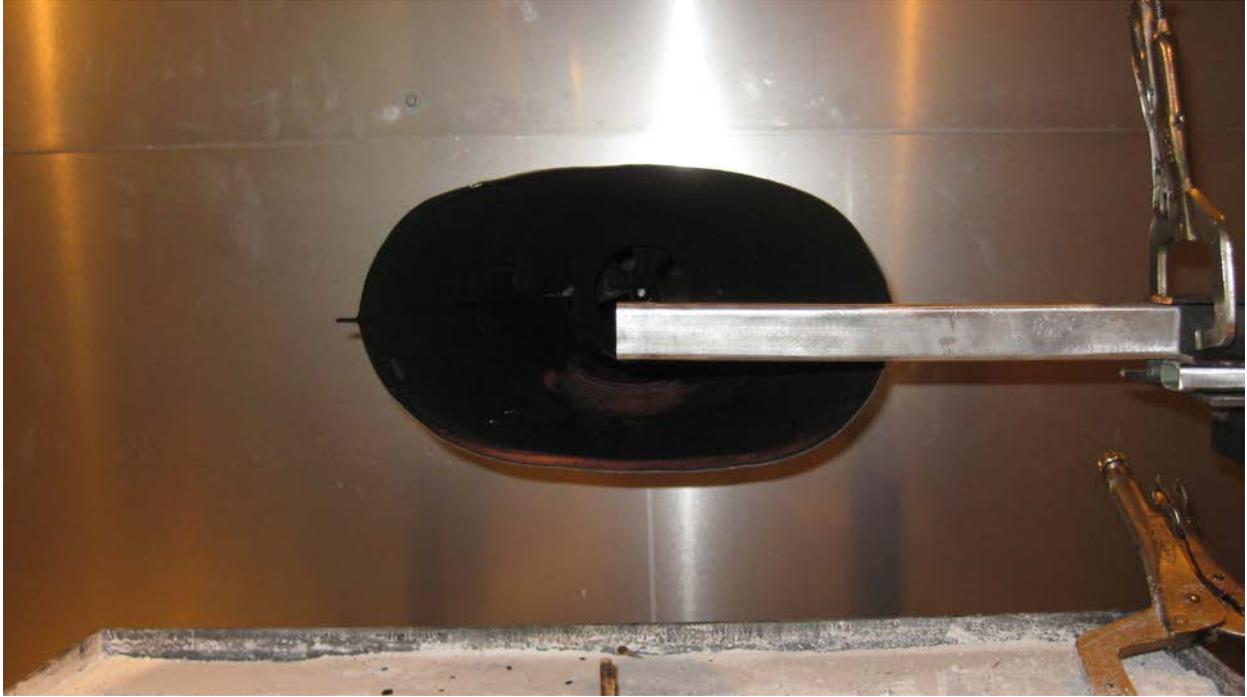
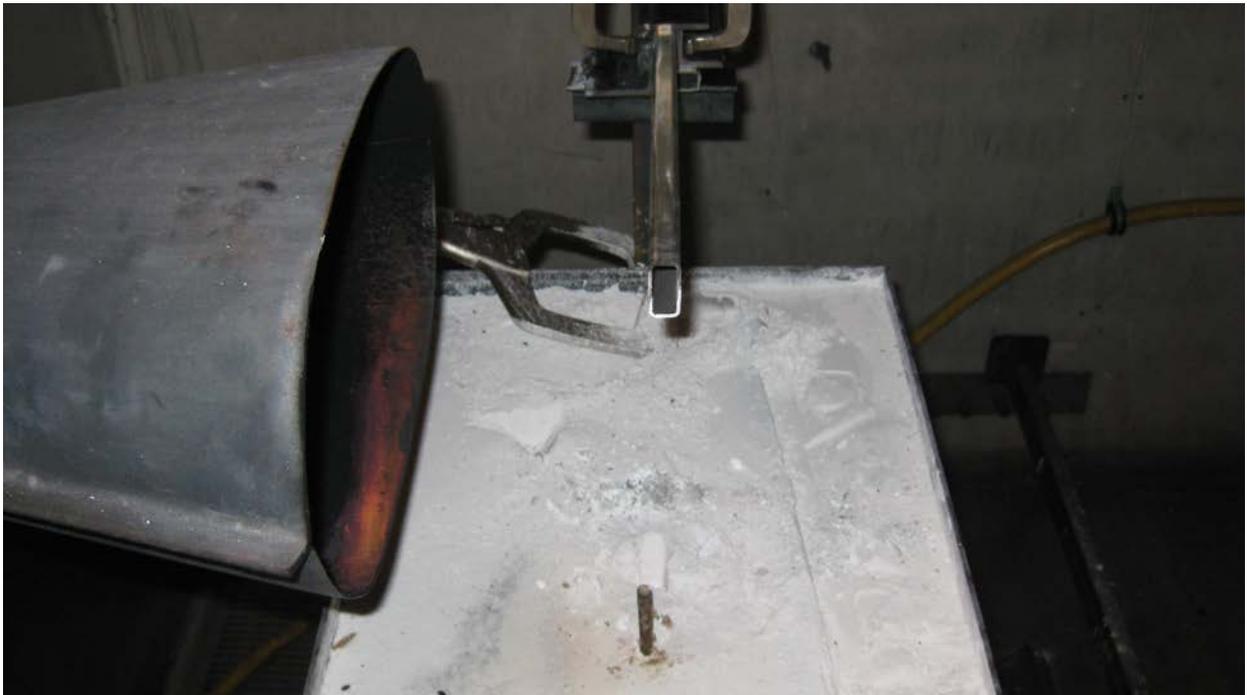
Figure 63. Small Rectangular WE43 Box Section Component Mounted Horizontally, Front View (9/22/2011)

Figure 64. Small Rectangular WE43 Box Section Component Mounted Horizontally, Side View (9/22/2011)

Because of the favorable result with the horizontally mounted box section, and because of availability, a follow-up test was run in a similar fashion on the smaller baggage bar component of the seat. This component was also a rectangular box section with rounded edges, but smaller and thinner in dimension. These components measured 0.5 inch by 1 inch with a wall thickness of 0.0625 inch. As conducted previously, a 12-inch length of the component was cut and mounted horizontally in front of the burner (figures 63 and 64).

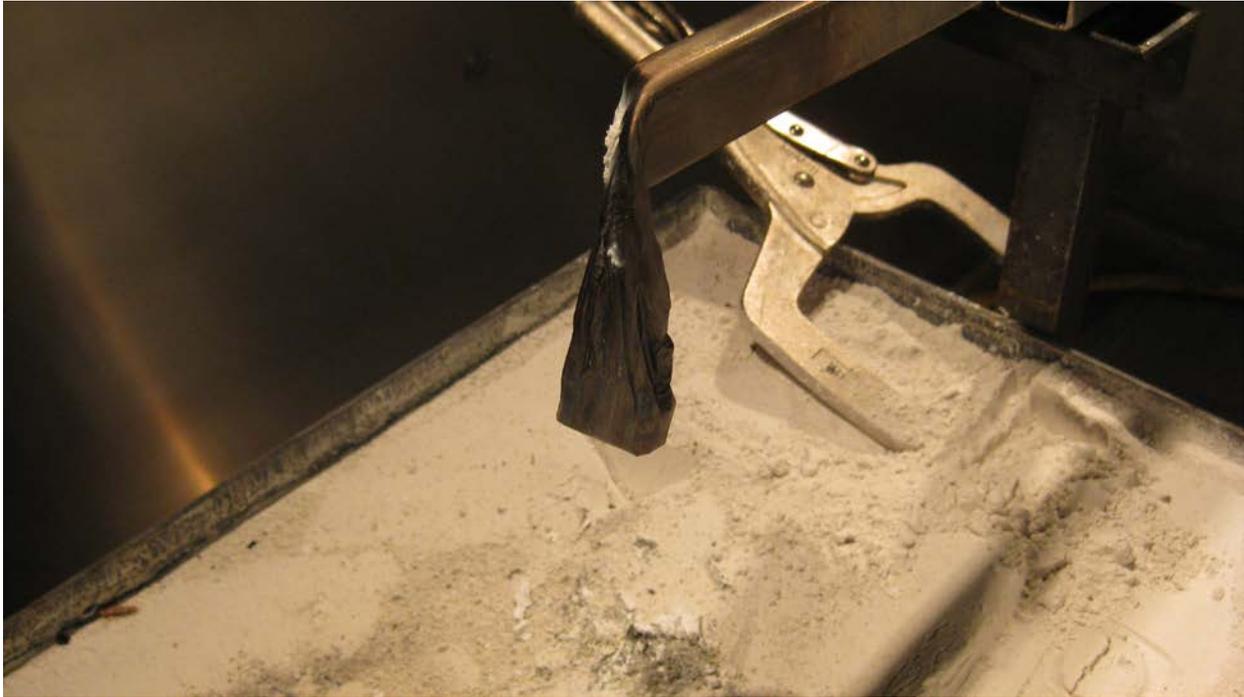
Figure 65. Smaller Rectangular WE43 Box Section Component, Post-Test (9/22/2011)

After moving the sample into the test position following burner warmup, the sample quickly began to yield at 1 minute. Although no immediate ignition occurred, the sample continued to collapse downward for the next minute, then ignited at 2 minutes. The burning intensified as the sample continued to slump and the burner flames were terminated at 4 minutes. Burning continued for an additional 20 seconds, at which point the sample self-extinguished (figure 65).

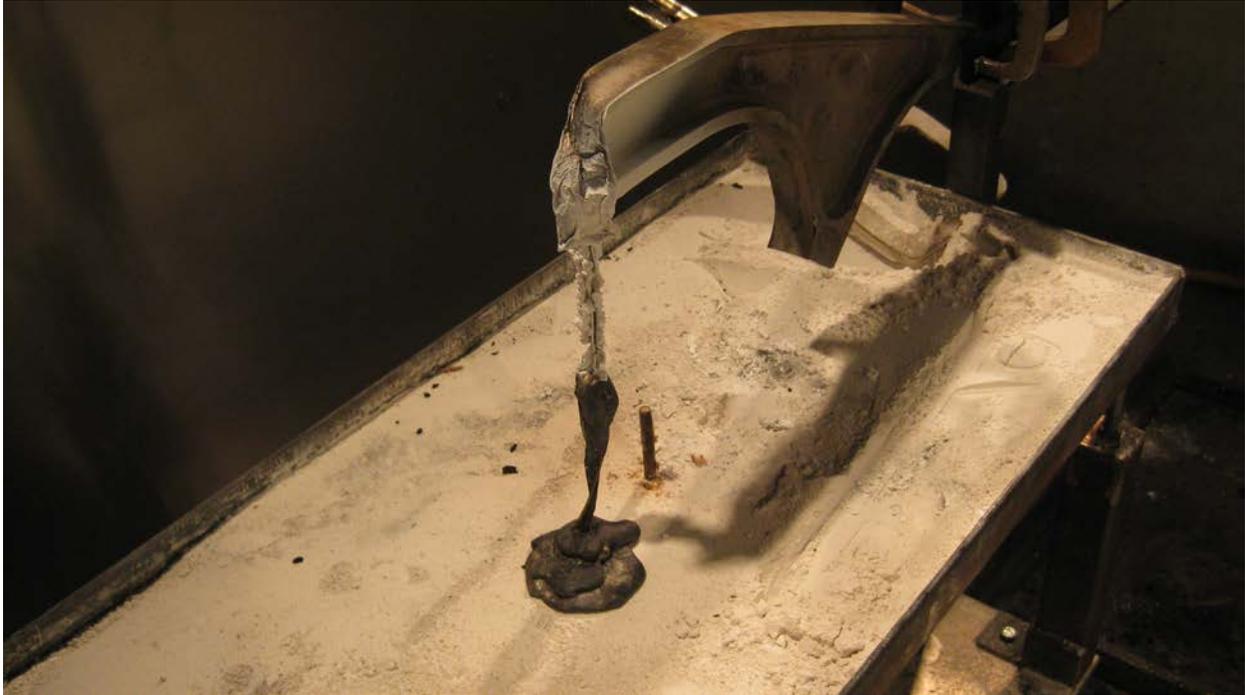
Figure 67. Thin I-Beam Cross-Section Sample, Post-Test (9/22/2011)

Following normal application of the burner flames, the sample began to melt at 3 minutes and 15 seconds. The melting occurred near the exposed end, which slumped downward. As the melting continued, the sample ignited at 3 minutes and 32 seconds. The burning intensified as the molten material eventually reached the catch pan below, forming a small puddle (figure 67). The burner flames were terminated at 5 minutes and the sample self-extinguished at 6 minutes and 30 seconds. This was a favorable outcome, as the amount of burning after flame removal was at the target amount.

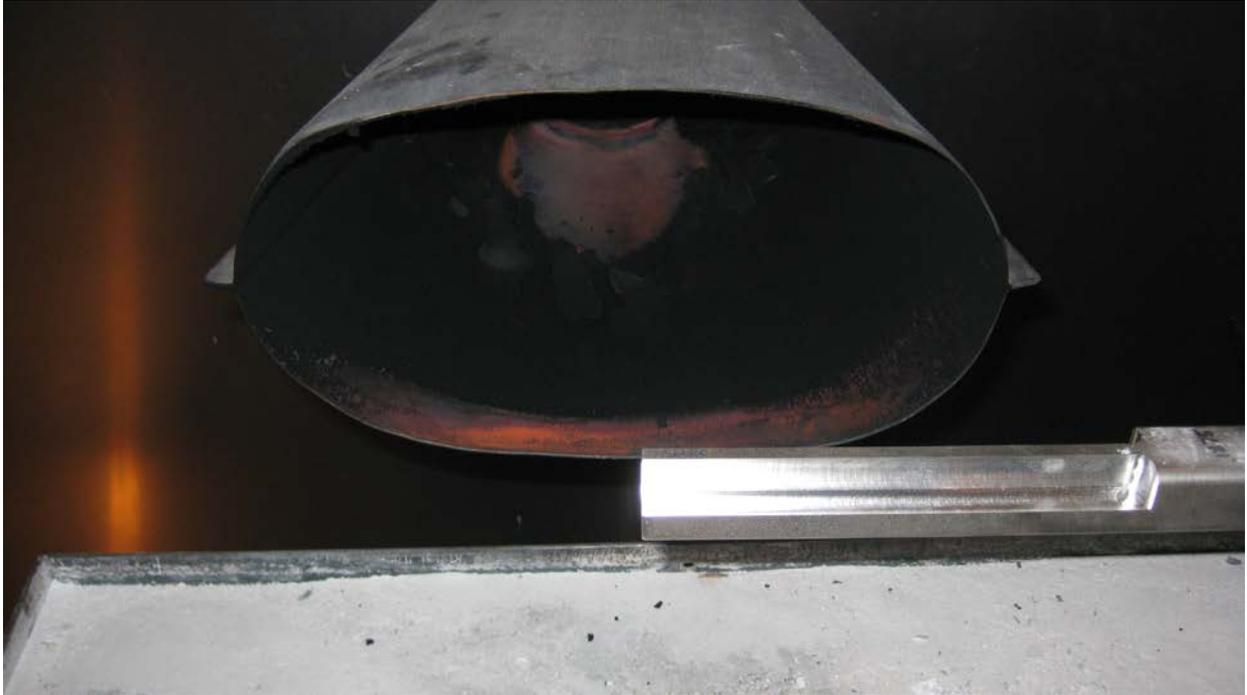
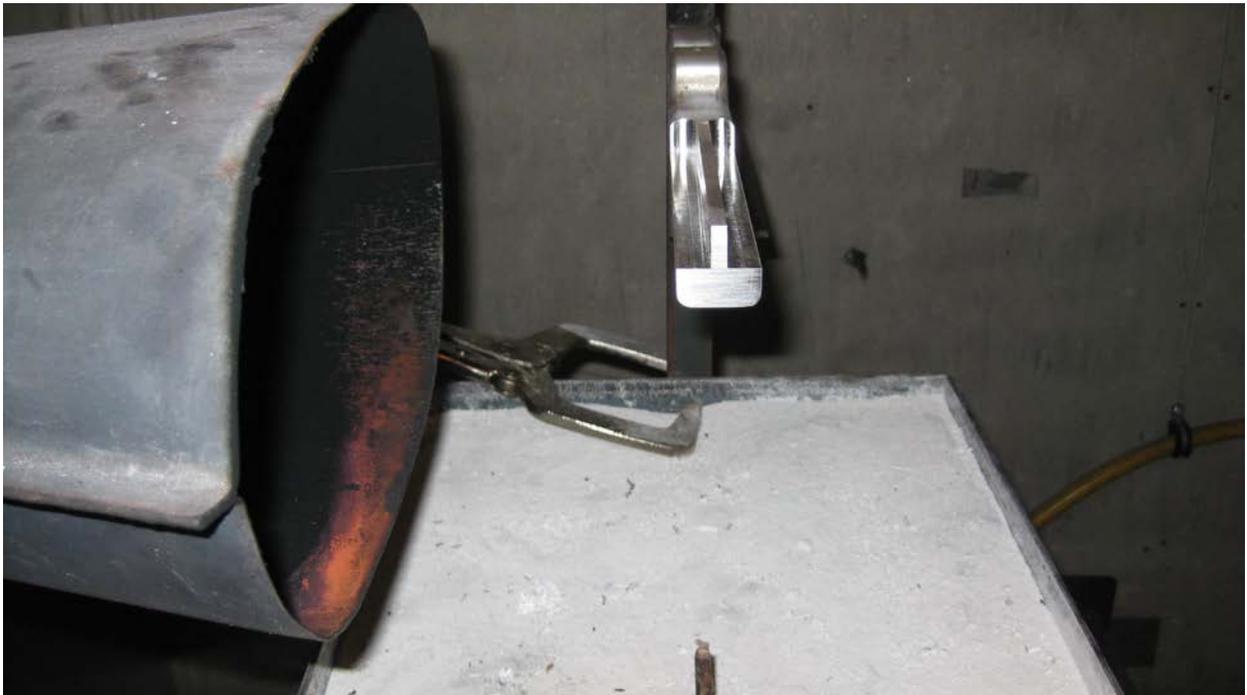
Figure 68. Thin T-Beam Cross-Section Sample Machined From Seat-Leg Component, Front View (9/27/2011)

Figure 69. Thin T-Beam Cross-Section Sample Machined From Seat-Leg Component, Side View (9/27/2011)

Testing continued on a T-Beam cross-section sample that was machined from a 12-inch-long solid square bar leg component. The 1-inch by 1-inch square cross section was machined on two faces, leaving a T formation approximately 6 inches in length, which was mounted horizontally in front of the burner (figure 68). The bottom web was approximately 0.5 inch thick, whereas the vertical flange measured 0.1875-inch thickness by a height of 0.5 inches (figure 69). The front face of the vertical flange was positioned 4 inches from the exit plane of the burner cone.

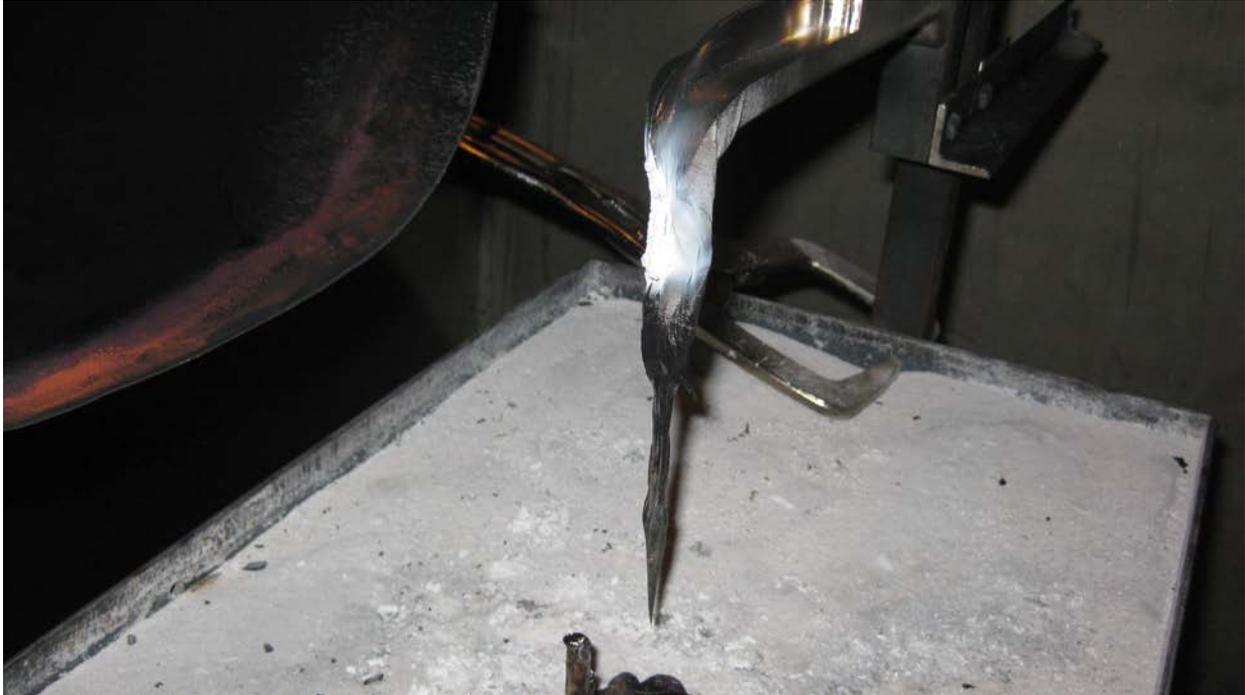
Figure 72. Thin T-Beam Cross-Section Sample, Post-Test (9/28/2011)

Although this T-shaped cross section showed initial promise, the results were again inconsistent in terms of the duration of burning following termination of the burner flames. Because the machining process needed to produce these samples was very time consuming, the testing was discontinued in favor of a more realistic and affordable approach. Although the testing performed to that point did not result in the final selection of a particular sample configuration, the experiments were viewed as exploratory, thus providing information for future experiments.

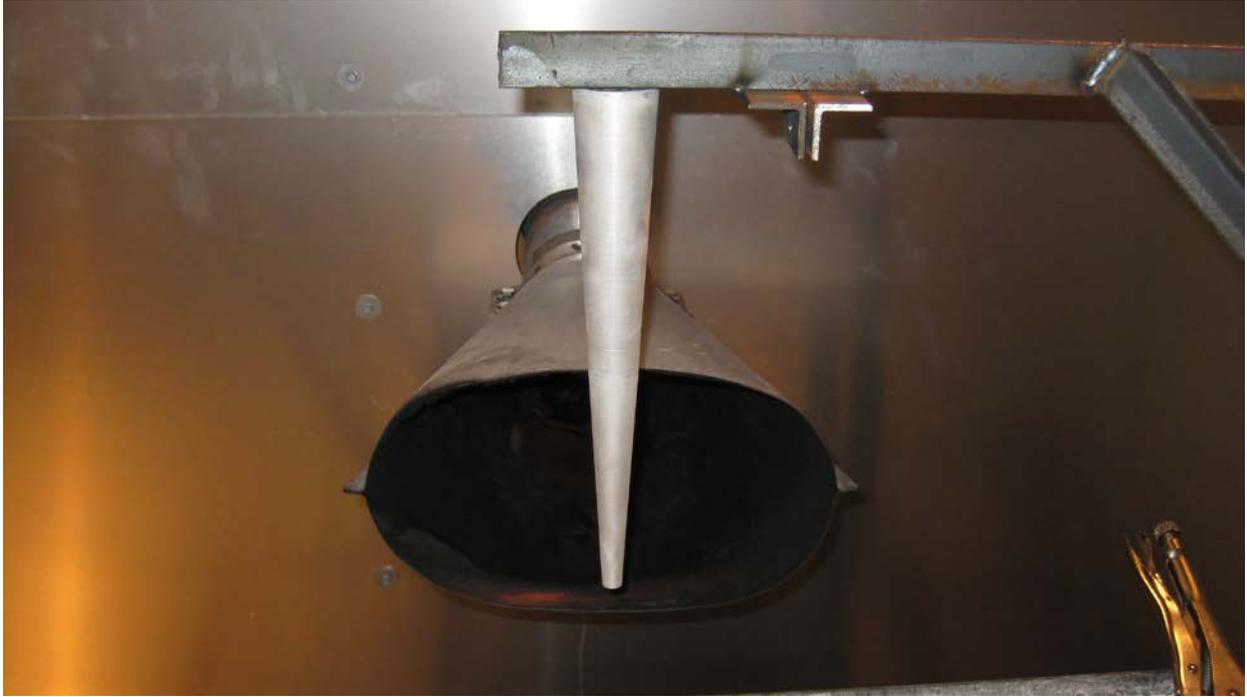
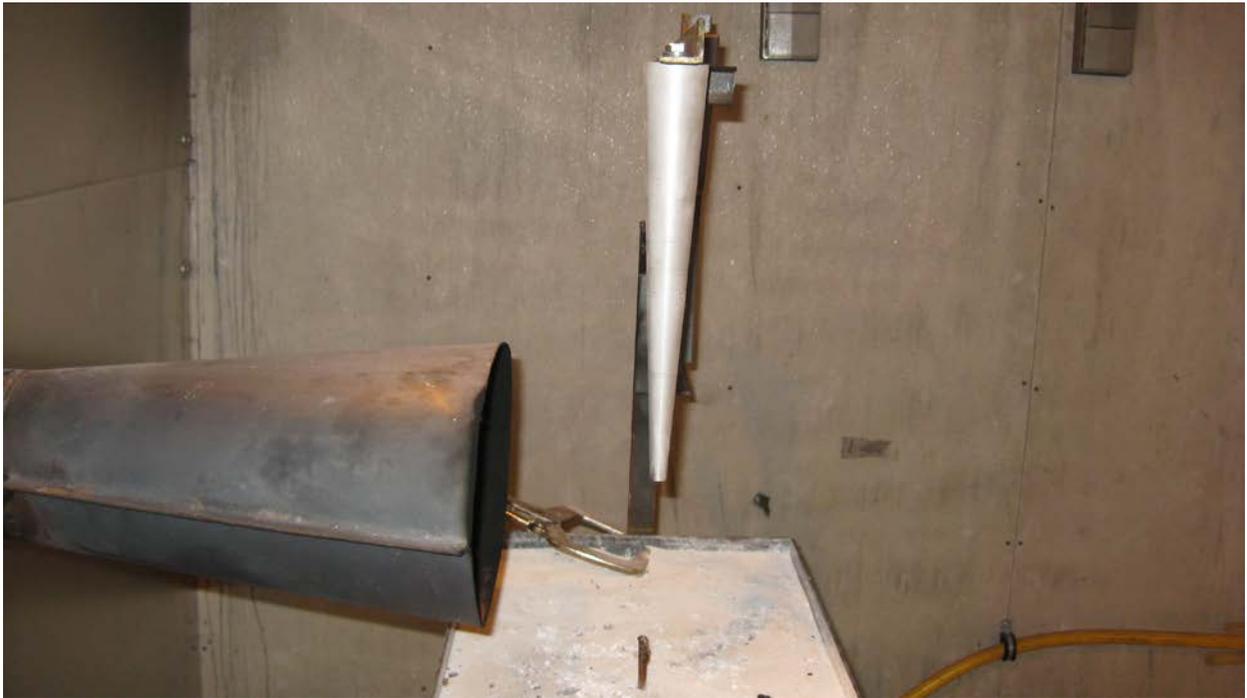
Figure 73. Inverted Truncated WE43 Cone Suspended From Hanger, Front View (9/29/2011)

Figure 74. Inverted Truncated WE43 Cone Suspended From Hanger, Side View (9/29/2011)

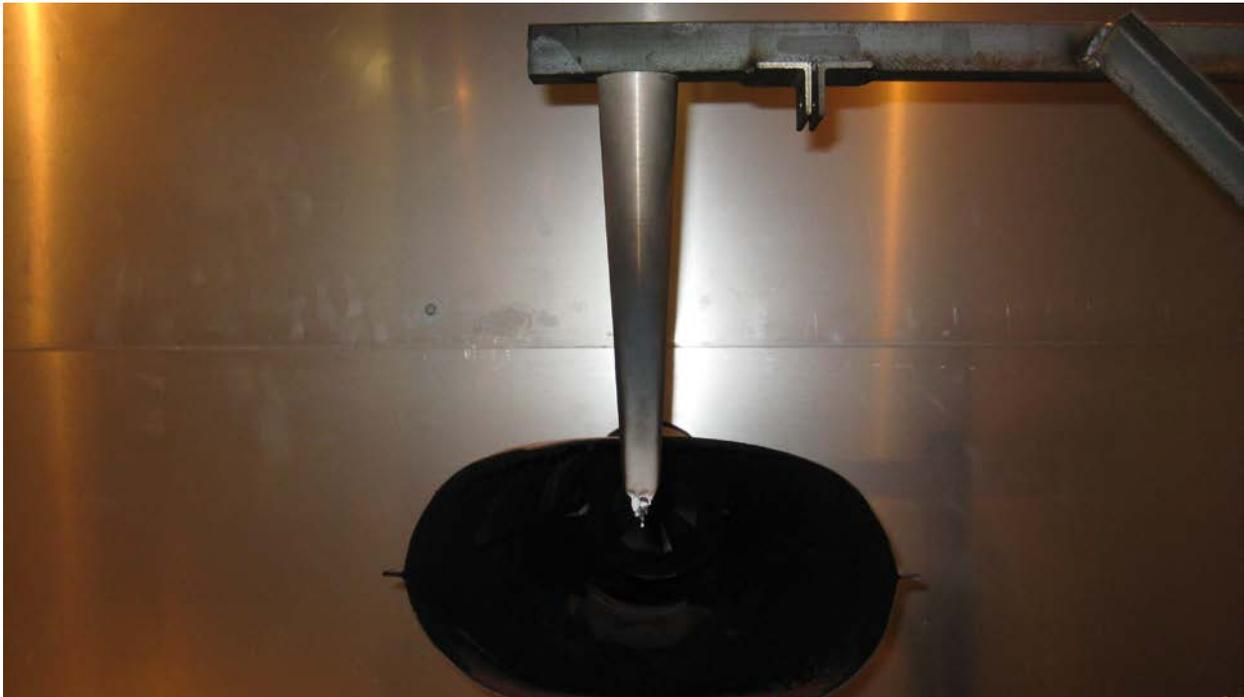
Figure 75. Inverted Truncated WE43 Cone, Post-Test (9/29/2011)

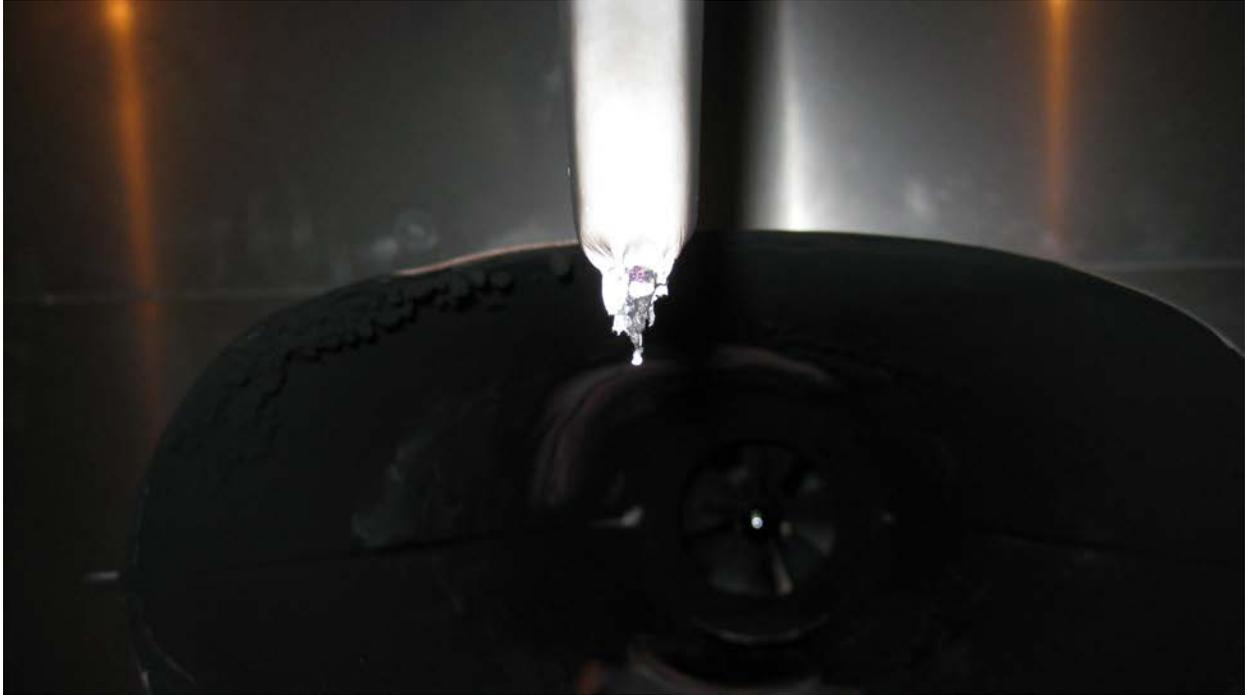
Figure 76. Closeup of Inverted Truncated WE43 Cone, Post-Test (9/29/2011)

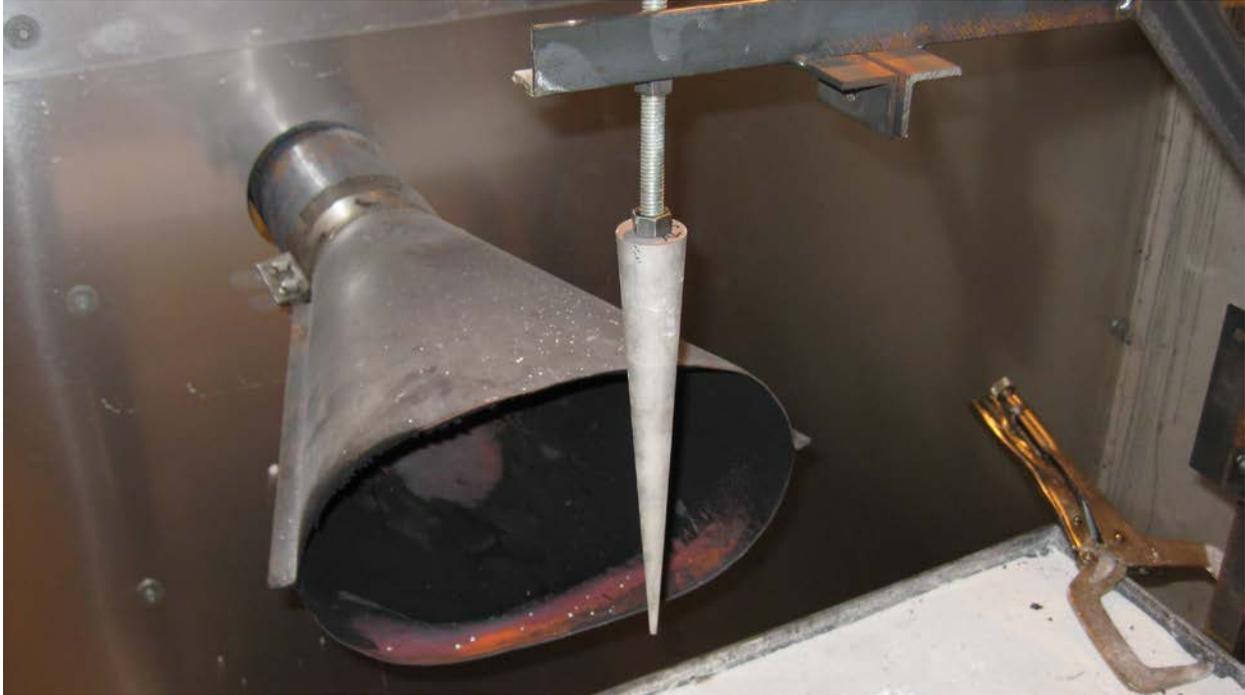
Figure 77. Inverted Pointed AZ31 Cone Suspended From Hanger (9/29/2011)

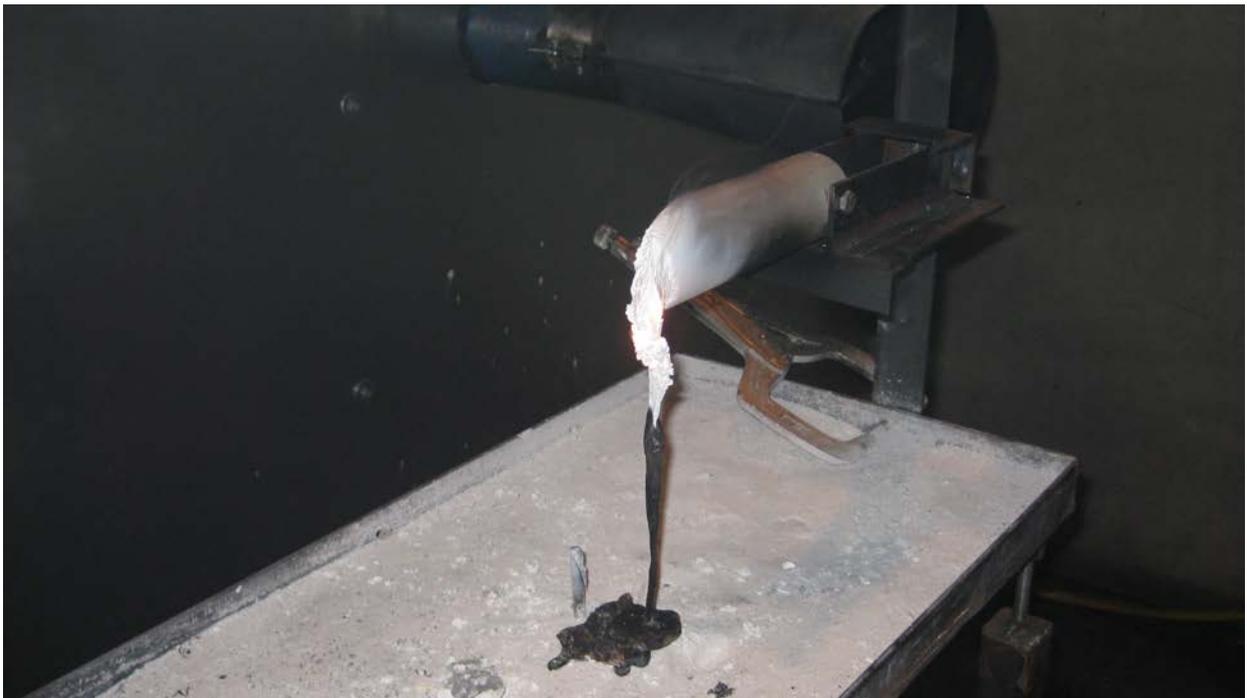
Figure 83. Horizontally Mounted Cylindrical Tubing Sample, Post-Test (9/30/2011)

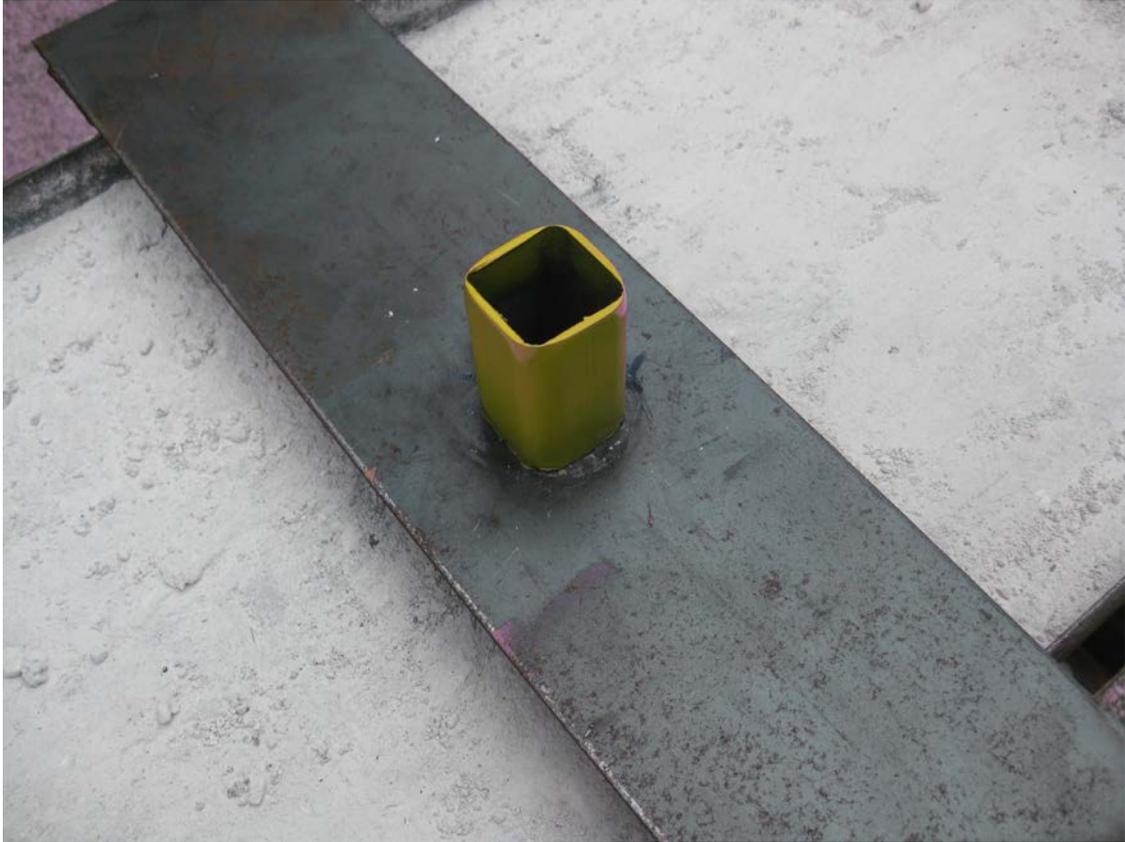
Figure 84. Box Tubing Stub Holder for Cylindrical Sample

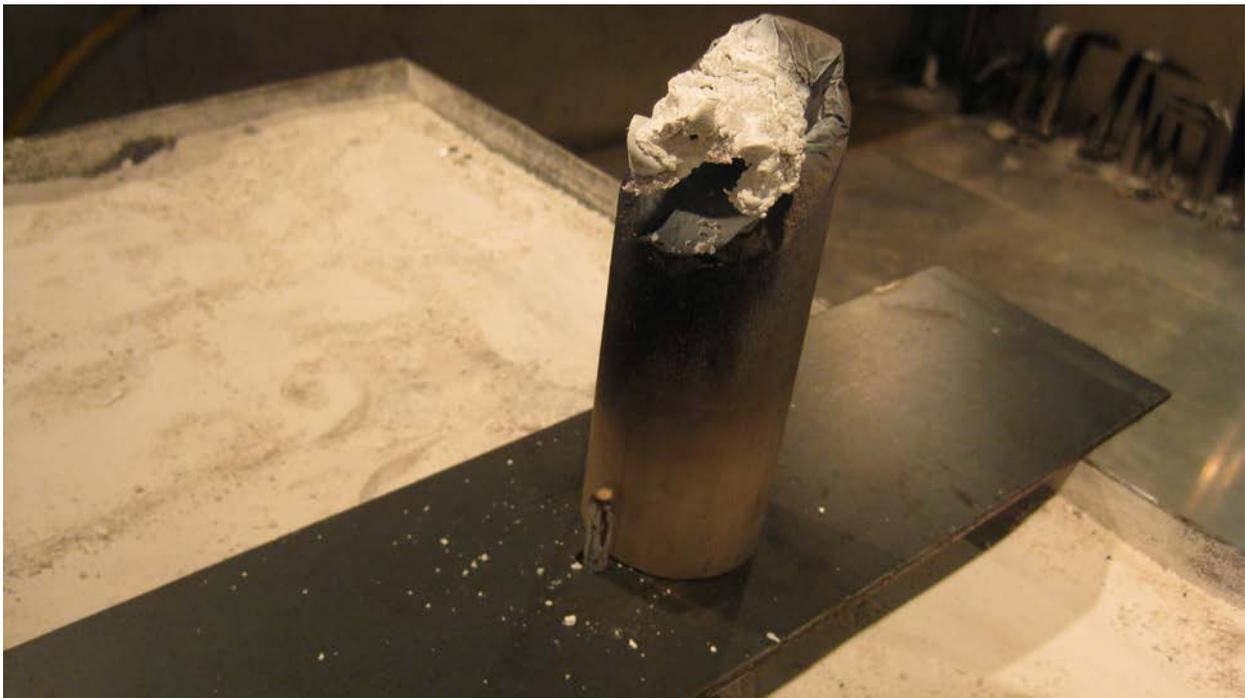
Figure 87. Vertically Mounted Cylindrical Tubing Sample, Post-Test (9/30/2011)

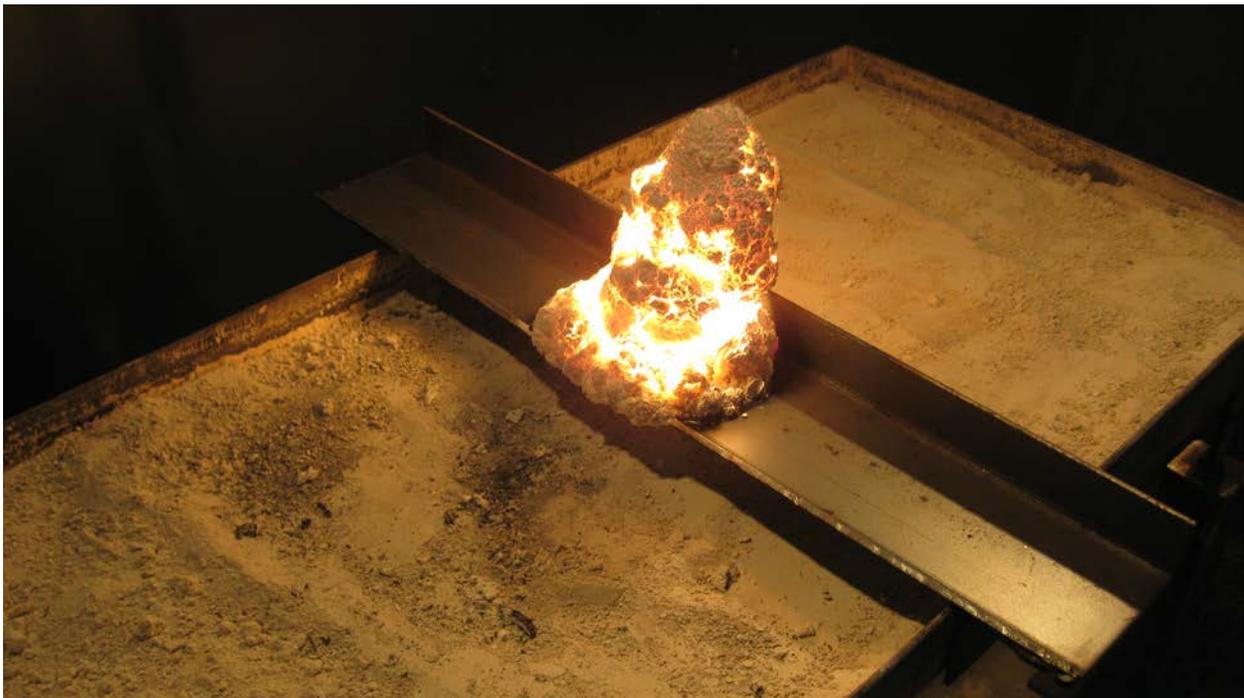
Figure 91. Truncated WE43 Cone Sample With Center Bore, Post-Test (10/04/2011)
