DOT/FAA/TC-13/52

Development of a Laboratory- Scale Flammability Test for Magnesium Alloys Used in Aircraft Seat Construction

Final Report

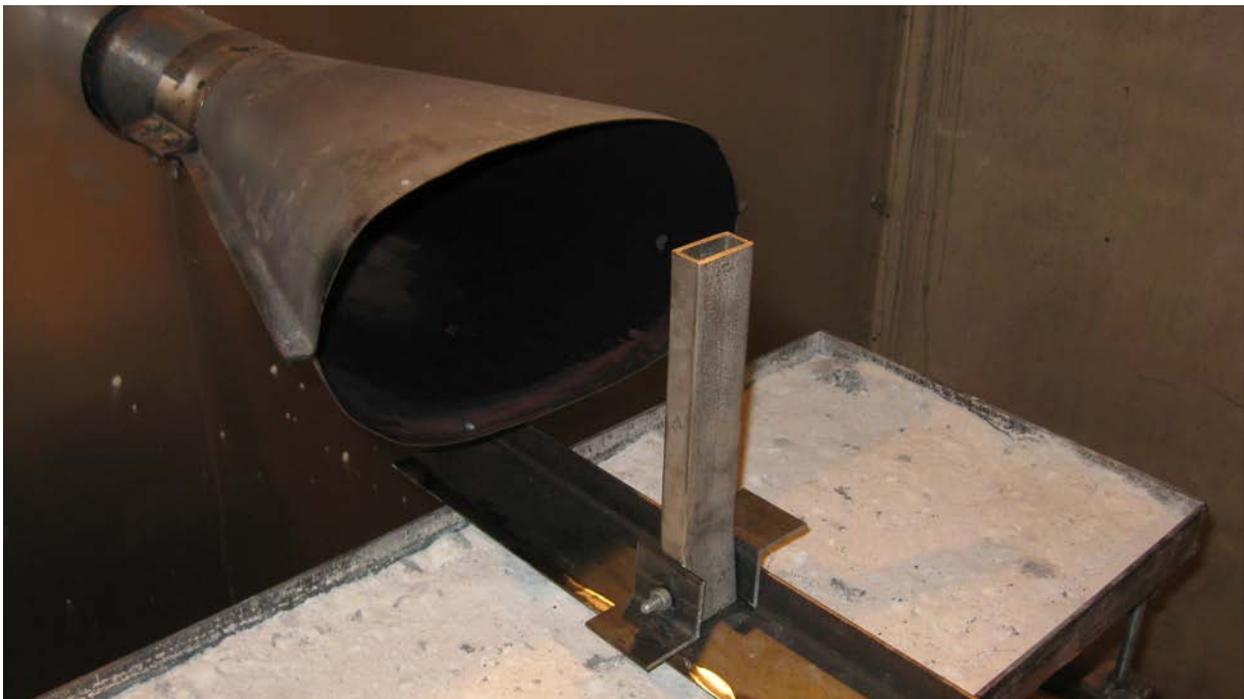
Figure 92. Vertically Oriented Rectangular Cross-Section Sample (10/6/2011)

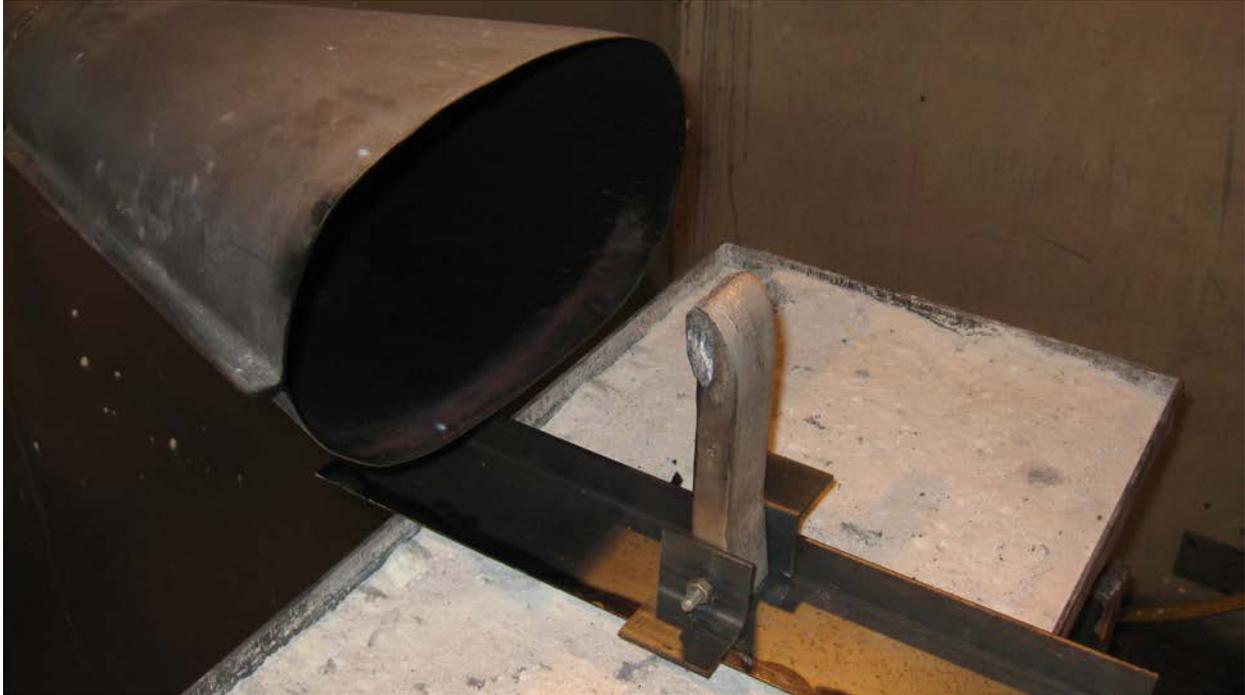
Figure 93. Vertically Oriented Rectangular Cross-Section Sample, Post-Test (10/6/2011)

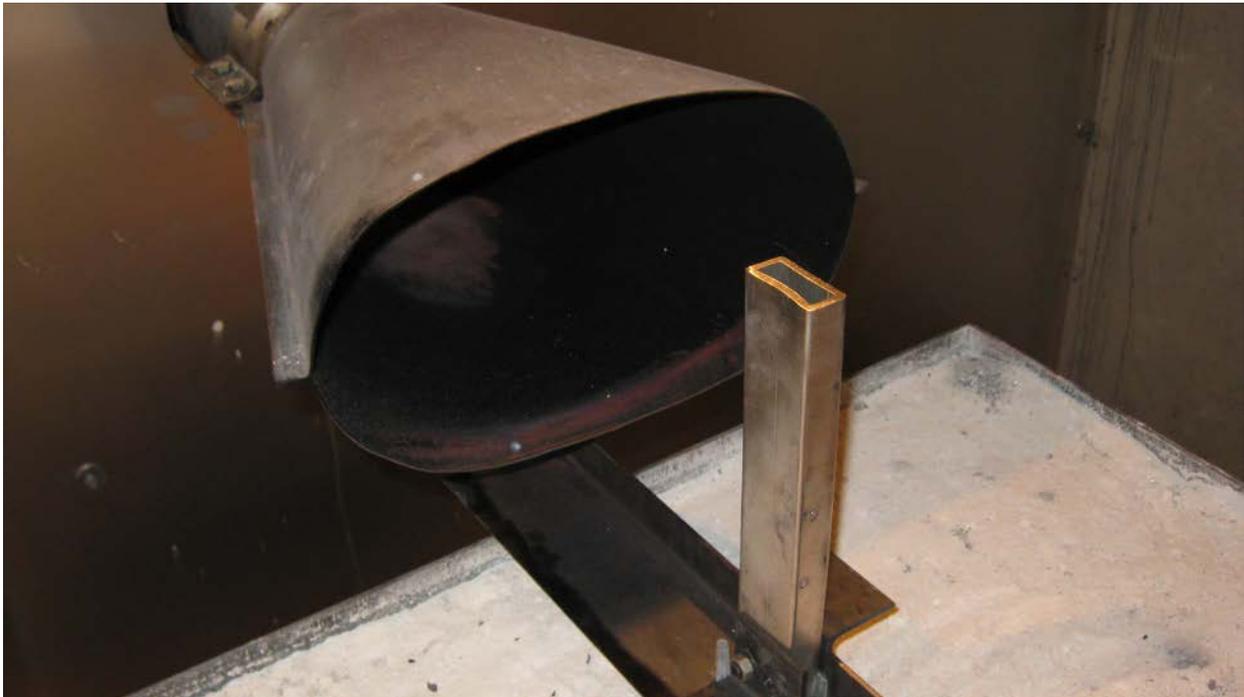
Figure 95. Vertically Oriented Rectangular Cross-Section Sample (10/6/2011)

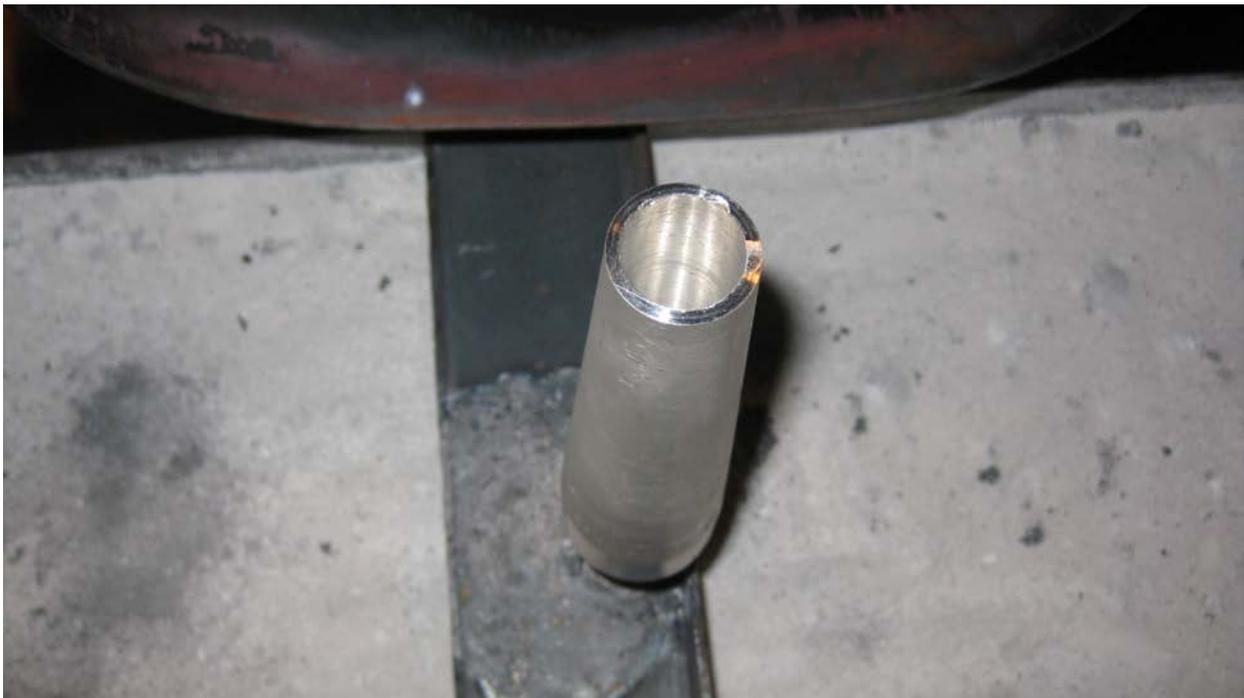
Figure 98. Closeup of Specially Prepared Truncated WE43 Cone Sample With Center Bore (10/11/2011)

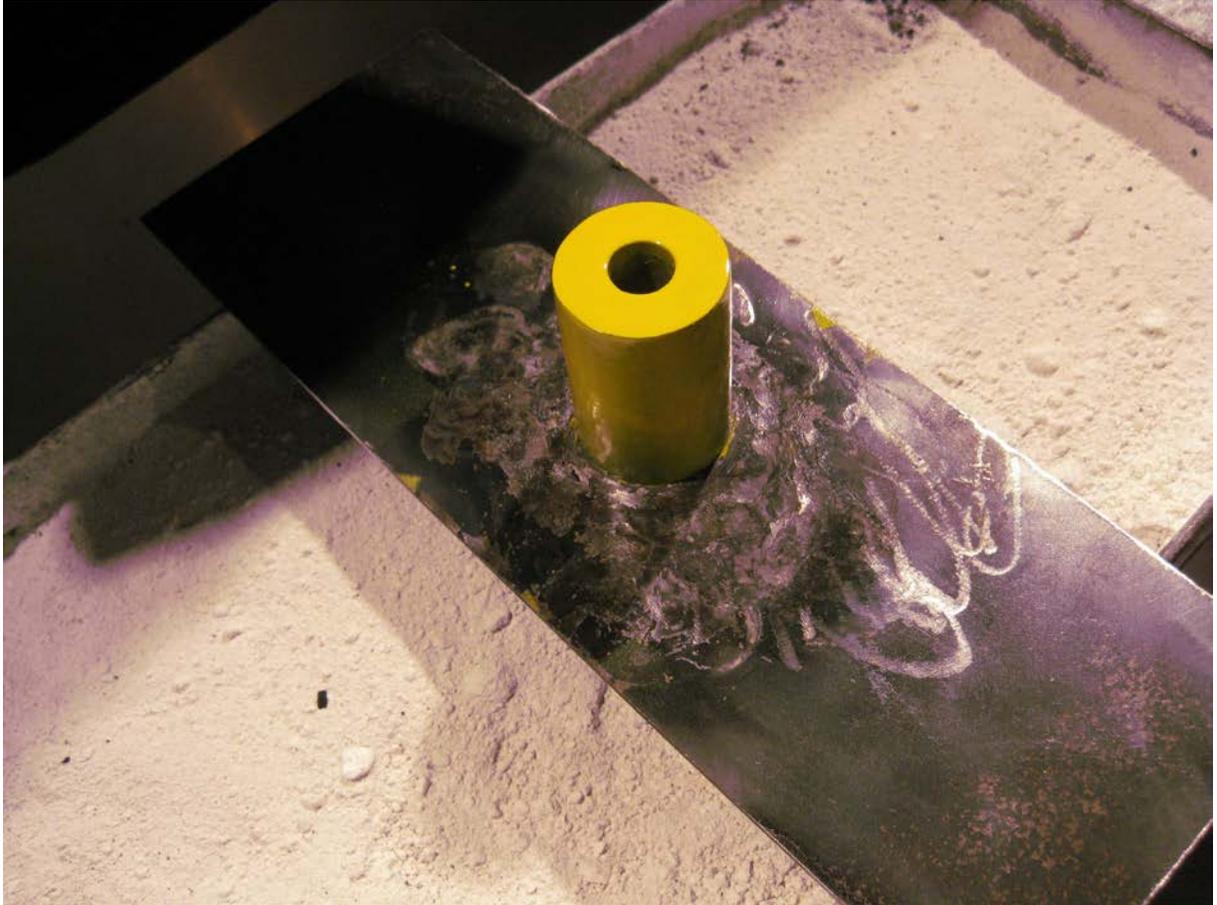
Figure 108. Cylindrical Steel Mounting Stub for Reduced-Diameter Test Samples

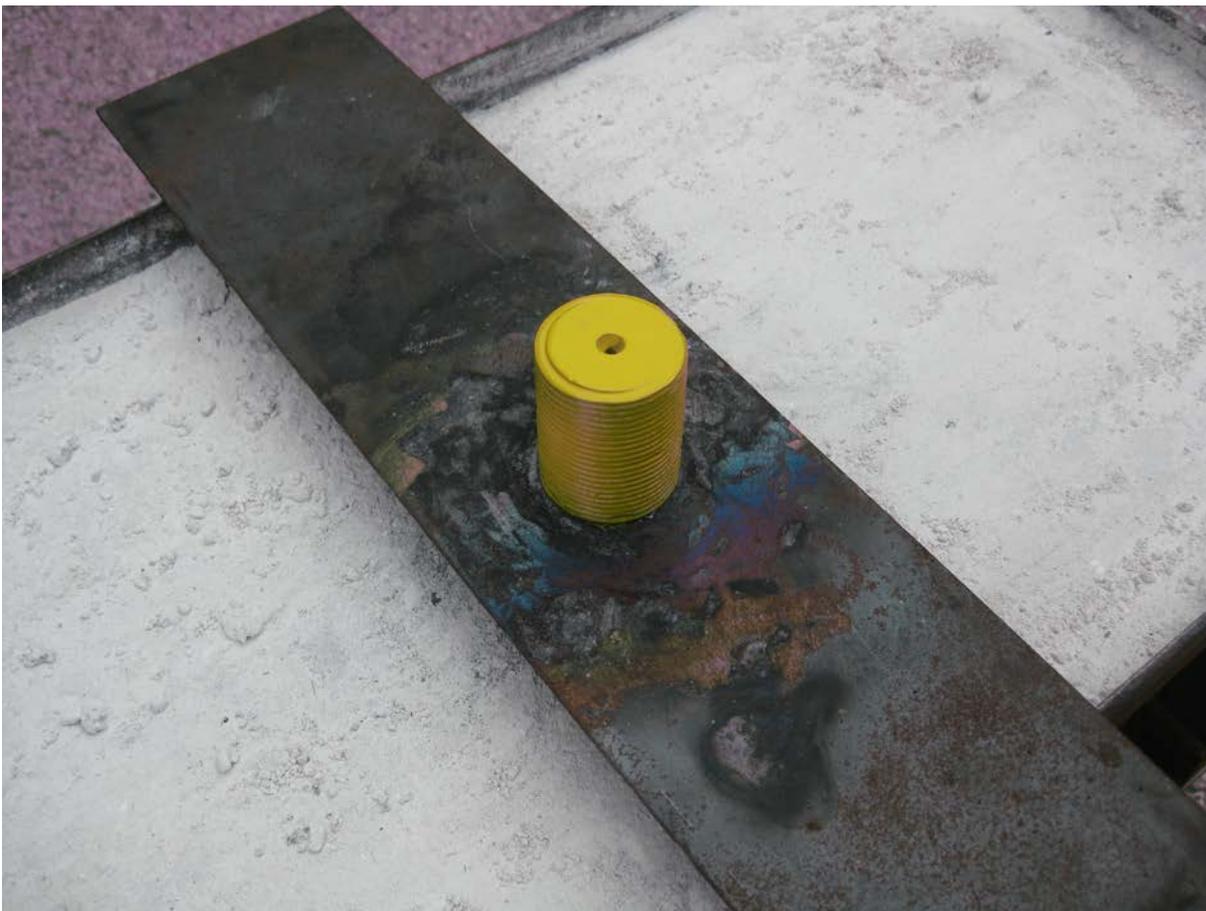
Figure 110. Sample Holder Used for 1.75-Inch OD Samples With 0.125-Inch Wall Thickness

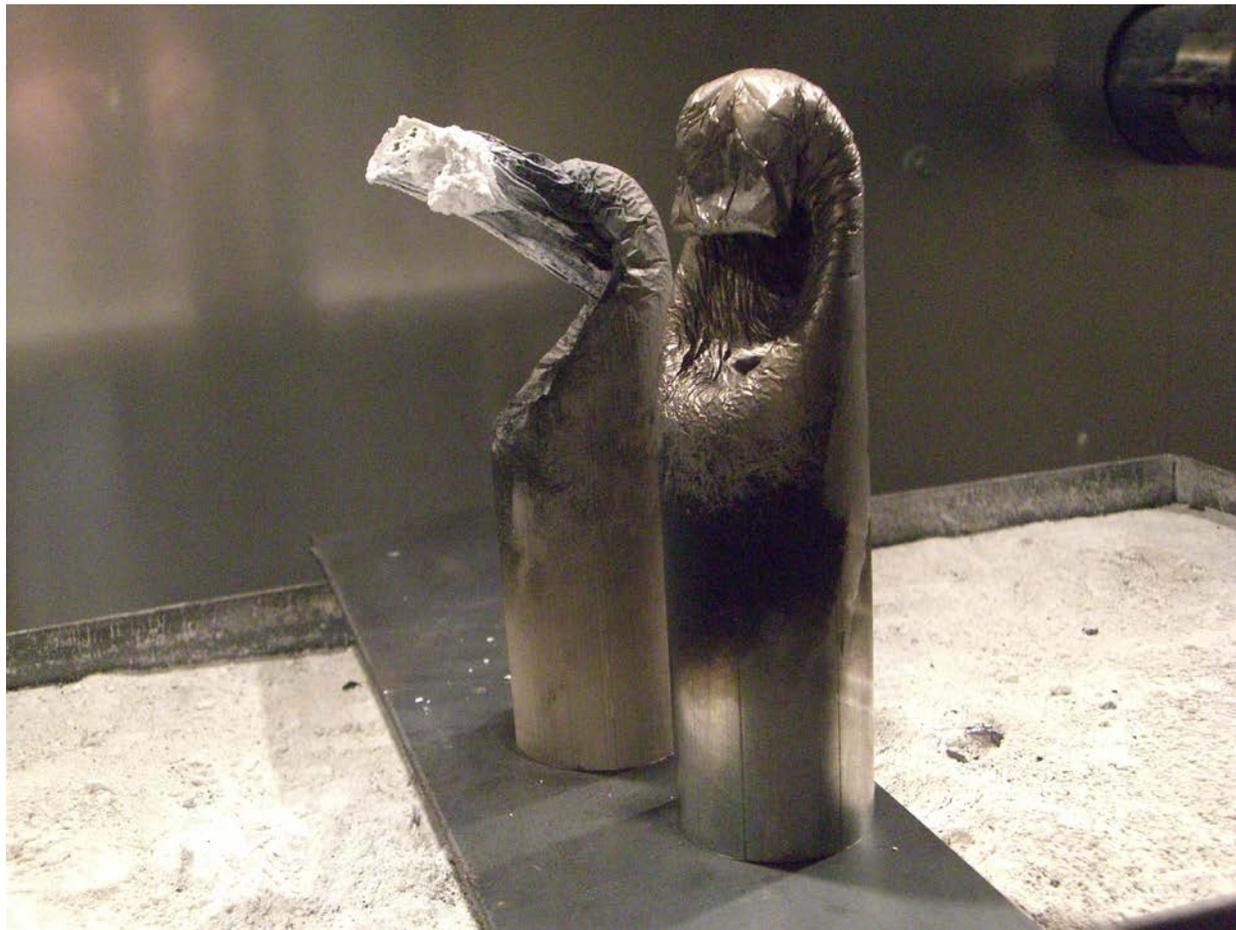
Figure 111. Post-Test Comparison of Original Sample (left) and Newer Sample (right)

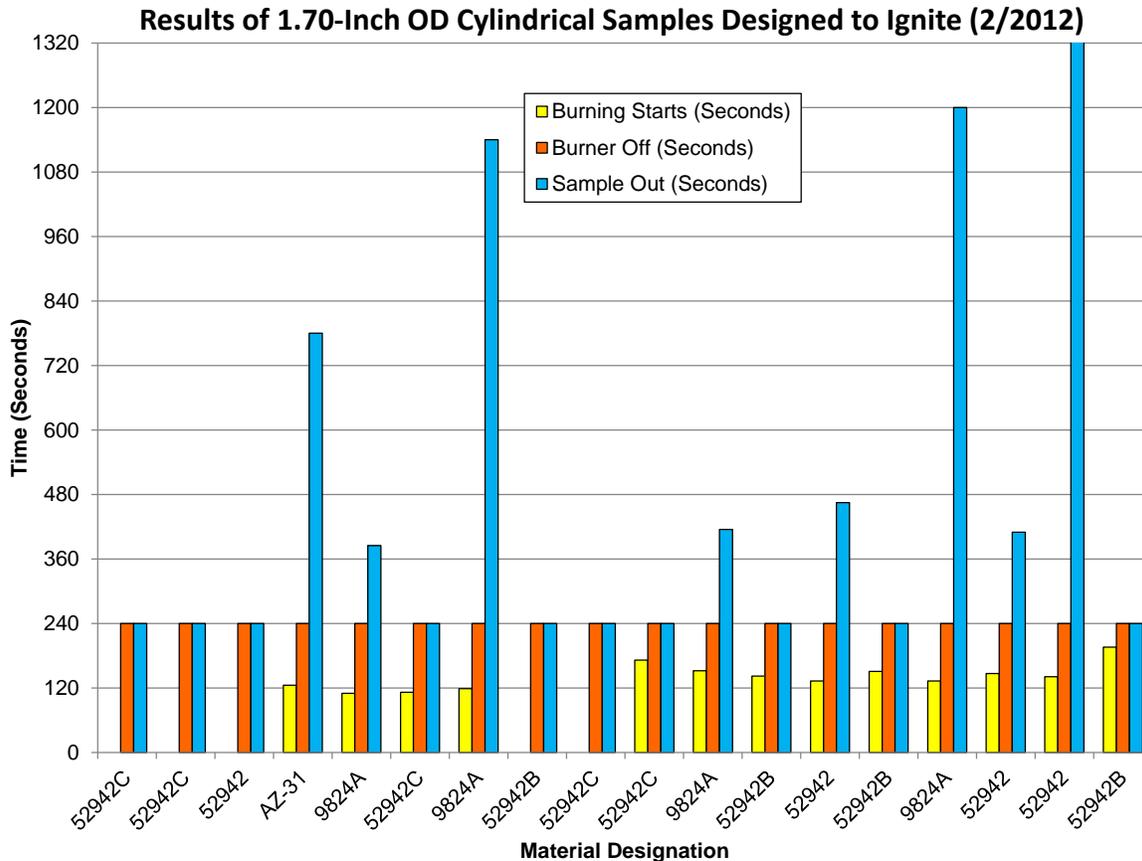
Figure 114. Test Results on 1.70-Inch Cylindrical Samples Designed to Ignite

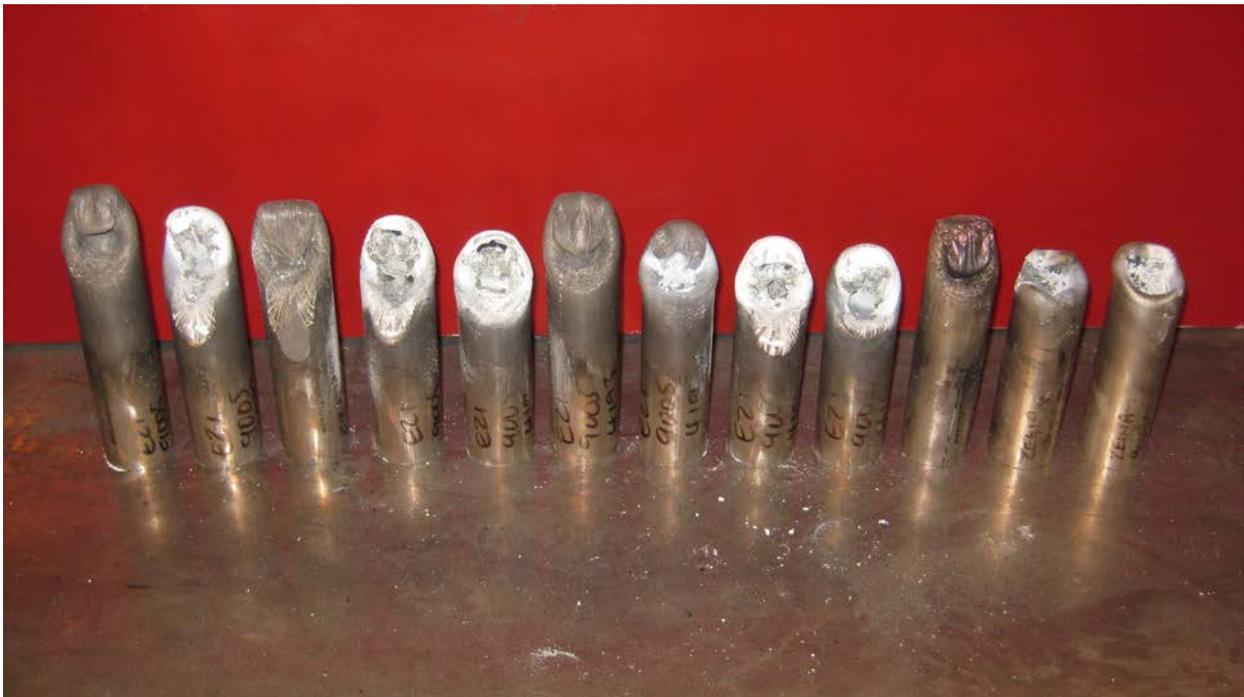
Figure 115. Post-Test Inspection of Cylinder Samples

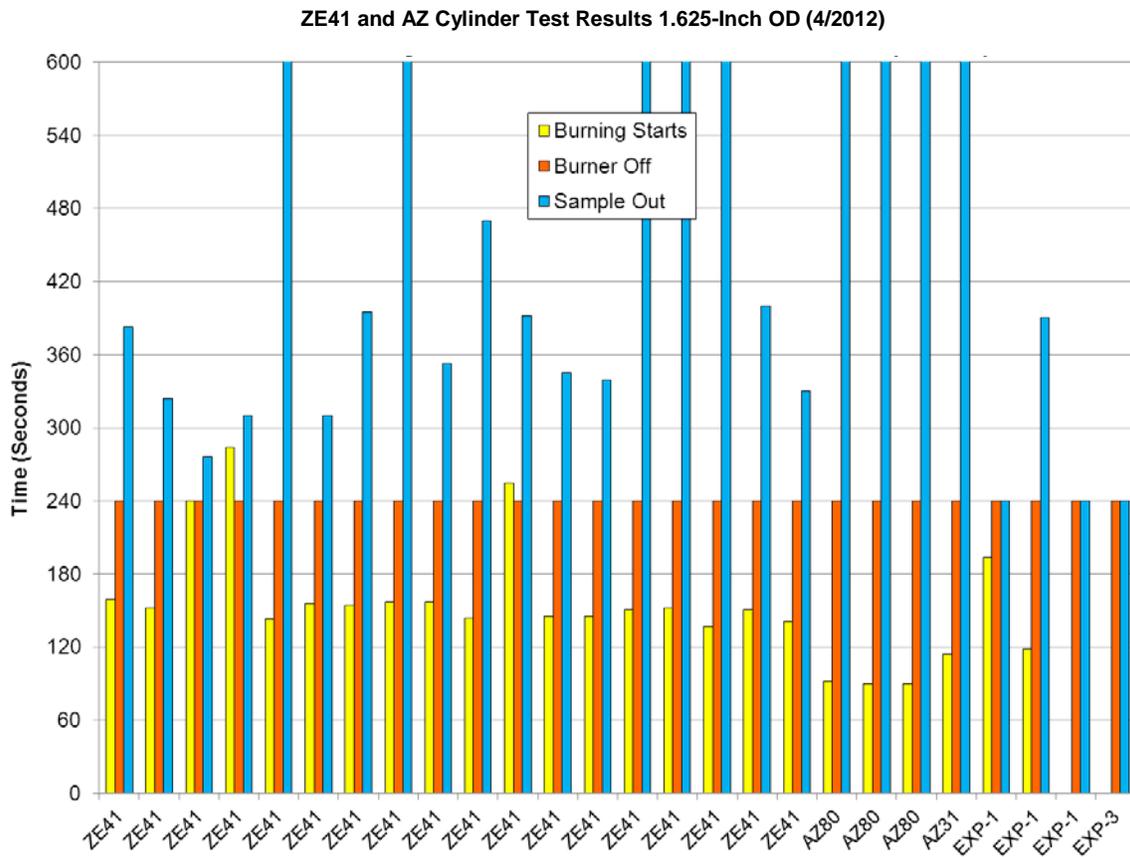
Figure 118. Test Results on ZE-41 and AZ-80 Cylindrical Samples

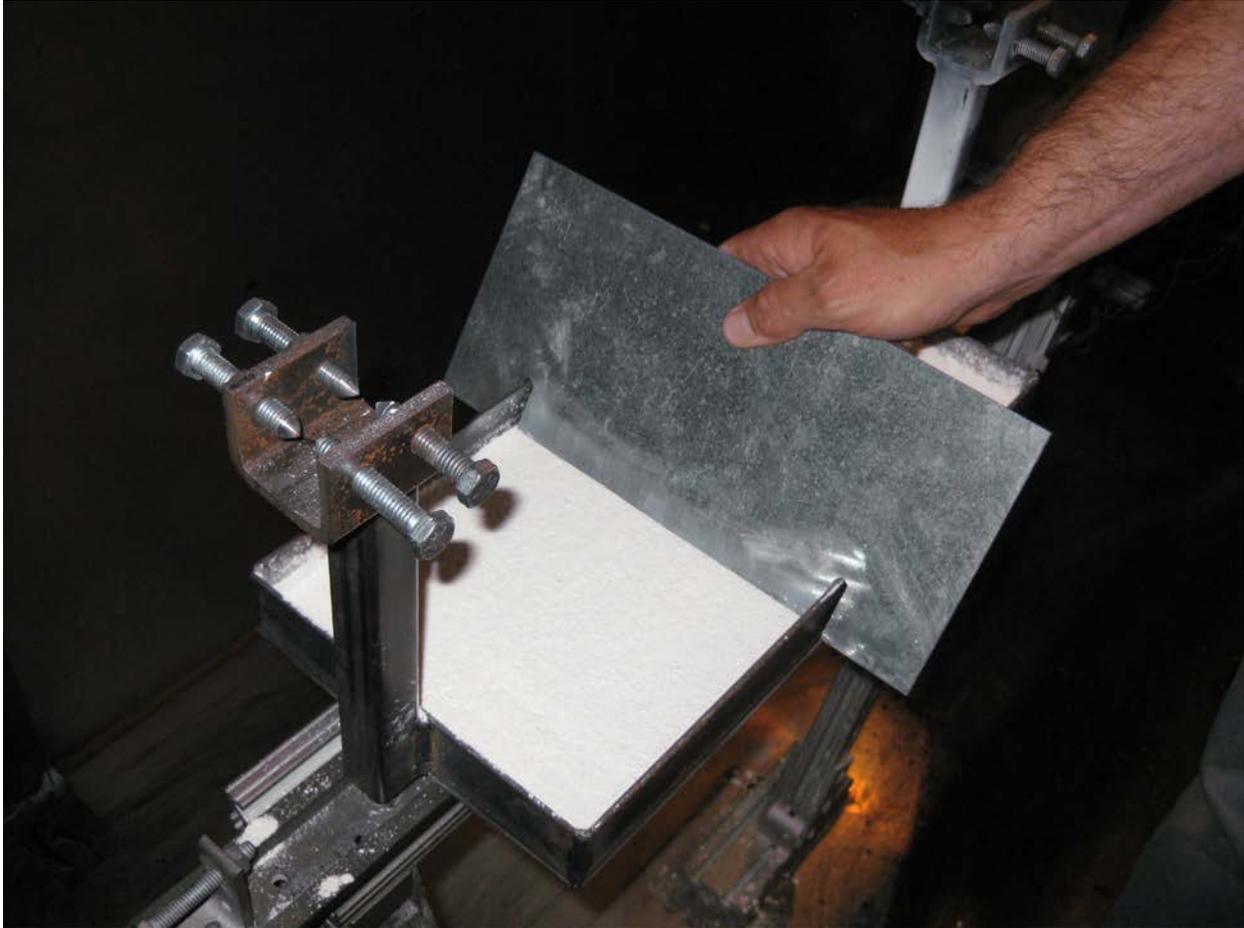
Figure 121. Screeding Device Used to Level off Layer of Talc in Catch Pan

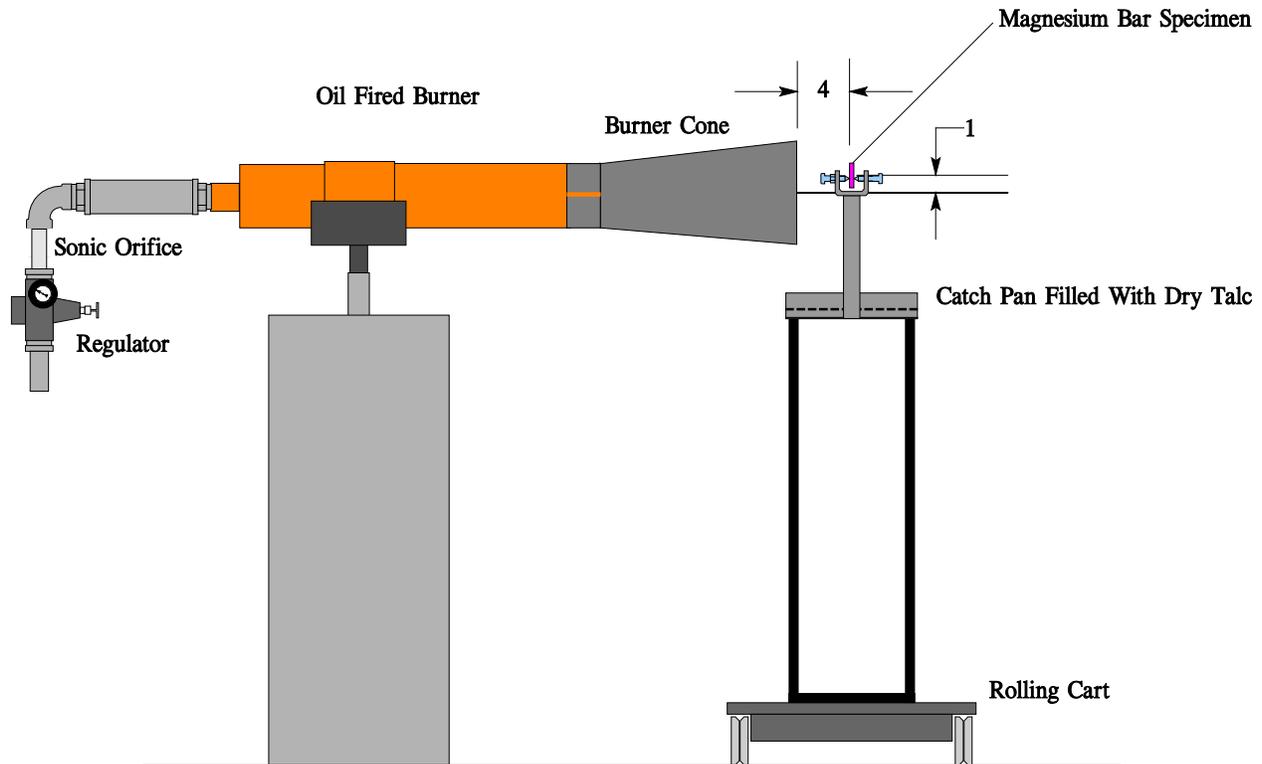
Figure 122. Basic Test Configuration for Horizontal Bar Sample Tests

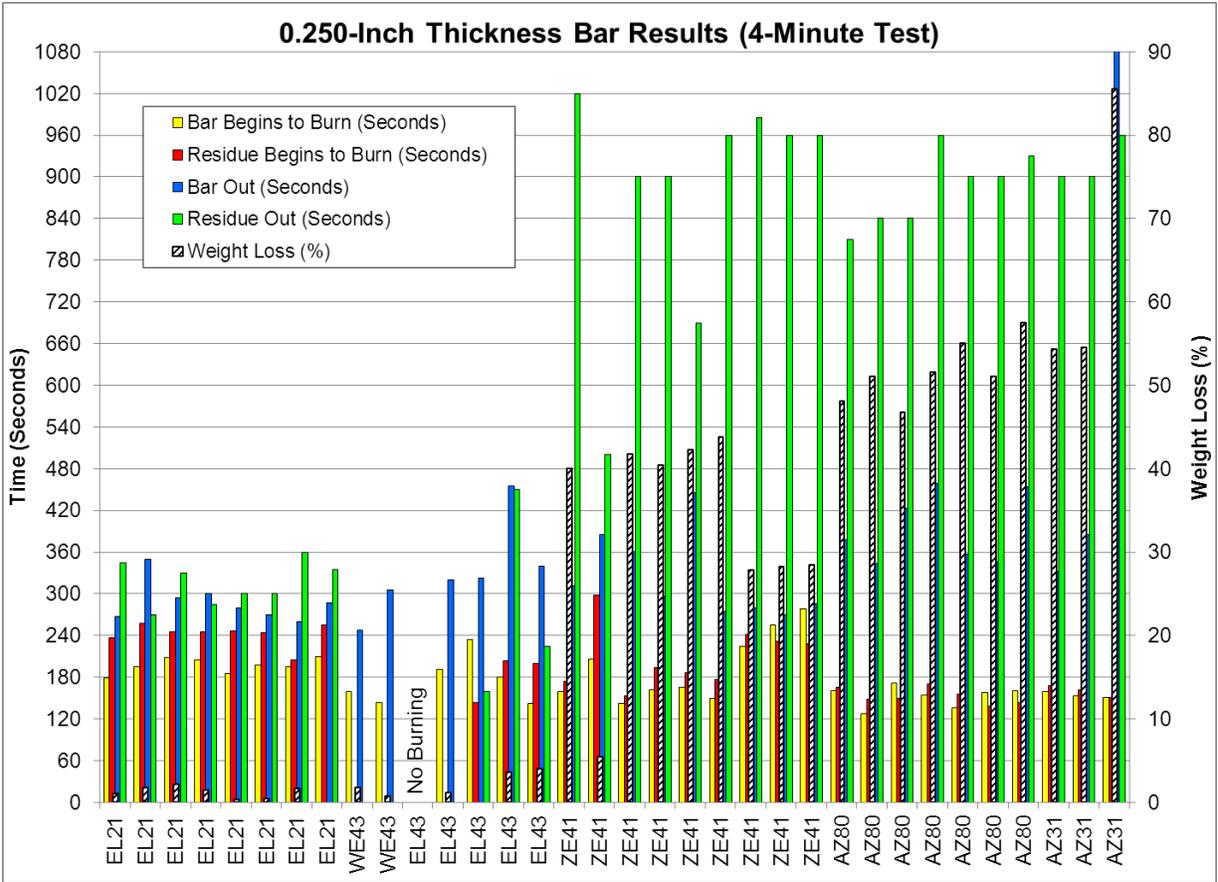
Figure 127. The 0.250-Inch-Thickness Bar Test Results

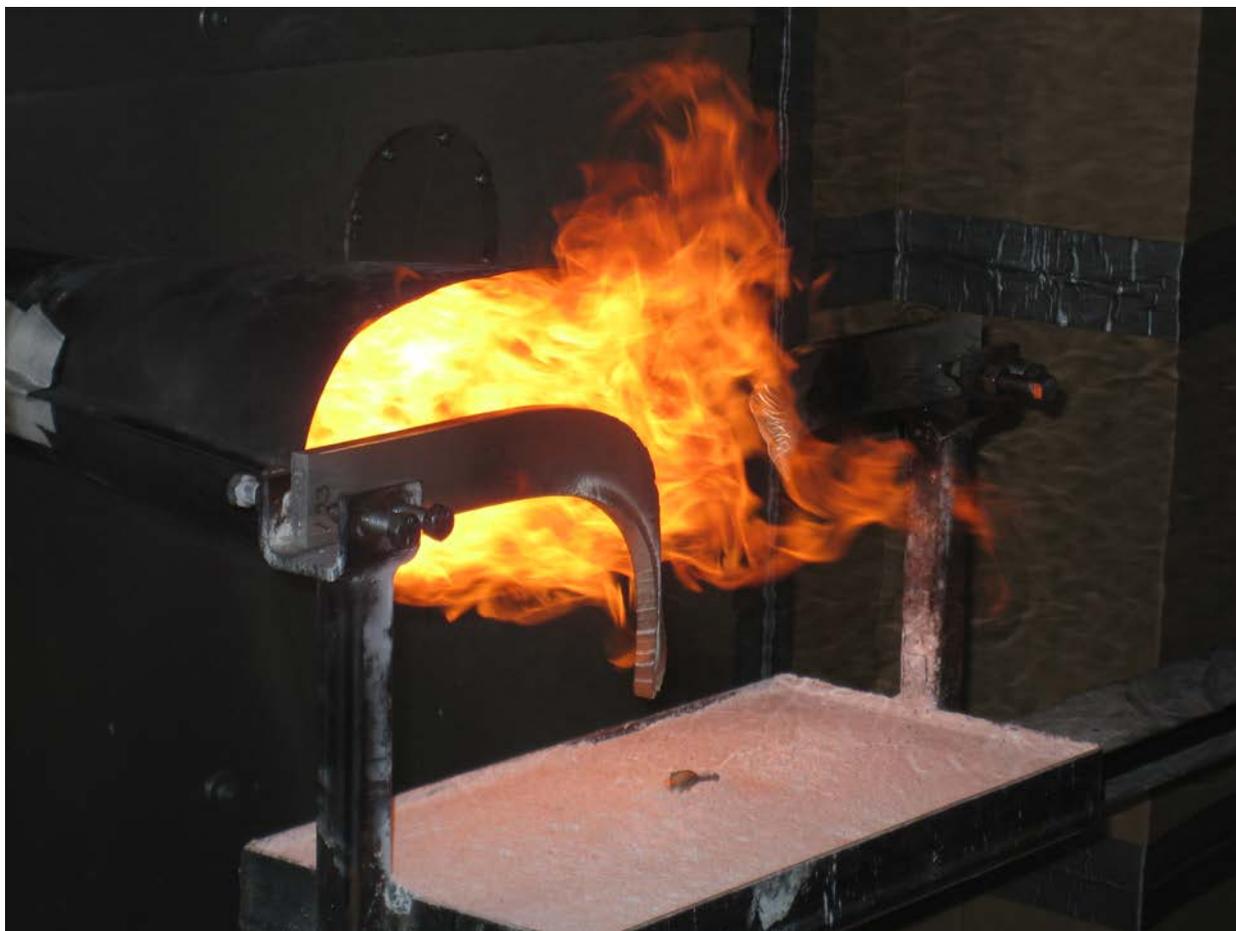
Figure 128. Sample Material Melting and Rotating Into Catch Pan Below

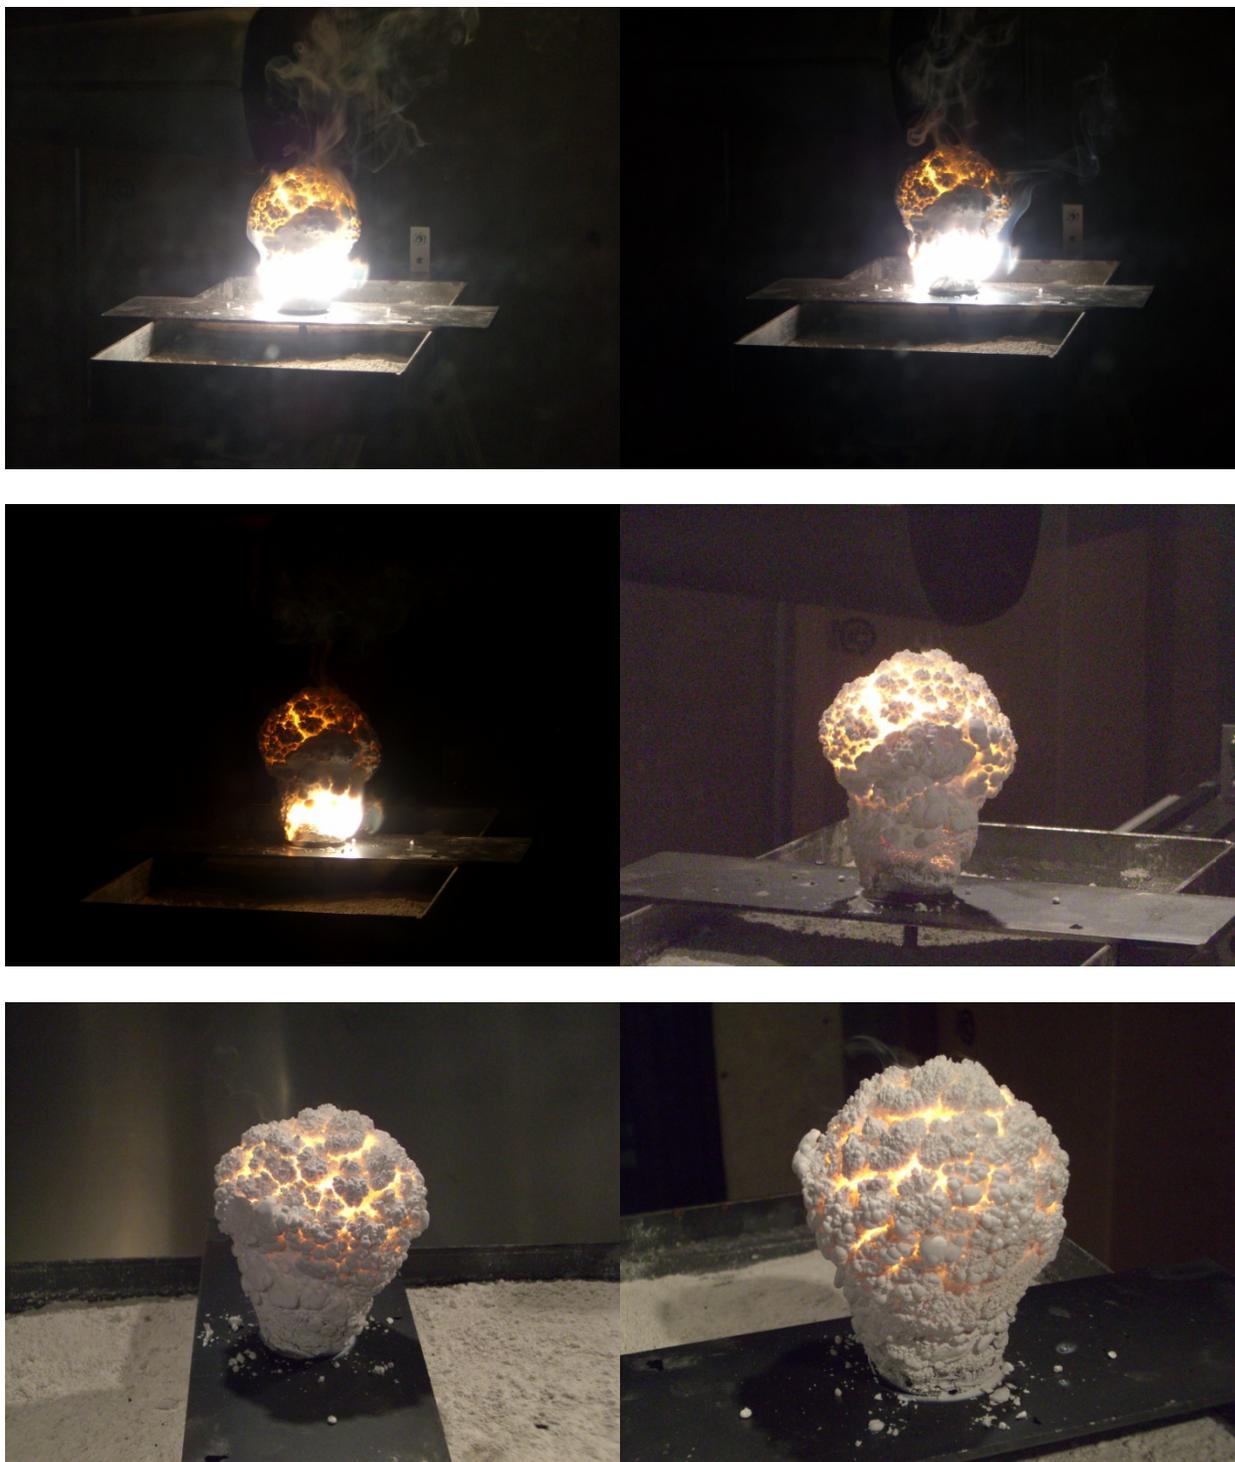
Figure 129. Burning and Cooling of a Magnesium Test Sample, Illustrating the Difficulty in Determining Self-Extinguishment Time

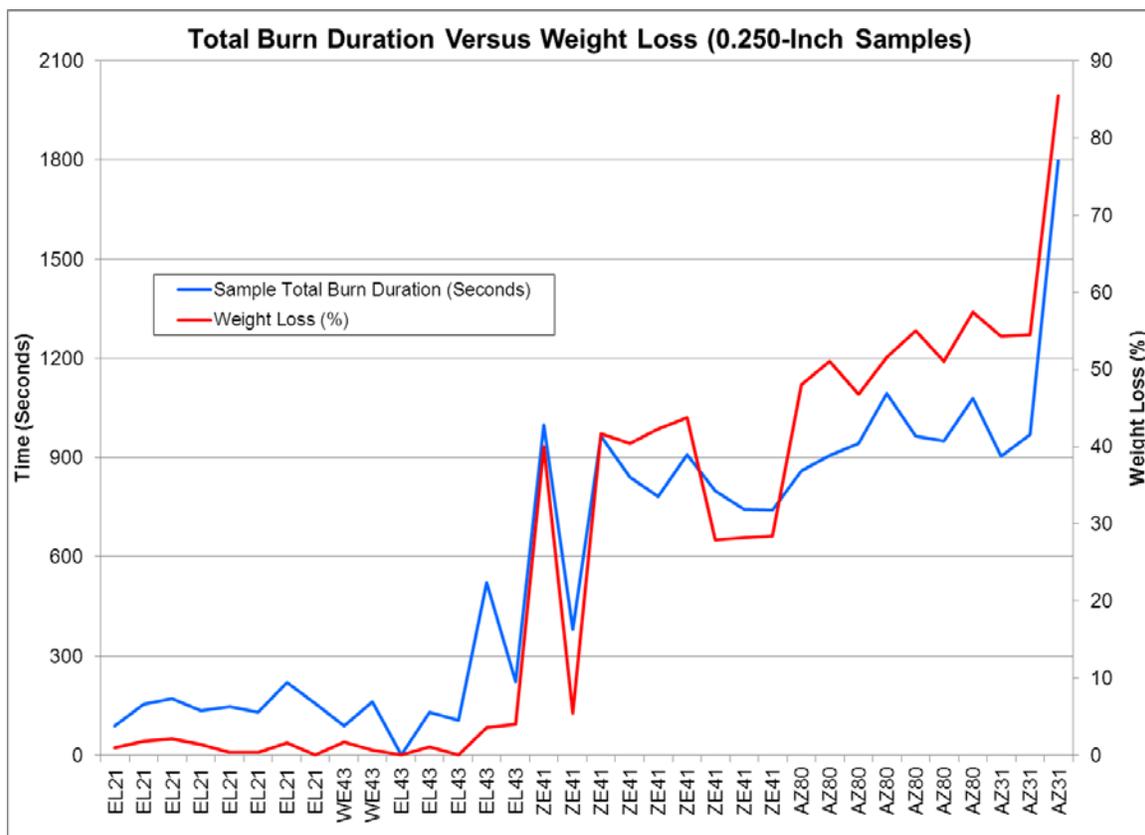
Figure 130. Burn Duration vs. Weight Loss of 0.250-Inch Thickness Samples

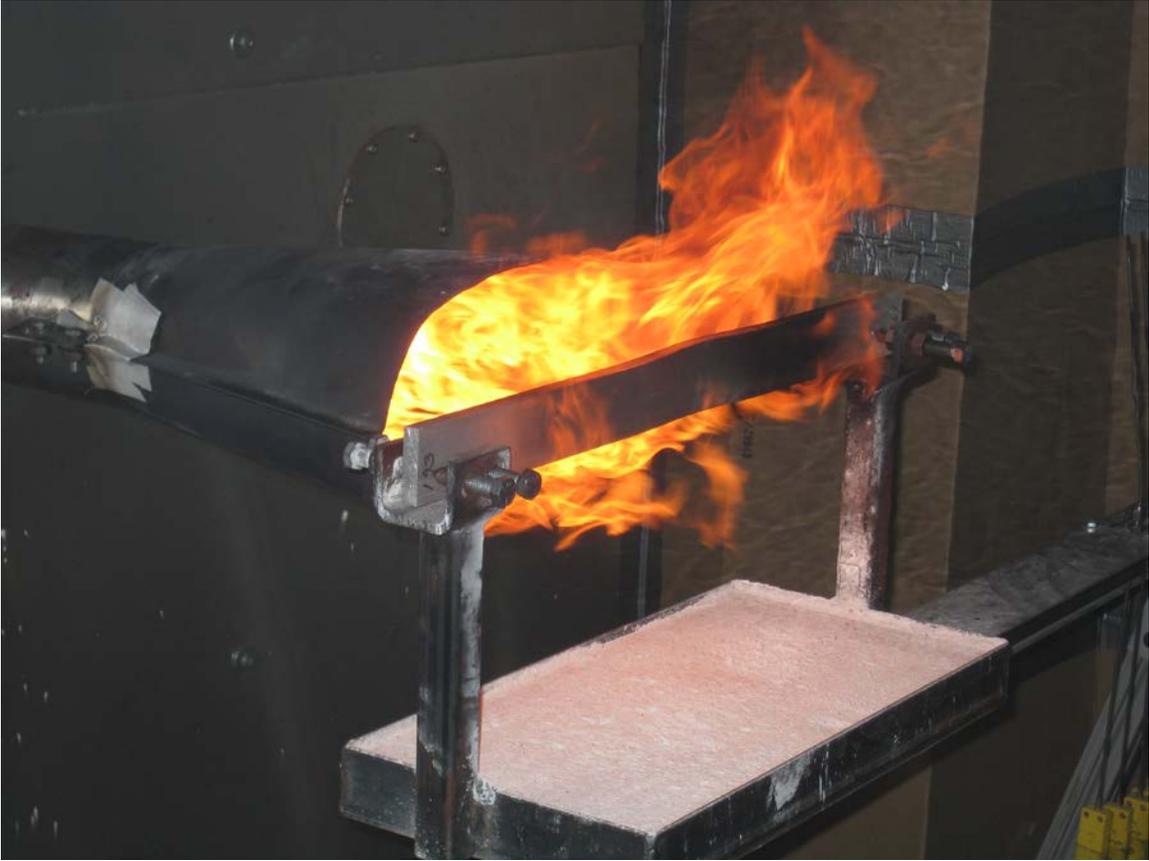
Figure 131. Test Showing a Talc Depth of Approximately 1 Inch

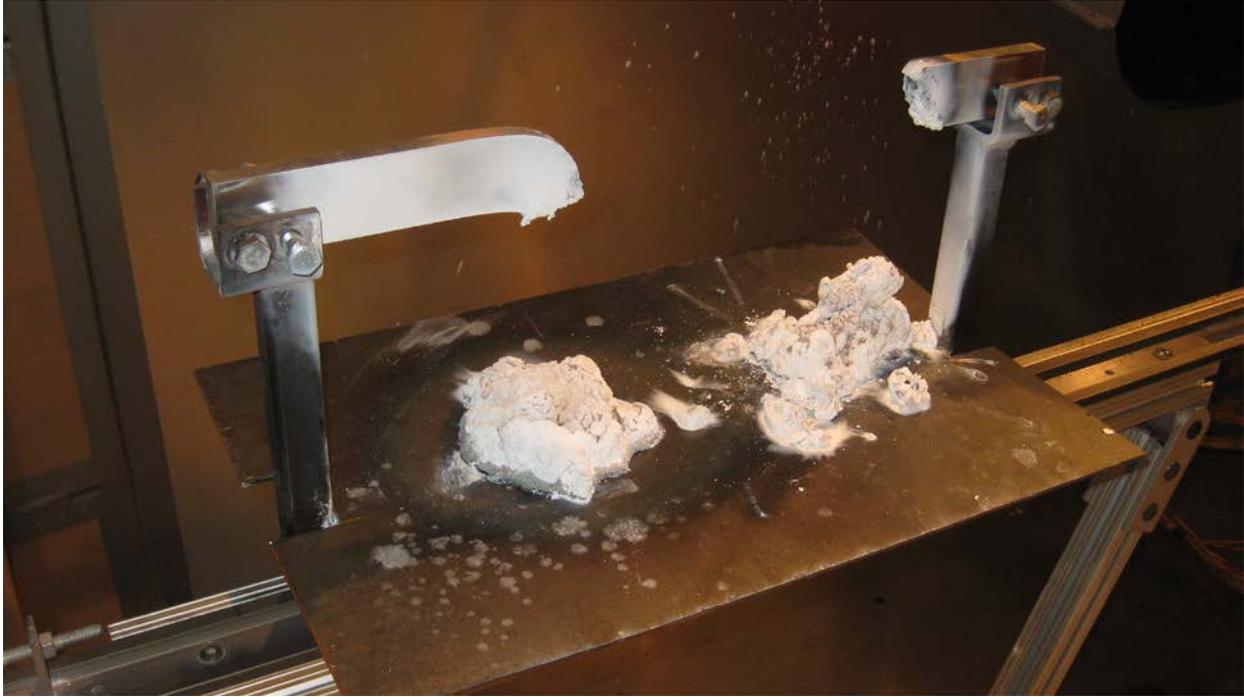
Figure 133. Test Showing the Use of Sheet Steel in Place of a Catch Pan (5/23/2012)

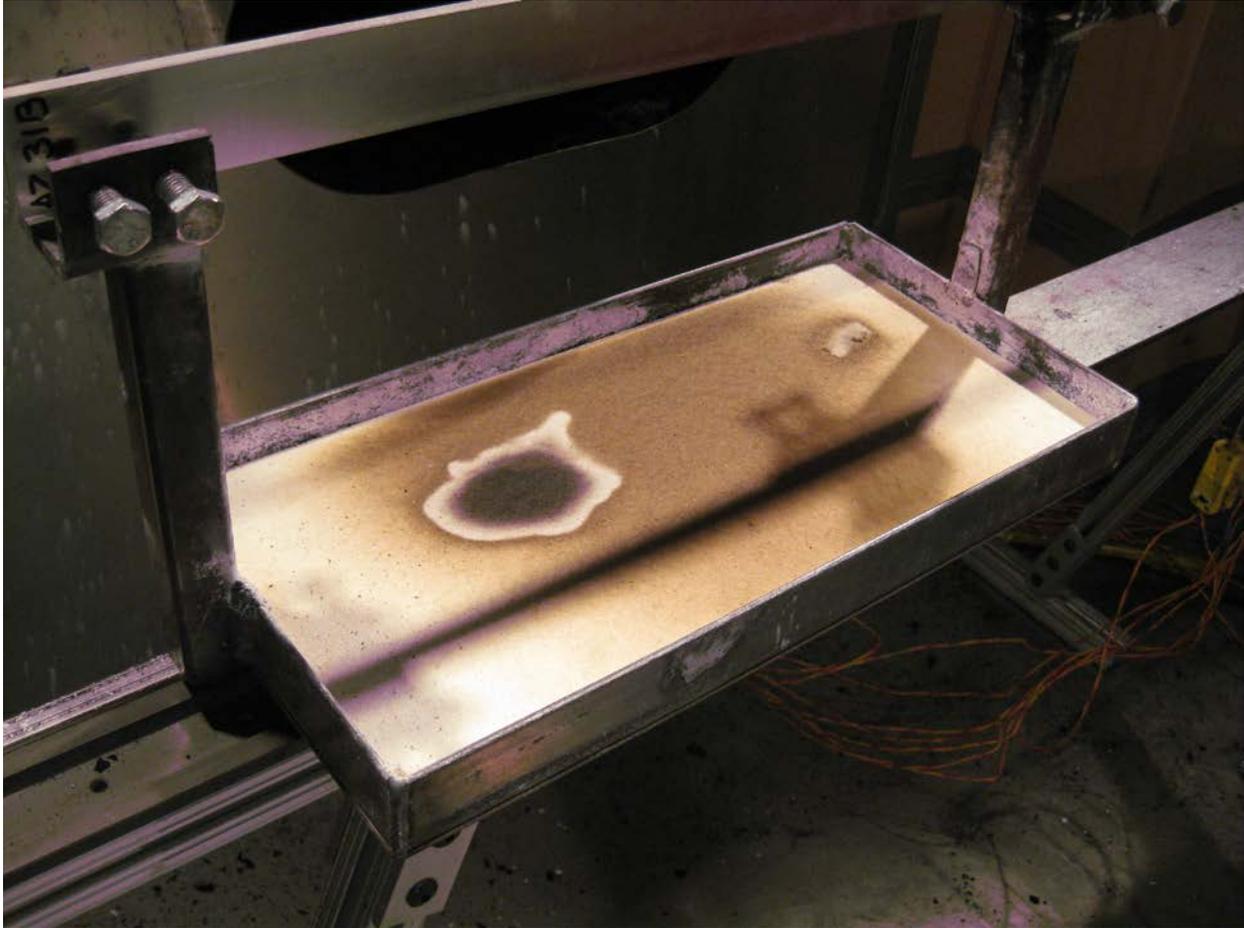
Figure 134. Test Arrangement Using Kaowool™ Board in Catch Pan (2/20/2013)

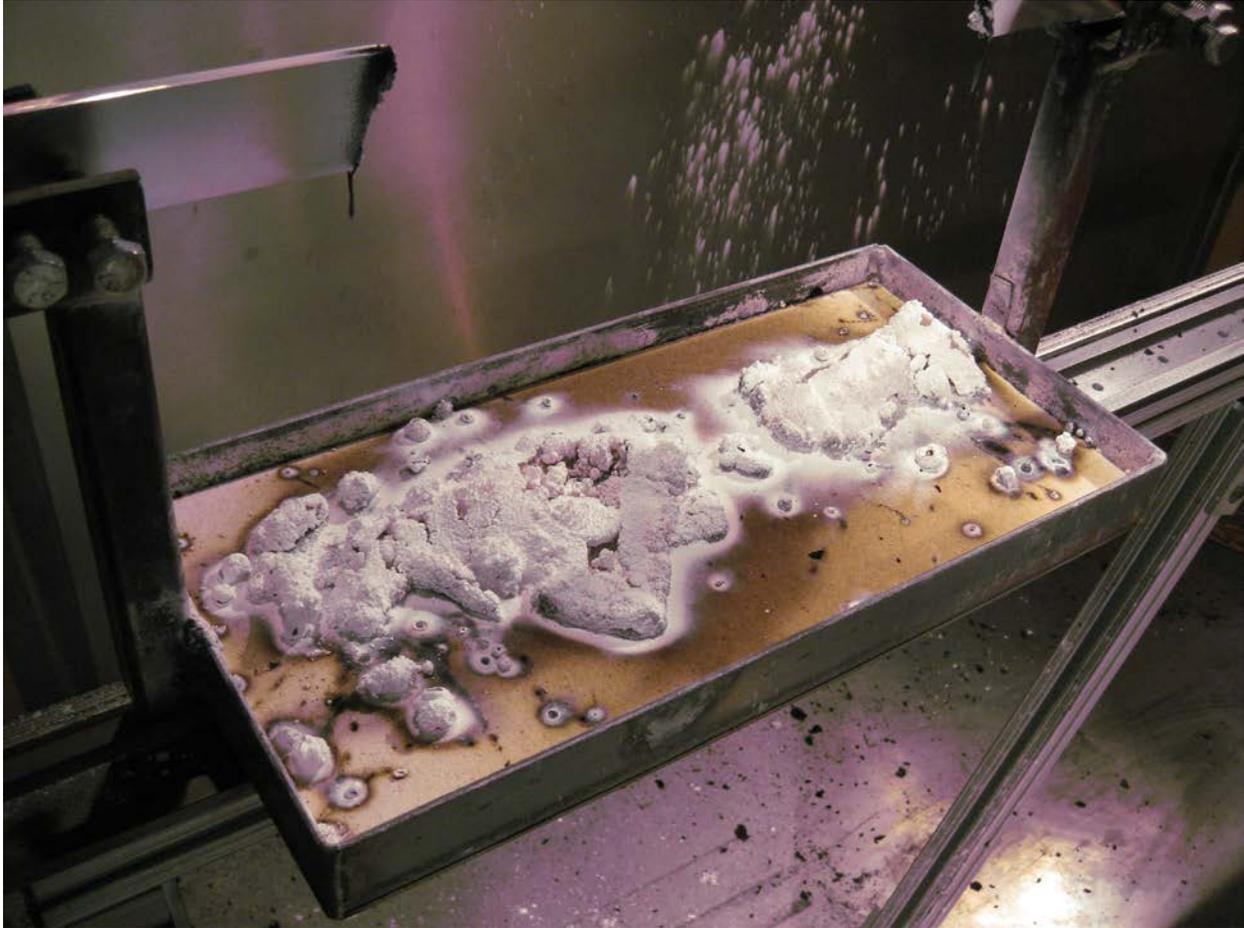
Figure 135. The AZ31 Test Result Using Kaowool™ Board in Catch Pan (2/20/2013)

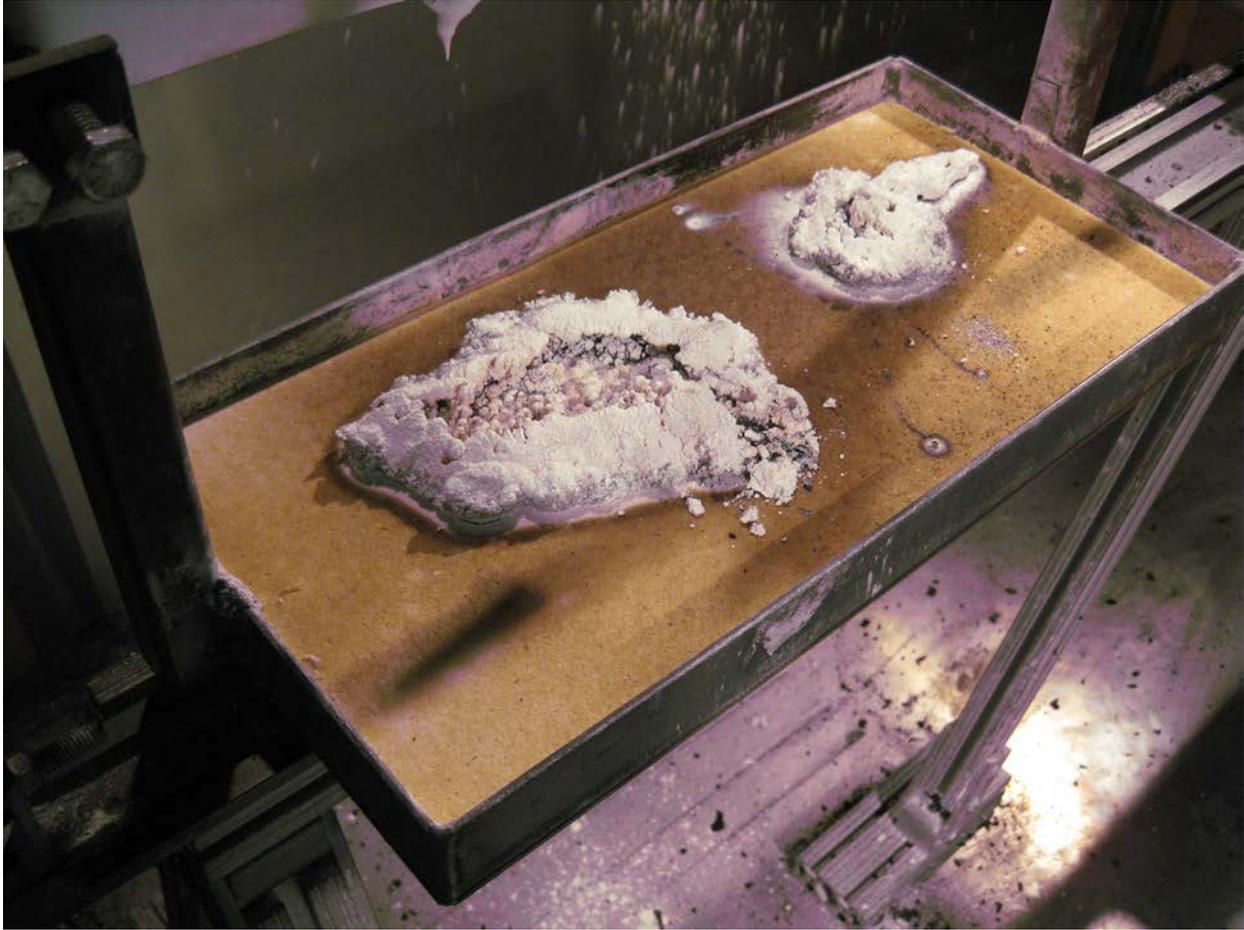
Figure 136. The AZ80 Test Result Using Kaowool™ Board in Catch Pan (2/20/2013)
