DOT/FAA/TC-13/52

Development of a Laboratory- Scale Flammability Test for Magnesium Alloys Used in Aircraft Seat Construction

Final Report

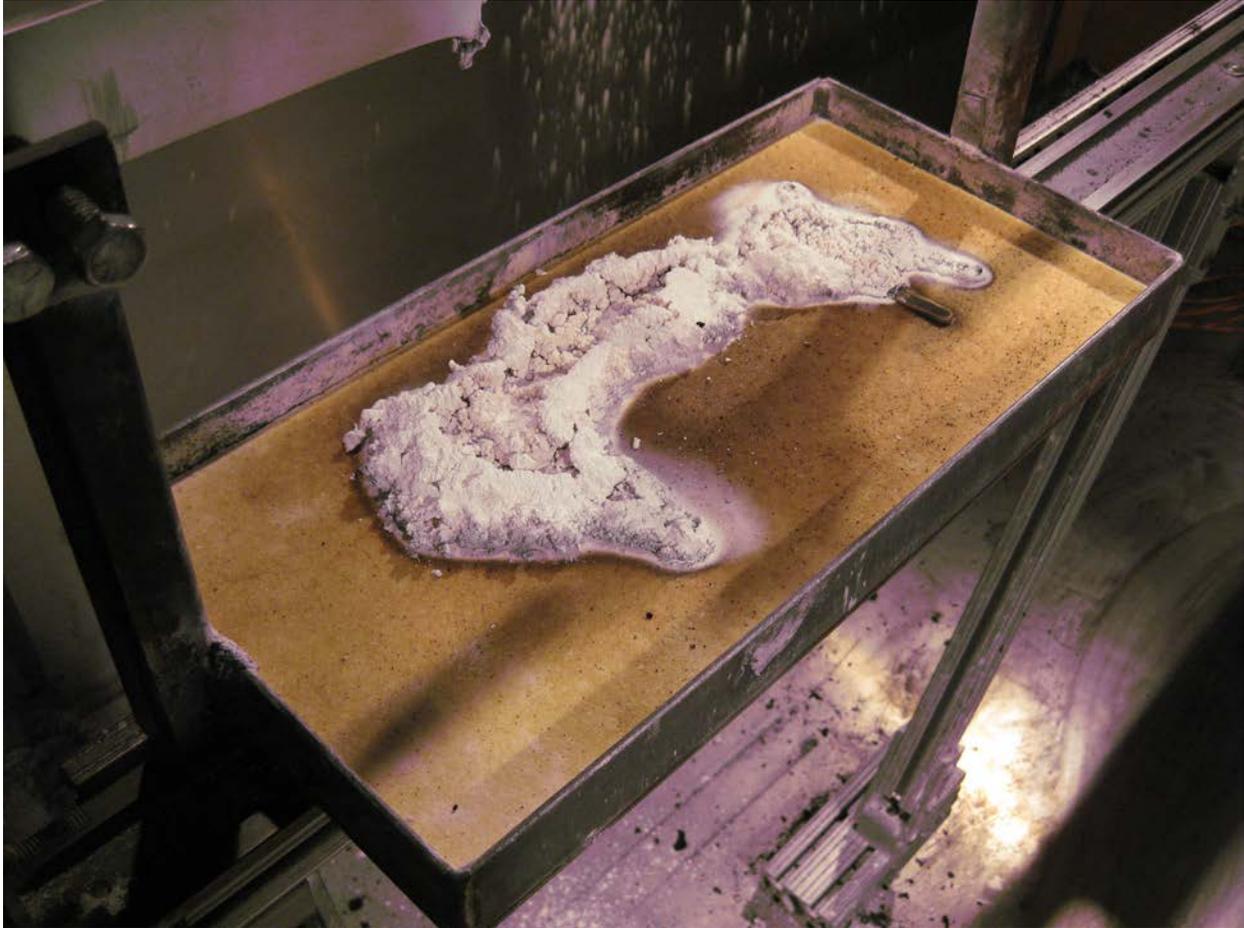
Figure 137. The ZE41 Test Result Using Kaowool™ Board in Catch Pan (2/20/2013)

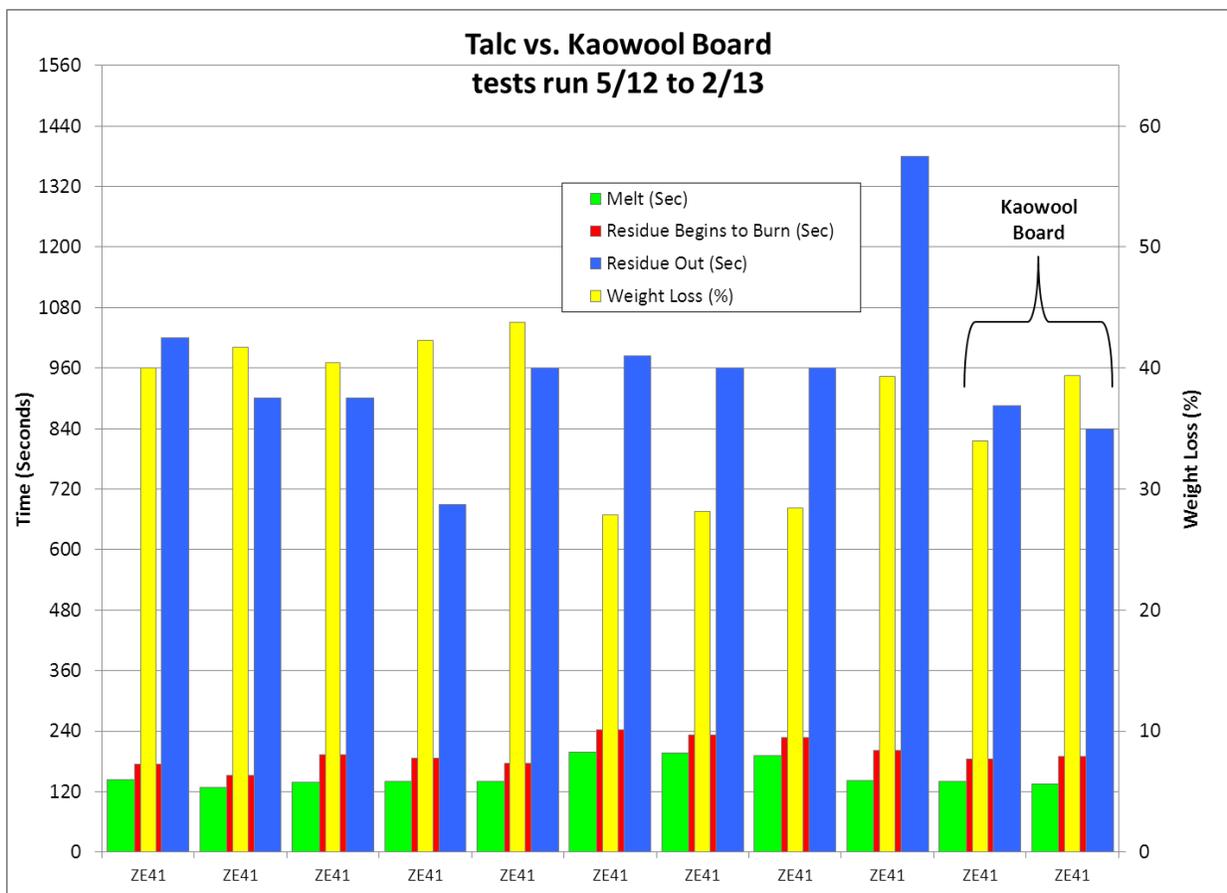
Figure 138. The ZE41 Test Results Comparing Talc and Kaowool™ Board in Catch Pan

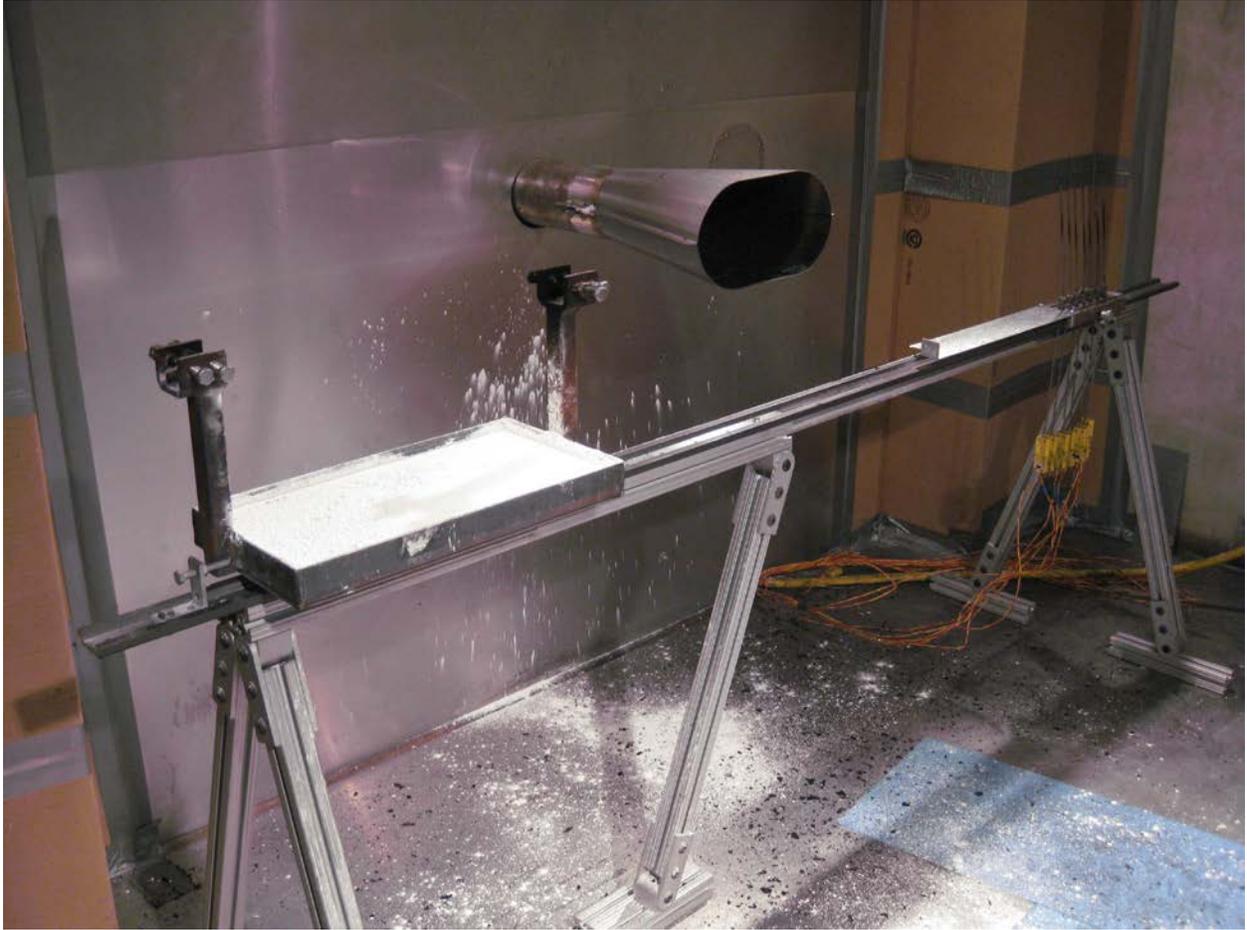
Figure 139. Round Robin Test Arrangement in Lab A (10/12/2012)

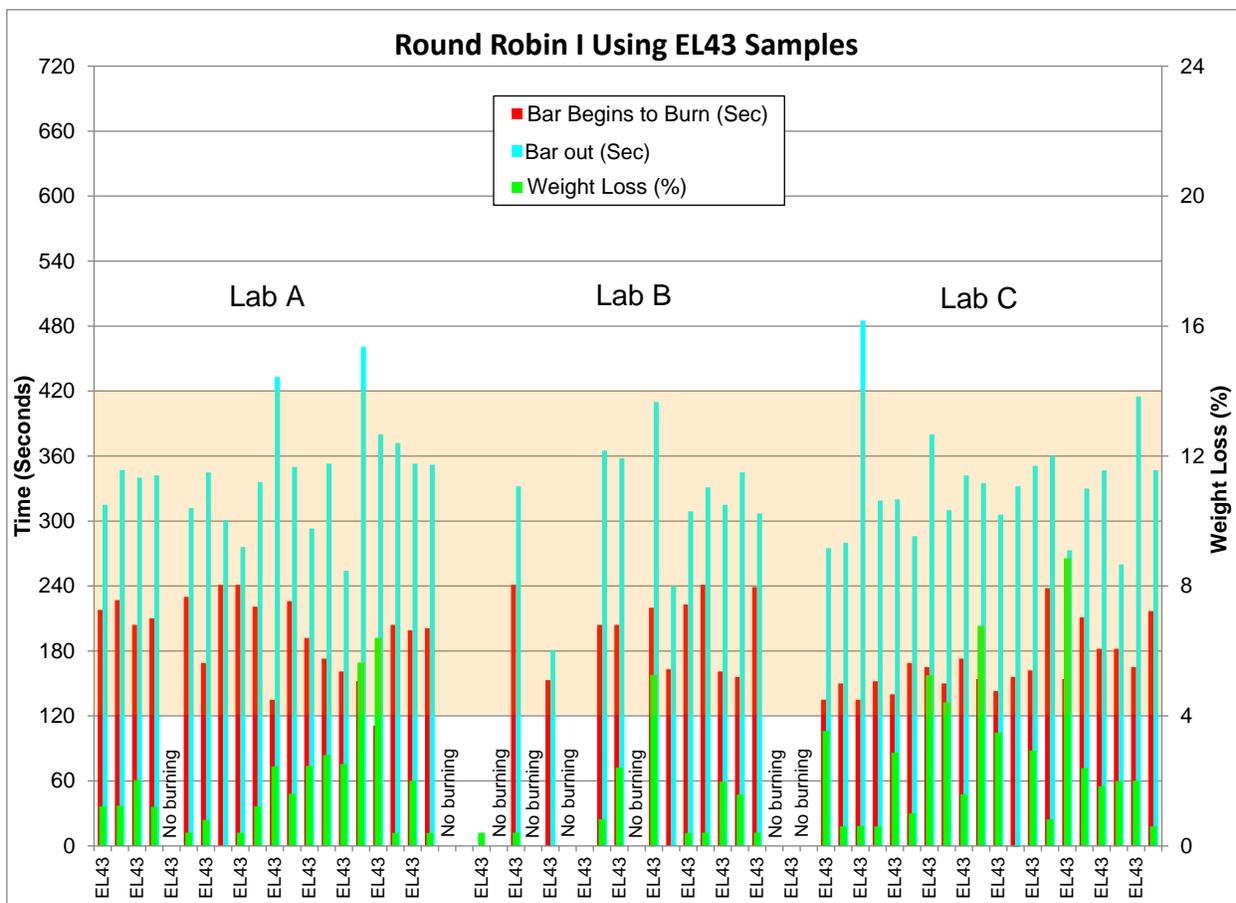
Figure 143. Round Robin I Test Results (three labs)

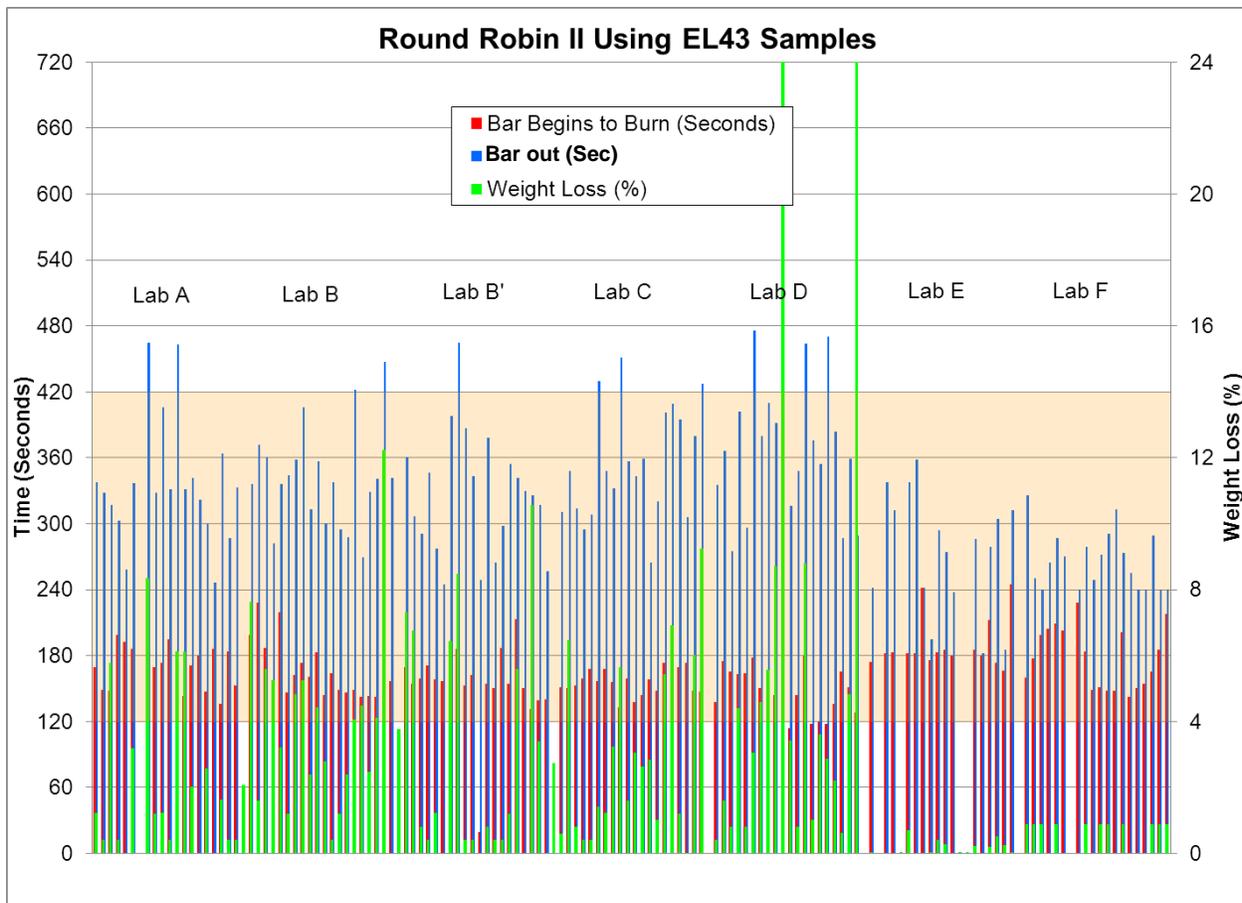
Figure 144. Round Robin II Test Results (seven labs)

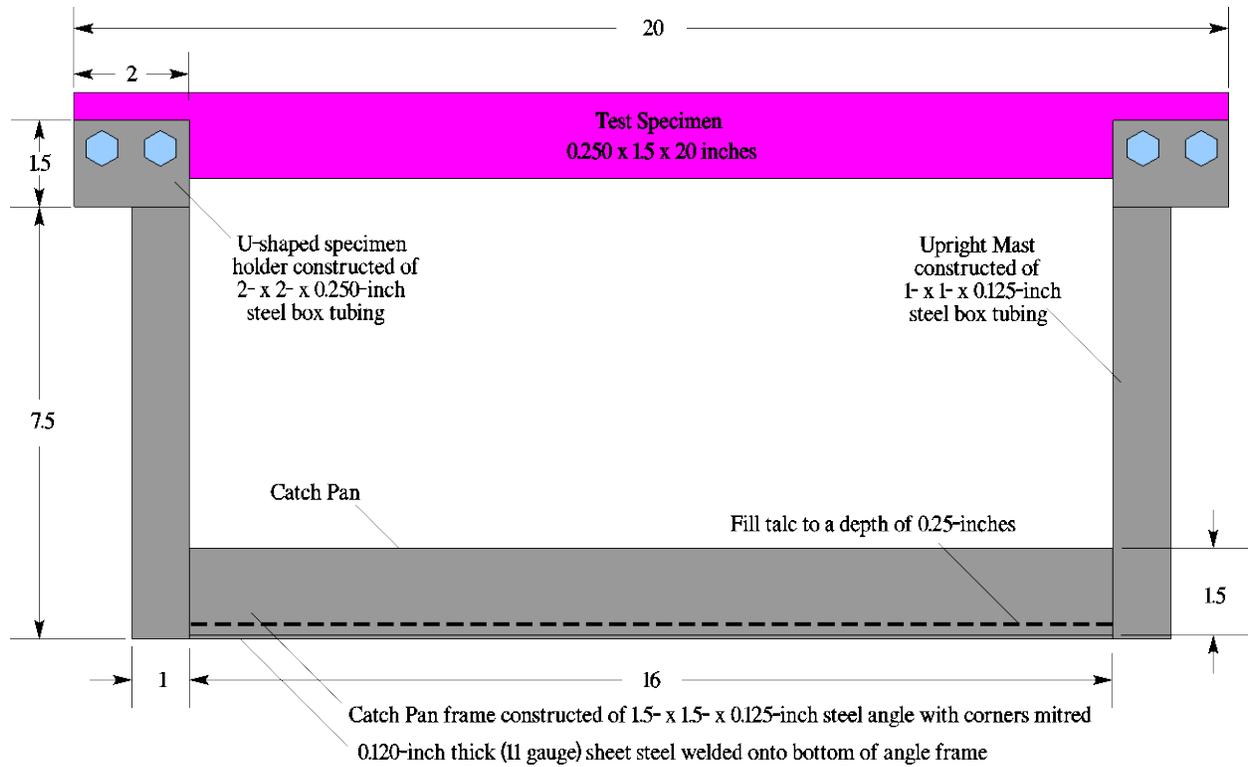
Figure A-3. Magnesium Alloy Test Specimen Mounting Stand and Holder (front)

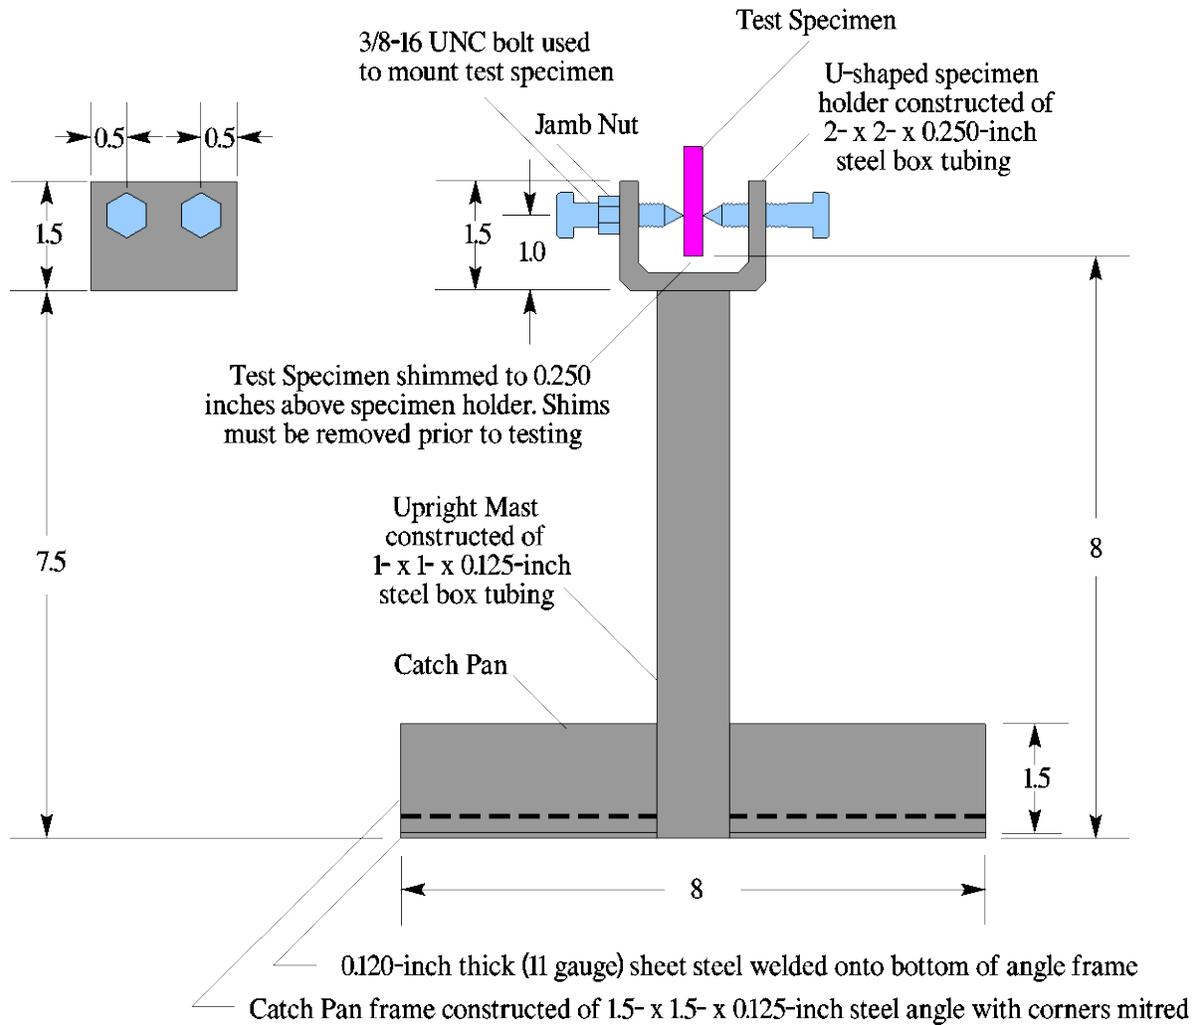
Figure A-4. Magnesium Alloy Test Specimen Mounting Stand and Holder (side)

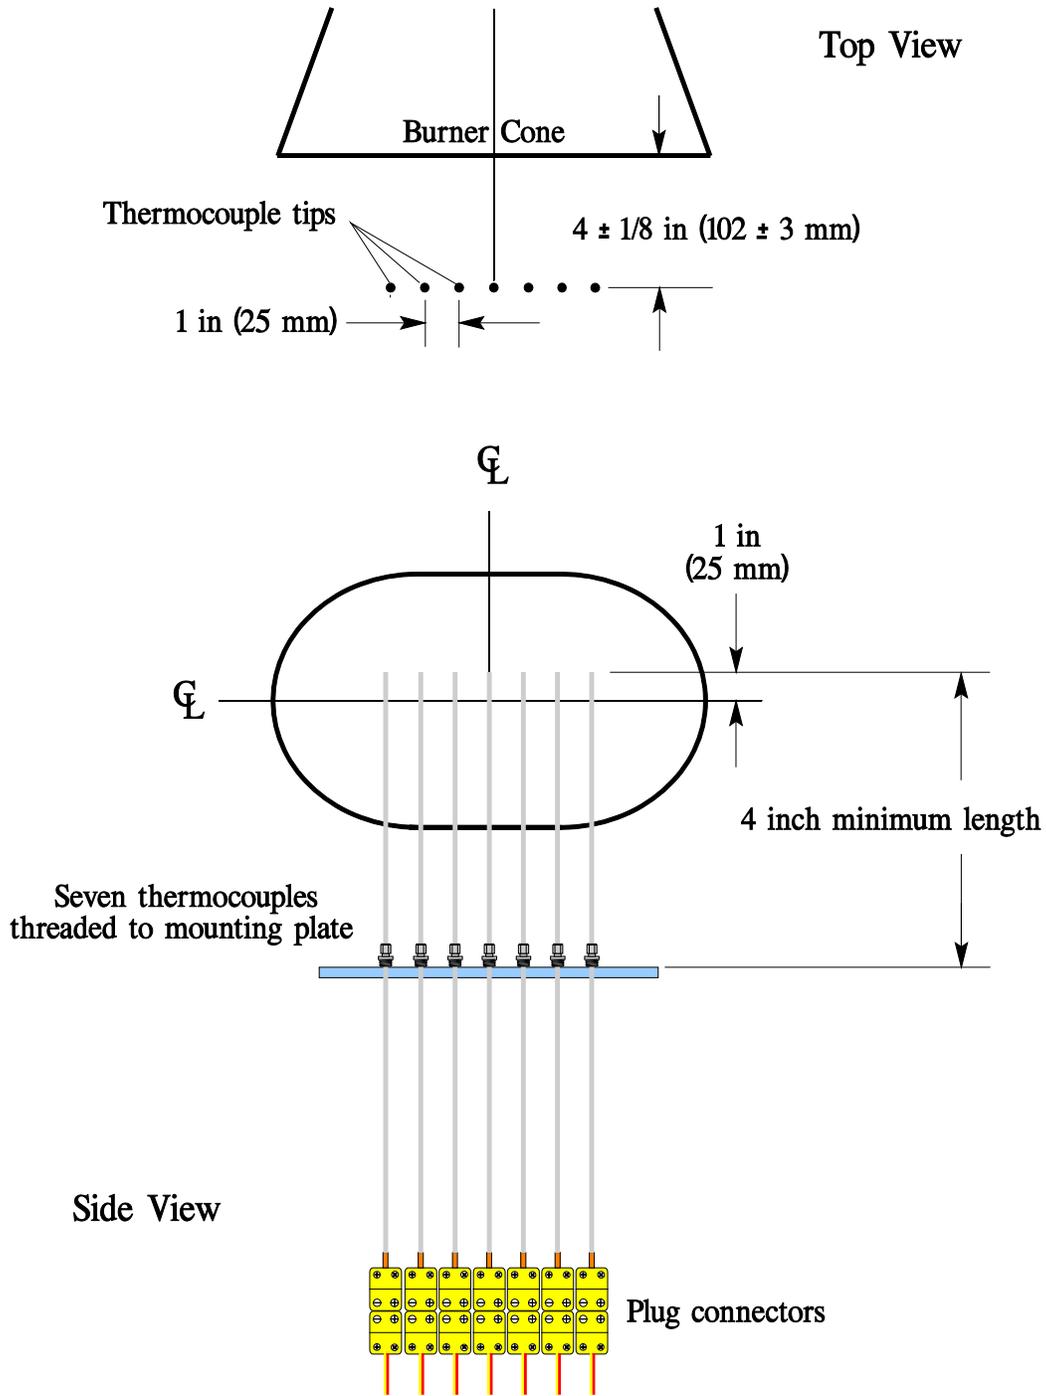
Figure A-6. Top and Side View of Thermocouple Rake Bracket
