## **Activation of Oxygen Generators in Proximity to Combustible Materials**

May 1999

DOT/FAA/AR-TN99/9

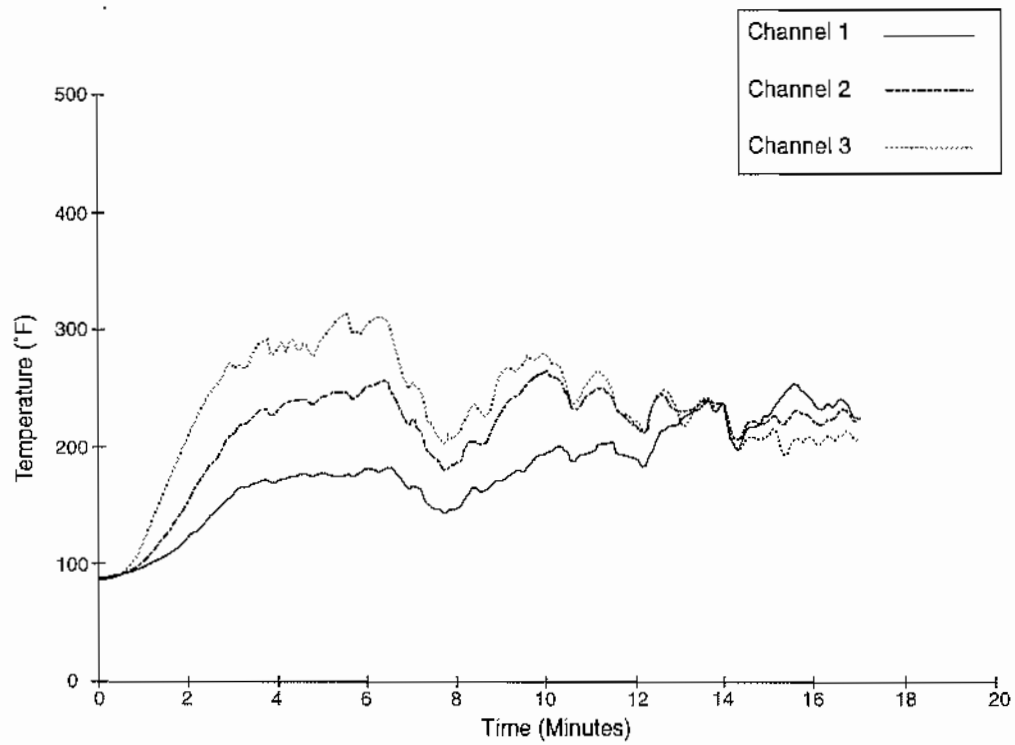
FIGURE 3. TEST RESULTS AFTER THREE THERMOCOUPLES WERE SAFETY WIRED TO THE SIDE OF A GENERATOR

TEST 4. Three thermocouples were placed along side the generator and held in place with safety wire. The generator was then activated by pulling the firing pin. The temperature at the firing end increased initially, followed by the middle and the outlet end as the reaction progressed. A high temperature of 305°F was recorded at the firing end. After running this test, it was found that the thermocouples had come loose from the side of the generator and may have compromised the temperature readings. See figure 3.

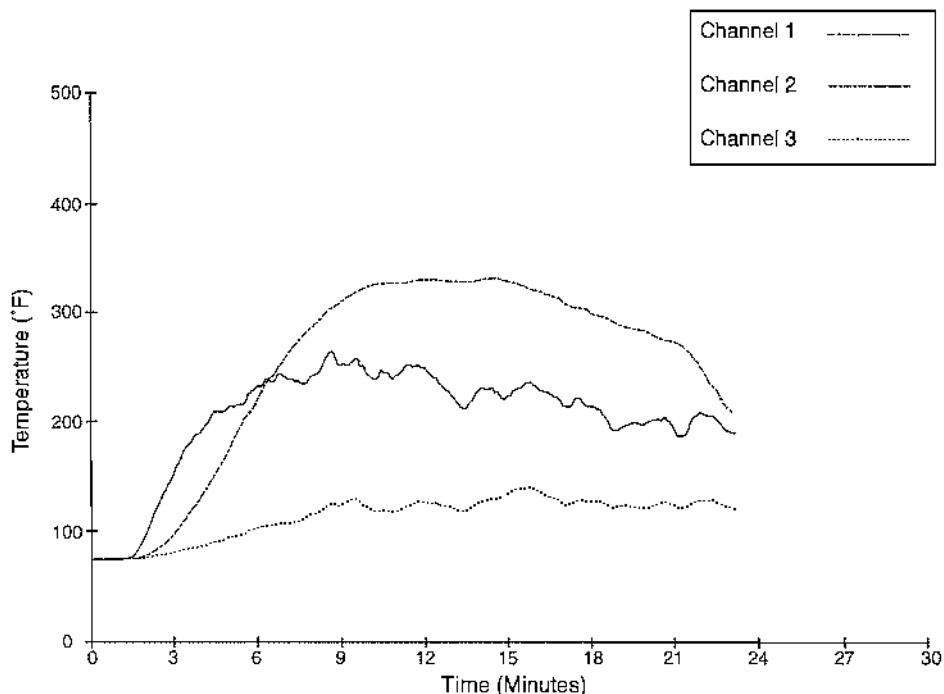
FIGURE 4. TEST RESULTS AFTER THREE THERMOCOUPLES WERE HELD AGAINST THE SURFACE OF A SCOTT 801386-05 GENERATOR WITH SCREWS

TEST 6. Three thermocouples were securely attached to the side of the generator with screws. The high temperature was recorded in the middle of the generator at approximately 330°F. See figure 4.

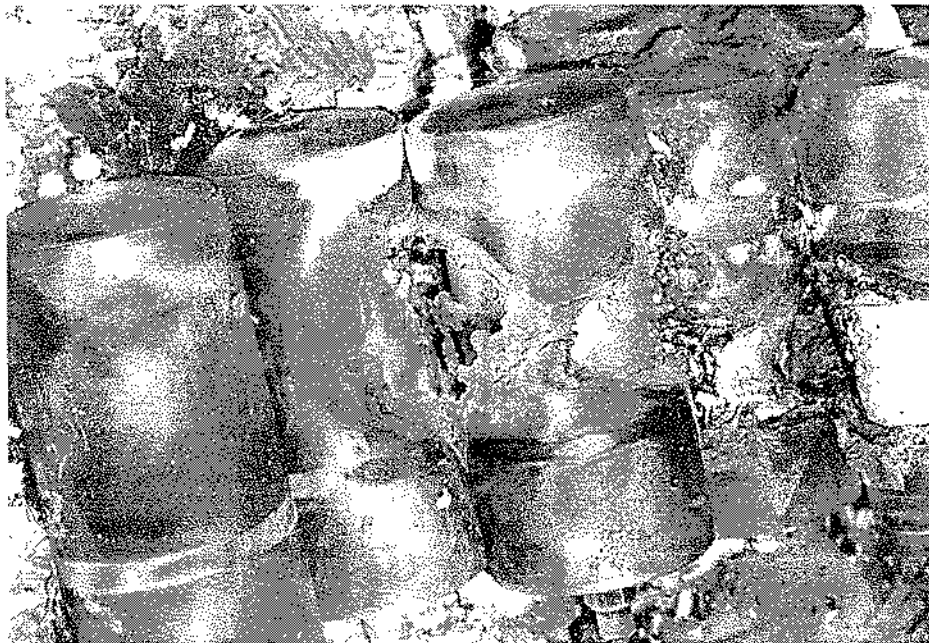
FIGURE 6. MELTED GENERATORS

TEST 14. Eleven generators were packed in a box identical to test 11. A wire was attached to the firing pin on a generator at the top of the box, next to the bubble pack. The box was placed on its side and the firing pin pulled. The box ignited and all 11 generators were activated. Most of the generators' stainless steel shells were melted through. See figure 6.

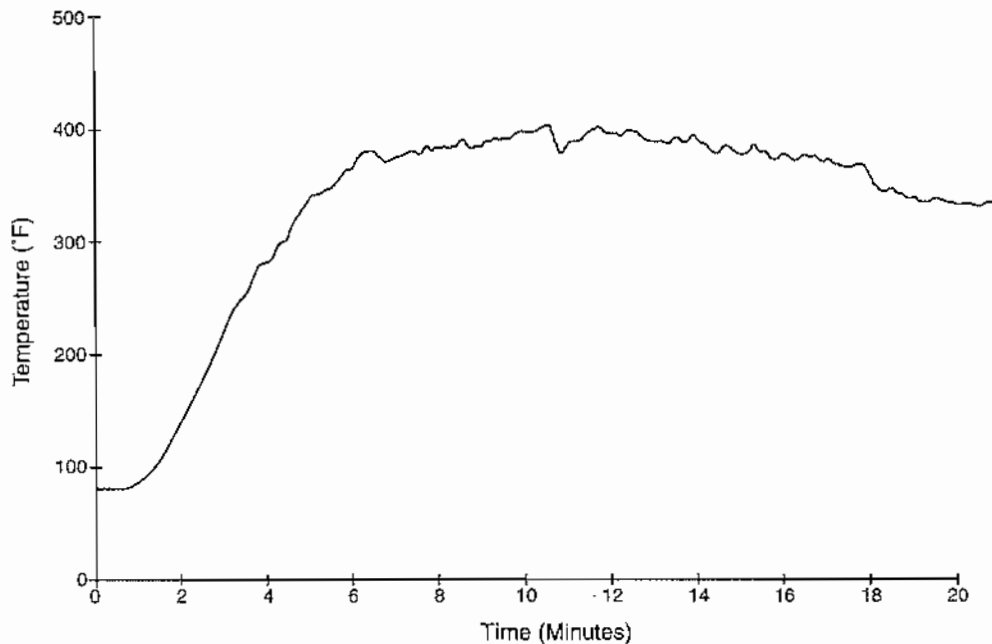
FIGURE 10. RESULTS OF THE SPOT-WELDED GENERATOR TEST

TEST 21. In order to more accurately read the surface temperature, a thermocouple was spot welded to the side of a Scott 801386-06 three-person generator. The surface temperature peaked at 410°F 9 minutes after activating the generator. This is much closer to but still less than the manufacturer's maximum allowable 500°F surface temperature. There were no visible signs of smoke, sparking, or physical distortion. See figures 9 and 10.

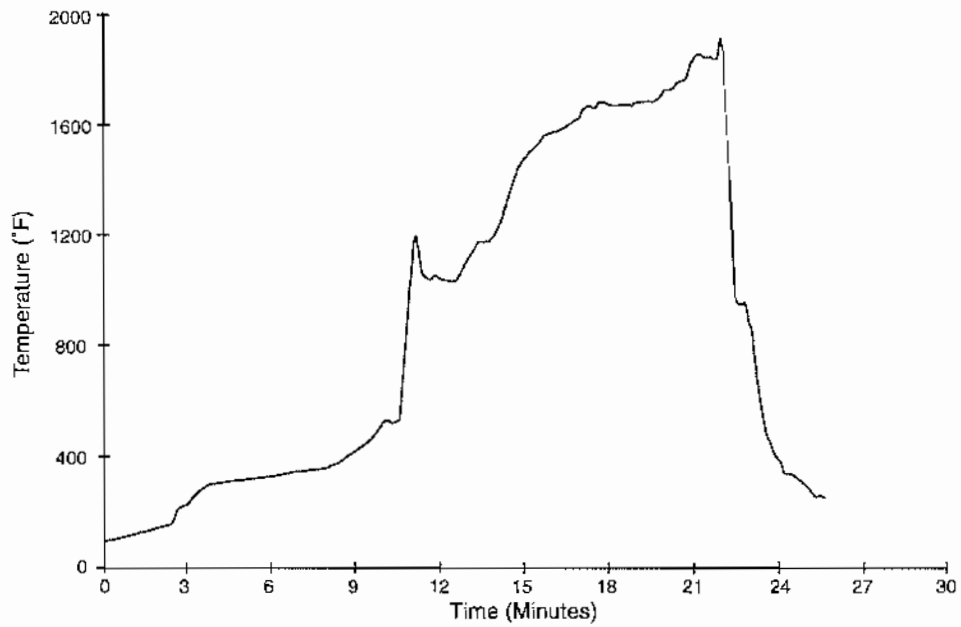
FIGURE 12. TEST RESULTS AFTER SIX GENERATORS WERE PACKED IN TUBES AND PACKED IN A BOX AND THE BOX PLACED ON ITS SIDE

TEST 23. Six generators were packed in a cardboard box with bubble plastic on top. A wire was threaded from the outside, through the box, to a firing pin on the generator in the middle. A thermocouple was placed in the box to indicate successful ignition and to measure box temperature. The box was placed on its side with the activated generator in the bottom center. Smoke was noticed 3 to 4 minutes after the generator was activated. Fire developed shortly after, completely consuming the box. The other five generators were activated by the fire. The temperature in the box reached 1900°F. See figure 12.

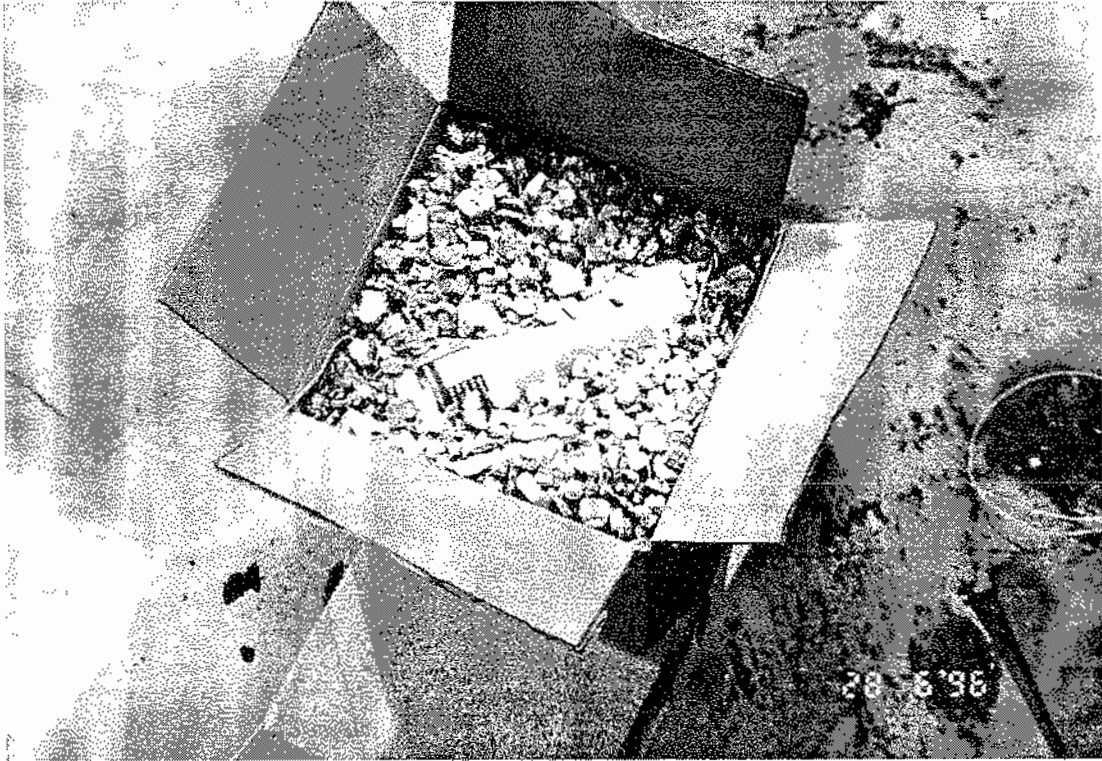
FIGURE 13. GENERATOR PACKED IN NONCOMBUSTIBLE MATERIAL

TEST 24. Two generators, the Puritan-Bennett 117003-13 and the Scott 801386-83, were completely surrounded with vermiculite and packed in a cardboard box. The Puritan-Bennett generator was placed on the bottom and activated. The Scott generator was not activated. The box was closed after activation, and the test ran for 20 minutes. Although the box got warm, no flames or smoke were observed. After unpacking and inspecting the box, generators, and vermiculite, no heat damage was found other than the color change of the activation band on the Puritan-Bennett generator. See figures 13 and 14.
