DOT/FAA/AR-00/56

Vertical Drop Test of a Narrow- Body Transport Fuselage Section With a Conformable Auxiliary Fuel Tank Onboard

September 2000

Final Report

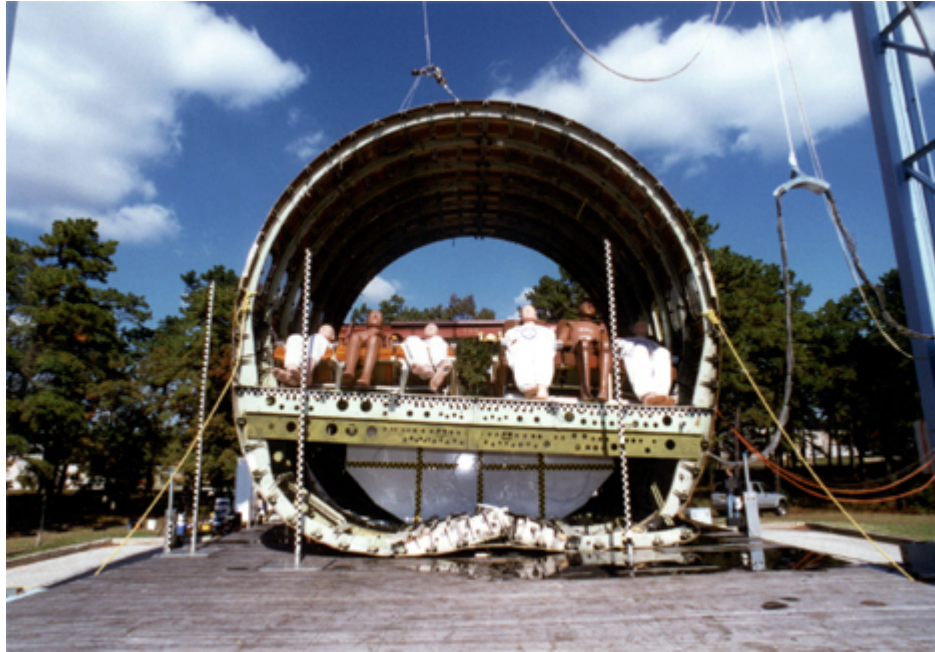
FIGURE 22. FRONT VIEW—LOWER FUSELAGE CRUSH

The test section experienced permanent deformation of the cargo area due to the platform impact (figure 22 and table 13). The left side experienced 21.7 inches of crush in the front and 20.7 inches of crush in the aft end. The right side experienced 10.7 inches of crush in the front and 10.5 inches of crush in the aft end. The difference was due to the support provided by the rigid and stiff reinforced cargo doorframe, located on the right side and slightly offset to the rear of the

test section spanning FS 443 through FS 490. A review of the H/S film showed that the test article impacted the platform at a level attitude; and then the forward section pivoted downward. Such a motion would account for the larger crush measurements in the forward area. The deformation measurements were taken from the four corners of the cabin floor to the surface of the drop test platform.

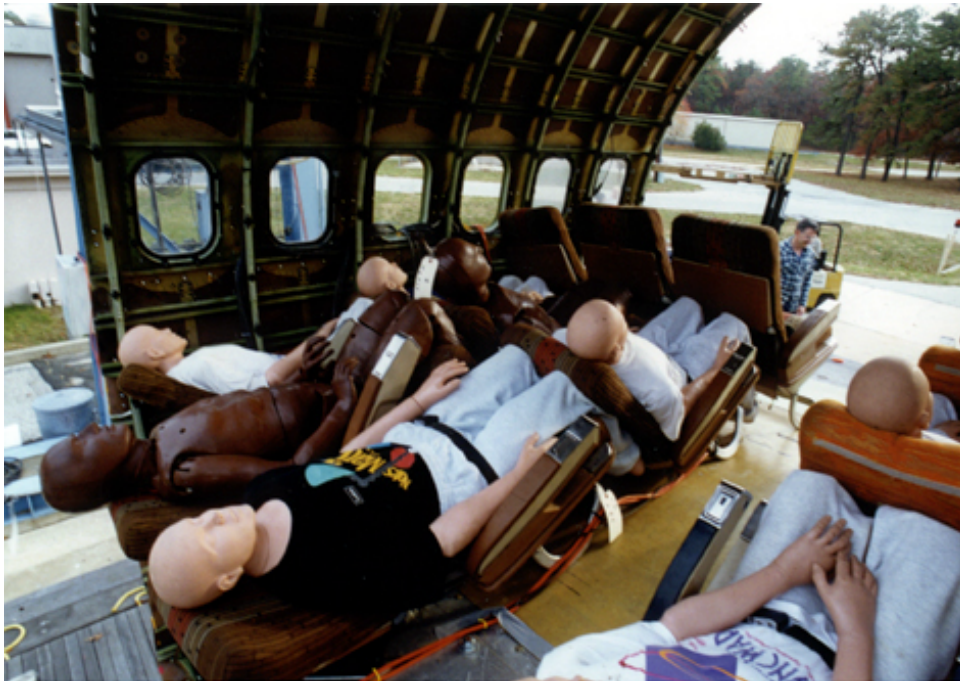
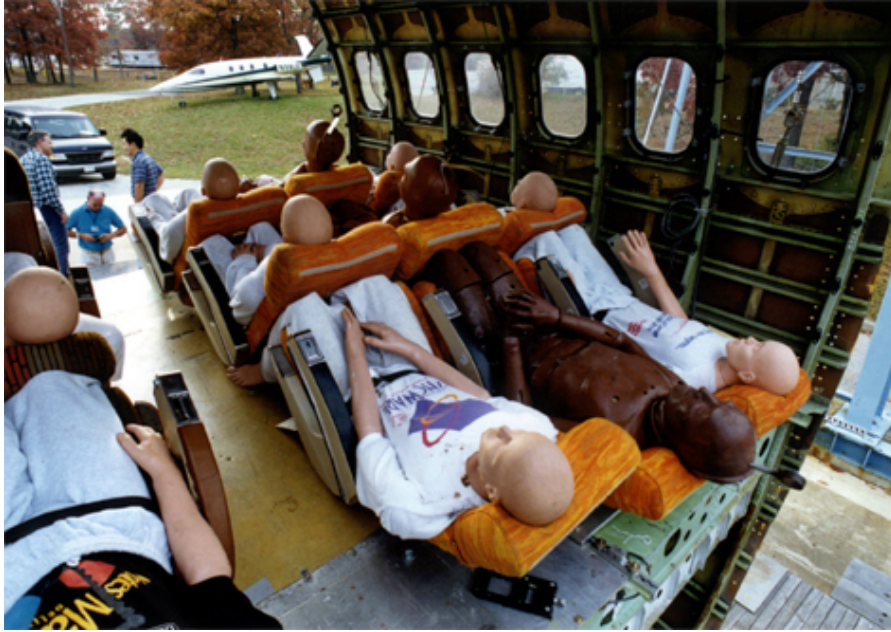
FIGURE 28. POSTTEST—LEFT SIDE SEATS

FIGURE 29. POSTTEST—RIGHT SIDE SEATS

A postcrash inspection determined that all seat pans remained intact; all seat legs remained attached to the seat tracks; and only four seats located in the last row sustained seat back damage (i.e., excessive reclining). The legs of the mannequins and the ATDs, located in Rows 2 and 3, supported the seat backs in Rows 1 and 2 respectively. A camera mounted on the floor closely behind the back of the UOP aisle seat, located in the last row, provided sufficient support to prevent seat back damage. The Weber seat located in the last row at position A did not sustain seat back damage. This was attributed to the bending of the cross tube support and subsequent separation of the seat from the frame. Seat damage was remarkably different for the two types of seats. The UOP seat predominately suffered from the bending of the leg supports (figures 35 through 40). The Weber seat suffered from bending and severing of the cross tubes and spreader tubes (figures 41 through 46). A list of the seat damage is found in table 14. As was previously mentioned, the seats were not of primary interest in this test. The test was primarily structured to be a fuel tank test. An actual crash impact imparts a longitudinal drag load on the aircraft that will significantly change the load distribution in a seat. Thus, the seat fracture modes observed in this test are not necessarily reflective of what may occur in service. Therefore, special consideration must be given when considering the results of seat test data obtained from this vertical drop test.

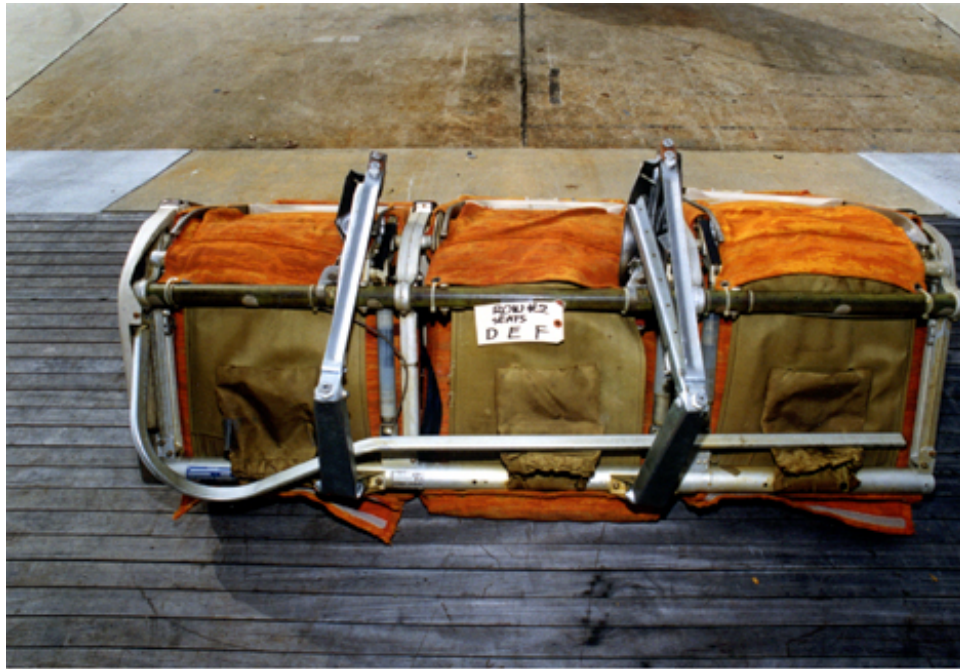
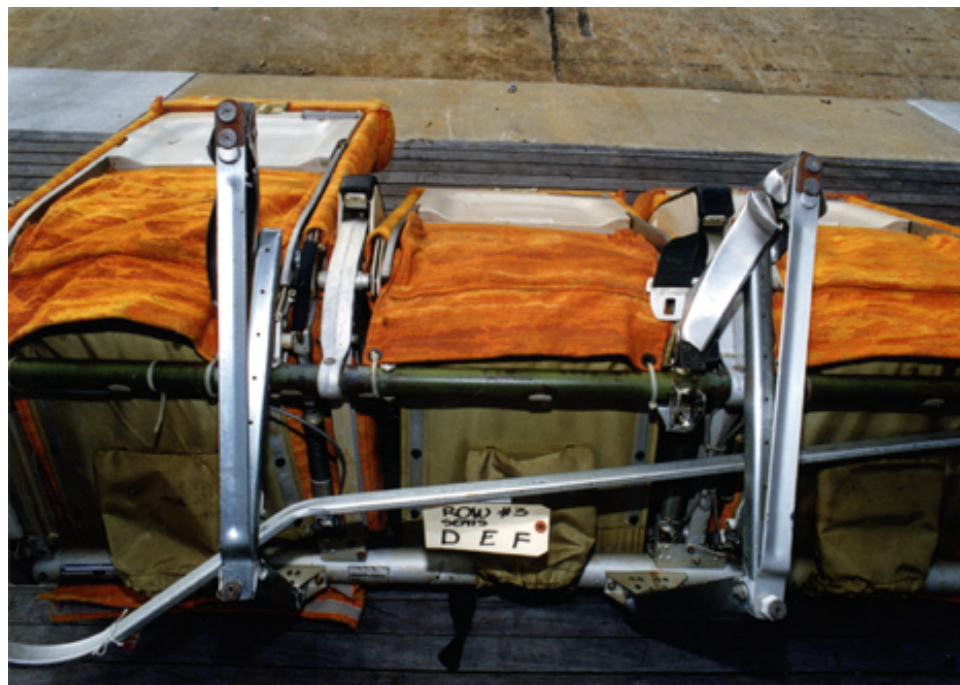
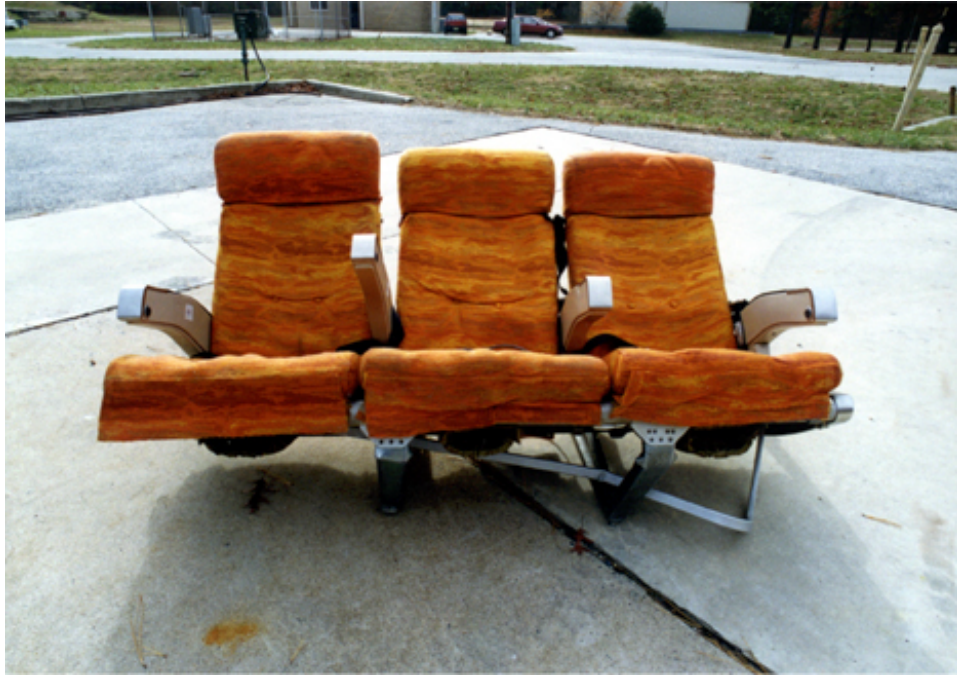
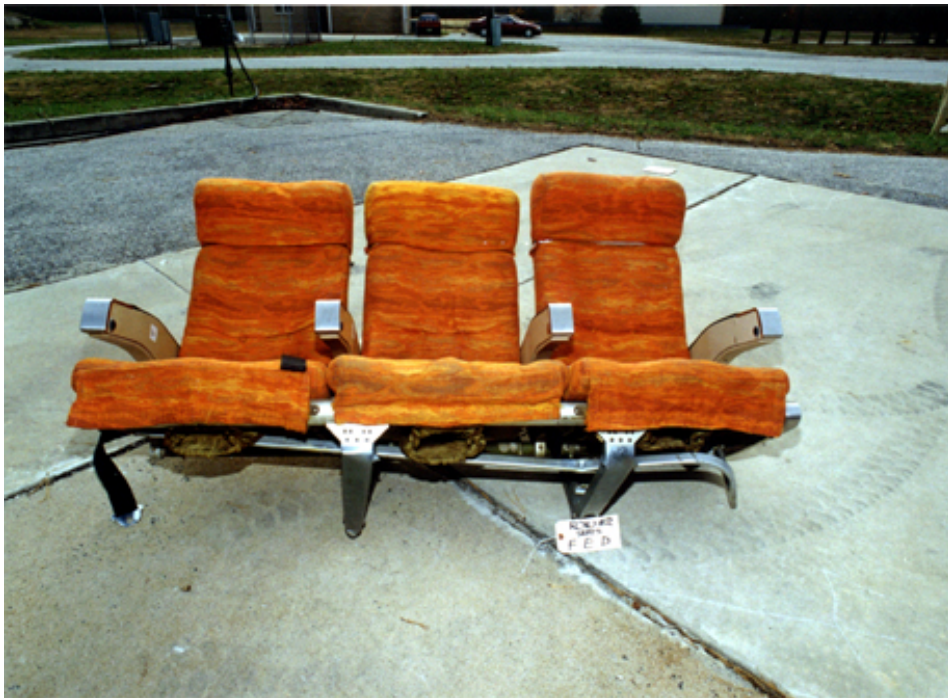
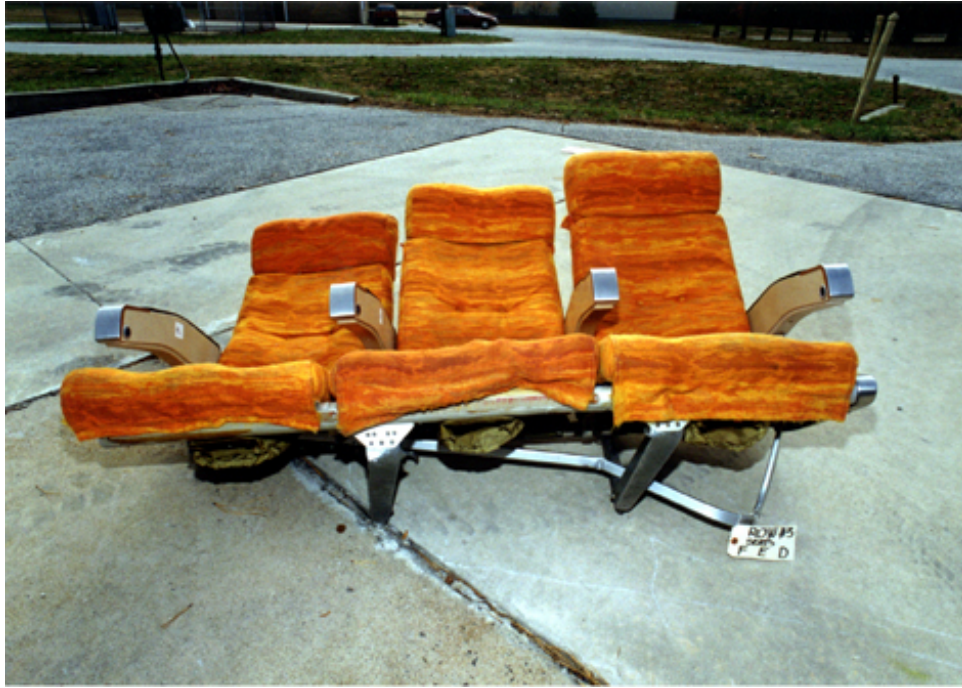
Left Side - Weber Seats					
Row	Seat Legs	Seat Frames	Aisle Seat Back	Center Seat Back	Window Seat Back
1	Intact	Fractured	Upright	Upright	Upright
2	Intact	Fractured	Upright	Upright	Upright
3	Intact	Fractured	Reclined	Reclined	Upright
Right Side - UOP Seats					
Row	Seat Legs	Seat Frames	Aisle Seat Back	Center Seat Back	Window Seat Back
1	Fractured	Intact	Upright	Upright	Upright
2	Fractured	Intact	Upright	Upright	Upright
3	Fractured	Intact	Upright	Reclined	Reclined

FIGURE 36. POSTCRASH—ROW 2, UOP SEAT, BOTTOM VIEW

FIGURE 37. POSTCRASH—ROW 3, UOP SEAT, BOTTOM VIEW

FIGURE 38. POSTCRASH—ROW 1, UOP SEAT

FIGURE 39. POSTCRASH—ROW 2, UOP SEAT

FIGURE 40. POSTCRASH—ROW 3, UOP SEAT

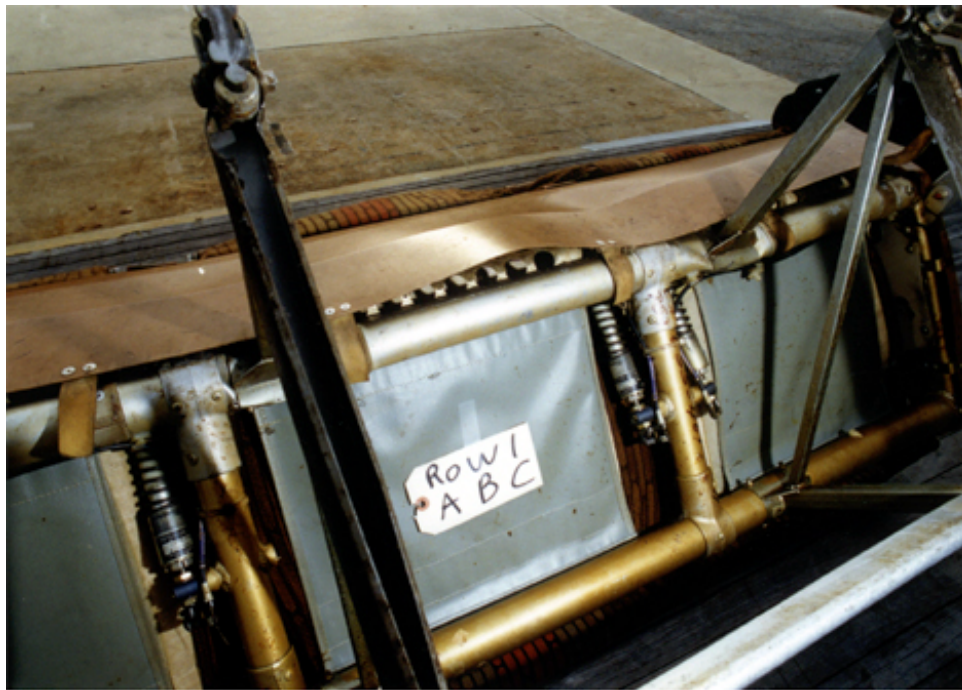
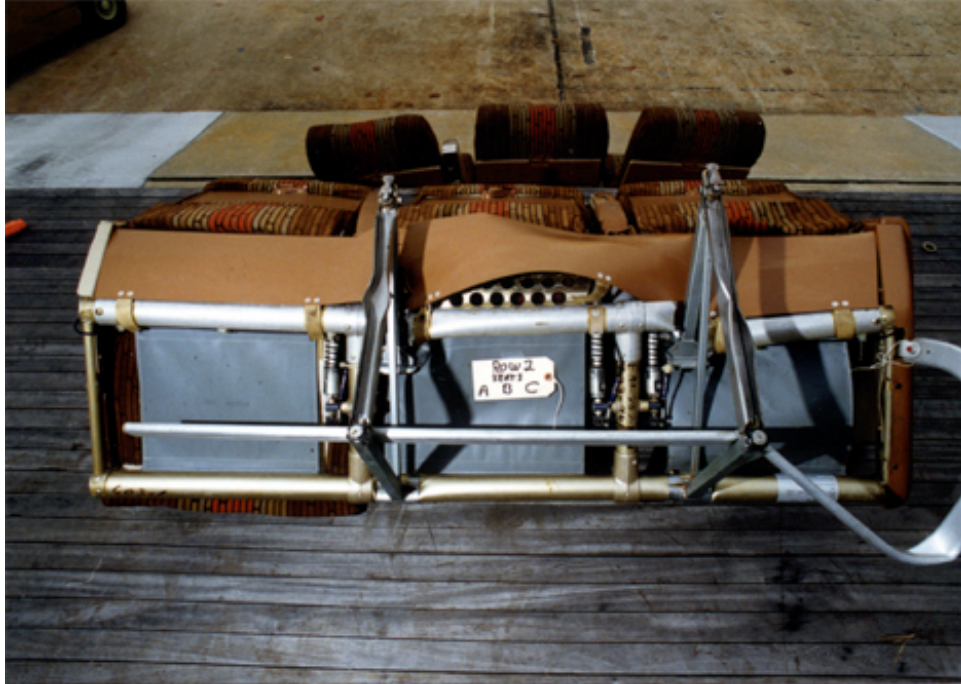
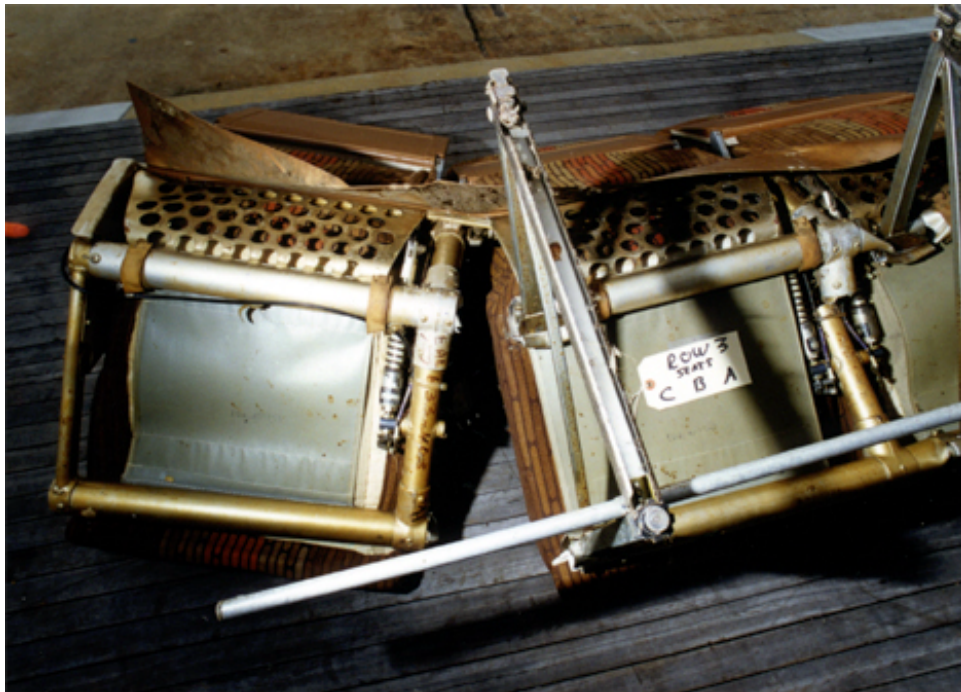
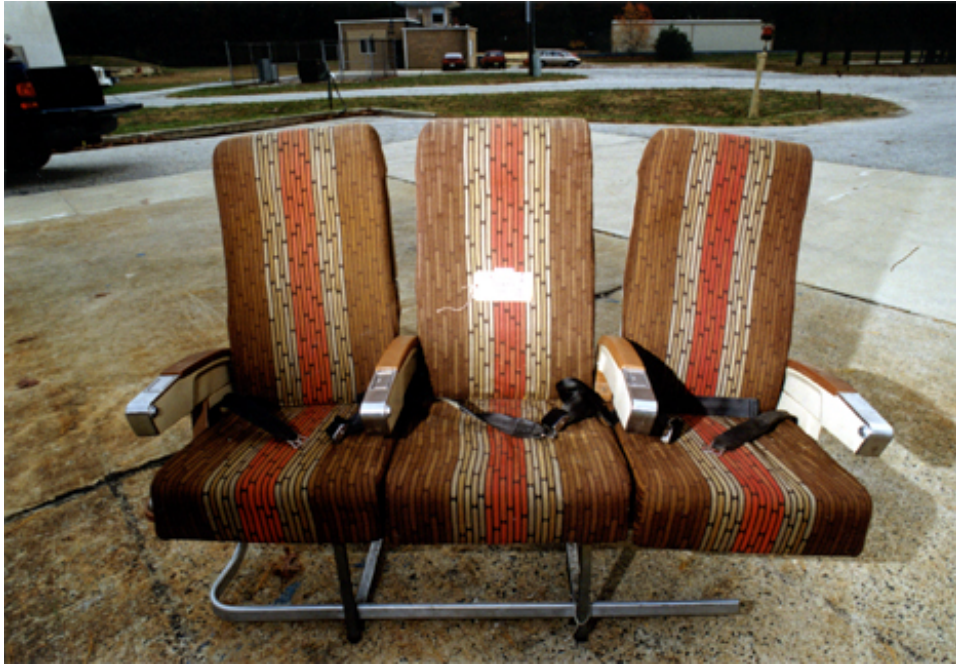
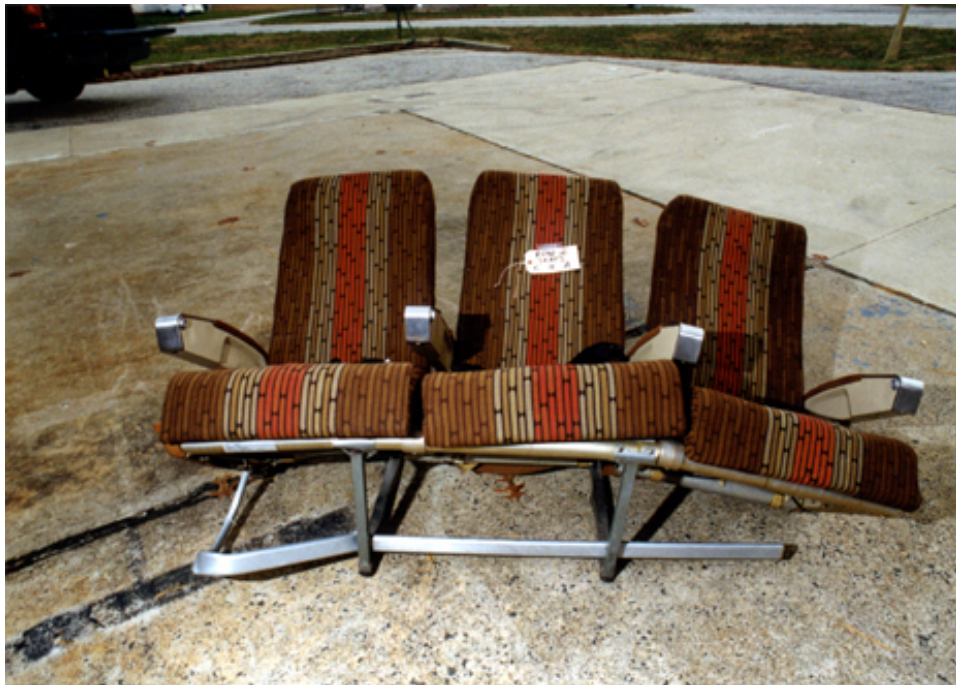
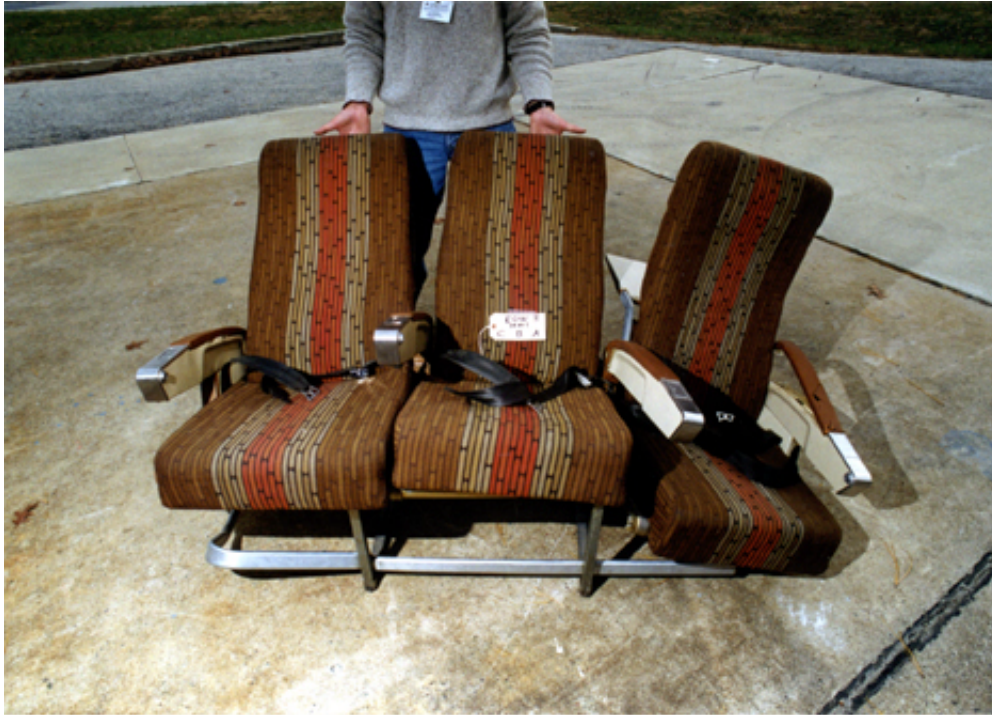
FIGURE 41. POSTCRASH—ROW 1, WEBER SEAT, BOTTOM VIEW

FIGURE 42. POSTCRASH—ROW 2, WEBER SEAT, BOTTOM VIEW

FIGURE 43. POSTCRASH—ROW 3, WEBER SEAT, BOTTOM VIEW

FIGURE 44. POSTCRASH—ROW 1, WEBER SEAT

FIGURE 45. POSTCRASH—ROW 2, WEBER SEAT

FIGURE 46. POSTCRASH—ROW 3, WEBER SEAT

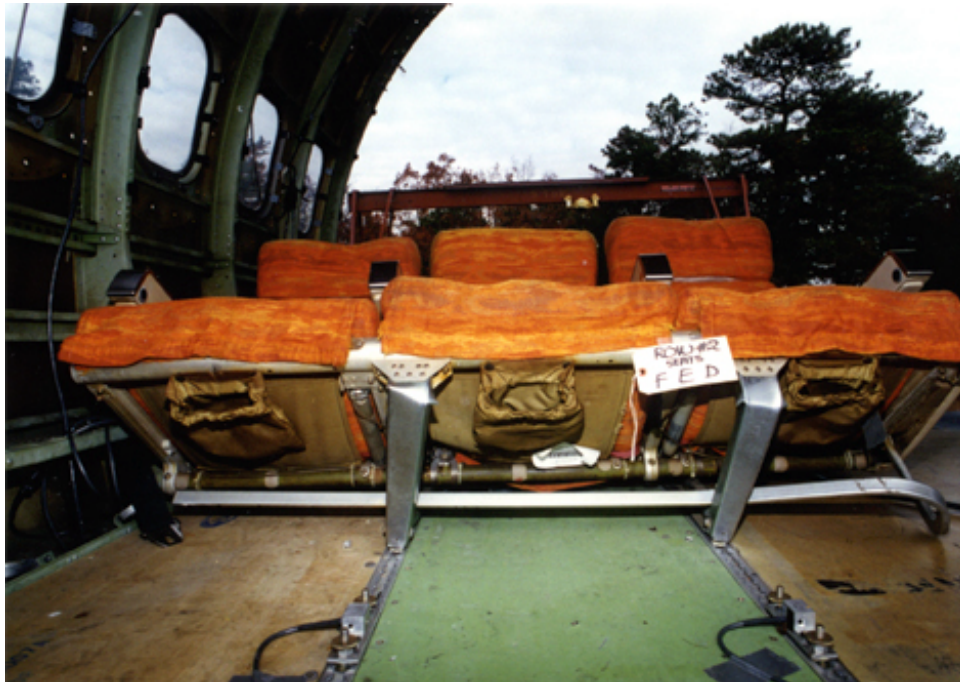
FIGURE A-60. ROW 2, UOP SEAT—RIGHT SIDE

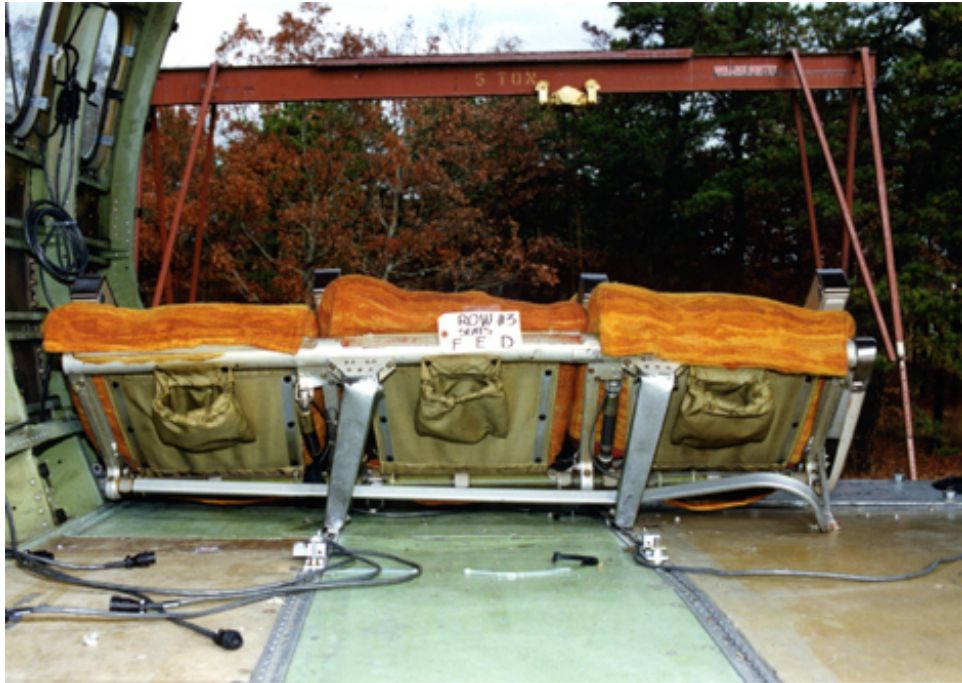
FIGURE A-61. ROW 3, UOP SEAT—RIGHT SIDE

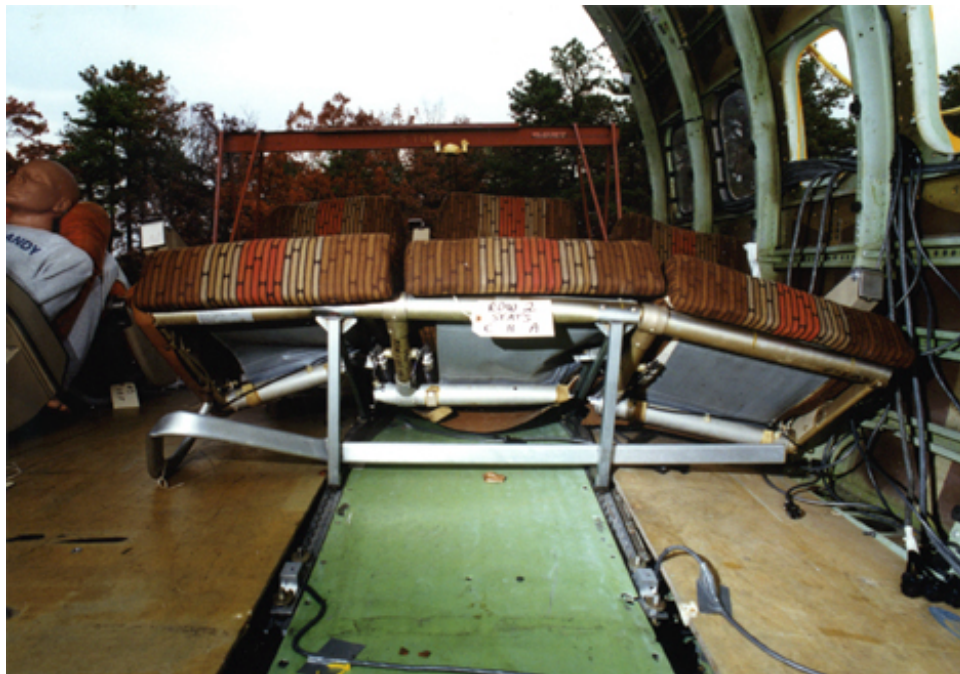
FIGURE A-66. ROW 2, WEBER SEAT—LEFT SIDE

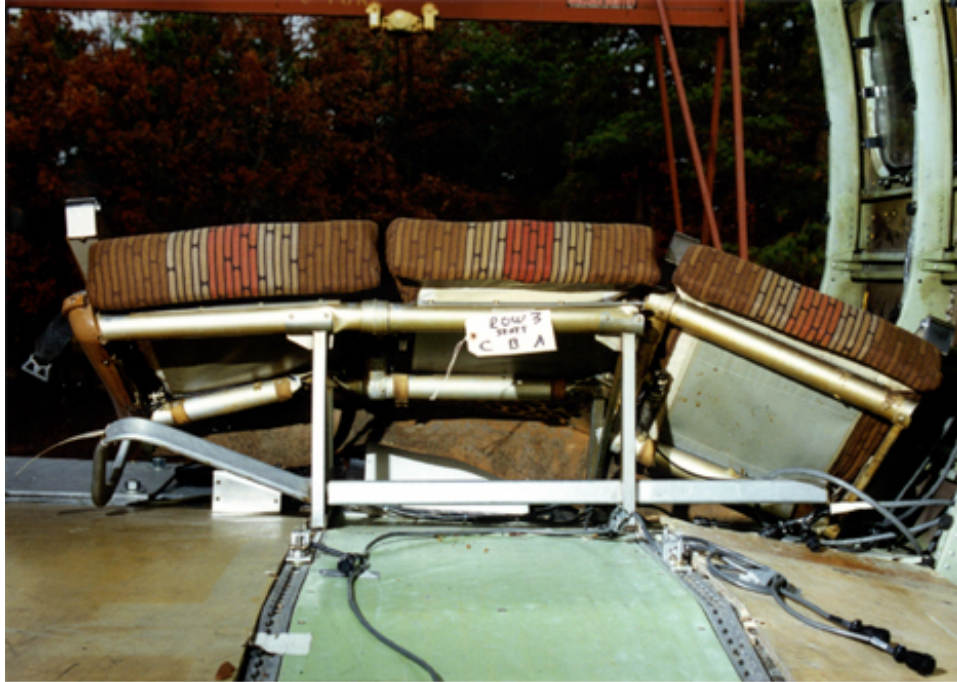
FIGURE A-67. ROW 3, WEBER SEAT—LEFT SIDE
